SITE CHARACTERIZATION RAPID REFUEL PIT NO. 1

Roosevelt Roads Naval Station
Ceiba, Puerto Rico

Contract Number N62470-93-4021

June 1995

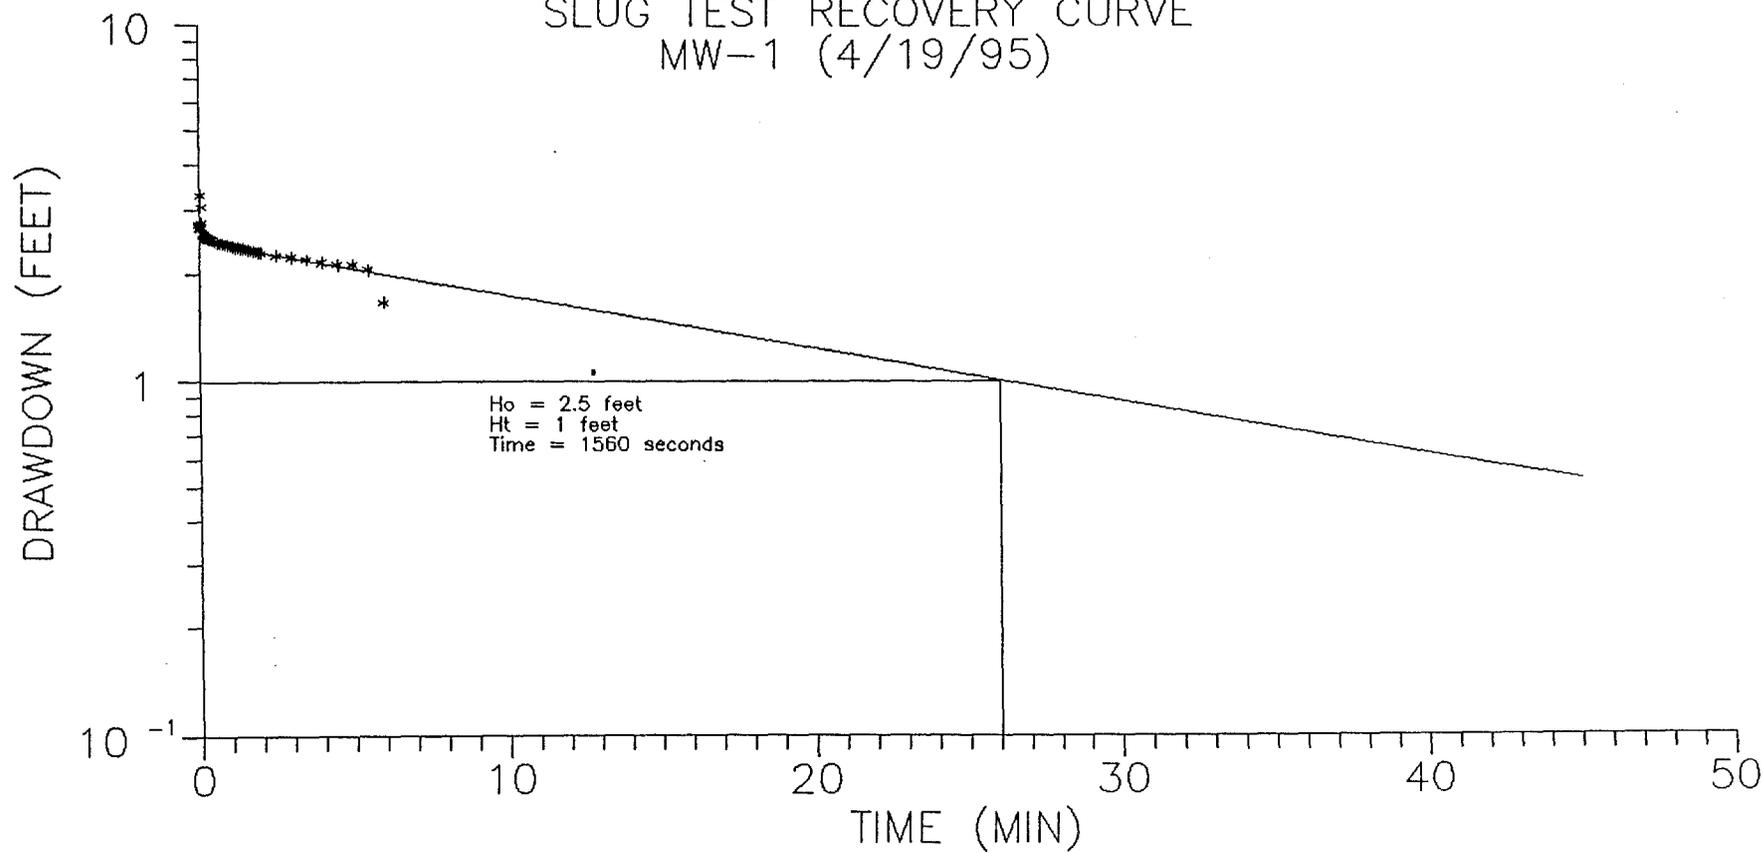
U.S. NAVAL STATION
ROOSEVELT ROADS, PUERTO RICO
SLUG TEST RECOVERY CURVE
MW-1 (4/19/95)

Slug tests were performed on May 19, 1995, in monitoring wells RRP#1-MW1 and RRP#1-MW2, to determine the aquifer characteristics beneath the site. Slug tests were performed by quickly removing a slug of water from the well using a centrifugal pump and measuring the recovery rate with a Hermit data logger and associated pressure transducer. The slug test results were plotted on semi-logarithmic graphs and analyzed using the Bouwer and Rice method (Bouwer and Rice, 1976). The hydraulic conductivities calculated from the slug tests ranged from 2.2×10^{-1} feet per day (ft/day) to 6.7×10^{-2} ft/day. The slug test raw data, graphs, and calculations are presented in **Appendix E**. The slug tests indicate that the surficial clays at this site have low hydraulic conductivities.
