UNEXPLODED ORDNANCE EMERGENCY REMOVAL ACTION

INSTALLATION RESTORATION SITE 1
ALAMEDA POINT
ALAMEDA, CALIFORNIA

SUMMARY REPORT

December 4, 1998

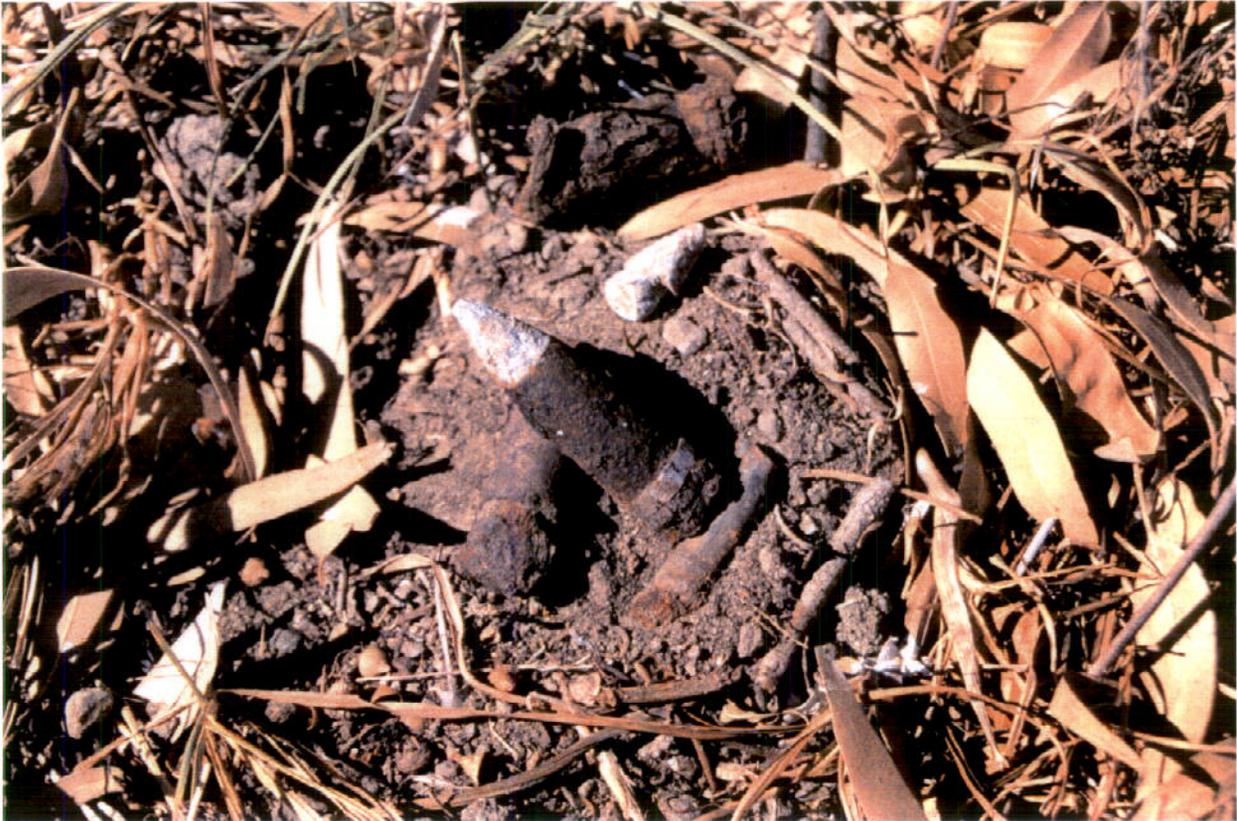
Radiological control personnel from the Superintendent of Shipbuilding, Conversion, and Repair, Portsmouth, Virginia (SSPORTS) Environmental Detachment Vallejo, CA were conducting a radiation survey of the IR-1 landfill site during the week of September 28, 1998 when they located a single 20mm high explosive projectile approximately 100 yds east of the small arms range backstop. Additional projectiles were found on October 8, 1998 by the radiation survey team near the right edge of the small arms range backstop. Air Force Explosive Ordnance Disposal (EOD) personnel from Travis Air Force Base responding to this incident removed over twenty 20mm projectiles. Several were suspected to contain high explosive, the remainder were "practice" (inert non-explosive) projectiles. SSSPORTS Unexploded Ordnance (UXO) Program representatives visited the site on 10/9/98 with Roger Caswell of the Alameda Point Navy Transition Office and observed additional projectiles in the same location near the range backstop (Figure 2). Since approximately 8 acres of the IR-1 landfill site remained to be surveyed and because of the risk posed by the ordnance found there, the radiation survey was suspended until a surface clearance of exposed ordnance could be accomplished.

FIGURE 2 – 20MM PROJECTILES ON SURFACE (9 OCT 98)

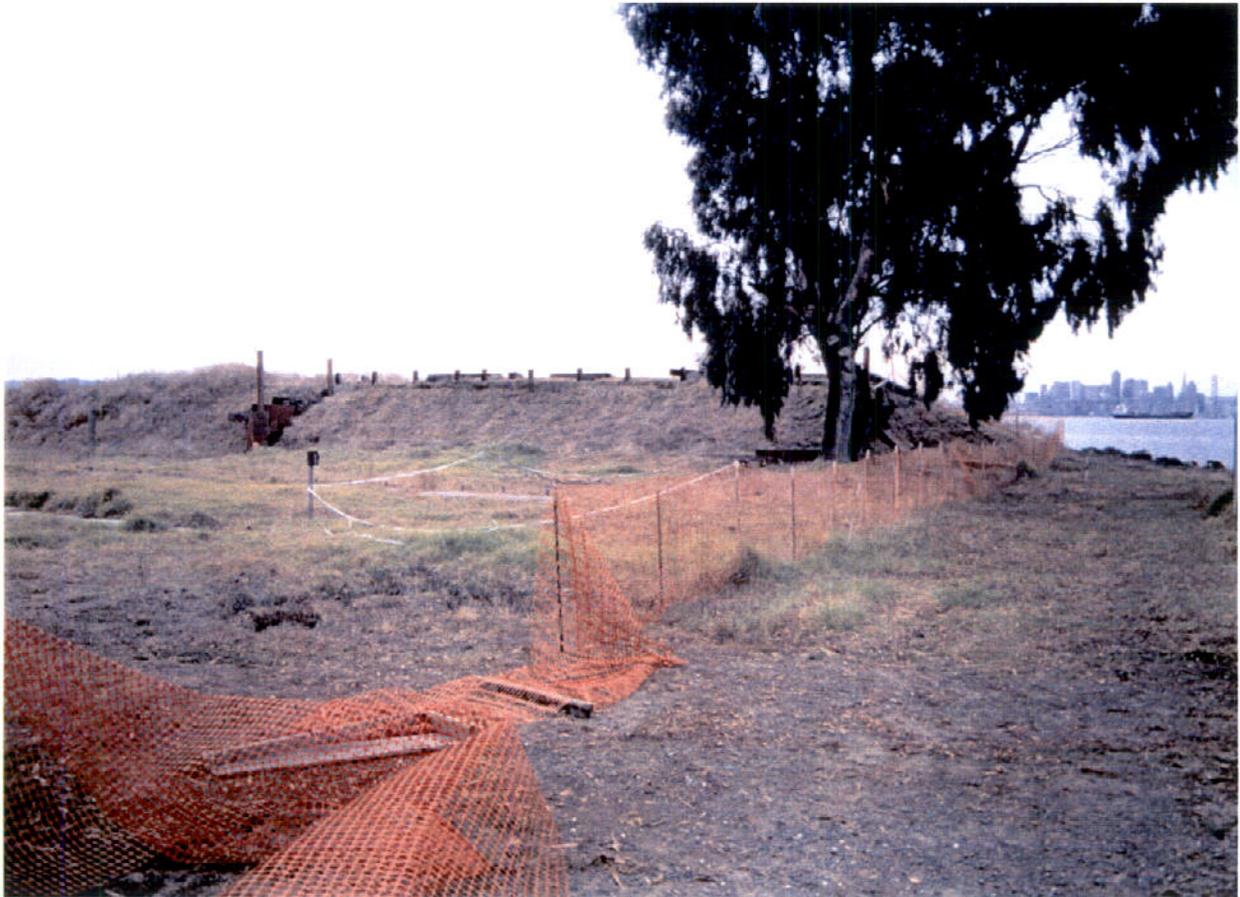
FIGURE 4 – ORDNANCE AREA (WHITE TAPE) NEAR SMALL ARMS RANGE

The ordnance deposit inside the 10 x 20 foot area near the small arms range backstop was excavated using non-sparking hand tools. Most of the ordnance recovered during the removal action came from this deposit. Ordnance was found in a layer approximately 8-12 inches thick under a bed of surface vegetation. All ordnance within the boundaries of this deposit was removed.

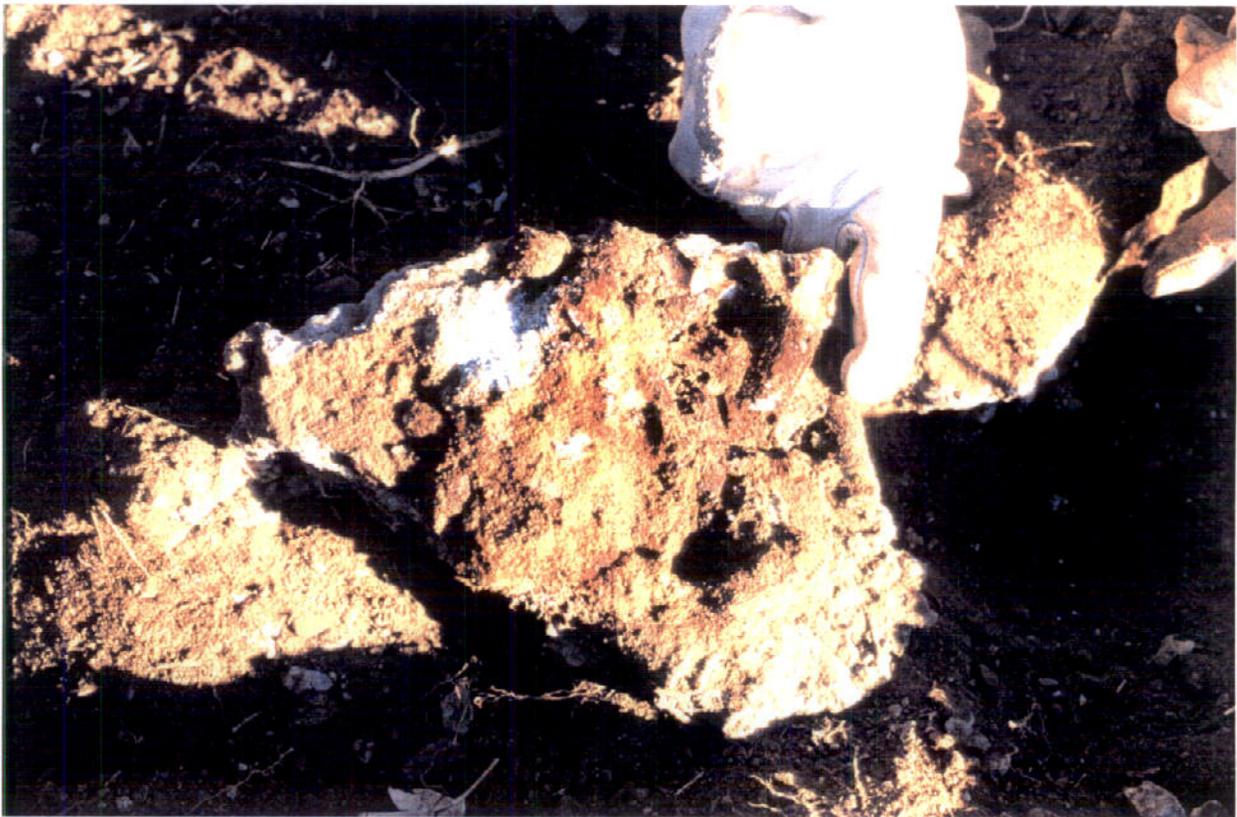
20mm projectiles were also found embedded in the concrete support anchors for range targets and in personnel walkways at the 50 foot firing line (Figure 5). This observation supports verbal reports from Mr. Winkleman that fired projectiles were used as aggregate in concrete structures at the range. Projectiles entrained in the concrete were not removed.

FIGURE 5 –20MM PROJECTILES ENTRAINED IN CONCRETE

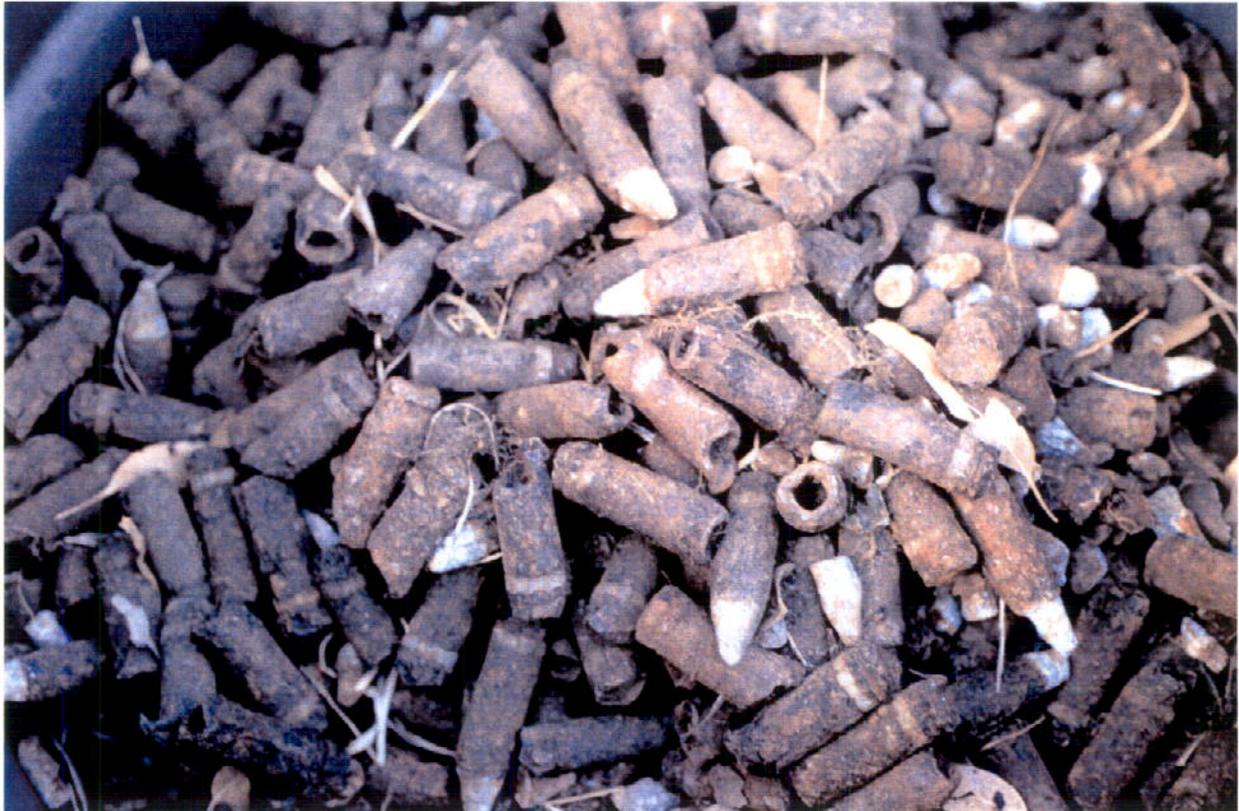
A total of 335 live 20mm high explosive projectiles and 2 live small arms cartridges (one .45 caliber ball round, and one .30 caliber ball round) were recovered during the removal action. Additional inert ordnance material recovered included: 12,259 20mm

projectiles (Figure 6), 1,686 .50 caliber armor piercing projectiles, and 359 assorted brass cartridge cases.

FIGURE 6 – RECOVERED INERT 20MM PROJECTILES

Ordnance items inspected by a UXO Specialist and determined not to pose an ordnance hazard (non-hazardous ordnance material) were placed in bins for recycling through the Defense Reutilization and Marketing Office (DRMO). The written certification by a SSPTS Unexploded Ordnance Specialist verifying the material to be non-hazardous was provided to allow acceptance by DRMO.
