Final Wetland Assessment Installation Restoration Site 34

Alameda Point
Alameda, CA

December 2010
Document Control No: KCH-2622-0006-0066

CH2M HILL Kleinfelder,
A Joint Venture (KCH)

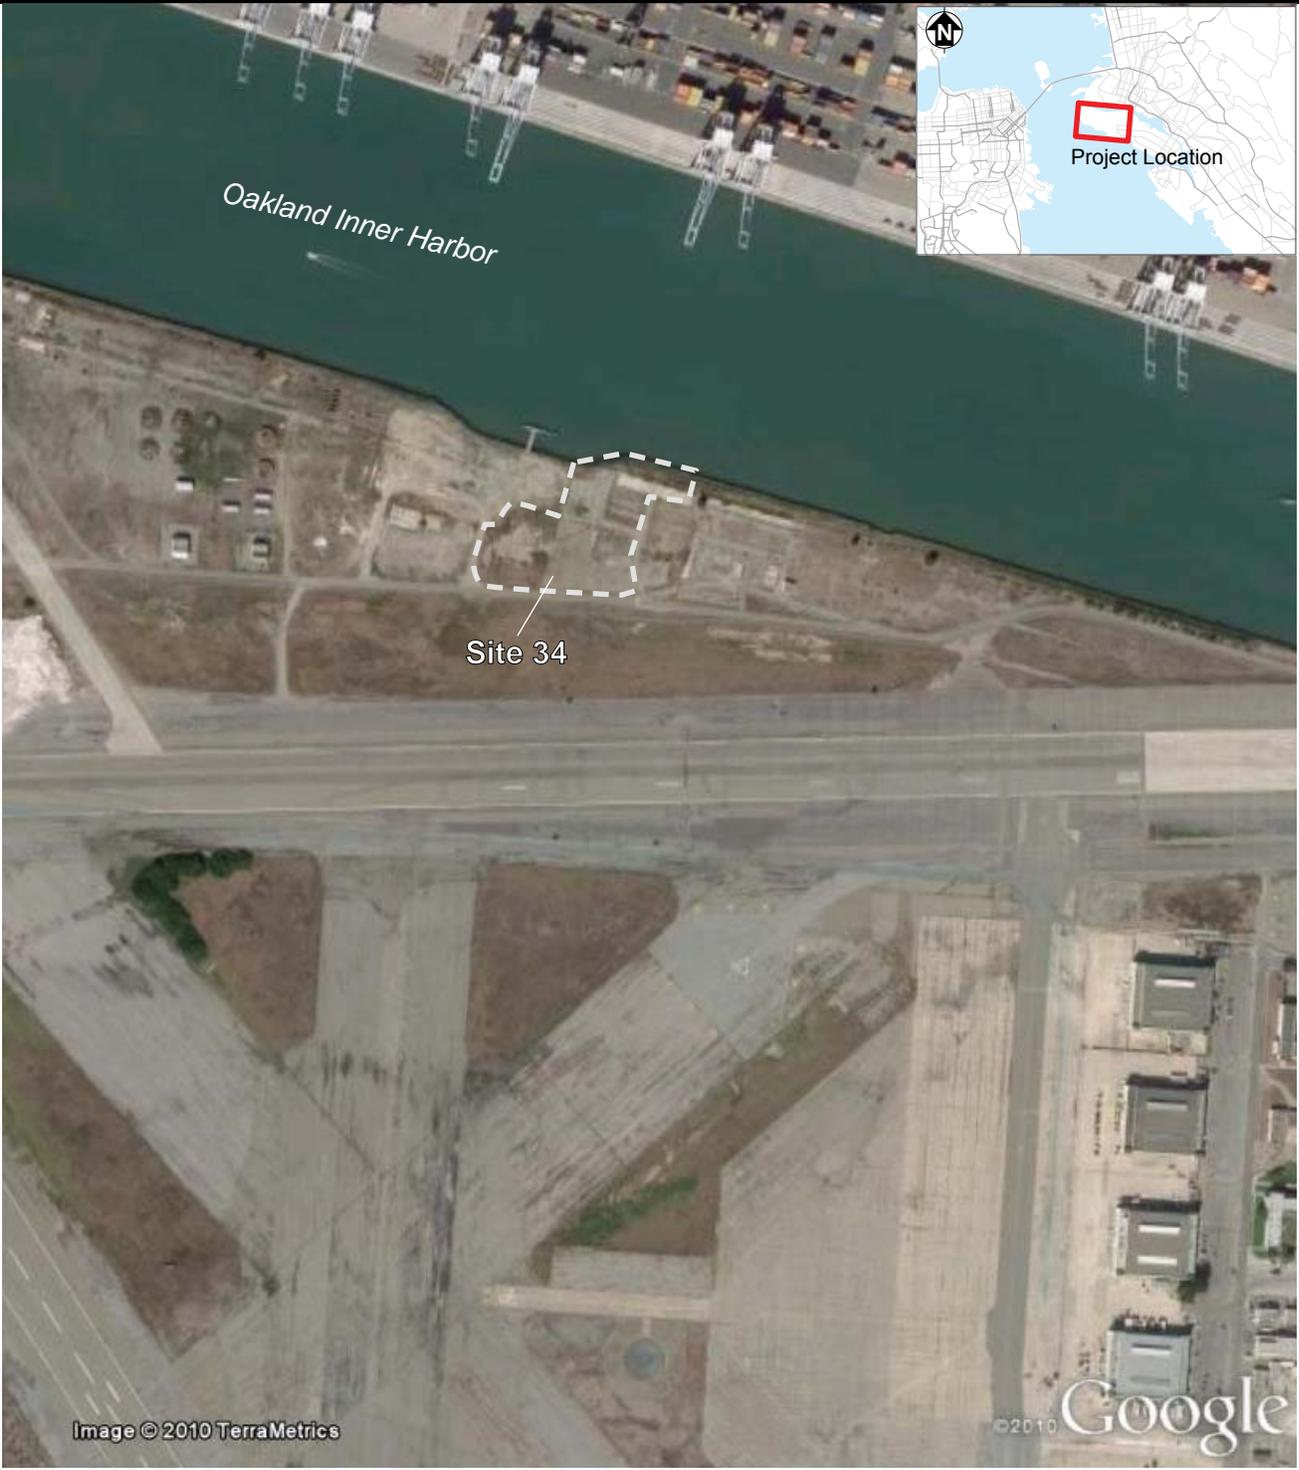
IR Site 34 is a 4.18-acre site located along the northern border of Alameda Point, immediately south of the Oakland Inner Harbor in Alameda County, California (Figure 1).

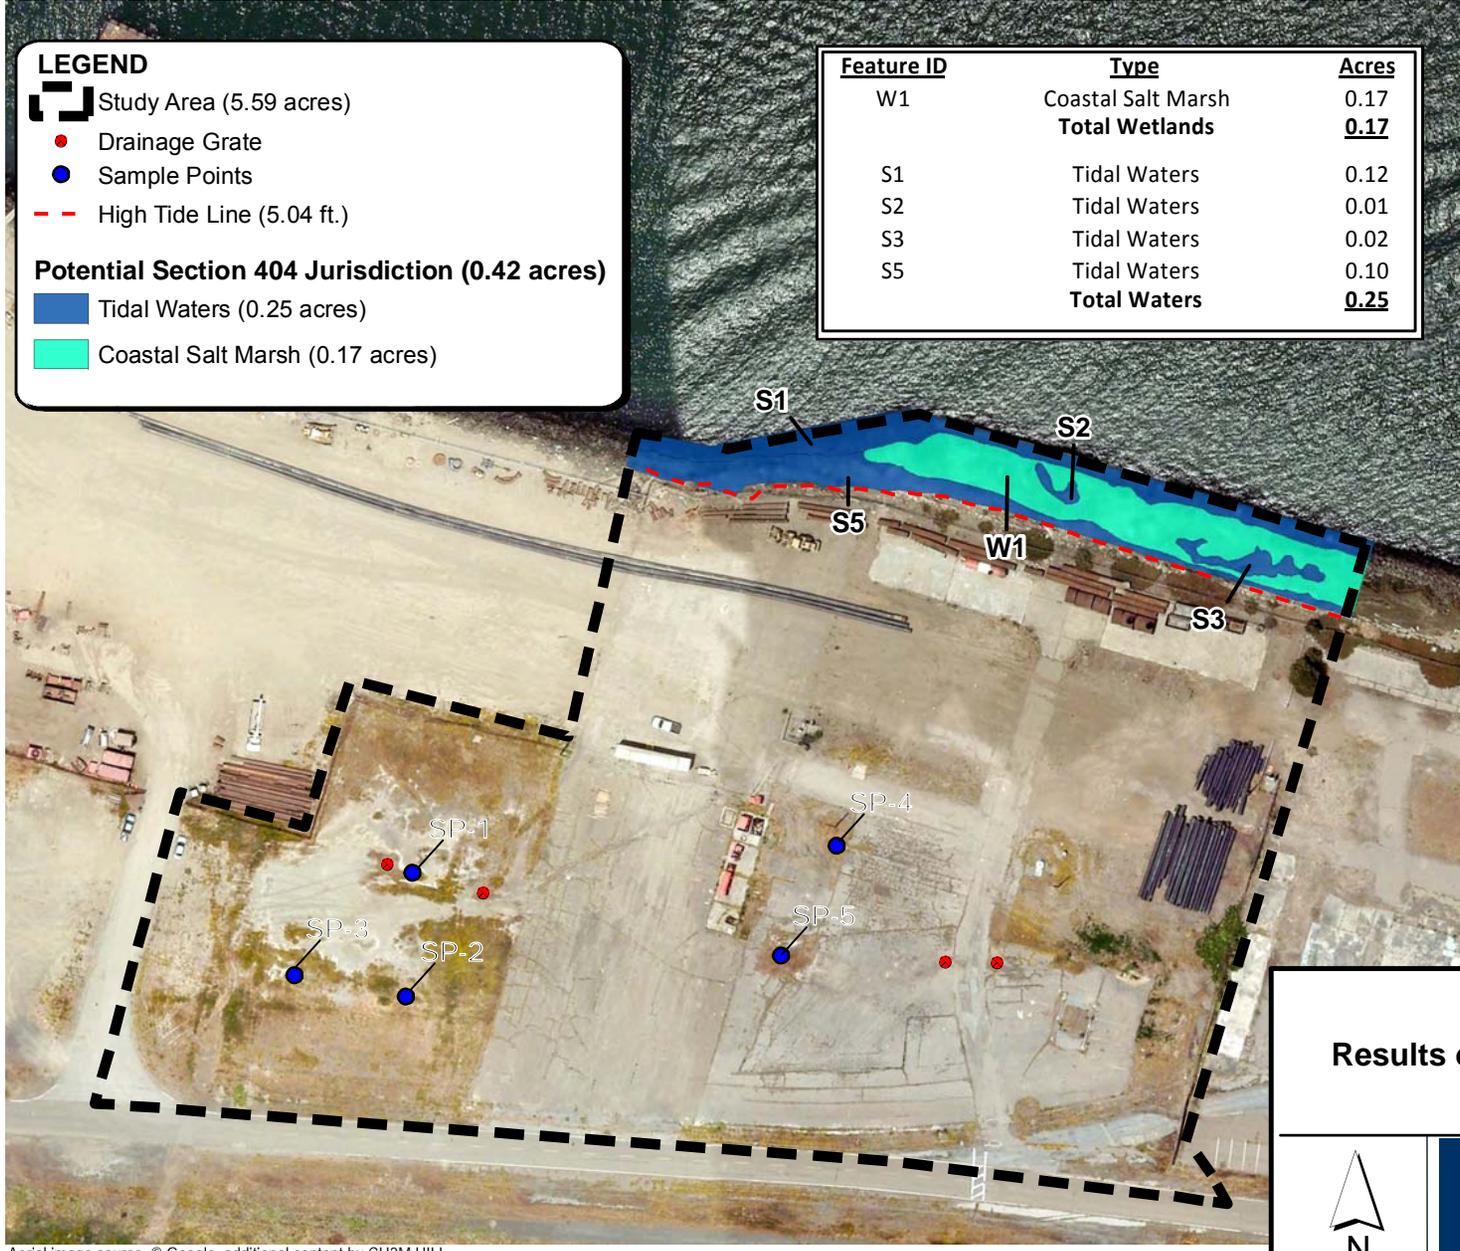
ES071410053357BAO_IRSite_34_wetland_results_v2.ai 11-24-10 lho

A total of five sample points were established to characterize the vegetation hydrology at the site (Figure 2). The wetland determination data forms are included in Appendix B. No additional sample points were located in the coastal salt marsh area as the data sheets from the *Final Wetland Delineation Report for Installation Restoration Site 34* (ChaduxTt, 2010) and field observations during the present survey clearly indicate this area is a wetland.

This sample point was located adjacent to a storm drain in the southwestern corner of IR Site 34 (Figure 2). This area was previously mapped as seasonal wetland W2 (ChaduxTt, 2010). Vegetation is characterized by low-growing salt grass with stunted brass buttons and rabbitsfoot grass (*Polygonum monspeliensis*) (Photo 3, Appendix C). Soil consists of dredged sandy fill material with no evidence of reducing conditions (USDA, 2010; ChaduxTt, 2010). Topography in this area is flat and no evidence of prolonged seasonal saturation or inundation was observed during the KCH July 2010 field survey.

These sample points were established in the south central area of IR Site 34 adjacent to old building foundations (Figure 2) in areas mapped as seasonal wetlands W5 and W6 (ChaduxTt, 2010). Both locations are characterized by relatively high cover of small stunted rabbitsfoot grass along with stinkwort and birds-foot trefoil (Photo 5, Appendix C). Soils in these areas consist of mixed fill material with trace amounts of reddish yellow concentrations along gravel faces in some areas (USDA, 2010; ChaduxTt, 2010). Topography at both locations was flat and no evidence of prolonged seasonal saturation or inundation was noted in either location during the KCH surveys in July 2010.

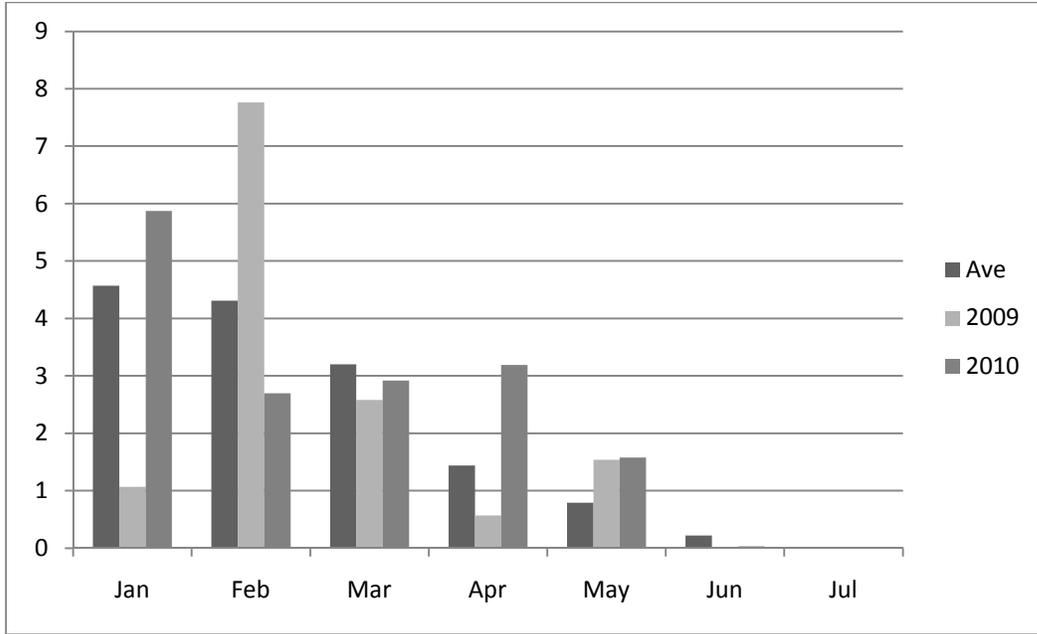
FIGURE 3
Monthly Rainfall (inches) between January and May 2009 and January and July 2010 for Oakland, California.

Seasonal weather patterns and conditions can influence the presence or absence of wetland hydrology indicators in the arid west region. In some years, typical indicators may be absent due to extended periods of drought. Conversely, periods of above average rainfall can result in indicators of wetland hydrology in nonwetland areas (USACE, 2008). Daily rainfall records from the Oakland Foothills weather station (UCIPM, 2010), located approximately 8 miles east of IR Site 34, were compared with the long-term average rainfall for Oakland, California, (WRCC, 2010) between January and May of 2009 and January and July of 2010. Total rainfall for these periods in 2009 and 2010 was approximately 94 percent and 97 percent of the average, respectively. While the total amount of rainfall was generally similar, the timing and amounts of rainfall were notably different between these 2 years (Figure 3). One notable difference in the rainfall patterns is over half of the total rainfall between January and May of 2009 occurred in a series of major storms in February, where rainfall was generally more evenly distributed throughout the season in 2010 (Figure 4).

No measurable precipitation was reported in the month of July 2010 (UCIPM, 2010). The ChaduxTt (2010) wetland delineation was conducted on May 14, 2009, 8 days after 1.54 inches of rainfall were recorded between May 1 and May 5 (UCIPM, 2010). Despite the recent storm events immediately prior to the May 2009 field surveys, no surface water, saturated soils, or moist soils were noted at any of the sample points established in areas mapped as seasonal wetlands in the *Final Wetland Delineation Report for Installation Restoration Site 34* (ChaduxTt, 2010).

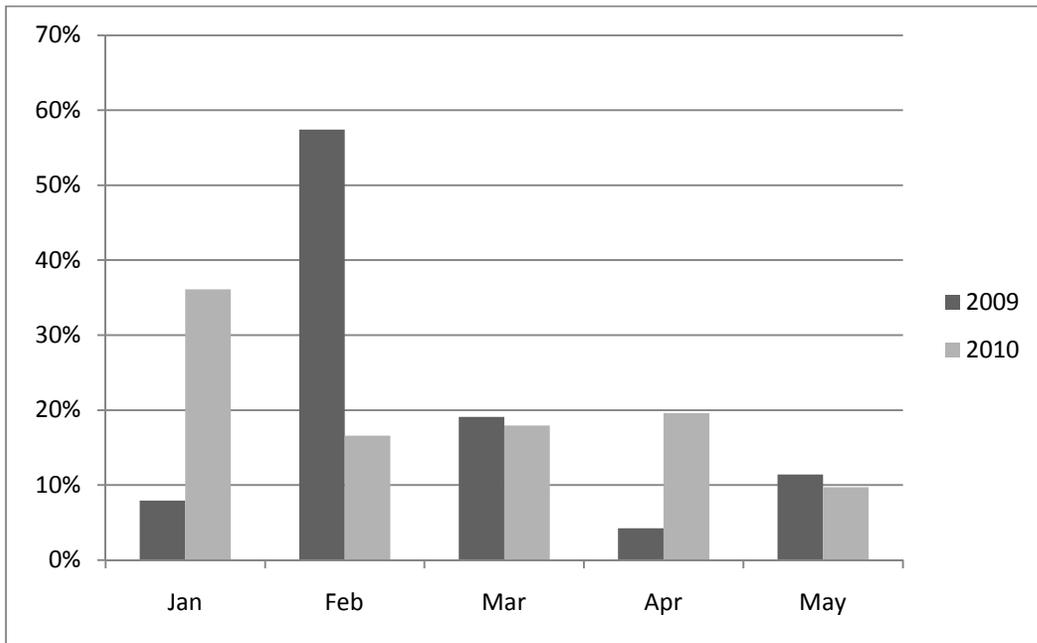
FIGURE 4
Percentage of Total Rainfall that Fell Each Month Between January and May of 2009 and 2010.

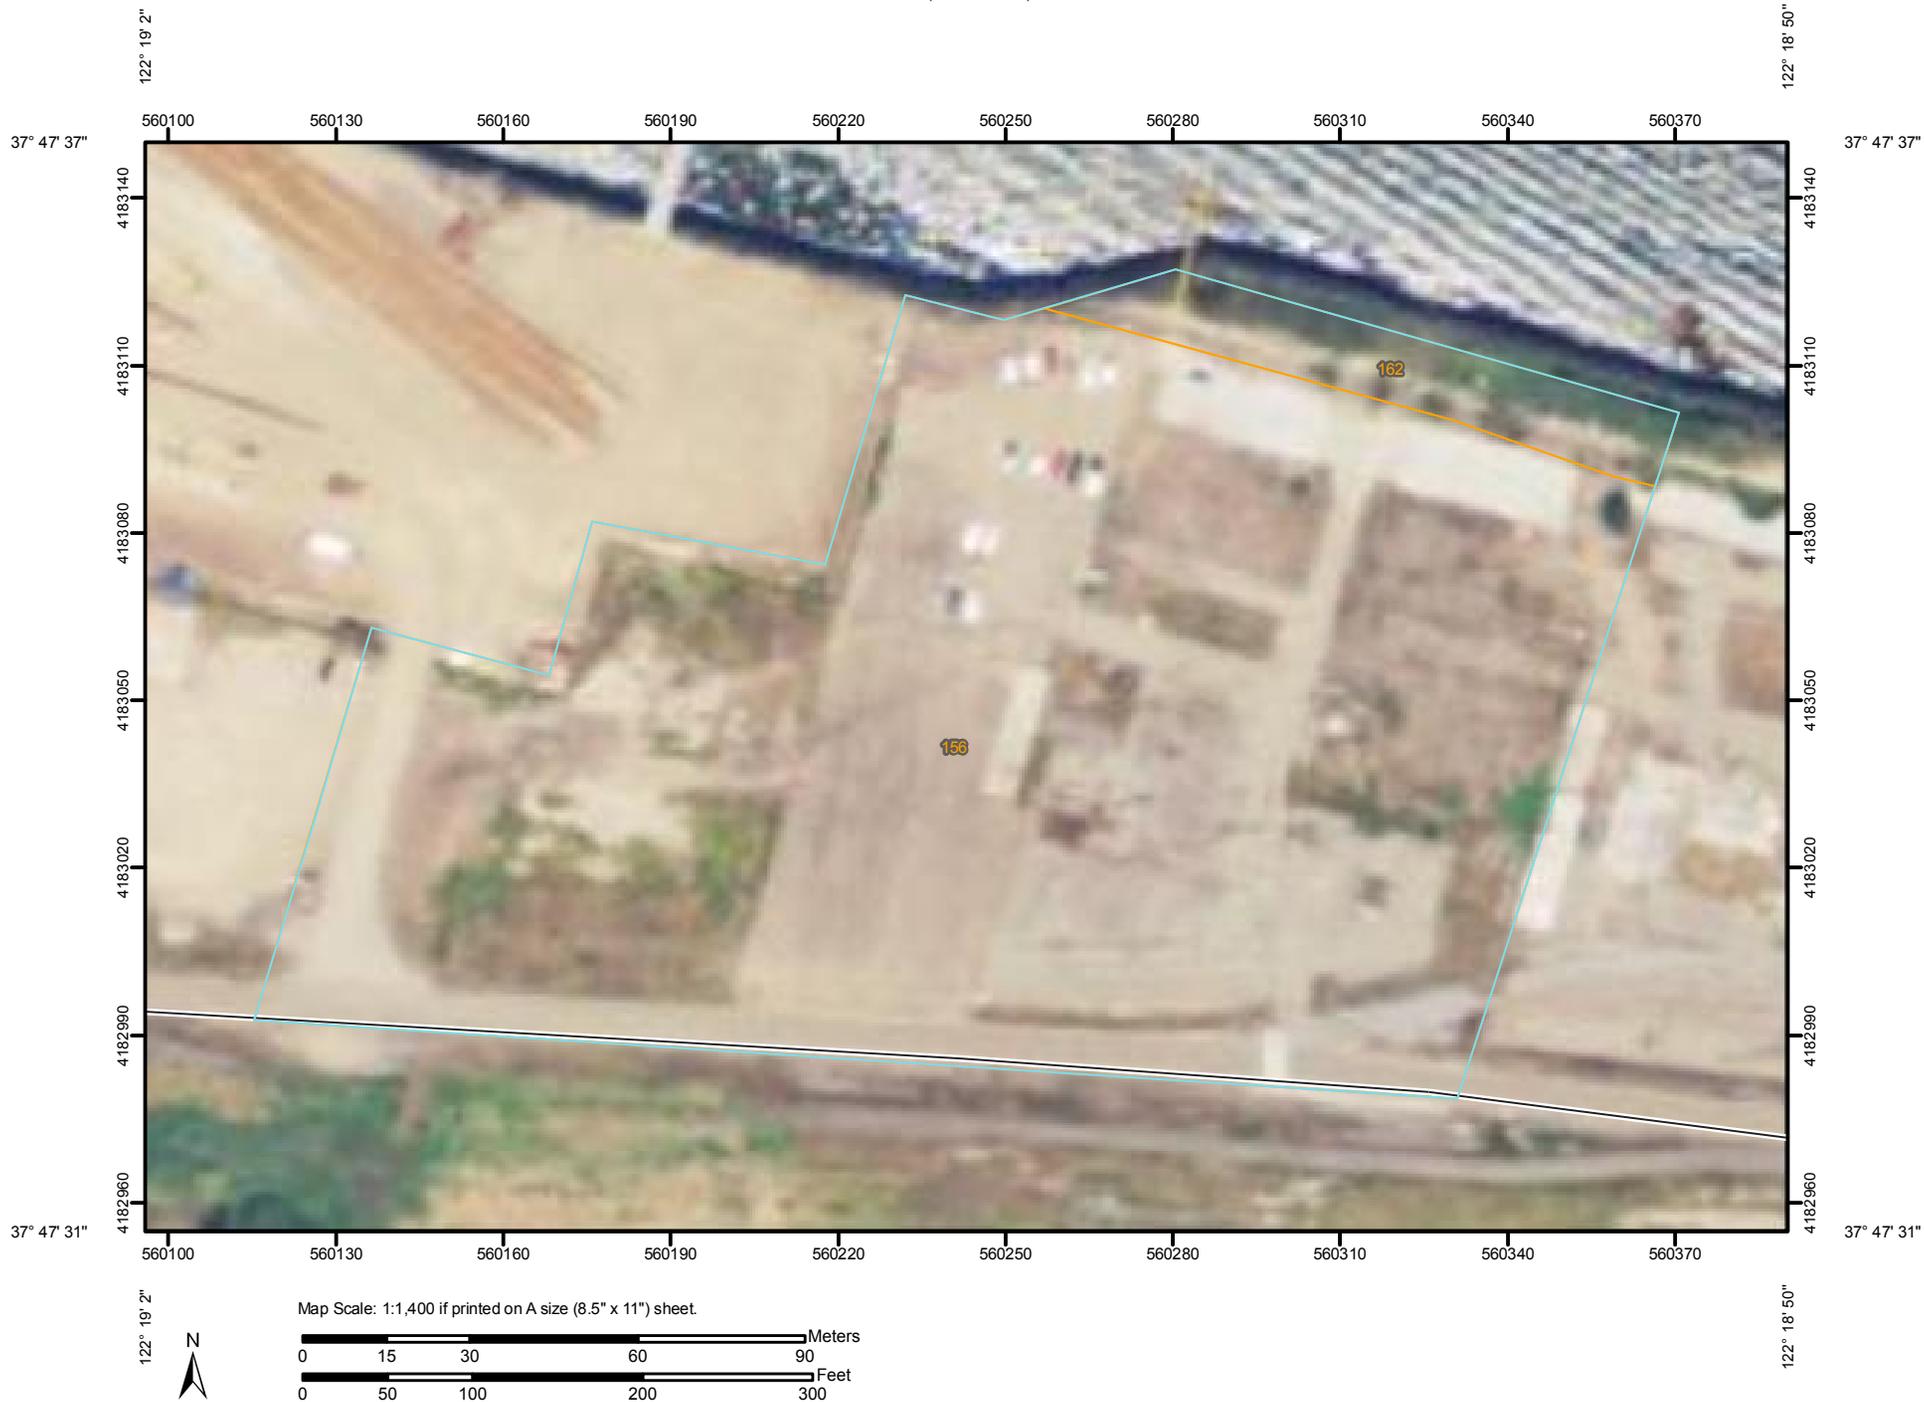
Soil Map—Alameda County, California, Western Part
(IR Site 34)

The entire area has been mapped as Xeropsamments fill by the United States Department of Agriculture (USDA, 2010). A soil map for the project area is included in Appendix A. This unit consists of sandy material that was dredged from old beach areas. Elevation ranges from near sea level to 10 feet with slopes less than 2 percent. Approximately 10 percent of the map area consists of areas that are underlain by strongly alkaline clay to a depth of 36 to 48 inches. An additional approximately 5 percent of the area includes concave areas that have a shallow water table (approximately 36 inches) and may be ponded during the winter. These soils are rapidly permeable but the root zone is restricted to a depth of 40 to 60 inches for water-sensitive plants (USDA, 1981).

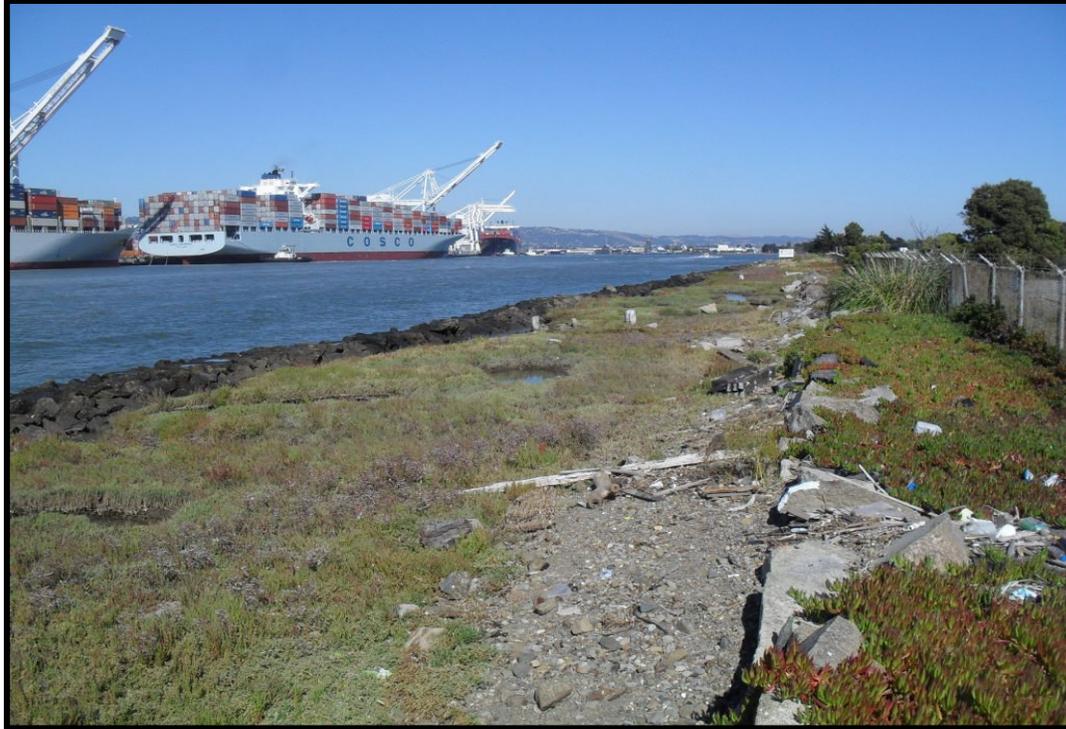
PHOTO 1
Coastal salt marsh and open water habitat along the Oakland Inner Harbor with distinct upland boundary at high tide limit.

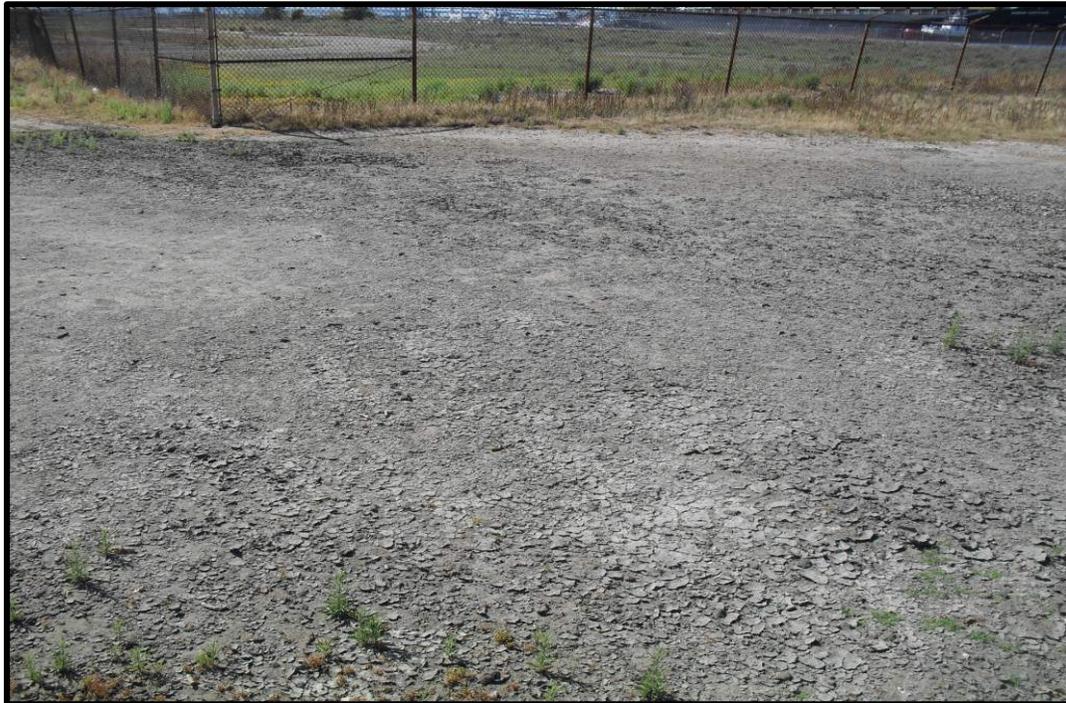
PHOTO 2
Shallow soil cracks indicative of ponded water in southwest part of IR Site 34, west of storm drain.

A very shallow, weakly expressed concave depression is present in the southwest corner of IR Site 34 to the west of a series of storm drains. Based on the presence of shallow surface soil cracks that formed as a result of drying and shrinking of fine grained sediments and organic material, this area appears to support some duration of surface ponding (Photo 2, Appendix C). The area where the surface soil cracks are present is devoid of vegetation. Soils in this area consist of dredged sandy fill material that lack evidence of reducing conditions (USDA, 2010; ChaduxTt, 2010).

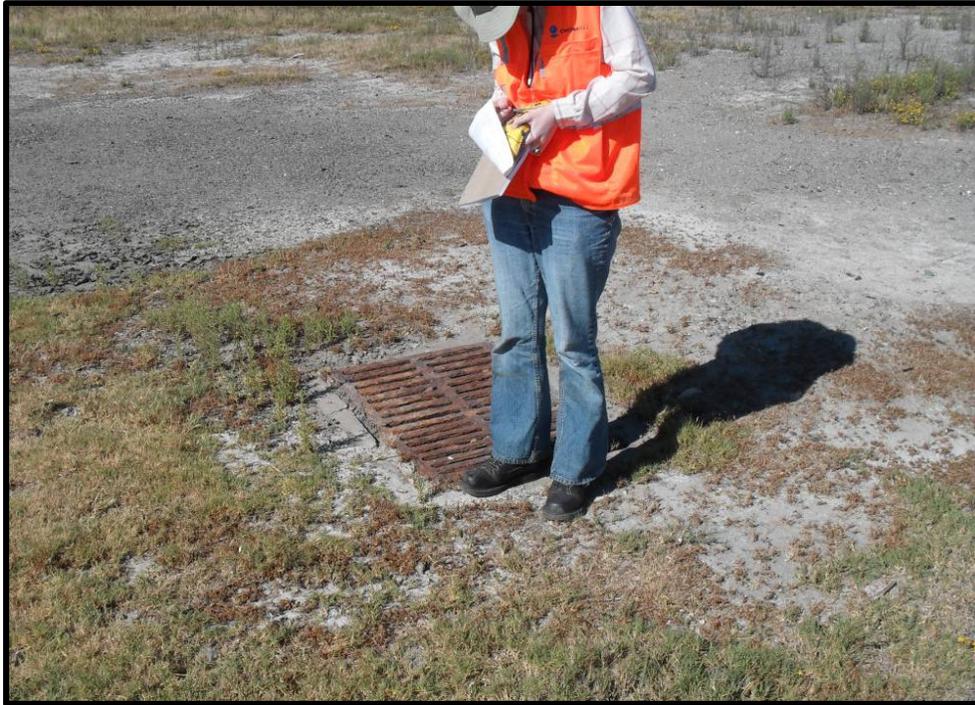
PHOTO 3
Sample Point SP-1 - Low saltgrass with stunted brass buttons and rabbitsfoot grass around storm drain.

During the July 2010 field surveys of IR Site 34 all three of the dominant FACW plant species (saltgrass, brass buttons, and rabbitsfoot grass) observed at sample locations in potential seasonal wetland areas were low-growing, stunted plants with limited flowering. Other plant species also common throughout the area, such as birds-foot trefoil, Mediterranean linseed, and stinkwort, did not exhibit any evidence of significantly reduced stature or flowering. In addition, saltgrass observed in the coastal salt marsh habitat at the north end of the site, exhibited relatively vigorous growth. It appears that plant species that are more commonly found in moist habitats were stressed relative to the same species found in the tidally flooded area and other FAC and nonwetland plants species on the site.

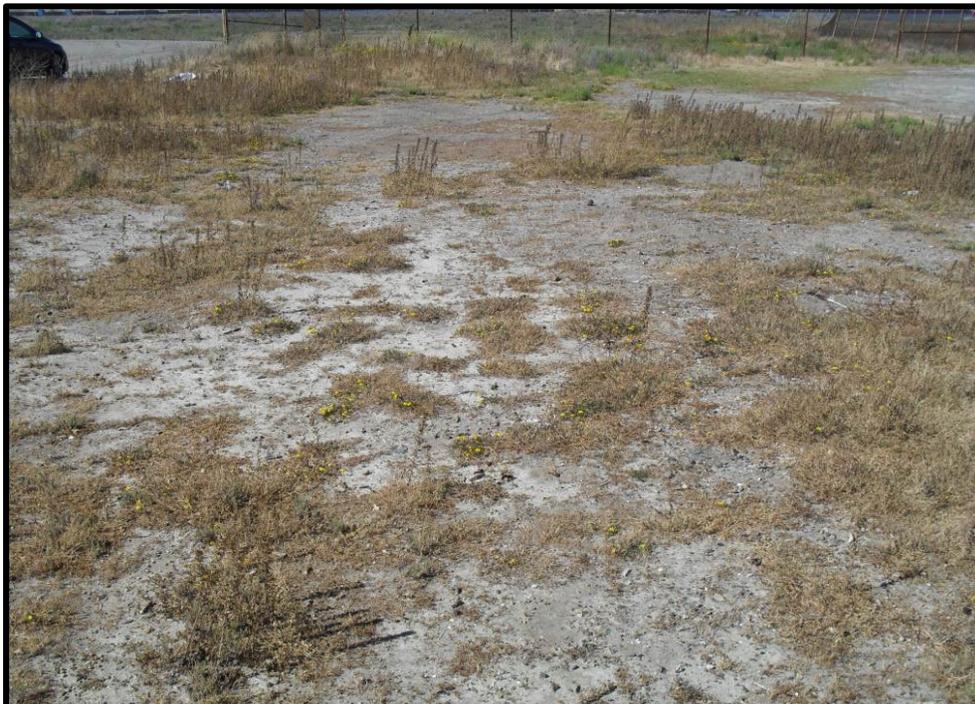
PHOTO 4
Sparse vegetation and powdery salt deposits in the southwest part of IR Site 34

Salt crust, when used as an indicator of wetland hydrology, refers to hard or brittle deposits of salts that form on the ground due to evaporation of saline surface water (USACE, 2008). No salt crusts were observed on IR Site 34 during the July 2010 field surveys conducted by KCH; however, fluffy, powdery salt deposits resulting from the capillary rise and evaporation of saline groundwater were observed in several locations. These powdery salt deposits are not considered salt crusts and are not indicative of seasonal wetland hydrology (USACE, 2008).

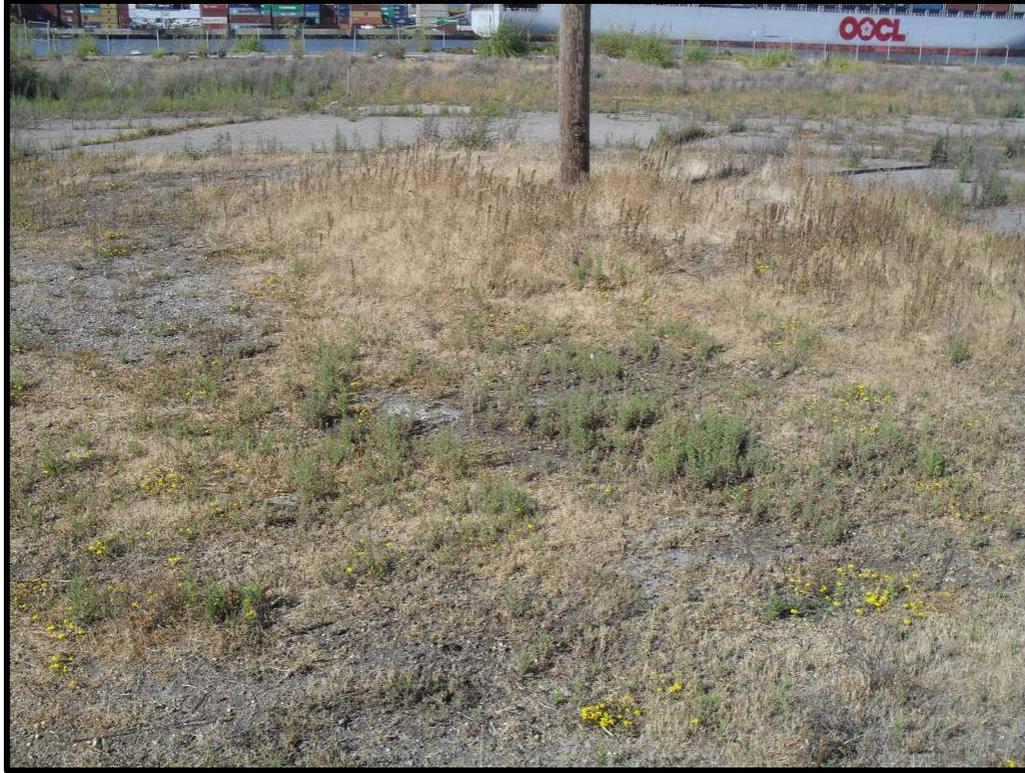
PHOTO 5

Sample Point SP-4 adjacent to building foundation, characterized by a mix of low stunted hydrophytic plants and non-wetland species.
