**Re: Tank Closure Report
Underground Storage Tank (UST) 155 at
Marine Corps Air Station El Toro, California
SWDIV Contract No. N68711-93-D-1459
DCN SW 7256, Delivery Order No. 70**

This Tank Closure Report summarizes the field activities conducted and associated with the removal of underground storage tank (UST) at Building 155. OHM Remediation Services Corp. (OHM) removed one UST designated as UST 155 from the Building 155 site at Marine Corps Air Station, El Toro, California (hereinafter referred to as "the Station"). The location of the Station is shown on Figure 1-1, Facility Location Map.

FACILITY LOCATION MAP
USCT 155

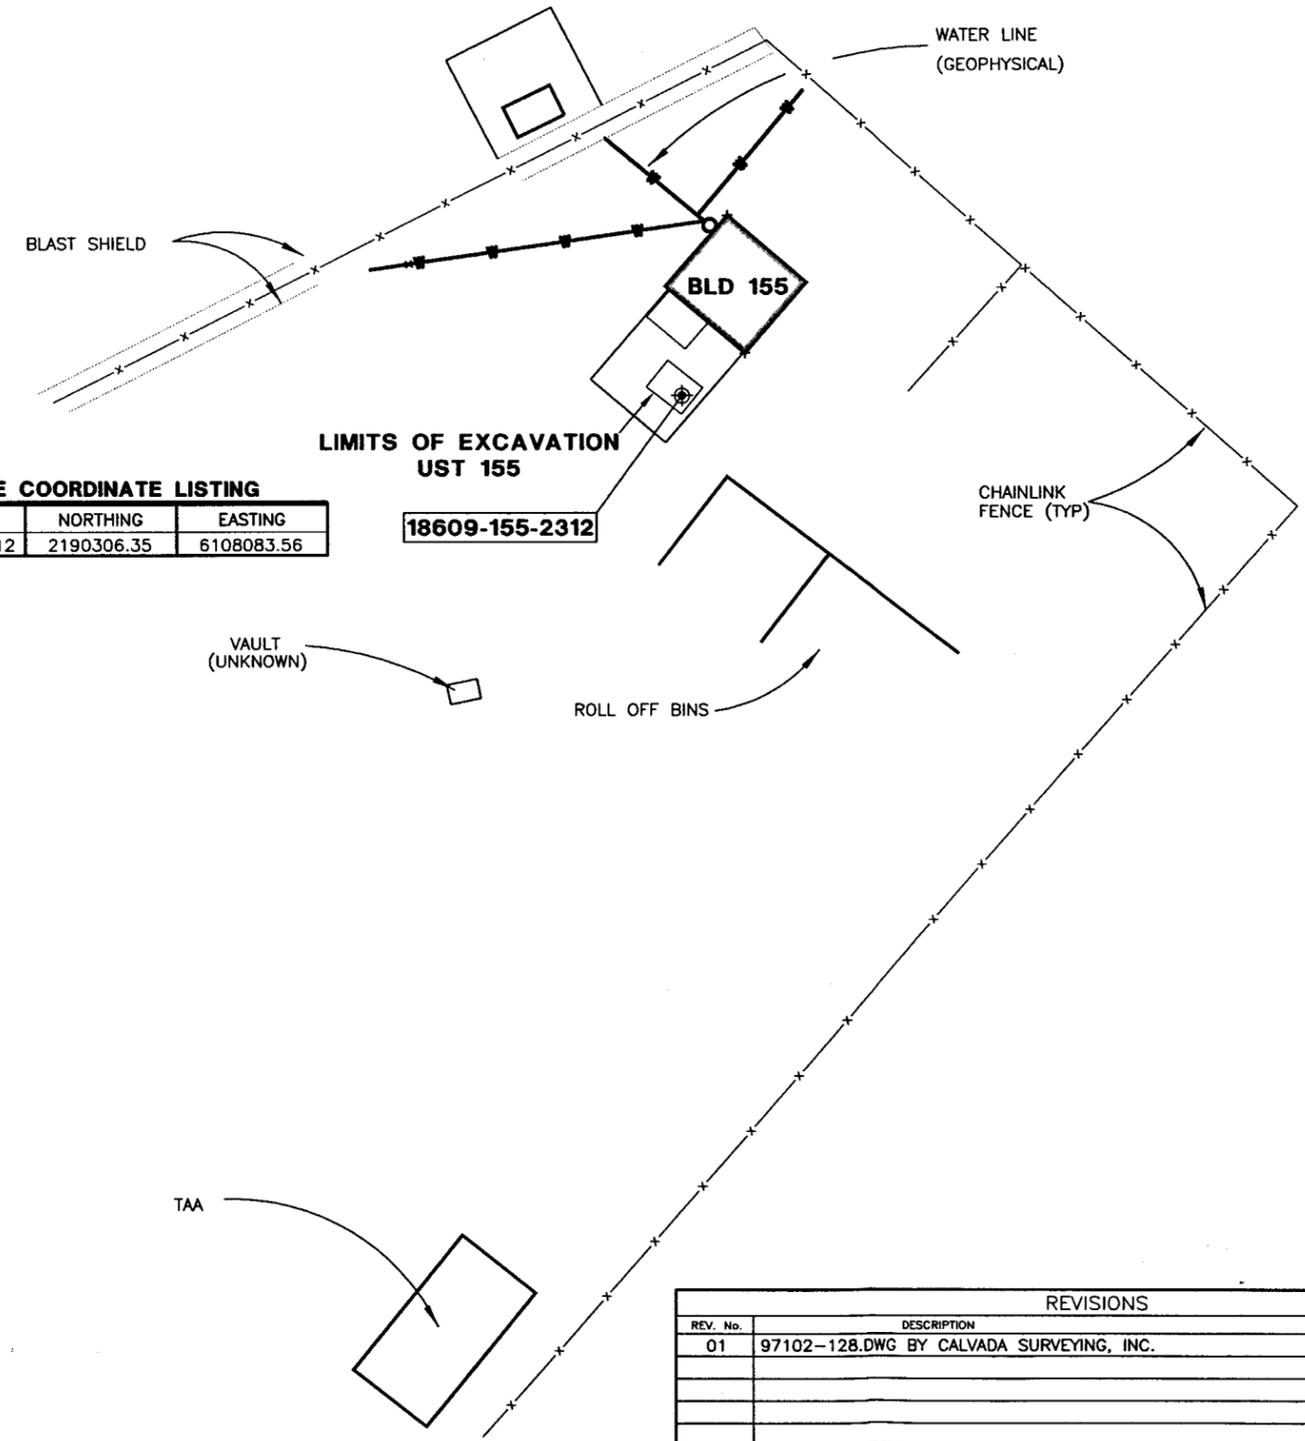
Following the removal of UST 155, one confirmation soil sample was collected on July 22, 1999 from the bottom of the excavation in the presence of an OCHCA field inspector. The confirmation soil sample location is shown in Figure 1-3, Site Plan.

SAMPLE COORDINATE LISTING

DESCRIPTION	NORTHING	EASTING
18609-155-2312	2190306.35	6108083.56

CONFIRMATION SOIL SAMPLE
- NG NATURAL GROUND
- FS FINISH SURFACE

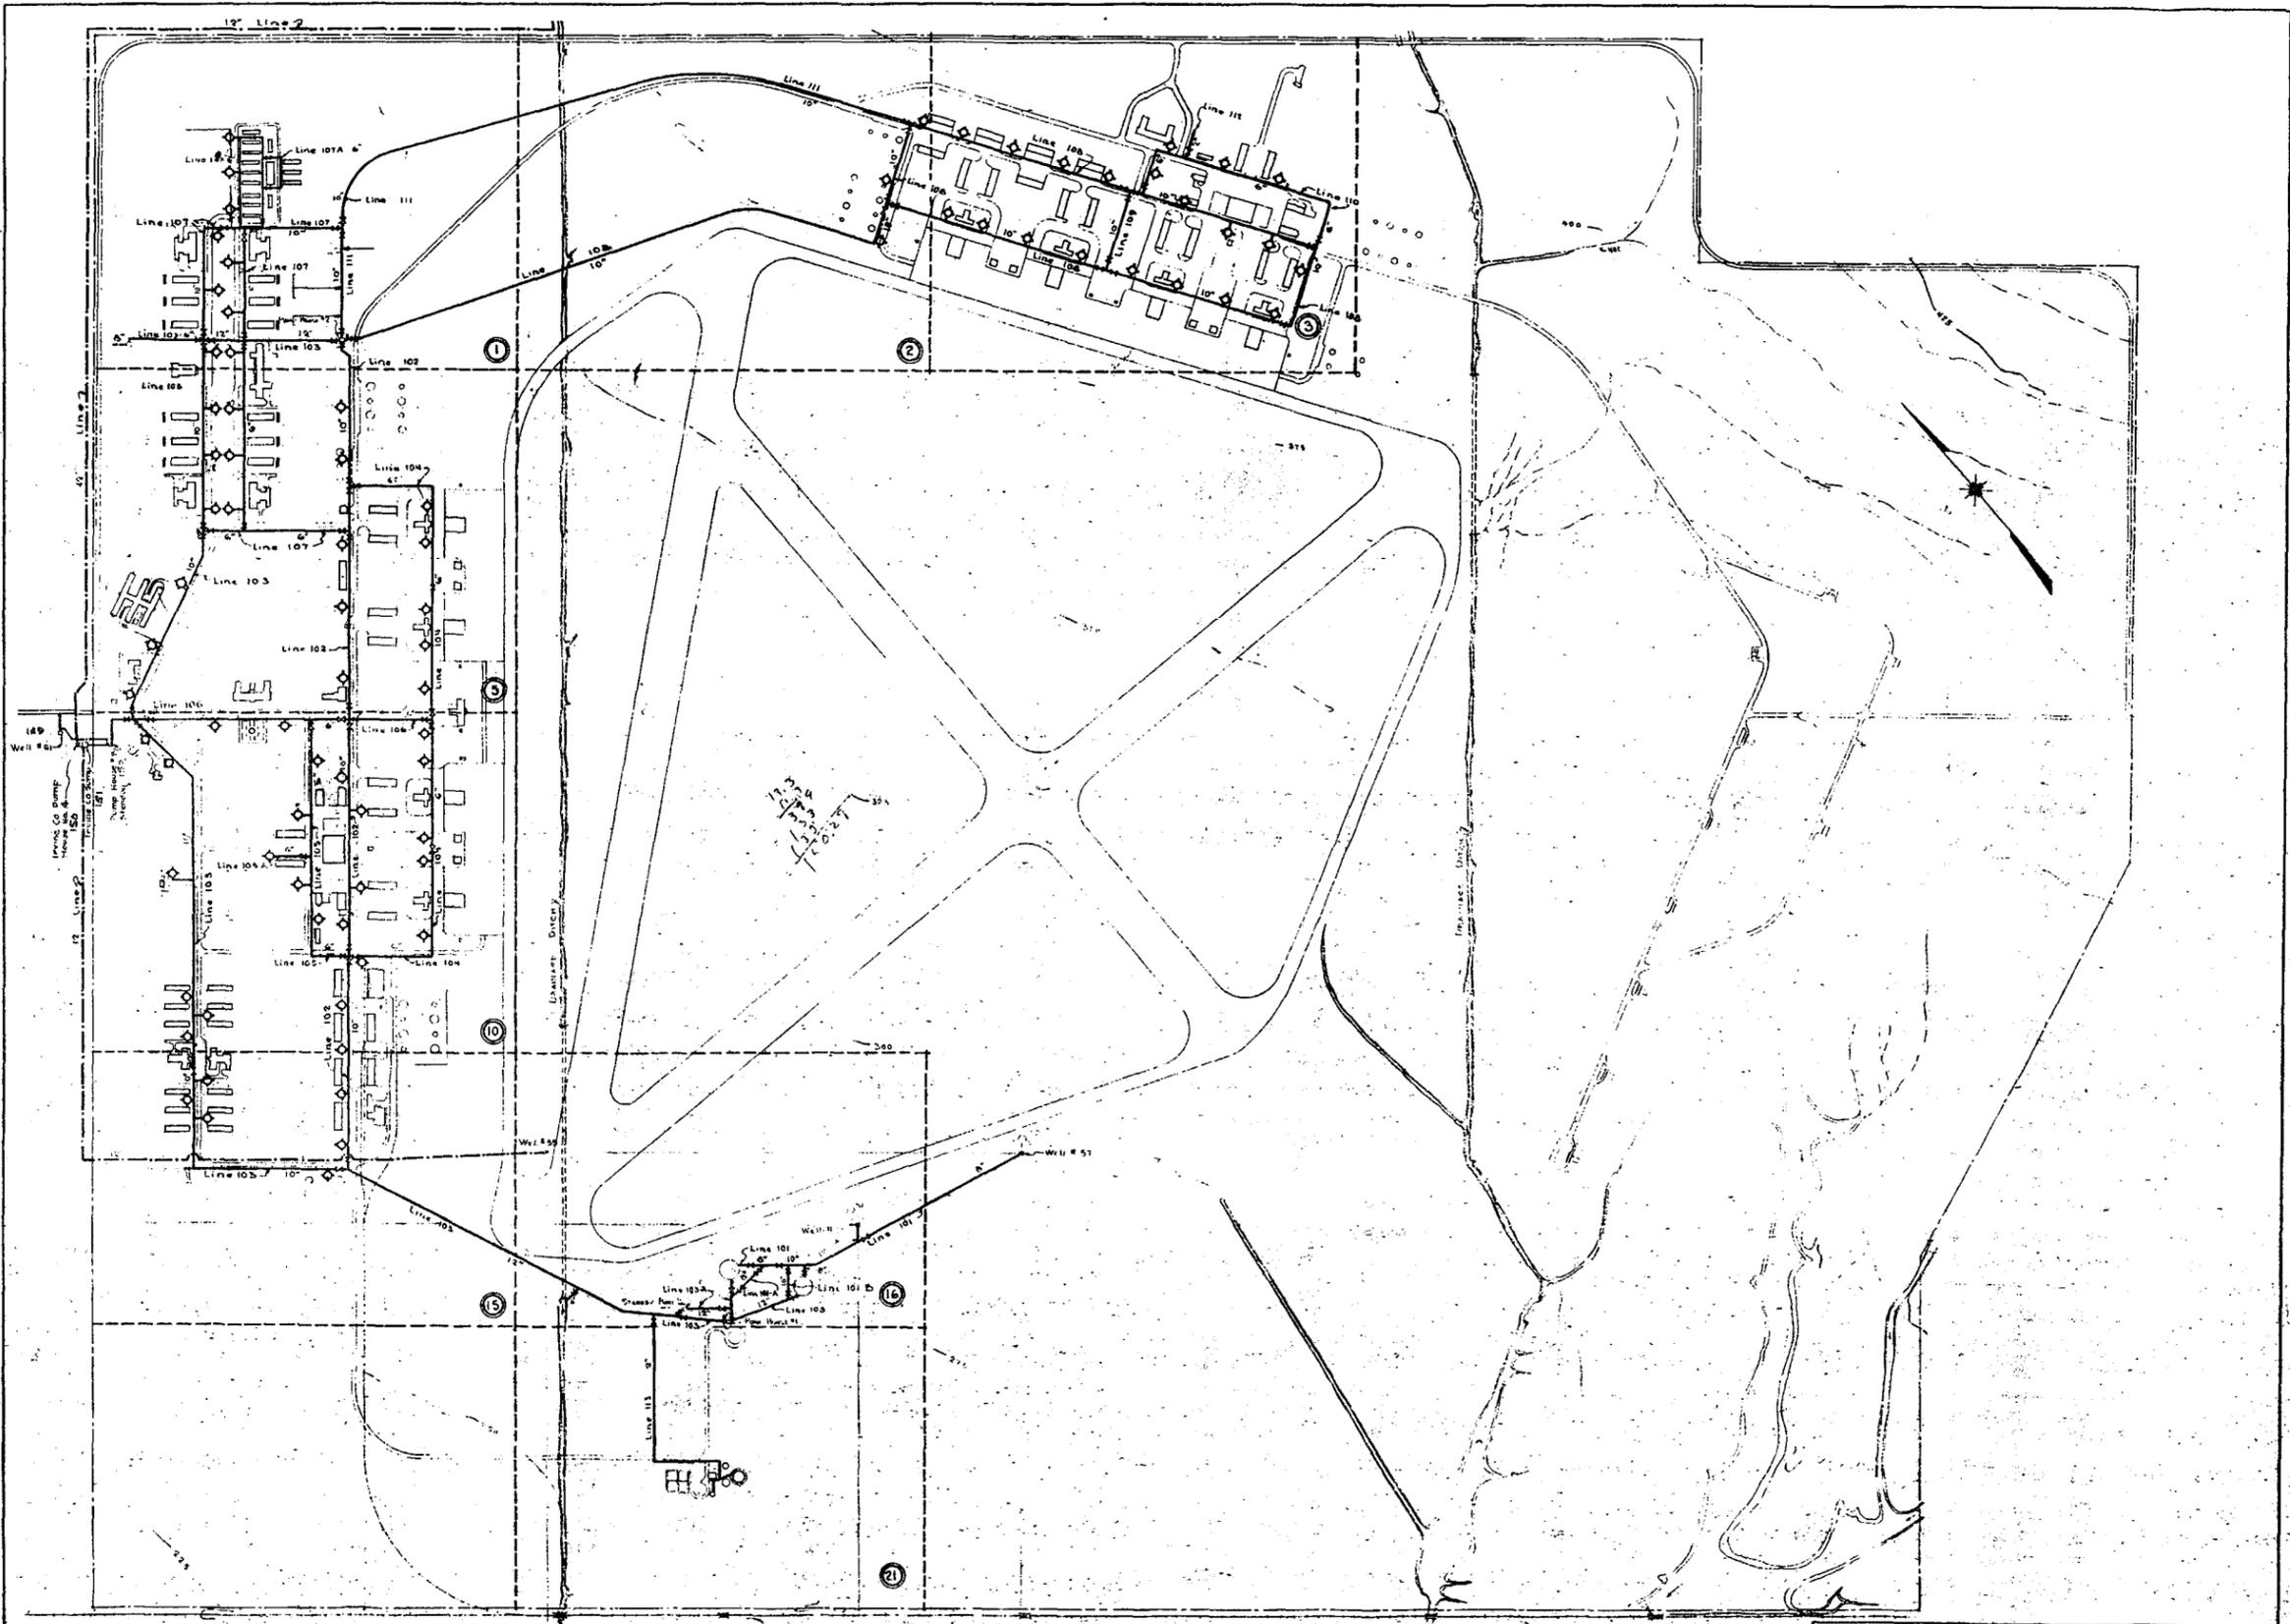
- Water Supply Key Plan – Building 155 (5, Nov 1942), Drawing No. 224411
- Site Plan Reservoirs No. 1 and 2. Pumping Plant No. 1 Standby Unit, Drawing No. 224412
- Standby Unit Mechanical Details, Drawing No. 224416

OHM reviewed these drawings and confirmed that UST 155 was a steel, 280 gallon UST used for storage of fuel for standby units associated with Building 155 for a water distribution system. OHM used these drawing to further investigate location of UST 155 and associated utilities. Copies of these drawings are included in Appendix A, Station Drawings.

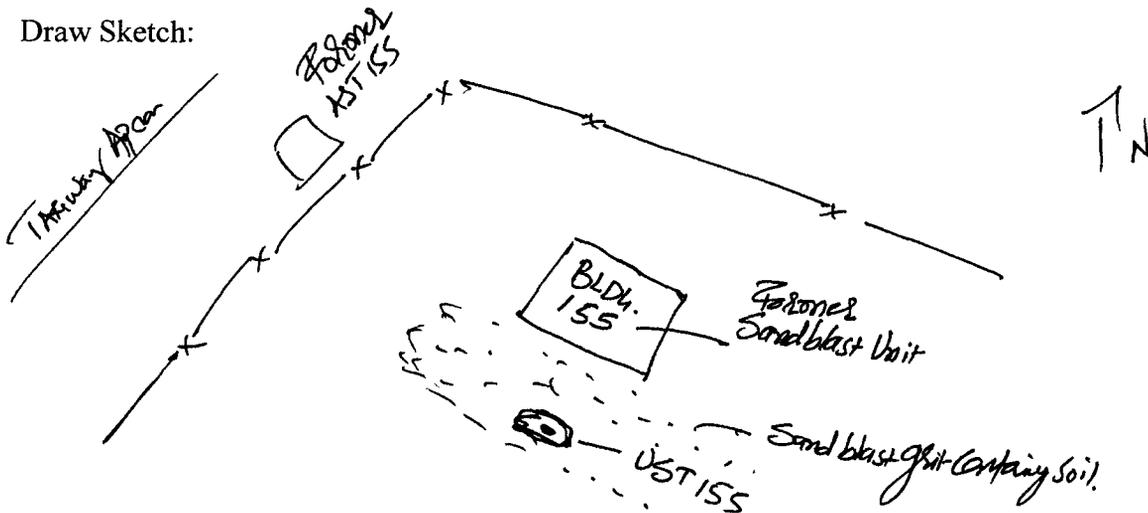
Draw Sketch:

- Nearest Building or Structure Distance: Building 155, approx. 9 feet, North of UST 155.
Former Pump house for water distribution system, unpaved vehicle pad.
- Any Underground Piping/Lines, or Transformer Observed: None. Utilities were marked by geophysical survey.
- Overhead Utility Lines/Poles: None
- Site Setup Constrains: None.

UST 155 seems to be filled with sand/soil. No manhole cover observed or any fill part visible. Sandblast grit mixed with surrounding soil within UST 155 area. No visible stains on surrounding soil. Also field probe investigation revealed that most likely UST may not be intact or in one piece UST could be 300 gallons. During excavation entire UST may not come out of ground.

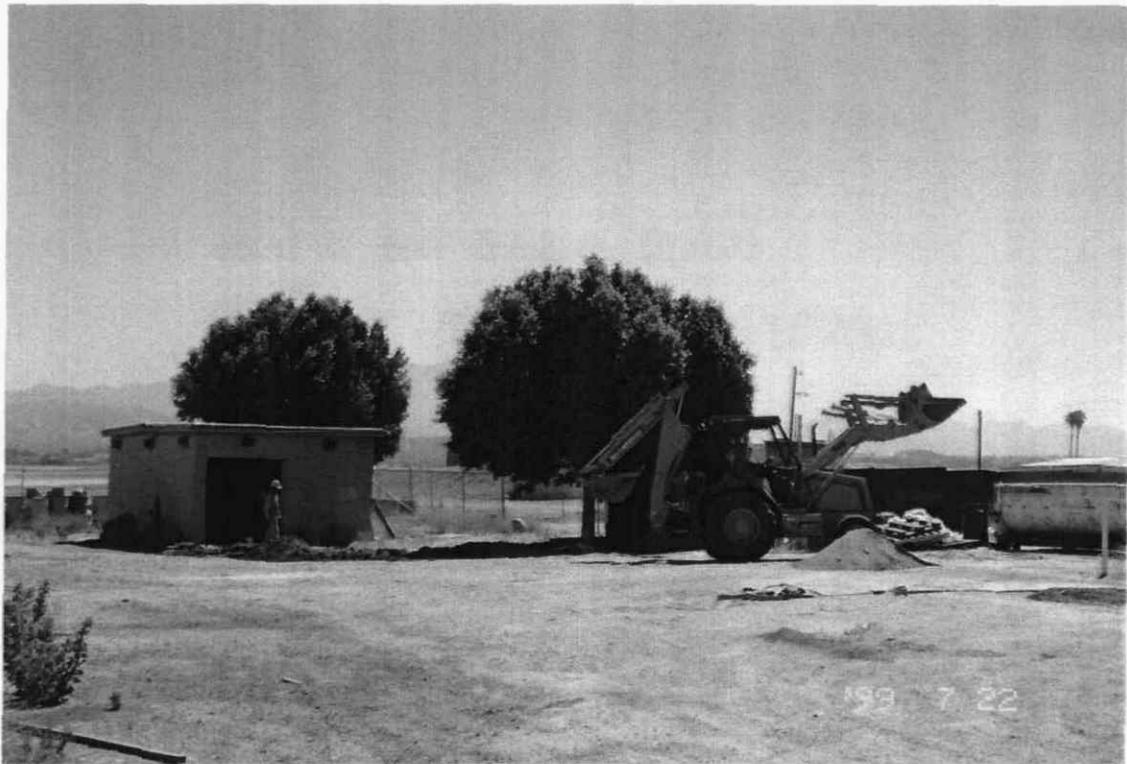
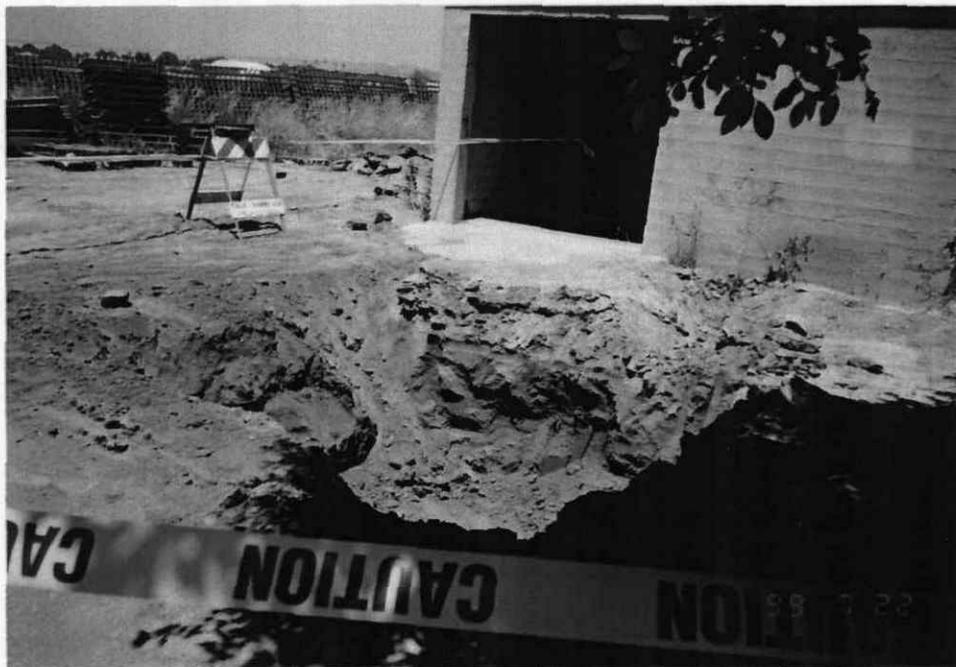
OHM removed UST 155 on July 22, 1999 in the presence of an OCHCA field inspector. UST 155 was not intact and pieces of steel (mainly one big piece and three other small pieces) were dug out with soil. The bottom of the excavation was at a depth of approximately 6 feet below ground surface (bgs). Approximately 18 cubic yards (yd³) of soil were excavated to remove UST 155. No visual stains, spills, smell of fuel or

discolored soil were observed at the bottom of the excavation

Photograph No. 1 and 2: UST 155 Removal Field Work and Excavation.

The UST 155 excavation was backfilled on July 23, 1999 using Non-Hazardous, clean stockpiled soil from the Station's central treatment facility. The site was restored to original grade. Compaction was accomplished using a compaction wheel and backhoe.
