# Summary Report

*Former Electronic Equipment Storage Area PCB A2*  
Marine Corps Air Station, El Toro, California

24 January 2001

Summary Report, Former Electronic Equipment  
Area PCB A2

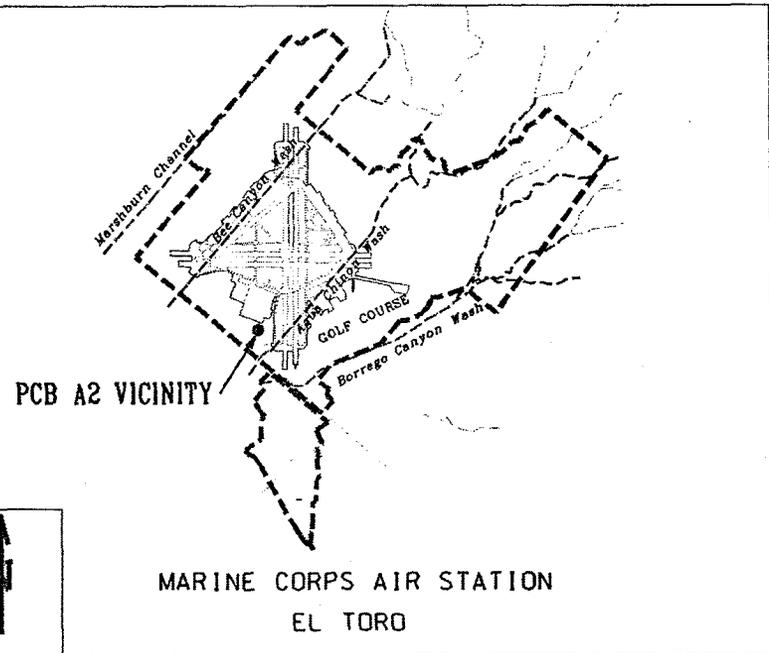
Figure 1.  
 MISCELLANEOUS LOCATION OF CONCERN  
**PCB A2 VICINITY MAP**  
 MARINE CORPS AIR STATION, EL TORO

- 1) Approximate Scale: 1 inch = 200 feet
- 2) X designates the location of soil gas survey points in the vicinity of PCB A2 (JEG, 1994)

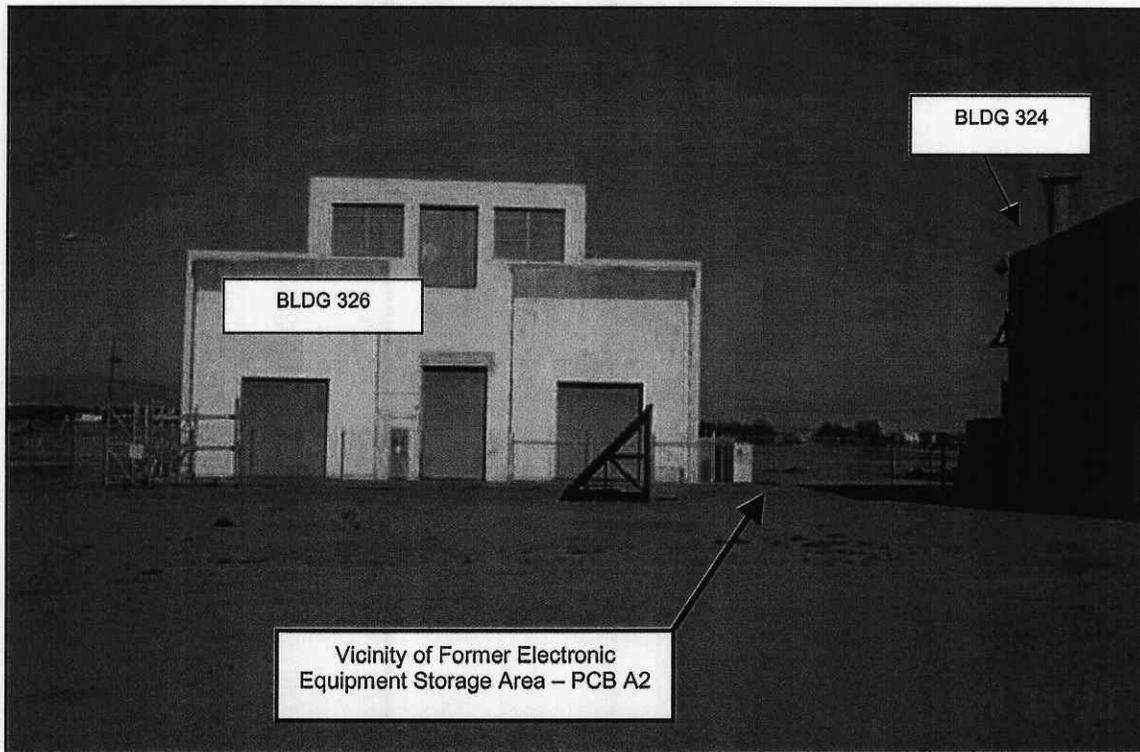
**Photograph 2. PCB A2 Vicinity.**  
Former Electronic Equipment Storage Area Near Buildings 324 and 326.  
Looking Approximately North-Northeast Toward Building 296.  
Marine Corps Air Station, El Toro

Date of Photograph: 27 December 2000

**Current Site Conditions:** PCB A2 is located adjacent to the west-northwest side of Building 326 and the north-northeast side of Building 324. Much of the area is unpaved and covered with gravel. No stains or discolored areas were observed. No electronic equipment or other equipment was being stored at the site during the inspections. Empty pallets were observed near the exterior wall of Building 326 during the 1999 inspection. A vapor extraction well for Installation Restoration Program (IRP) Site 24 (the Volatile Organic Compound (VOC) Source Area) – 24SVE117 – is located north-northeast of PCB A2 and north-northeast of Building 326.

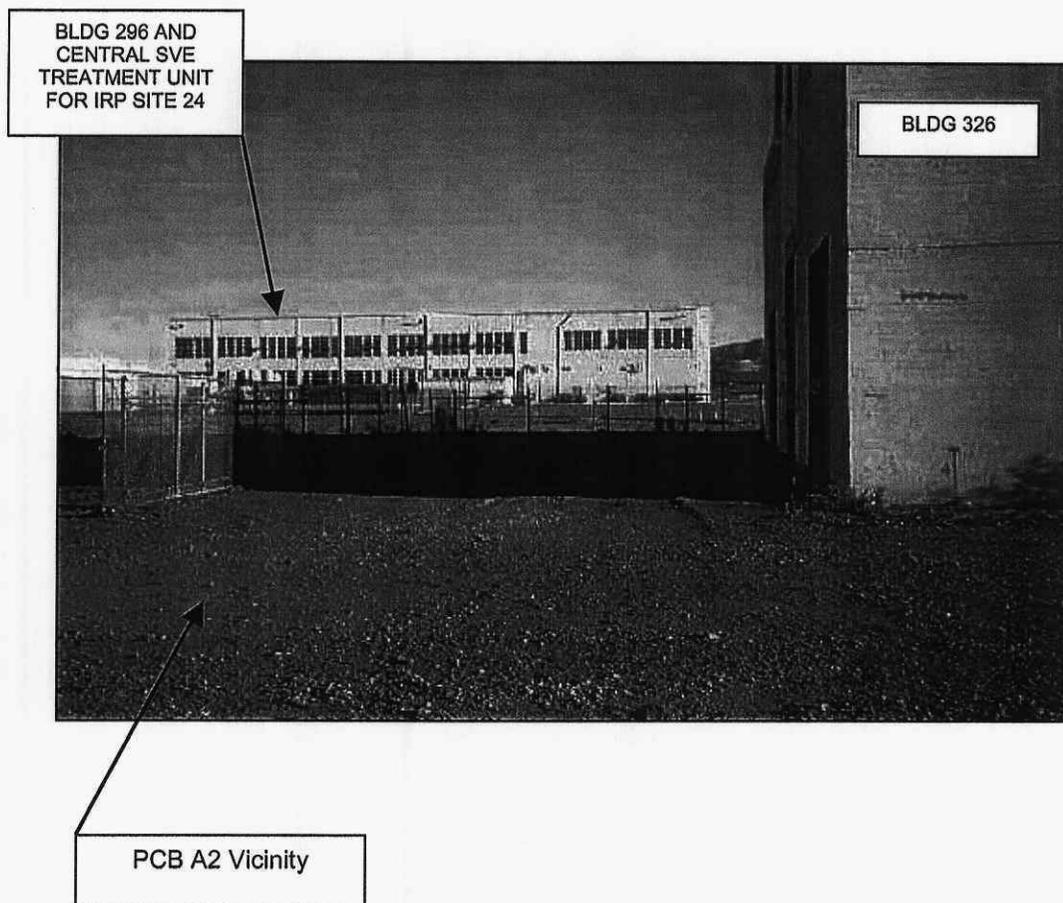
**Photograph 3. PCB A2 Vicinity.**  
**Former Electronic Equipment Storage Area Near Buildings 324 and 326.**  
**Marine Corps Air Station, El Toro**

Date of Photograph: 21 November 1999

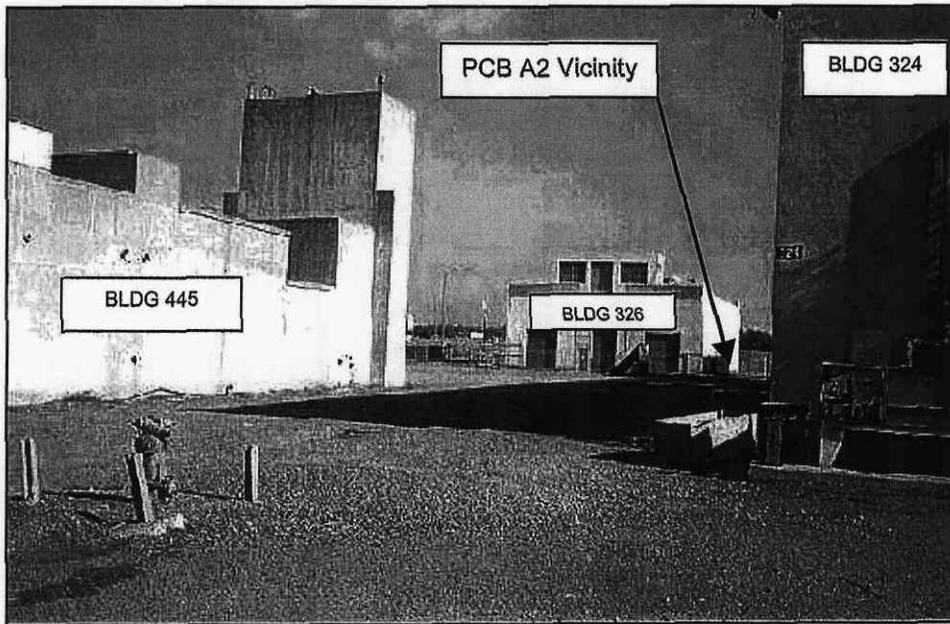
**Photograph 4. PCB A2 Vicinity.**  
**Former Electronic Equipment Storage Area Near Buildings 324 and 326.**  
**Marine Corps Air Station, El Toro**

Date of Photograph: 21 November 1999

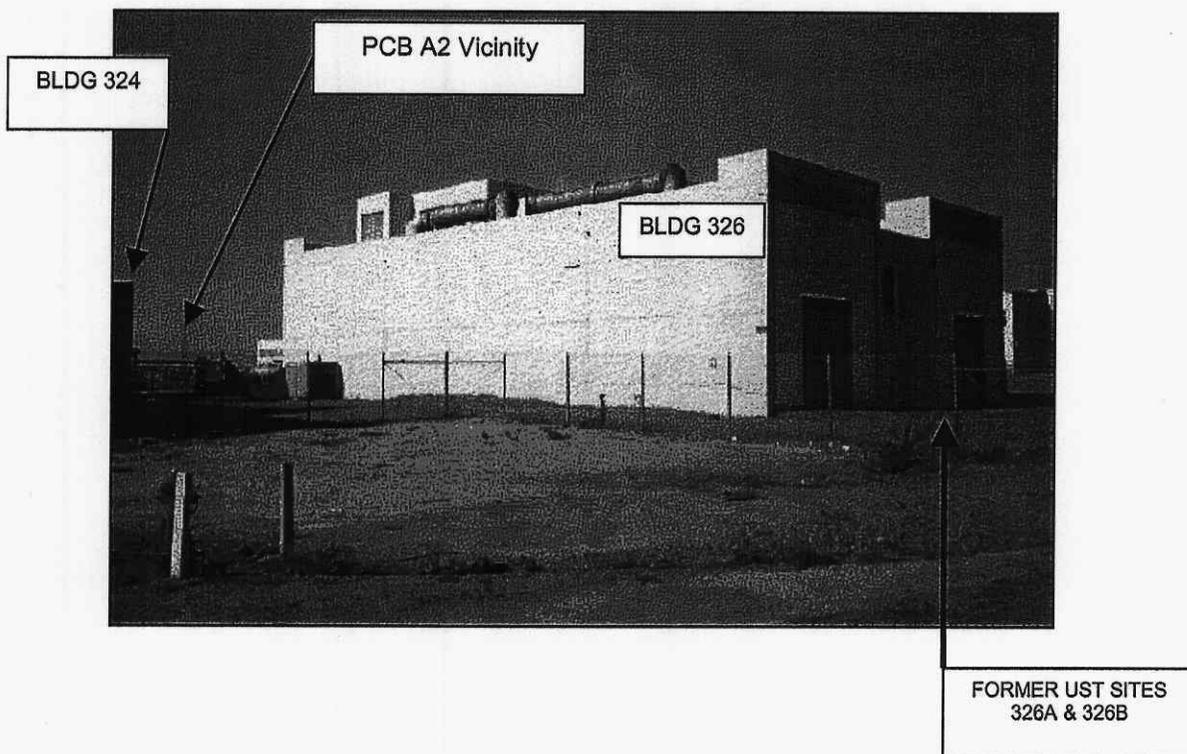
**Photograph 5. PCB A2 Vicinity.**  
**Former Electronic Equipment Storage Area Near Buildings 324 and 326.**  
**Marine Corps Air Station, El Toro**

Date of Photograph: 1994

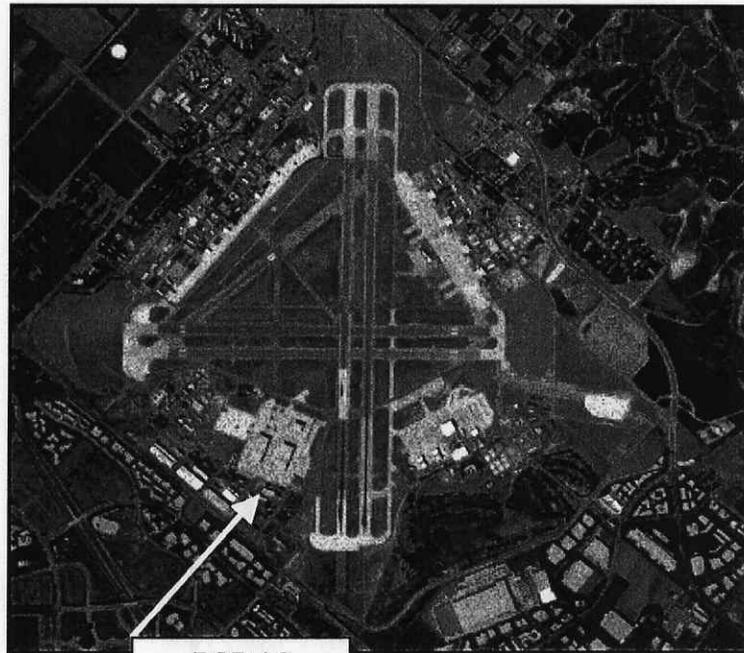
PCB A2  
Vicinity

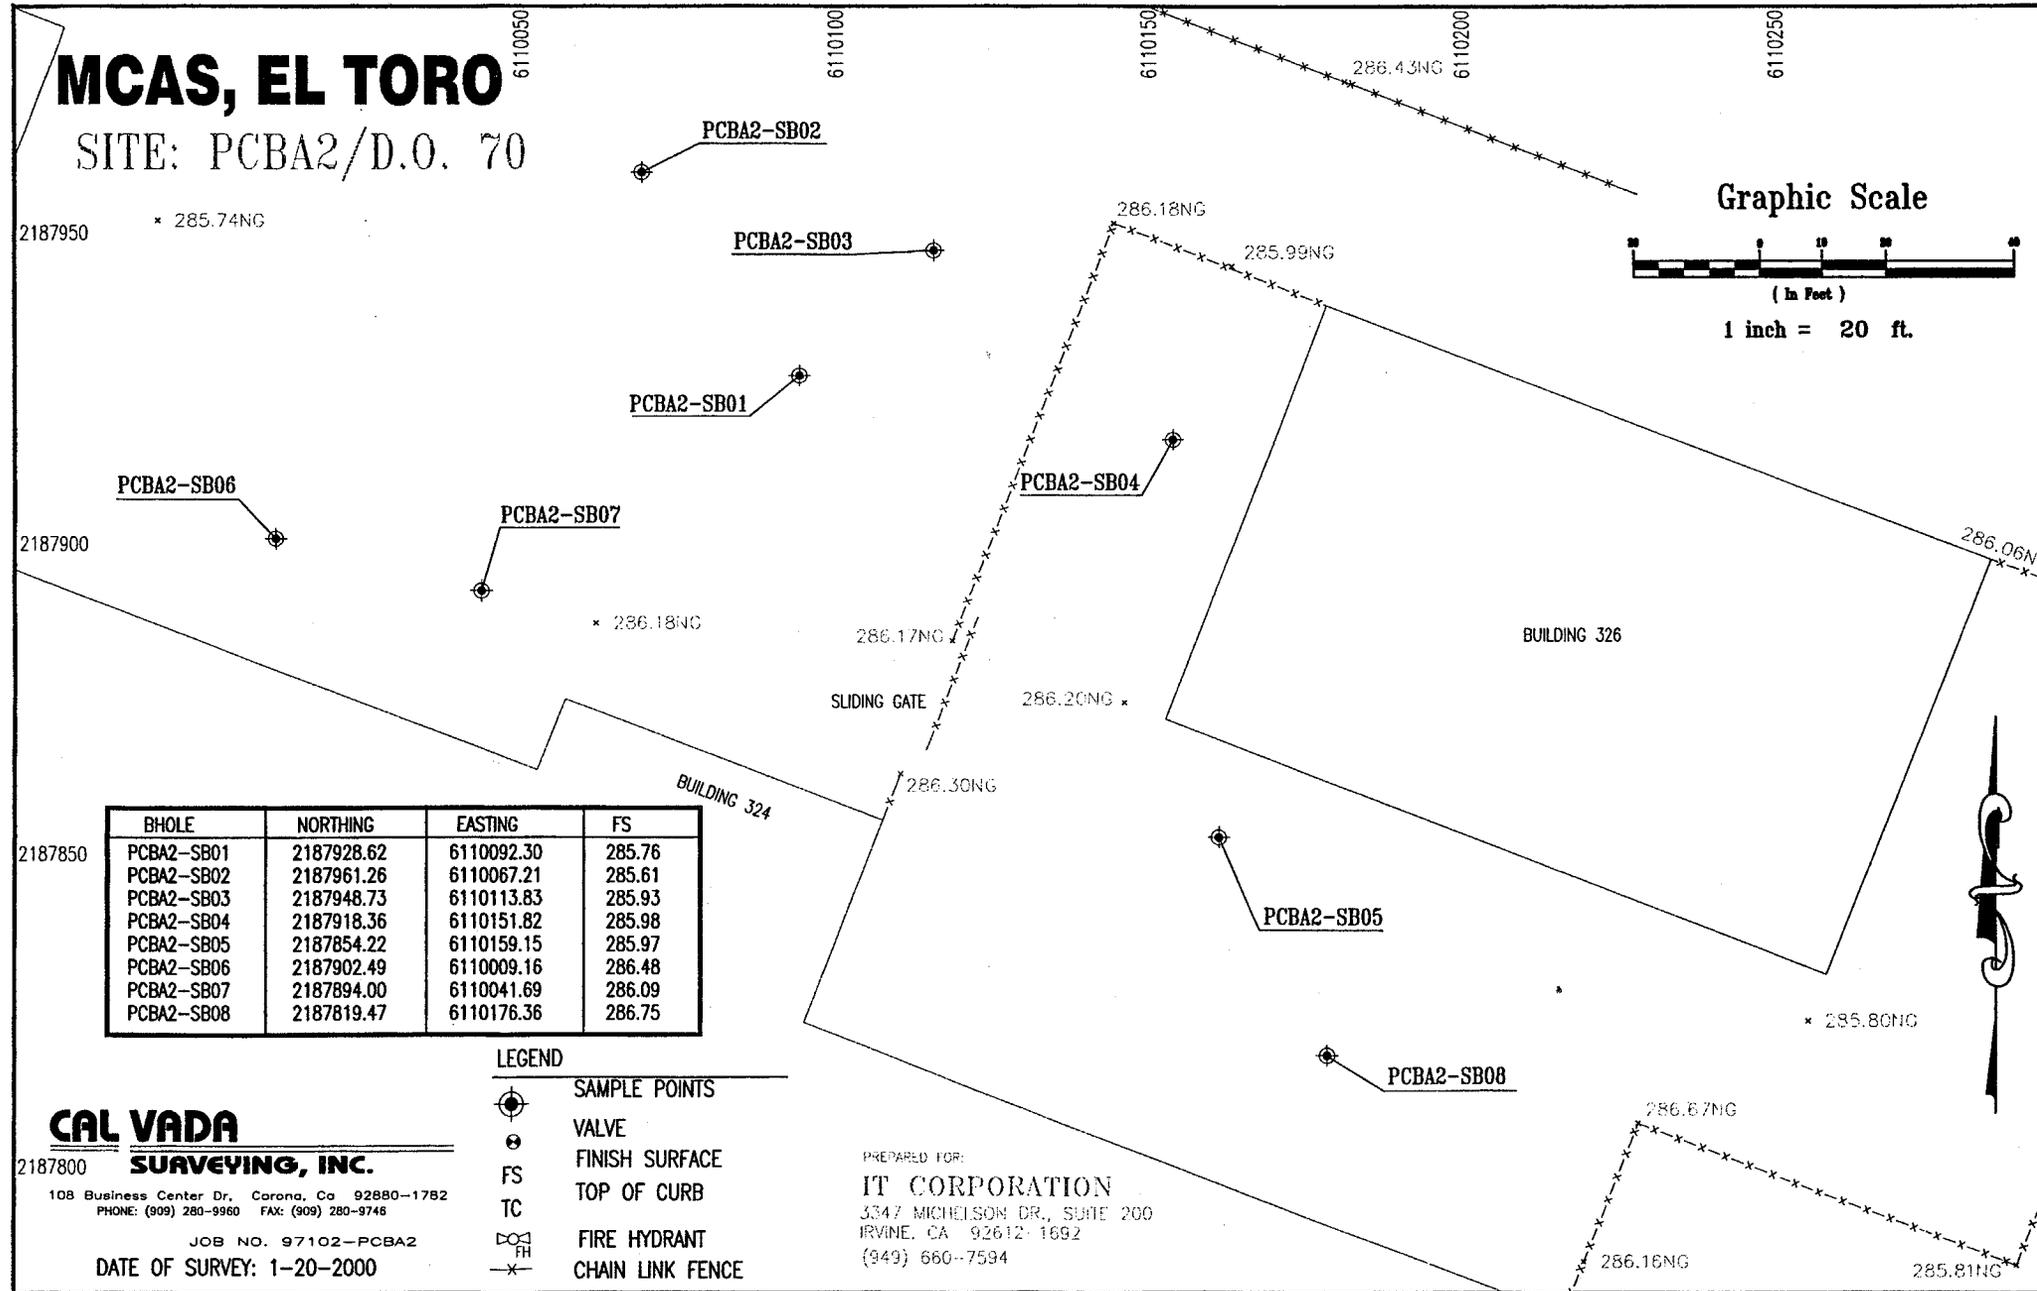
## SITE: PCBA2/D.O. 70

BHOLE	NORTHING	EASTING	FS
PCBA2-SB01	2187928.62	6110092.30	285.76
PCBA2-SB02	2187961.26	6110067.21	285.61
PCBA2-SB03	2187948.73	6110113.83	285.93
PCBA2-SB04	2187918.36	6110151.82	285.98
PCBA2-SB05	2187854.22	6110159.15	285.97
PCBA2-SB06	2187902.49	6110009.16	286.48
PCBA2-SB07	2187894.00	6110041.69	286.09
PCBA2-SB08	2187819.47	6110176.36	286.75

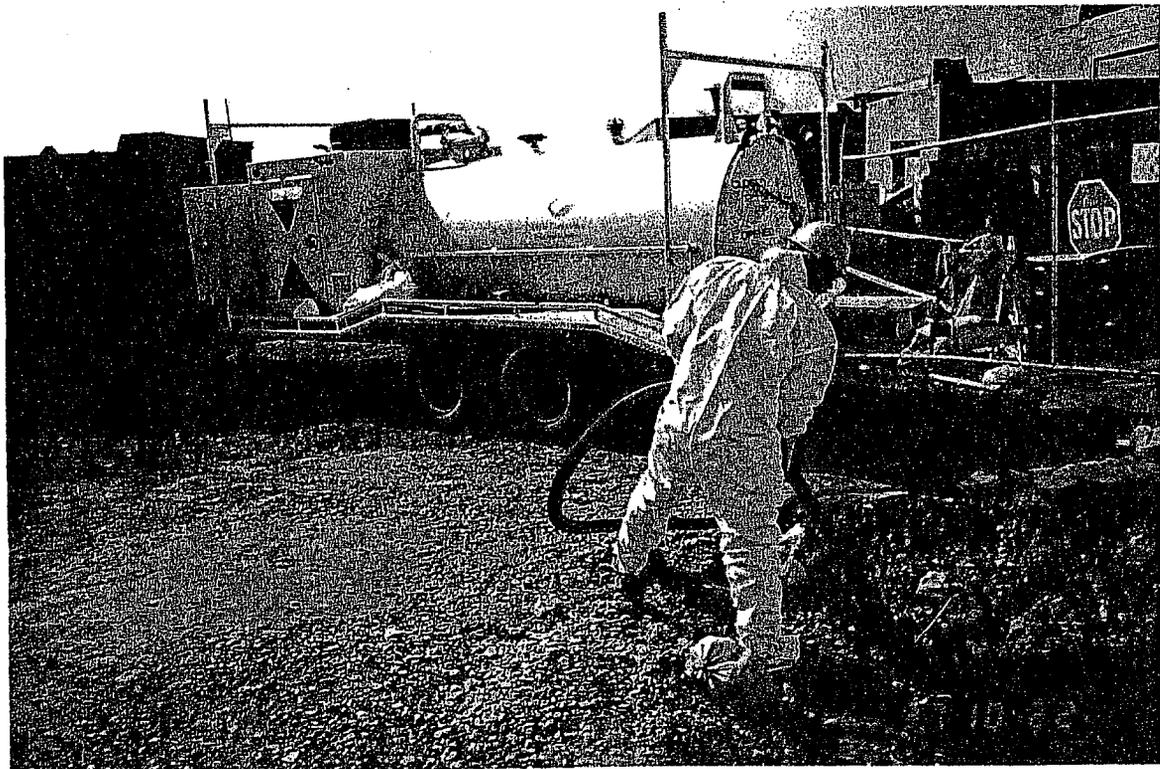
Photograph No. 2: Pumping of liquid products from the USTs 326A and 326B

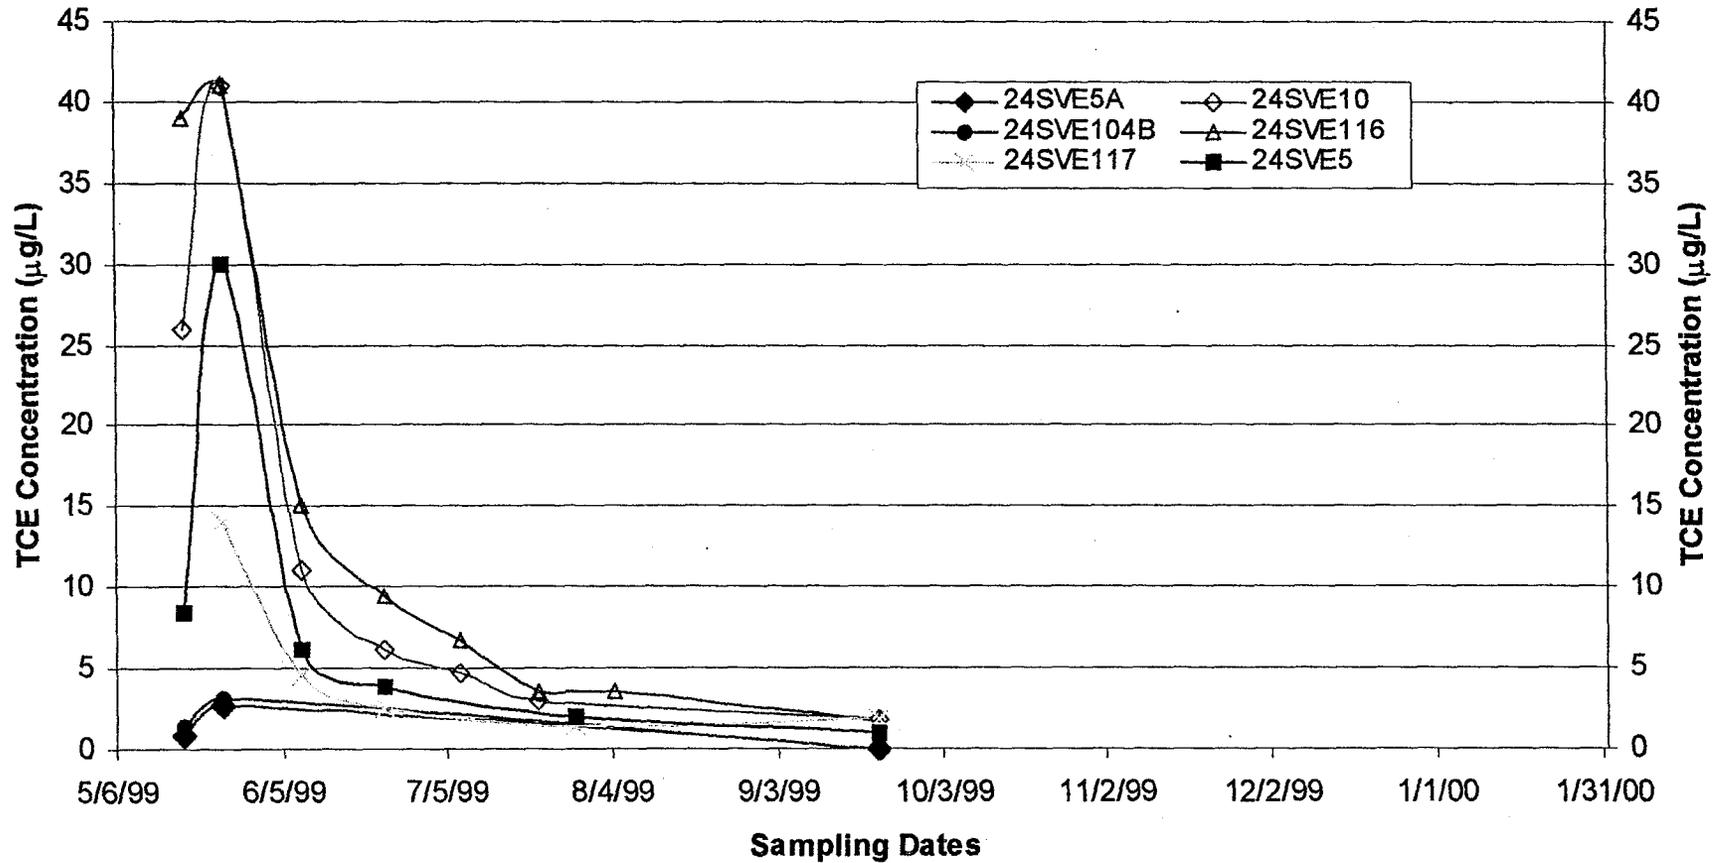
Progress Report - February 2000		
Extracted Vapor Concentrations from SVE Wells - Group I Site 24 - Vadose Zone Remediation		
Date: 2-00	MCAS, El Toro	Figure
Project No. 29307	EARTH

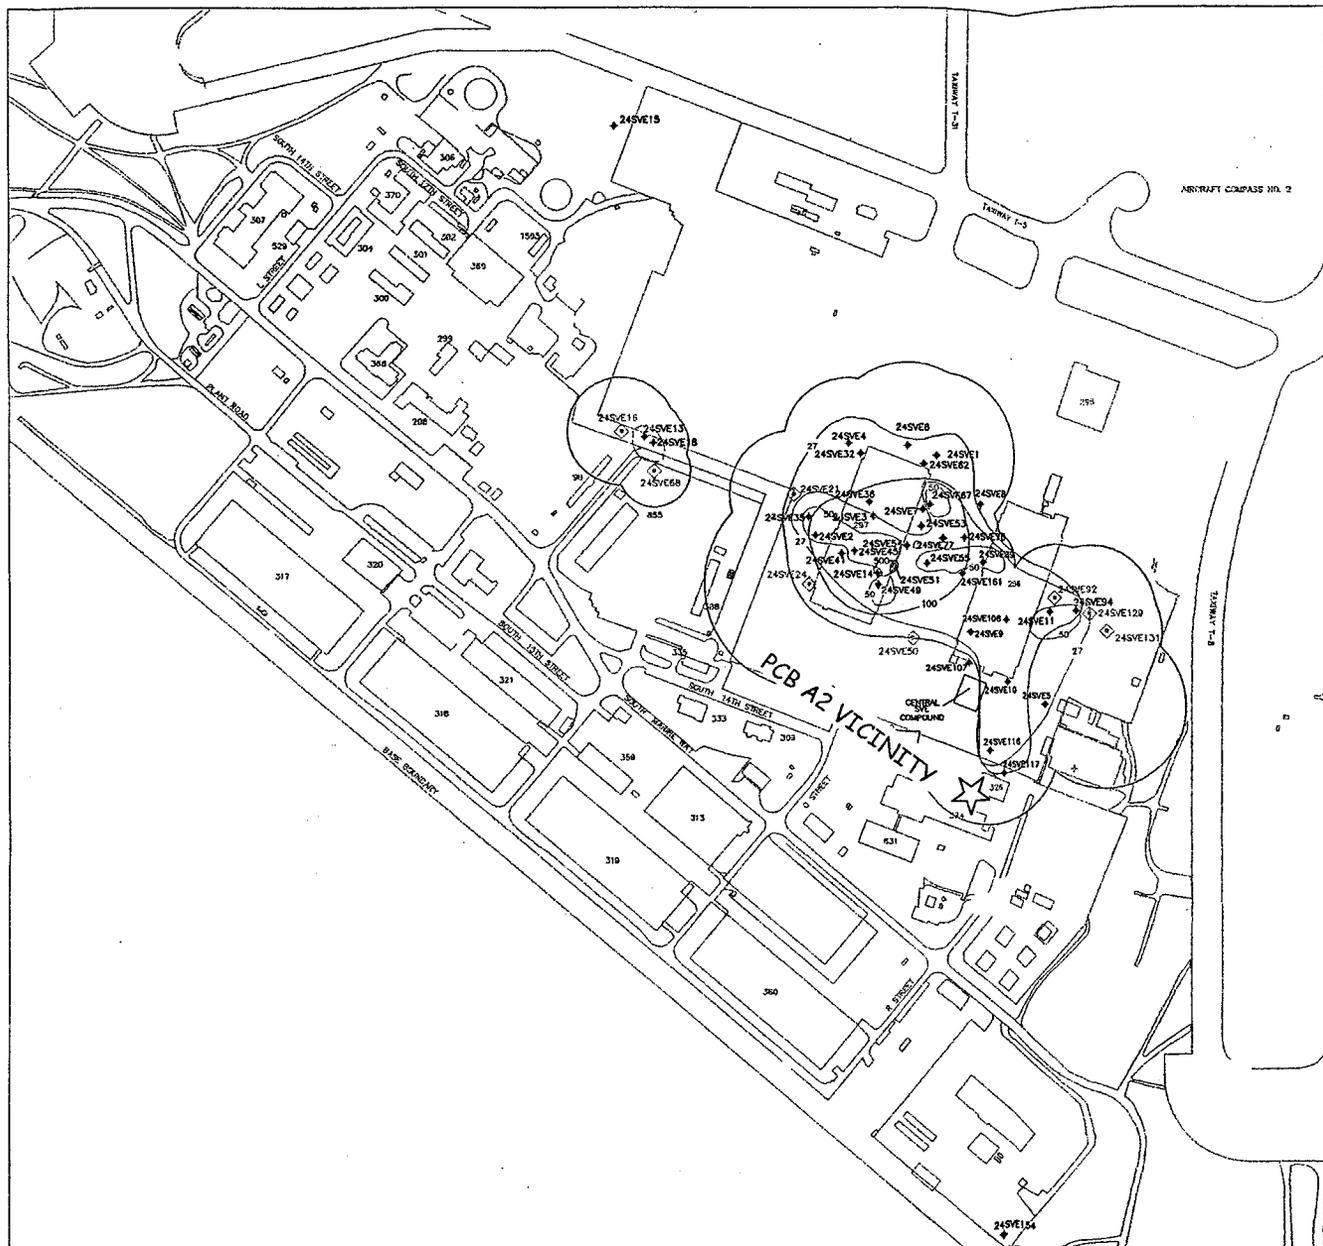
Progress Report - February 2000		
<b>Deep Zone Baseline TCE Concentrations vs EROI and Proposed Well Locations Site 24 - Vadose Zone Remediation</b>		
Date: 2-00	MCAS, El Toro	
Project No. 29307
