CONTRACT NO. N68711-98-D-5713
CTO No. 0022

FINAL
IMPLEMENTATION PLAN
August 7, 2001

VEGETATION CLEARING
AT INSTALLATION RESTORATION SITES 2 AND 17
MARINE CORPS AIR STATION
EL TORO, CALIFORNIA

FOSTER WHEELER ENVIRONMENTAL CORPORATION

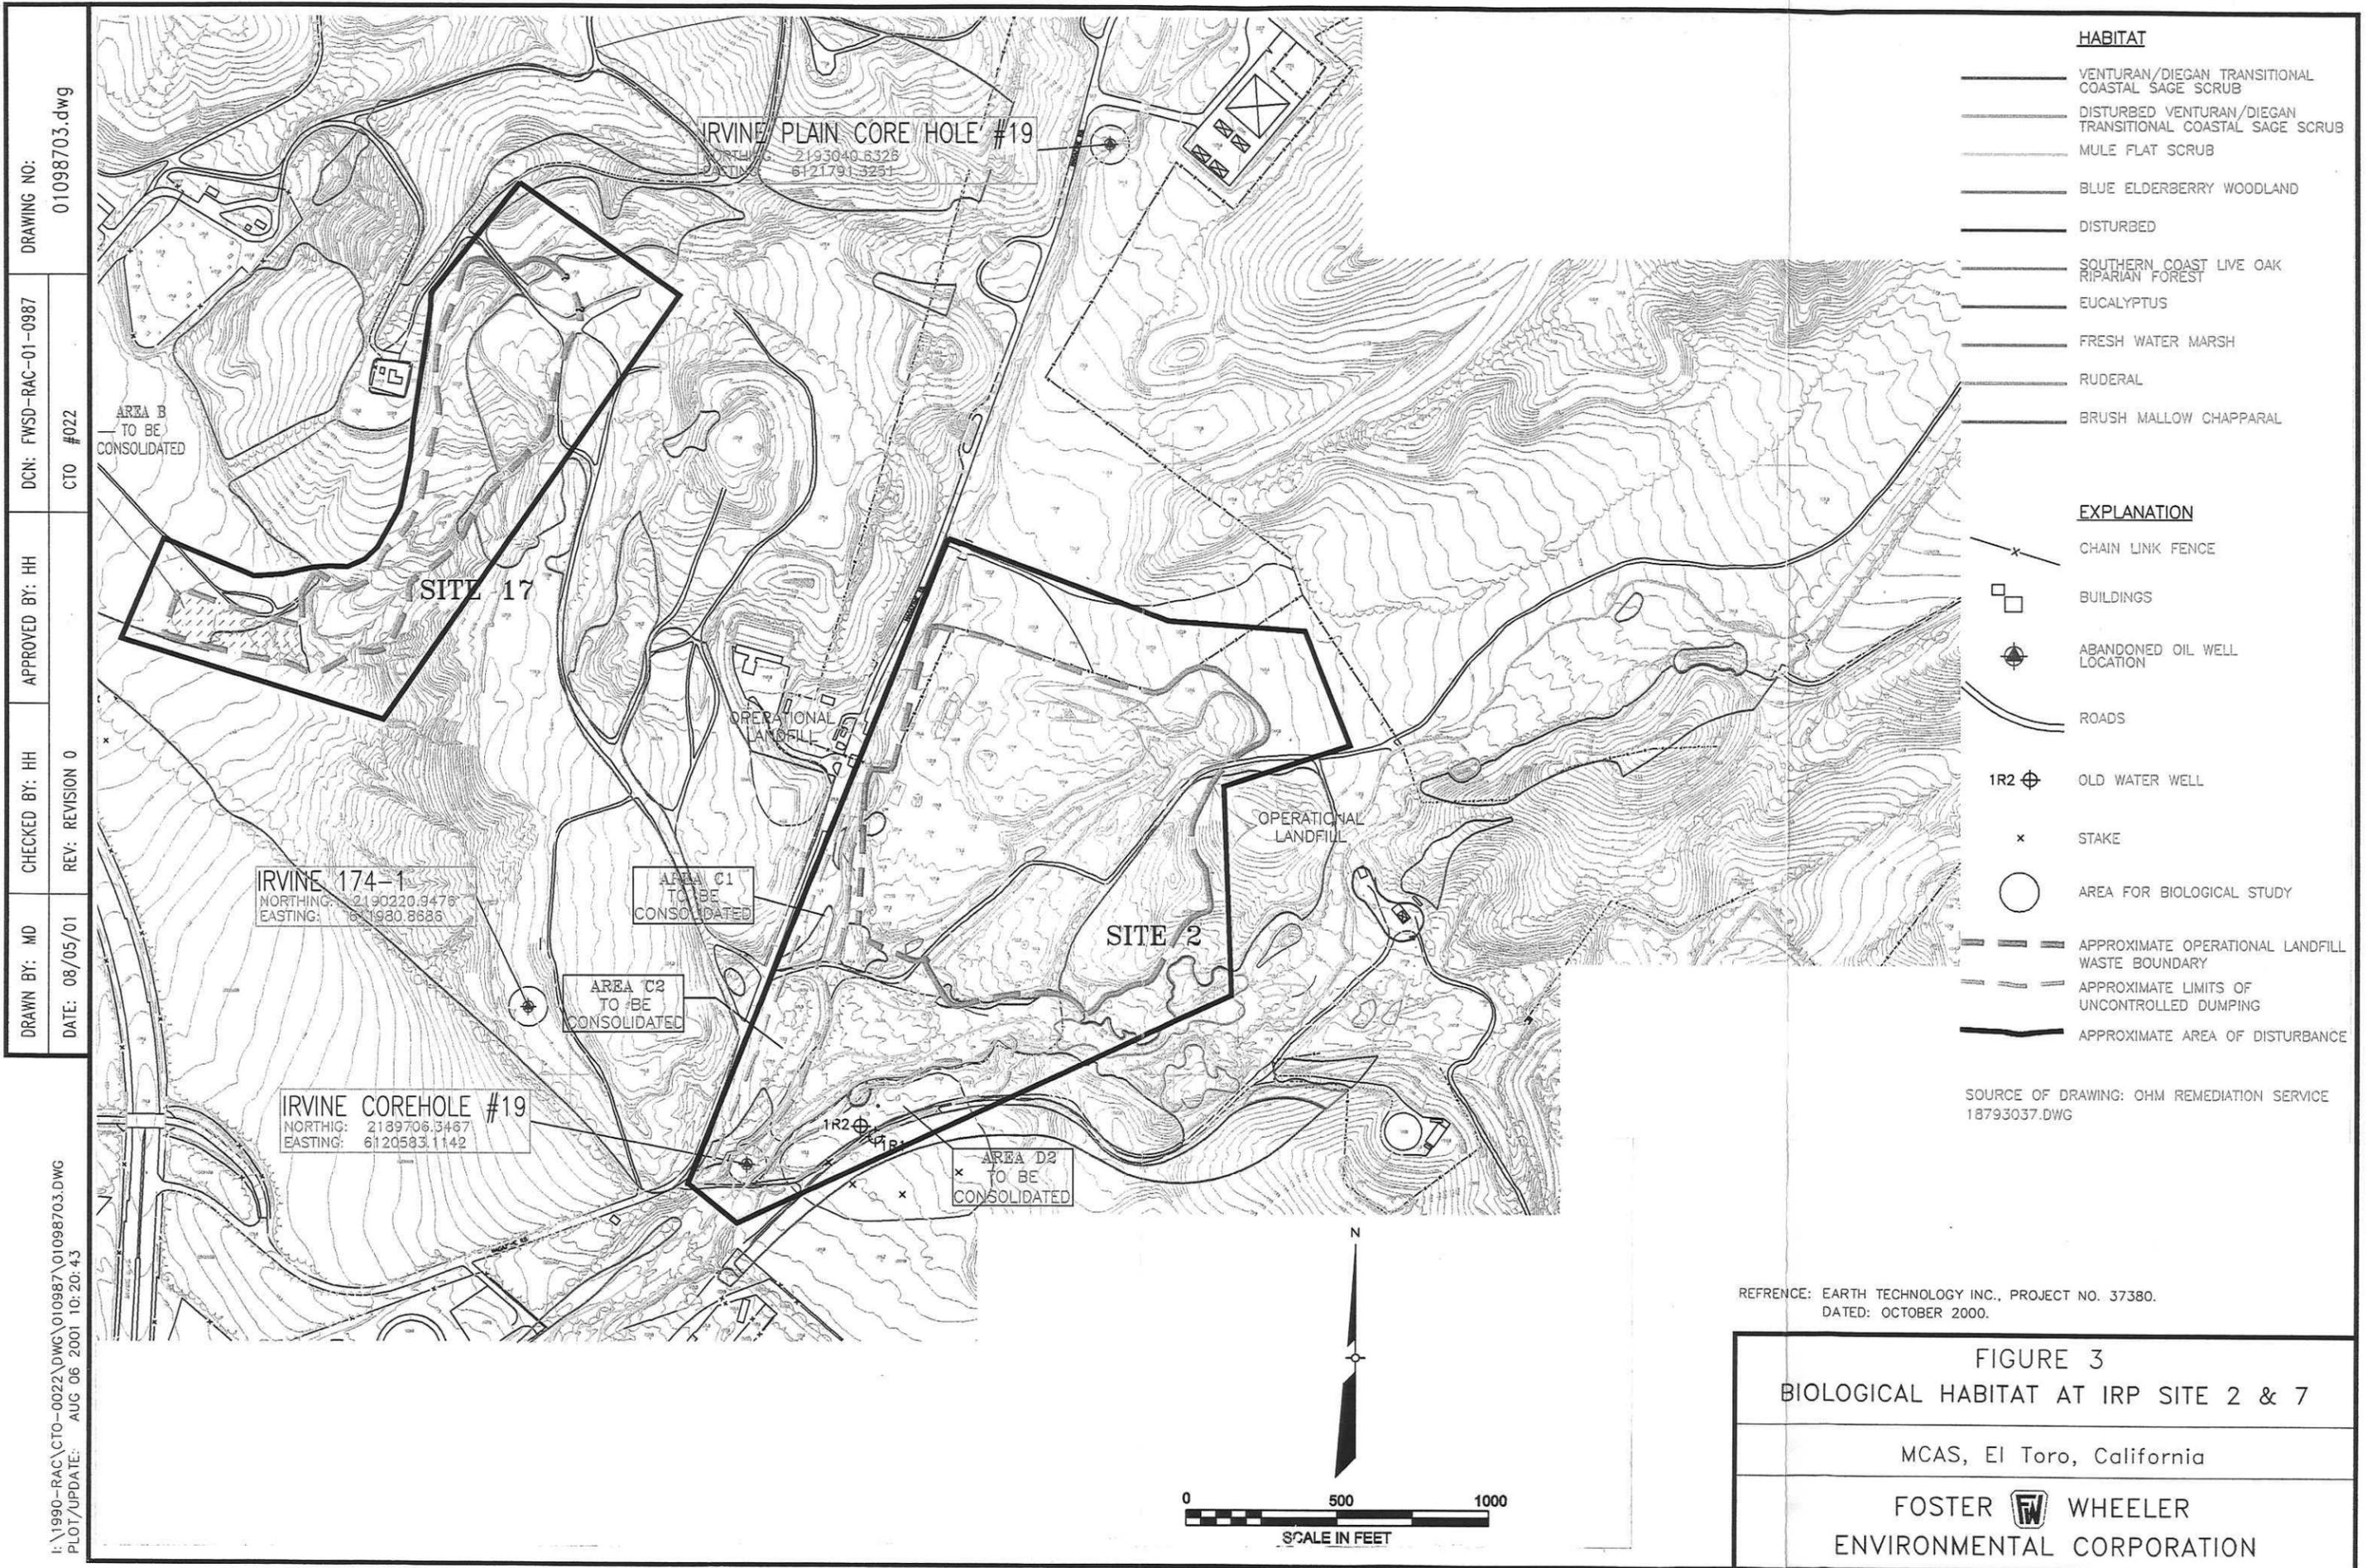
- HABITAT**
- VENTURAN/DIEGAN TRANSITIONAL COASTAL SAGE SCRUB
 - DISTURBED VENTURAN/DIEGAN TRANSITIONAL COASTAL SAGE SCRUB
 - MULE FLAT SCRUB
 - BLUE ELDERBERRY WOODLAND
 - DISTURBED
 - SOUTHERN COAST LIVE OAK RIPARIAN FOREST
 - EUCALYPTUS
 - FRESH WATER MARSH
 - RUDERAL
 - BRUSH MALLOW CHAPPARAL
- EXPLANATION**
- X — CHAIN LINK FENCE
 - BUILDINGS
 - ⊙ ABANDONED OIL WELL LOCATION
 - ROADS
 - 1R2 ⊕ OLD WATER WELL
 - X STAKE
 - AREA FOR BIOLOGICAL STUDY
 - — — APPROXIMATE OPERATIONAL LANDFILL WASTE BOUNDARY
 - — — APPROXIMATE LIMITS OF UNCONTROLLED DUMPING
 - — — APPROXIMATE AREA OF DISTURBANCE

IRP Site 2, Magazine Road Landfill, is located in the foothills of the Santa Ana Mountains in the northeastern portion of MCAS El Toro (Figure 3). IRP Site 2 occupies approximately 27 acres and is situated at the lower end of the Borrego Canyon drainage basin. Borrego Canyon Wash enters IRP Site 2 from the east and exits at the south end of the site onto the Tustin Plain. A tributary channel enters the site from the west and joins the main Borrego Canyon Wash in the southern half of IRP Site 2. Site 2 is bounded on the west by Magazine Road and on the south and east by a dirt road.

IRP Site 17, Communications Station Landfill (Figure 3), occupies approximately 11 acres (Earth Tech, 2000). It is located in a small canyon between Borrego Canyon Wash and Aqua Chinon Wash in the northeast portion of MCAS El Toro (west of the Magazine Road Landfill). It extends beyond the canyon mouth onto a flat, weed-covered field that was formerly used for agriculture (Figure 5).

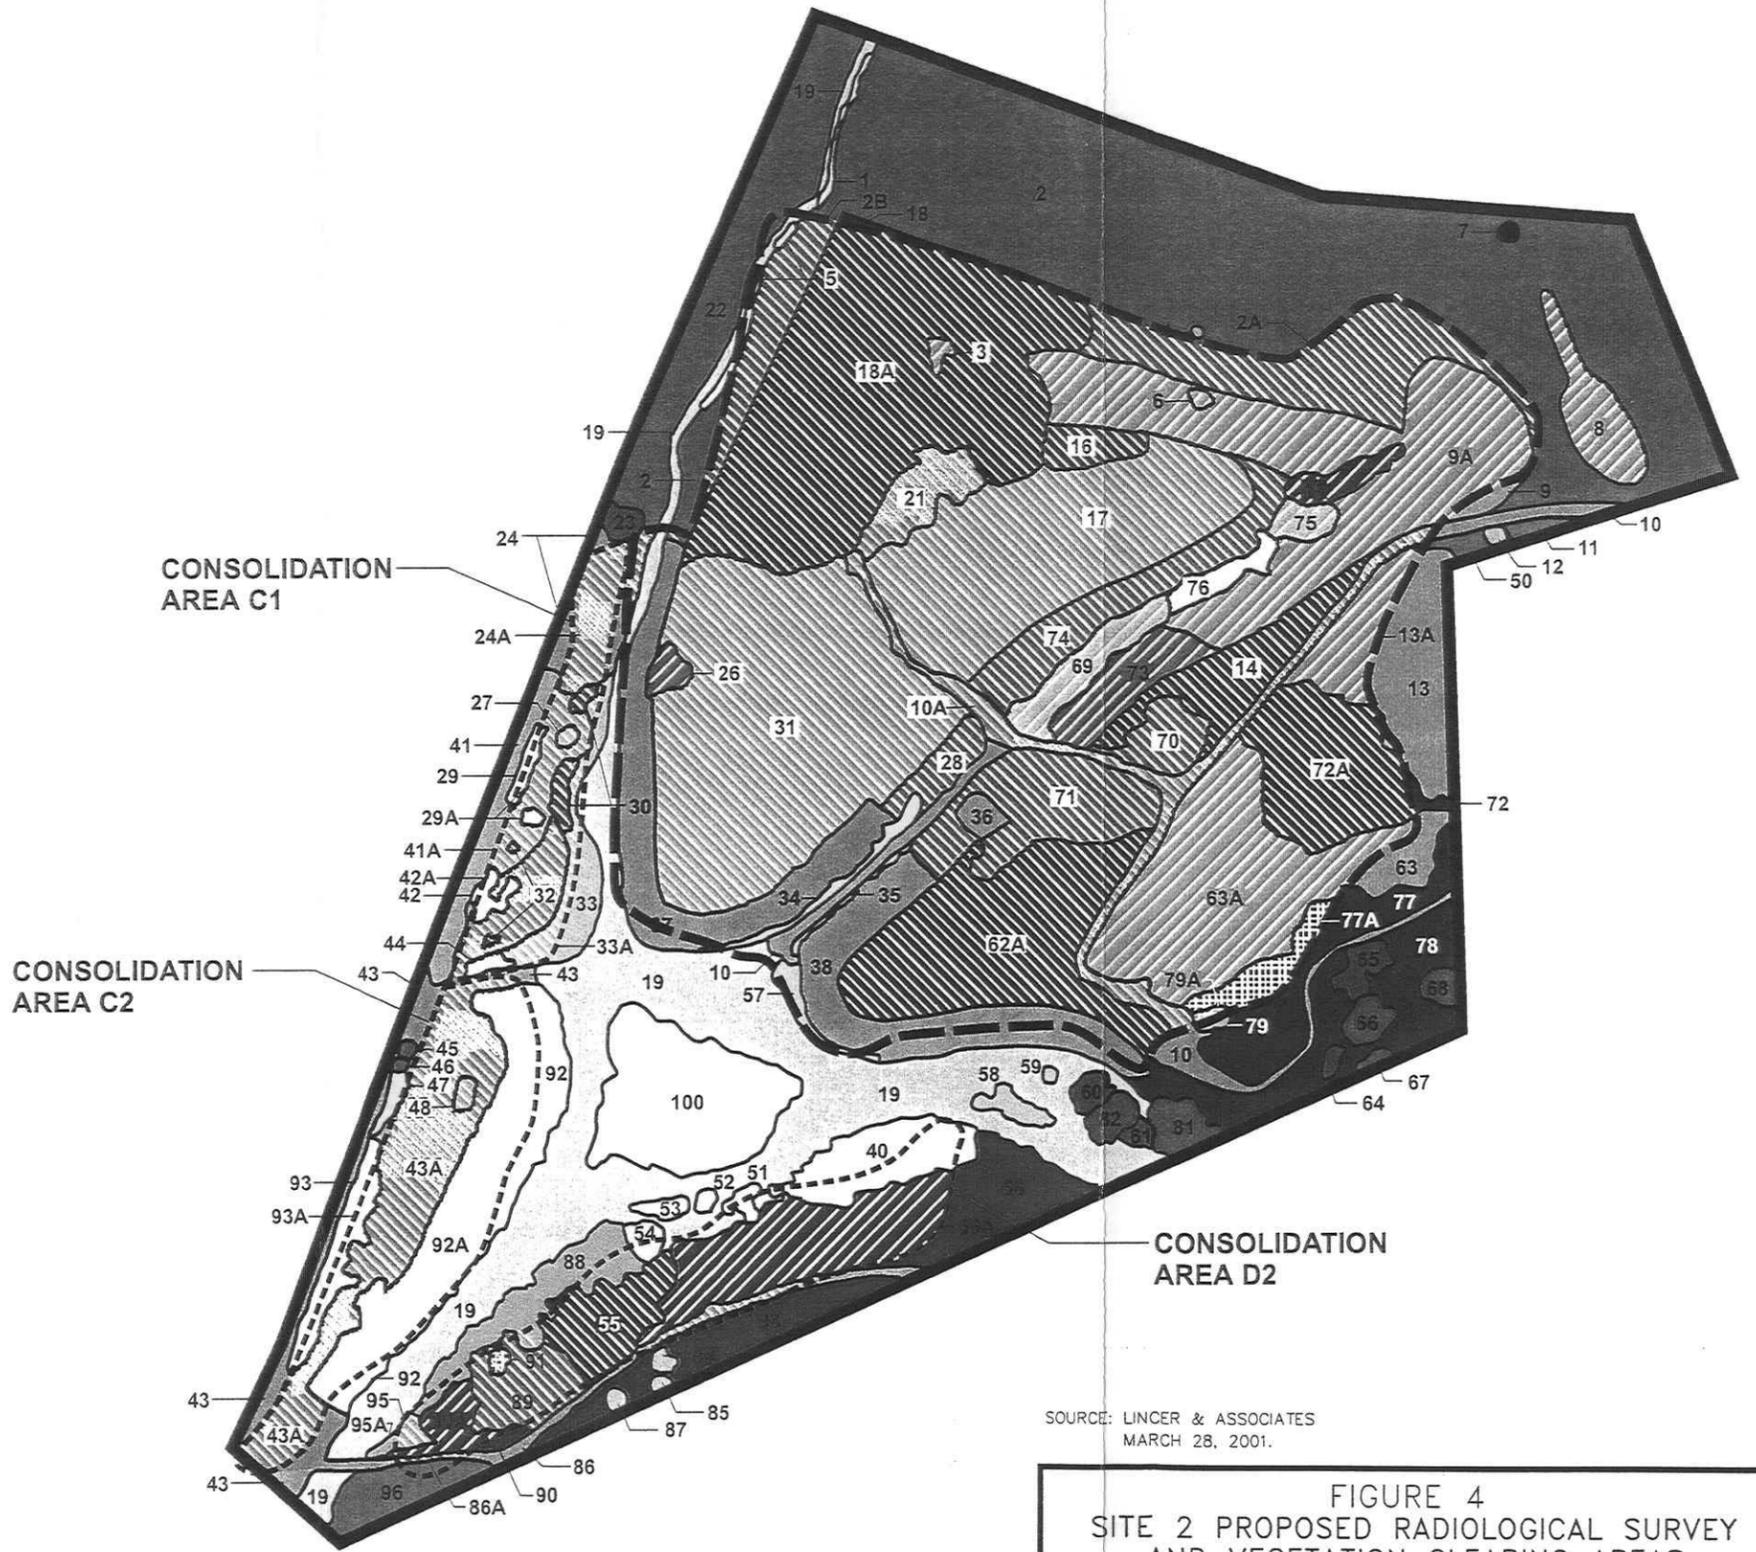
FIGURE 4
SITE 2 PROPOSED RADIOLOGICAL SURVEY AND VEGETATION CLEARING AREAS
MCAS, El Toro, California
FOSTER

SOURCE: LINCER & ASSOCIATES
MARCH 28, 2001.

IRP Site 2 consists of six waste disposal areas. These areas are identified as Areas A, B, C₁, C₂, D₁, and D₂ (Figure 4). Areas A and B are considered the main operational areas of the landfill. A fill cover of unknown thickness has been placed over Areas A and B. Areas D₁ and D₂ include scattered surface debris and waste piles that were dumped at these locations. An unlined drainage

channel (man-made) that trends northeast southwest bisects the site between Areas A and B. Clearing of vegetation will occur at Areas A, B, C₁, C₂, and D₂.

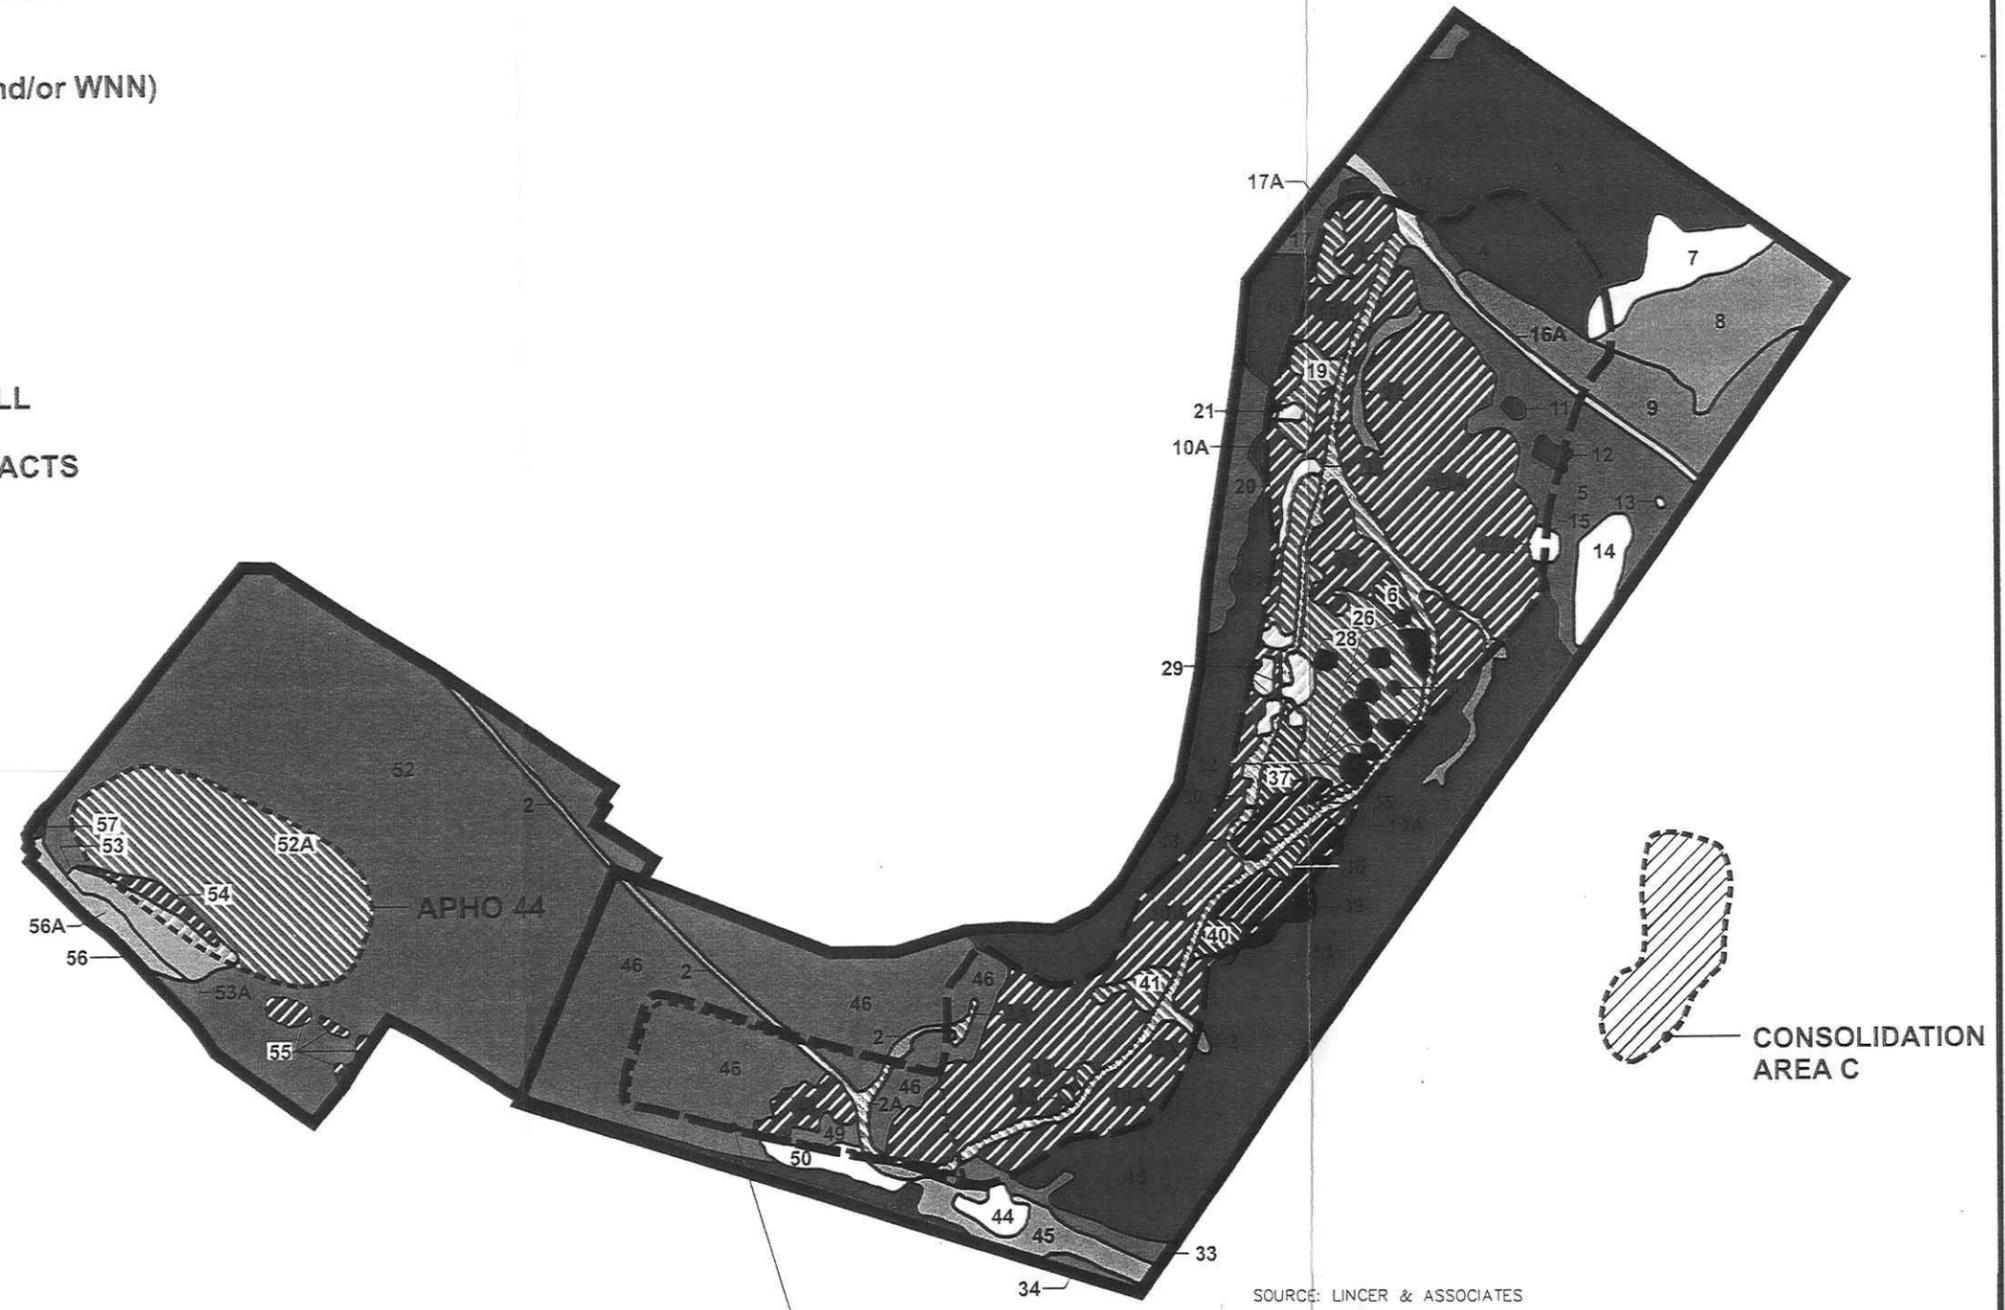
FIGURE 5
SITE 17 AND APHO 44 PROPOSED RADIOLOGICAL SURVEY AND VEGETATION CLEARING AREAS
MCAS, El Toro, California
FOSTER

SOURCE: LINCER & ASSOCIATES
MARCH 28, 2001.

higher local moisture levels (e.g., non-wetland stands of mulefat and elderberry; see Figures 5 and 6). The determination of unsuitability of these areas for gnatcatchers based on vegetation structure is supported by a lack of recorded sightings throughout the survey history of the area, as detailed above.

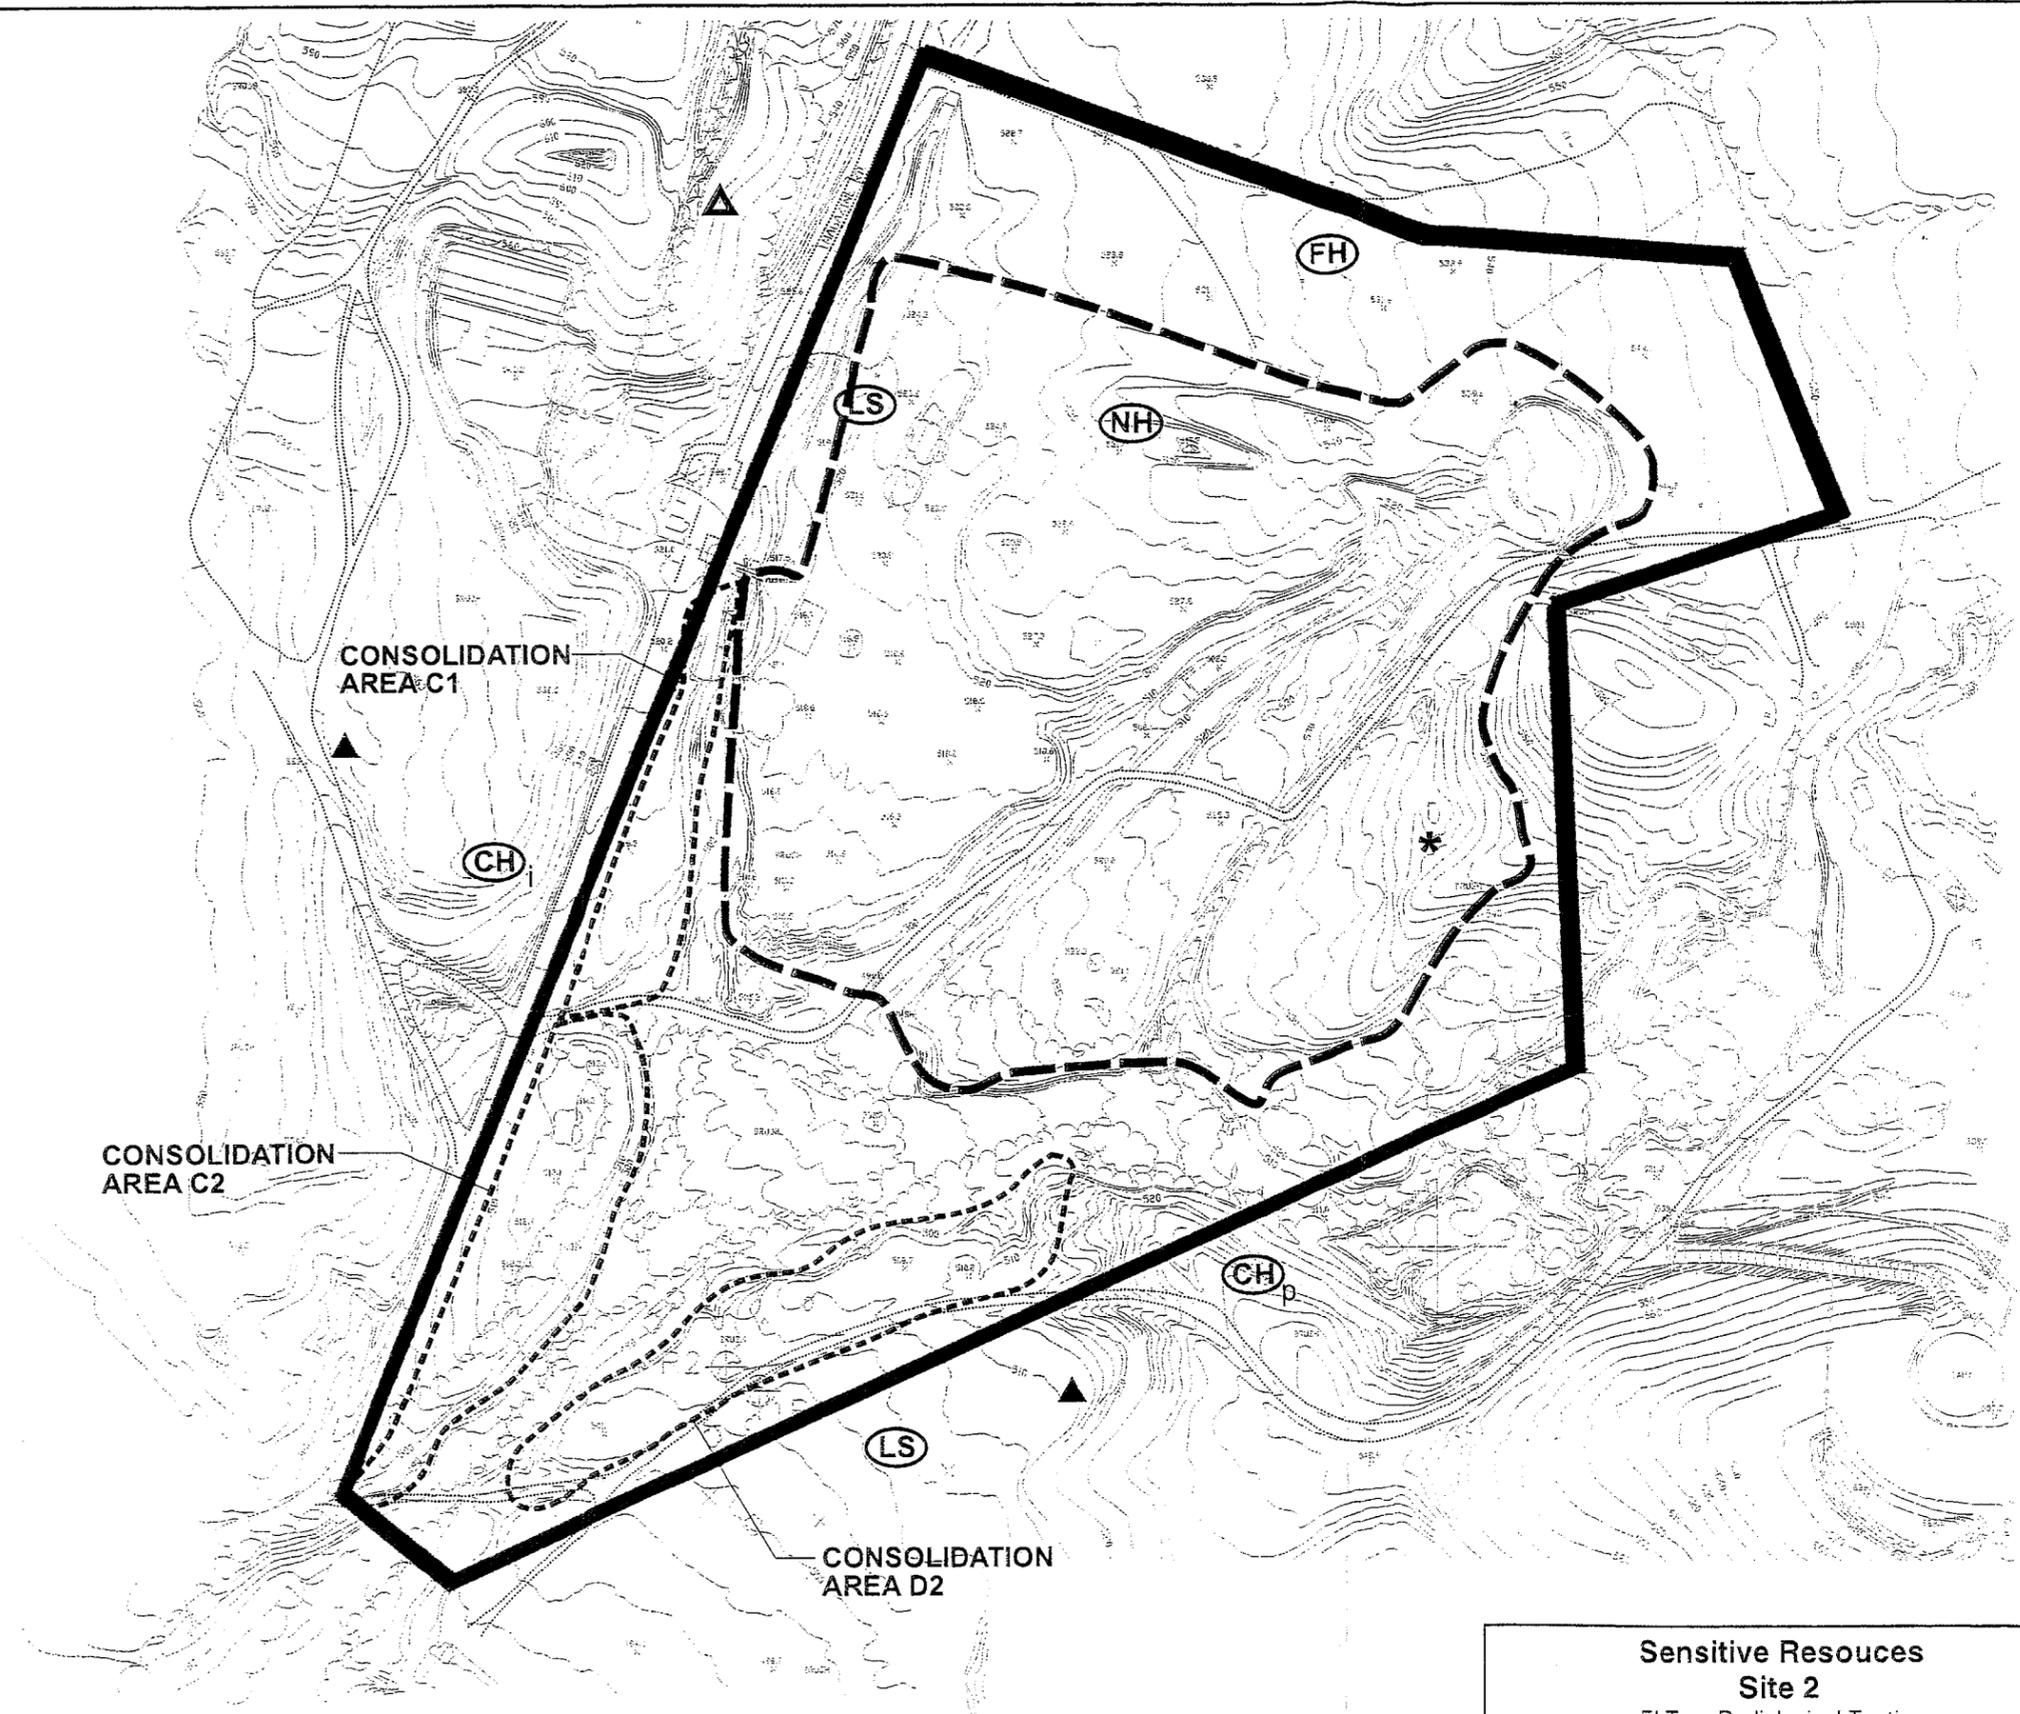
- ESTIMATED LIMIT OF HISTORIC LANDFILL
- █ MAXIMUM LIMITS OF REMEDIATION IMPACTS
- * Gnatcatcher Winter Use Area
- ▲ Coastal California Gnatcatcher (pair)
- △ Coastal California Gnatcatcher (defending male)
- (LS) Loggerhead Shrike
- (CH)_p Cooper's Hawk (pair)
- (CH)_i Cooper's Hawk (immature)
- (NH) Northern Harrier
- (FH) Ferruginous Hawk

The results of current gnatcatcher surveys on Site 2 show consistent use of the vicinity by gnatcatchers. Current gnatcatcher surveys (Lincer & Associates, in prep.) suggest that one pair of gnatcatchers likely nests beyond the operational landfill, roughly two to three hundred feet south of Consolidation Area D2 (Figure 3). A second location, discovered during the first three of the nine recent protocol surveys, has been of a single individual just within the "estimated limit of historical landfill." This bird was observed utilizing both DCSS and RUD-C habitat (Figure 5). However, this bird has not been seen during the last six surveys (2/9, 2/16, 2/22, 3/7, 3/15, and 3/22/01). This is the same area where two or three gnatcatchers were observed by J. Lincer (Lincer and Associates) and J. Lovio (SWDIV Natural Resource Office) in the winter of 2000-2001. Since the positive sightings were made early in the season, it is very possible that this individual was simply foraging in winter habitat (CSS recovering from a fire a few years ago) and has since moved to better habitat for breeding.

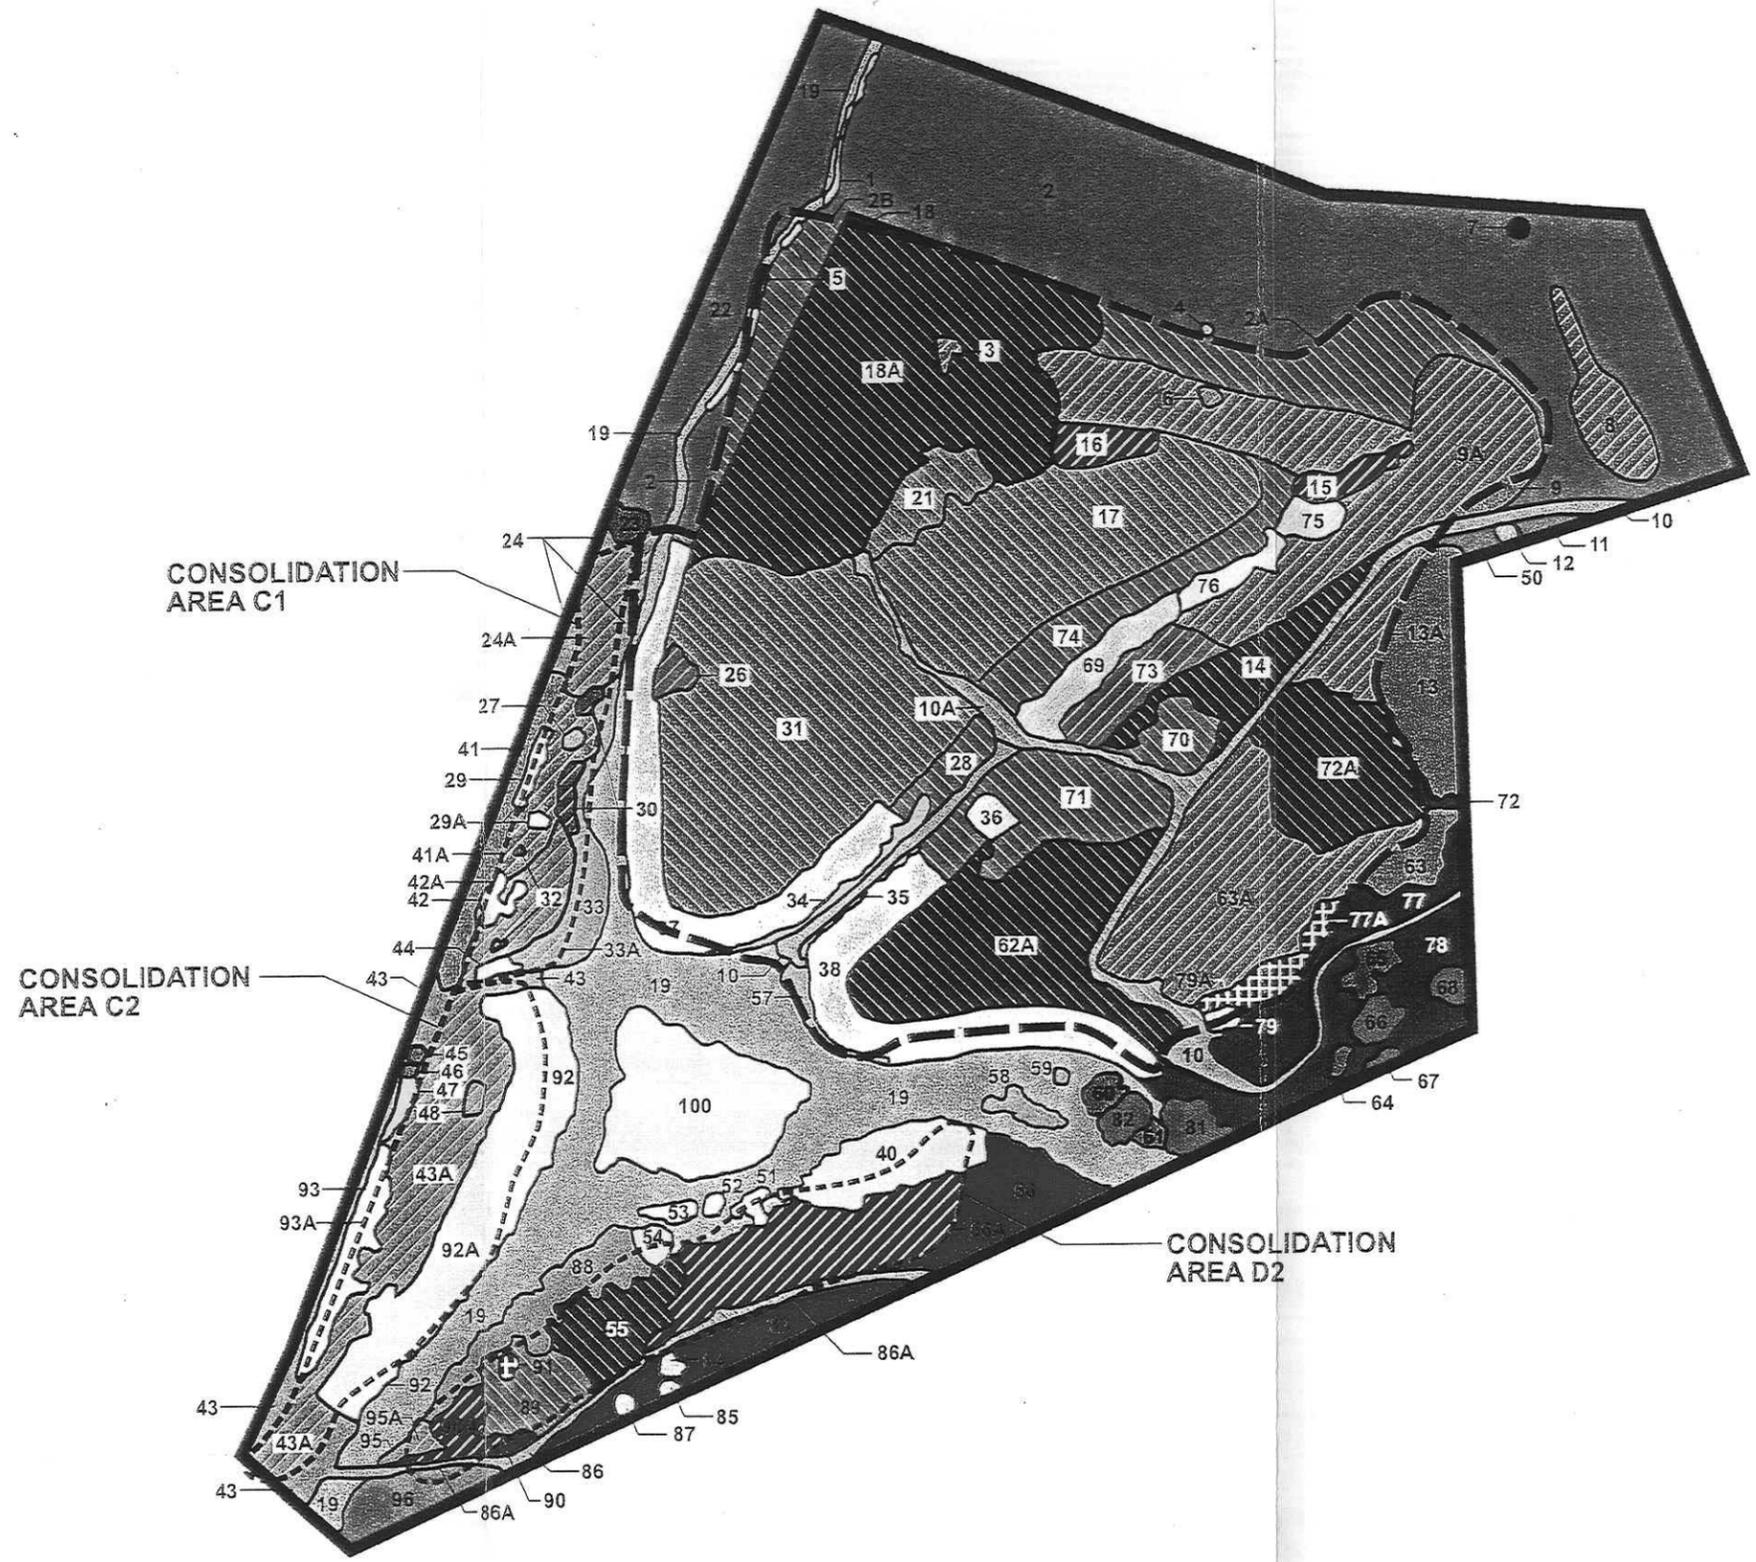
Proposed Brush Clearing Site 2		
El Toro Radiological Testing		
Date 4-01	MCAS El Toro California	
Project No. 37380	EARTH

No radiological testing (no pattern).

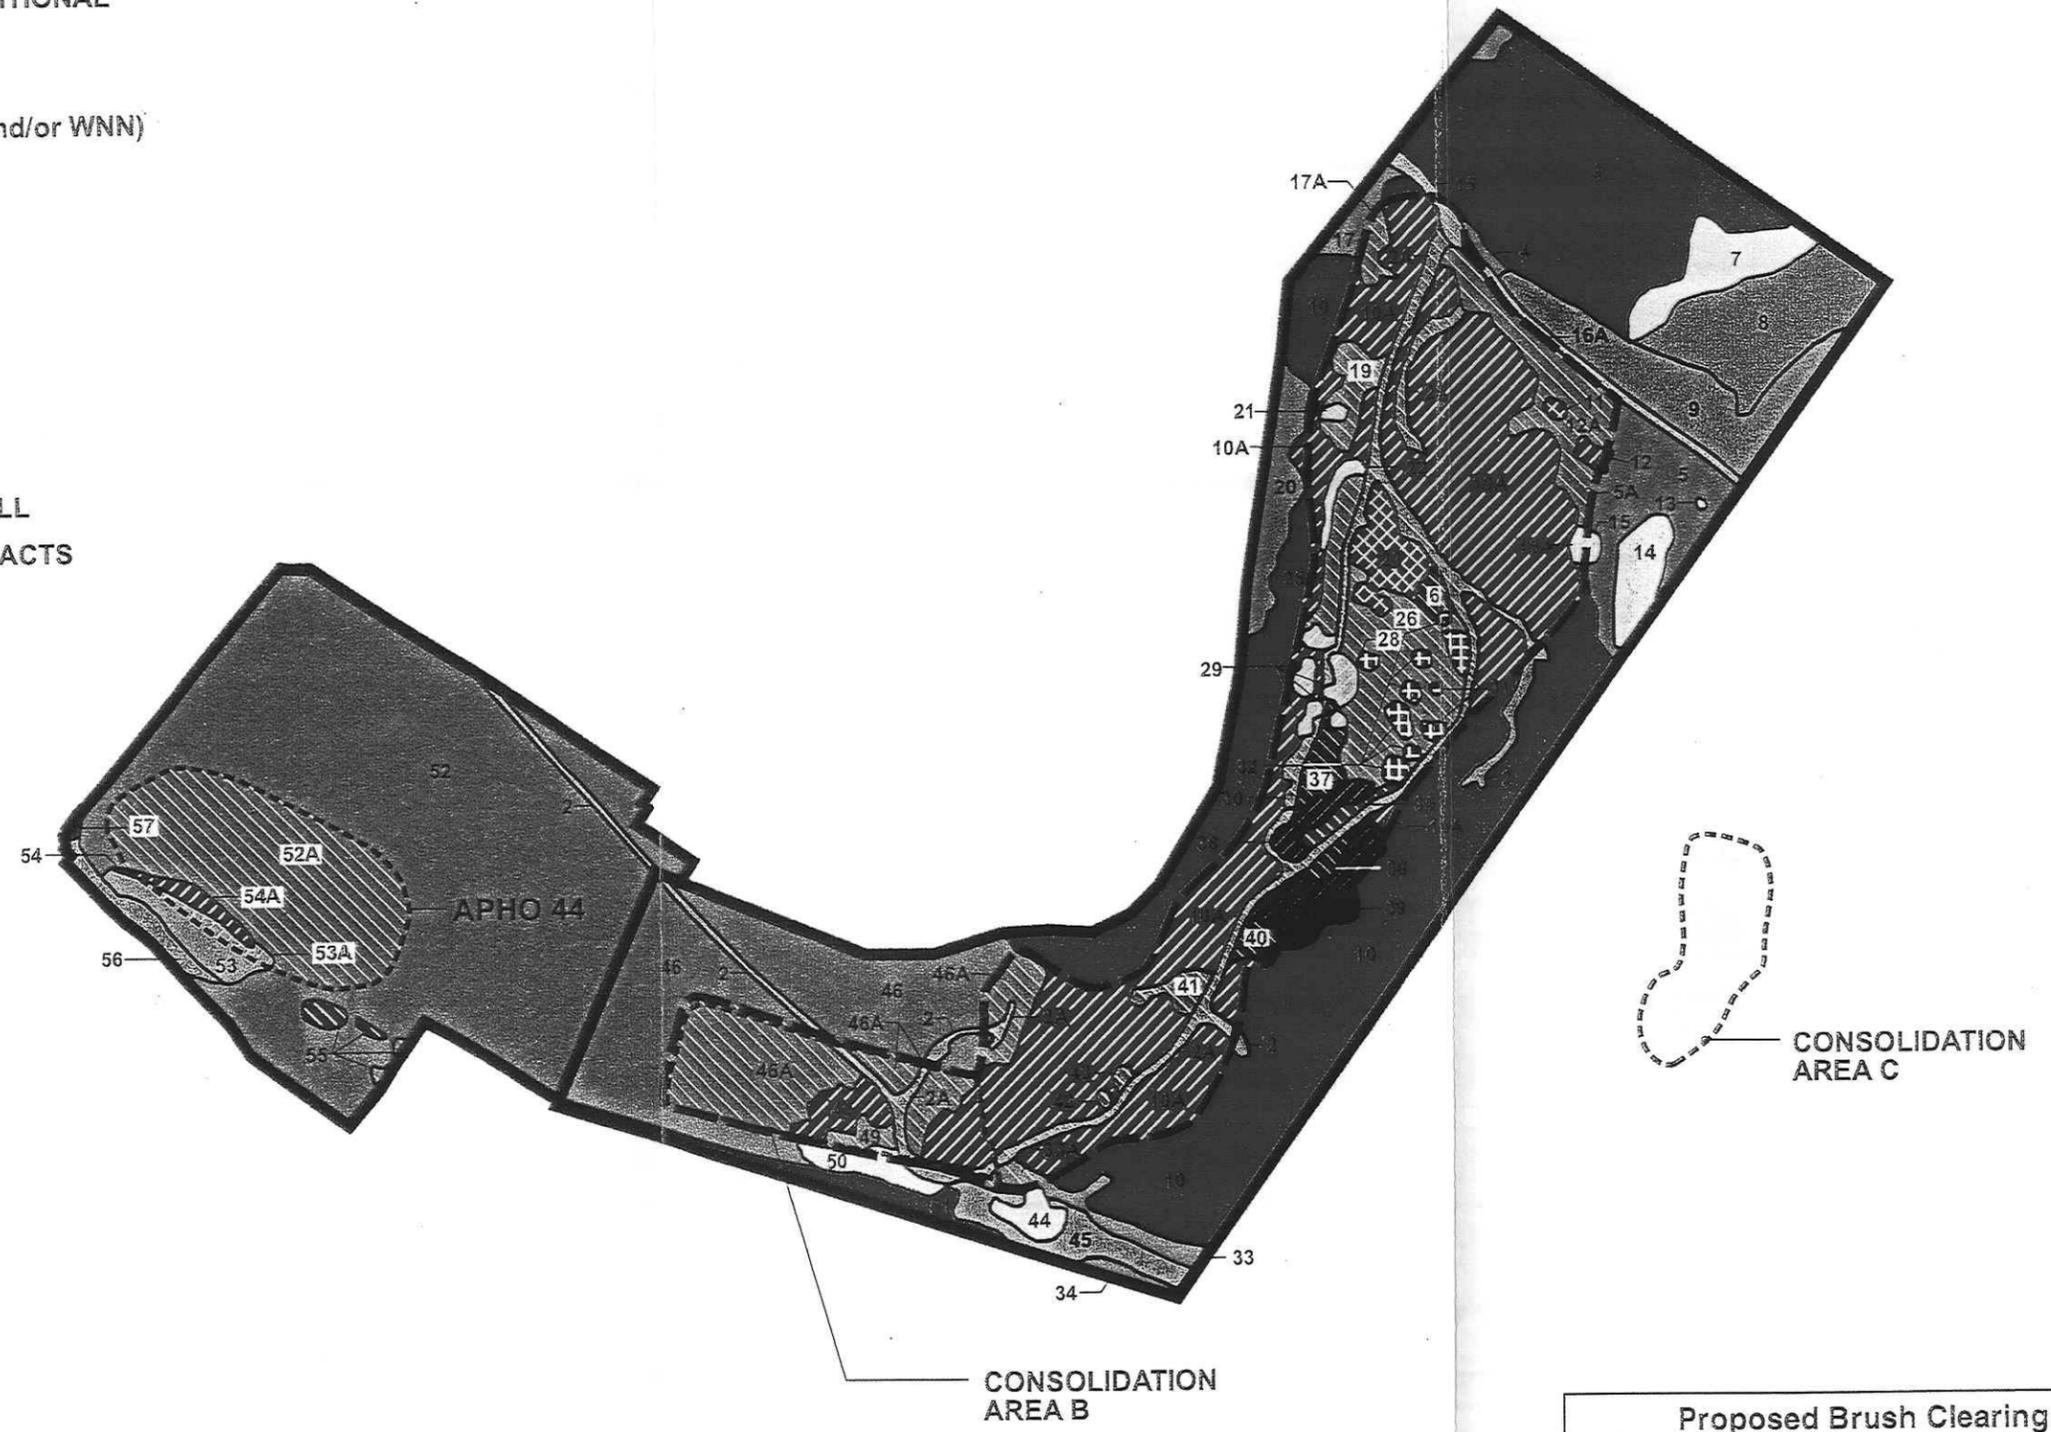
Proposed Brush Clearing		
Site 17		
El Toro Radiological Testing		
Date 4-01	MCAS El Toro California	Figure
Project No. 37380	EARTH

No radiological testing (no pattern).
