# Summary Report

*Former Temporary Accumulation Area (TAA) Number 626*  
Marine Corps Air Station, El Toro, California

15 August 2001

*Prepared by:*  
Southwest Division, Naval Facilities Engineering Command  
BRAC Programs Office  
San Diego, CA 92101-2404

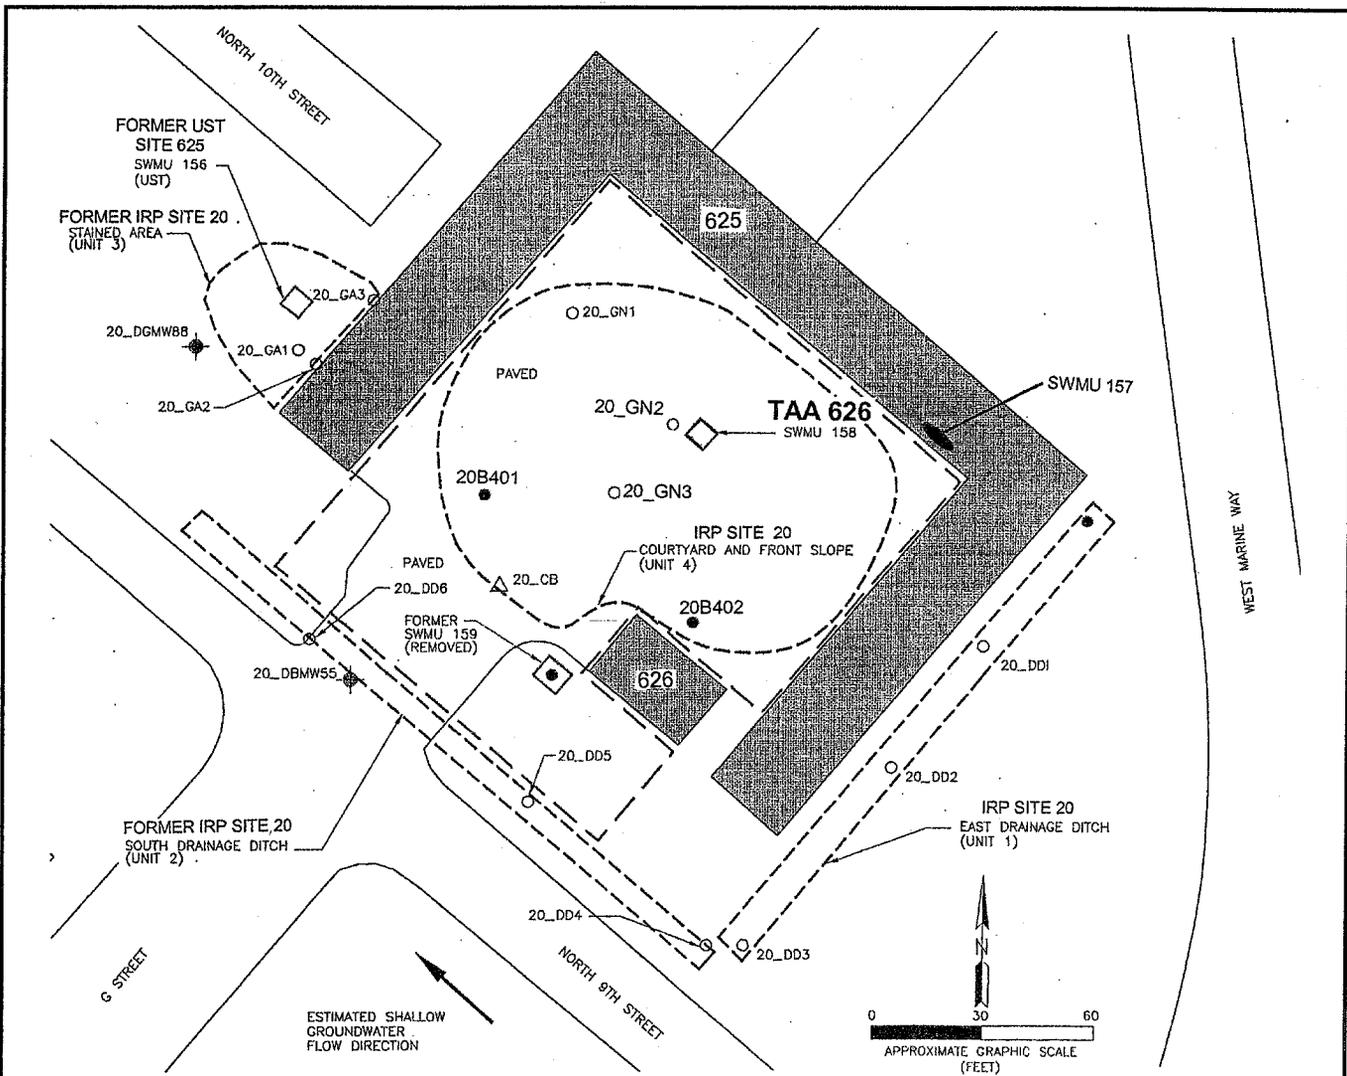
**Figure 1.**  
**FORMER TEMPORARY ACCUMULATION AREA 626**  
**SOLID WASTE MANAGEMENT UNIT 158**

**VICINITY MAP**

NOTE: THE APPROXIMATE LOCATION OF TAA 626 IS IDENTIFIED WITH A STAR SYMBOL: ☆

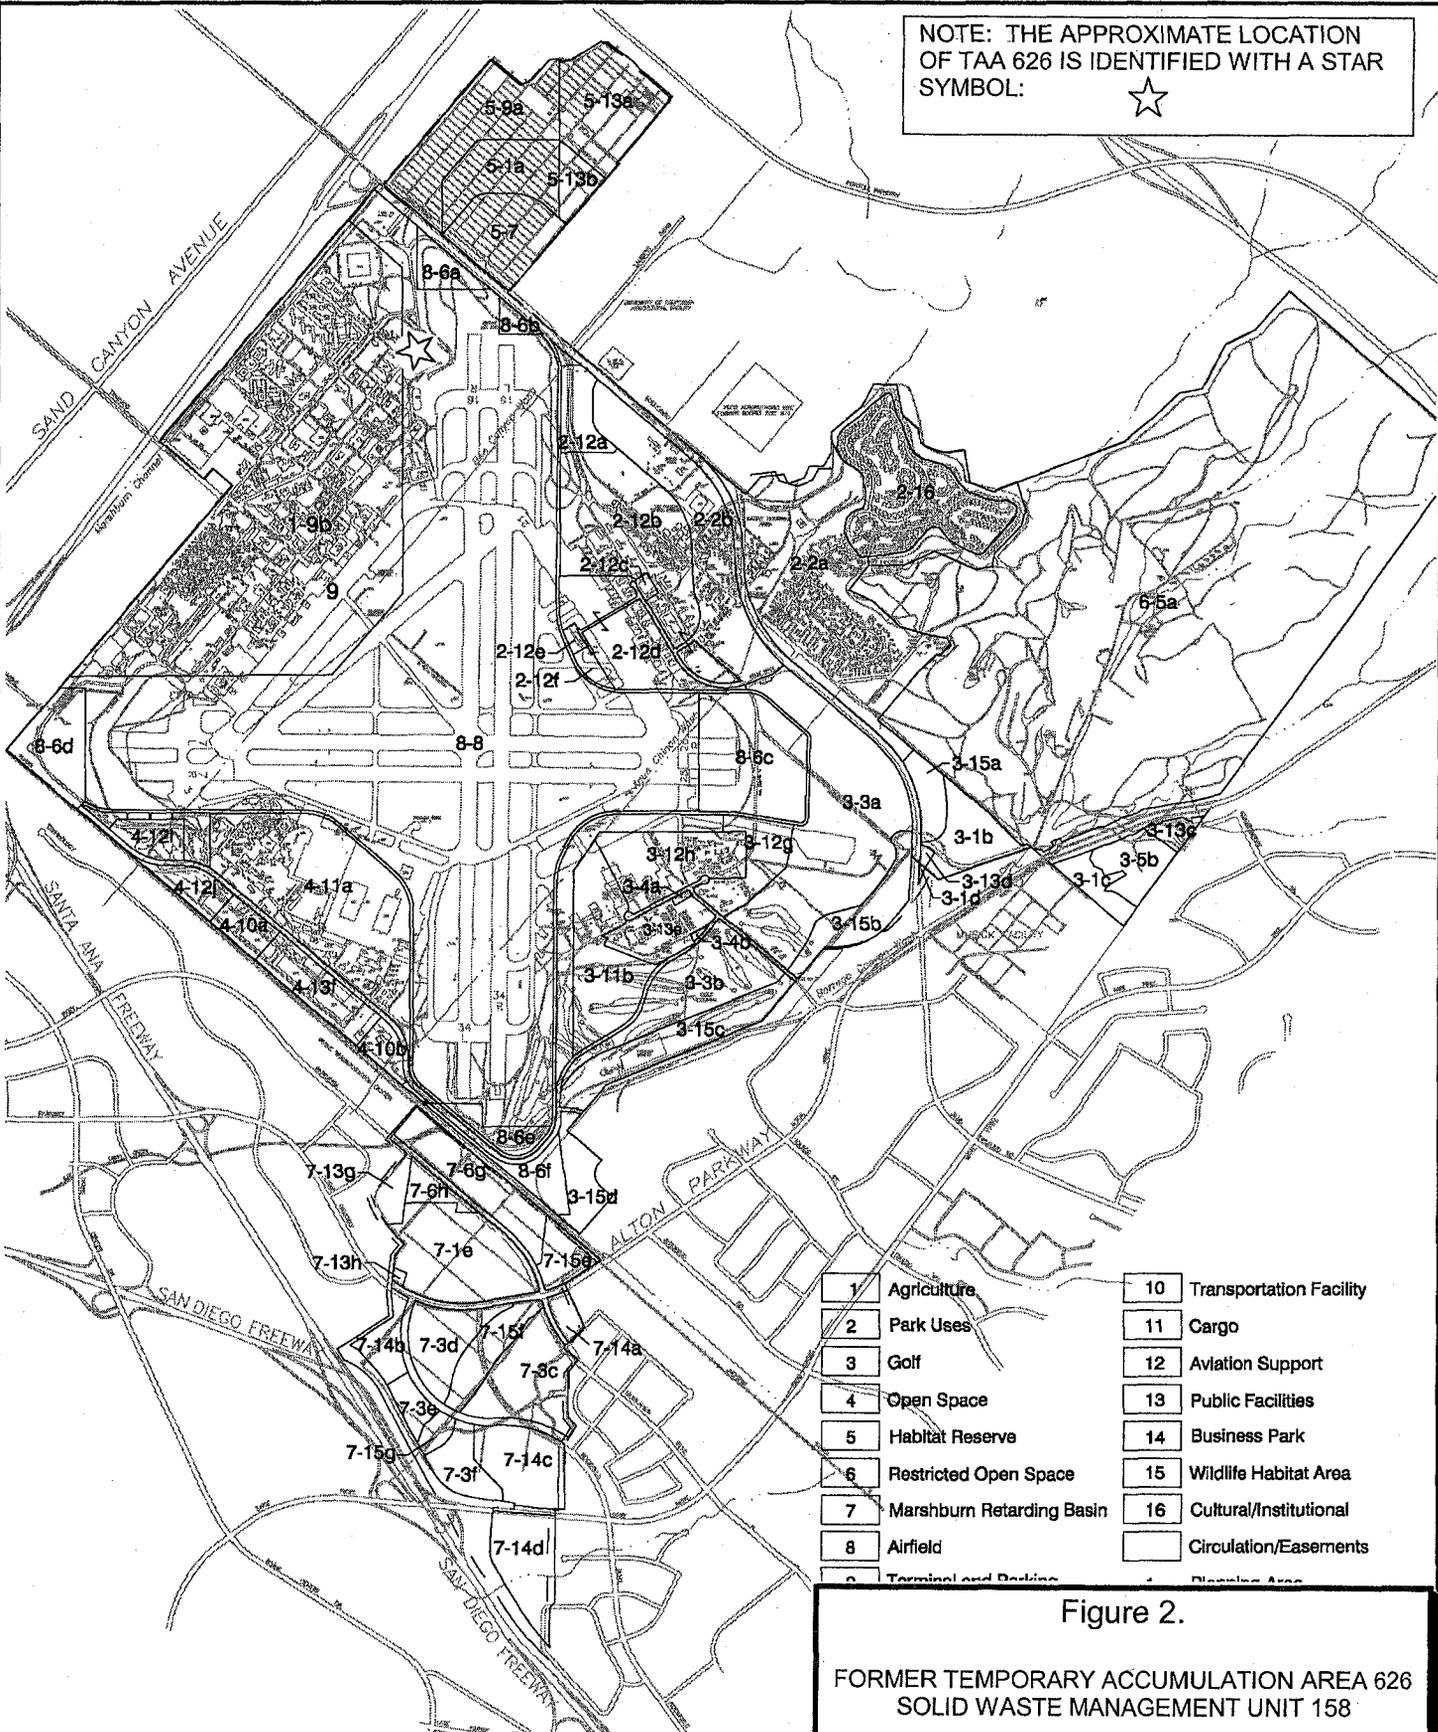
NOTE: PARCEL IDENTIFIERS ARE PROVIDED FOR THE PURPOSE OF ILLUSTRATION AND ARE SUBJECT TO FINAL DESIGN AND PHASING.

The Station closed on 2 July 1999 in accordance with the Base Realignment and Closure Act of 1993 (BRAC III). Former TAA Site 626 is located within a parcel designated for future use as the airfield according to *The Preferred Land Use Plan, Concept B* (County of Orange, August 1999) as shown on Figure 2.

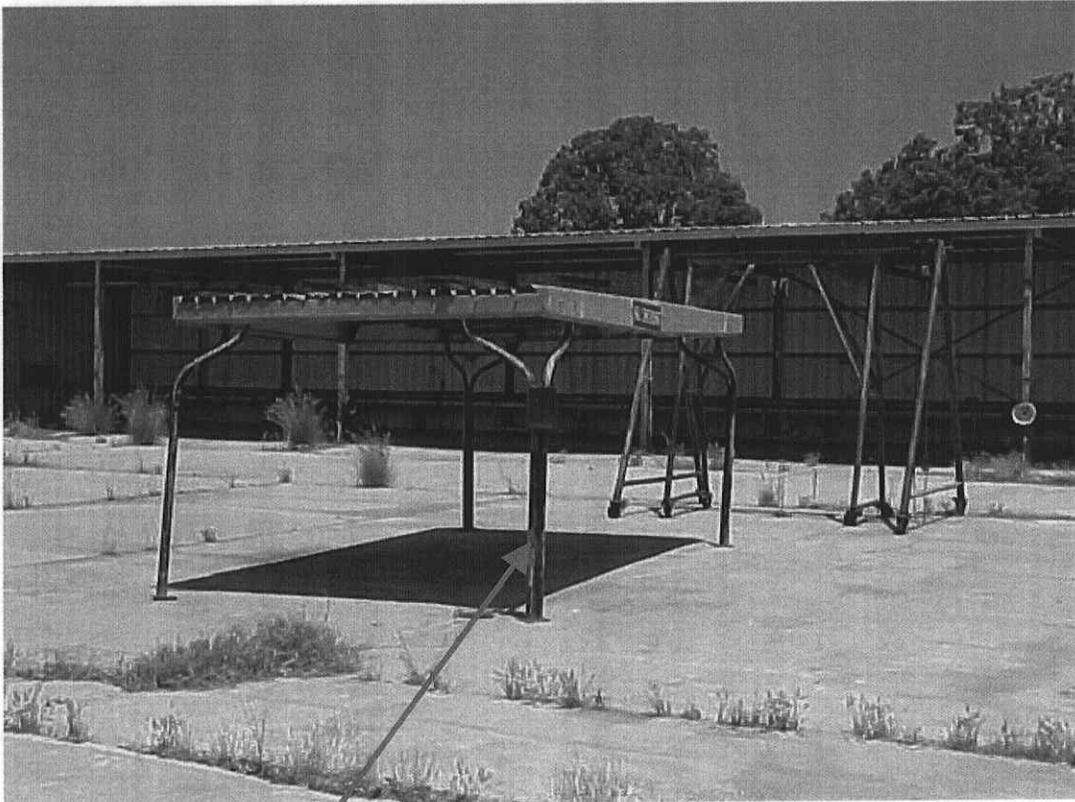
**Photograph 1. Former Temporary Accumulation Area (TAA) 626  
Auto Hobby Shop (Buildings 625 and 626)  
Marine Corps Air Station, El Toro**

The former TAA Site 626 was visually inspected by Navy representatives during 1998 and 1999 when investigations for nearby environmental locations of concern were in progress. No stains were observed on the portland cement concrete foundation or near the temporary accumulation area during those inspections. The hobby shop closed in early 1999 and the facility has been vacant since early 1999. The site was also inspected during July and August 2001, and no stains were observed on the courtyard pavement at or near the TAA.

TAA 626 included a portable metal structure, open on all sides with a roof, that was located near the central section of the hobby shop courtyard area. The courtyard area is paved with portland cement concrete, and the paved surface was in excellent condition. Vegetation was observed to be growing through joints in the concrete pavement during the inspections in July and August 2001.

**Date of Photograph: July 2001**

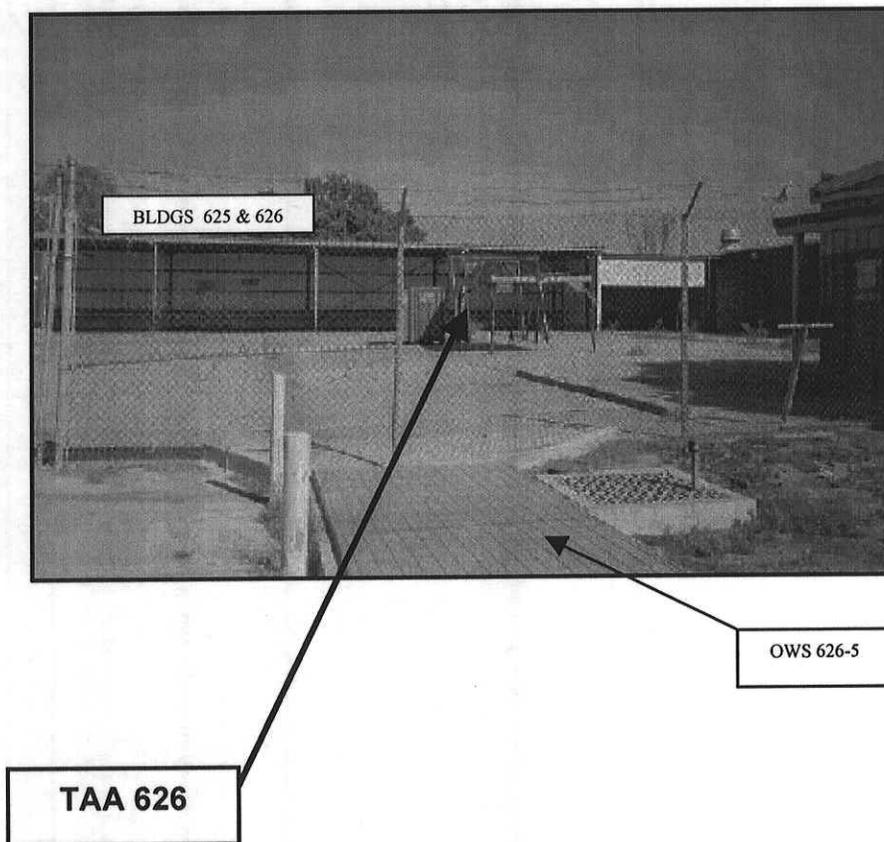
**Photograph 2. Former Temporary Accumulation Area 626.  
Hobby Shop Facility, Buildings 625 and 626  
Installation Restoration Program Site 20**

**TAA 626**

**Date of Photograph: 30 October 1999**

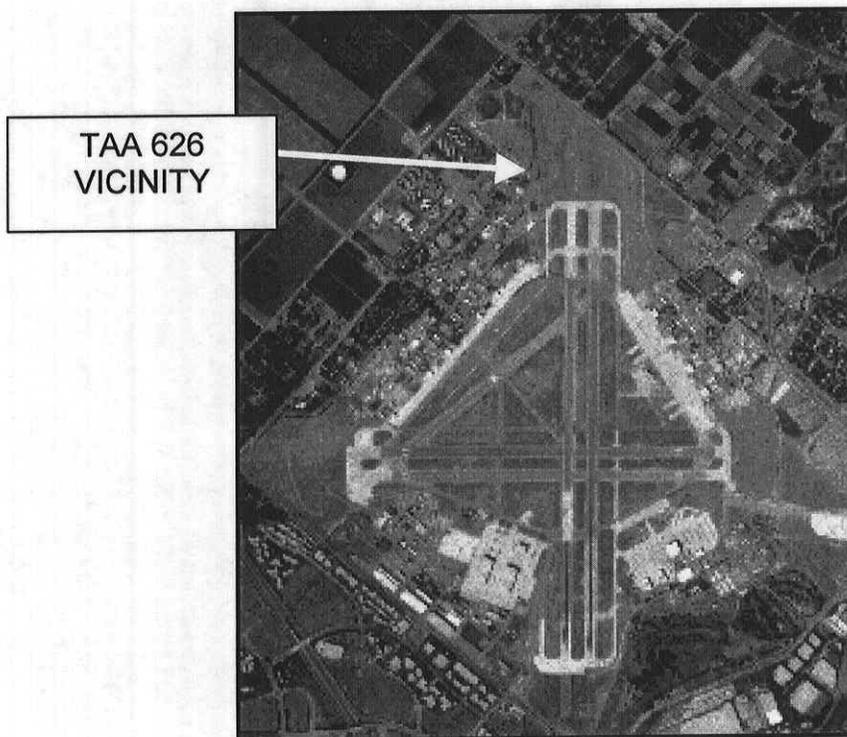
Photograph 3. TAA 626 Vicinity.  
Marine Corps Air Station, El Toro

Date of Aerial Photograph: 1994

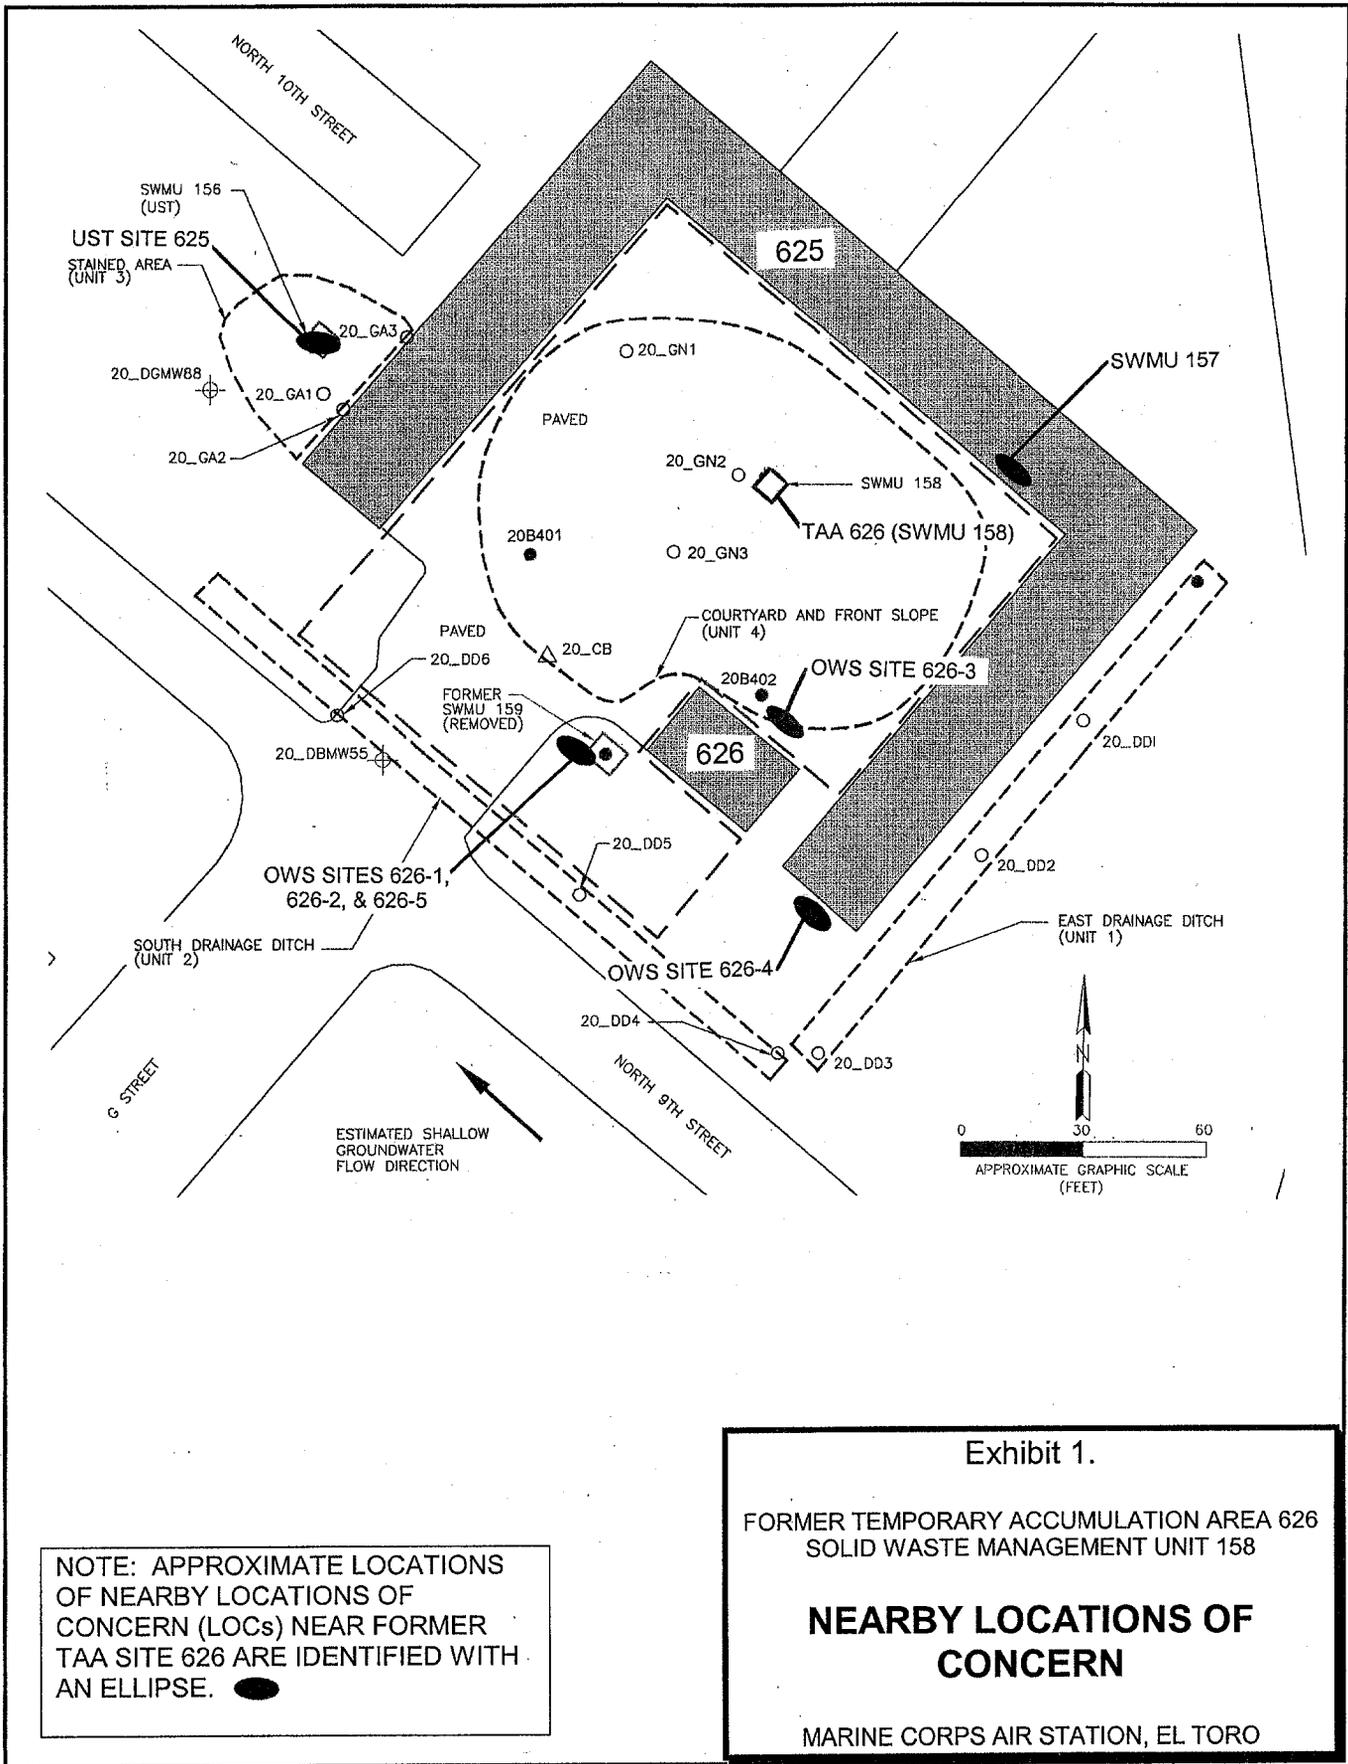
Exhibit 1.  
 FORMER TEMPORARY ACCUMULATION AREA 626  
 SOLID WASTE MANAGEMENT UNIT 158  
**NEARBY LOCATIONS OF CONCERN**  
 MARINE CORPS AIR STATION, EL TORO

NOTE: APPROXIMATE LOCATIONS OF NEARBY LOCATIONS OF CONCERN (LOCs) NEAR FORMER TAA SITE 626 ARE IDENTIFIED WITH AN ELLIPSE. ●

The Station's environmental compliance program management plans were acquired and reviewed in order to identify any locations at or near Former TAA Site 626 that were addressed during previous investigations and field sampling activities. No Further Action decision documents for nearby environmental locations of concern are presented in the Appendix. Additionally, Exhibit 1 in the Appendix shows the approximate locations of nearby locations of concern.

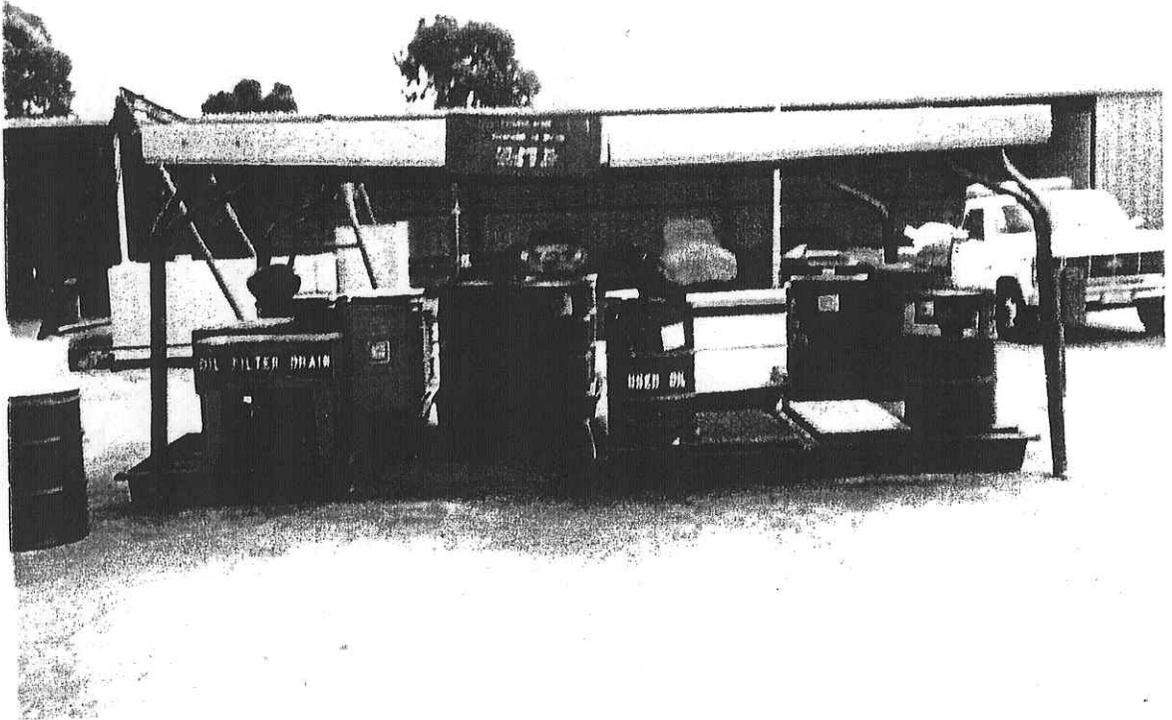
Auto Hobby Shop

Bldg 626
