**Solid Waste Management Unit 7
Transformer Storage Area
Marine Corps Air Station
El Toro, California**

SWDIV Contract No. N68711-93-D-1459 — Delivery Order No. 0070 — Revision 0
OHM Project No. 18609 — Document Control No. SW5247 — October 21, 1998

Closure Report

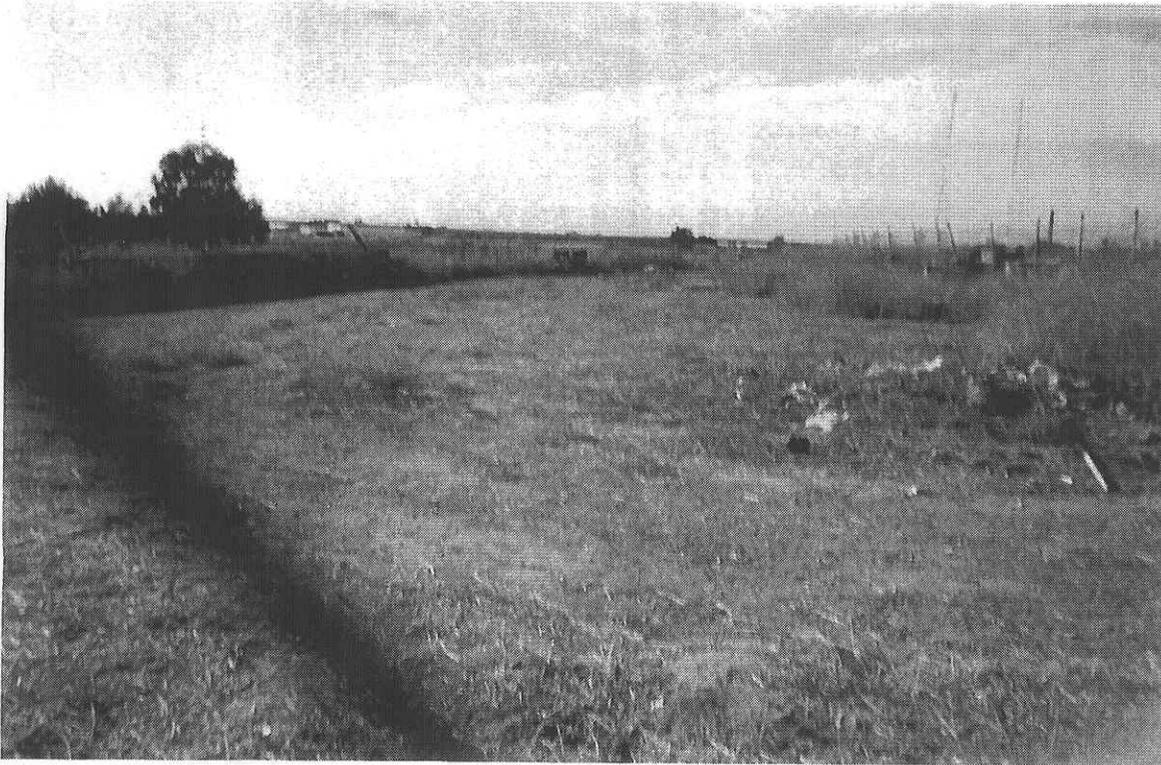
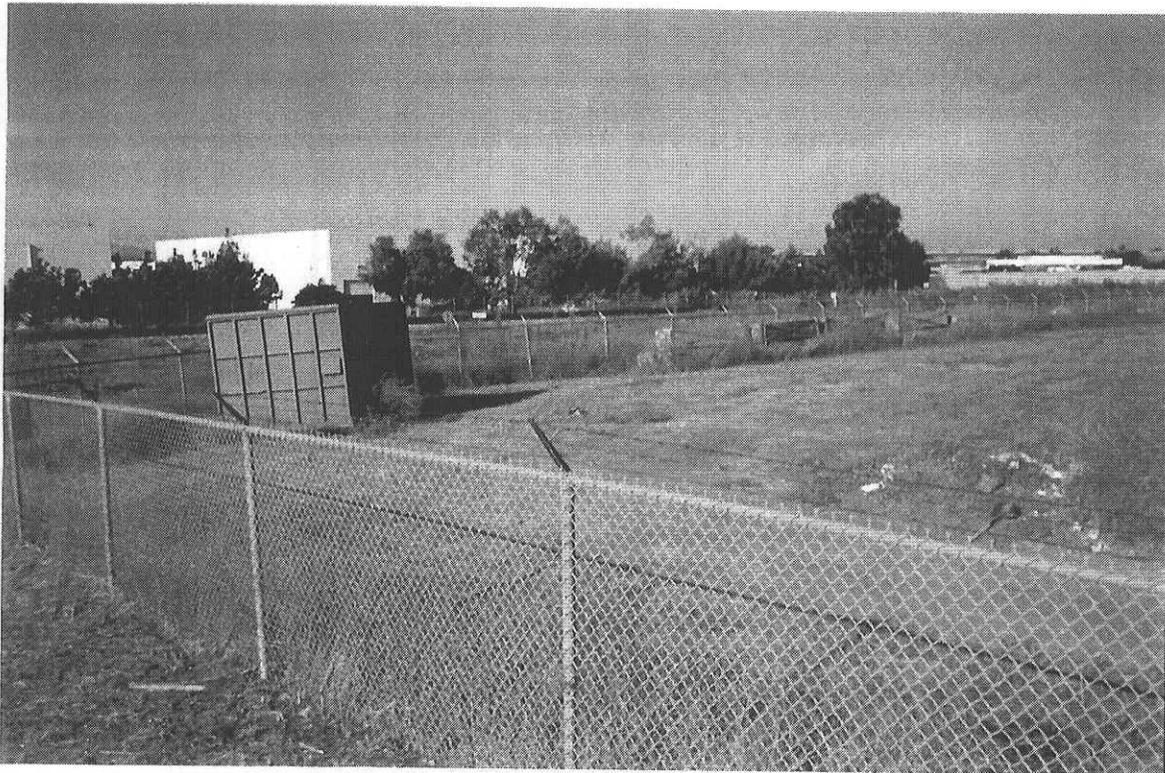
Final Site Condition After Soil Removal at SWMU 7

The objectives of this project were achieved; PCB-contaminated soil and PPE waste were removed and disposed of to an appropriate off-site facility. Confirmation sampling analytical results detected concentrations of PCB compounds at levels below the EPA Residential PRGs. Based on the information provided, closure goals were achieved with respect to limited soil removal remedial action for the SWMU 7 site; therefore, it is recommended that the SWMU 7 (Transformer Storage Area) site be identified as “closed”.
