Aerial Photograph Anomaly Area 5
APHO 31, APHO 43, APHO 66, APHO 67, and APHO 68
Marine Corps Air Station
El Toro, California

SWDIV Contract No. N68711-93-D-1459 — Delivery Order No. 0070 — Revision 0
OHM Project No. 18609 — Document Control No. SW9704 — May 9, 2001

Addendum to Summary Report

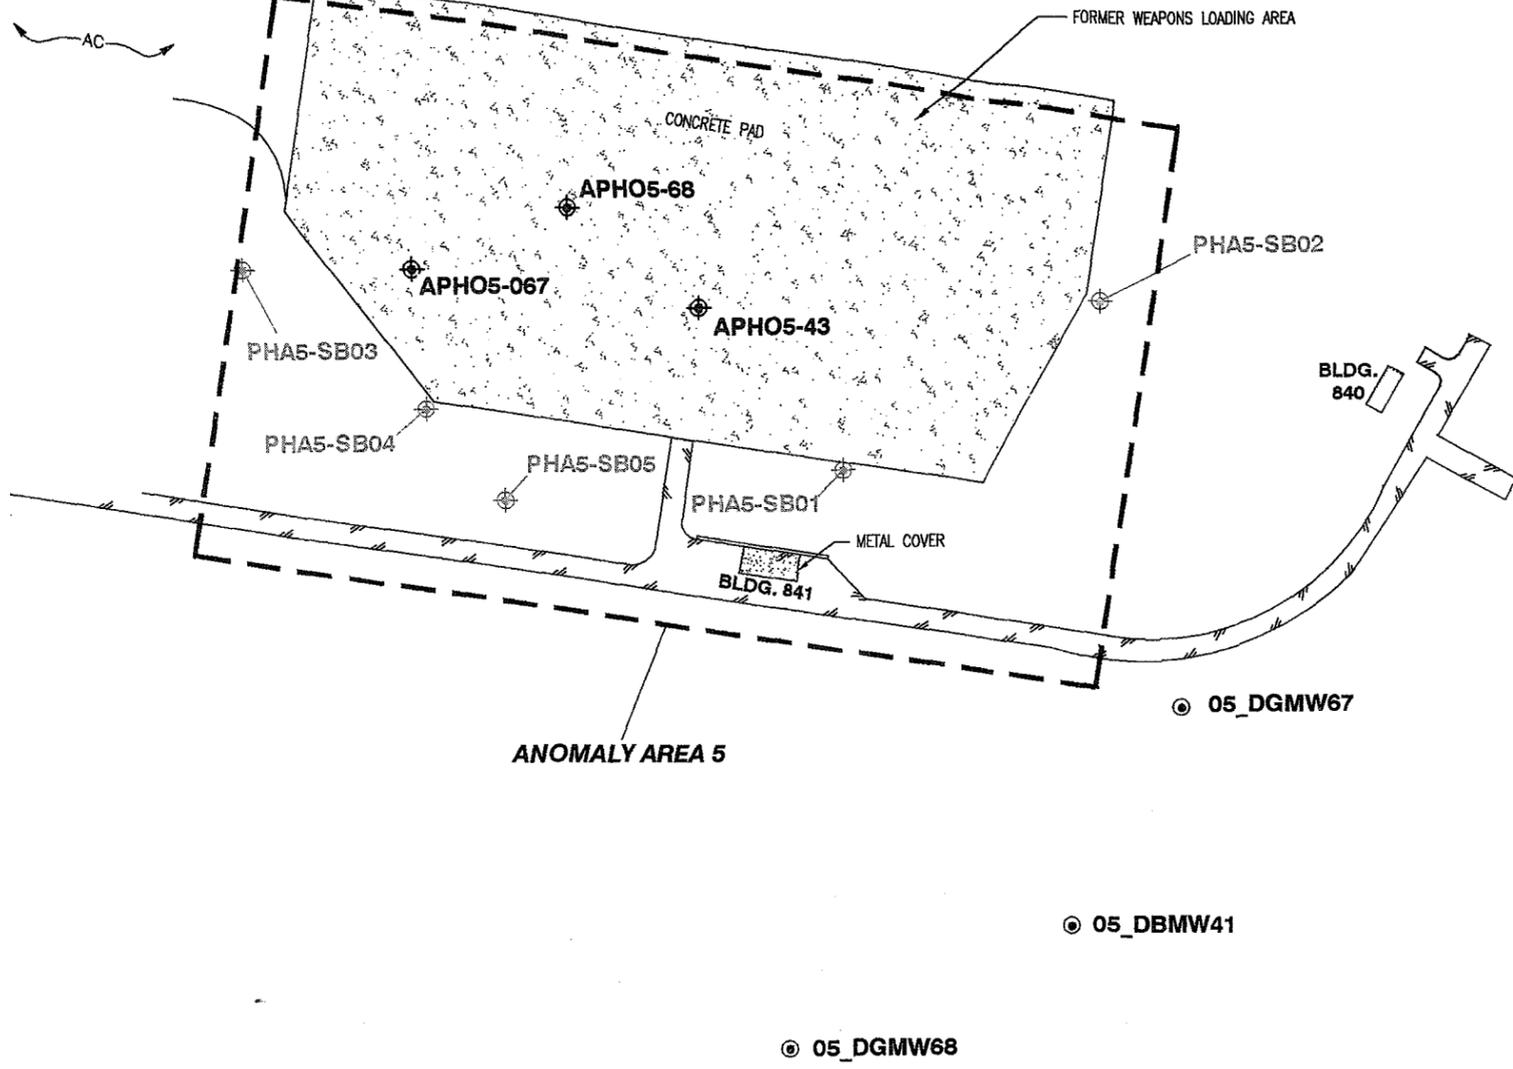
The RWQCB noted that no borings were advanced near anomalies APHO-43, APHO-67, and APPO-68 in the concrete pad in Anomaly Area 5. Therefore, OHM advanced three (3) soil borings in February 2001, (APHO5-43, APHO5-67 and APHO5-68) under the concrete pad near the three anomalies at Anomaly Area 5. Locations of these soil borings were selected and placed using historical and geophysical survey data and are shown on Figure 2-1. A summary of field activities is provided in this section.

- PHA5-SB01 ⊕ SOIL BORINGS IN DECEMBER 1999
- APH05-43 ⊕ SOIL BORINGS IN FEBRUARY 2001
- 05_DGMW67 ⊕ MONITORING WELL
- /// EDGE OF PAVEMENT
- APPROXIMATE SITE BOUNDARY OF ANOMALY AREA 5

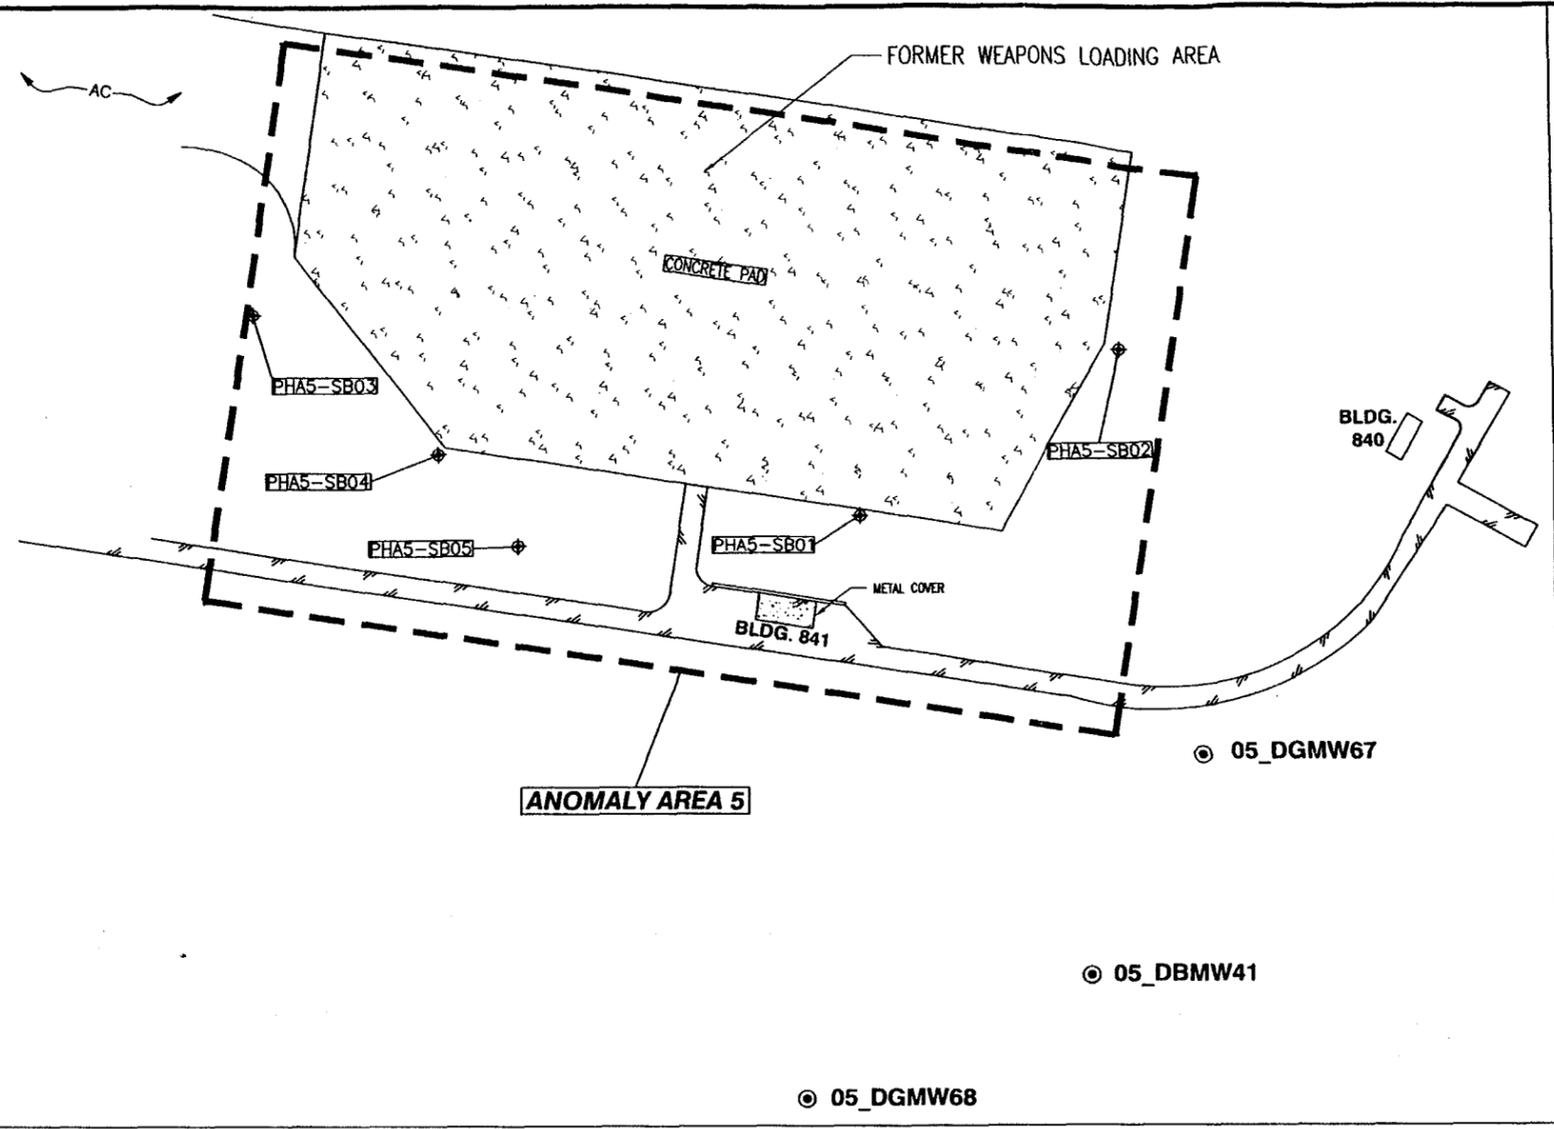
On December 10, 1999, OHM conducted verification drilling and sampling activities at Anomaly Area 5 to evaluate the sub surface conditions. A total of 5 soil borings were advanced (PHA5 SB-01 through PHA5 SB-05) to approximate total depths of 15 feet below ground surface. These boring locations were selected based on field visit. The soil boring locations are shown in Figure 4-1.

- PHA5-SB01 ⊕ SOIL BORING
- 18_BGMW02A ⊙ MONITORING WELL
- /// EDGE OF PAVEMENT
- - - - - APPROXIMATE SITE BOUNDARY OF ANOMALY AREA 5

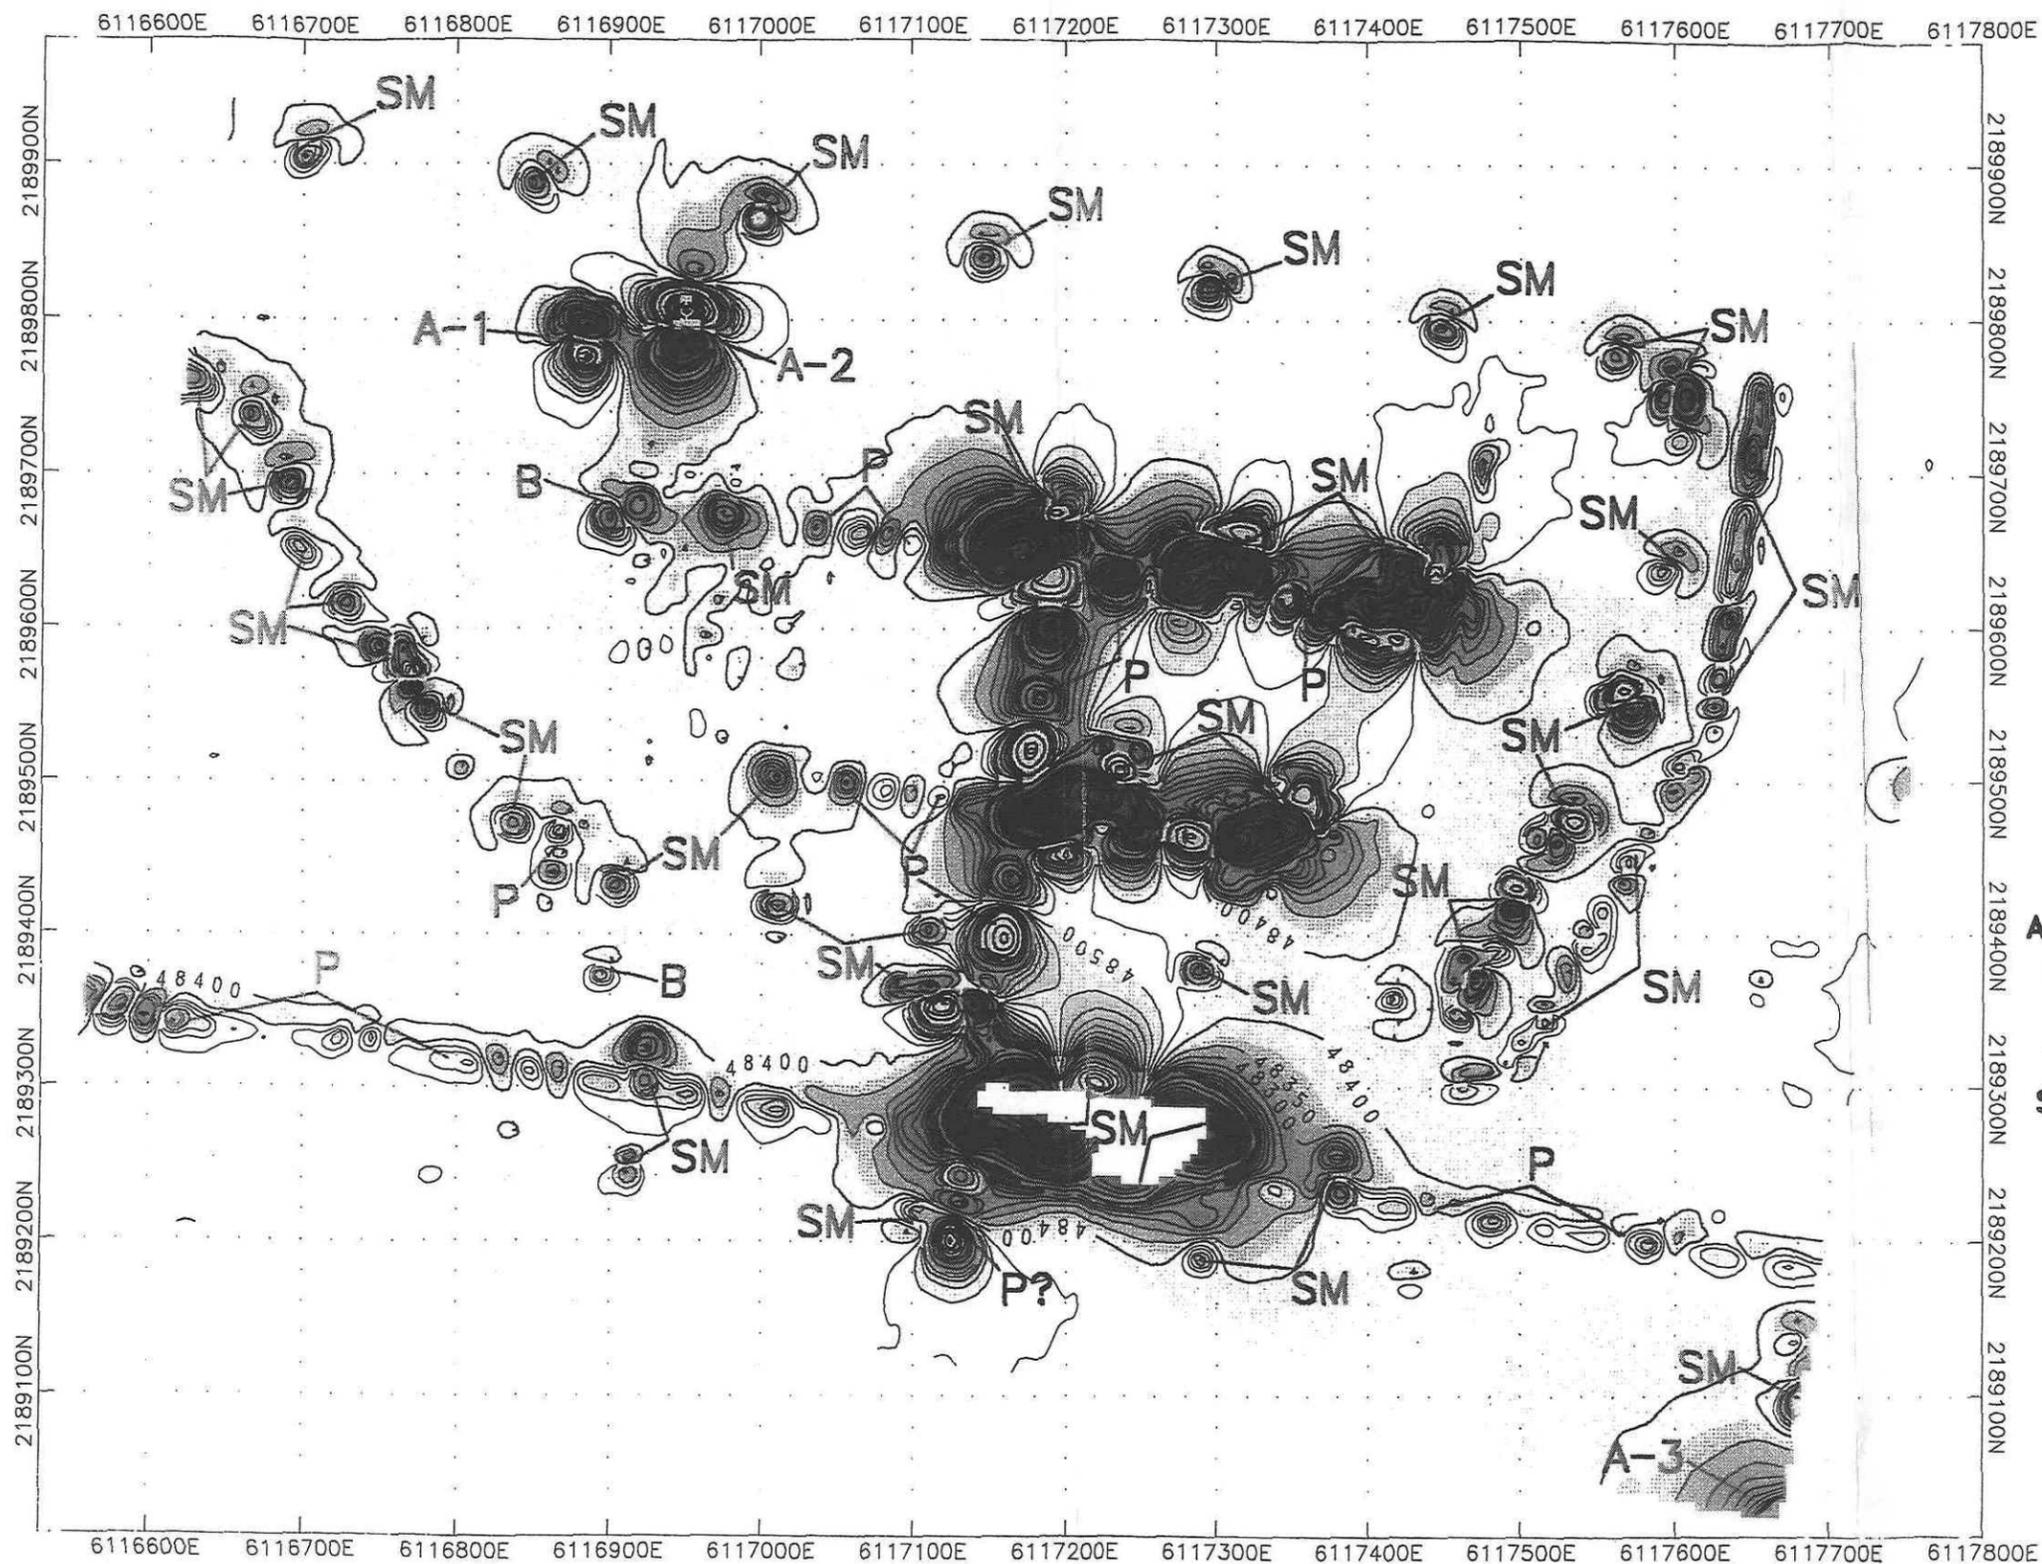
- A-1** GEOPHYSICAL ANOMALY DISCUSSED IN REPORT
- P** ANOMALY CAUSED BY BURIED PIPE
- B** ANOMALY CAUSED BY SMALL BURIED METALLIC OBJECT OR DEBRIS
- SM** ANOMALY CAUSED BY SURFACE METALLIC OBJECT OR DEBRIS

FIGURE 3
CONTOUR MAP OF TOTAL MAGNETIC FIELD INTENSITY
 AERIAL PHOTOGRAPHIC ANOMALY AREA 5
 MCAS EL TORO, CALIFORNIA
 PREPARED FOR
 THE IT GROUP
 GEOVISION GEOPHYSICAL SERVICES

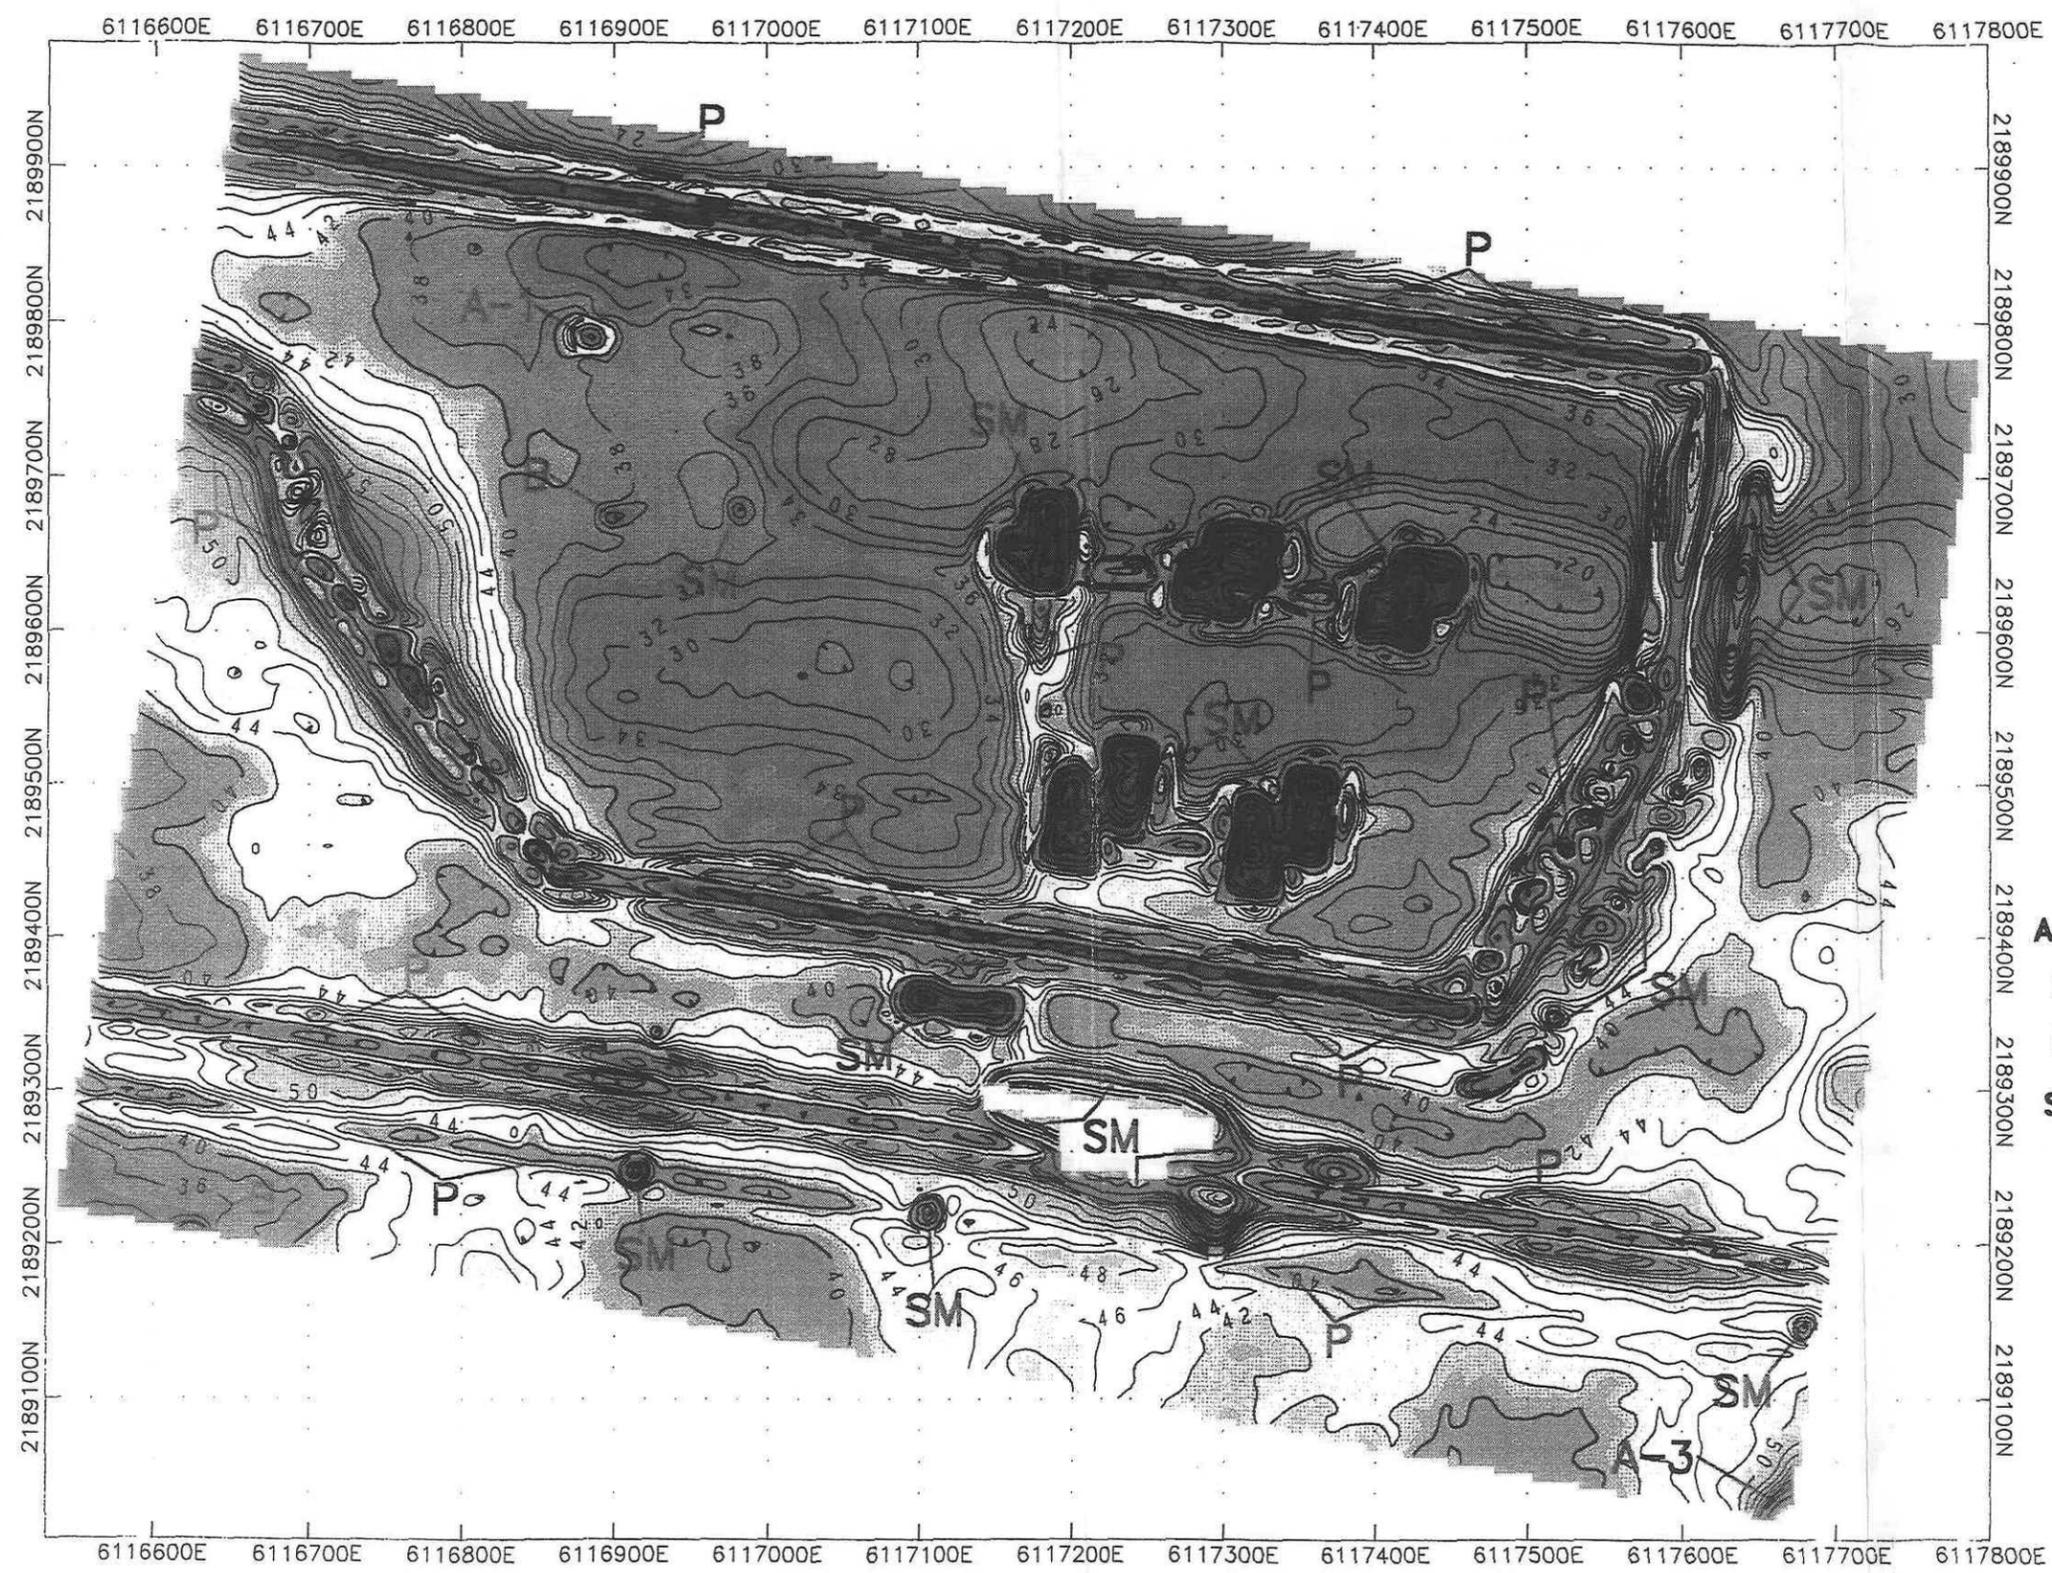
CONTOUR INTERVAL = 2 MILLISIEMENS PER METER

FIGURE 4
CONTOUR MAP OF GEONICS EM31 CONDUCTIVITY RESPONSE
 AERIAL PHOTOGRAPHIC ANOMALY AREA 5
 MCAS EL TORO, CALIFORNIA
 PREPARED FOR
 THE IT GROUP
 GEOVISION GEOPHYSICAL SERVICES

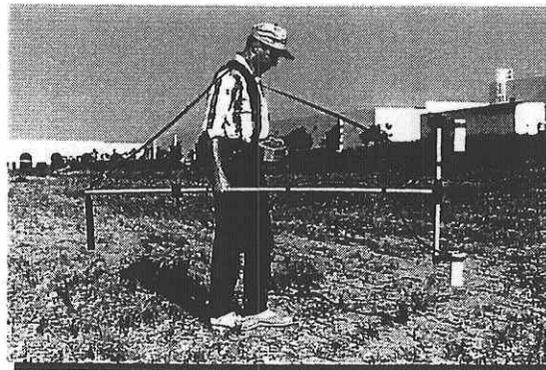
Larger metallic objects can often be located to greater depths. Induced magnetic anomalies over buried objects such as drums, pipes, tanks, and buried metallic debris generally exhibit an asymmetrical, south up/north down signature (positive response south of the object and negative response to the north).

Geometrics G858 Cesium Magnetic Gradiometer

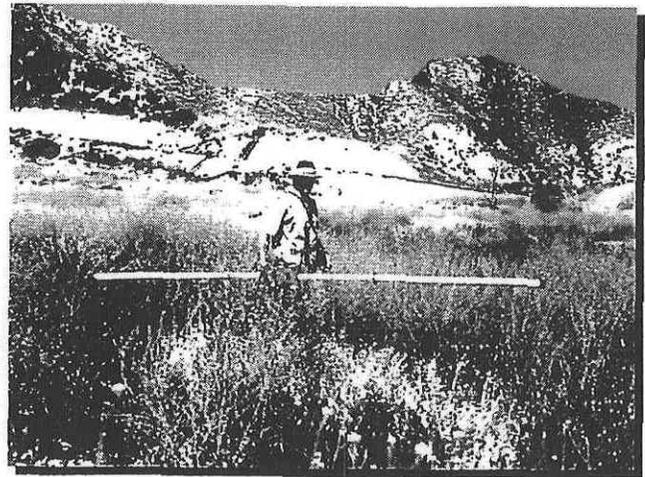
EM induction surveys are often conducted using the Geonics EM-31 terrain conductivity meter (EM-31). The EM-31 consists of a transmitter coil mounted at one end and a receiver coil mounted at the other end of a 3.7-meter long plastic boom. Electrical conductivity and in-phase component field strength are measured and stored along with line and station numbers in a digital data logger. In-phase component measurements generally only respond to buried metallic objects; whereas conductivity measurements also respond to conductivity variations caused by changes in soil type, moisture or salinity and the presence of nonmetallic bulk wastes. The EM-31 must pass over or immediately adjacent to a buried metallic object to detect it. Typical EM-31 anomalies over small, buried metallic objects consist of a negative response centered over the object and a lower amplitude positive response to the sides of the object. When the instrument boom is oriented parallel to long, linear conductors such as pipelines a strong positive response is observed. The EM-31 can explore to depths of about 6 meters, but is most sensitive to materials about 1 meter below ground surface. Single buried drums can typically be detected to depths of about 5 feet.

Geonics EM-31 Terrain Conductivity Meter

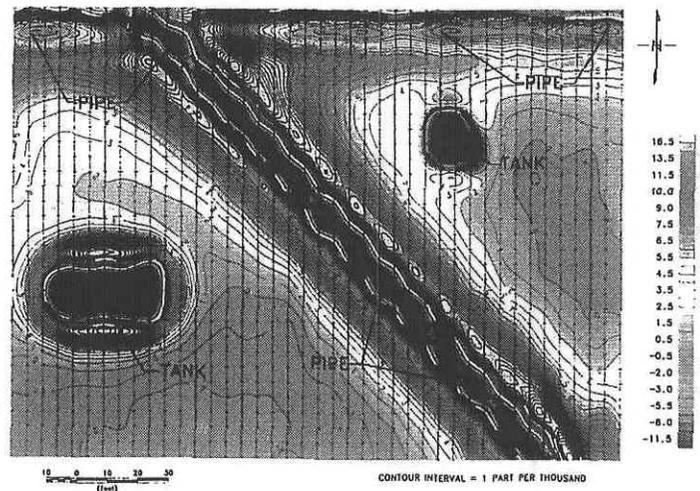
Geonics EM-31 Survey to Locate Underground Storage Tanks

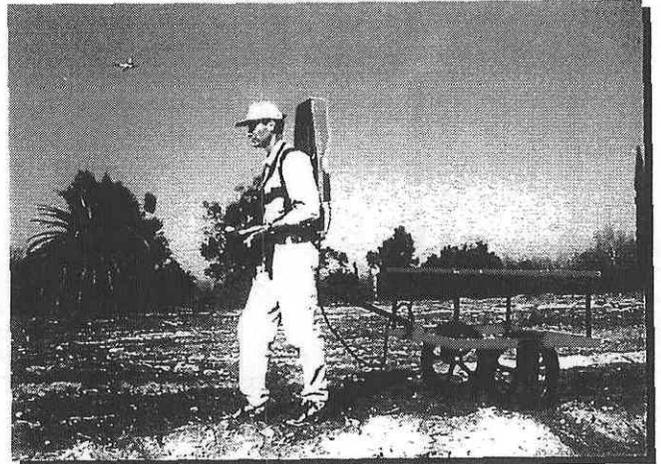
In practice, the usable depth of investigation of the EM-61 depends on the size and shape of the object and the amount of above ground interference encountered at the site. A single buried drum can often be detected at a depth of about 10 feet.

Geonics EM-61 Digital Metal Detector

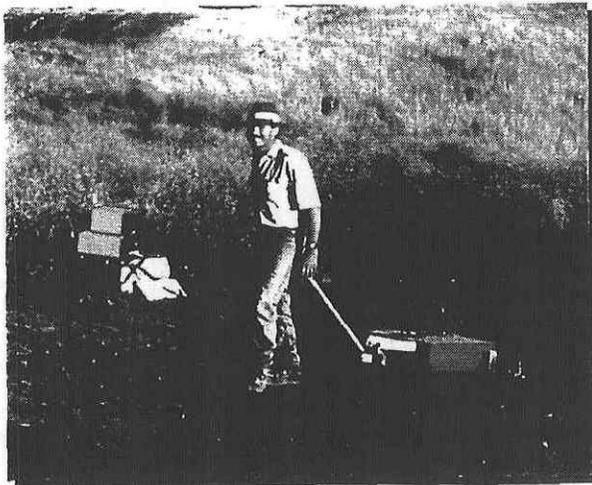
GSSI SIR-10A GPR Unit

GPR Methods

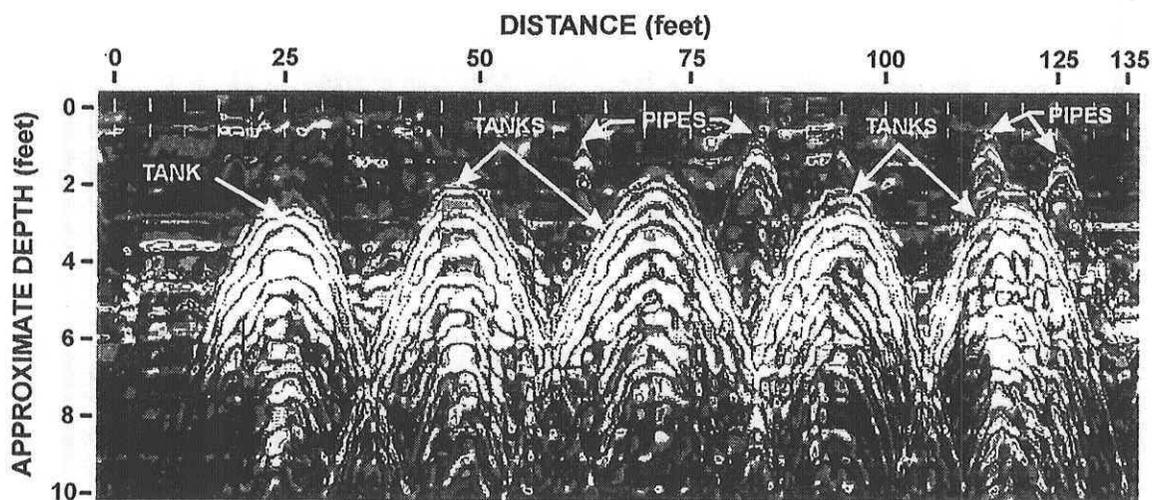
Geophysical Survey Systems Inc. (GSSI) SIR-2 or SIR-10 GPR systems with antennas in the frequency range of 50 to 1,000 MHz are often used during GPR investigations. Mala Geoscience and Sensors and Software, Ltd also manufacture GPR systems. GPR data is processed using a variety of software including the RADAN™ or GRADIX software packages by GSSI and Interpex Ltd., respectively.

GPR Survey to Locate Underground Storage Tanks
