Summary Report

*Former Temporary Accumulation Area 800
Solid Waste Management Unit (SWMU) 229
Former Marine Corps Air Station, El Toro, California*

19 April 2002

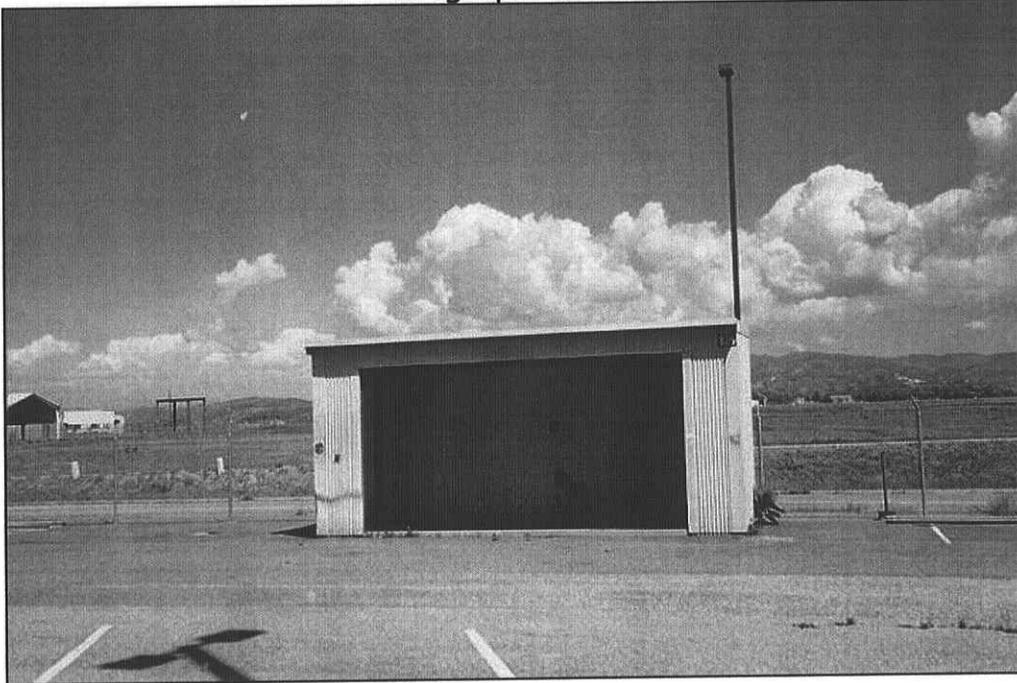
**Photograph 1. Former Temporary Accumulation Area (TAA) 800
Solid Waste Management Unit (SWMU) 229
(structure is approximately 10 feet wide by 25 feet long)
Marine Corps Air Station, El Toro
Date of Photograph: 15 March 2002**

Representatives from the Navy conducted visual inspections of the former TAA 800 on 15 March 2002 and 11 April 2002. On 15 March 2002, the surface of the concrete floor was inspected closely and no significant stains or cracks were observed on the concrete floor or on the curb. The concrete floor and curb appeared to be in excellent condition. Additionally, no stains or discolored areas were observed on the asphalt-paved areas adjacent to former TAA 800 on in the drainage ditch northeast of the TAA. Photographs from the visual inspections of March and April 2002 are included in the Appendix.

- The Navy inspected the former TAA 800 on 15 March and 11 April 2002. No significant stains were observed on the concrete surfaces of the floor or on the curb of the TAA. No significant cracks were observed in the concrete surfaces of the floor or on the curb. No stains or discolored areas were observed on the asphalt-paved areas surrounding the TAA or in the drainage ditch located northeast of the TAA.

Based upon the absence of visual evidence of a significant release at or near former TAA 800, the results of the screening risk calculations, and the excellent condition of the concrete floor and curb, it is recommended that no further action status be designated for TAA 800 in the next BRAC Business Plan Update

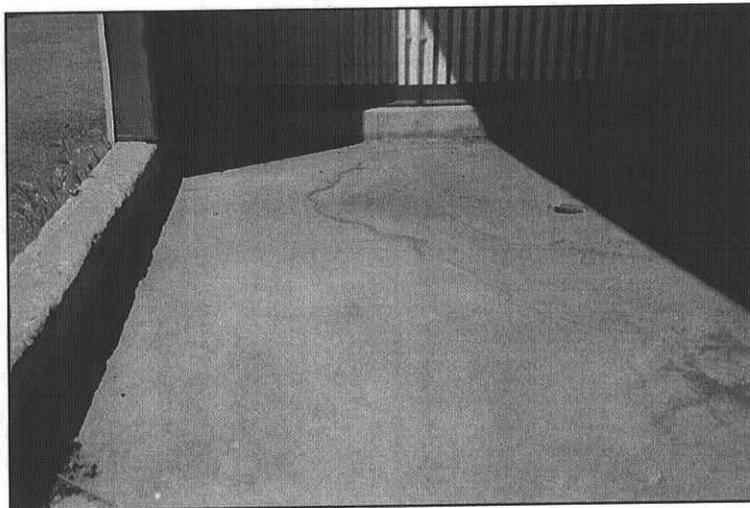
A small drain-like feature, approximately 4 inches in diameter, is located near the northwestern wall of TAA 800, and this feature is shown on Photograph 2 in the Appendix. The purpose of this feature was not determined during the visual inspections of the TAA. Utility plans and as-built drawings were reviewed, and no sewer lines are shown at TAA 800.

**Photograph 2. Concrete Floor of Former TAA 800
Marine Corps Air Station, El Toro
Date of Photograph: 15 March 2002**

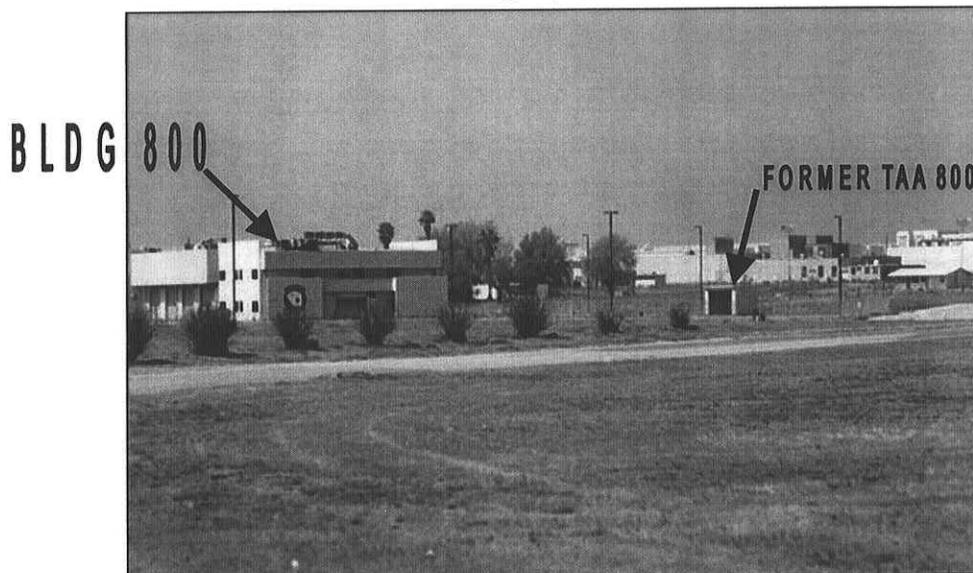
Photograph 3. Former TAA 800 Vicinity.
Building 800 at center left and TAA 800 (Building 825) at center right.
Marine Corps Air Station, El Toro
Date of Photograph: 11 April 2002

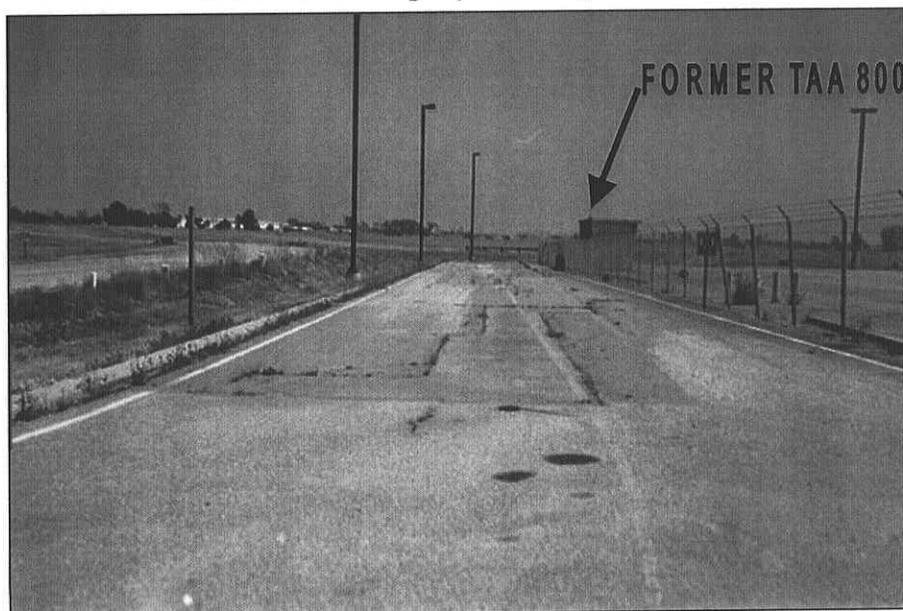
Former TAA 800 is located northwest of Agua Chinon Wash that was investigated as IRP Site 25 – the major drainages – and no further action status was achieved for IRP Site 25 in September 1997. Soil, sediment, surface water, and soil gas samples were collected during the investigation of Site 25. A small drainage ditch that discharges to Agua Chinon Wash is located northeast of former TAA 800, and no evidence of spills or discolored soils was observed in the drainage ditch during the visual inspection of April 2002.

Photograph 4. Former TAA 800 at right side of access road to Building 800 compound.
Drainage ditch at left side of access road.
Marine Corps Air Station, El Toro
Date of Photograph: 11 April 2002

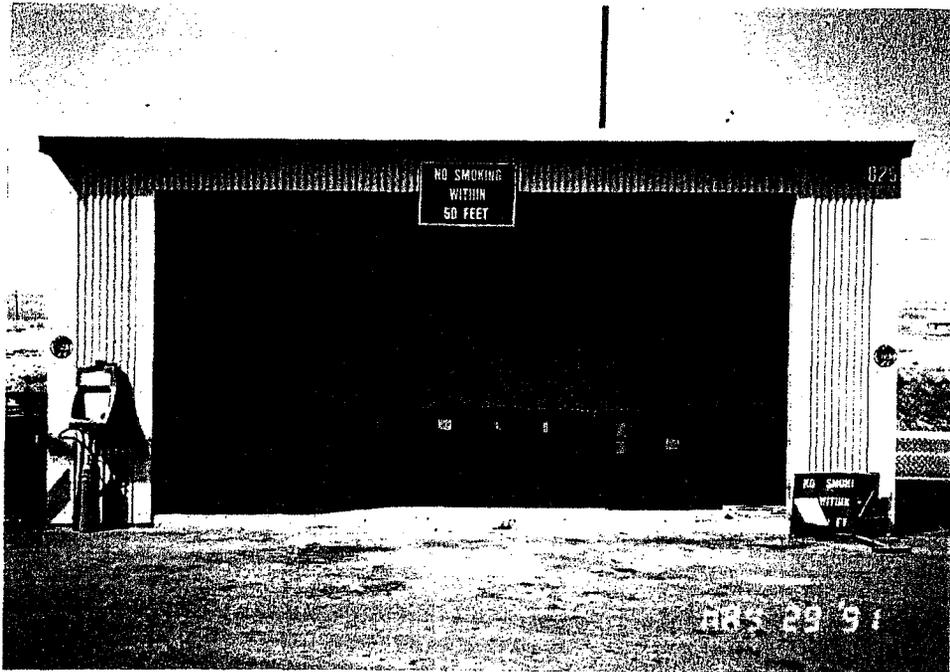
Date of Site Visit: 25 April 1991

This HWSA is located east of Building 800, adjacent to the southeastern boundary fence of the facility. The HWSA measures 10 x 20 ft in size. It consists of a concrete storage area surrounded by an 8-in. concrete berm. The storage area is protected on three sides by aluminum siding and covered by an aluminum roof. The HWSA is used to store waste oil, antifreeze, expired batteries, hydraulic fluid, and waste grease. The storage area is lightly stained. There are no significant cracks in the concrete storage surface or berm.

Light staining on storage surface

Although there was no evidence of a release outside of the storage area, the past and present HWSAs at MCAS El Toro are recommended for a sampling visit.

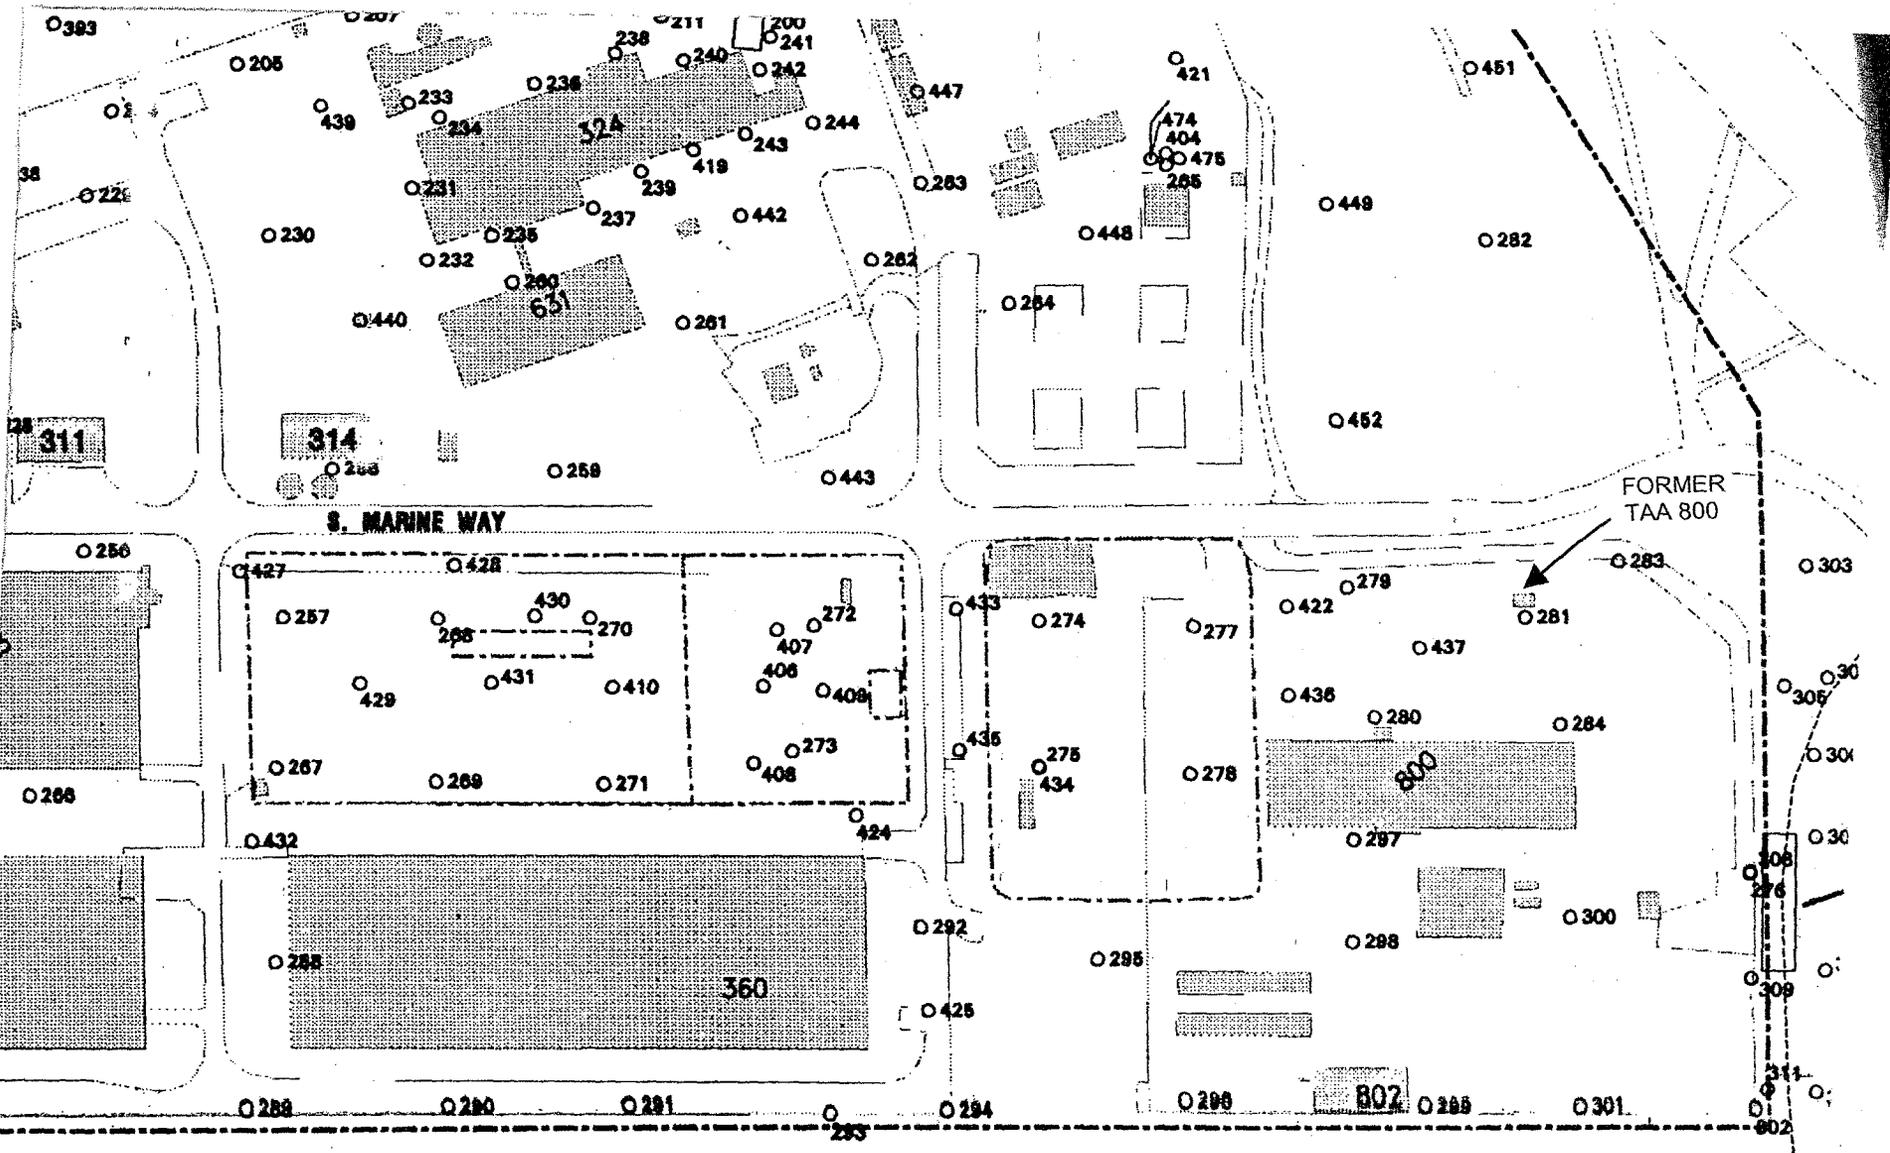
**SAMPLE LOCATIONS
SOIL GAS SURVEY OF 1994 (from JEG 1994)**

Annotations have been made by the writer of the Summary Report to identify features near the former TAA 800.

Soil gas sample locations from 1994 are identified with a numeric identifier, such as 281. Table C-1 uses the long version of the sample identifier, 24_SG281.

Former TAA 800 is located within the investigation boundary of Installation Restoration Program (IRP) Site 24 – the Volatile Organic Compound (VOC) Source Area. Soil, soil gas, and groundwater samples were collected in the general vicinity of TAA 800 during the remedial investigation and vadose zone remediation activities at IRP Site 24. More than ten soil gas samples were collected within the Building 800 compound during the soil gas survey of 1994 (JEG 1994).

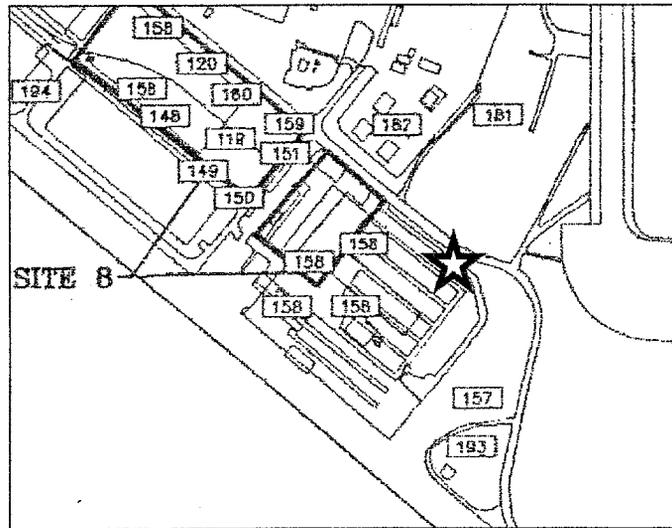
Exhibit 1. USEPA Aerial Photograph Anomalies near Former TAA 800, MCAS El Toro

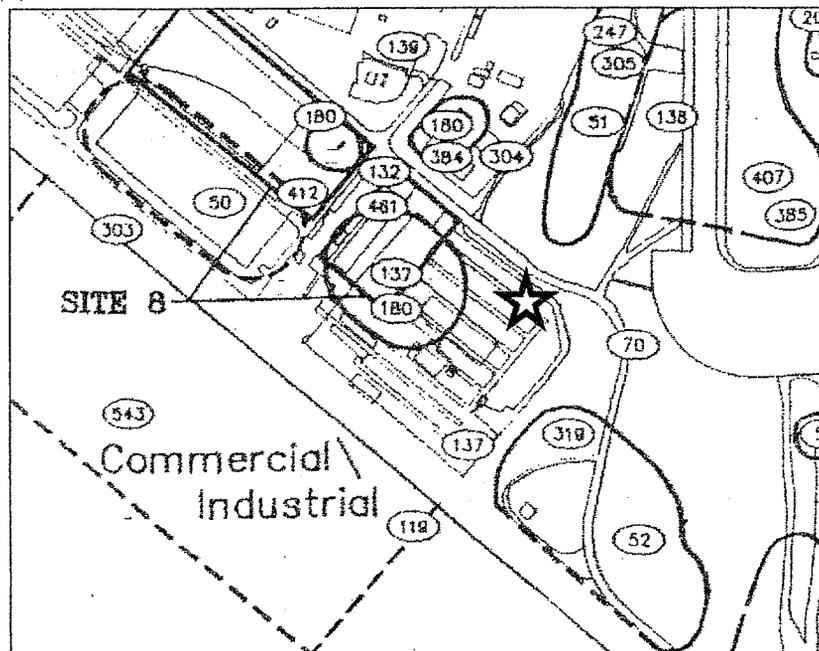
Exhibit 2. SAIC Aerial Photograph Anomalies near Former TAA 800, MCAS El Toro

NOTES: 1) Approximate location of Former TAA 800 (Bldg 825) is identified with a star symbol. 2) Anomaly locations were extracted from "Final Report, Aerial Photograph Assessment, MCAS El Toro" (SAIC 1993).
