Summary Report

*Former Temporary Accumulation Area (TAA) 371A
Solid Waste Management Unit (SWMU) 107
Former Marine Corps Air Station, El Toro, California*

10 May 2002

Prepared by:
Southwest Division, Naval Facilities Engineering Command
BRAC Programs Office
San Diego, CA 92101-2404

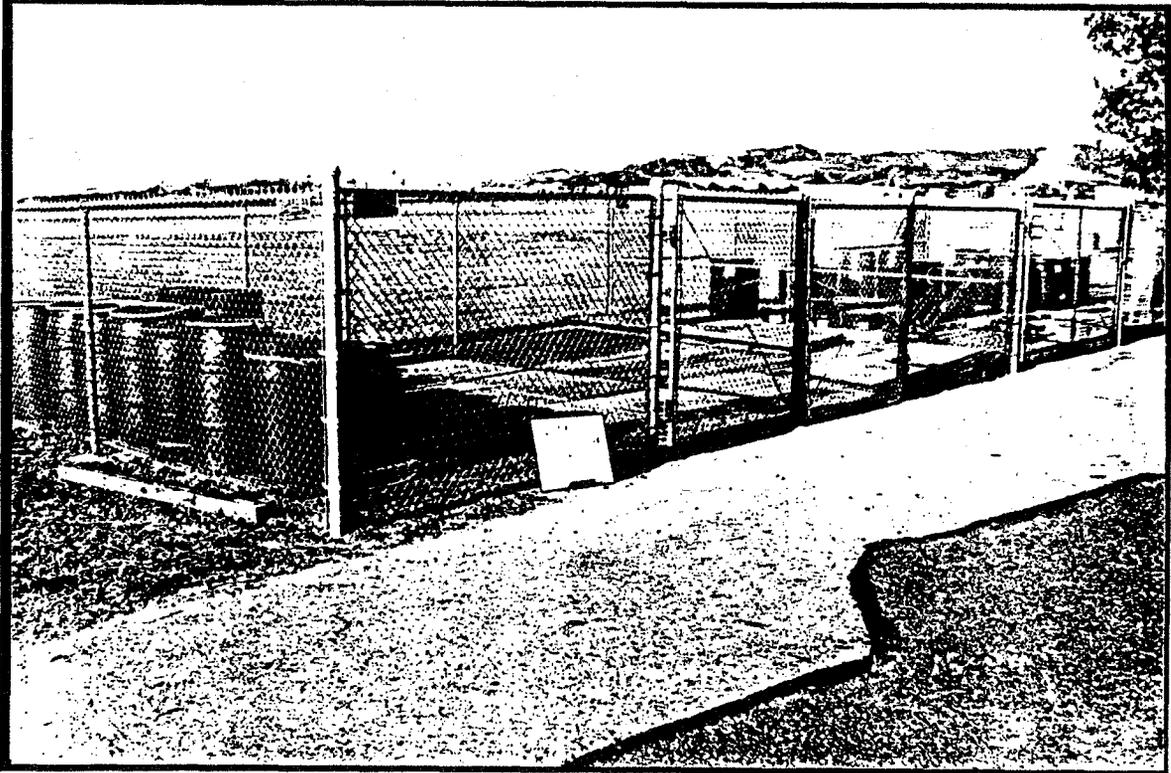
SWMU #: 107

Observations: Waste Area #29; Concrete bermed pad is clean. no stains seen on the soil surface. 13 of 19 drums are labeled "LUBE OIL."

"Stain(s)" : None observed.

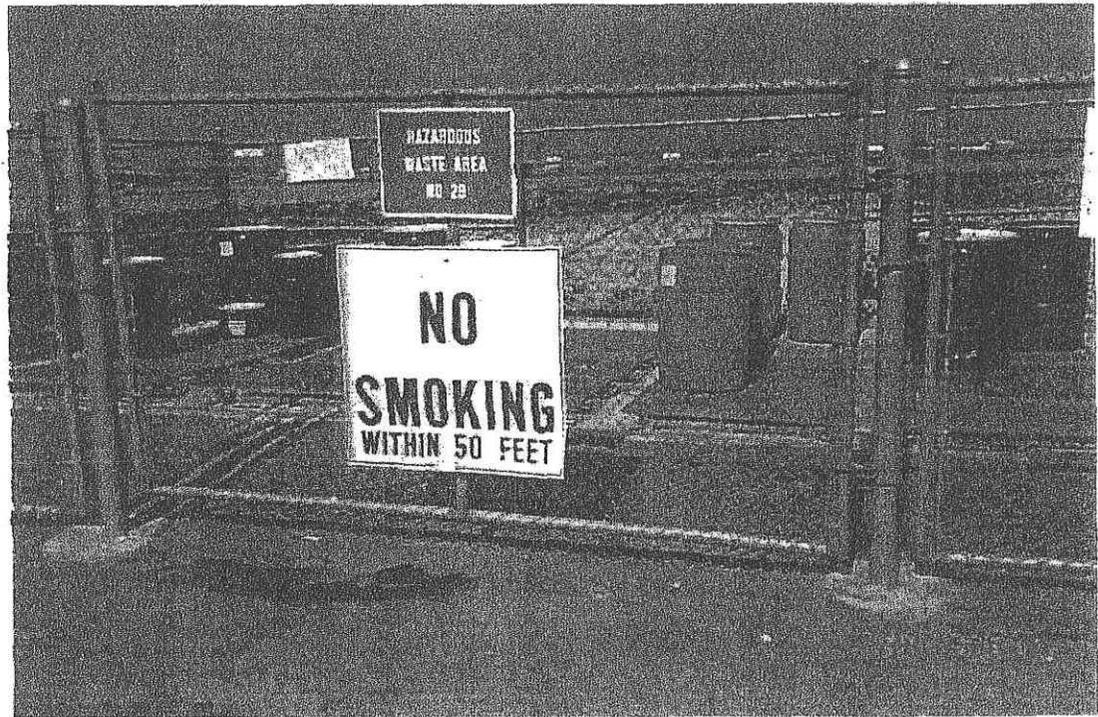
Bldg 371

Marine Fighter Attack Training Squadron 101 (VFMAT 101)
