# Summary Report

*Phantom Drum Storage Area  
Solid Waste Management Unit (SWMU) 32  
Marine Corps Air Station, El Toro, California*

17 December 2001

Southwest Division, Naval Facilities Engineering Command  
BRAC Programs Office  
San Diego, CA 92101-2404

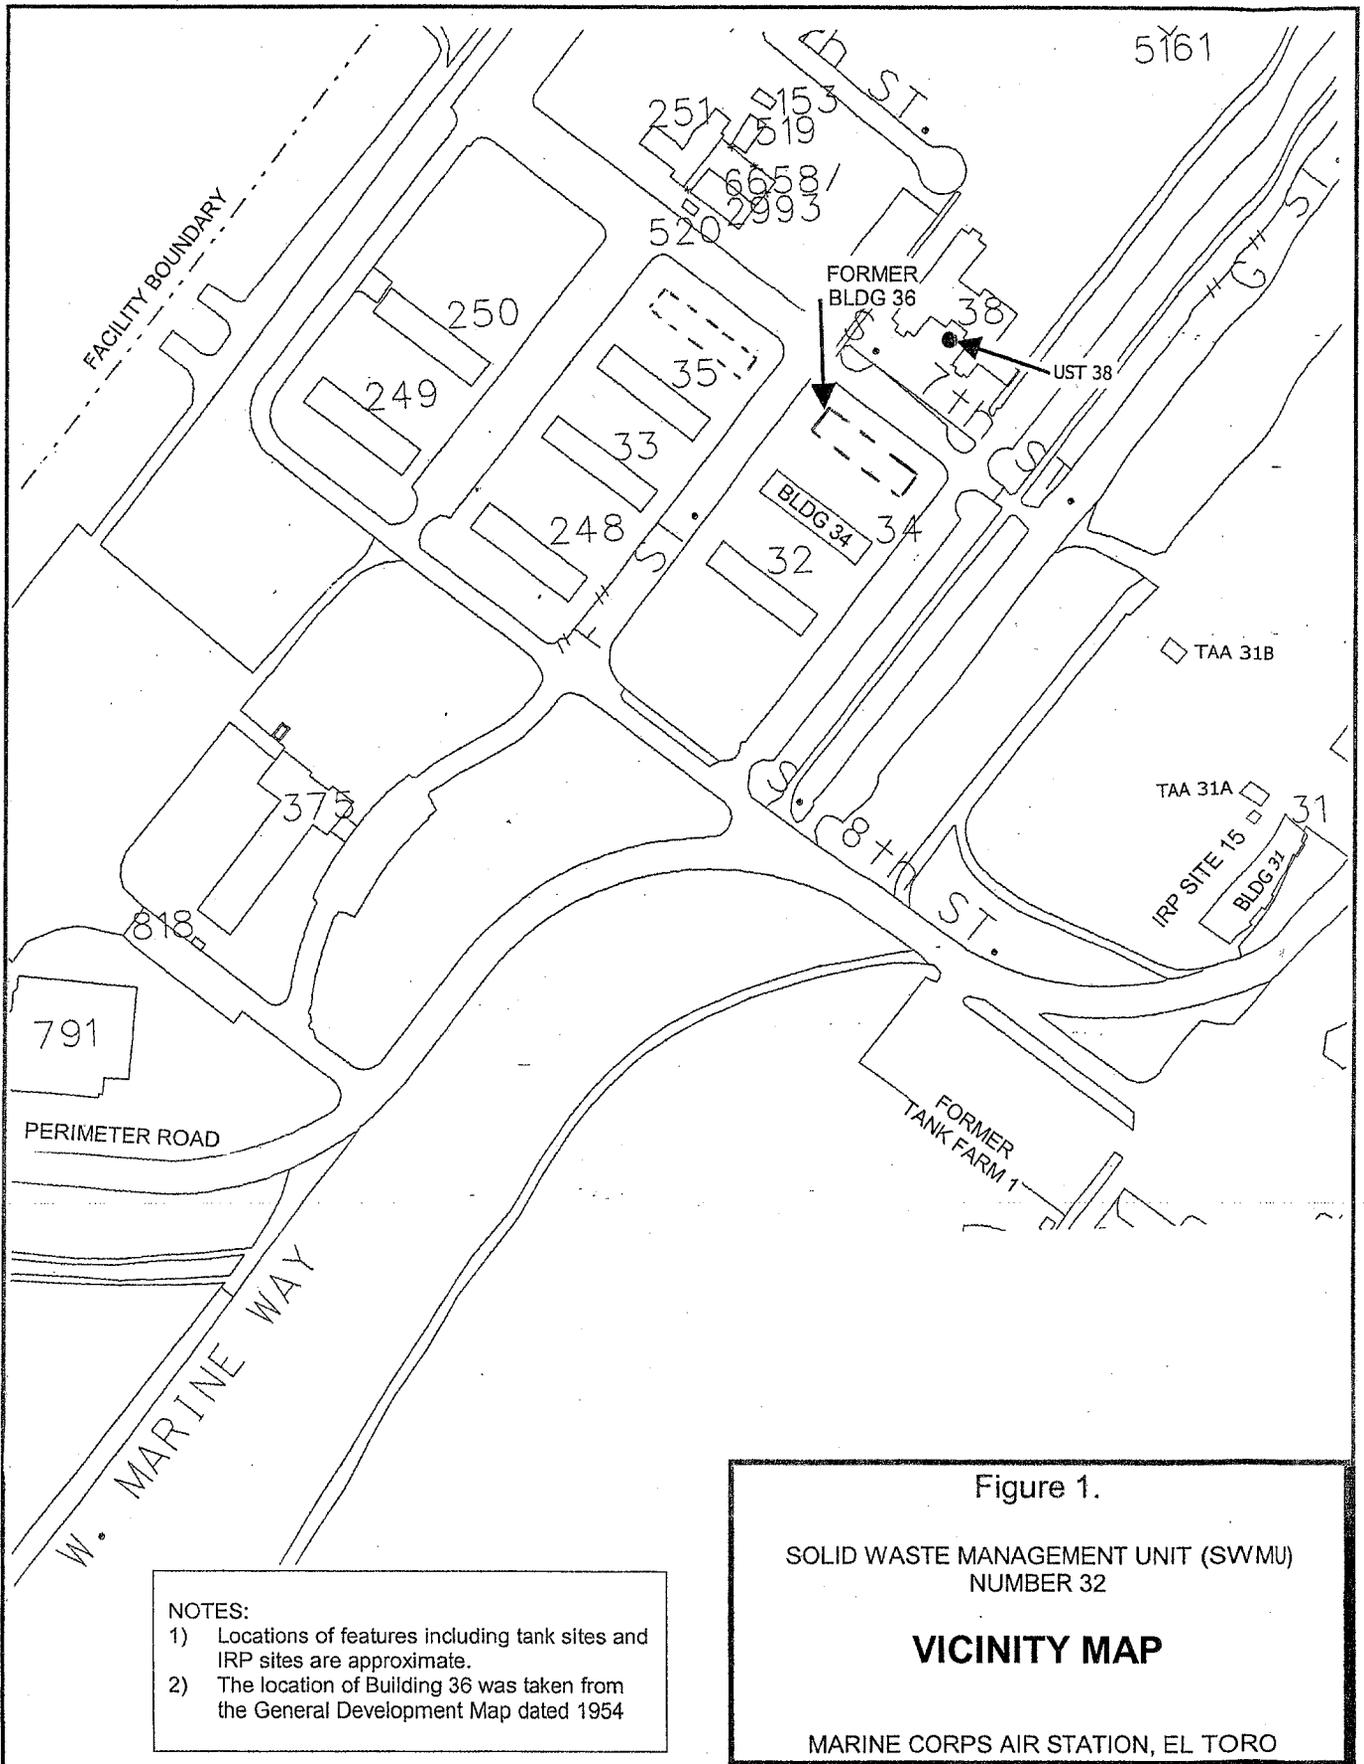
Figure 1.  
 SOLID WASTE MANAGEMENT UNIT (SWMU)  
 NUMBER 32  
**VICINITY MAP**  
 MARINE CORPS AIR STATION, EL TORO

NOTES:  
 1) Locations of features including tank sites and IRP sites are approximate.  
 2) The location of Building 36 was taken from the General Development Map dated 1954

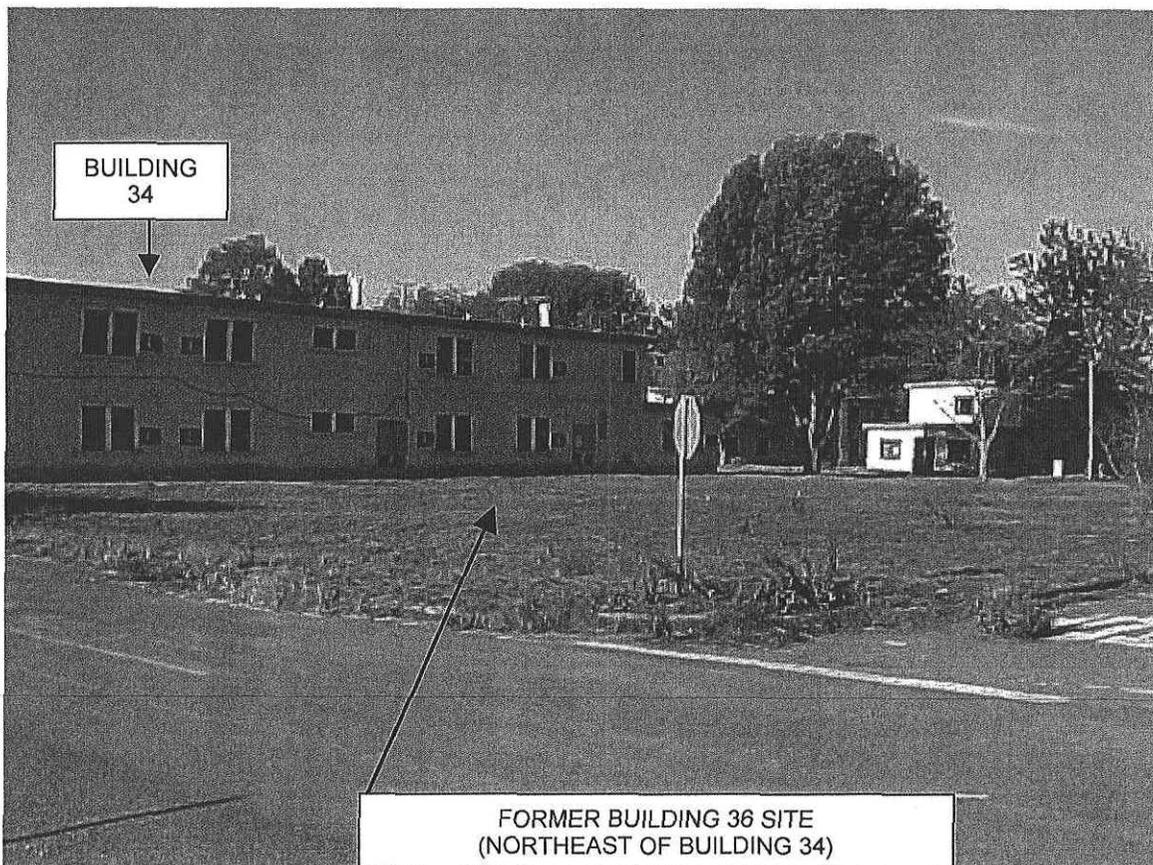
Photograph 1. Vicinity of Suspected Drum Storage Area  
Former Building 36  
Solid Waste Management Unit (SWMU) 32  
Marine Corps Air Station, El Toro  
Date of Photograph: 28 November 2001

The SWMU 32 vicinity was visually inspected by representatives of the Navy on 26 and 28 November and on 4 December 2001. The site is a relatively level, unpaved lot between Building 34 and Building 38. No stains or discolored areas of soil were observed during the site visits. The site is located near the vehicle storage lot near Building 29 and Building 31. Photographs of the site, dated 26 and 28 November 2001, are included in the Appendix.

- No stains or discolored areas were observed during the visual inspections that were conducted of the former Building 36 vicinity in late November and early December 2001.

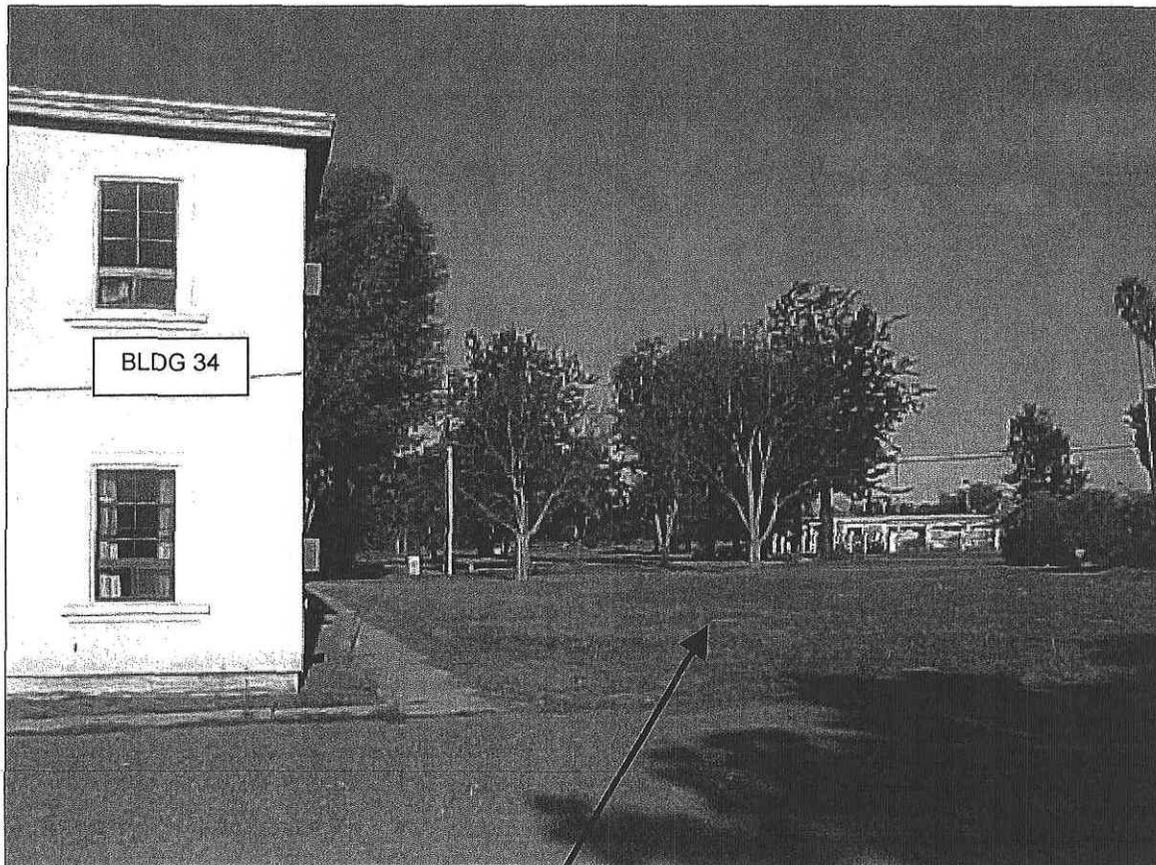
Photograph 2. Vicinity of Suspected Drum Storage Area  
Former Building 36  
Solid Waste Management Unit (SWMU) 32  
Marine Corps Air Station, El Toro  
Date of Photograph: 28 November 2001

FORMER BUILDING 36 SITE  
(NORTHEAST OF BUILDING 34)

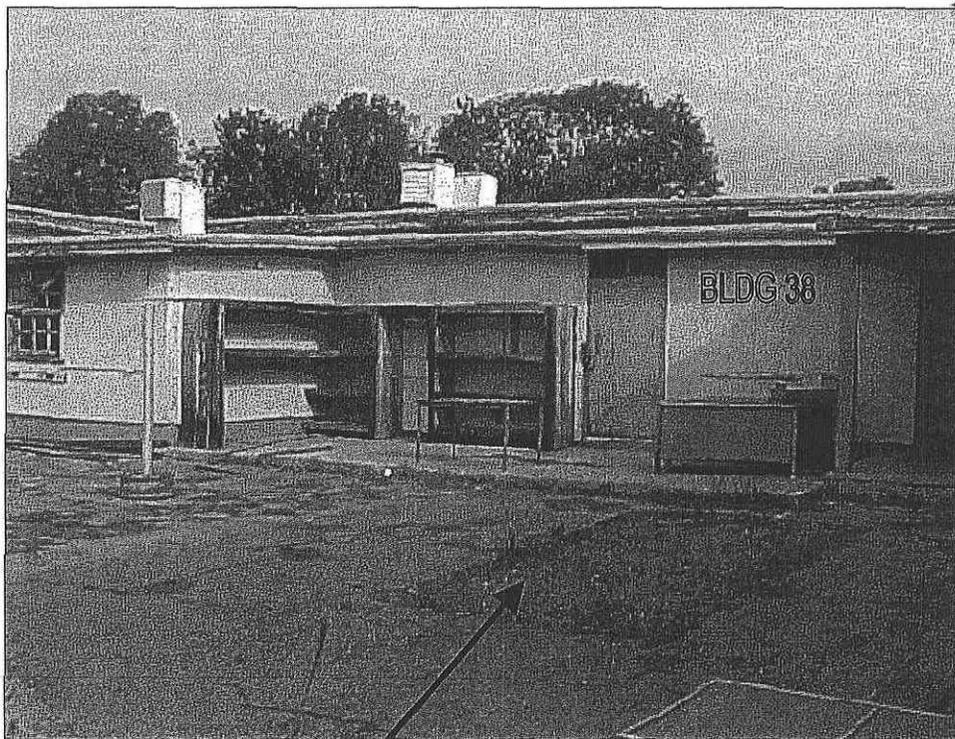
Photograph 3. Building 38 located adjacent to and northeast of  
Former Building 36 Site  
(Pavement Patch for Former UST 38 in the Foreground)  
Marine Corps Air Station, El Toro

FORMER UST SITE 38  
LOCATED NORTHEAST OF  
FORMER BUILDING 36

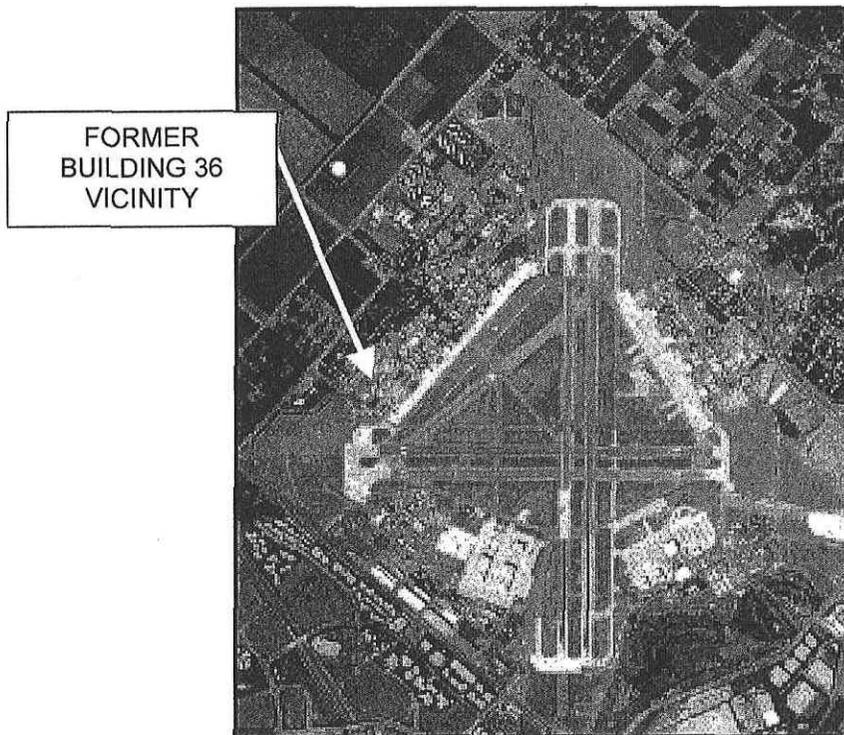
Photograph 4. Vicinity of Former Building 36  
Marine Corps Air Station, El Toro

Date of Aerial Photograph: 1994

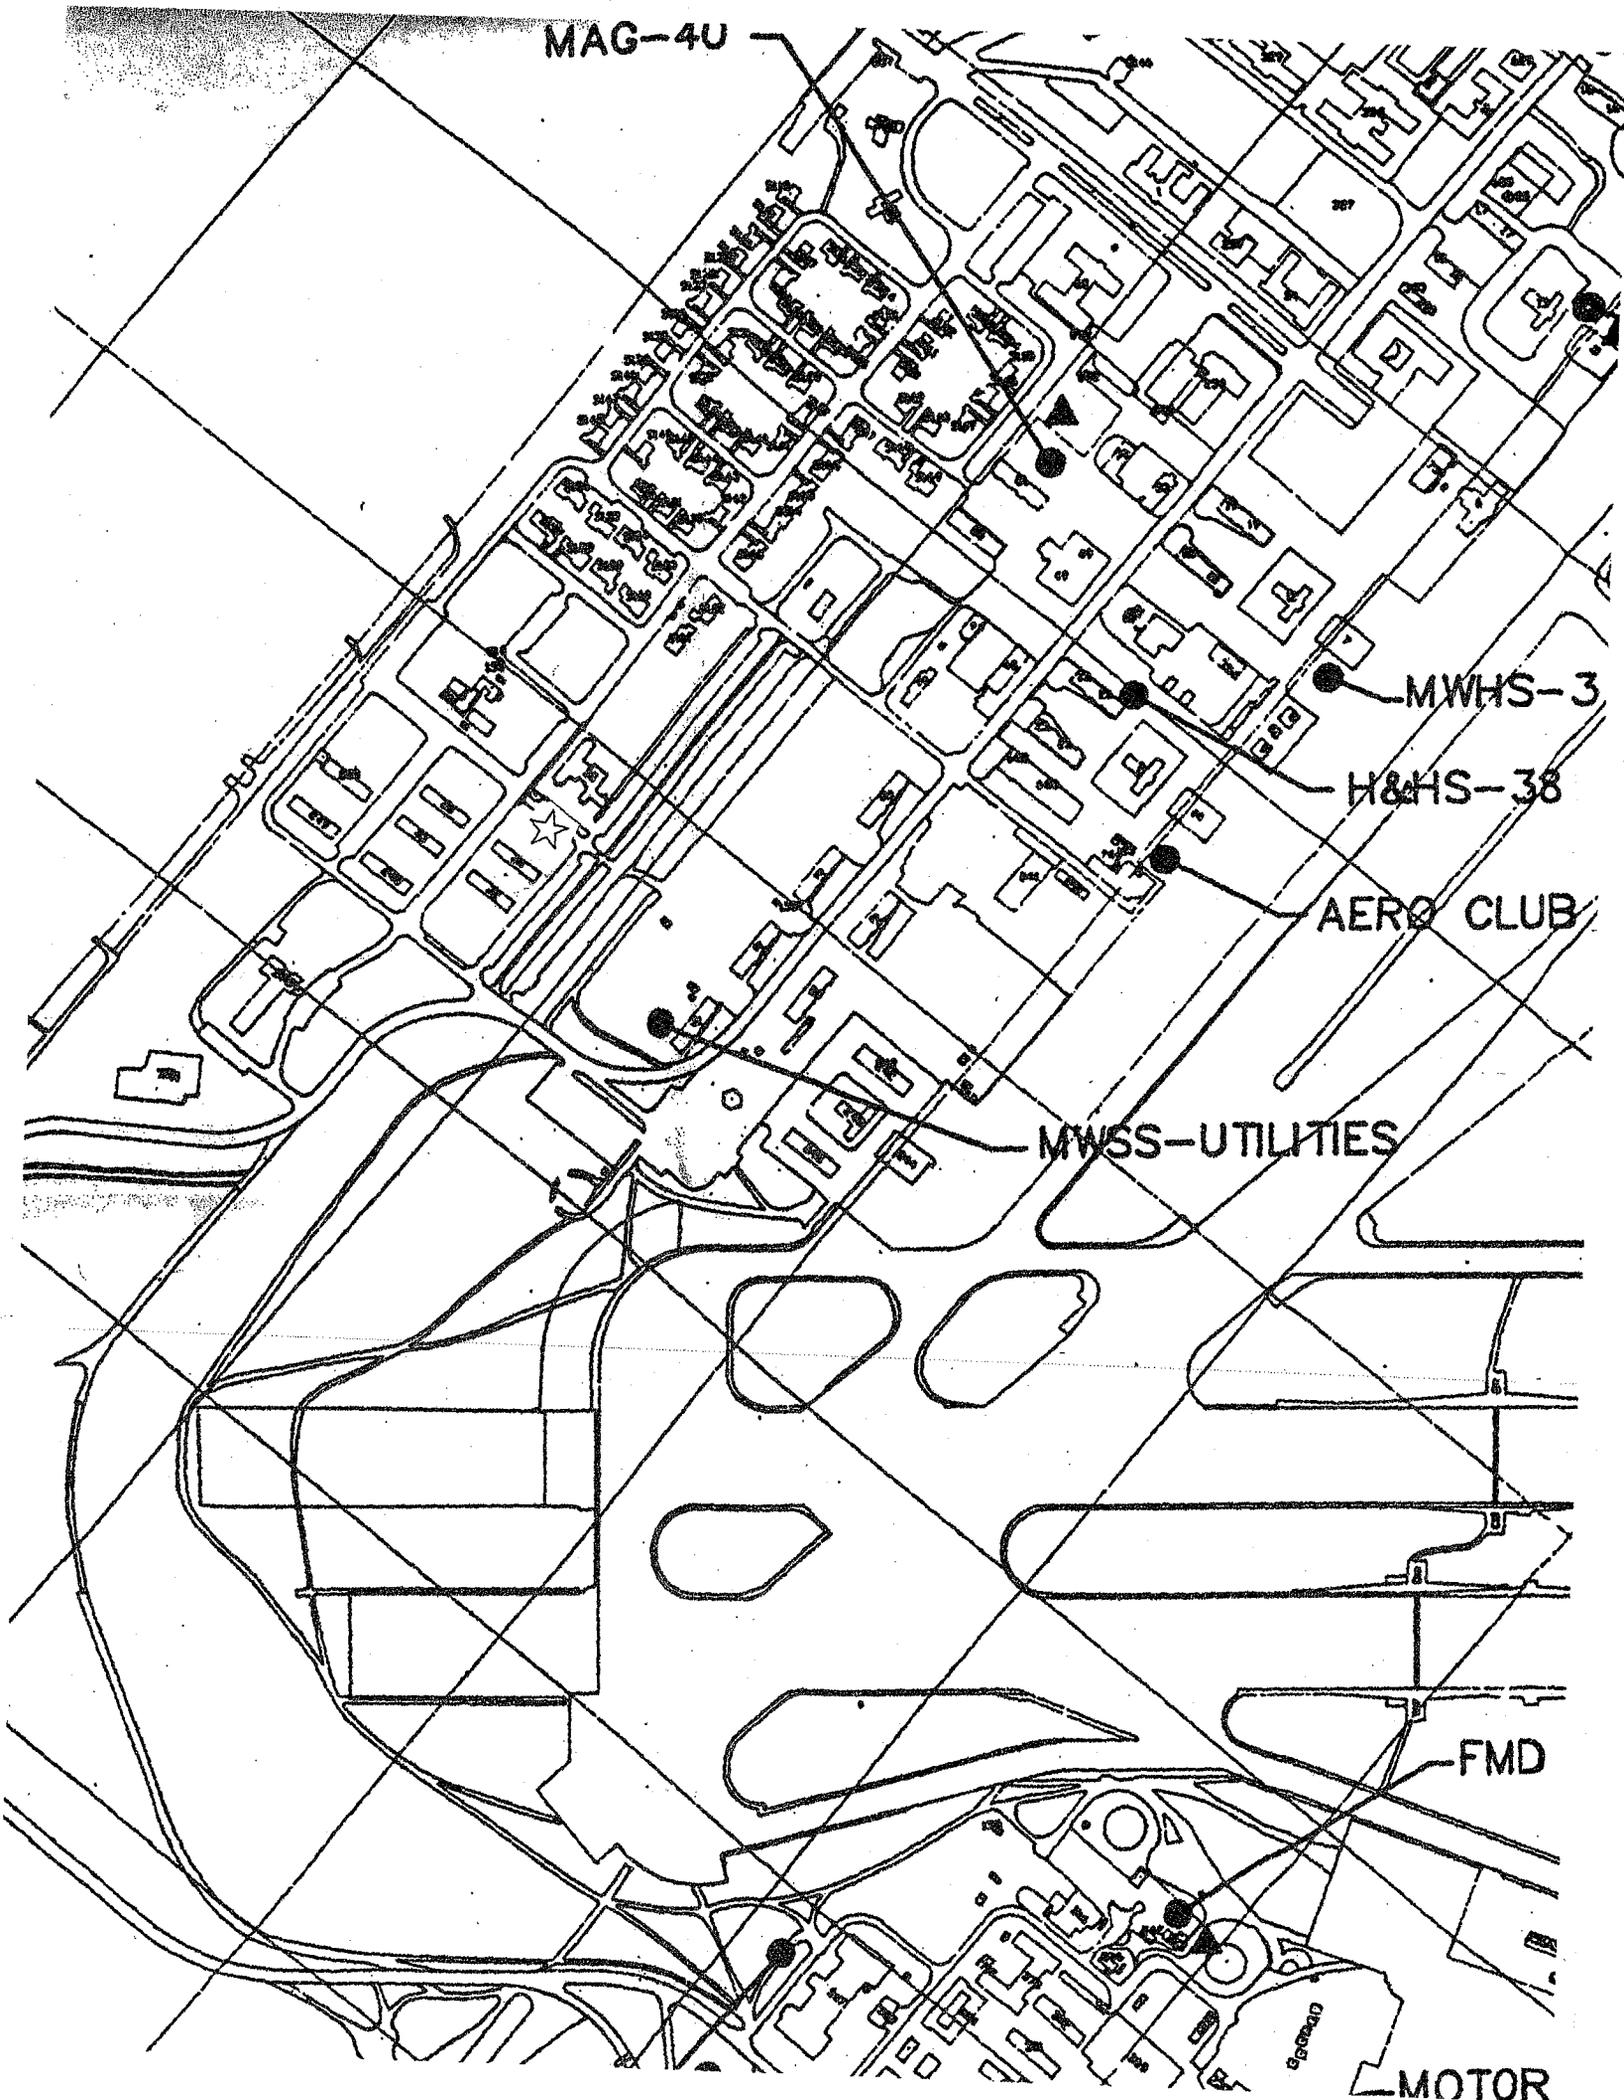
☆ The HM/HWMP does not identify a TAA near the former site of Building 36. The nearest existing building with a TAA is Building 31.

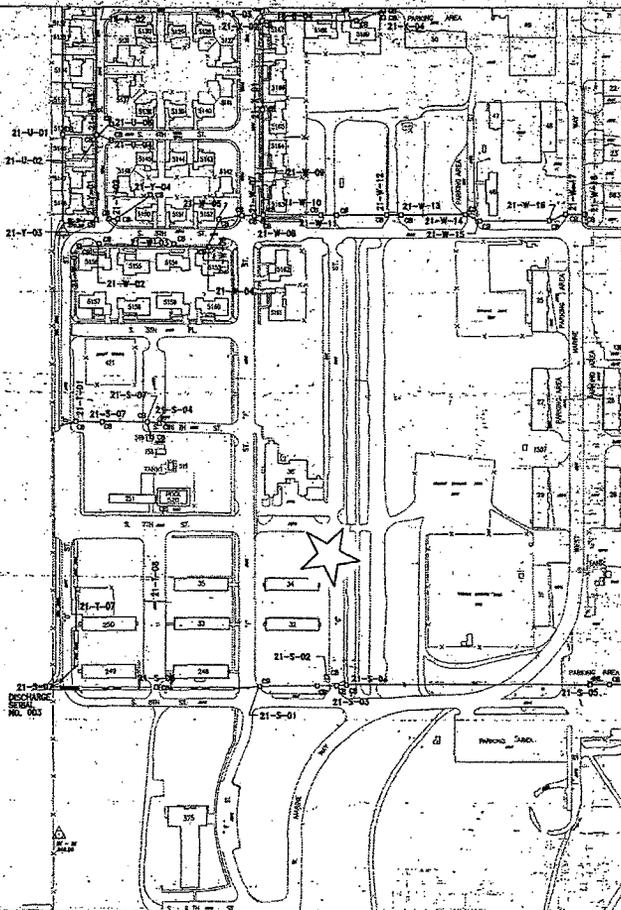
**MCAS EL TORO - AREA 21**  
SCALE: 1"=150'-0"

Star symbol identifies the approximate location of former Building 36.

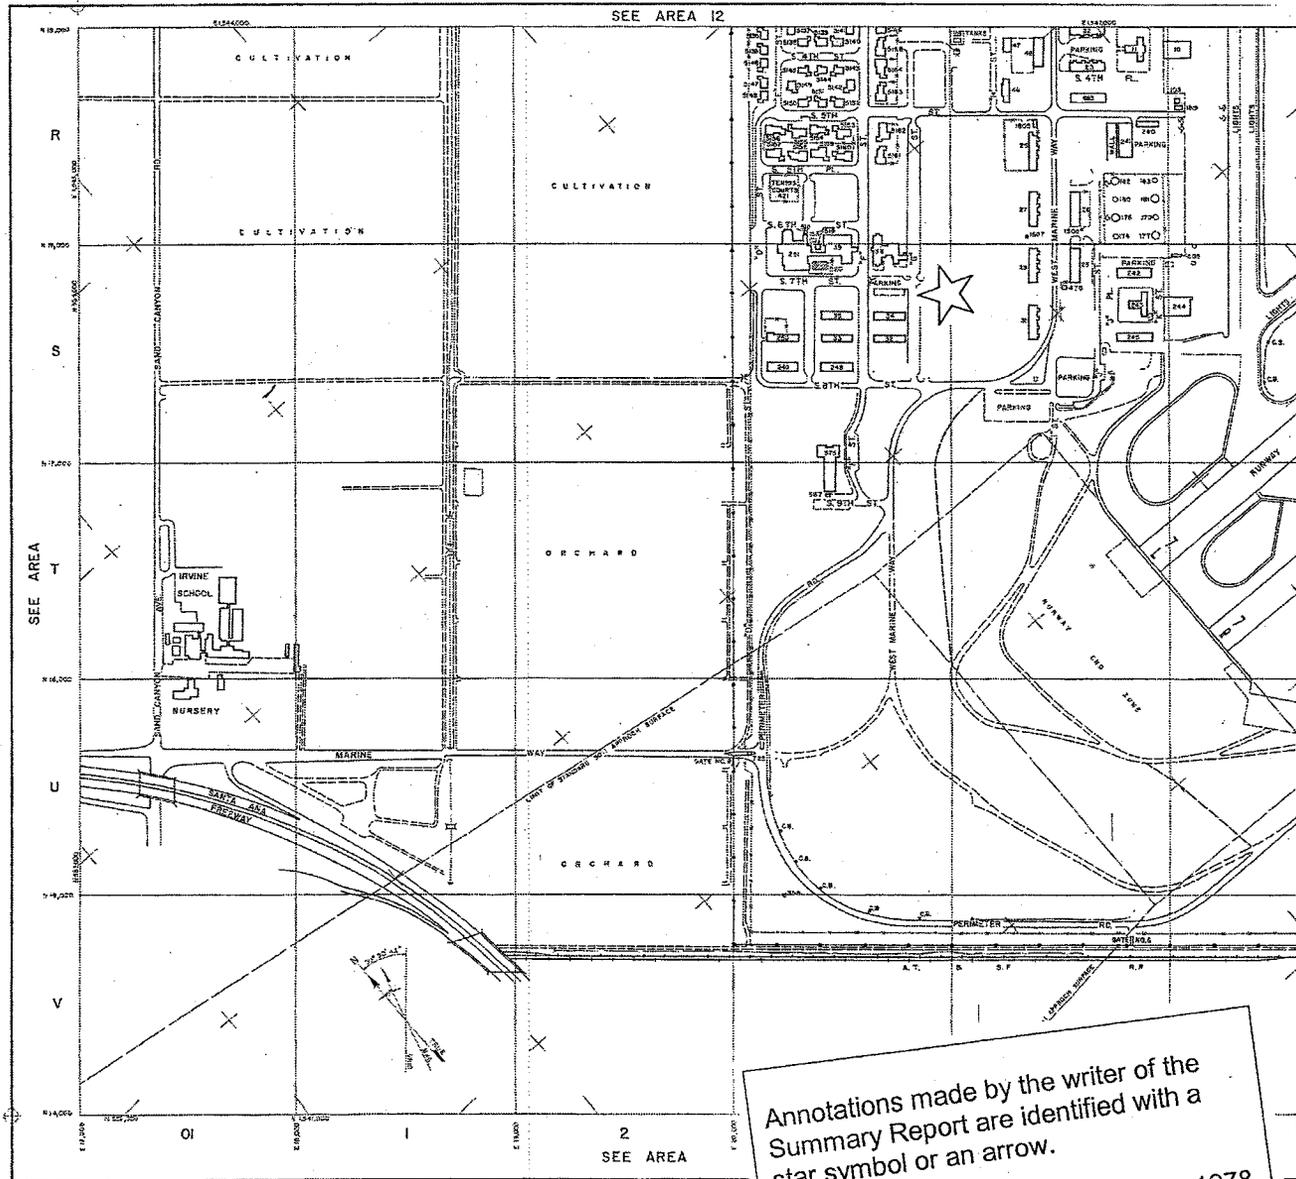
Annotations made by the writer of the Summary Report are identified with a star symbol or an arrow.  
 ☆ The 1954 General Development Map Shows Building 36.

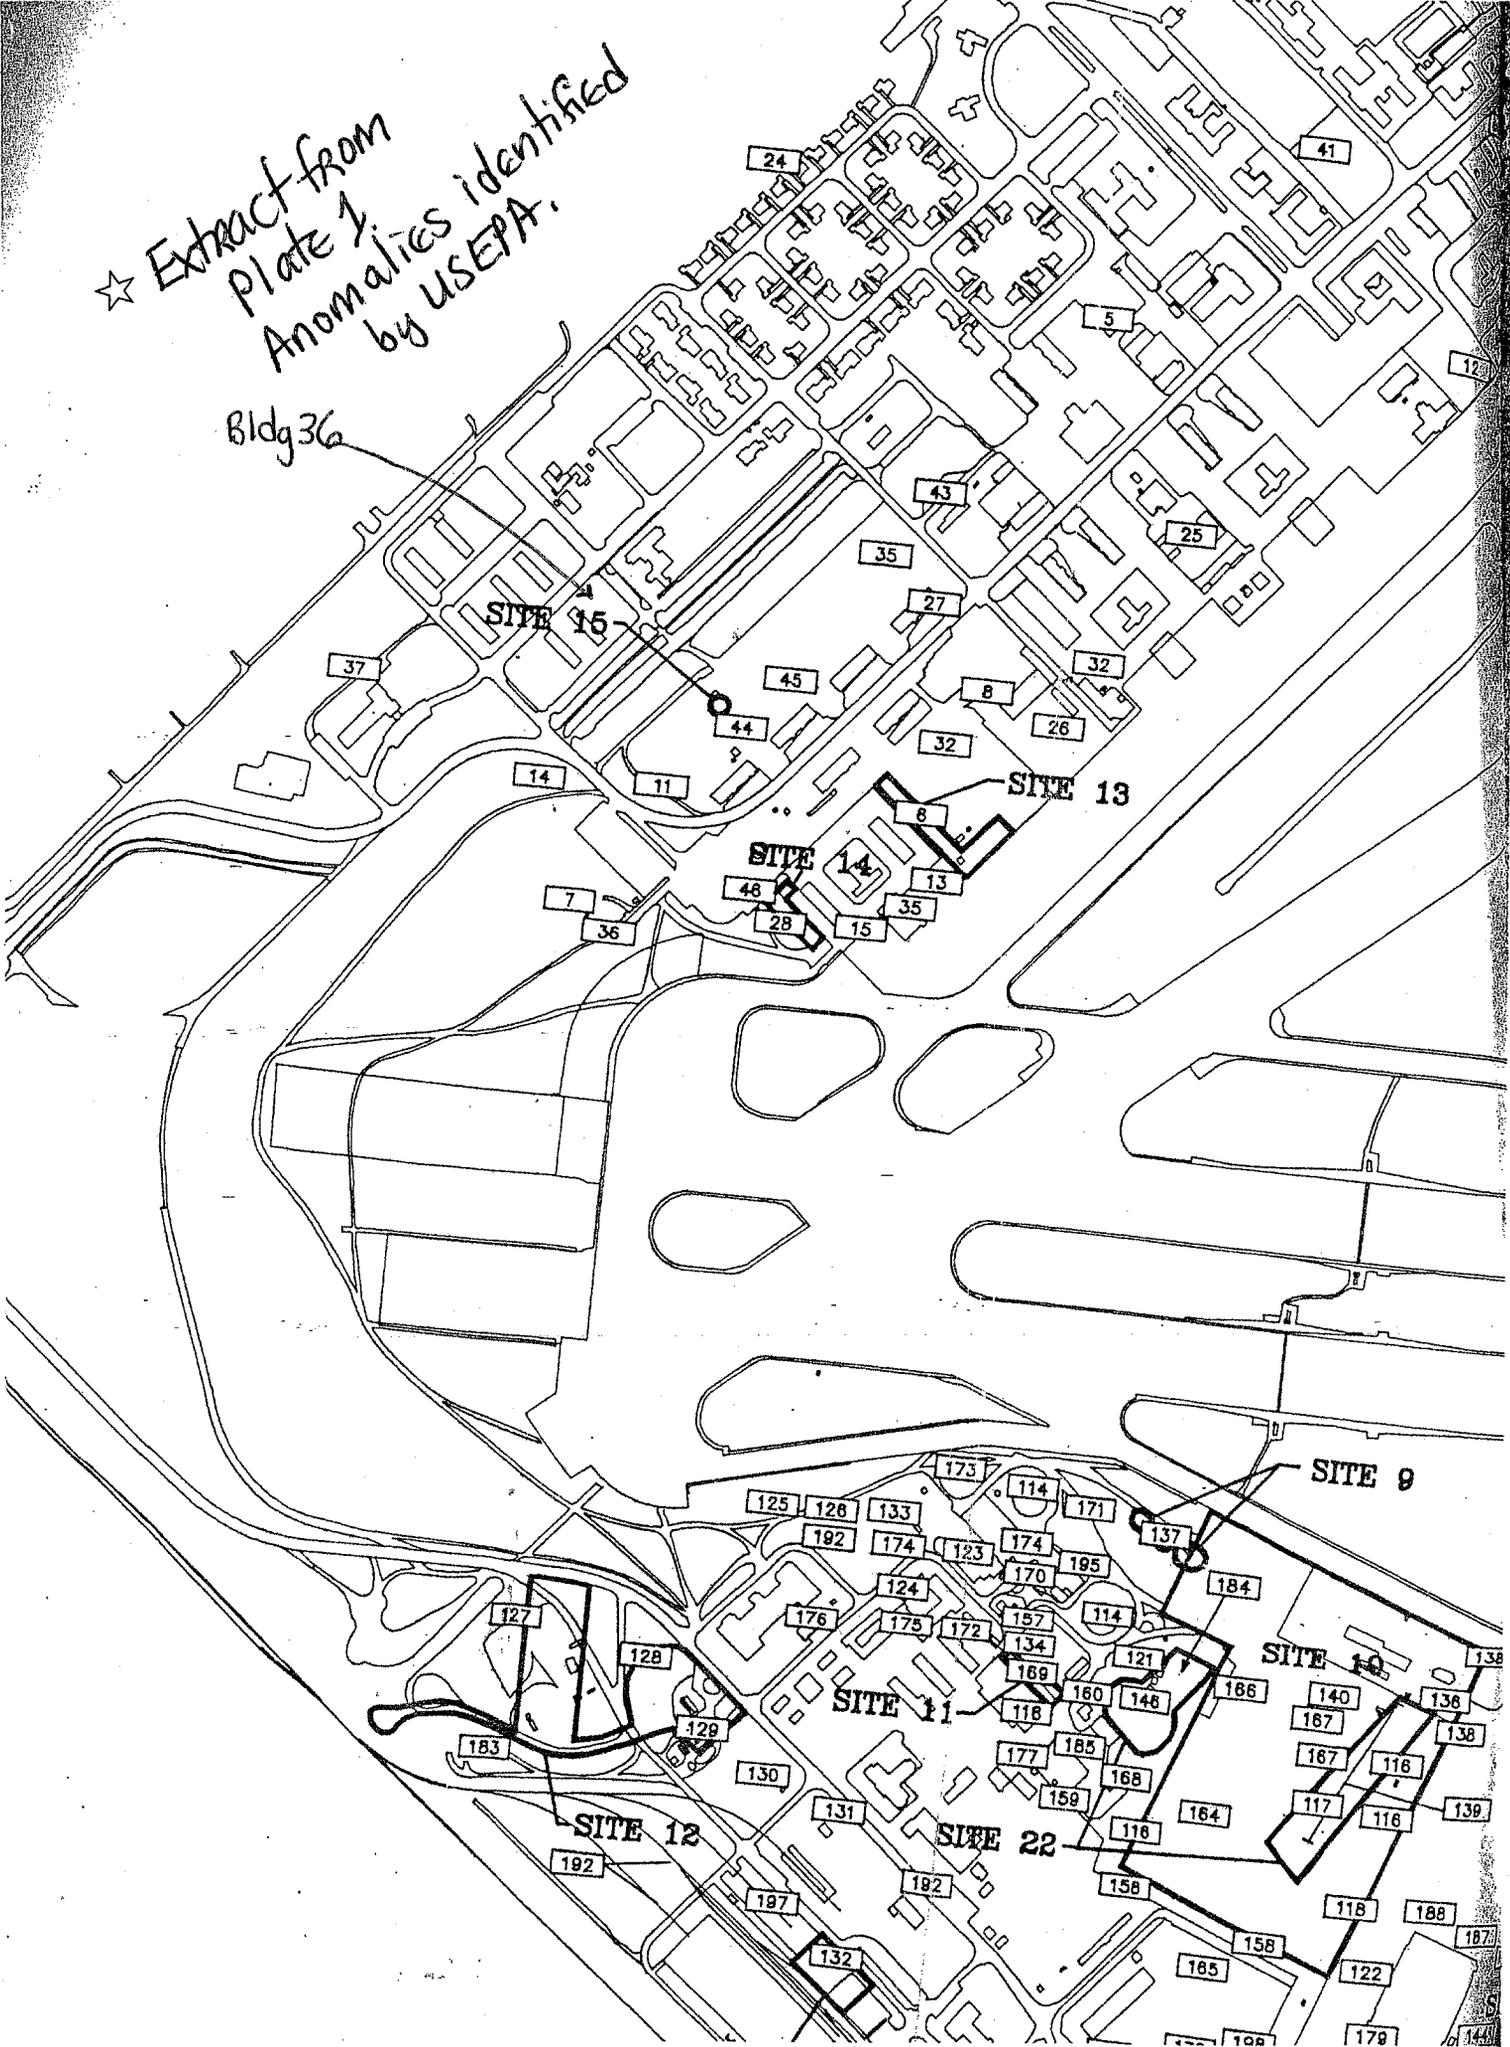
☆ Extract from  
Plate 1  
Anomalies identified  
by USEPA.

Bldg 36

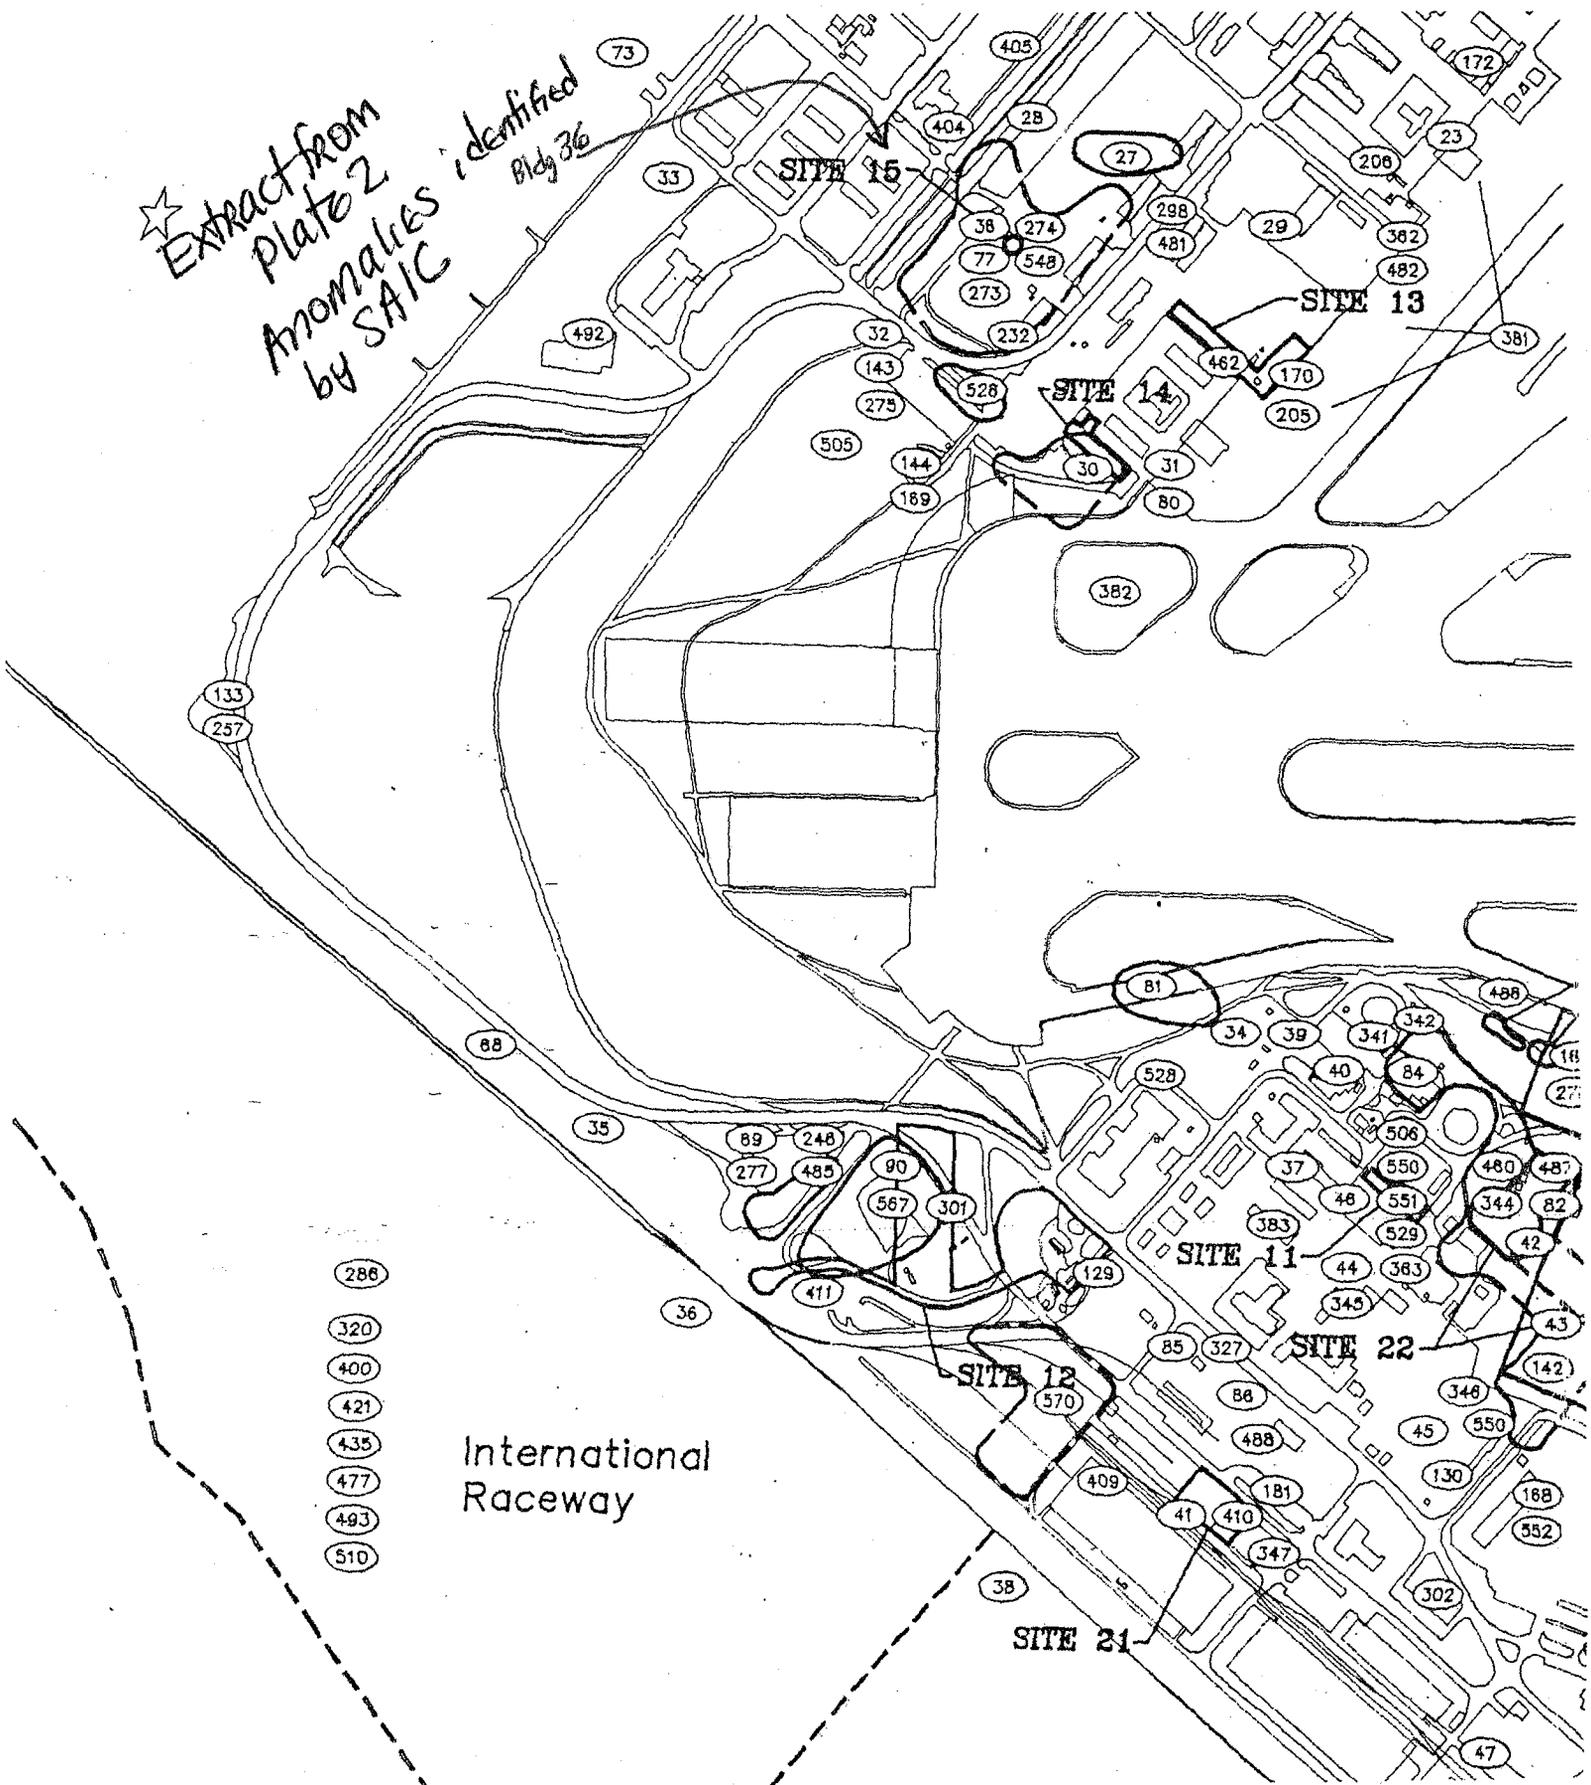
☆ Extract from  
plate 2  
Anomalies  
by SAIC

identified  
Bldg 36
