Summary Report

*Phantom Drum Storage Area
Solid Waste Management Unit (SWMU) 121
Marine Corps Air Station, El Toro, California*

4 January 2002

Prepared by:
Southwest Division, Naval Facilities Engineering Command
BRAC Programs Office
San Diego, CA 92101-2404

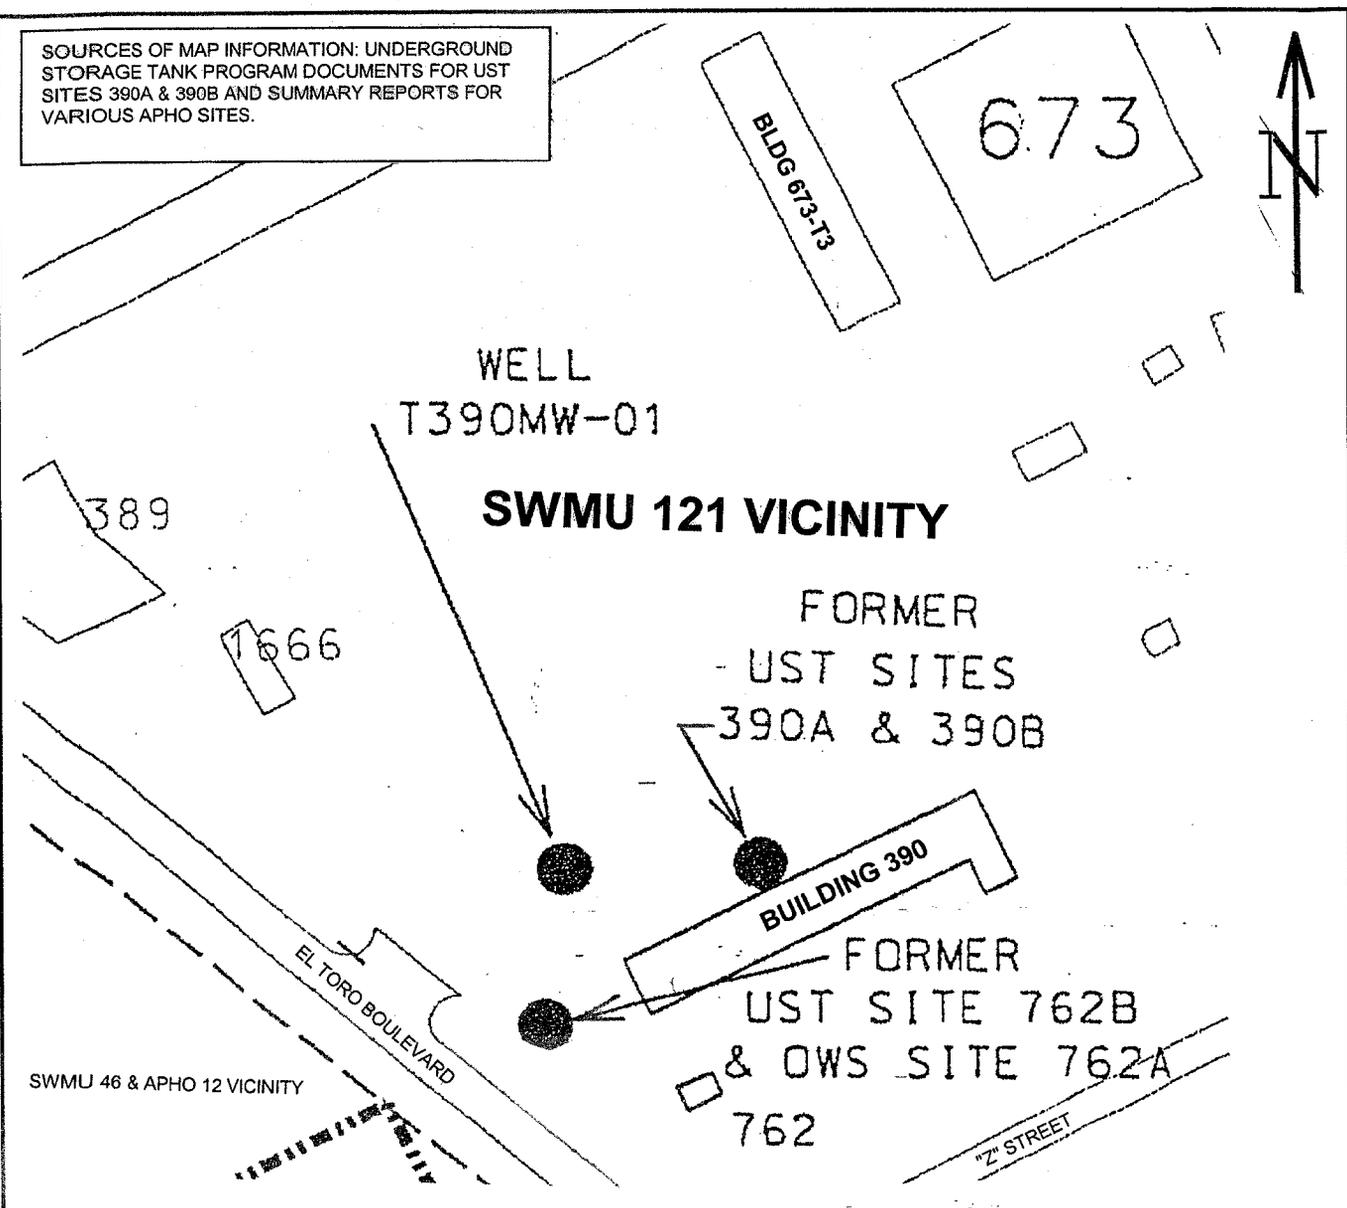
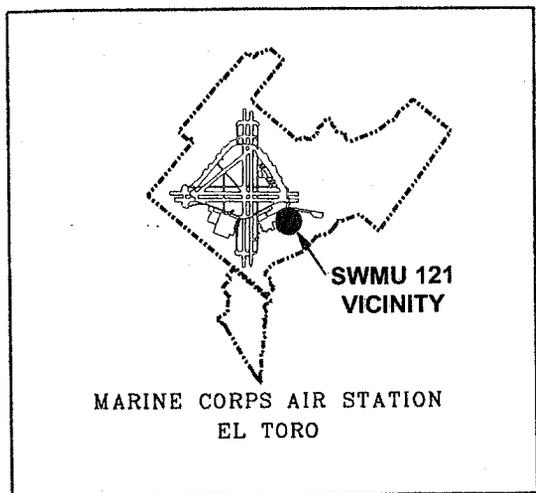
Figure 1.
SOLID WASTE MANAGEMENT UNIT (SWMU) NUMBER 121
VICINITY MAP
MARINE CORPS AIR STATION, EL TORO

NOTES:
(1) APPROXIMATE SCALE IS 1 INCH = 100 FEET
(2) LOCATIONS OF WELLS, TANKS, AND OTHER FEATURES ARE APPROXIMATE.

The approximate location of SWMU 121 is identified with a star symbol.

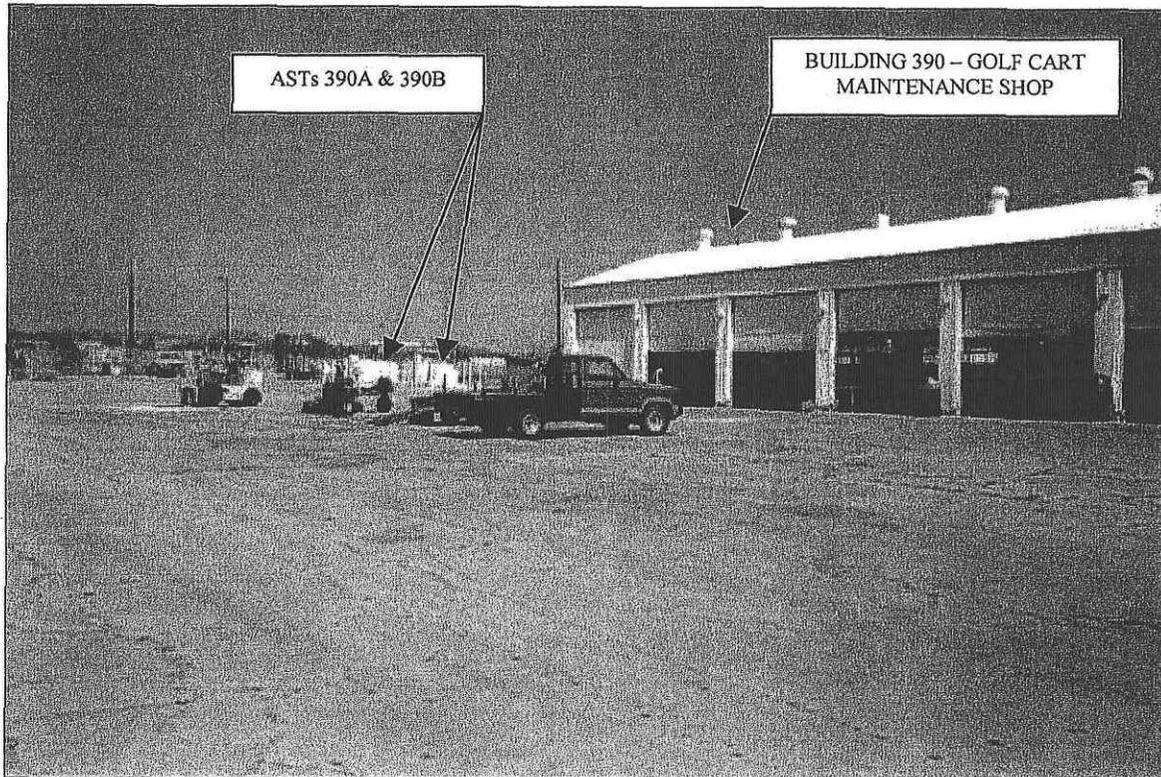
Photograph 1. Building 390 Vicinity Looking East.
Phantom Solid Waste Management Unit (SWMU) 121 Vicinity.
Marine Corps Air Station, El Toro

Date of Photograph: June 1999

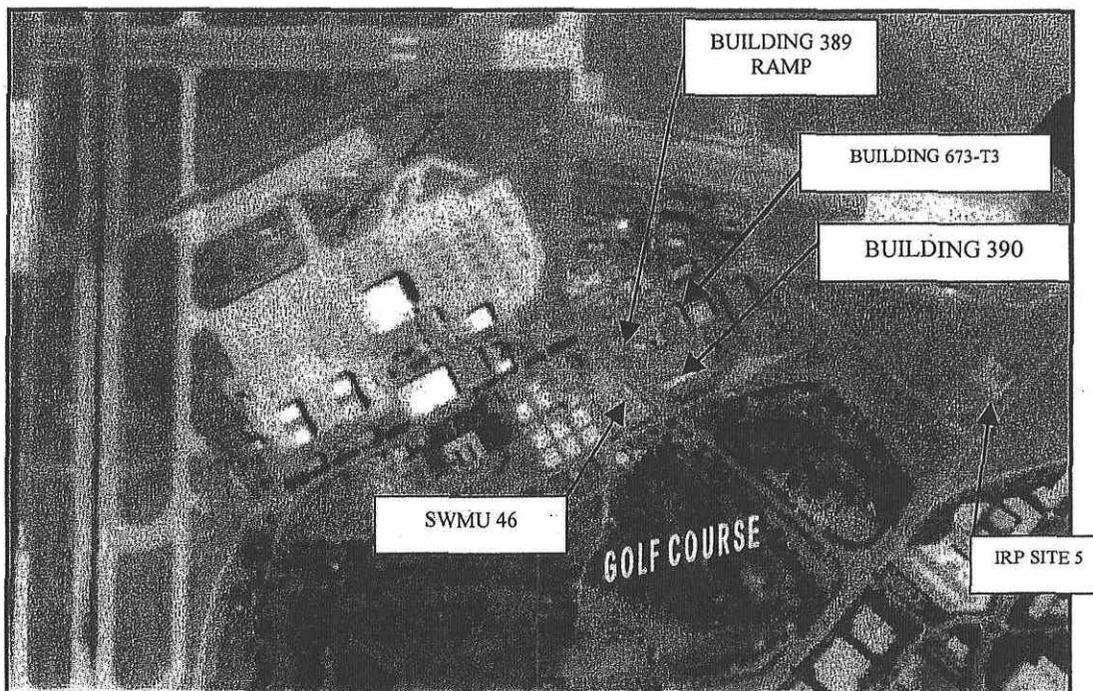
Photograph 4. Building 390 / Phantom SWMU 121 Vicinity.
Marine Corps Air Station, El Toro

Date of Photograph: 1994

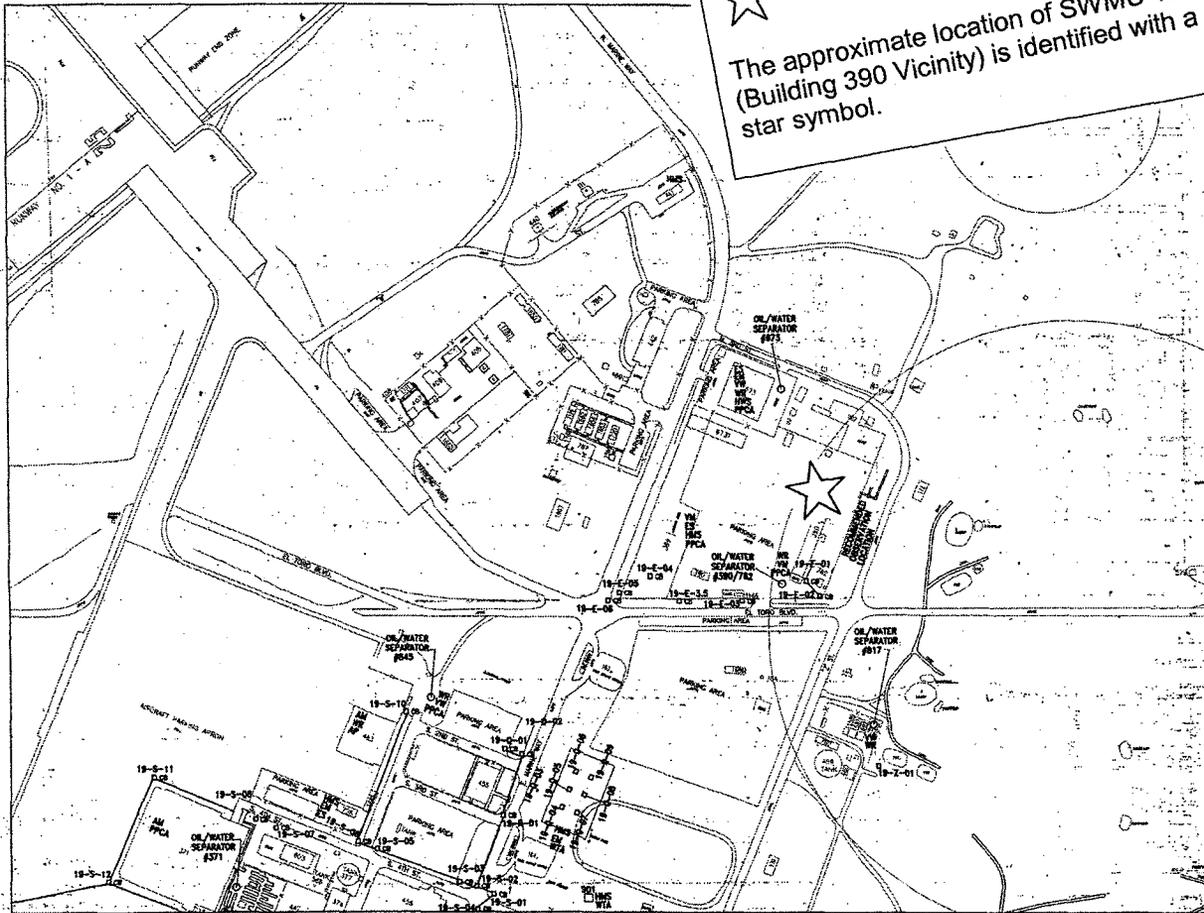
'MCAS' EL TORO - AREA 19
 SCALE: 1"=150'-0"

★
 The approximate location of SWMU 121
 (Building 390 Vicinity) is identified with a
 star symbol.

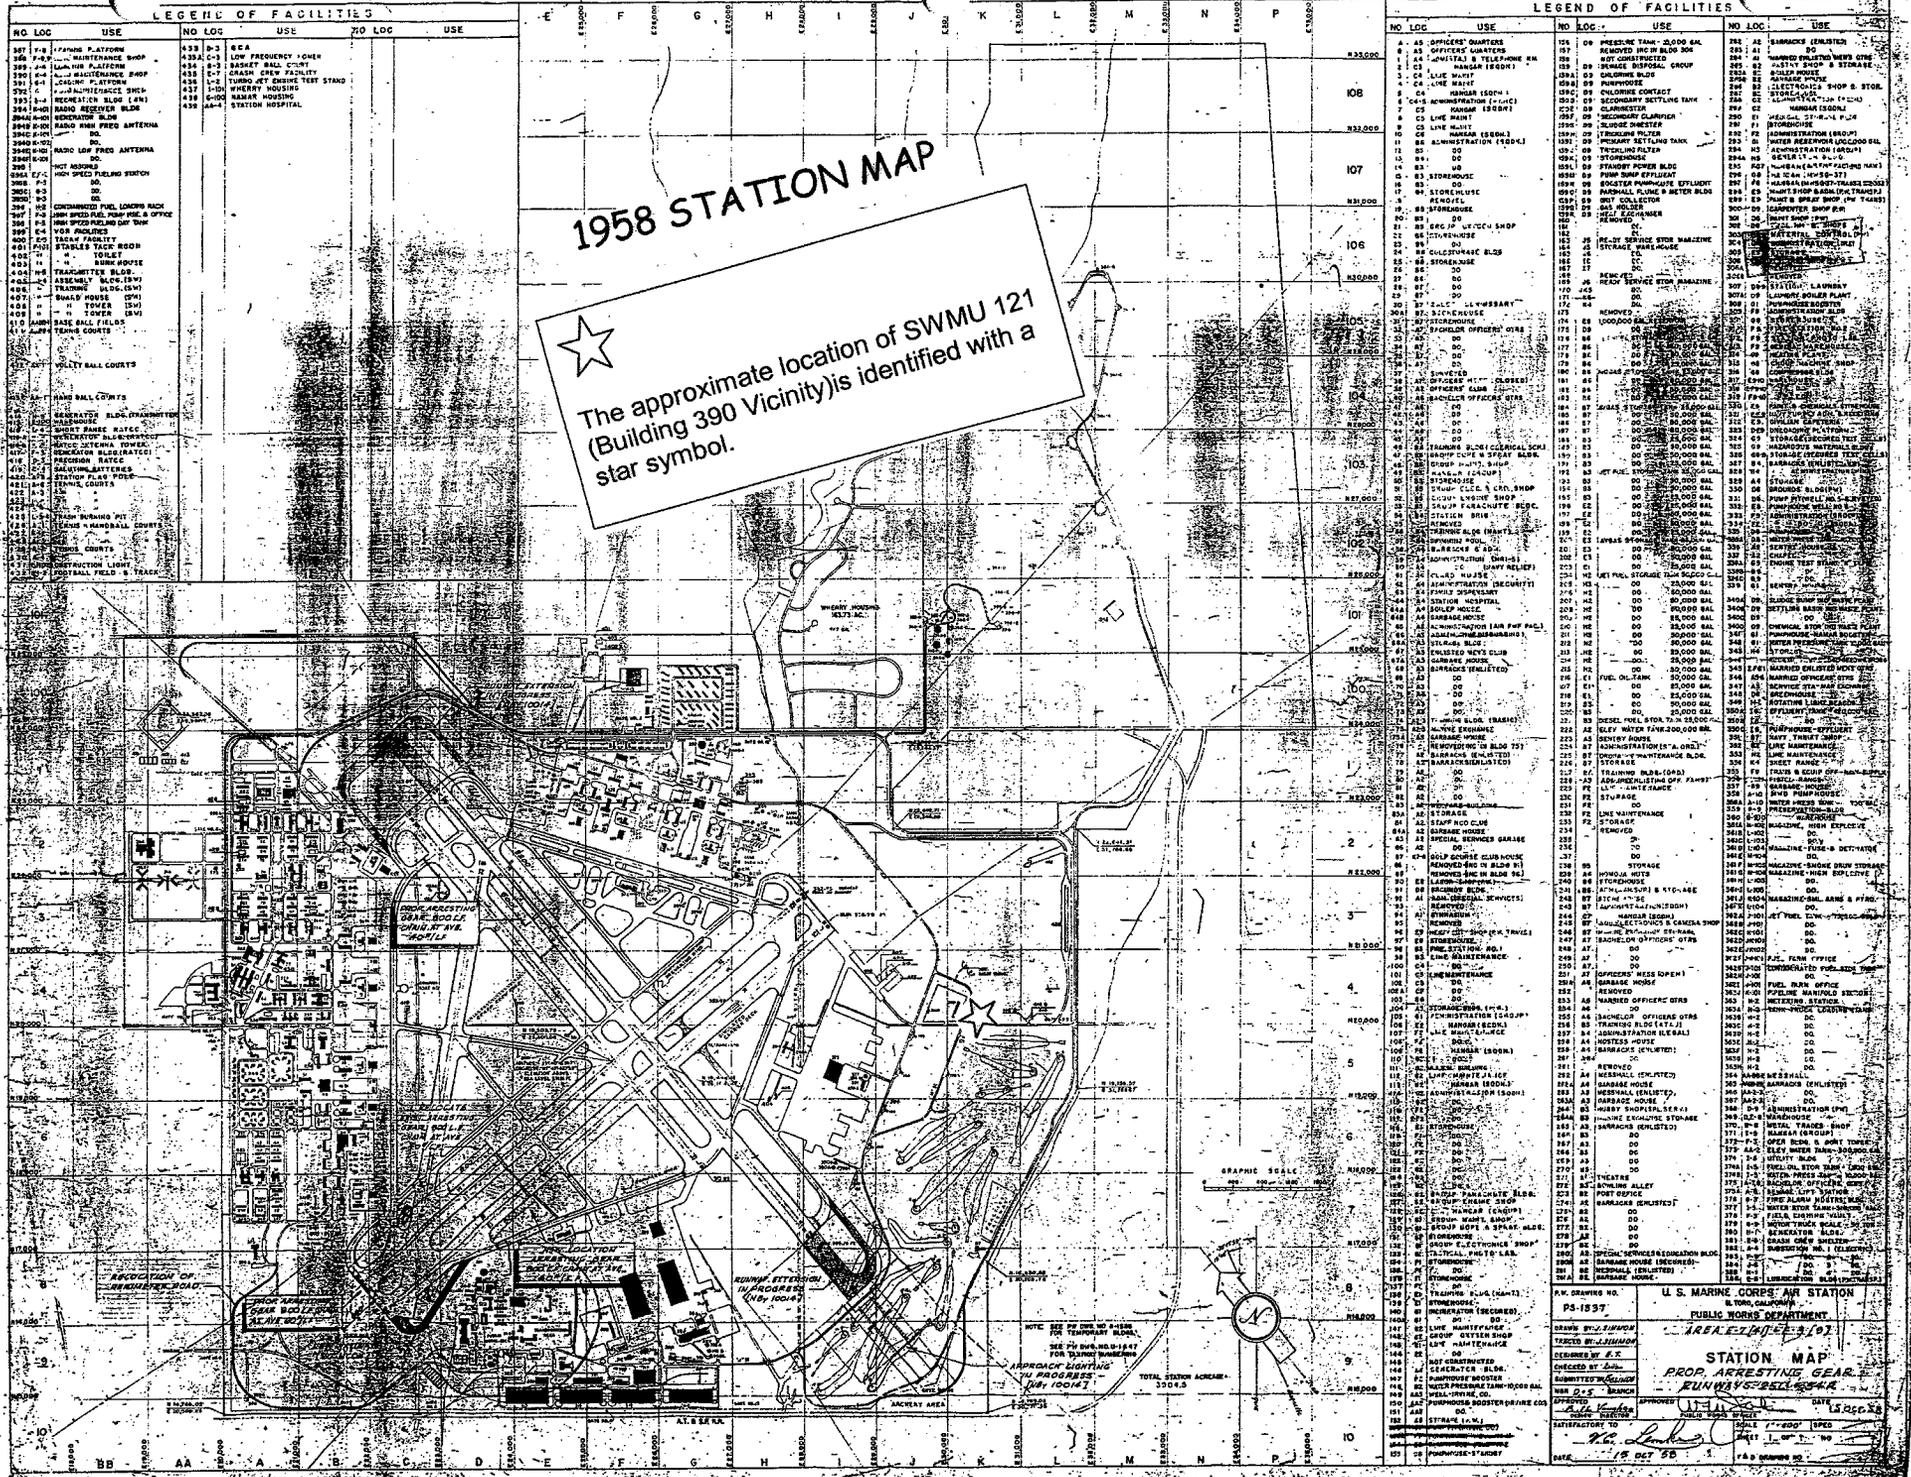
1958 STATION MAP

The approximate location of SWMU 121 (Building 390 Vicinity) is identified with a star symbol.

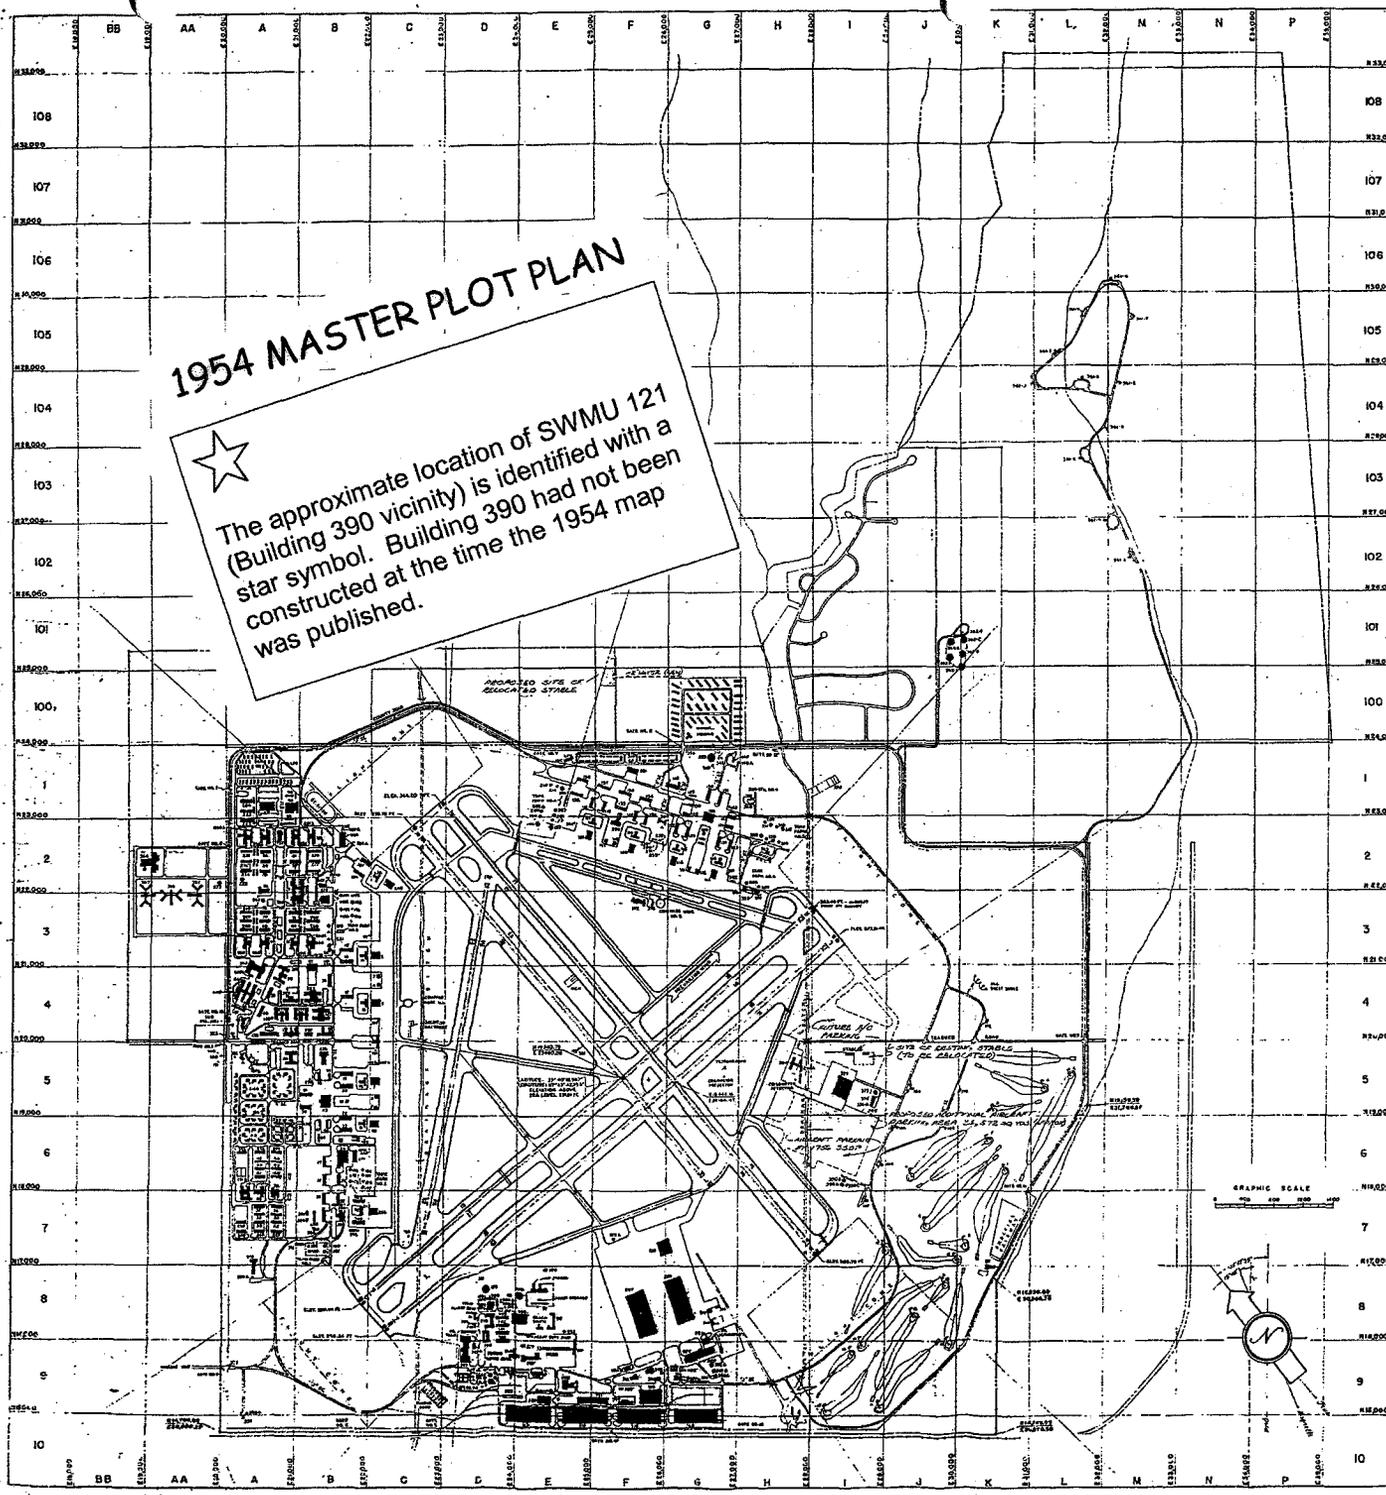
1954 MASTER PLOT PLAN

★ The approximate location of SWMU 121 (Building 390) vicinity is identified with a star symbol. Building 390 had not been constructed at the time the 1954 map was published.

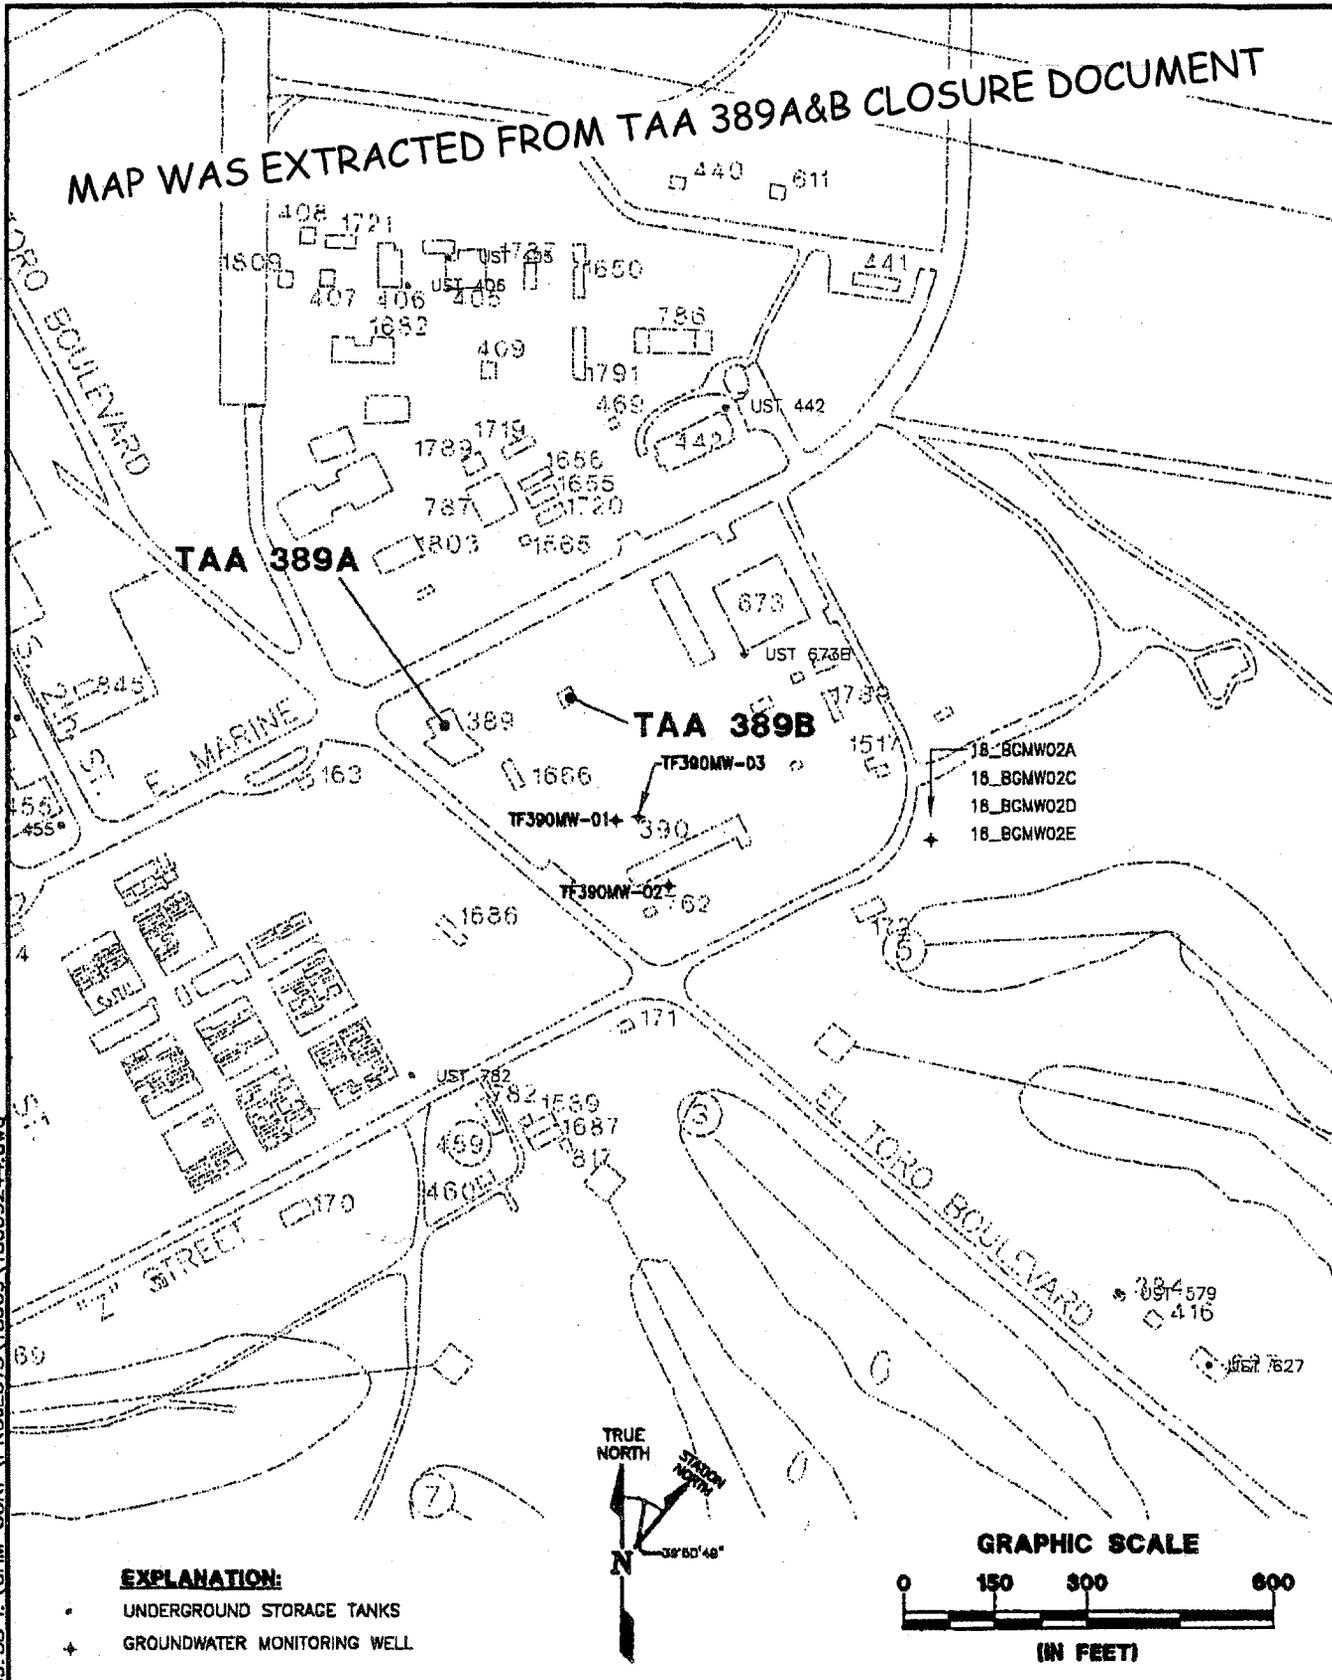
MAP WAS EXTRACTED FROM TAA 389A&B CLOSURE DOCUMENT

- EXPLANATION:**
- UNDERGROUND STORAGE TANKS
 - + GROUNDWATER MONITORING WELL

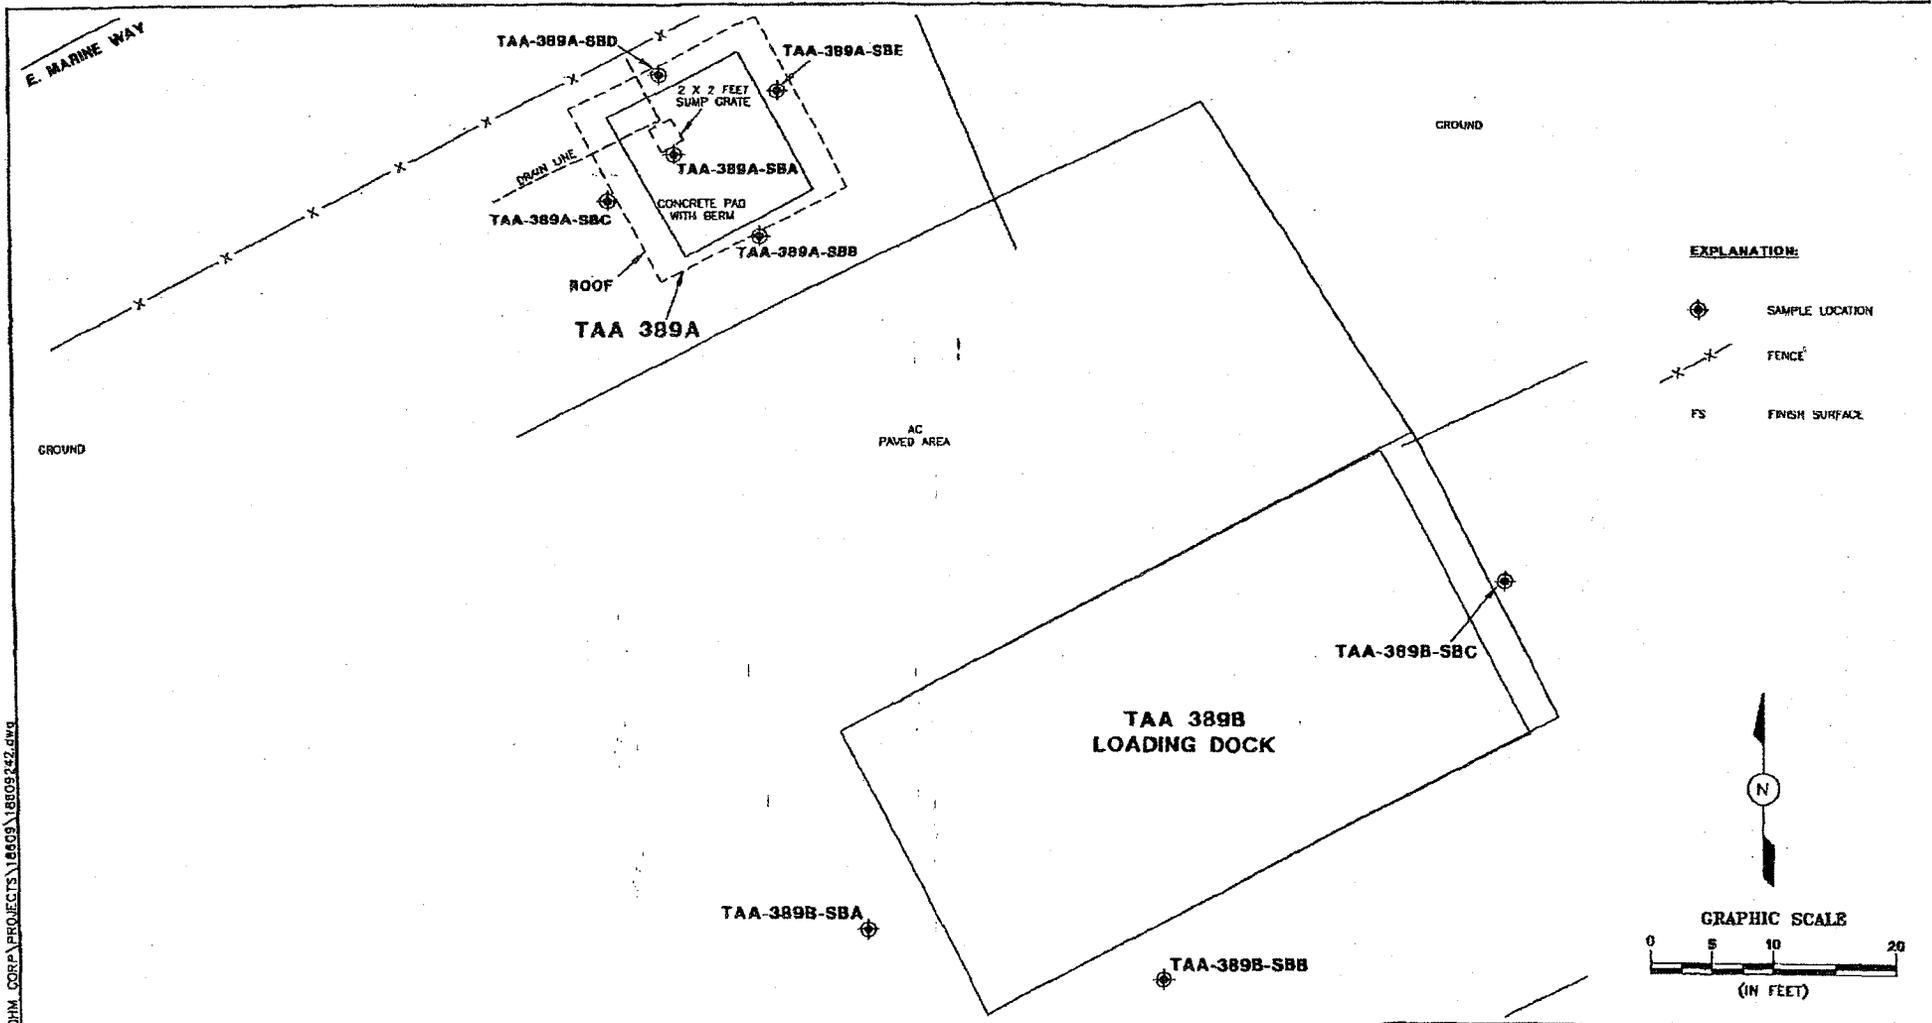
MAP WAS EXTRACTED FROM TAA 389A&B CLOSURE DOCUMENT

- EXPLANATION:**
- SAMPLE LOCATION
 - FENCE
 - FINISH SURFACE

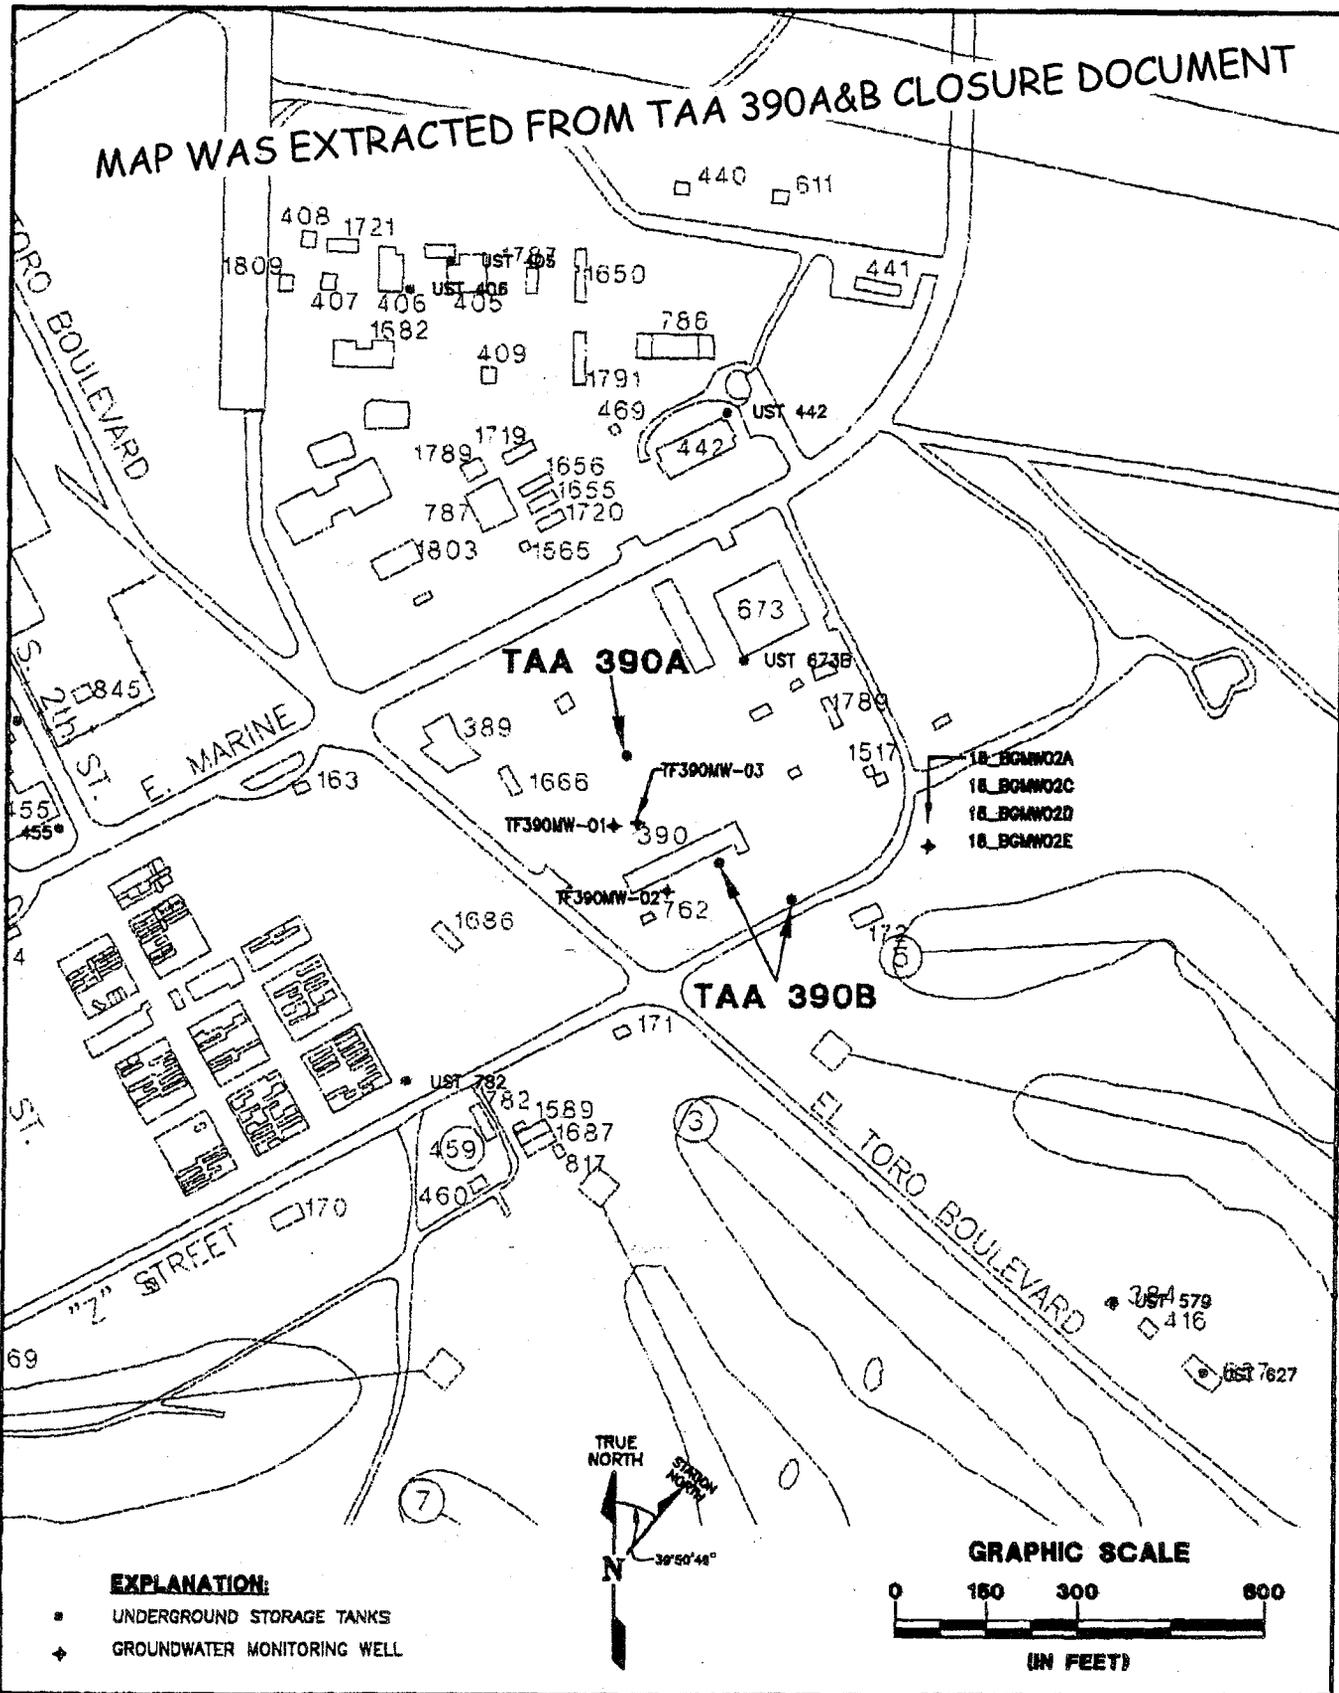
MAP WAS EXTRACTED FROM TAA 390A&B CLOSURE DOCUMENT

- UNDERGROUND STORAGE TANKS
- ◆ GROUNDWATER MONITORING WELL

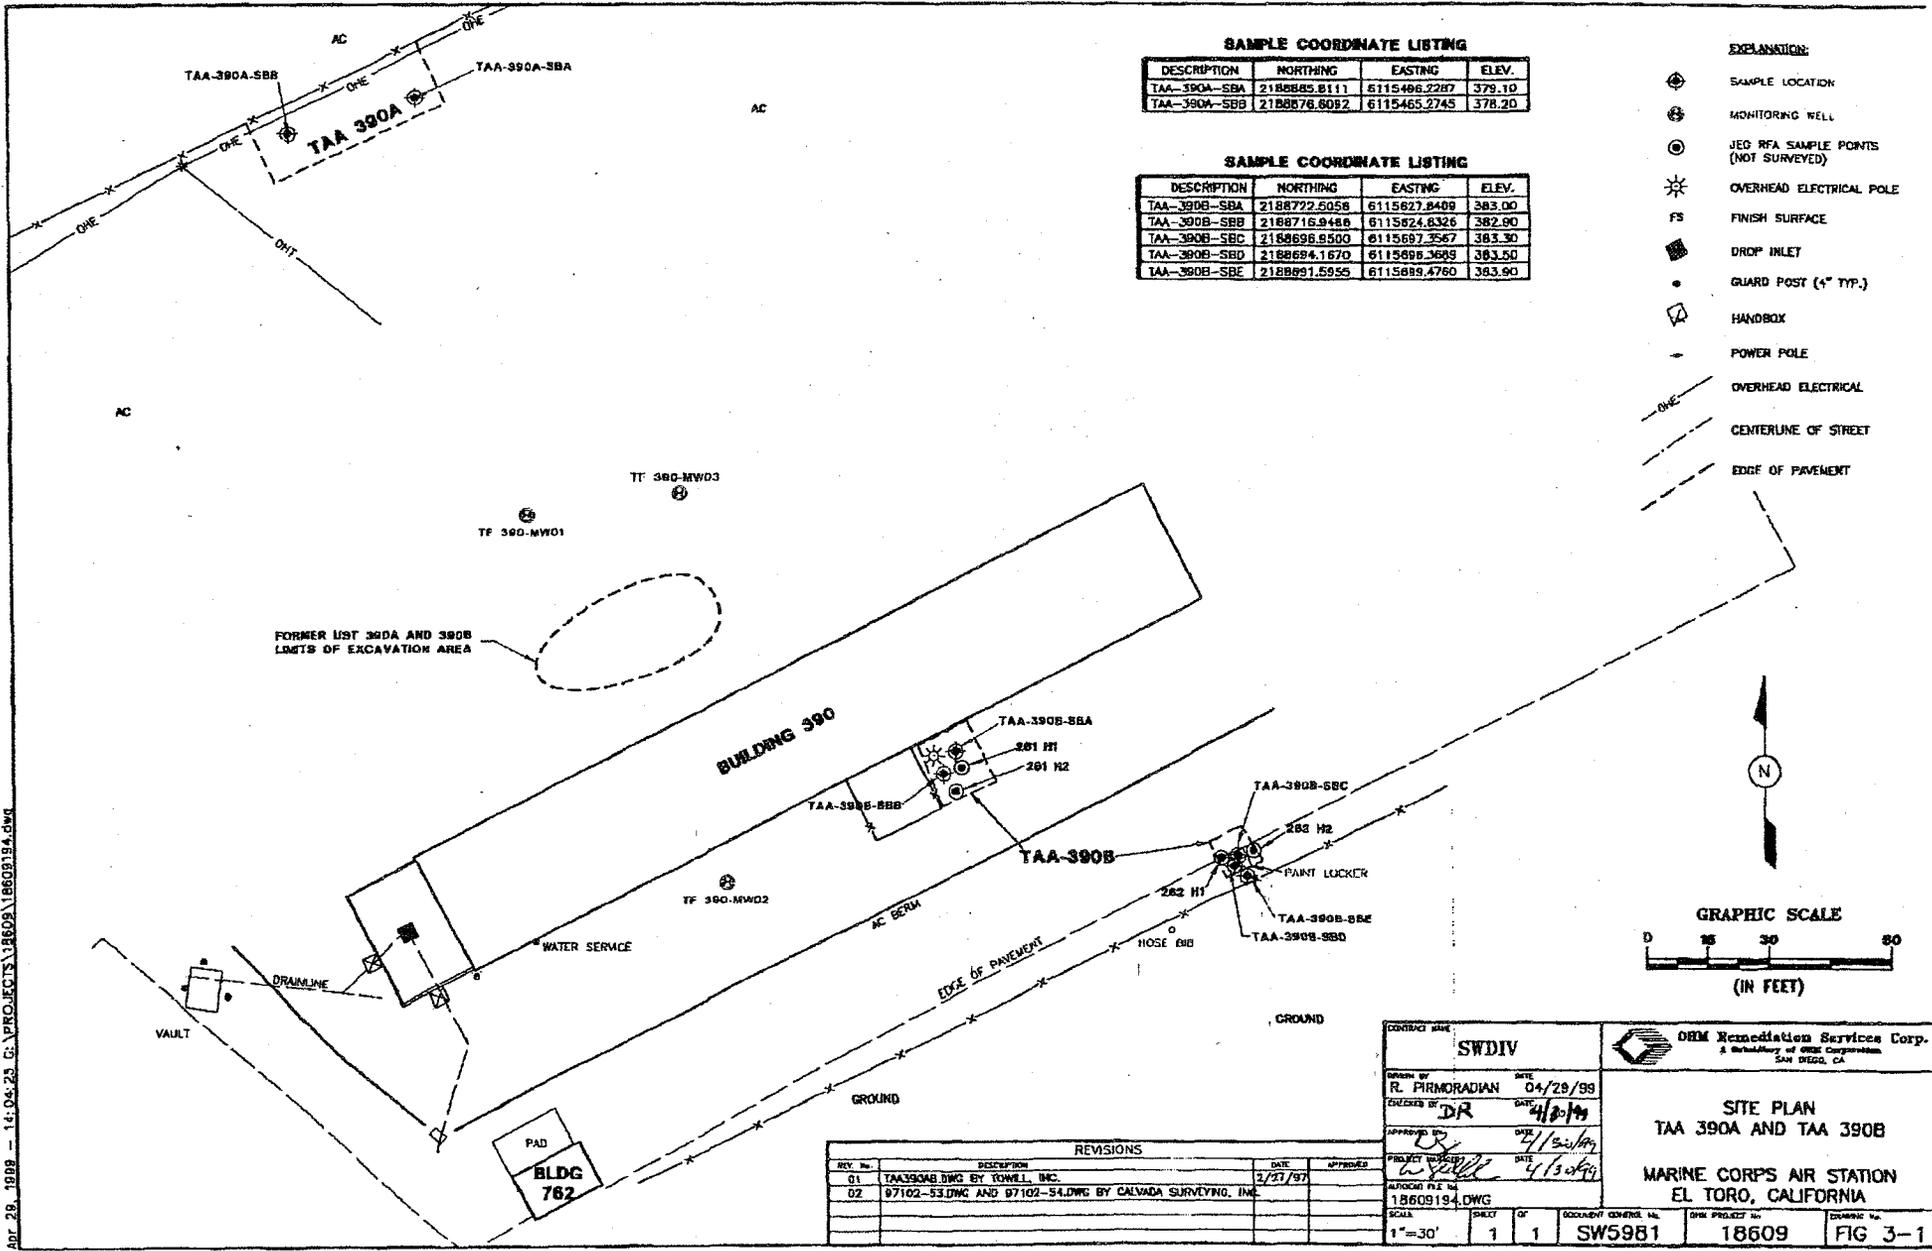
MAP WAS EXTRACTED FROM TAA 390A&B CLOSURE DOCUMENT

- EXPLANATION:**
- ⊙ SAMPLE LOCATION
 - ⊕ MONITORING WELL
 - ⊙ JED RFA SAMPLE POINTS (NOT SURVEYED)
 - ☼ OVERHEAD ELECTRICAL POLE
 - FS FINISH SURFACE
 - ⬇ DROP INLET
 - GUARD POST (4" TYP.)
 - ⊠ HANDBOX
 - POWER POLE
 - OVERHEAD ELECTRICAL
 - CENTERLINE OF STREET
 - EDGE OF PAVEMENT

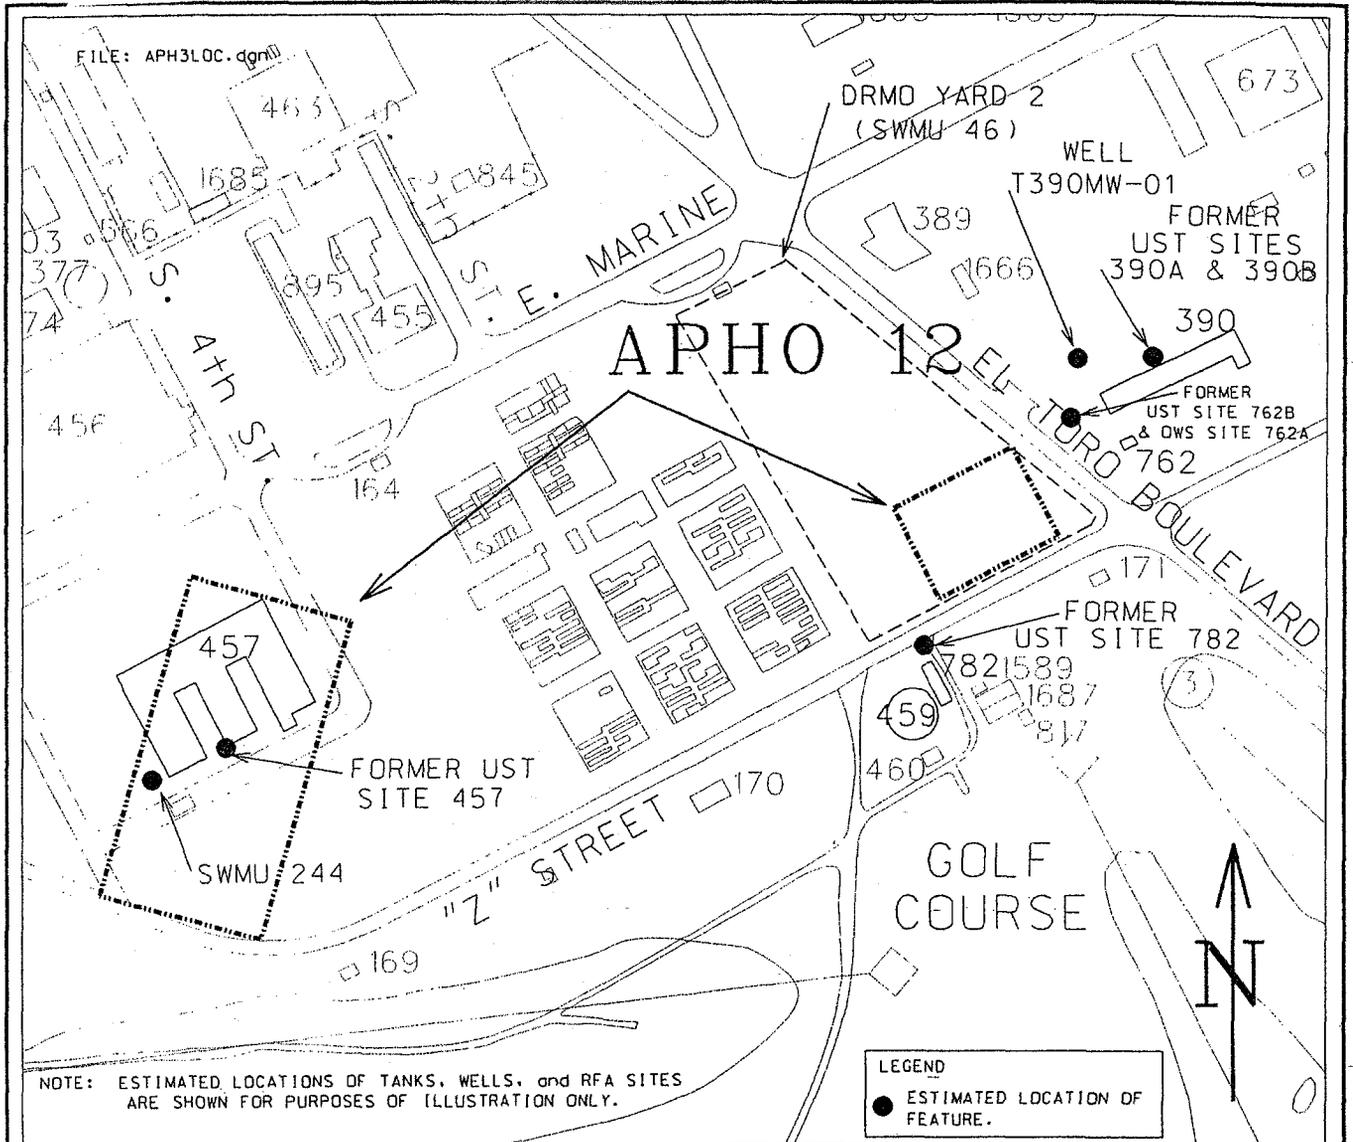
Figure 2.
AERIAL PHOTOGRAPH ANOMALY PROGRAM
NEARBY ENVIRONMENTAL
LOCATIONS OF CONCERN
MARINE CORPS AIR STATION, EL TORO

MAP WAS EXTRACTED FROM THE APHO 12 SUMMARY REPORT.
