Summary Report

*Phantom Drum Storage Area
Solid Waste Management Unit (SWMU) 121
Marine Corps Air Station, El Toro, California*

4 January 2002

Prepared by:
Southwest Division, Naval Facilities Engineering Command
BRAC Programs Office
San Diego, CA 92101-2404

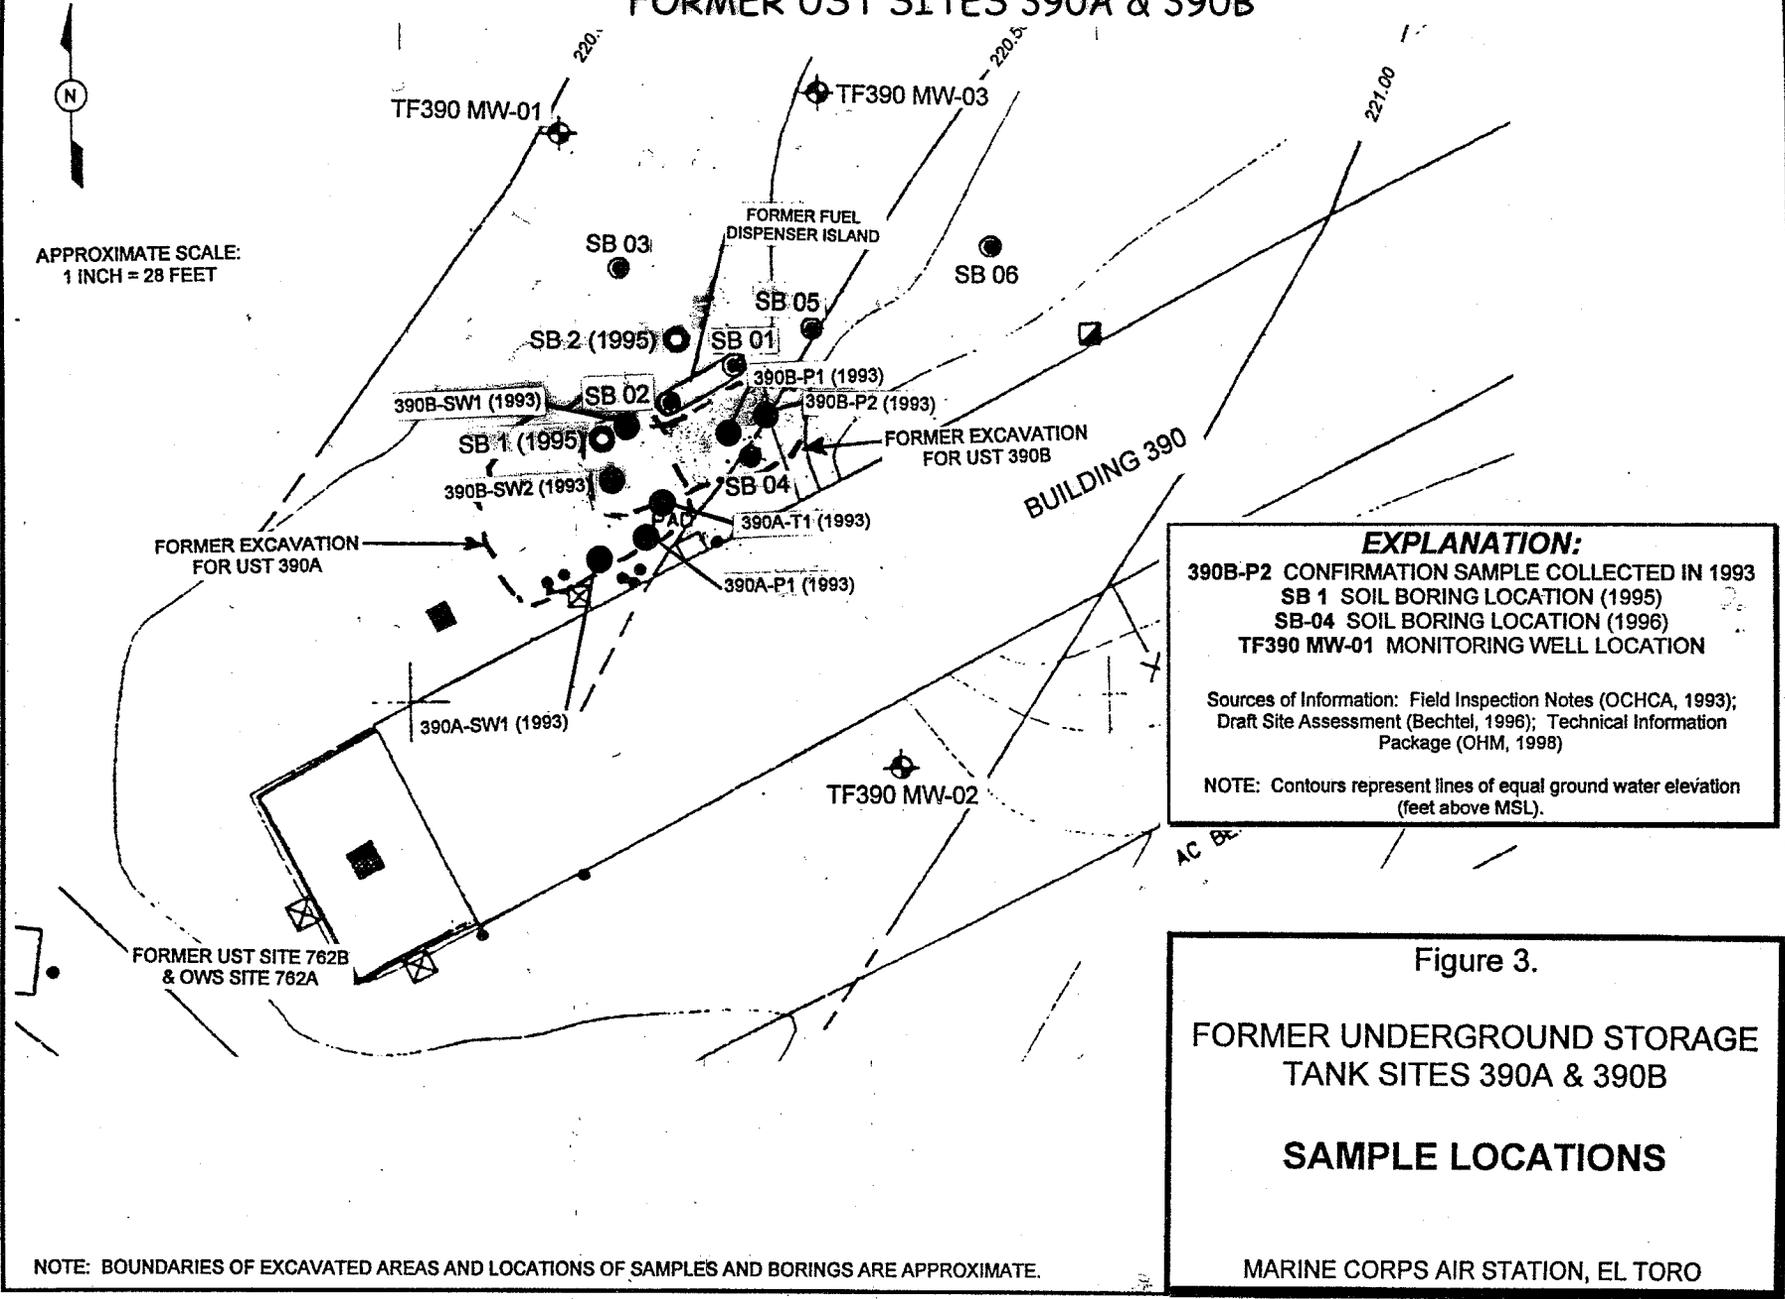
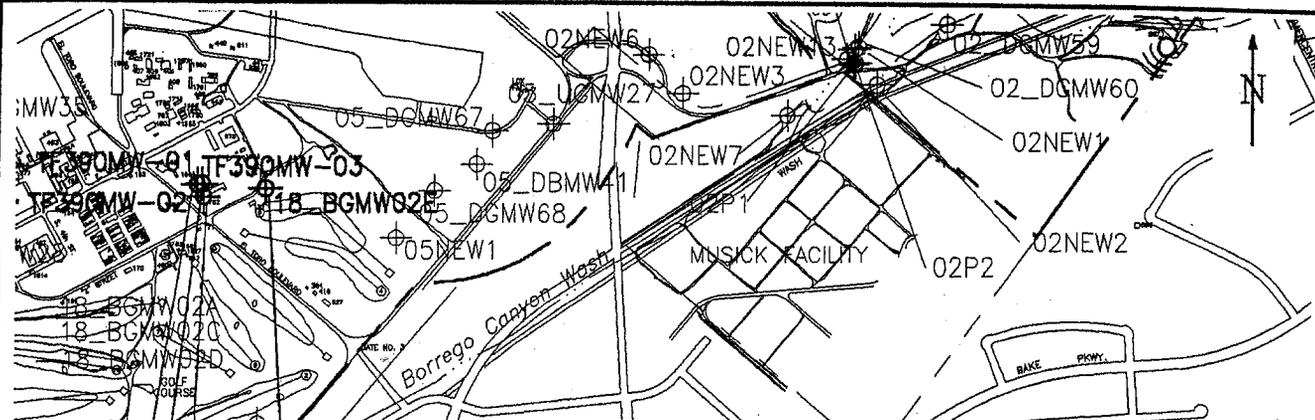
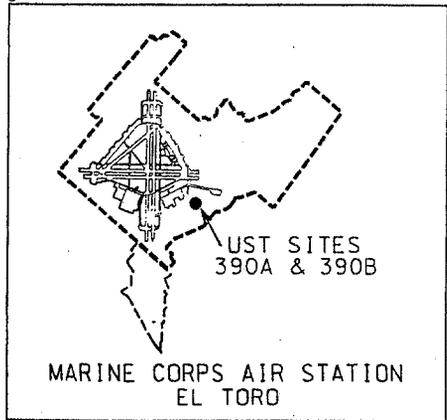
Figure 4.
FORMER UNDERGROUND STORAGE TANK SITES 390A & 390B
GROUND WATER CONDITIONS
MARINE CORPS AIR STATION, EL TORO

MAP WAS EXTRACTED FROM SITE ASSESSMENT REPORT FOR
FORMER UST SITES 390A & 390B

SOURCES OF INFORMATION:
OHM, 1997; SWDIV, 1998.

Ground water conditions have been investigated in the vicinity of Building 390 during the investigations at former UST Sites 390A and 390B. Three groundwater monitoring wells were constructed near Building 390 for the UST investigation, and results of monitoring activities have been submitted to the RWQCB.
