Aerial Photograph Anomaly APHO 40
Probable Drums
Aerial Photograph Anomaly Program
Marine Corps Air Station, El Toro, California

30 September 1999

Prepared by
Southwest Division, Naval Facilities Engineering Command
BRAC Program Office
1420 Kettner Boulevard, Suite 501
San Diego, CA 92101-2404

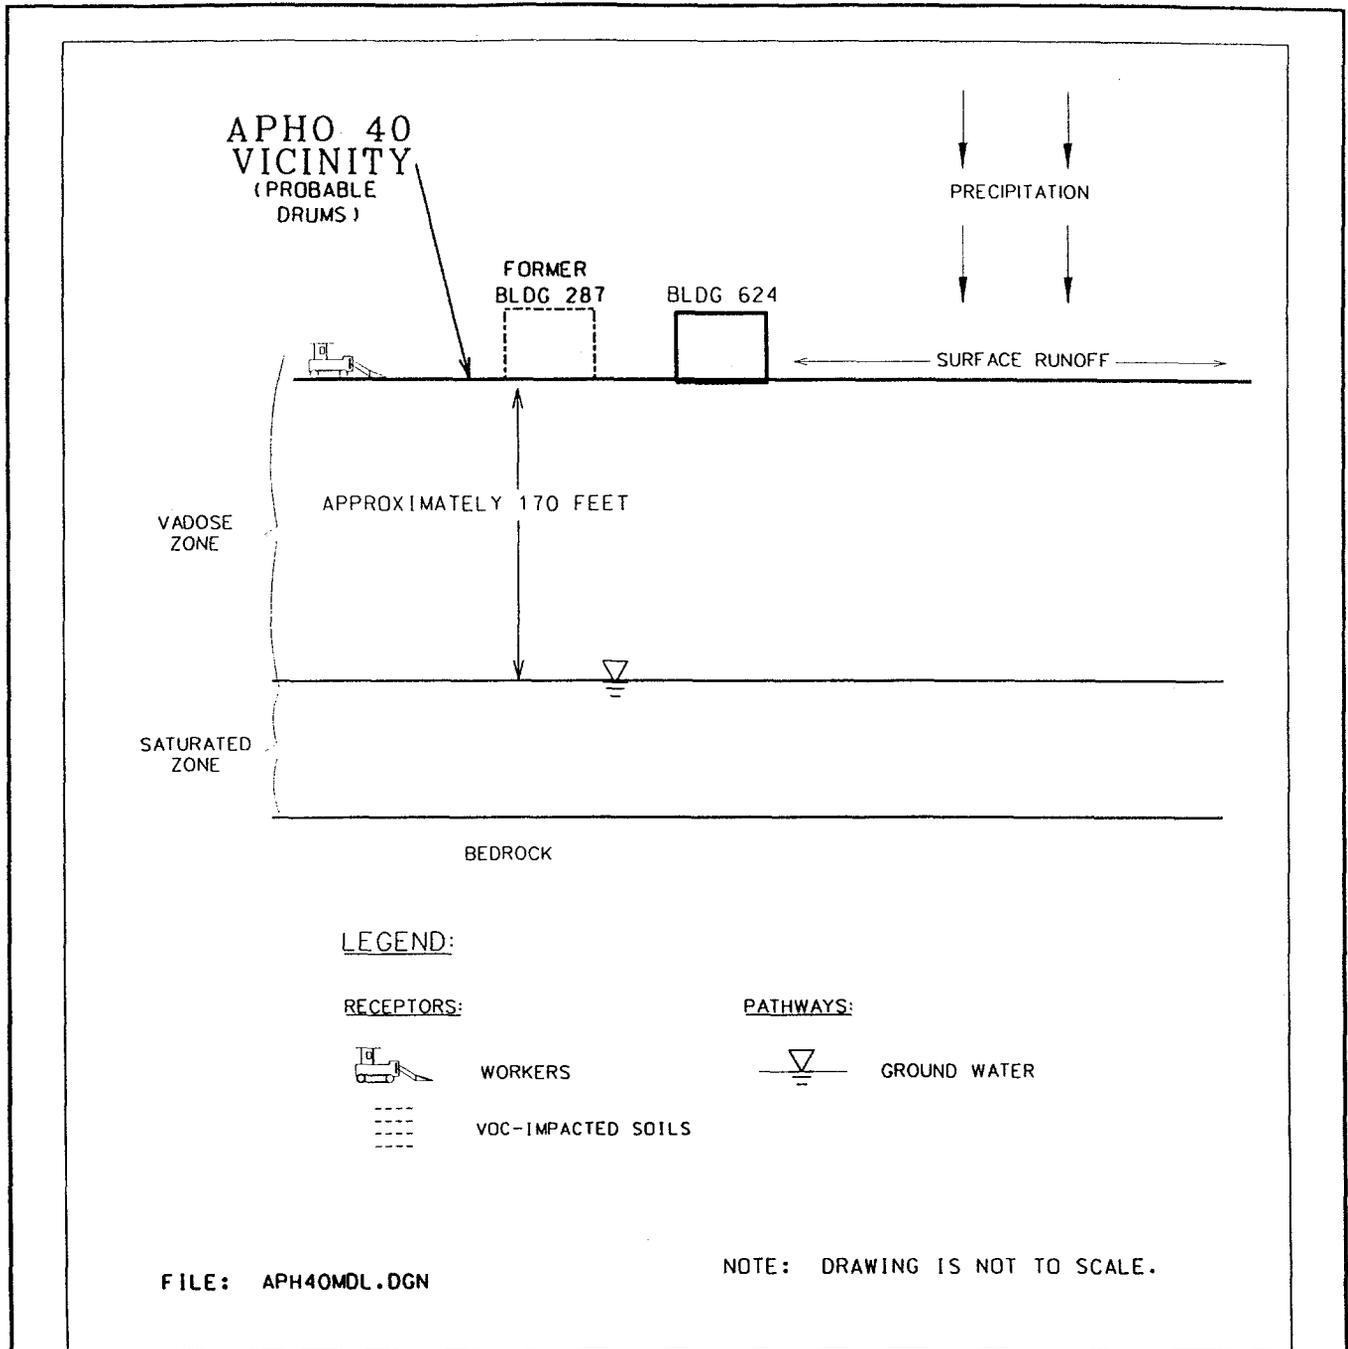
Figure 2.
AERIAL PHOTOGRAPH ANOMALY PROGRAM
**APHO 40 CONCEPTUAL SITE
MODEL**
MARINE CORPS AIR STATION, EL TORO

Ground water conditions have been investigated in the vicinity of APHO 40 during the verification of conditions at former Tank Farm 3. The wells that were constructed around the perimeter of Tank Farm 3 are located west and southwest of APHO 40. Ground water is located approximately 170 feet below ground surface based upon measurements from these wells. Selected information is presented in the Appendix, and a conceptual site model is shown on Figure 2.

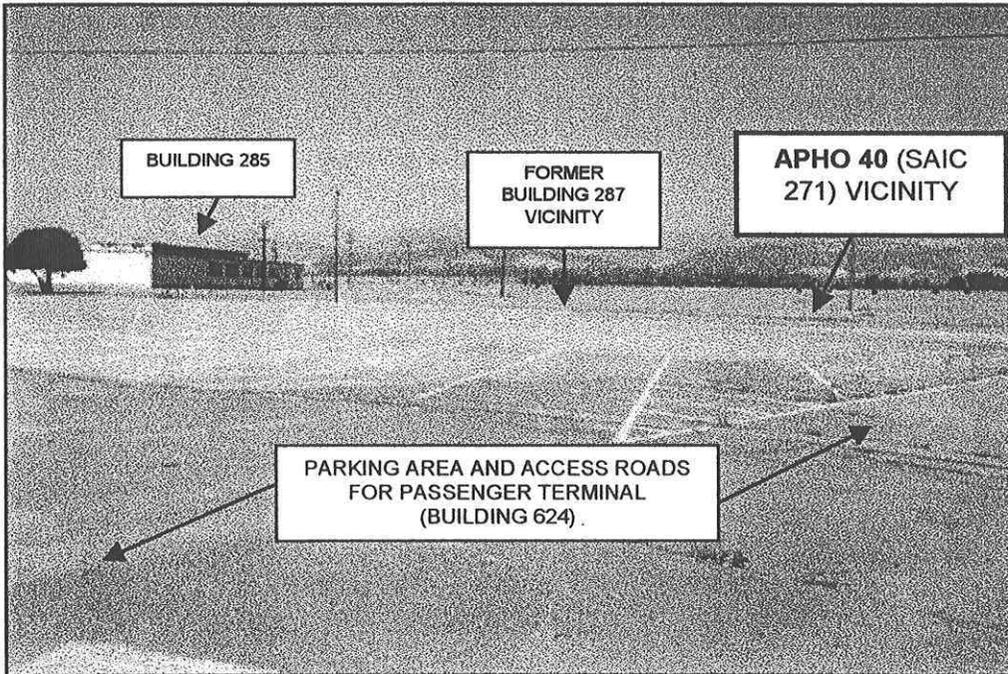
The vicinity of APHO 40 was visually inspected by the Navy in September 1999. APHO 40 and the former Building 287 vicinity are relatively level areas near the former passenger terminal (Building 624). Some of the areas are paved with asphalt-cement access roads and parking areas for the terminal, while some of the area is unpaved. West Marine Way is located immediately northwest of APHO 40. Building 624 is located southwest of APHO 40, and Building 288 (a former maintenance hangar space and search and rescue office) is located approximately south of APHO 40. No structures remain at the former Building 287 site. Buildings 288 and 624 and the associated parking areas were vacant at the time of the visual inspection. No drums were observed in storage at or near APHO 40 during the inspection. No stains were observed on the parking areas and access roads or on the unpaved areas of APHO 40 during the inspection.

**Photograph 1. APHO 40 (SAIC 271) Vicinity.
Probable Drums (identified on 1974 aerial photograph).**

Looking Approximately North
Aerial Photograph Anomaly Program
Marine Corps Air Station, El Toro

Based upon the results of the evaluation of historical records, the results of the visual inspection, and the absence of evidence of storage of hazardous materials or wastes at or near APHO 40, it is recommended that *no further action status* be designated for APHO 40 (also known as SAIC 271) and that *no further action status* be documented in the next BCP Update.

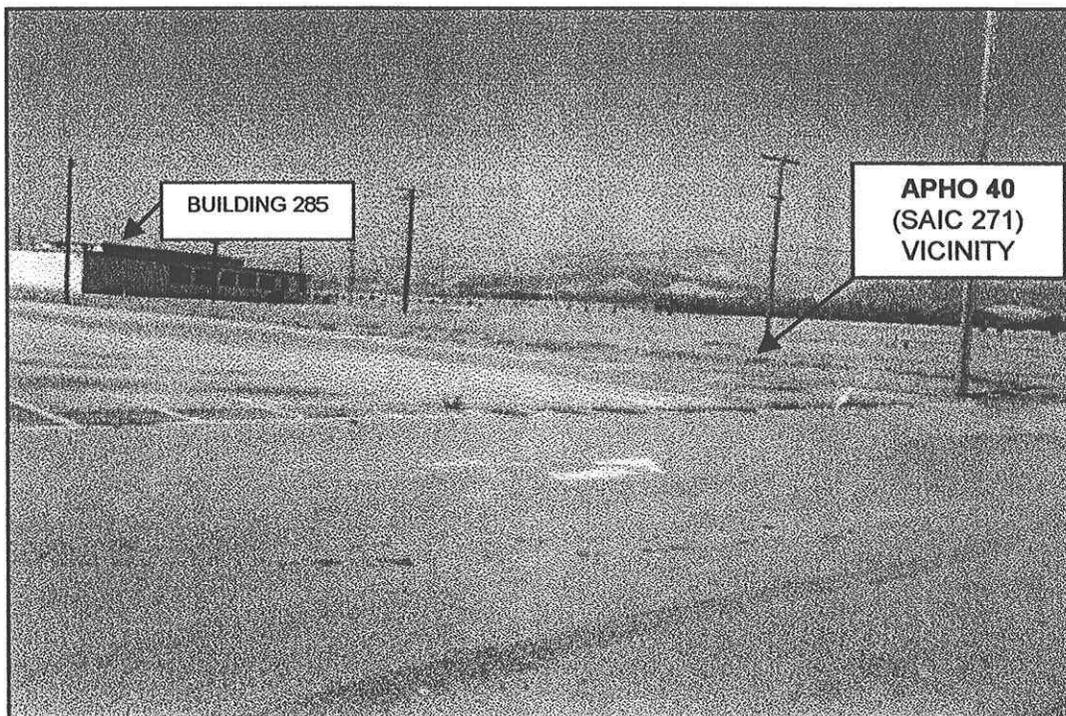
**Photograph 2. APHO 40 (SAIC 271) Vicinity.
Probable Drums (identified on 1974 aerial photograph).
Looking Approximately North
Aerial Photograph Anomaly Program
Marine Corps Air Station, El Toro**

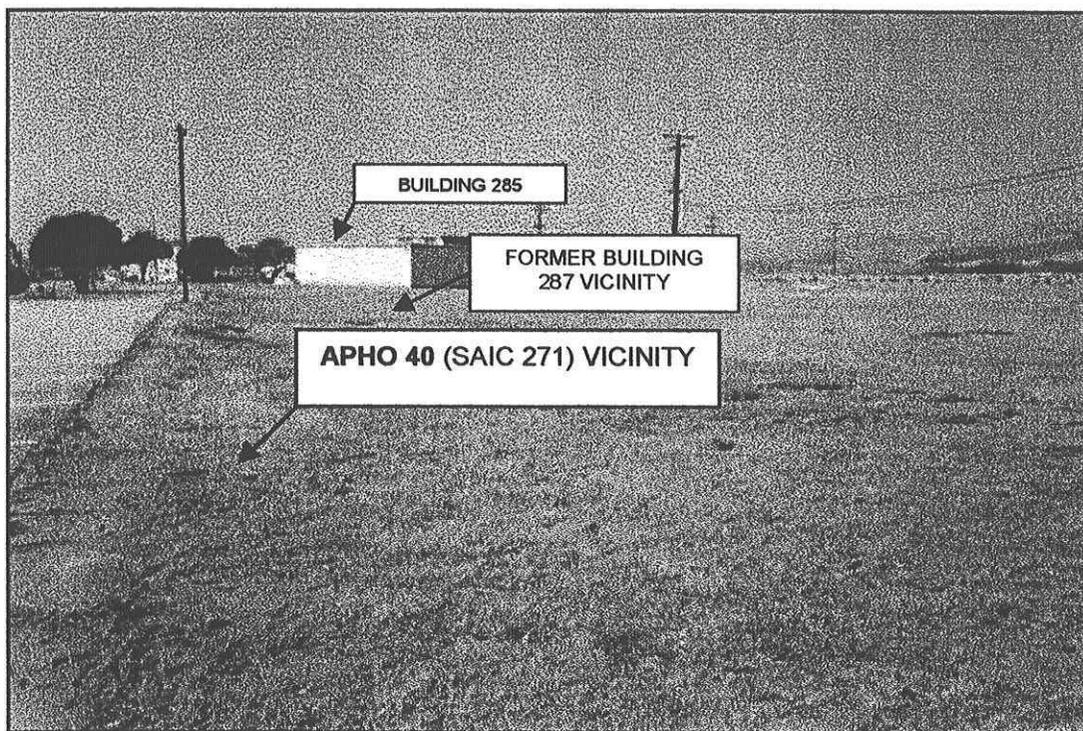
**Photograph 3. APHO 40 (SAIC 271) Vicinity.
Probable Drums (identified on 1974 aerial photograph).
Looking Approximately North-Northwest
Aerial Photograph Anomaly Program
Marine Corps Air Station, El Toro**

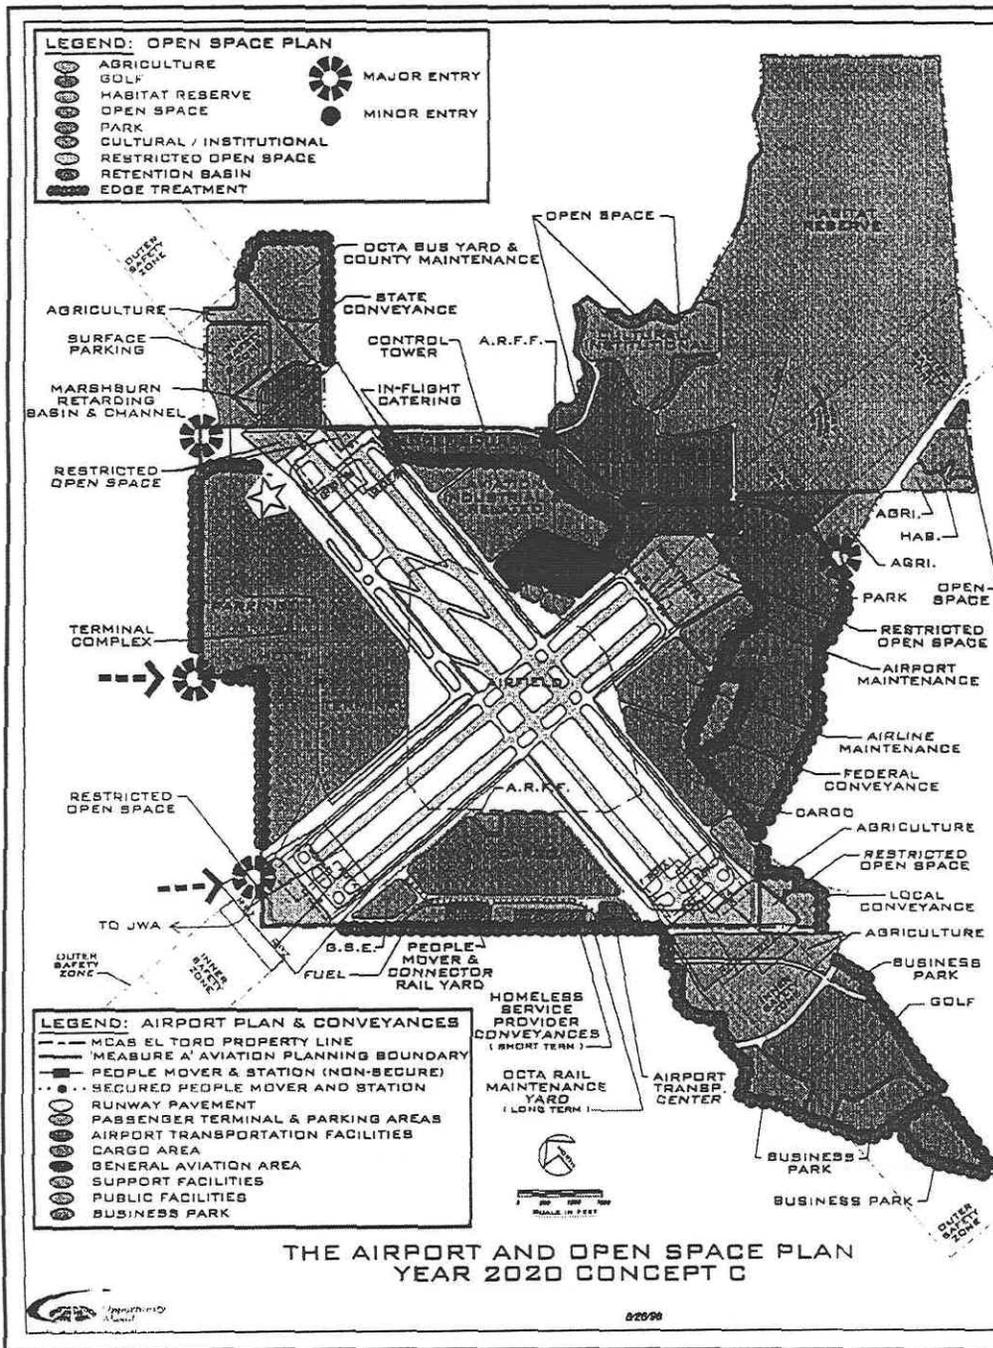
Exhibit 1.
 AERIAL PHOTOGRAPH ANOMALY PROGRAM
Tentative Reuse Plan
 The Airport and Open Space Plan, Year 2020, Concept C
 MARINE CORPS AIR STATION, EL TORO

NOTE: The approximate location of APHO 40 is identified by a star symbol.

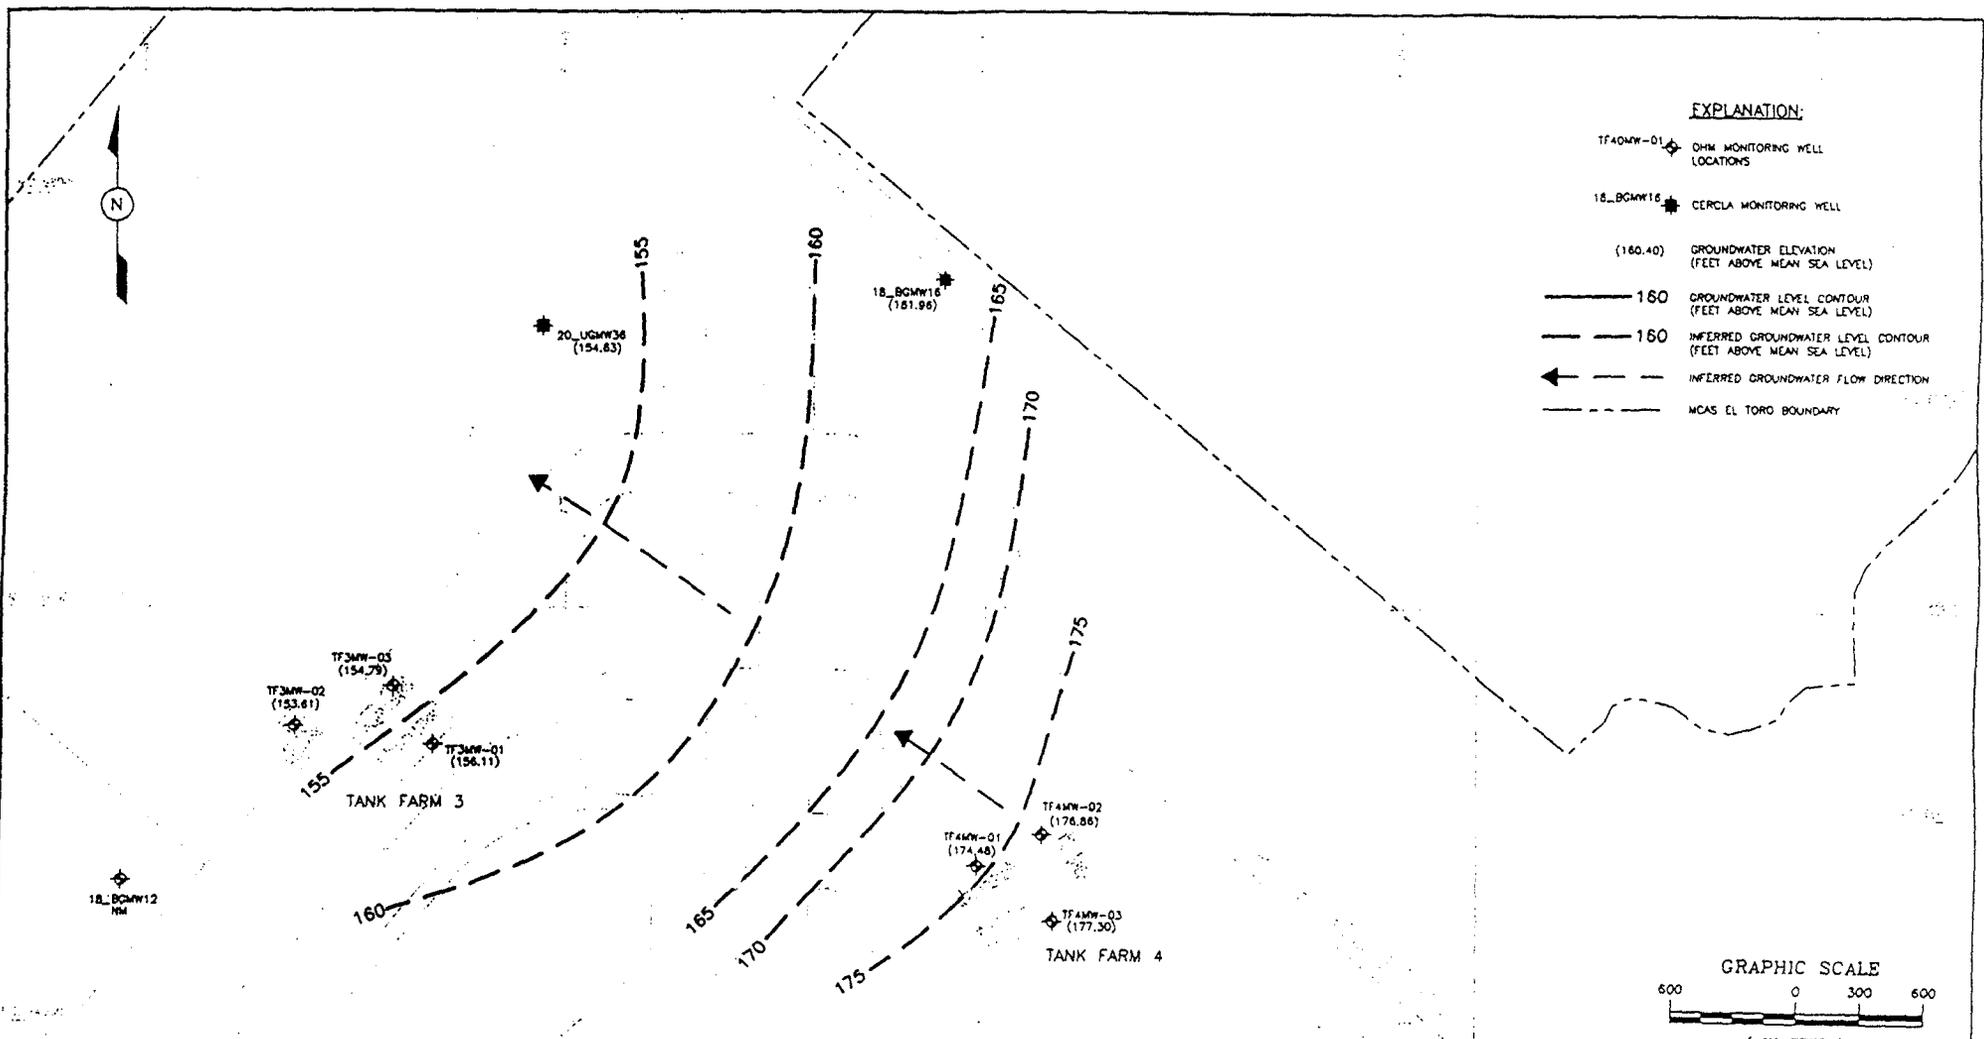
- TF4MW-01 ◊ OHM MONITORING WELL LOCATIONS
- 18_BGMW16 * CERCLA MONITORING WELL
- (160.40) GROUNDWATER ELEVATION (FEET ABOVE MEAN SEA LEVEL)
- 160 GROUNDWATER LEVEL CONTOUR (FEET ABOVE MEAN SEA LEVEL)
- - - 160 INFERRED GROUNDWATER LEVEL CONTOUR (FEET ABOVE MEAN SEA LEVEL)
- ← INFERRED GROUNDWATER FLOW DIRECTION
- - - - - MCAS EL TORO BOUNDARY
