Subj: Aerial Photograph Anomaly APHO 103 (SAIC 175)
Former Marine Corps Air Station, El Toro

Information Package

Aerial Photograph Anomaly APHO 103 (SAIC 175)

Former Marine Corps Air Station, El Toro

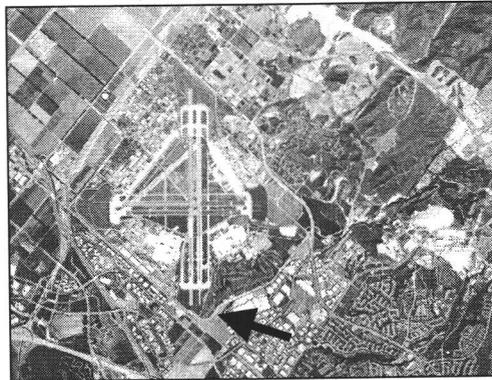
APHO 103 (SAIC 175) is located southeast of Perimeter Road and south of the south end of north-south Runway 34R. The anomaly is also located southeast of Borrego Canyon Wash that was investigated as Solid Waste Management Unit (SWMU) Number 5 during the Resource Conservation and Recovery Act Facility Assessment (RFA), and the RFA included field sampling along Borrego Canyon Wash in the general vicinity of APHO 103 (SAIC 175). The approximate location of APHO 103 (SAIC 175) is shown by the arrow on the following aerial photograph of Former MCAS El Toro.

Approximate Date of Photograph: 1997 (Source of Photograph: County of Orange)

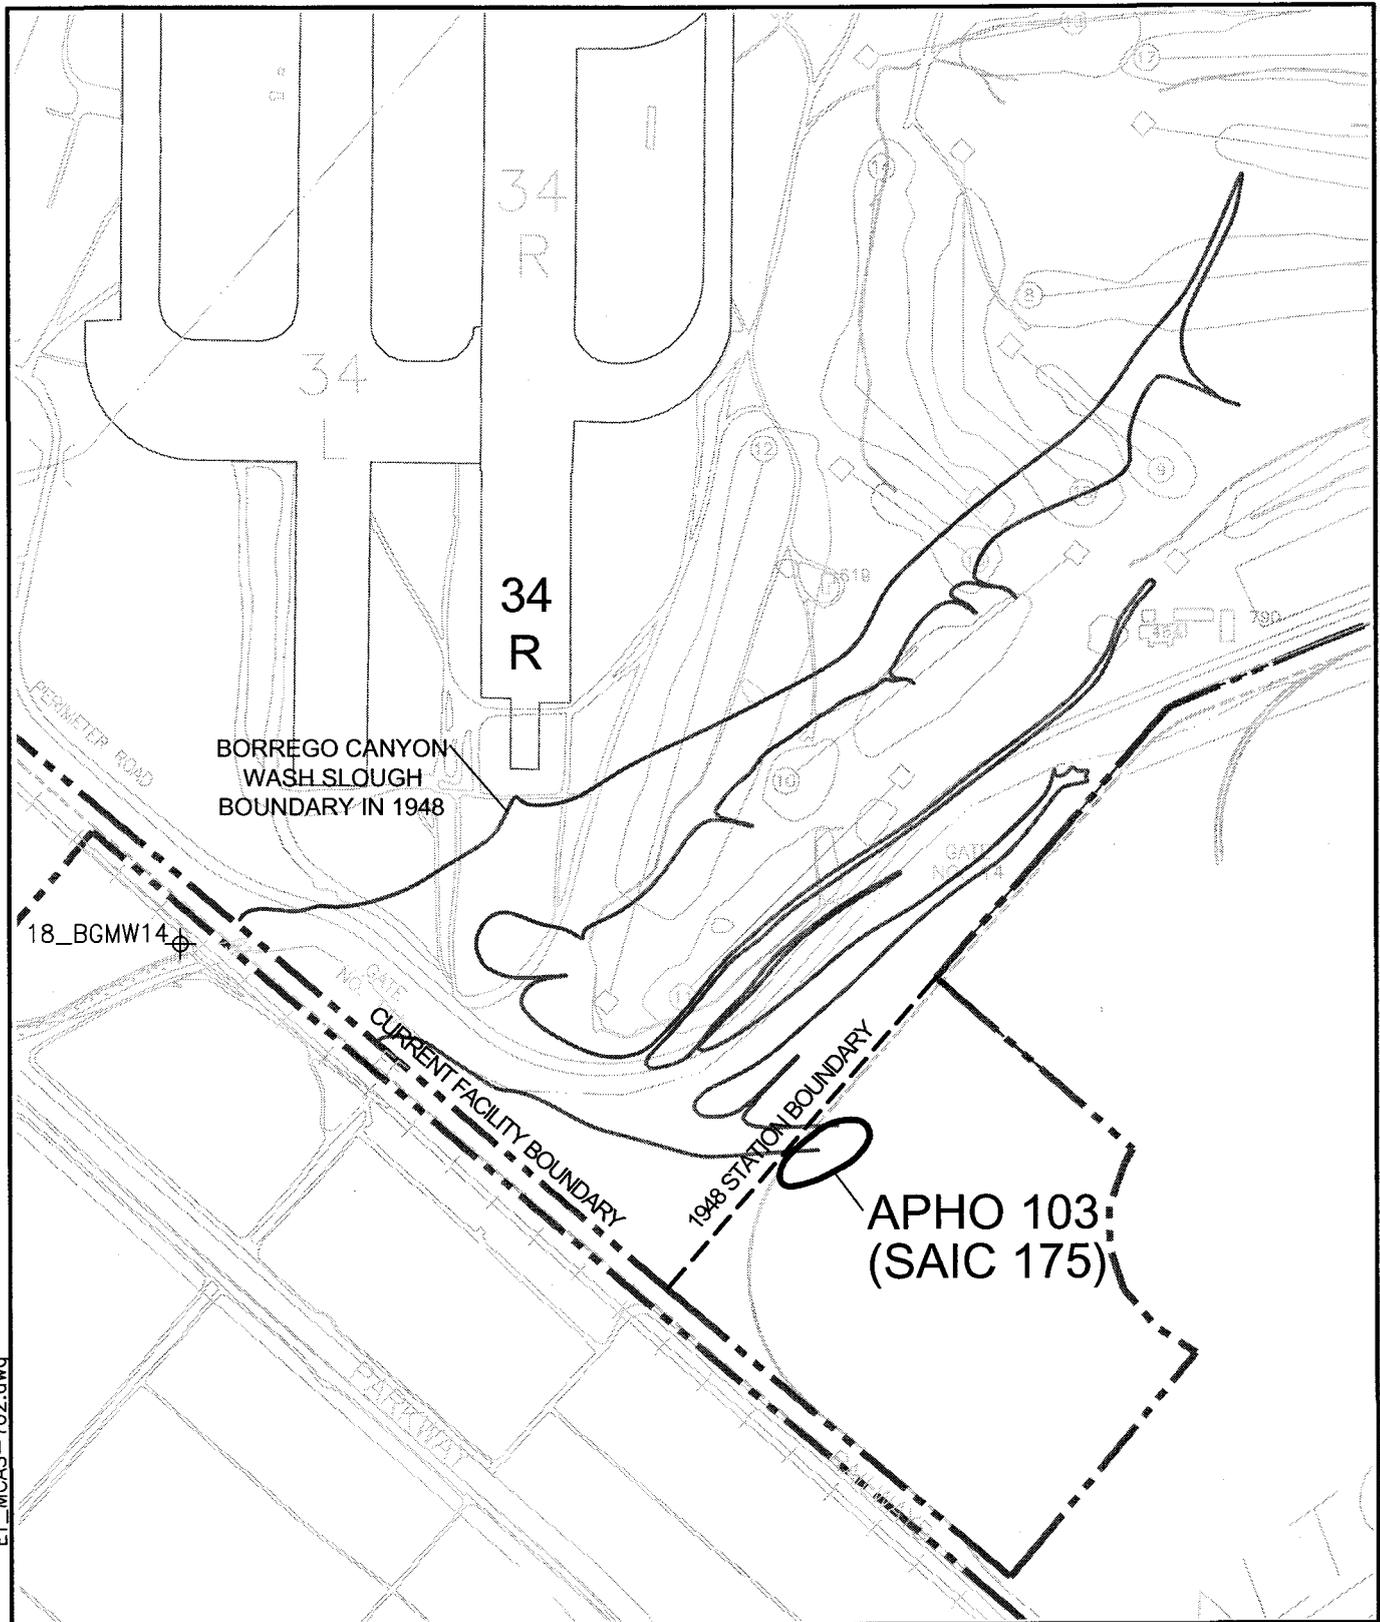
NOTE: SLOUGH BOUNDARY TAKEN FROM "MAP OF MARINE CORPS AIR STATION, EL TORO, CALIF., ELEVENTH NAVAL DISTRICT, SAN DIEGO, CALIF. SHOWING CONDITION ON JUNE 30, 1948".

The historical maps dated 1948, 1949, and 1950 show a former slough on Borrego Canyon Wash that coincides with the approximate location of APHO 103 (SAIC 175). Borrego Canyon Wash was improved during the 1950's and a paved reach was constructed near APHO 103 (SAIC 175). It is possible that one of the branches of the slough caused the appearance of an impoundment or closed-drainage depression on the 1968 aerial photograph.

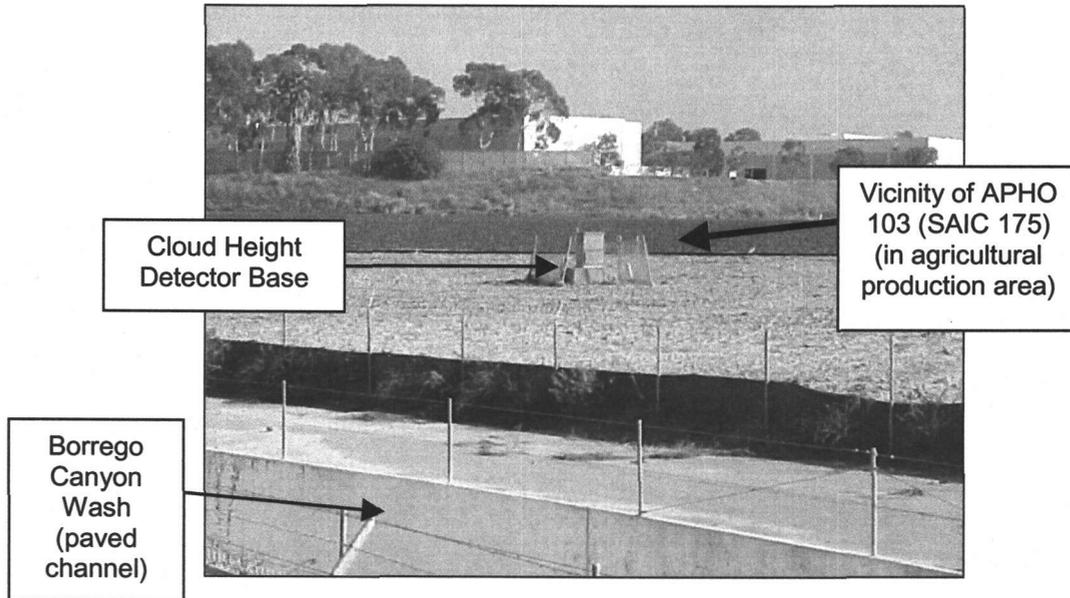
Photograph 1. Vicinity of APHO 103 (SAIC 175) Looking South-Southeast
Former MCAS El Toro

Date of Photograph: 8 January 2004

Visual inspections were conducted of the APHO 103 (SAIC 175) vicinity in December 2003 and on 8 and 12 January 2004. The anomaly area is relatively level, and the anomaly is located near the Cloud Height Detector Base, an existing structure that is visible from Perimeter Road. The APHO 103 (SAIC 175) vicinity was in use for agricultural production at the time of the visual inspections. No evidence of current or historical industrial or waste disposal activities was observed during the visual inspections. Photographs from the visual inspections of 8 and 12 January 2004 are included in the Appendix.

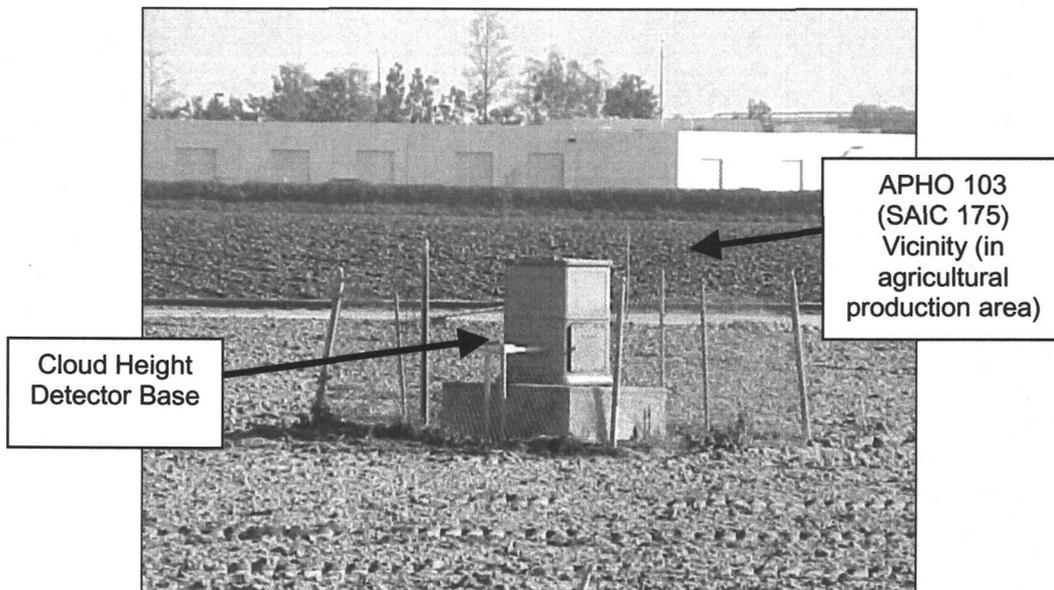
Photograph 2. Vicinity of APHO 103 (SAIC 175)
Former MCAS El Toro

Date of Photograph: 8 January 2004

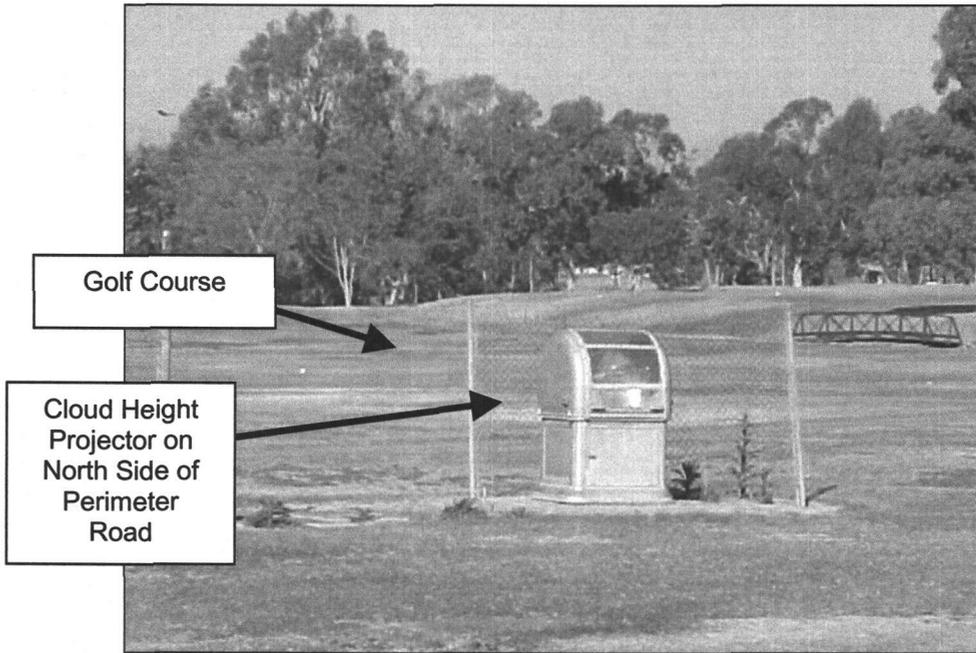
Photograph 3. Area North of APHO 103 (SAIC 175)

Date of Photograph: 8 January 2004

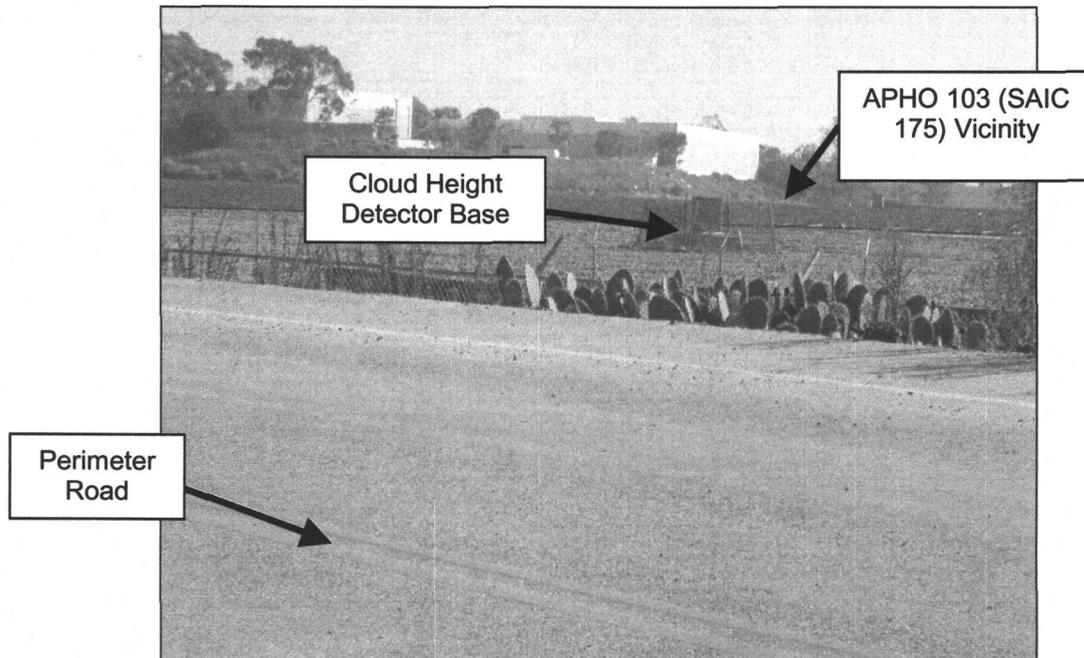
Photograph 4. Vicinity of APHO 103 (SAIC 175) From Perimeter Road

Date of Photograph: 12 January 2004

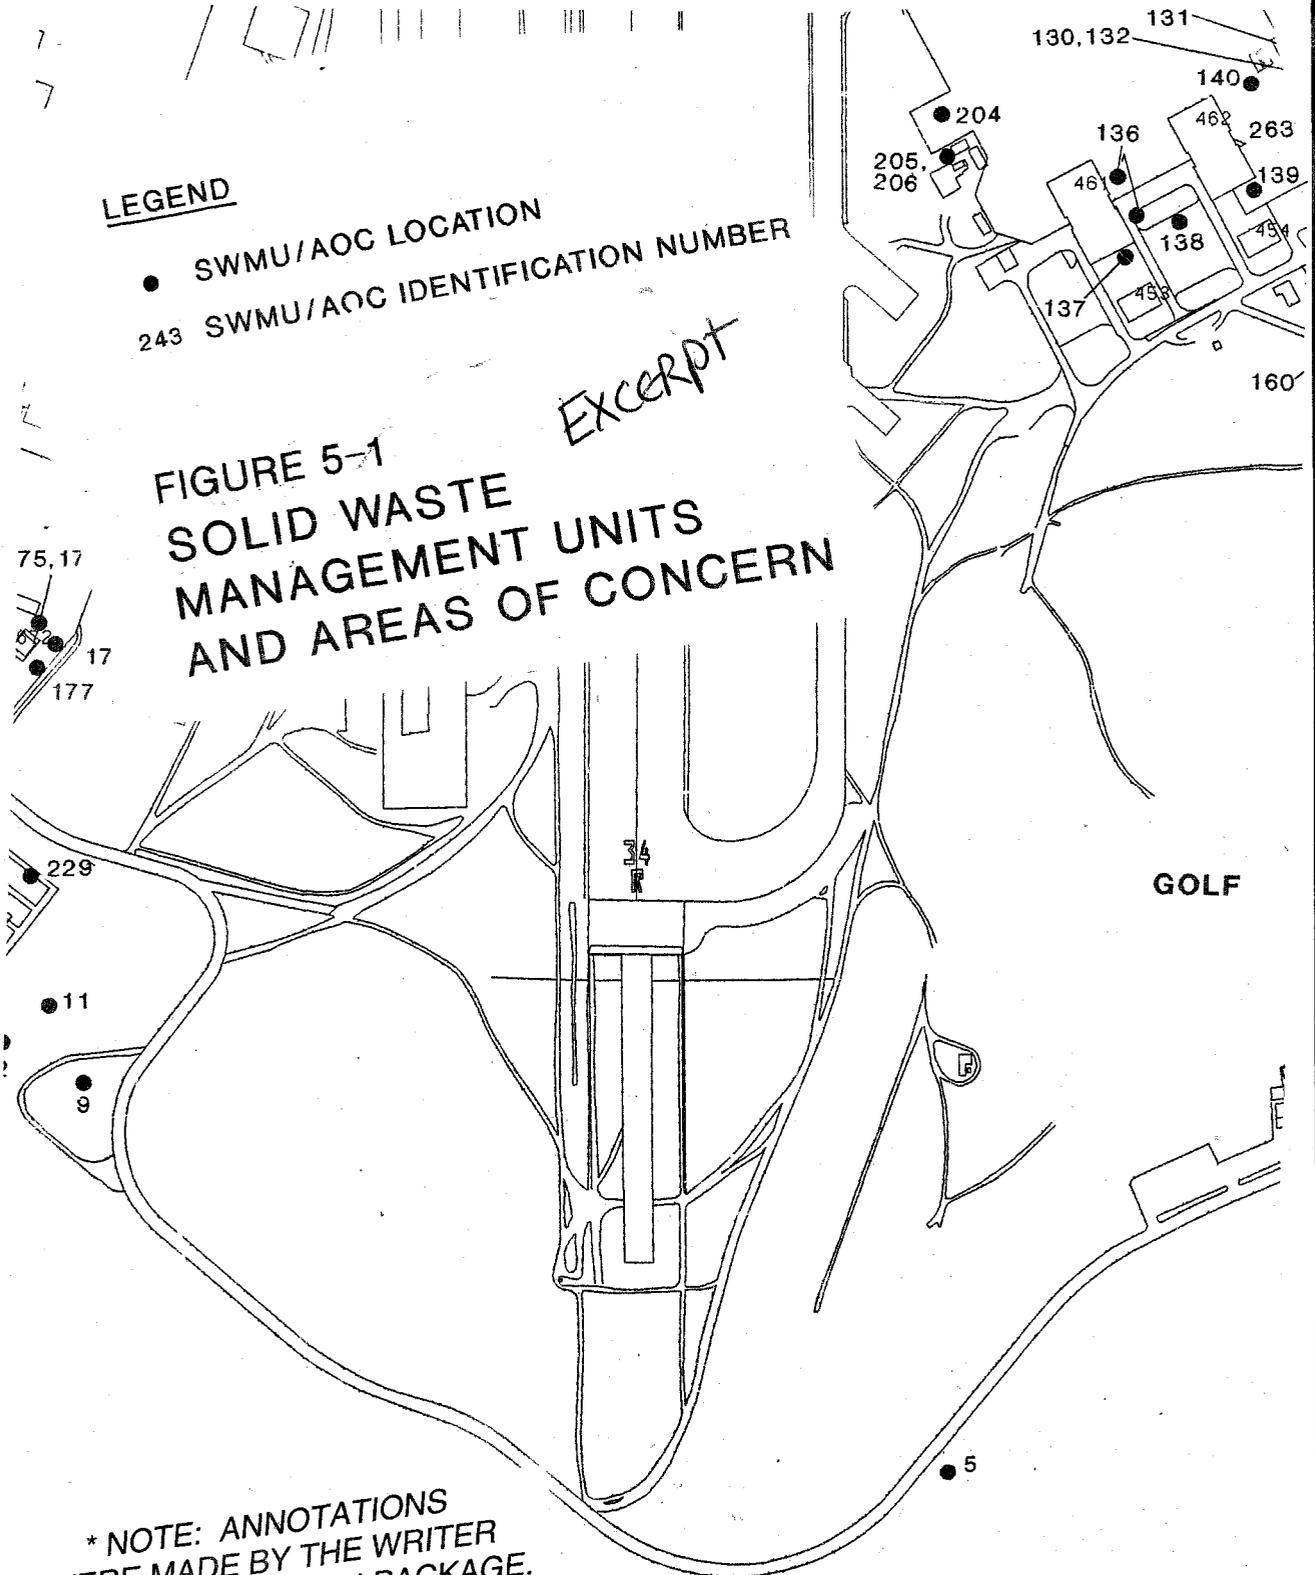
FIGURE 5-1
SOLID WASTE
MANAGEMENT UNITS
AND AREAS OF CONCERN

* NOTE: ANNOTATIONS
WERE MADE BY THE WRITER
OF THE INFORMATION PACKAGE.
THE LOCATION OF APHO 103
IS ESTIMATED.

○ ← APHO 103
VICINITY *

APHO 103 (SAIC 175) is adjacent to the concrete channel of Borrego Canyon Wash south of Runway 34R. Borrego Canyon Wash was identified as Solid Waste Management Unit (SWMU) Number 5 during the Resource Conservation and Recovery Act Facility Assessment (RFA). Soil samples were collected from two 60-foot angle borings (005A1 and 005A2) adjacent to Borrego Canyon Wash in the APHO 103 vicinity. The RFA recommended no further action for SWMU Number 5.

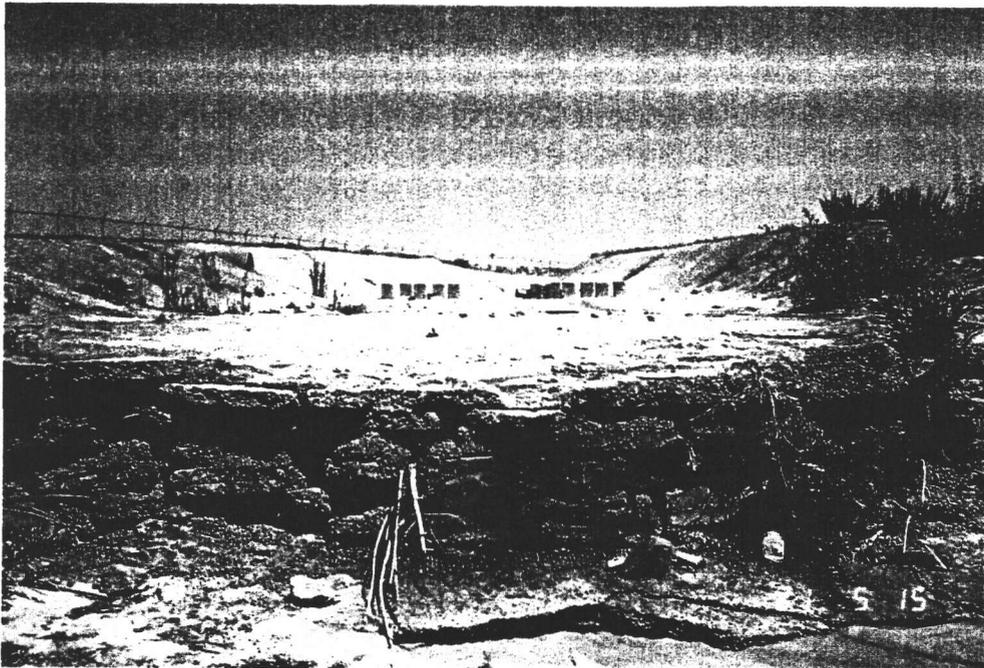
Size: Approximately 30 ft wide by 10 ft deep

Possible release may occur through the cracks in the western section of the wash

A sampling visit is recommended for the Borrogo Canyon Wash to evaluate the unlined section for potential release

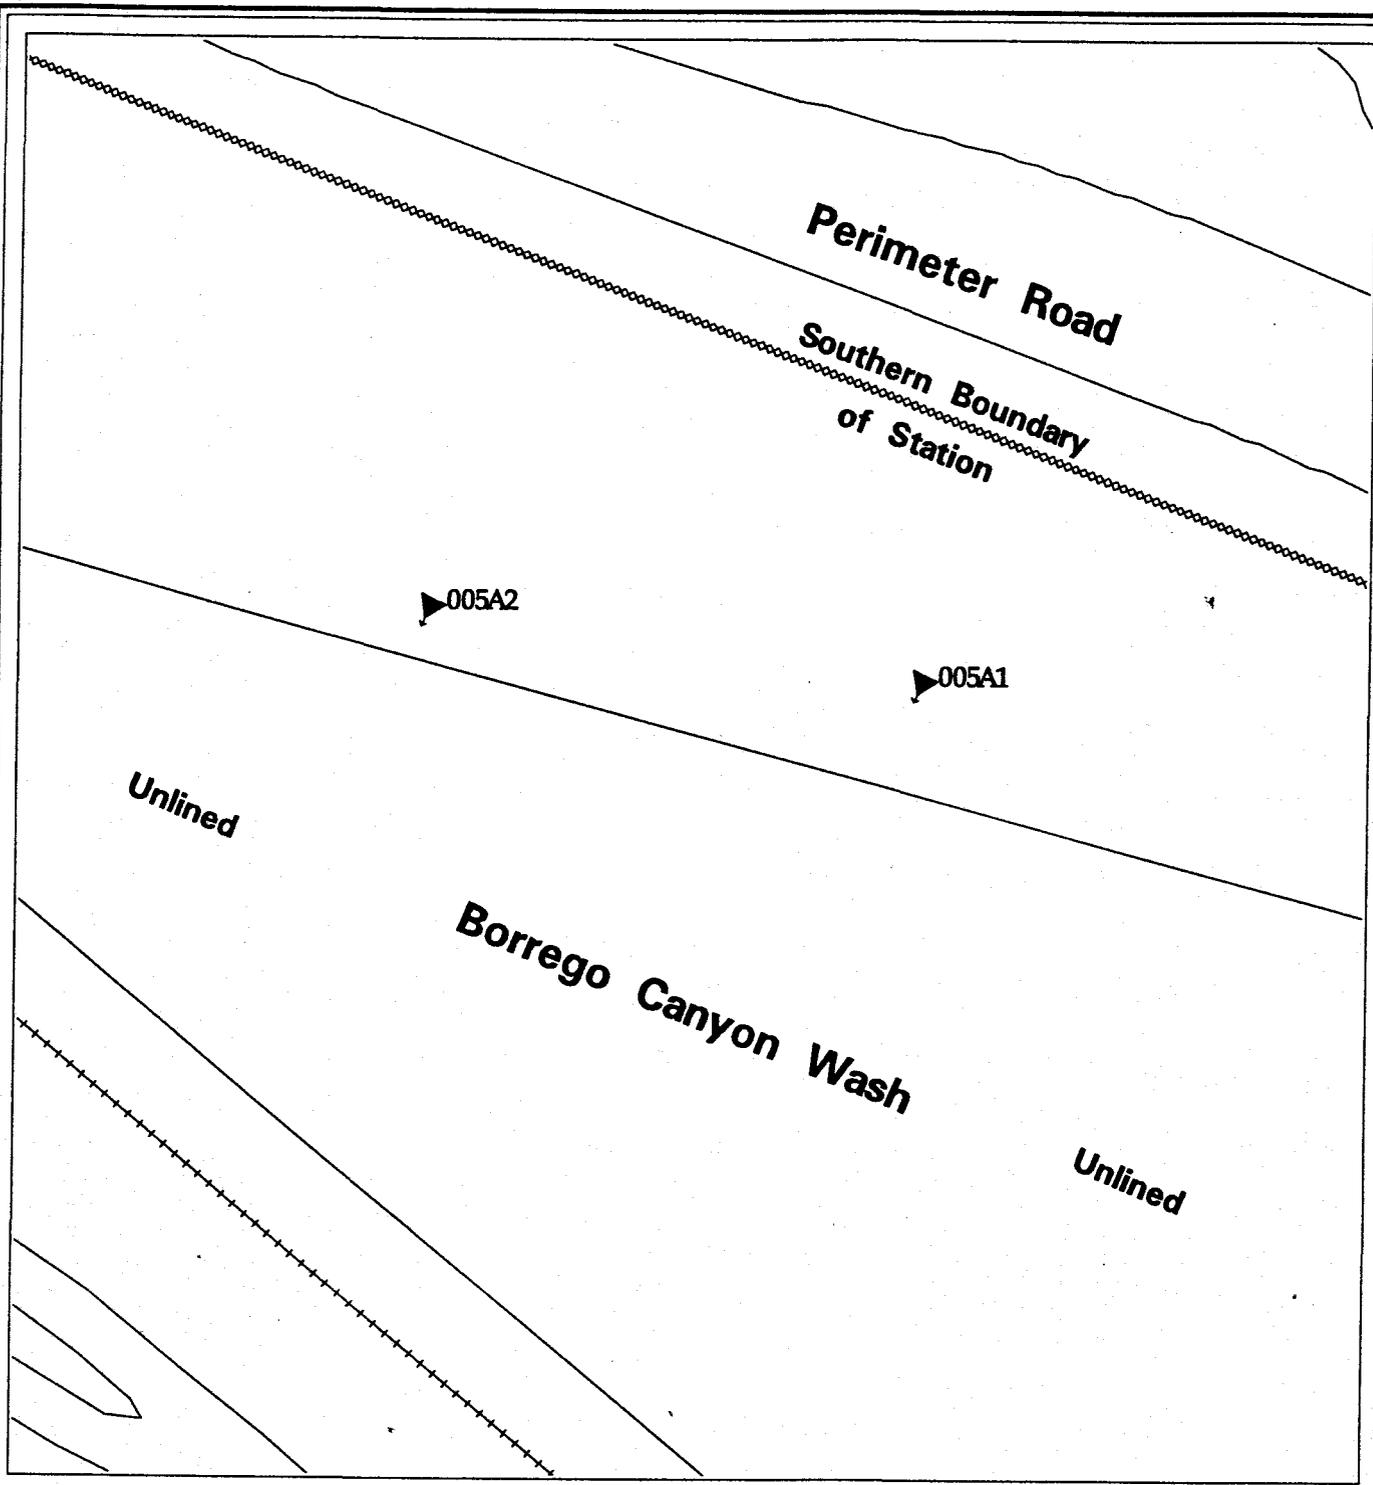
Figure 3 Sample Location Map

SWMU/AOC Number and Type:
5 - Borrego Canyon Wash

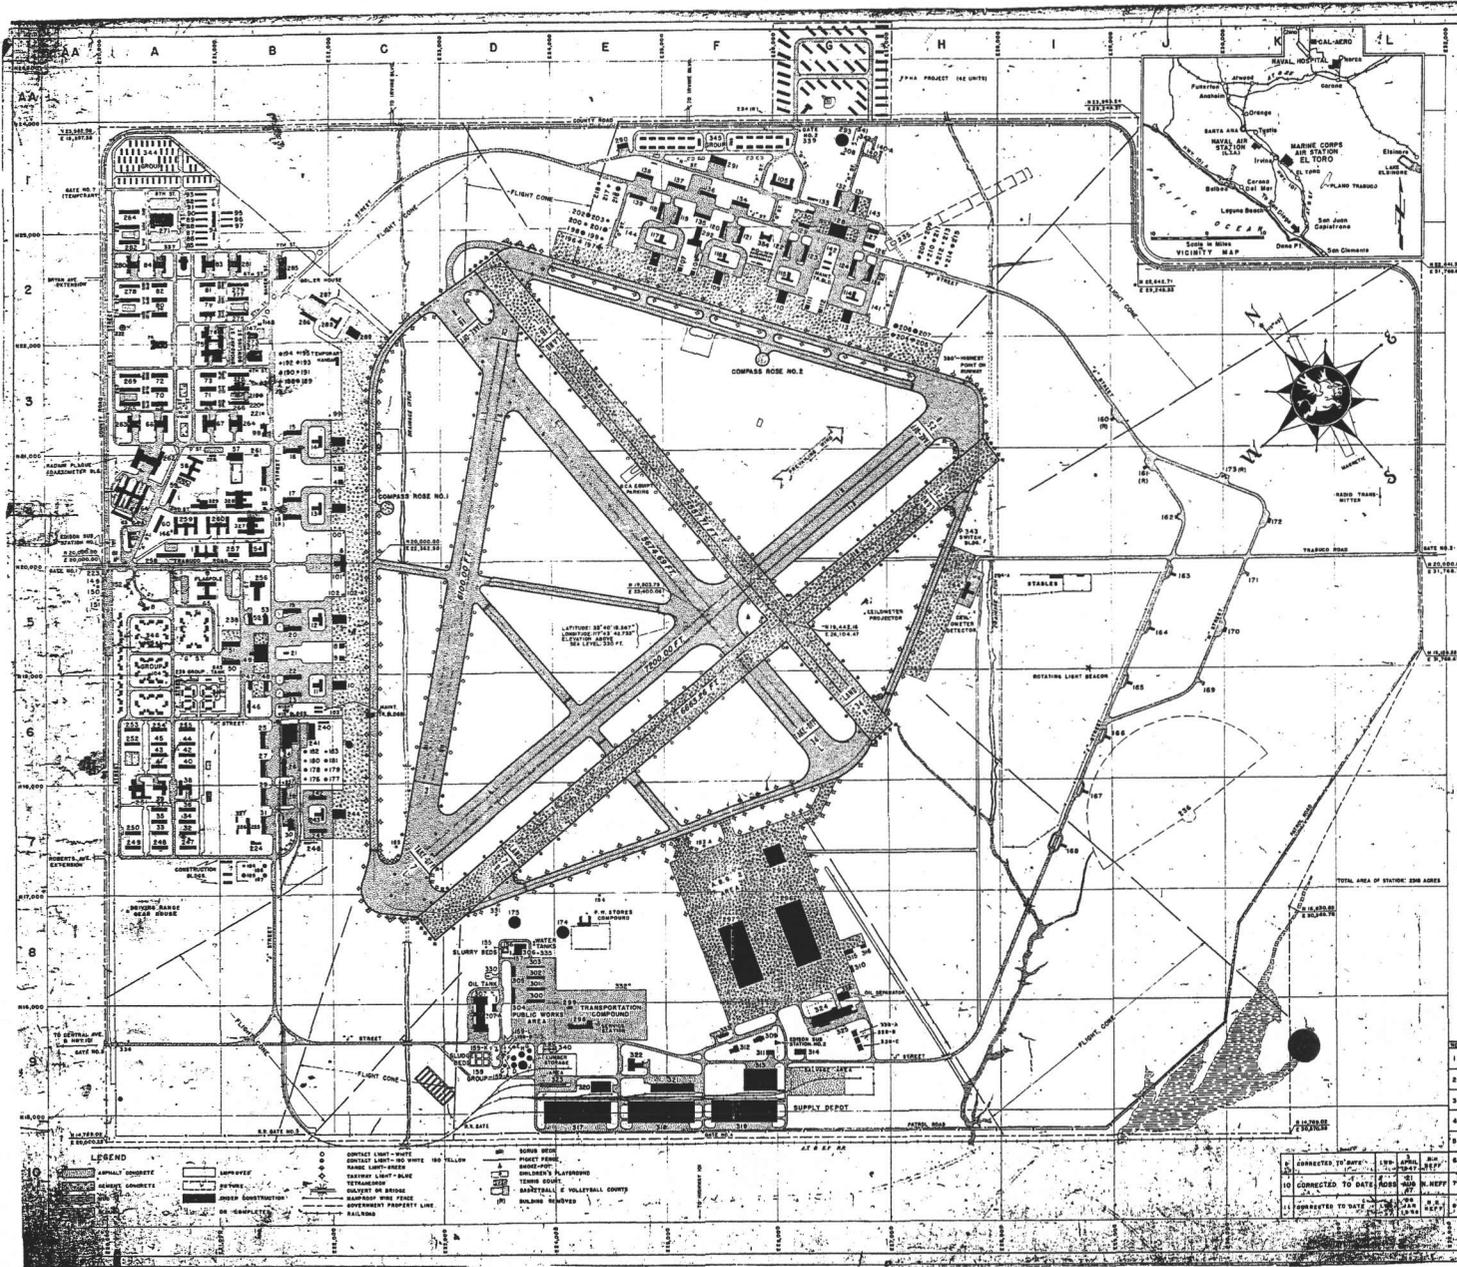
Historical Master Plot Plan Prepared in January 1948

NOTES: (1) The 1948 map is annotated with a solid circle symbol to show the approximate location of APHO 103 (SAIC 175). (2) The 1948 map shows the approximate location of APHO 103 at the Borrego Canyon Wash slough and adjacent to the feature designated as the FLIGHT CONE.

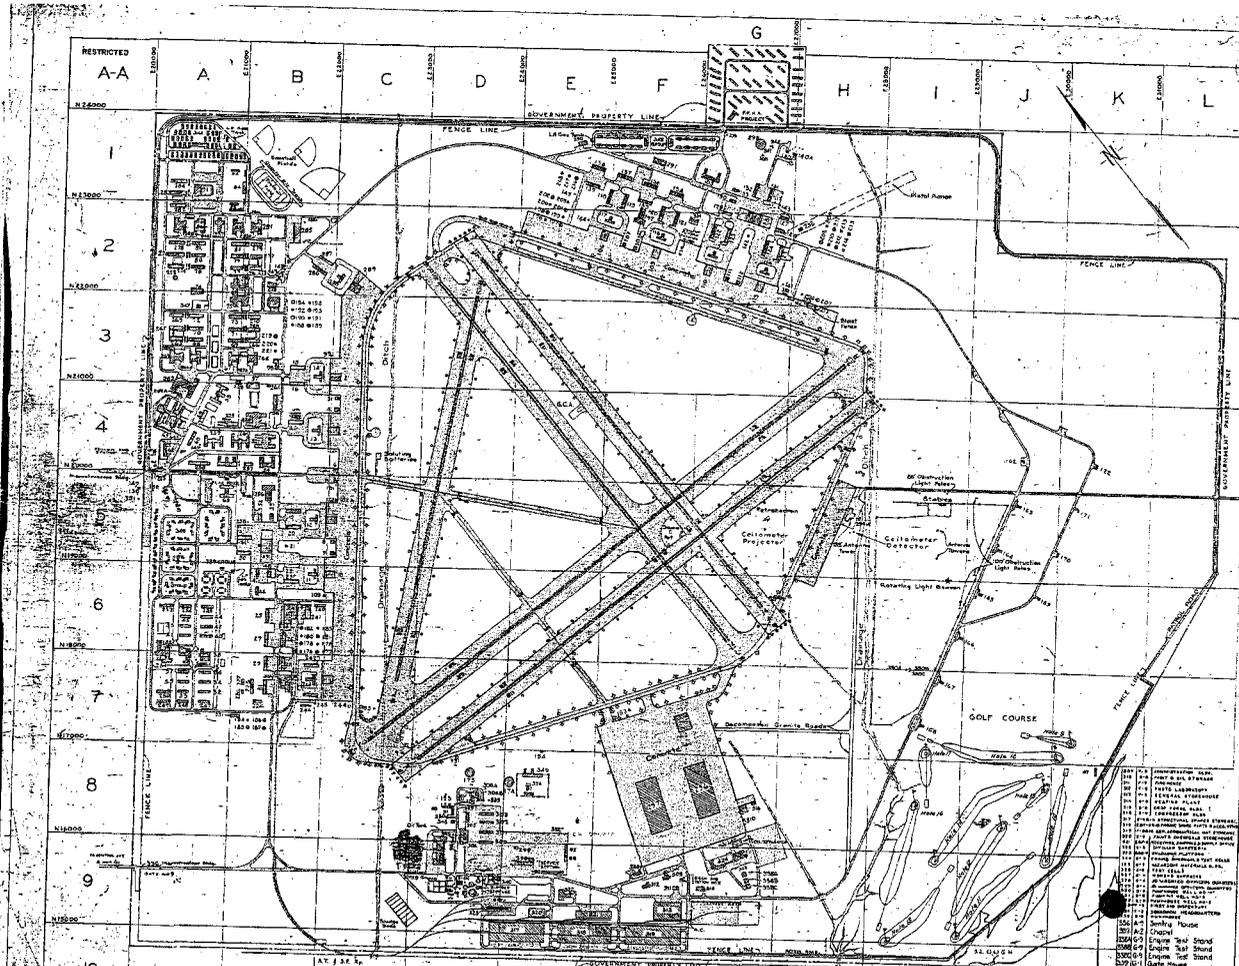
Historical Map of Conditions as of June 30, 1949

NOTE: The 1949 map is annotated with a solid circle symbol to show the approximate location of APHO 103 (SAIC 175).

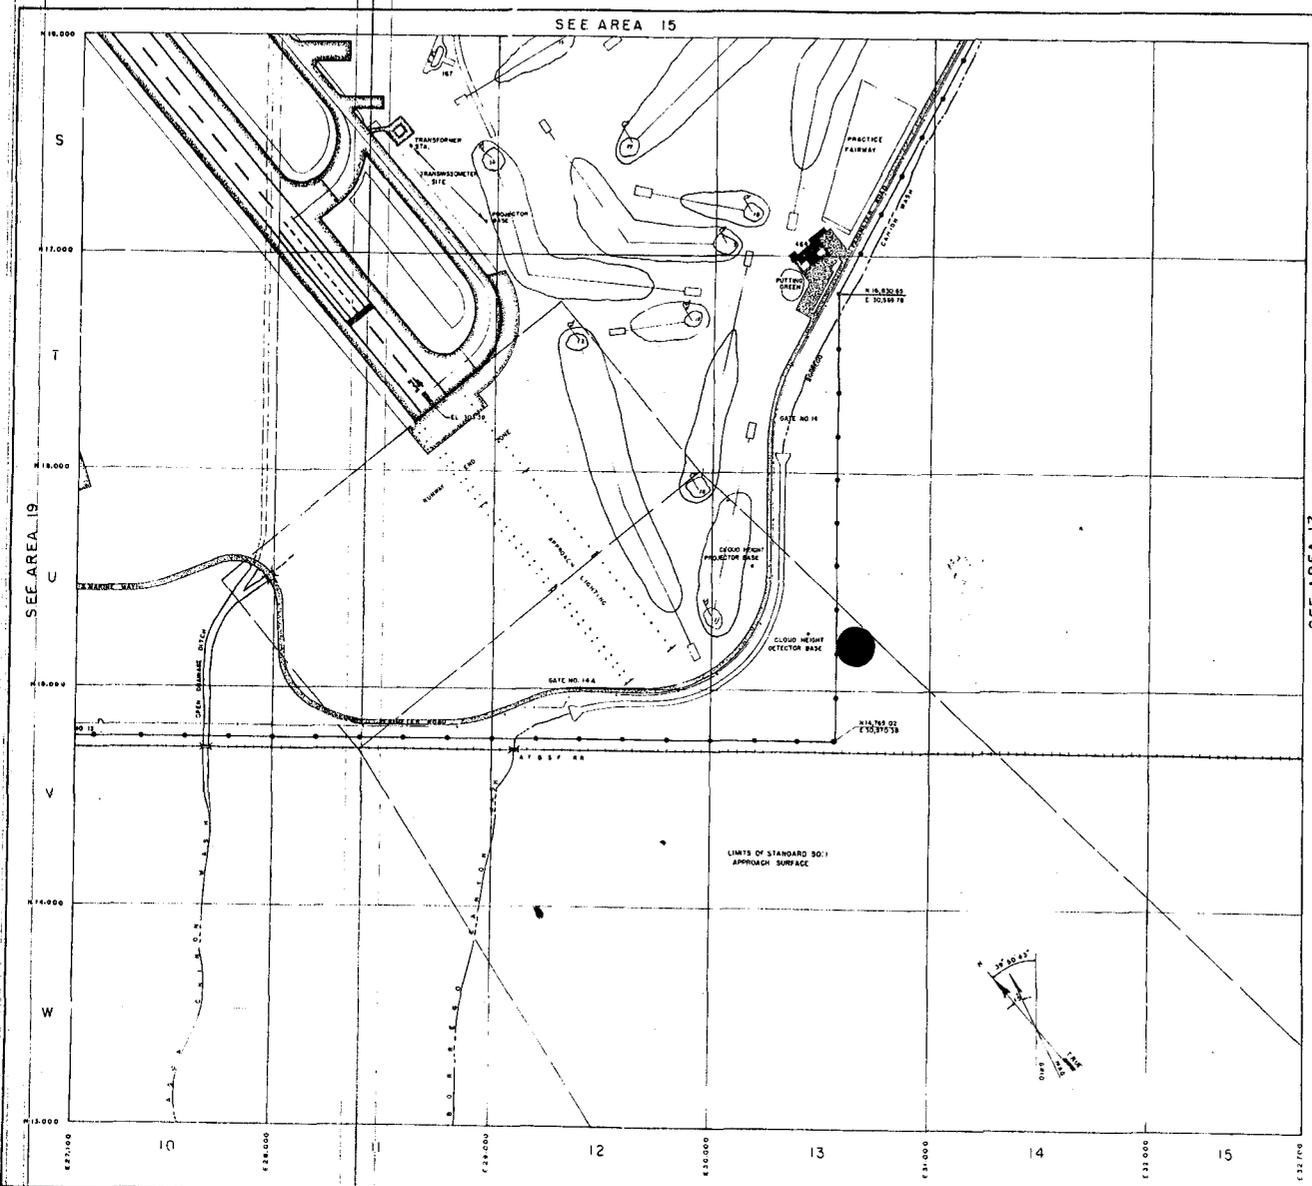
Excerpt from 1962 General Development Map

NOTE: The excerpt from the map has been annotated with a solid circle symbol at the approximate location of APHO 103. The map shows the runway approach surface.

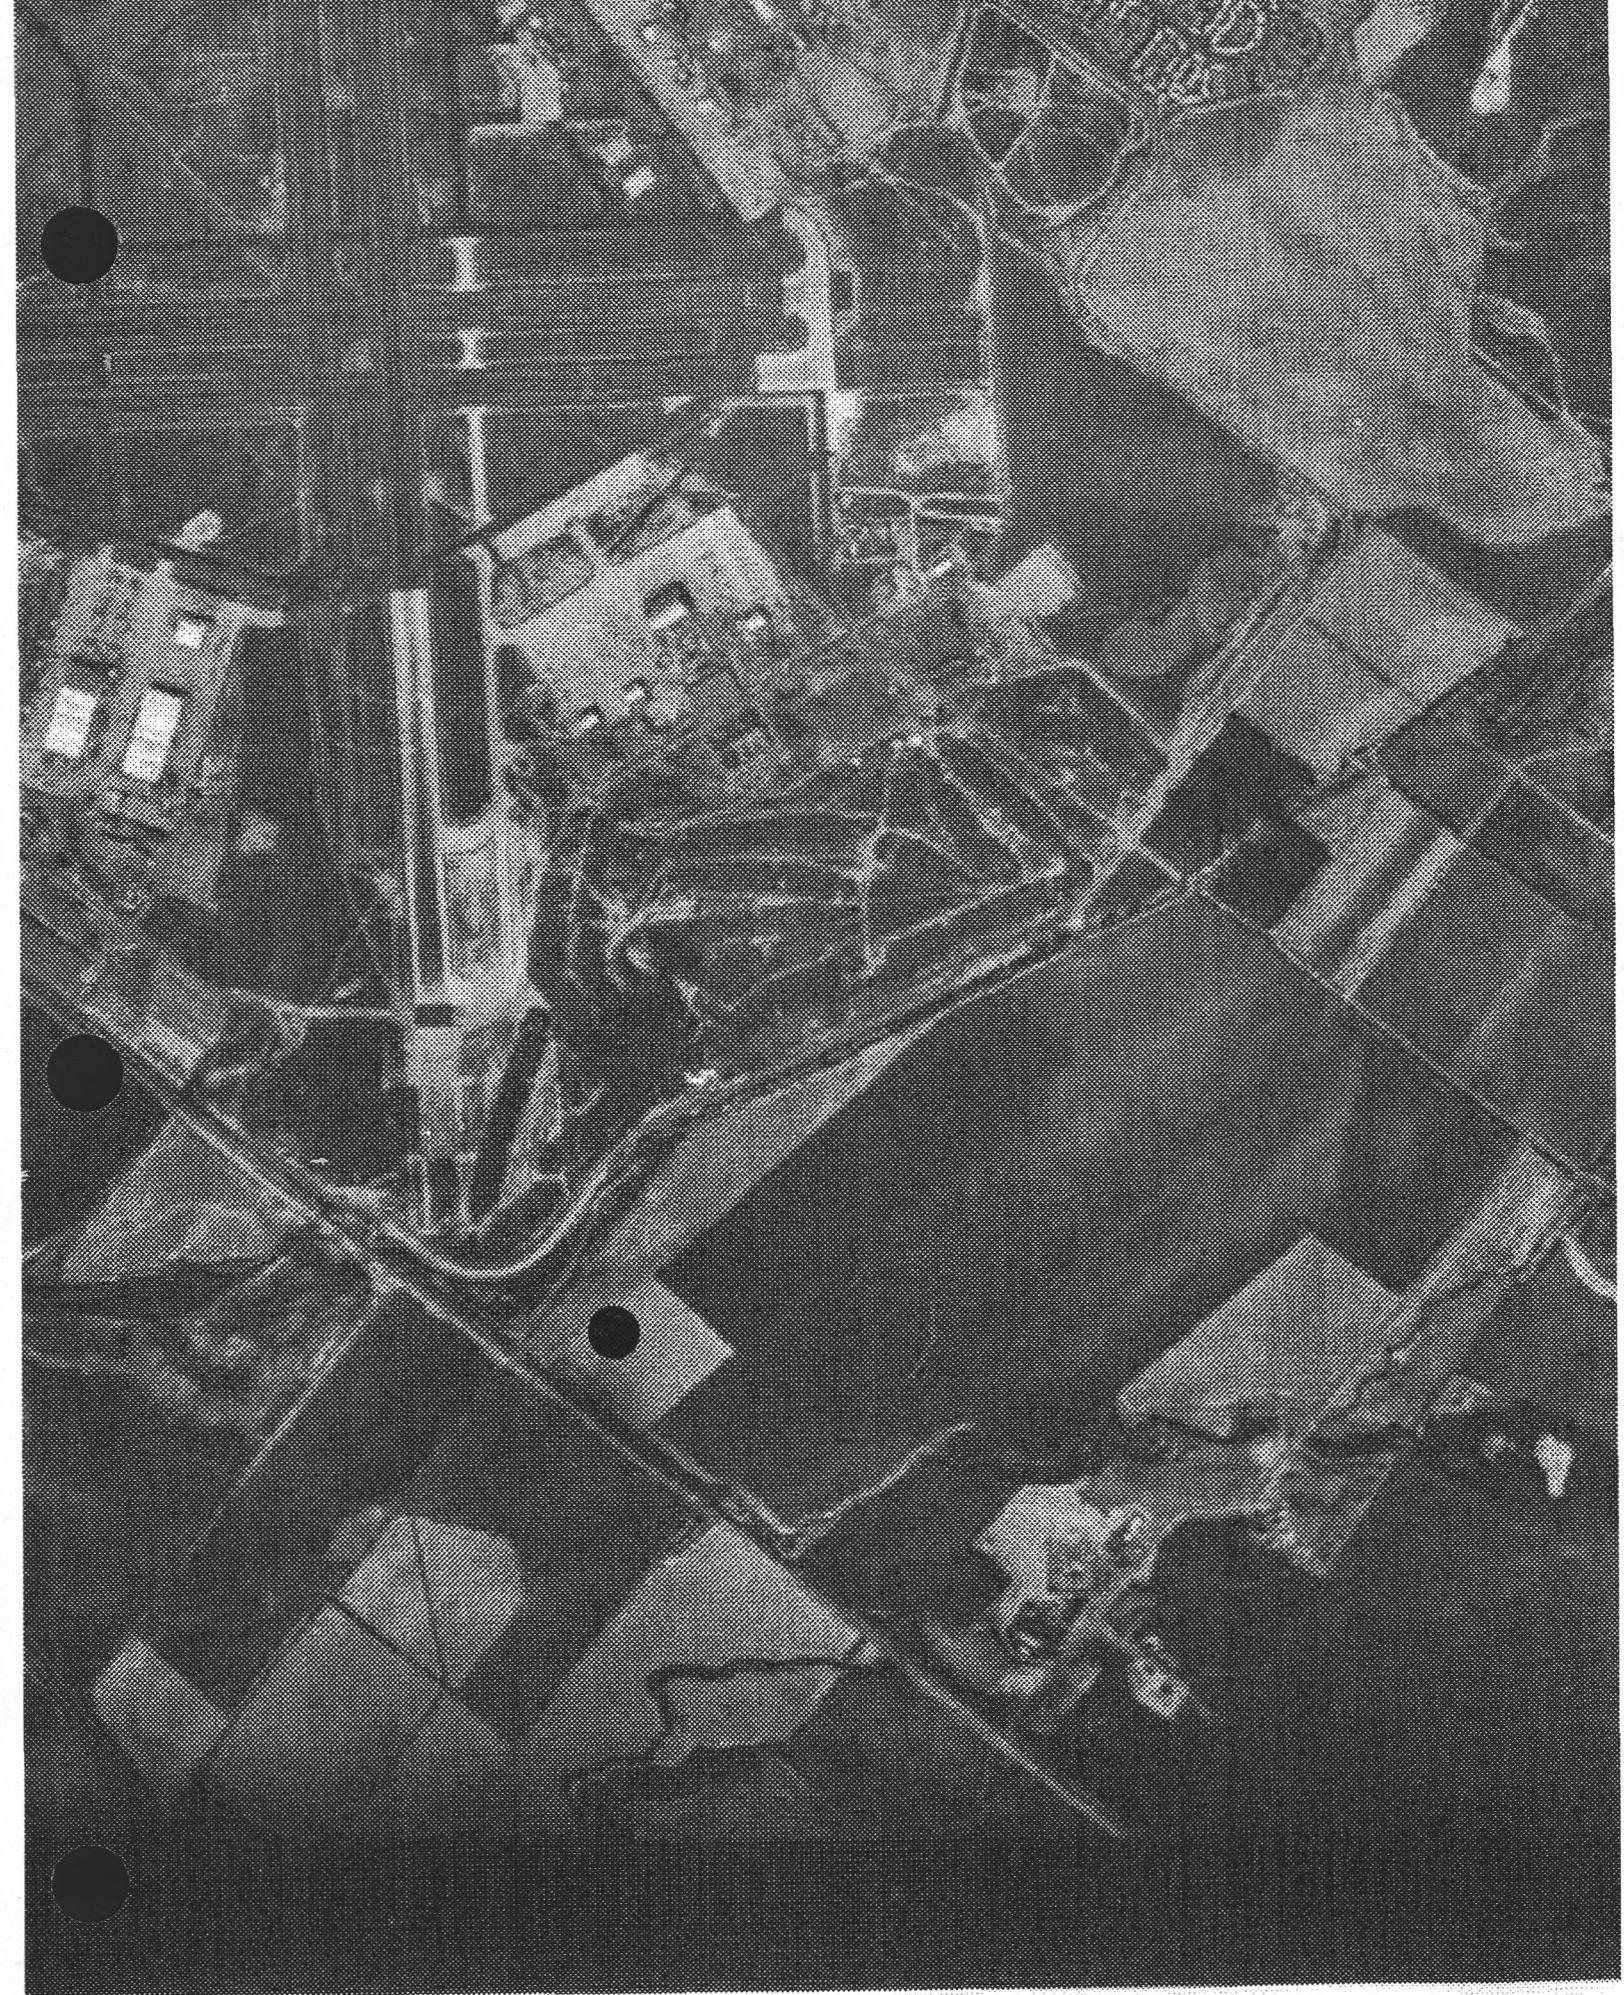
Excerpt from Historical Aerial Photograph
Date of Photograph: 28 February 1963
Source of Photograph: United States Geological Survey (USGS)
(Photo identifiers: GS VASK, XF6748, Frame 2-89, H15000)

NOTE: The excerpt from the 1963 aerial photograph is annotated with a solid circle symbol to show the approximate location of APHO 103 (SAIC 175).

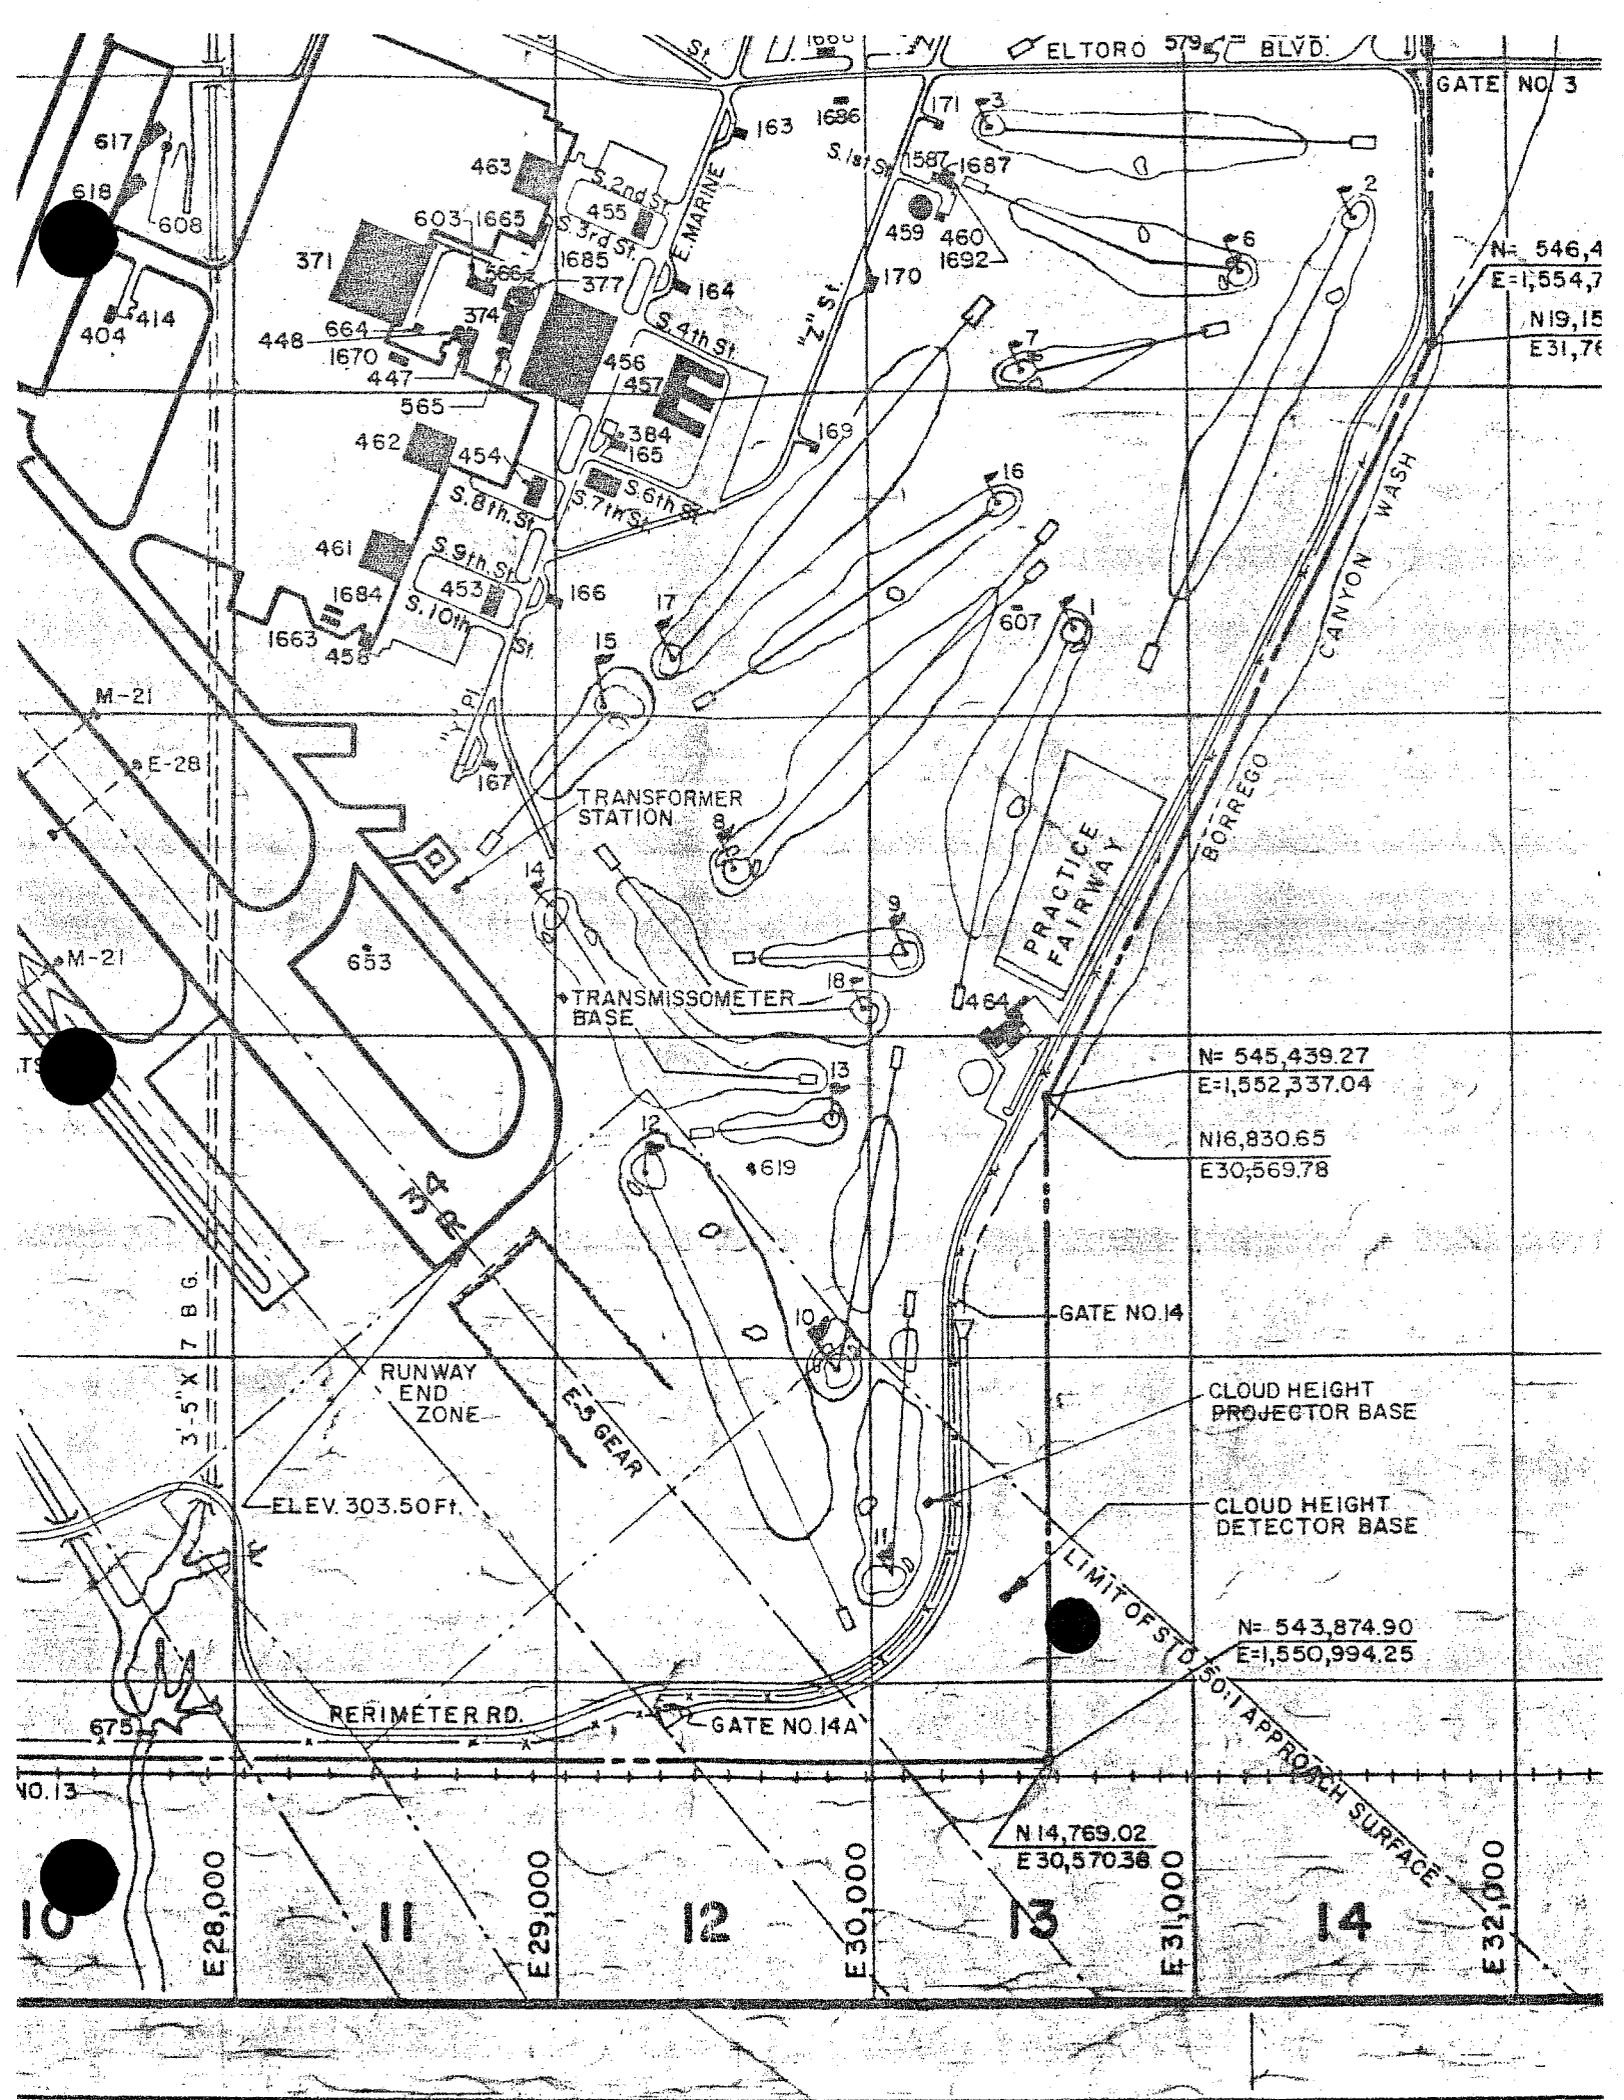
Excerpt from 1973 Station Map (Public Works Drawing S-2010)

NOTE: The excerpt from the Station Map shows the locations of Gate 14, Gate 14A, Borrego Canyon Wash, Perimeter Road, the CLOUD HEIGHT DETECTOR BASE and the CLOUD HEIGHT PROJECTOR, and the approximate location of APHO 103 (SAIC 175) (denoted by a solid circle symbol).
