Subj: Aerial Photograph Anomaly APHO 103 (SAIC 175)
Former Marine Corps Air Station, El Toro

Information Package

Aerial Photograph Anomaly APHO 103 (SAIC 175)

Former Marine Corps Air Station, El Toro

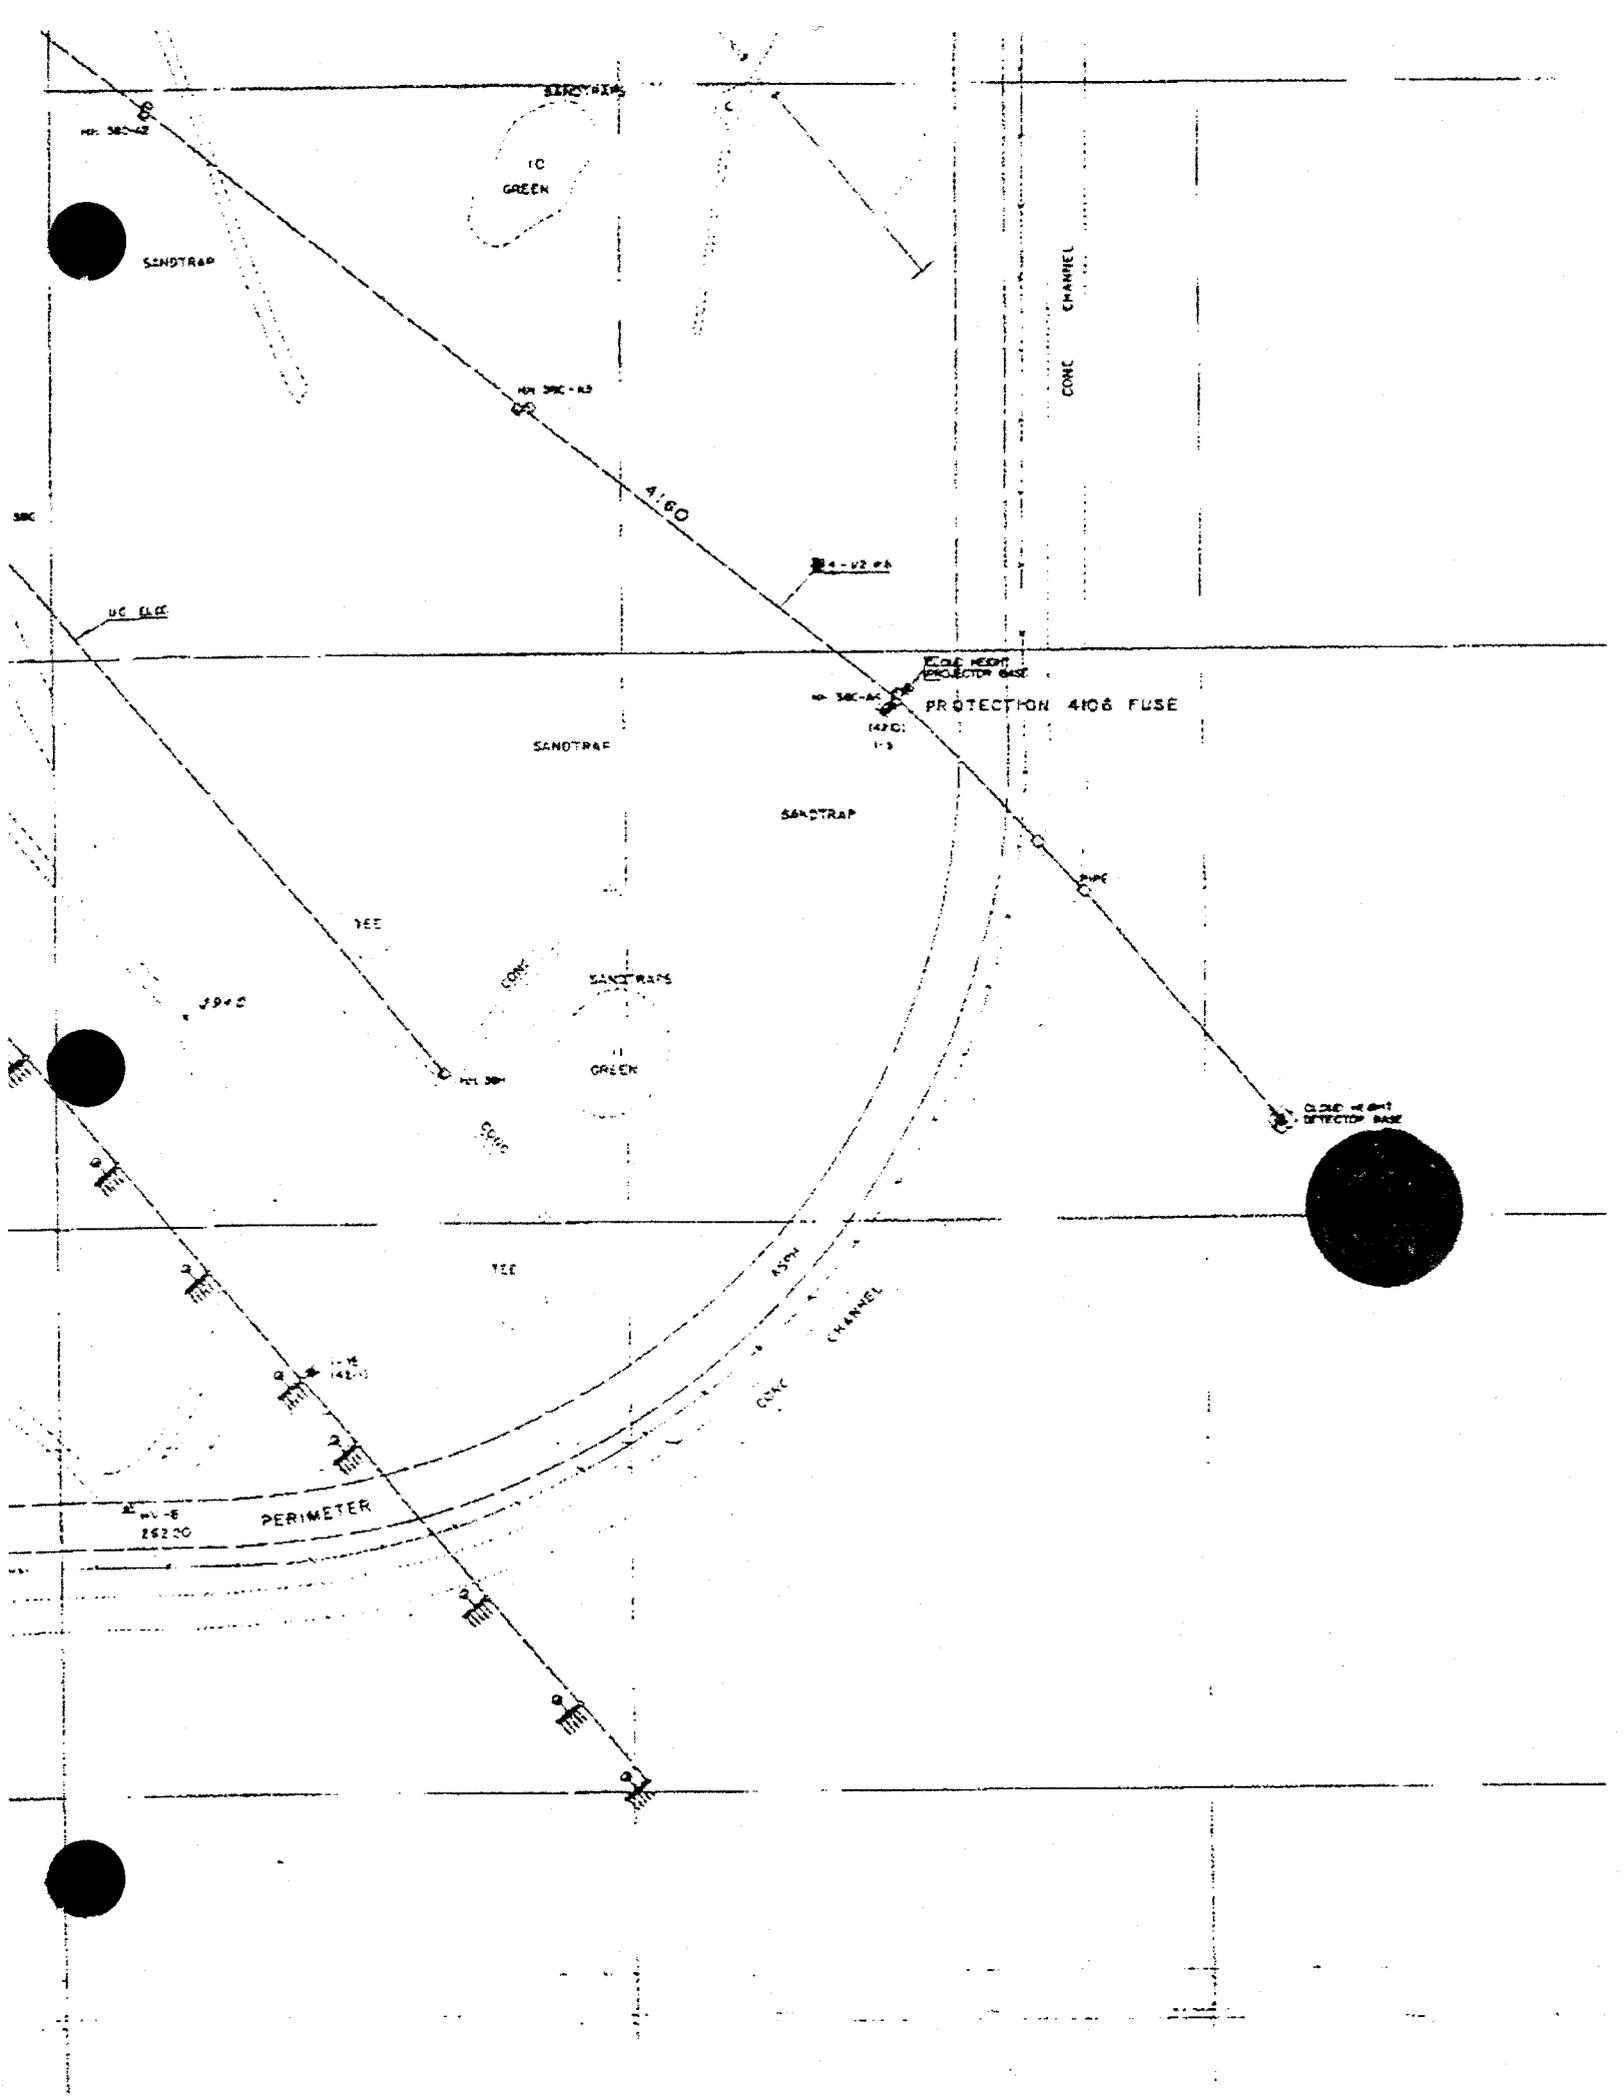
Excerpt from Area 29, Electrical Distribution Plan (U.S. Marine Corps Air Station,
El Toro, Public Works Department, Revised 14 April 1988)

NOTE: The excerpt from the electrical distribution plan has been annotated with a solid circle symbol for the approximate location of APHO 103 (SAIC 175), near the feature identified as the
CLOUD HEIGHT DETECTOR BASE.
