# Proposed Remedial Action

UXO 18, Cayo La Chiva

Former Vieques Naval Training Range

## Public Meeting

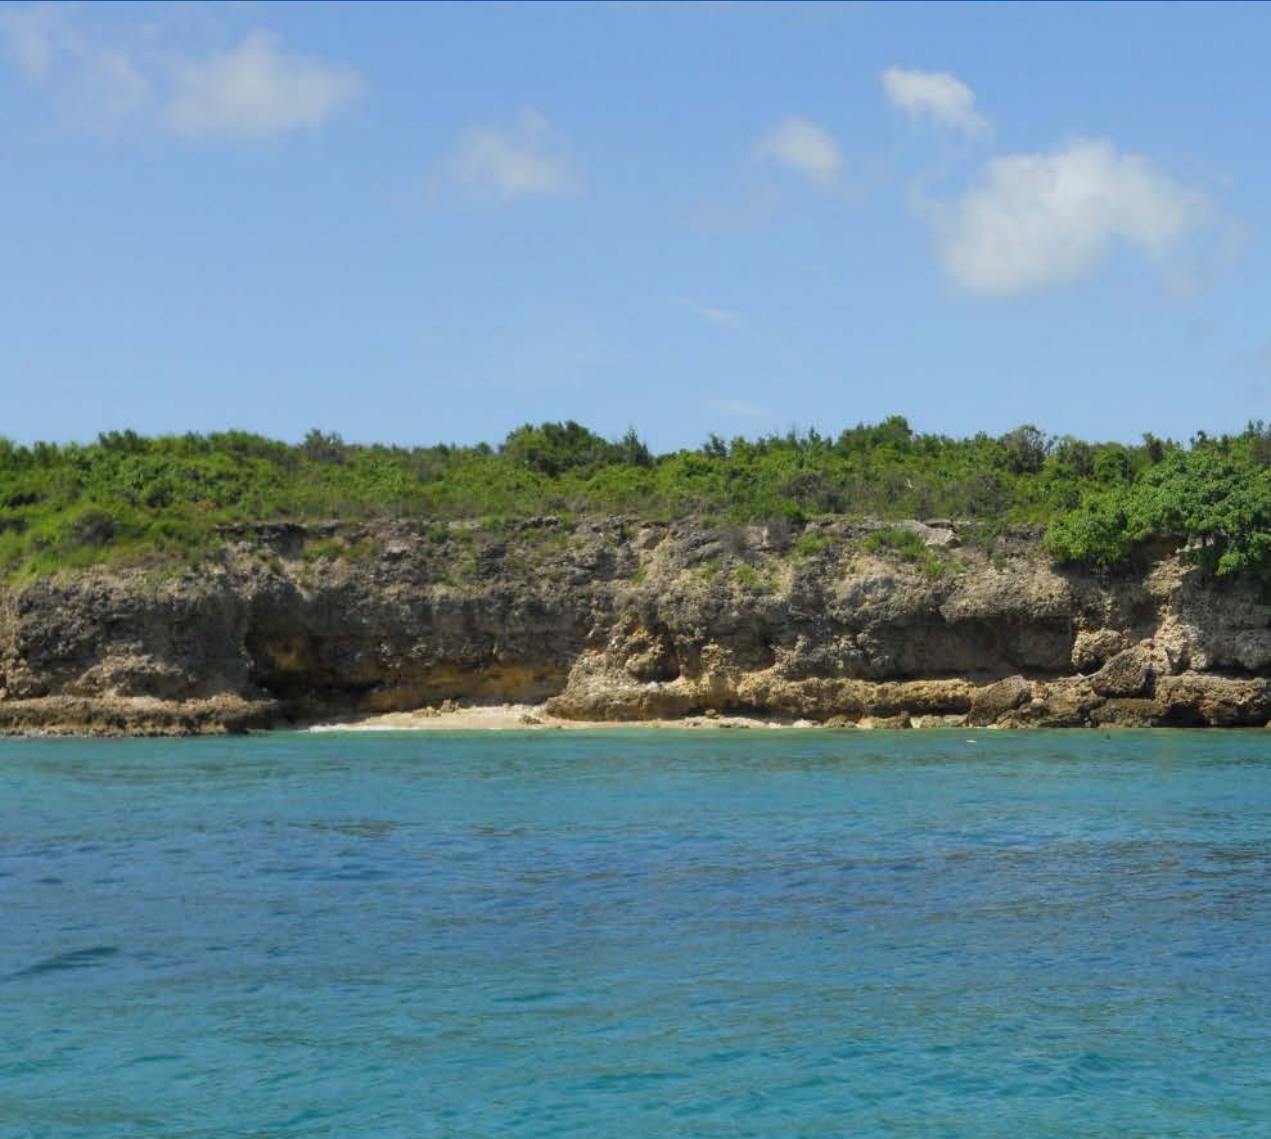
# Cayo La Chiva Features

- Cayo La Chiva is 12 acres, located several hundred yards offshore of Playa La Chiva (Blue Beach)
- Island is rocky, densely vegetated, and has steep cliffs on most sides
- Access to the island is limited to northern tip of island where a narrow sandy beach is present

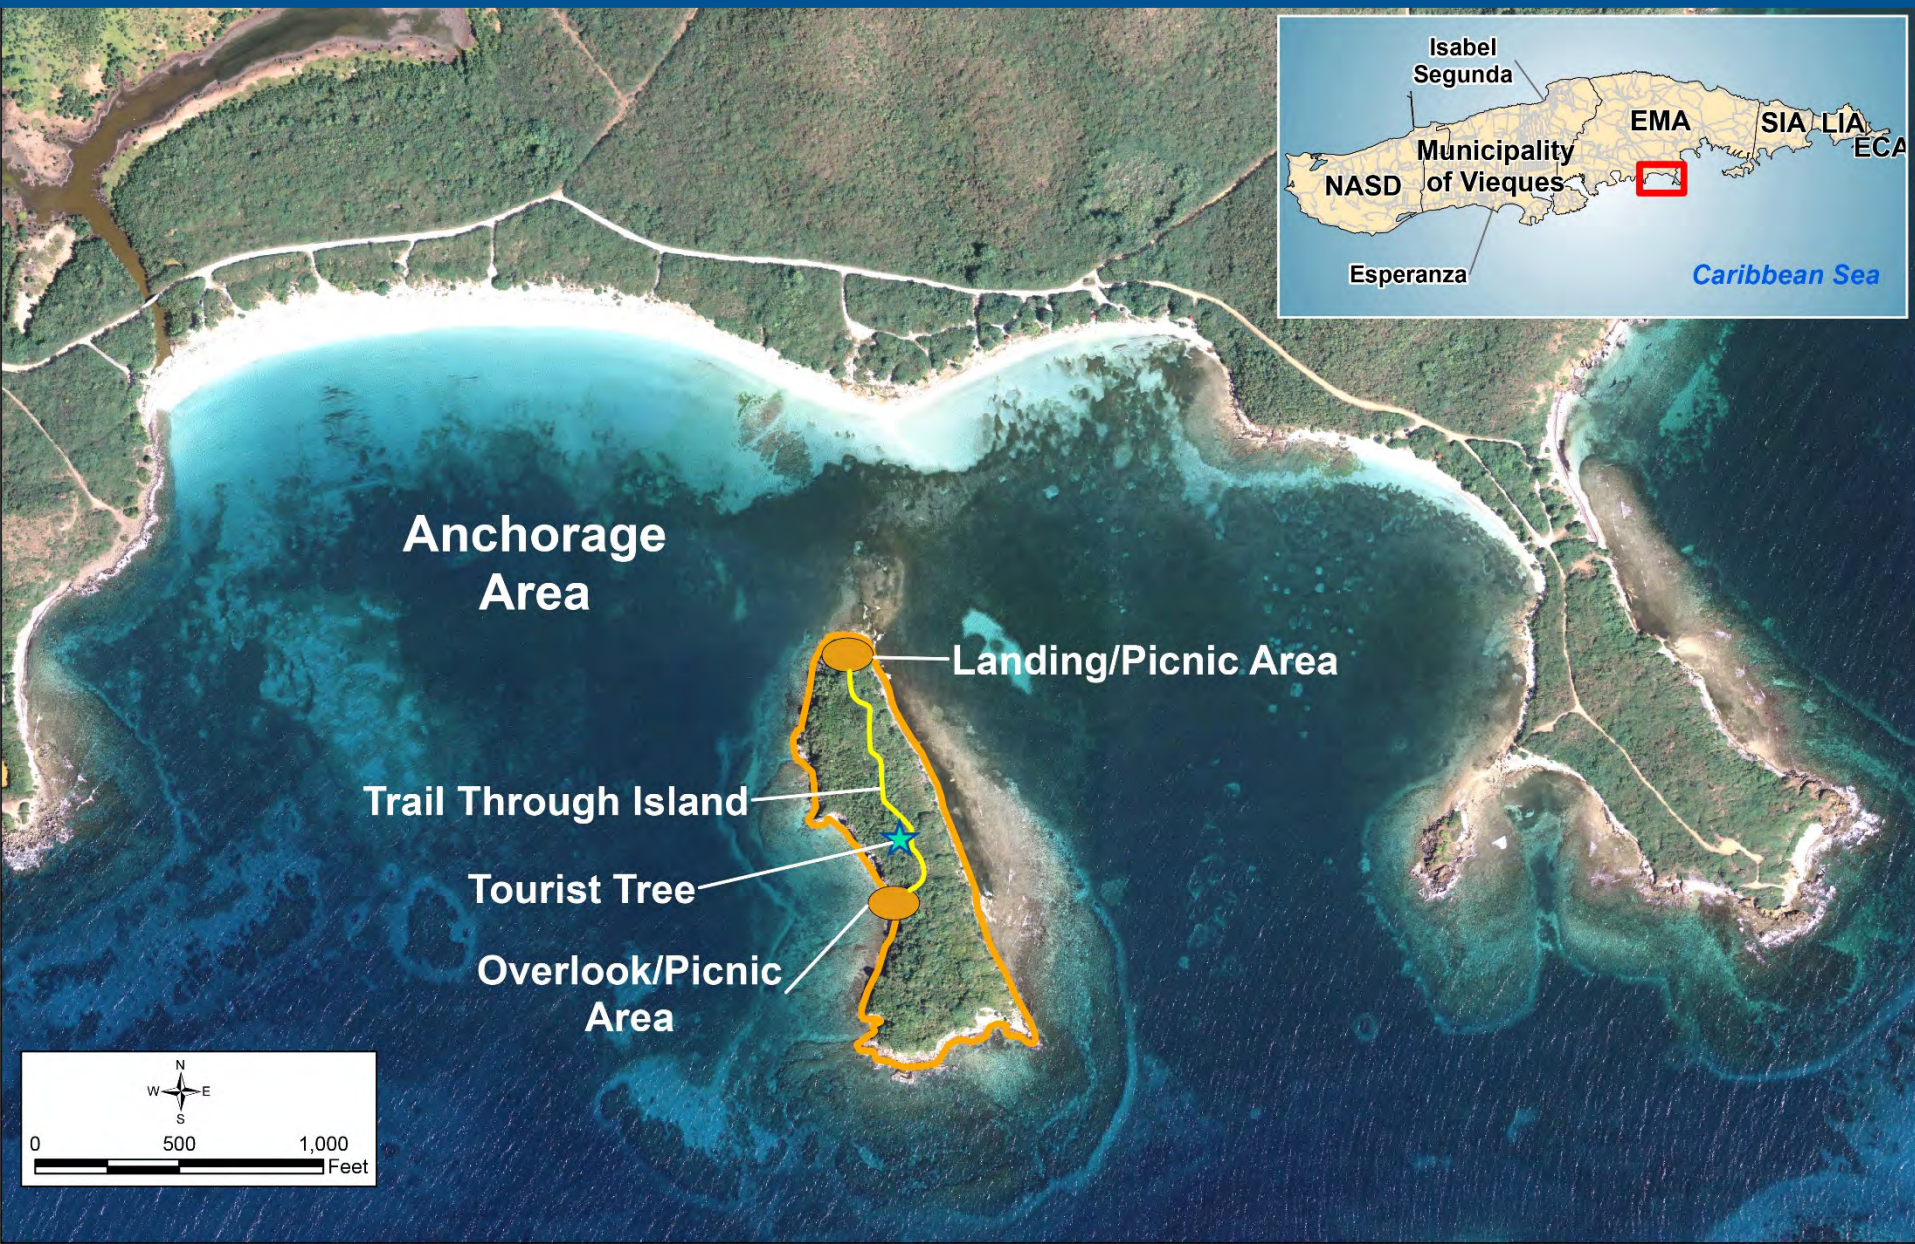
# Land Use Plan

- **Owned by the Commonwealth of Puerto Rico**
- **To be managed as a recreational area by Puerto Rico Department of Natural and Environmental Resources (PRDNER)**
- **Planned features include:**
  - Beach use
  - Picnic areas
  - Interpretive trail
  - Observation tower

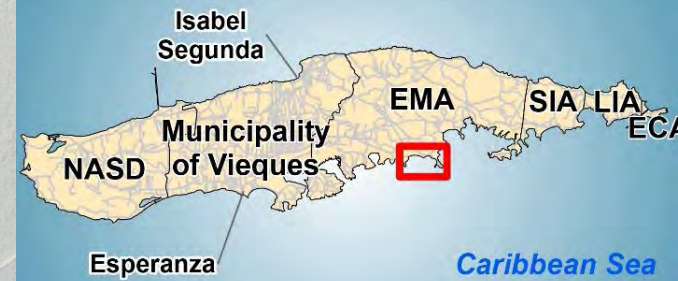
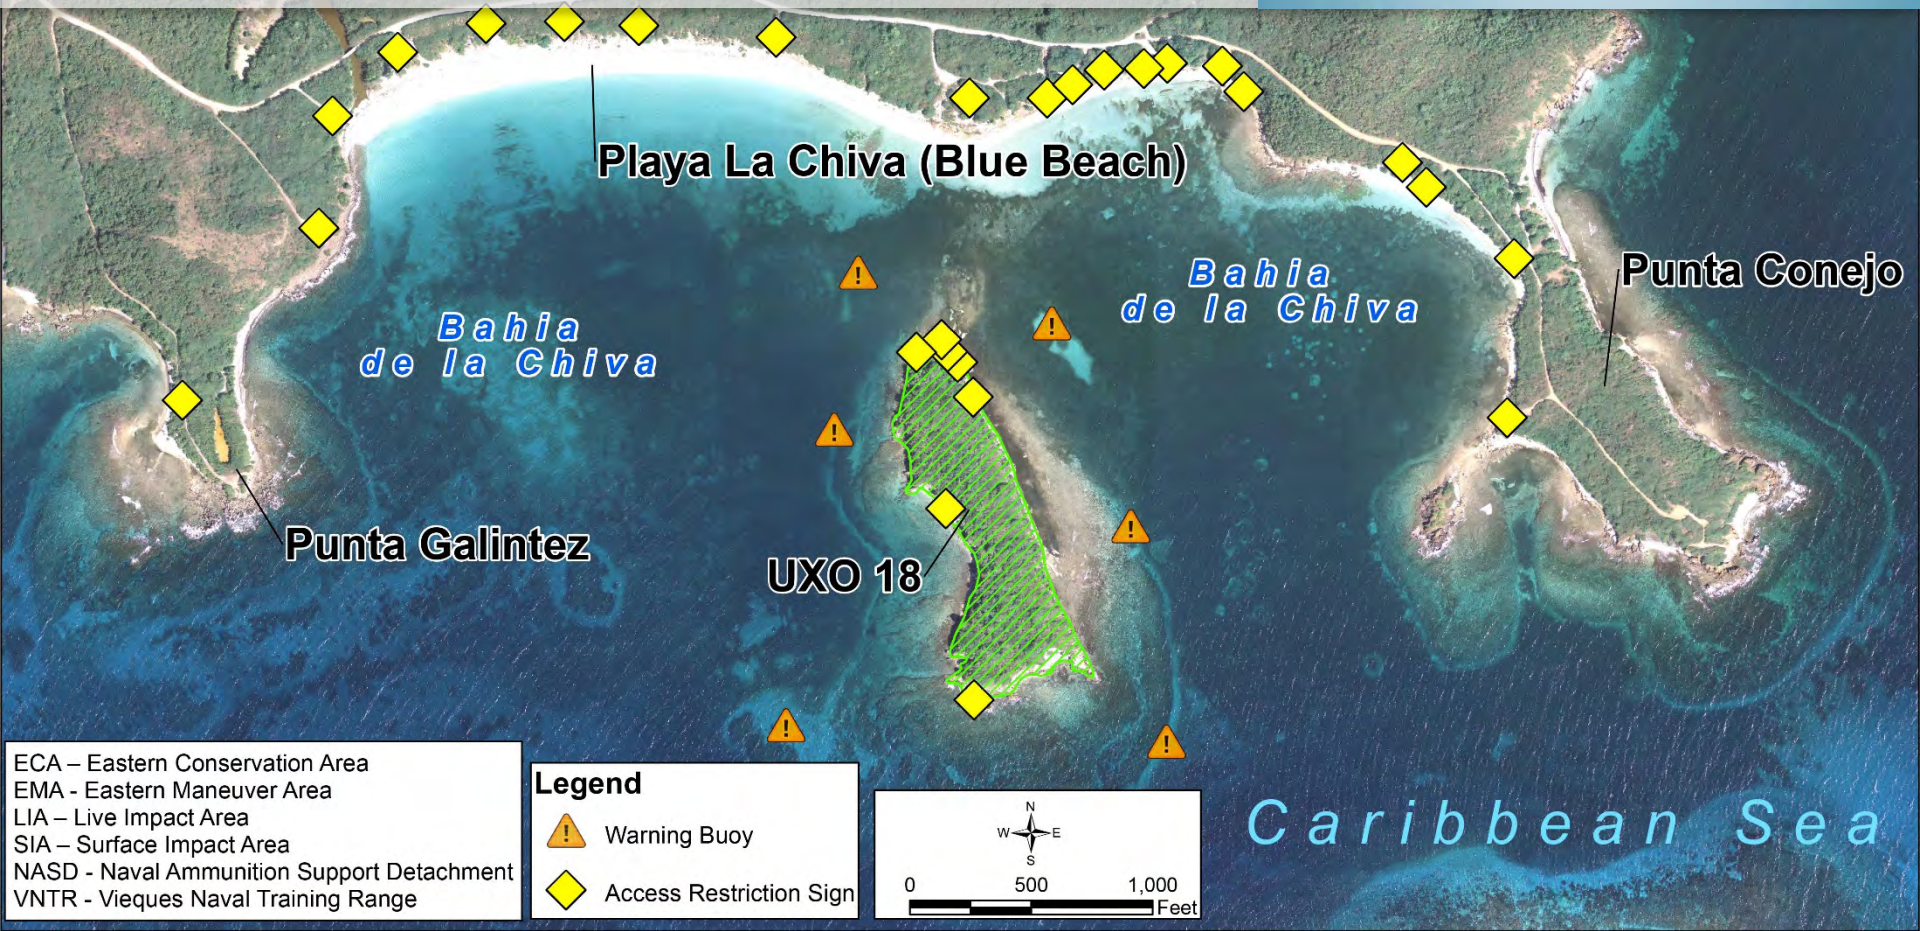
## Warning Buoy and Sign Installation (2012)

- 7 warning signs installed on Cayo La Chiva
- 6 warning buoys installed around Cayo La Chiva
- 20 warning signs installed at Playa La Chiva, Punta Galintez, and Punta Conejo

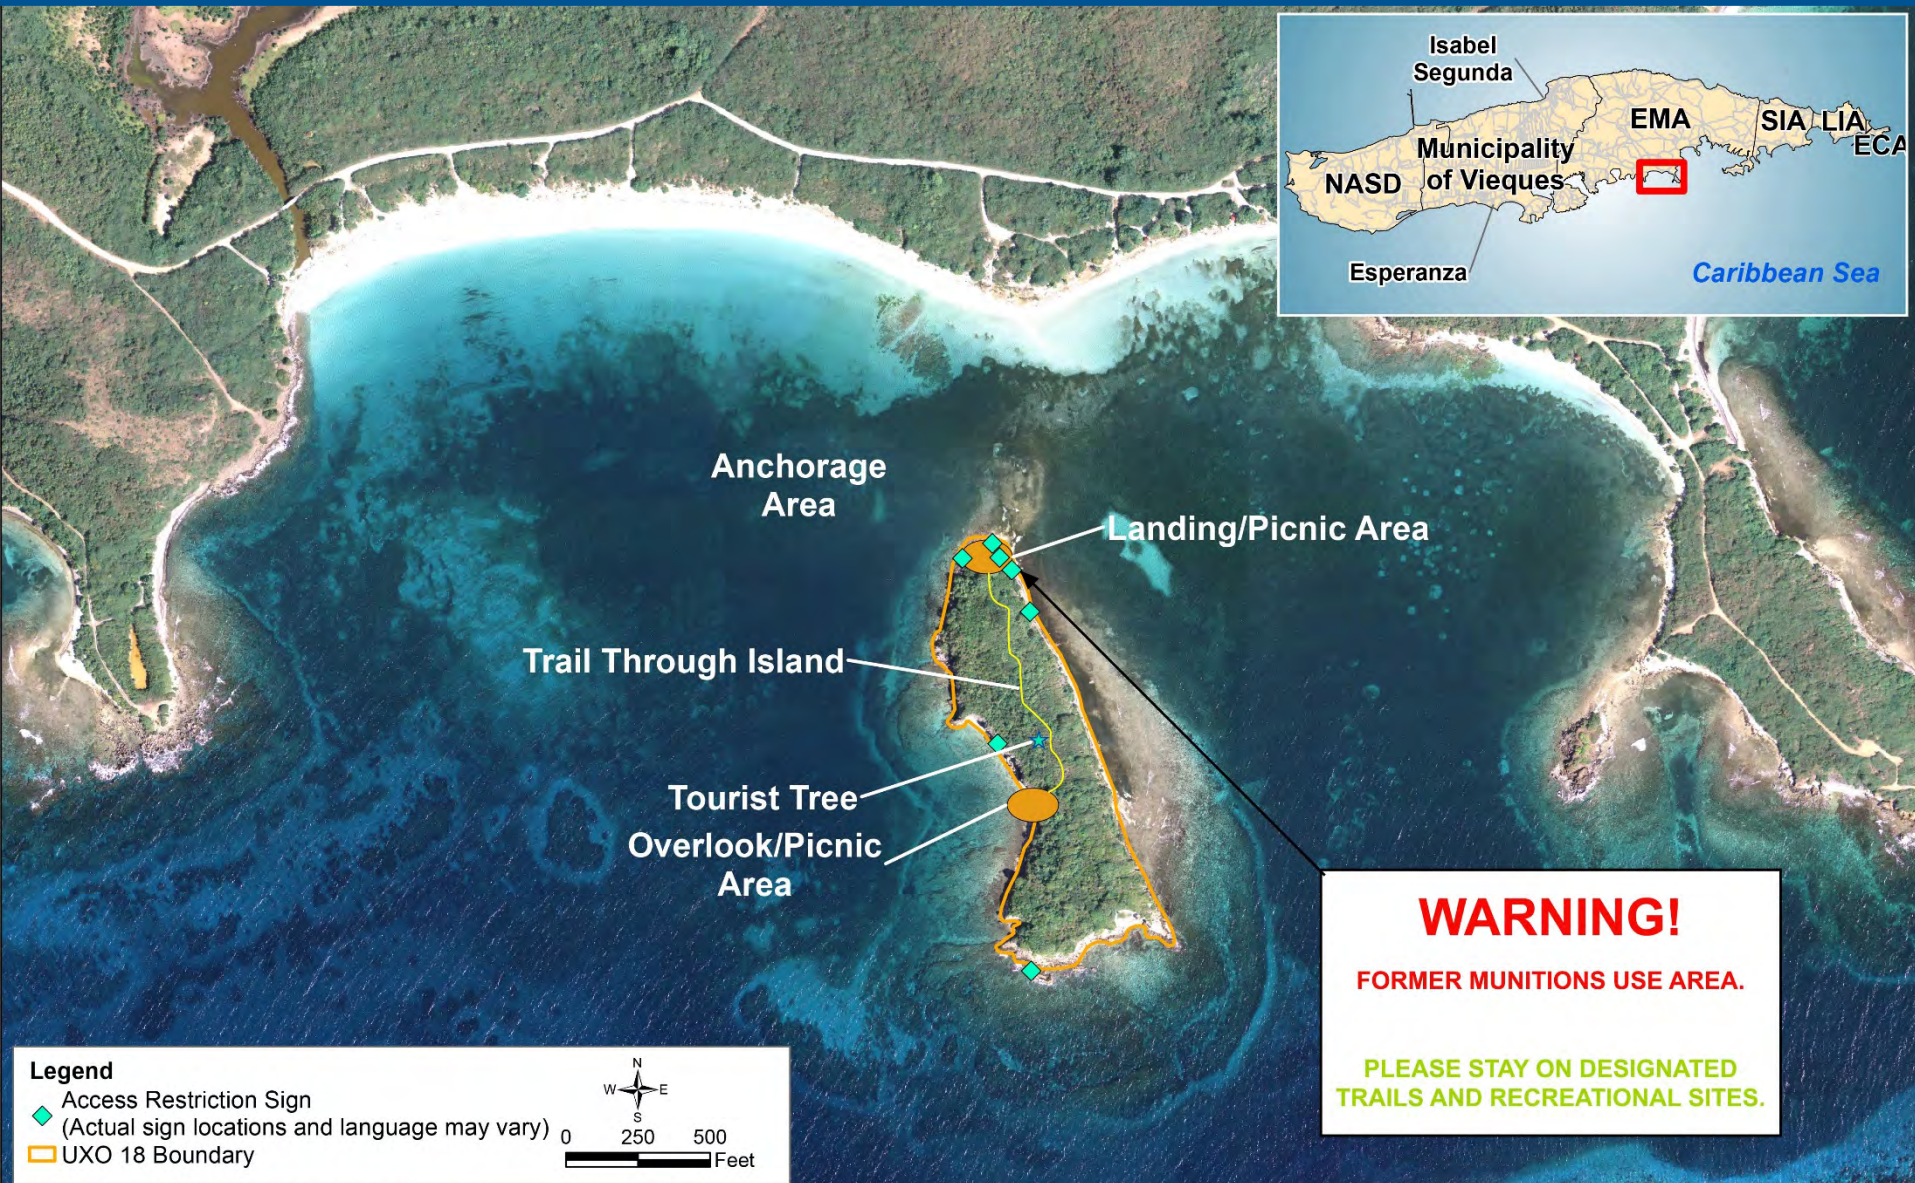
# Proposed Cleanup – Alternative 3

- **Alternative 1 – No action**
- **Alternative 2 – Land Use Controls and Inspections**
  - Warning signs and routine inspections to look for (and remove, if found) any munitions in areas being accessed
- **Alternative 3 – Focused Munitions Removal, Land Use Controls, and Inspections**
  - Munitions clearance in areas identified for recreational use
  - Land Use Controls and inspections similar to Alternative 2
- **Alternative 4 – Island-wide Munitions Removal, Land Use Controls, and Inspections**
  - Complete vegetation and munitions clearance across island
  - Land Use Controls and inspections similar to Alternative 2

- **Alternative 3 – Focused Munitions Removal, Land Use Controls, and Inspections**
- **Why Alternative 3 is the preferred cleanup:**
  - Vegetation and munitions clearance is focused in areas identified by PRDNER for recreational use
  - Island-wide vegetation and ecological habitat are preserved
  - Land Use Controls and routine inspections will continue to ensure reduced explosive hazard
- **Navy, EPA, PREQB, and PRDNER agree on the proposed cleanup alternative**
