RESTORATION ADVISORY BOARD (RAB) MEETING MINUTES HELD 10 APRIL 2014  
CALVERTON COMMUNITY CENTER NWIRP CALVERTON NY  
4/10/2014  
RESOLUTION CONSULTANTS

**RESTORATION ADVISORY BOARD MEETING  
NAVAL WEAPONS INDUSTRIAL RESERVE PLANT (NWIRP), CALVERTON  
CALVERTON COMMUNITY CENTER, CALVERTON, NEW YORK  
THURSDAY, APRIL 10, 2014**

**SITE 6A - SOUTHERN AREA FENCE LINE GROUNDWATER  
EXTRACTION TREATMENT SYSTEM (FLTS)  
APRIL 2014 RESTORATION ADVISORY BOARD**

**SITE 7 – FUEL DEPOT AIR SPARGING/SOIL VAPOR  
EXTRACTION SYSTEM EVALUATION  
APRIL 2014 RESTORATION ADVISORY BOARD**

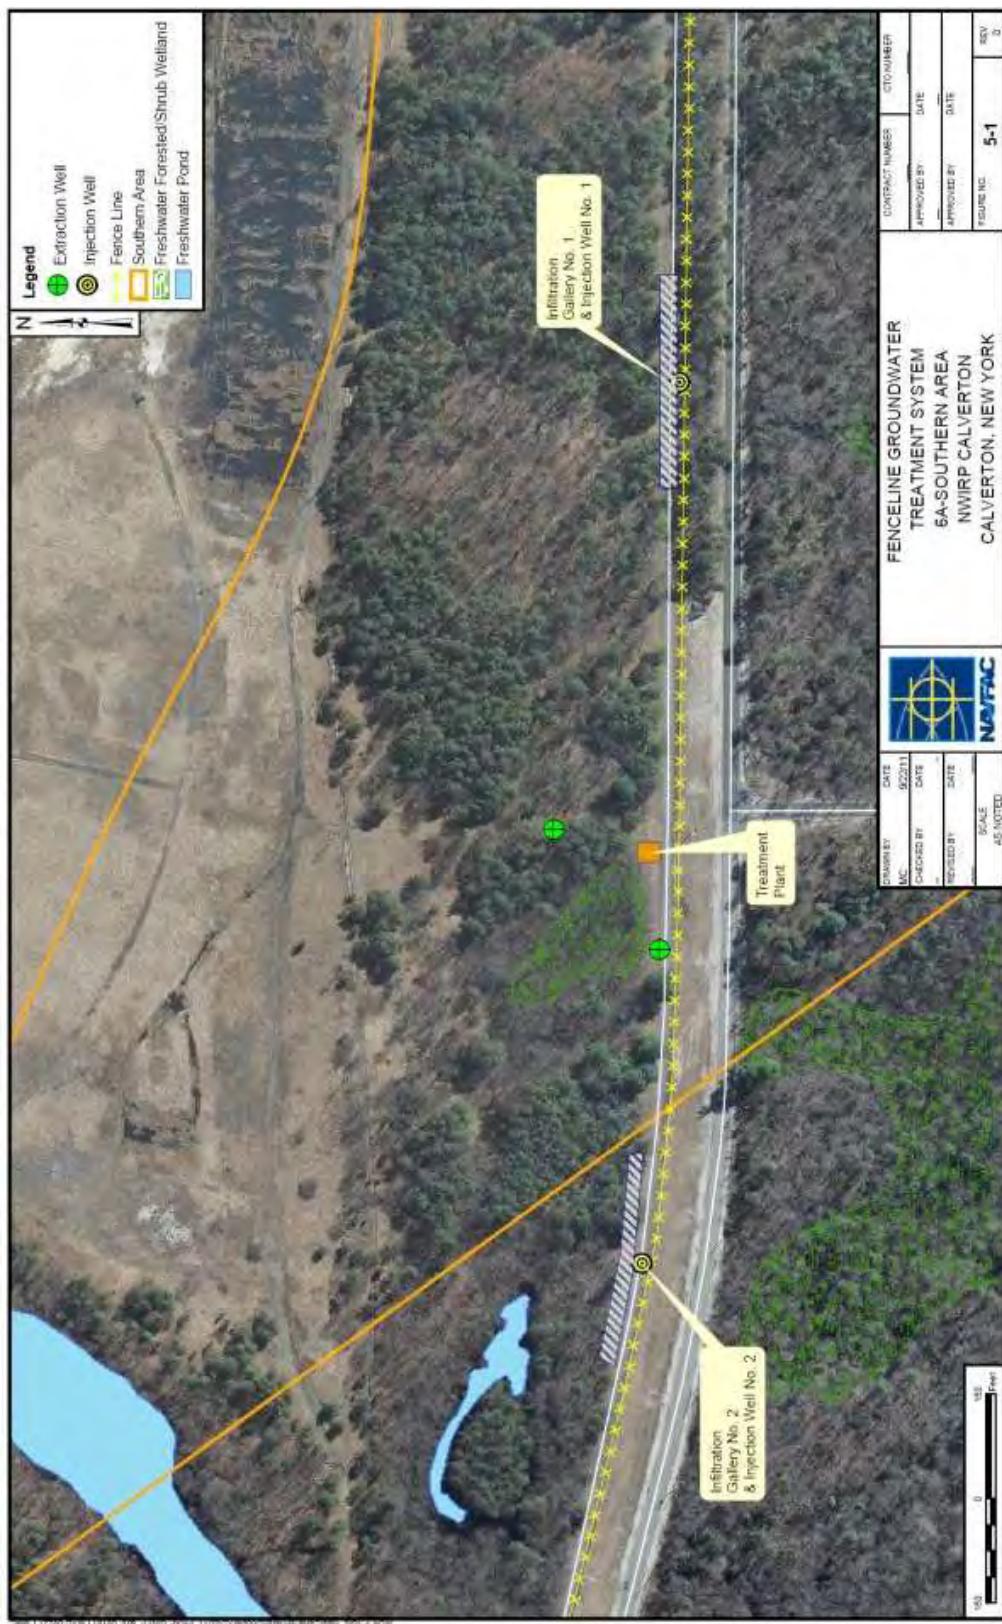
# Fence Line Treatment System Design Overview

- Record of Decision (ROD) in May 2012.
- Selected remedy for Fence Line Area – LUCs and monitoring with extraction, treatment, and infiltration .
- Remedial Design for Fence Line Treatment System (FLTS) in May 2012.
- Fence Line Treatment System overview:
  - Two extraction wells, total of 100 gallons per minute.
  - VOCs removed via air stripping.
  - Treated groundwater re-injected through infiltration galleries, meeting MCLs.
- Construction began in October 2012, continued into 2013.
- System start-up occurred 8 October 2013.

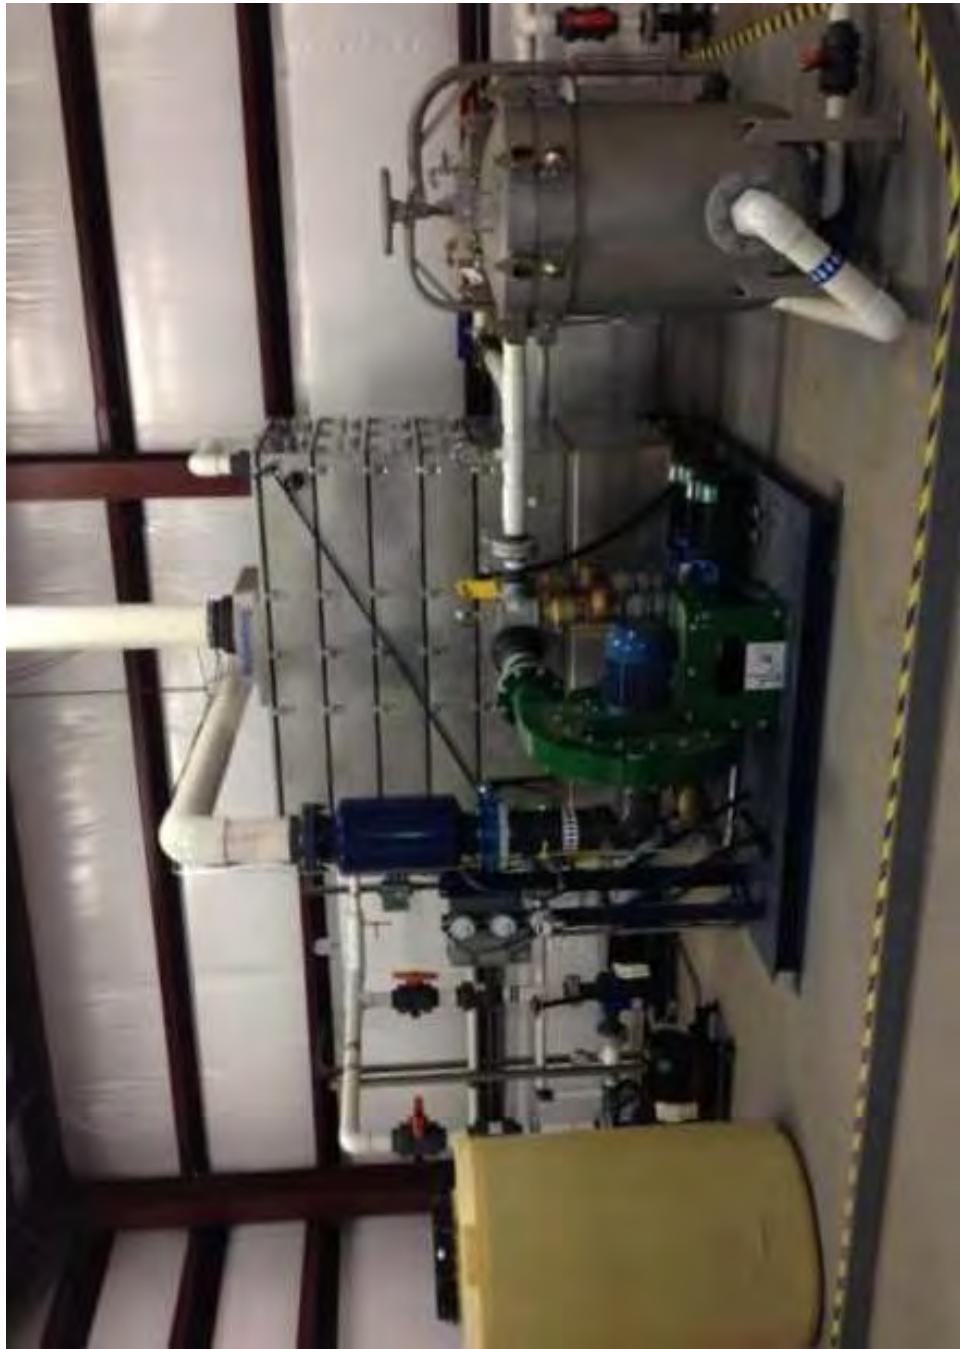
Inside View

# Fence Line Treatment System Completed

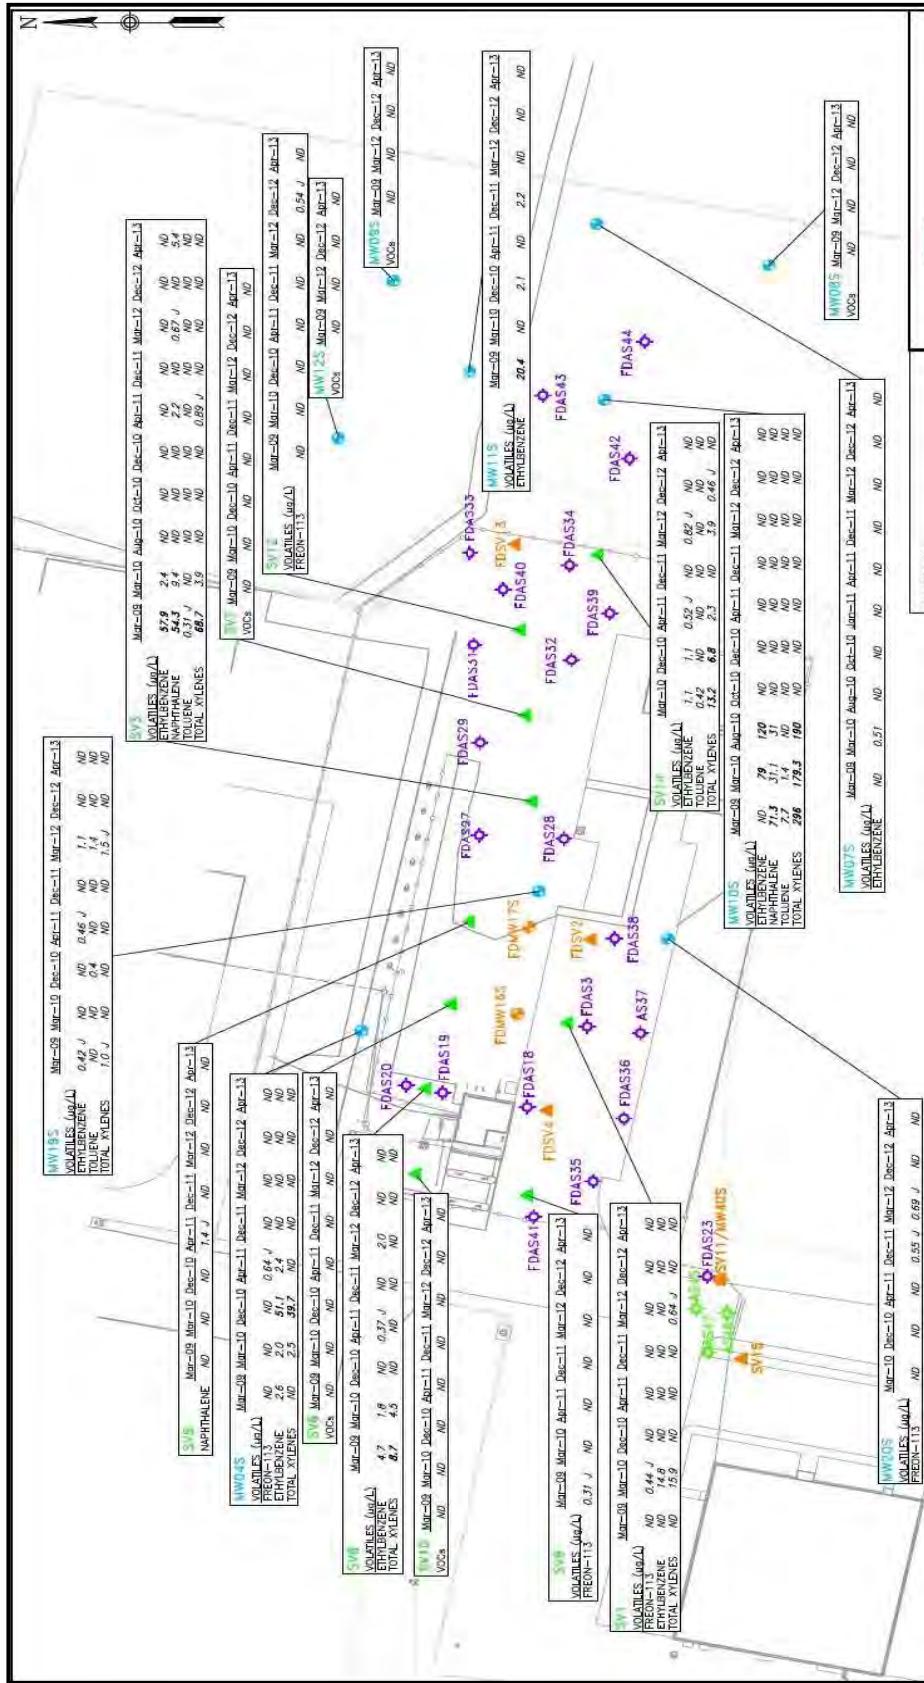
- 20 of 27 Wells have achieved the ROD remediation Goals

Site data over time was presented that indicates the majority of site groundwater has achieved remedial goals, as indicated by contaminant concentrations reaching goals at 20 of 27 monitor well locations. The remedial goals for soils were then summarized. It was noted that remedial goals specified in the ROD were originally developed based on NYSDEC's Technical and Administrative Guidance Memorandum (TAGM) 4046, but that this guidance has since been superseded by remedial goals specified in Part 375 of NYSDEC's regulations; the target concentrations are generally consistent, but some close-out goals will need to be updated.

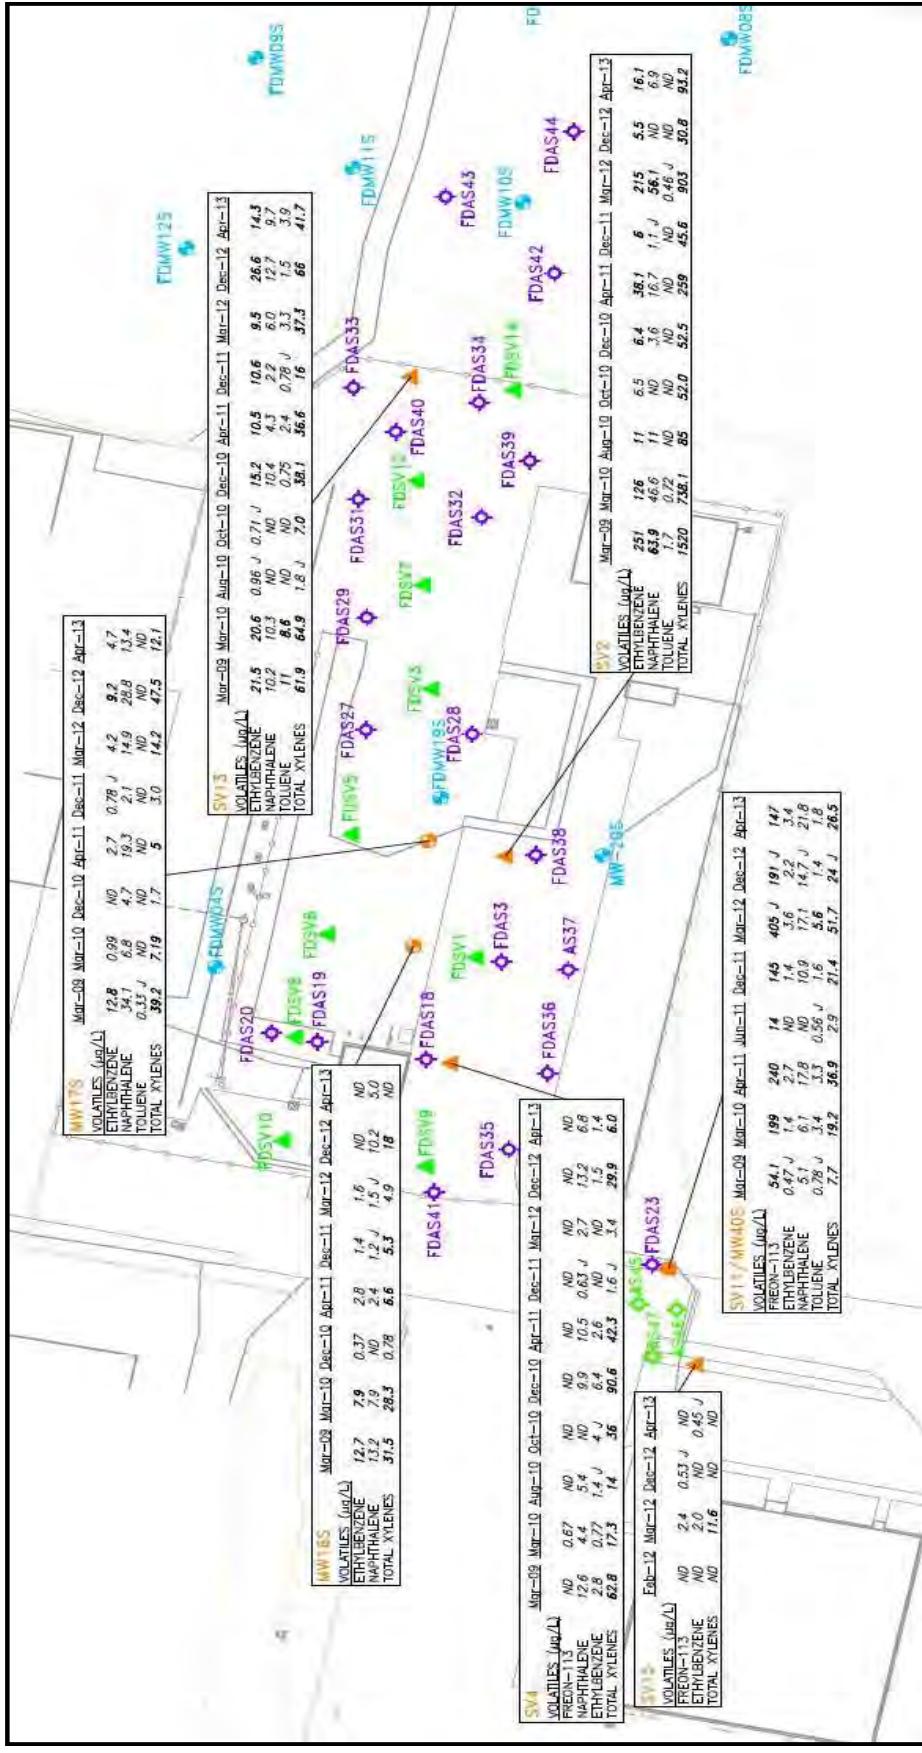
- 7 of 27 Wells have some exceedances of ROD Remediation Goals

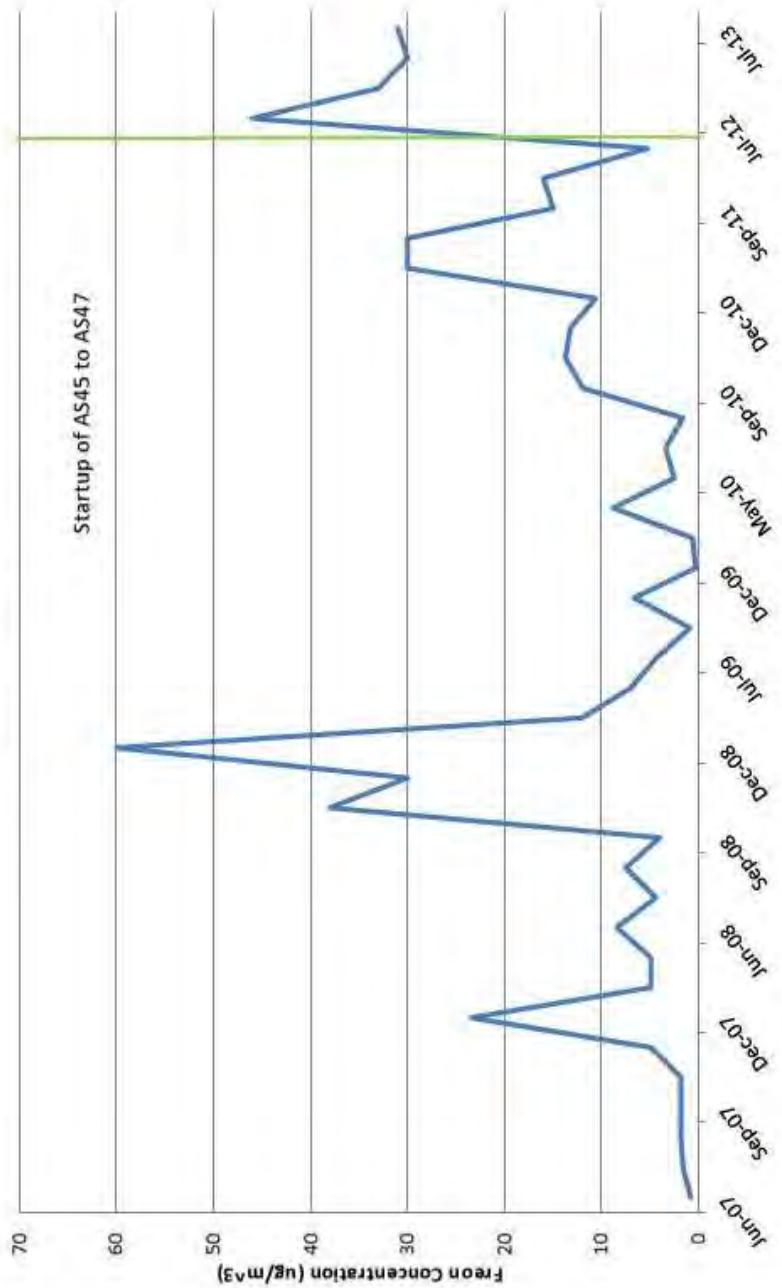
Figure 4-20  
Freon-113 Concentrations  
Pre-Carbon Vapor Samples  
Site 7 - Former Fuel Depot  
NWIRP Calverton, NY

There was some discussion about the history of monitor wells southwest of Site 7 proper that have been impacted by Freon; Mr. Brayack noted that this area was being treated by the AS/SVE system through wells added during an optimization that took place about two years ago. In response to a question about the depth of the contamination, Mr. Brayack further elaborated that the hydrocarbon contamination is

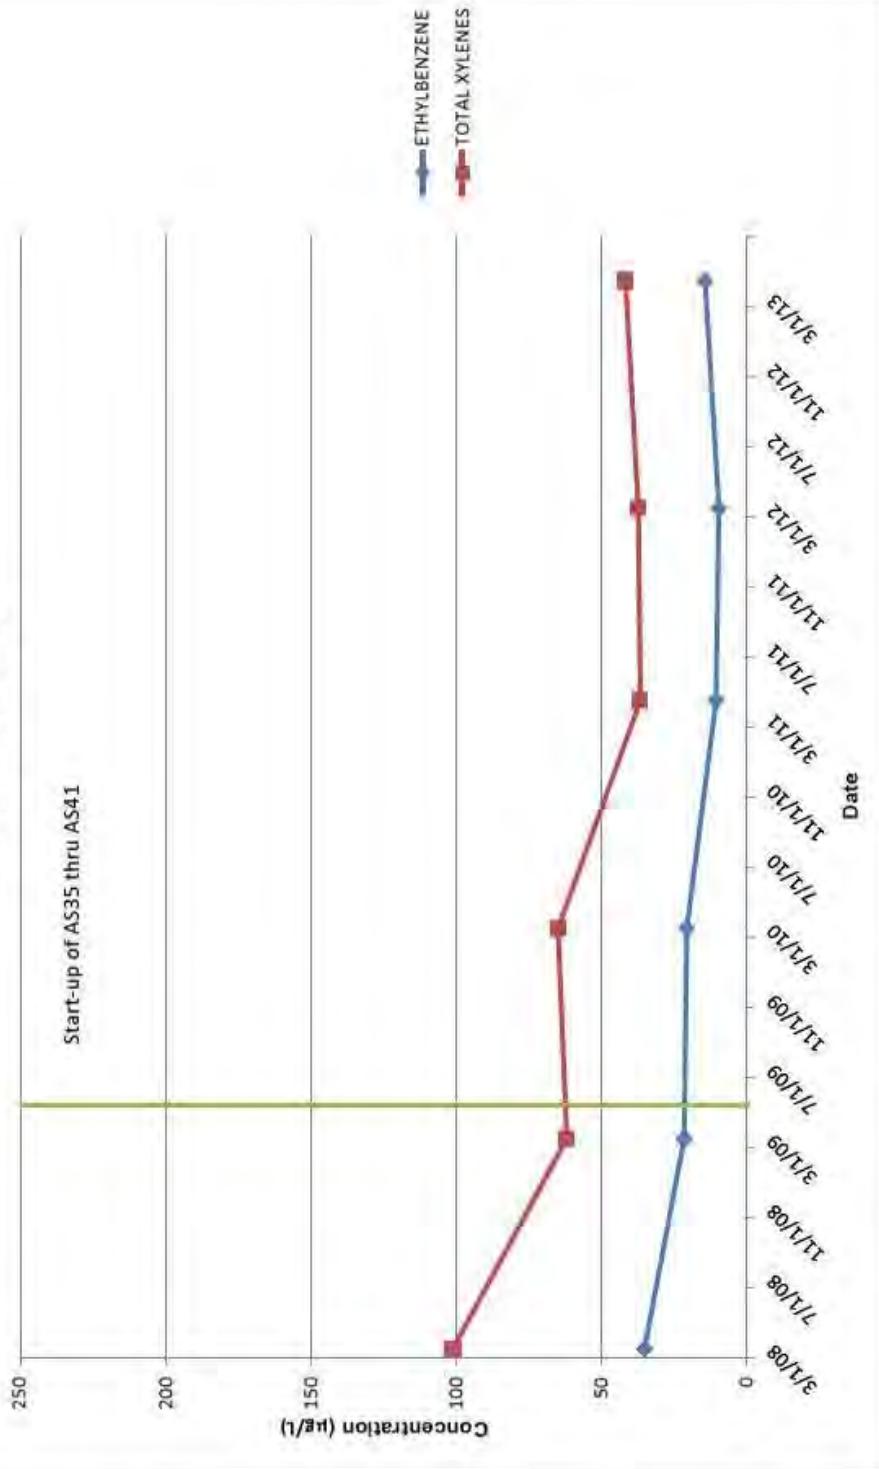
Figure 4-22  
Soil Vapor Extraction Well - SV13  
Ethylbenzene and Xylene Concentrations  
Prior to Seasonal Start-up (March/April)  
Site 7 - Former Fuel Depot  
NWIRP Calverton, NY

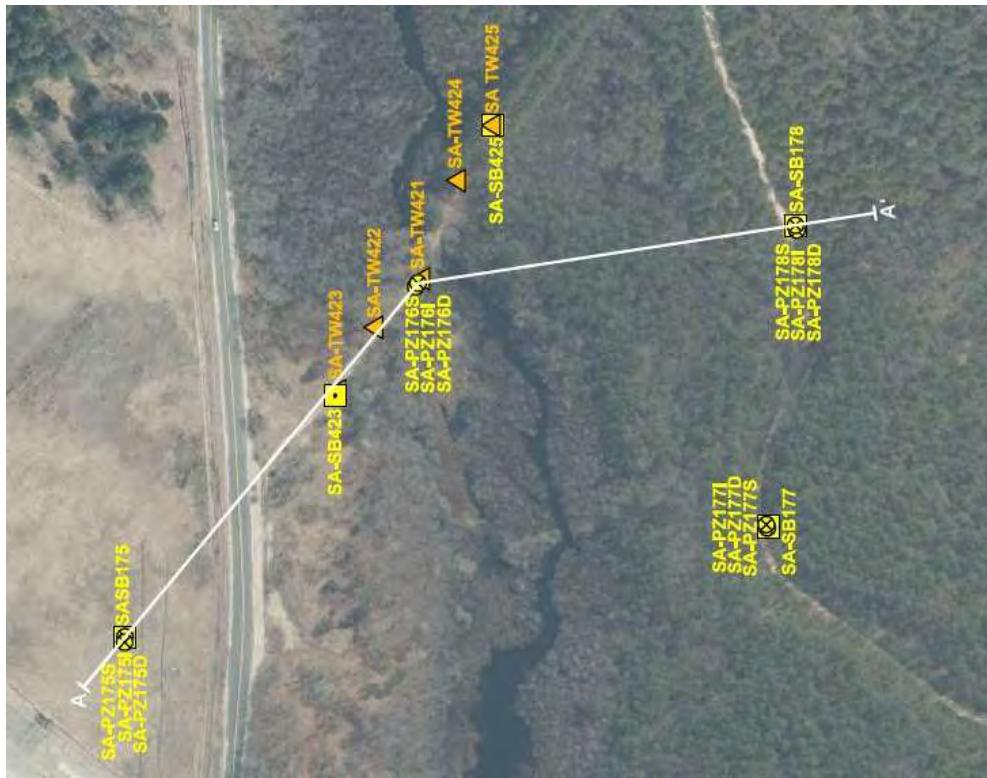
- Installed 5 soil borings to clay unit (approx. 120 feet) for lithology
- Installed 5 temporary wells, each with 9 to 12 water samples for analysis
- Installed 12 piezometers to evaluate horizontal and vertical flow
- Collected 3 rounds of water level measurements

Mr. Brayack continued with a summary of investigations conducted along the Peconic River in 2013. The presentation is included in Attachment 3. The objective of the 2013 Peconic River investigation was to determine whether a portion of the Site 6A – Southern Area plume of DCA is flowing beside or beneath the Peconic River downriver of Connecticut Avenue and south of the east runway. Activities included the installation of five soil borings to the clay unit for lithology, five temporary wells (each with nine to 12 water samples) for the collection of groundwater samples and 12 piezometers to evaluate groundwater flow, as well as three rounds of water level measurements.

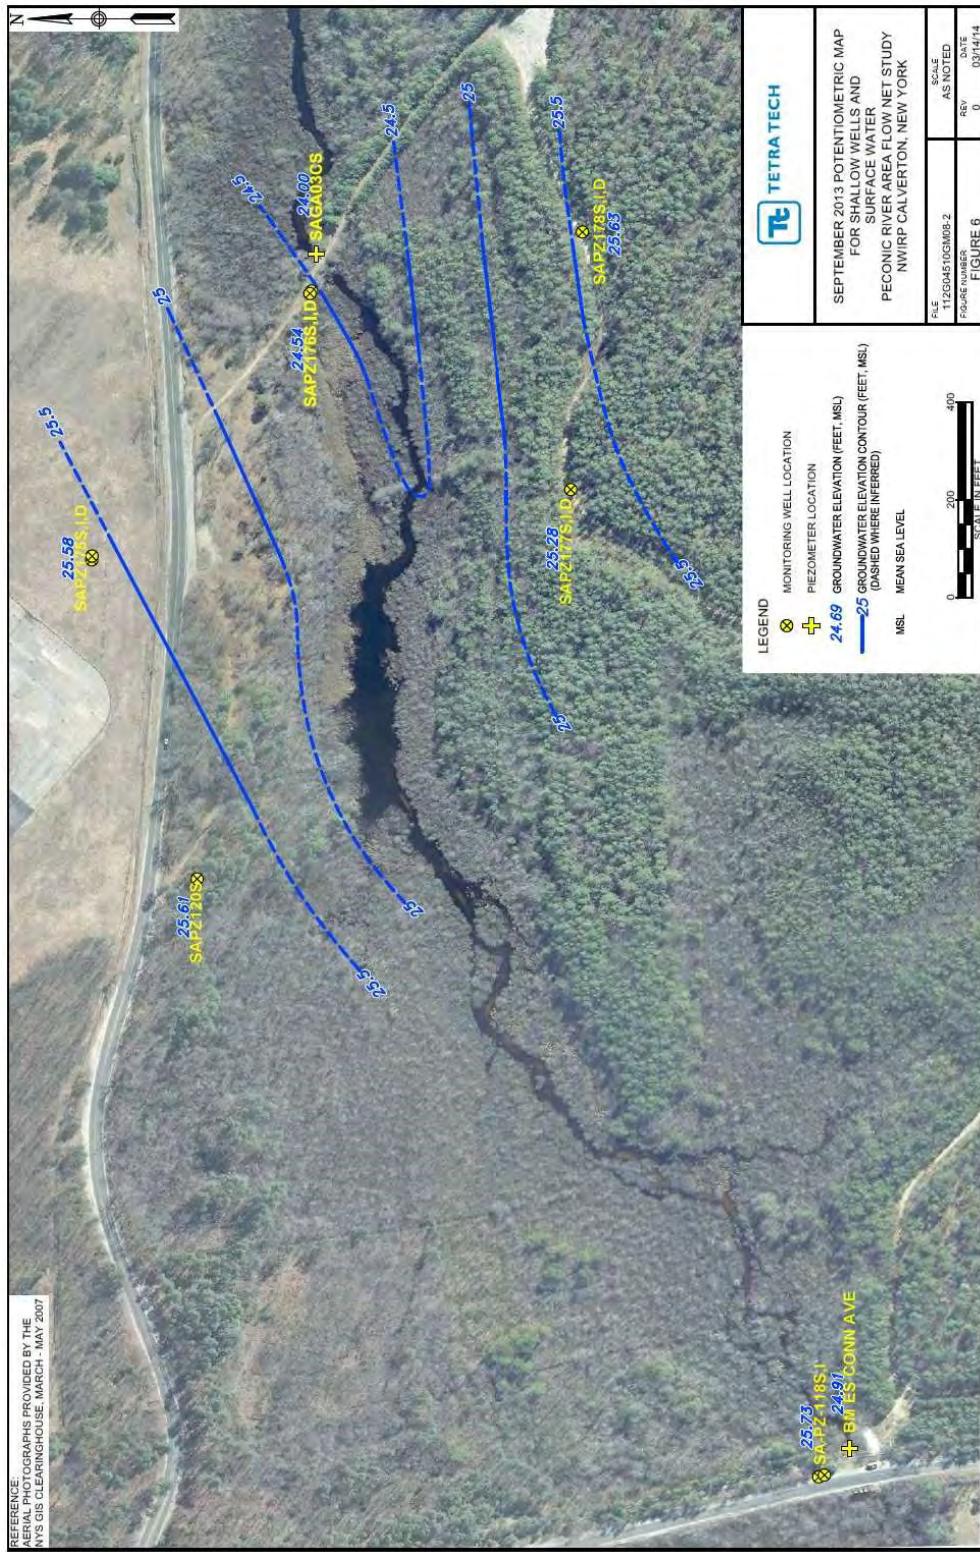
## Flow Net Study – Runway Area – September 2013

SEPTEMBER 2013 POTENTIOMETRIC MAP  
FOR SHALLOW WELLS AND  
SURFACE WATER  
PECONIC RIVER AREA FLOW NET STUDY  
NWIRP CALVERTON, NEW YORK

Analytical results did not indicate evidence that the Site 6A – Southern Area plume has migrated to this area. Similarly, a flow-net analysis of groundwater flow patterns suggests that the existing conceptual site model was correct, and that groundwater flows above the clay layer horizontally to the Peconic River and then discharges into the river. There is no evidence to suggest site contaminants are crossing to the south side of the river.

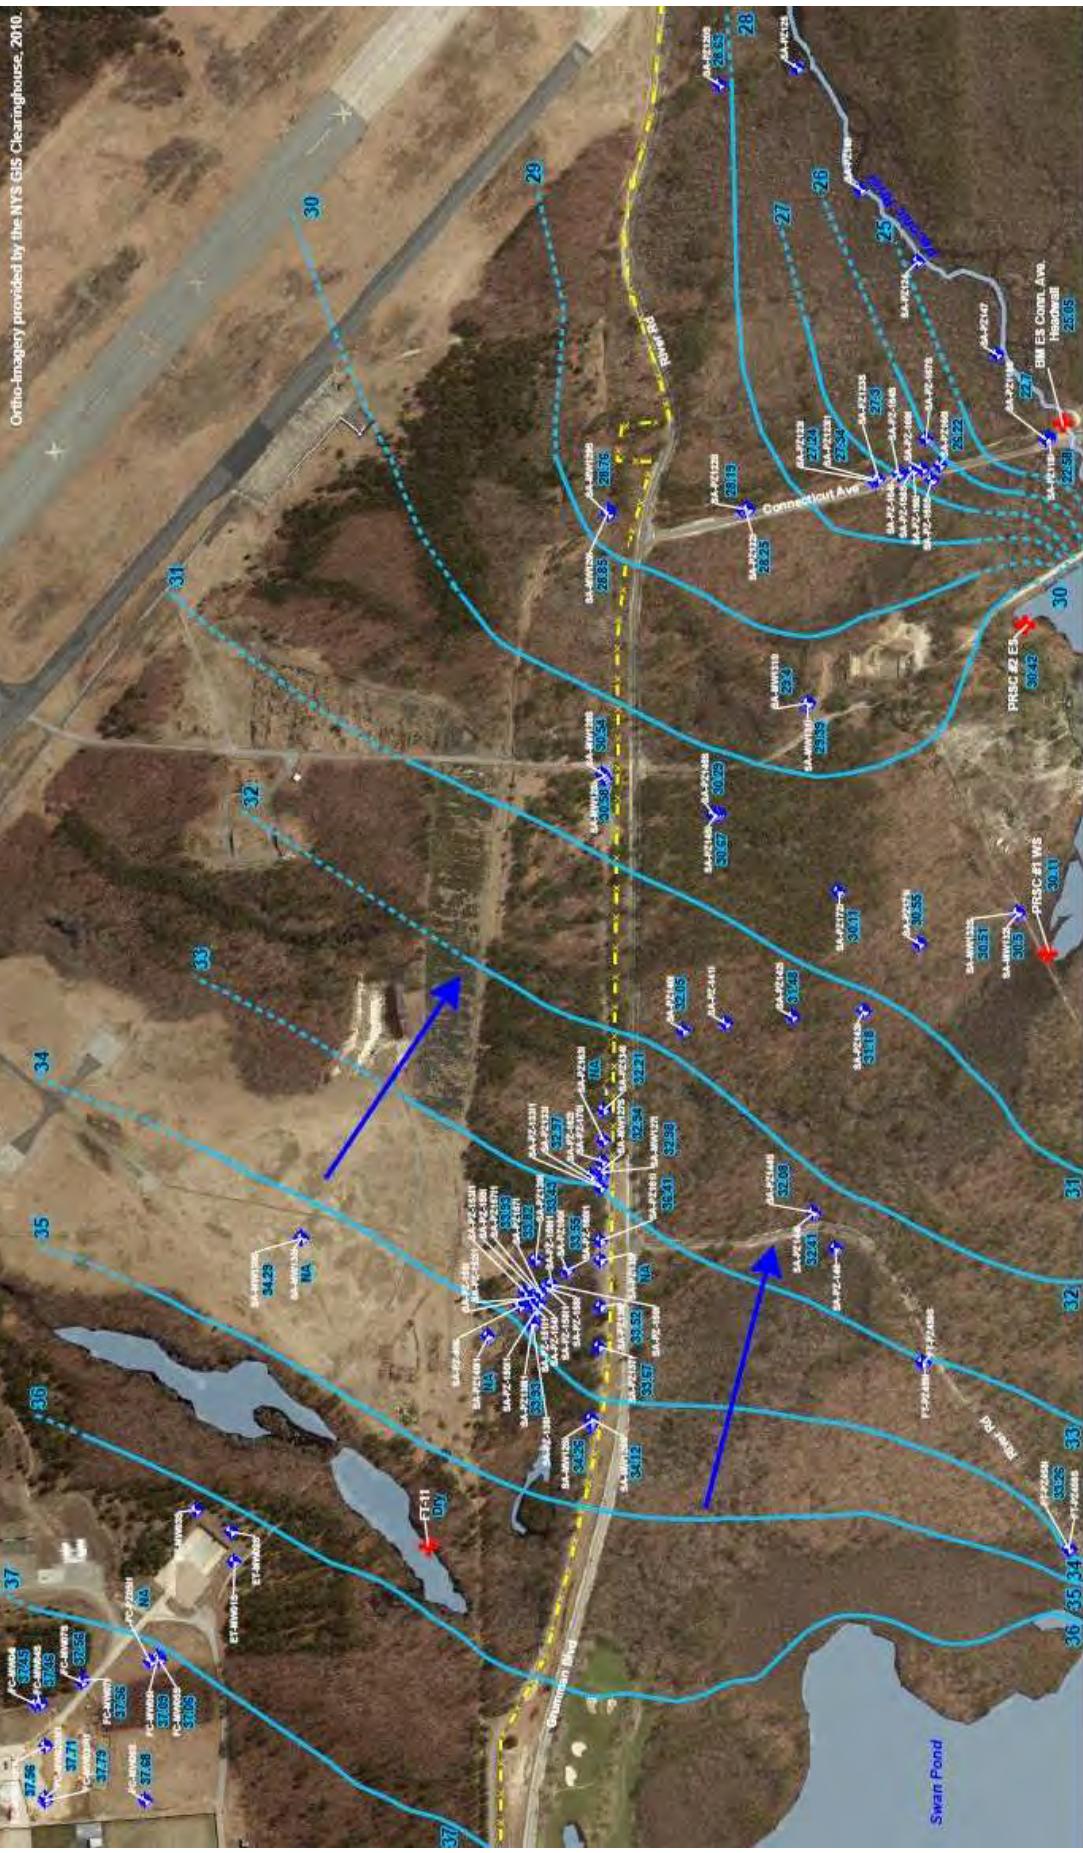
# Groundwater Flow (September 2012)

Mr. Forstner first reviewed figures showing the flow of groundwater and analytical results for Site 2. Generalized groundwater flow data for Site 2 indicate flow is to the southeast, consistent with previous observations. The groundwater elevation in September 2013 was found to be approximately one-half to one foot lower than that observed in September 2012. Regarding groundwater quality, trichloroethene (TCE) was detected at concentrations exceeding the MCL at two new monitor wells installed in 2013 (FT-MW09I and FT-MW10I), but at concentrations less than 10 µg/L. The 2013 groundwater data for Site 2 were otherwise generally consistent with 2012 results, and no MCLs were exceeded at any other on-property locations and most off-property locations. To the south and east of Swan Pond, however, TCE exceeded its MCL at two locations. Of particular note was FT-PZ460I, where a concentration of 370 µg/L was detected, consistent with an "anomaly" that has been seen at this location since it was first sampled in February 2012. Other VOCs also exceeded MCLs at this location, including DCA, 1,1-dichloroethene (DCE), 1,2-DCE and tetrachloroethene.

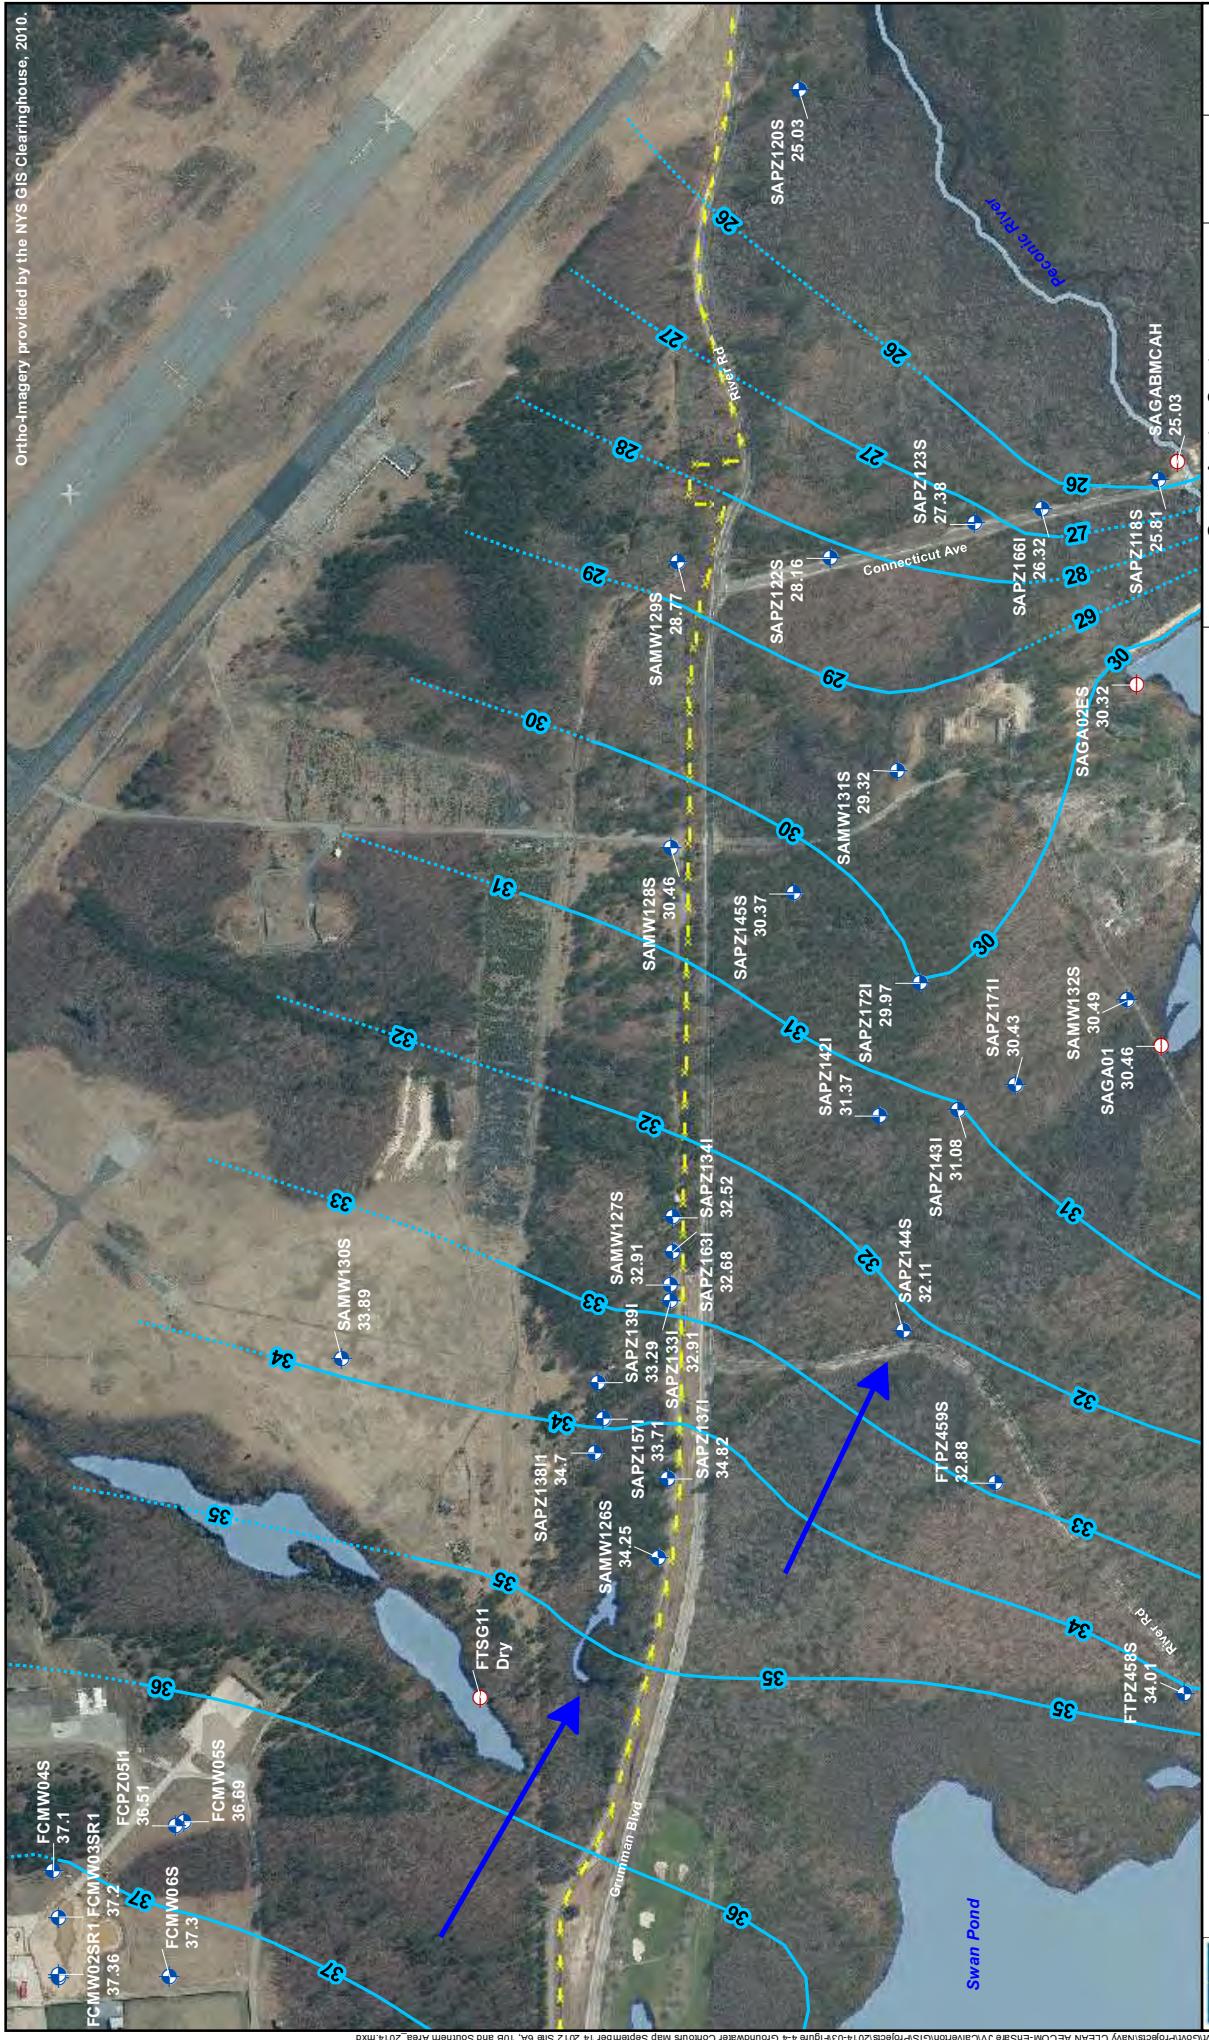
Grandview Control  
September 2013  
Site 6A and Southern Area  
NWIRP Calverton  
Calverton, New York

Mr. Forstner then moved on to figures showing results at Sites 6A/10B and the Southern Area. First, a figure summarizing the overall contaminant plume extending from Sites 6A/10B and the subareas it is divided into for discussion purposes was shown for orientation purposes. Similar to the groundwater flow data for Site 2, groundwater at Sites 6A/10B and the Southern Area generally flows to the southeast. Water levels to the northeast were found to be approximately one foot lower in elevation in 2013 than in 2012, but in the vicinity of the Peconic River water elevations in 2013 were generally similar to those observed in 2012. The review of the groundwater chemistry data then proceeded by subareas:
