MINUTES FROM THE 27 OCTOBER 2015 RESTORATION ADVISORY BOARD MEETING
NWIRP CALVERTON NY
3/30/2016
RESOLUTION CONSULTANTS

RESTORATION ADVISORY BOARD MEETING
NAVAL WEAPONS INDUSTRIAL RESERVE PLANT (NWIRP), CALVERTON
CALVERTON COMMUNITY CENTER, CALVERTON, NEW YORK
TUESDAY, OCTOBER 27, 2015

SITE 2 (FIRE TRAINING AREA) MUNITIONS RESPONSE

**SITE 6A - SOUTHERN AREA FENCE LINE
GROUNDWATER EXTRACTION TREATMENT SYSTEM**

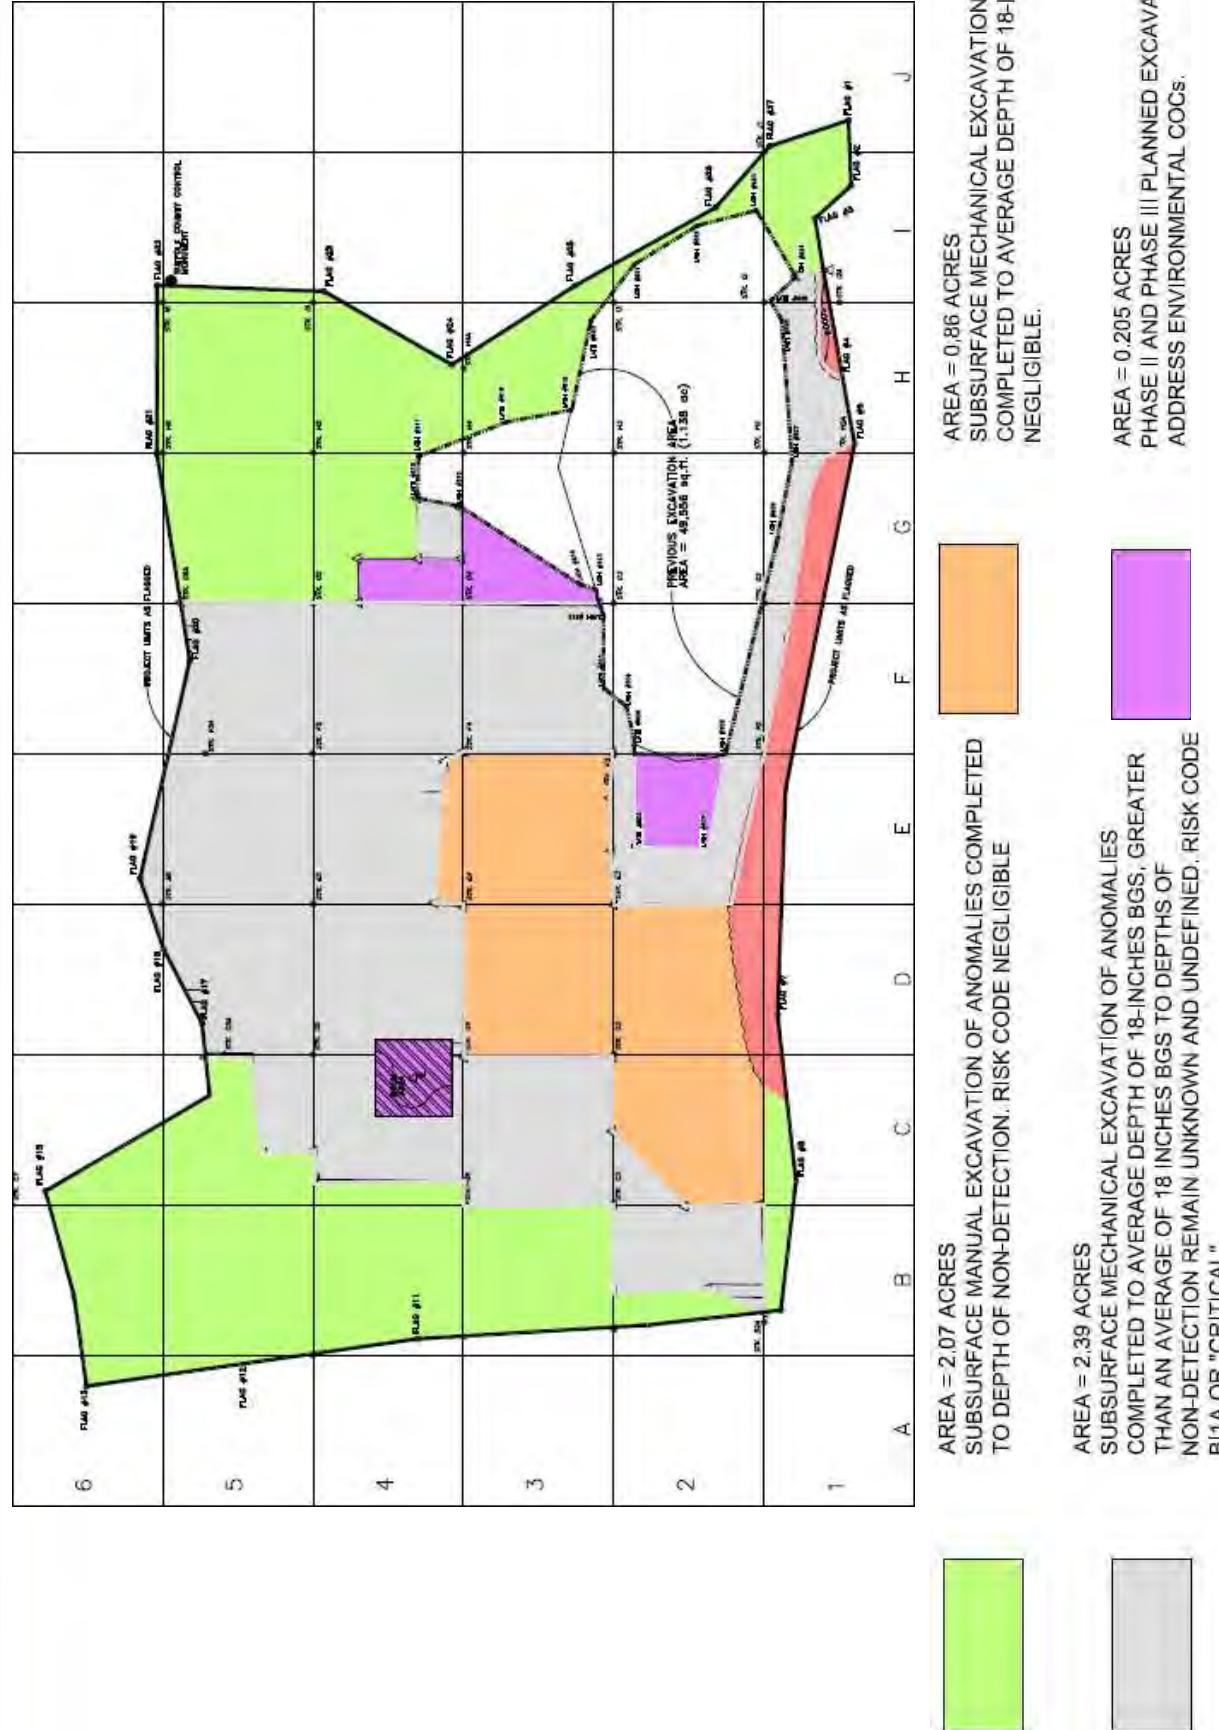
Site 2 Phase II and III Excavation Area

- Manual/mechanical excavation, screening and backfill
 - 6.9 acres approximately 12,500 cy³

- Remedial Action
 - Excavated potentially PCB- and petroleum-impacted soil (Grids C4, G4, G3, and E2)
 - Manual/mechanical excavation screening & backfill of 4,100 cy³ soil

Summaries of the various areas of excavation and quantities of MEC and Material Potentially Presenting an Explosive Hazard (MPPEH) handled during the 2012 and 2014 removal actions (identified as Phases II and III of the response, respectively) were presented. The most recent completed response action occurred between April and October 2014, and included munitions and environmental remedial activities. The munitions response operation used manual and mechanical screening to process approximately 4,100 cubic yards (CY) of soil. A total of 689 items classified as Material Designated as Safe (MDAS) were recovered and destroyed, and 323 items of MPPEH were destroyed in Phase III.

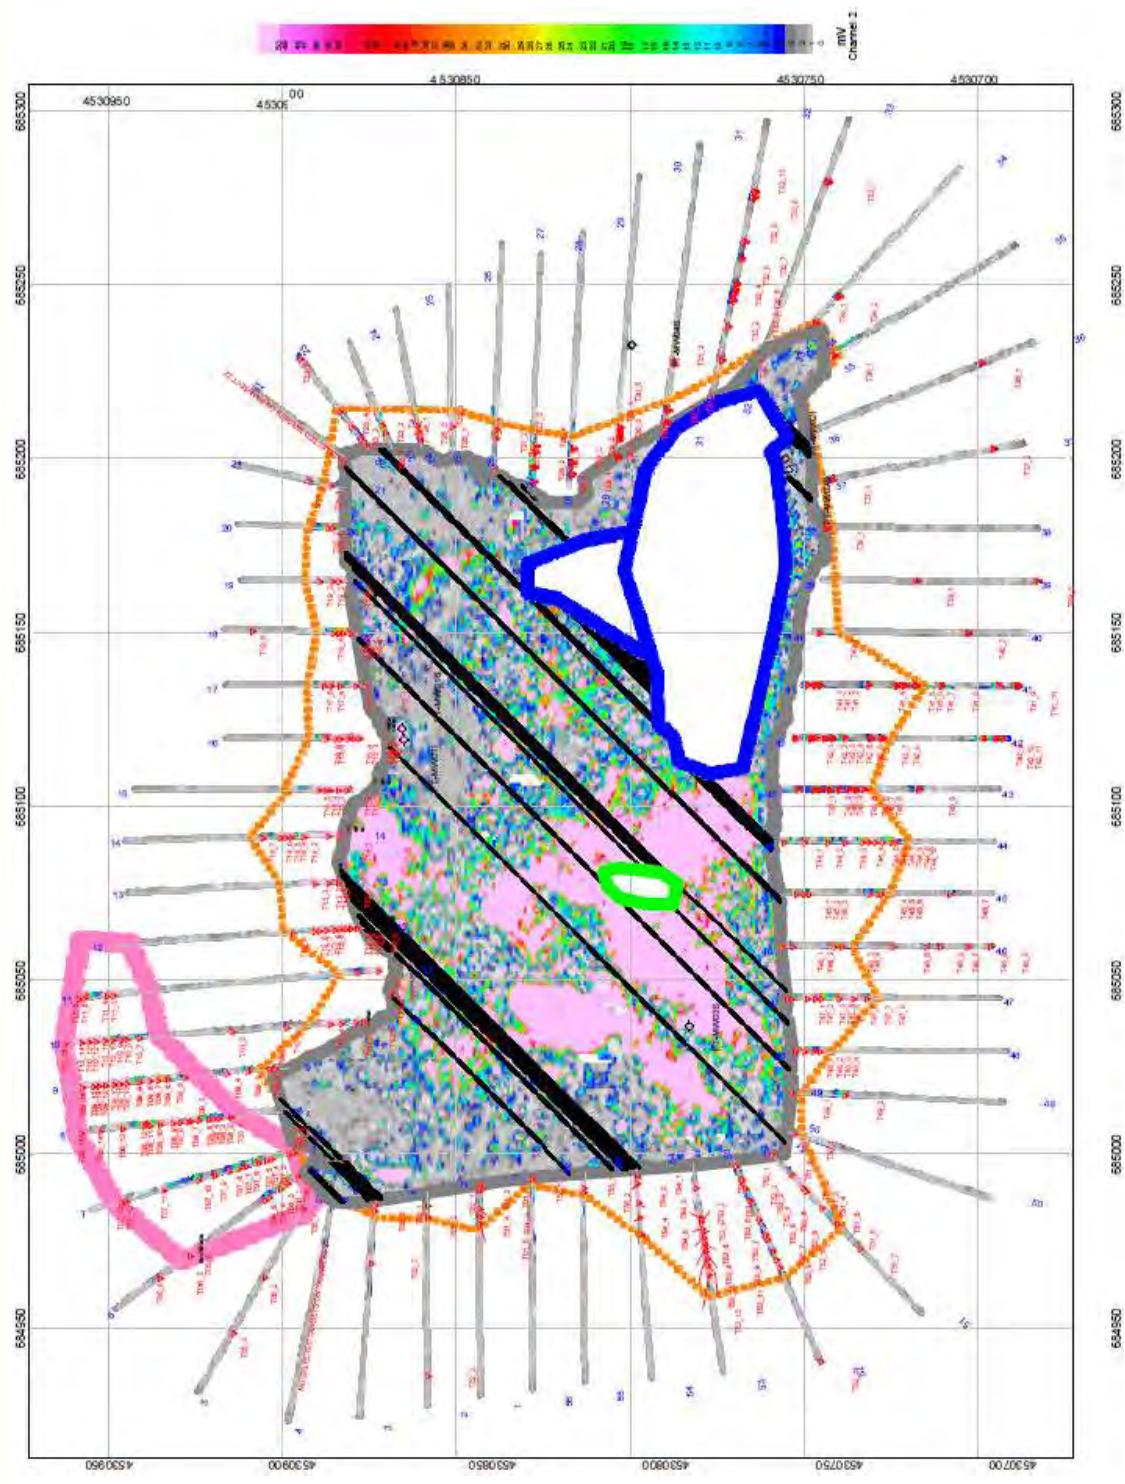
Site 2 Supplemental DGM Survey (2013)

- Supplemental DGM survey (2013)

The combined results of digital geophysical mapping (DGM) investigations (including the original full-coverage survey conducted in 2010 [referred to as Phase I of the response] and a supplemental survey conducted in 2013) were presented. Mr. Racaniello inquired as to the technology used to identify the individual targets and saturated areas shown in the DGM output; Mr. David Brayack (Tetra Tech) responded, indicating that magnetometer responses are the basis for the DGM mapping.

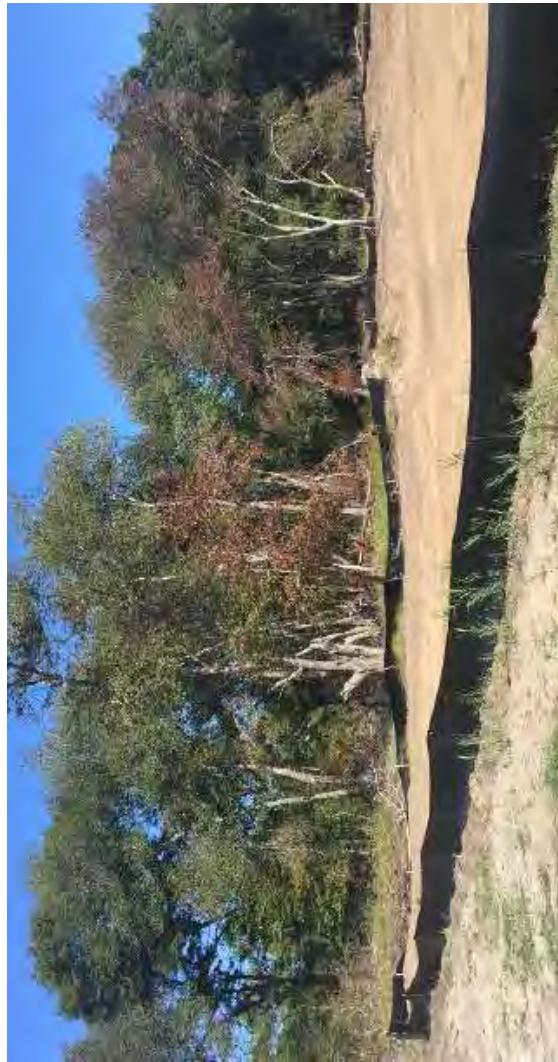
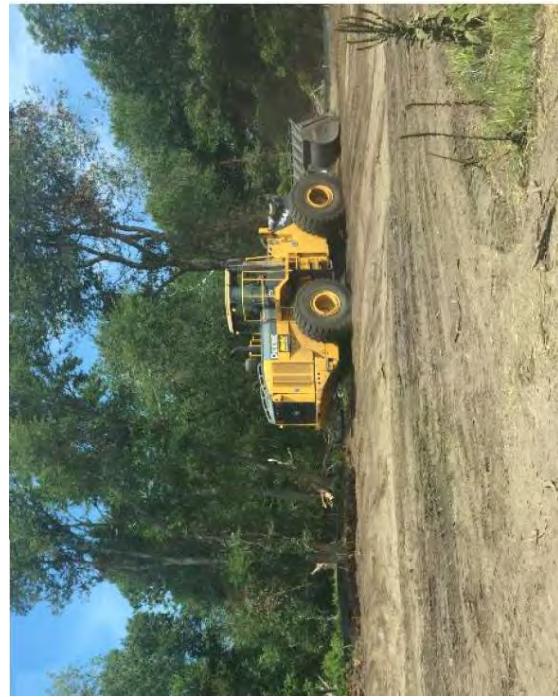
Overs - Material > 3/4" spread and screened by UXO Tech

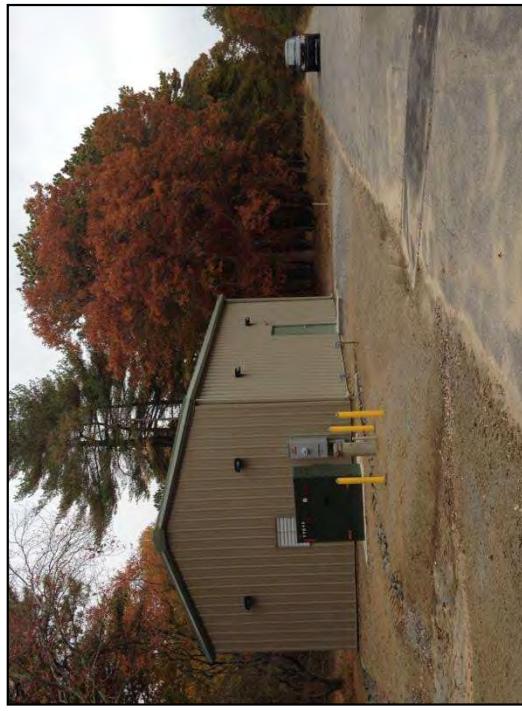
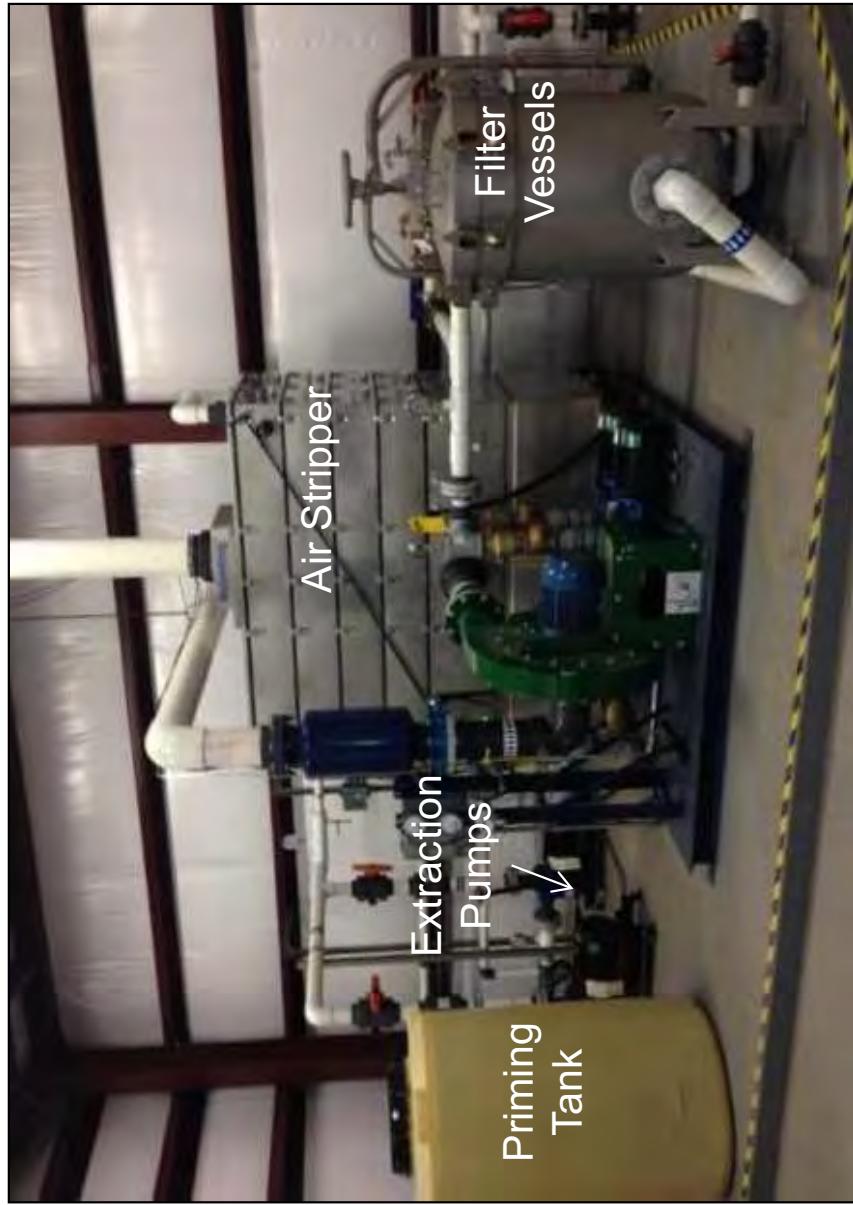
Treatment Plant Building

System Components

The FLTS system employs two extraction wells, air stripping equipment, and two infiltration galleries in order to control the VOC plume. Construction started in October 2012 and was completed in October 2013, and system start-up occurred on October 8, 2013.

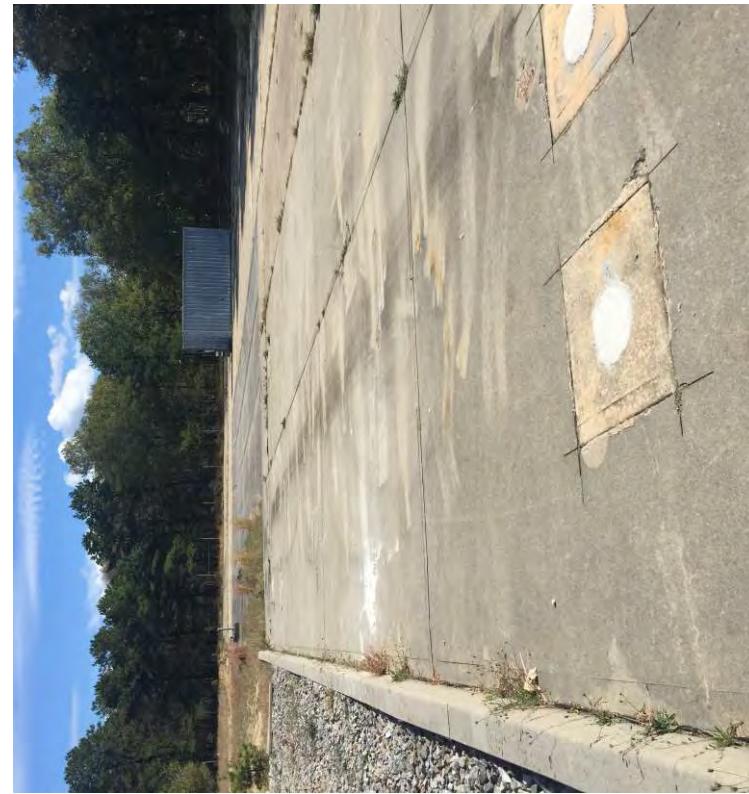
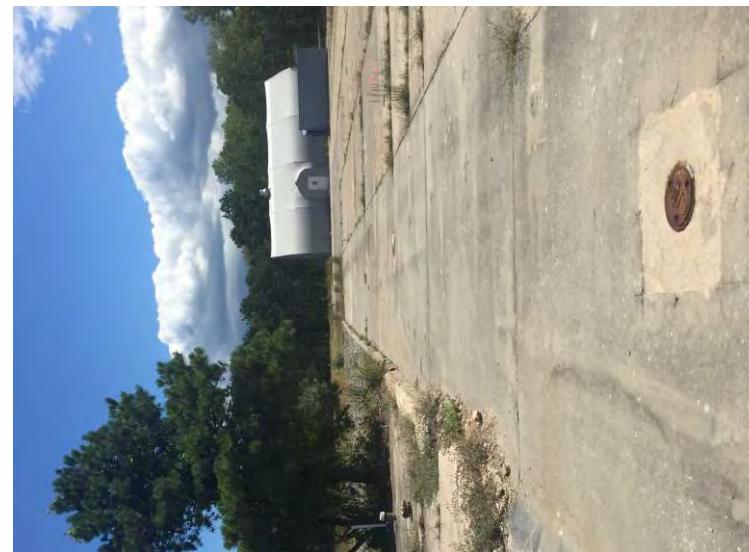
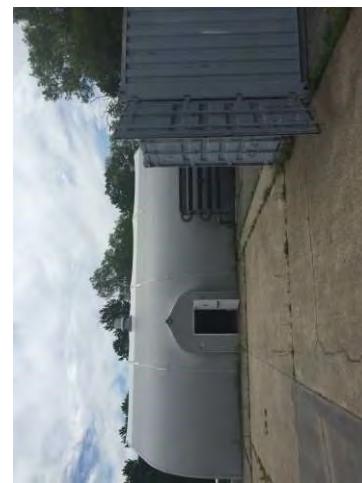
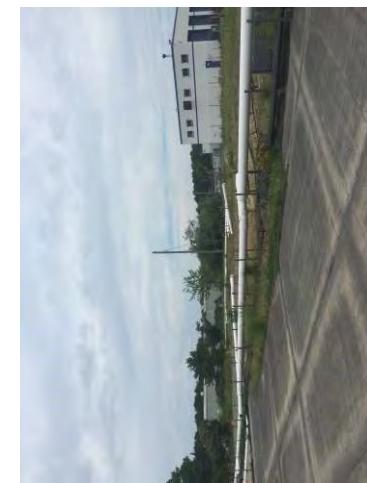
- Contractor mobilized August 10, 2015
- Piping removed and wells decommissioned during first week
- Fabric structure repurposed for a museum
- All other material decontaminated and recycled or disposed

Mr. Robert Forstner (Resolution Consultants) then described the decommissioning of the AS/SVE system and the path forward for the site. The demolition contractor mobilized to the site on August 10, 2015, and completed removal of piping and abandonment of wells during the first week of site work. The equipment within the fabric structure was removed and all material was decontaminated and recycled or disposed. The fabric structure itself was repurposed by the manufacturer for reuse by a museum. Photographs indicating the progress of the work, including the final site condition, were shown. A construction completion report from the contractor was pending. Regarding future work, additional action in the form of in-situ remediation was considered likely. Further analysis of options and contracting were underway, with implementation targeted for 2016.

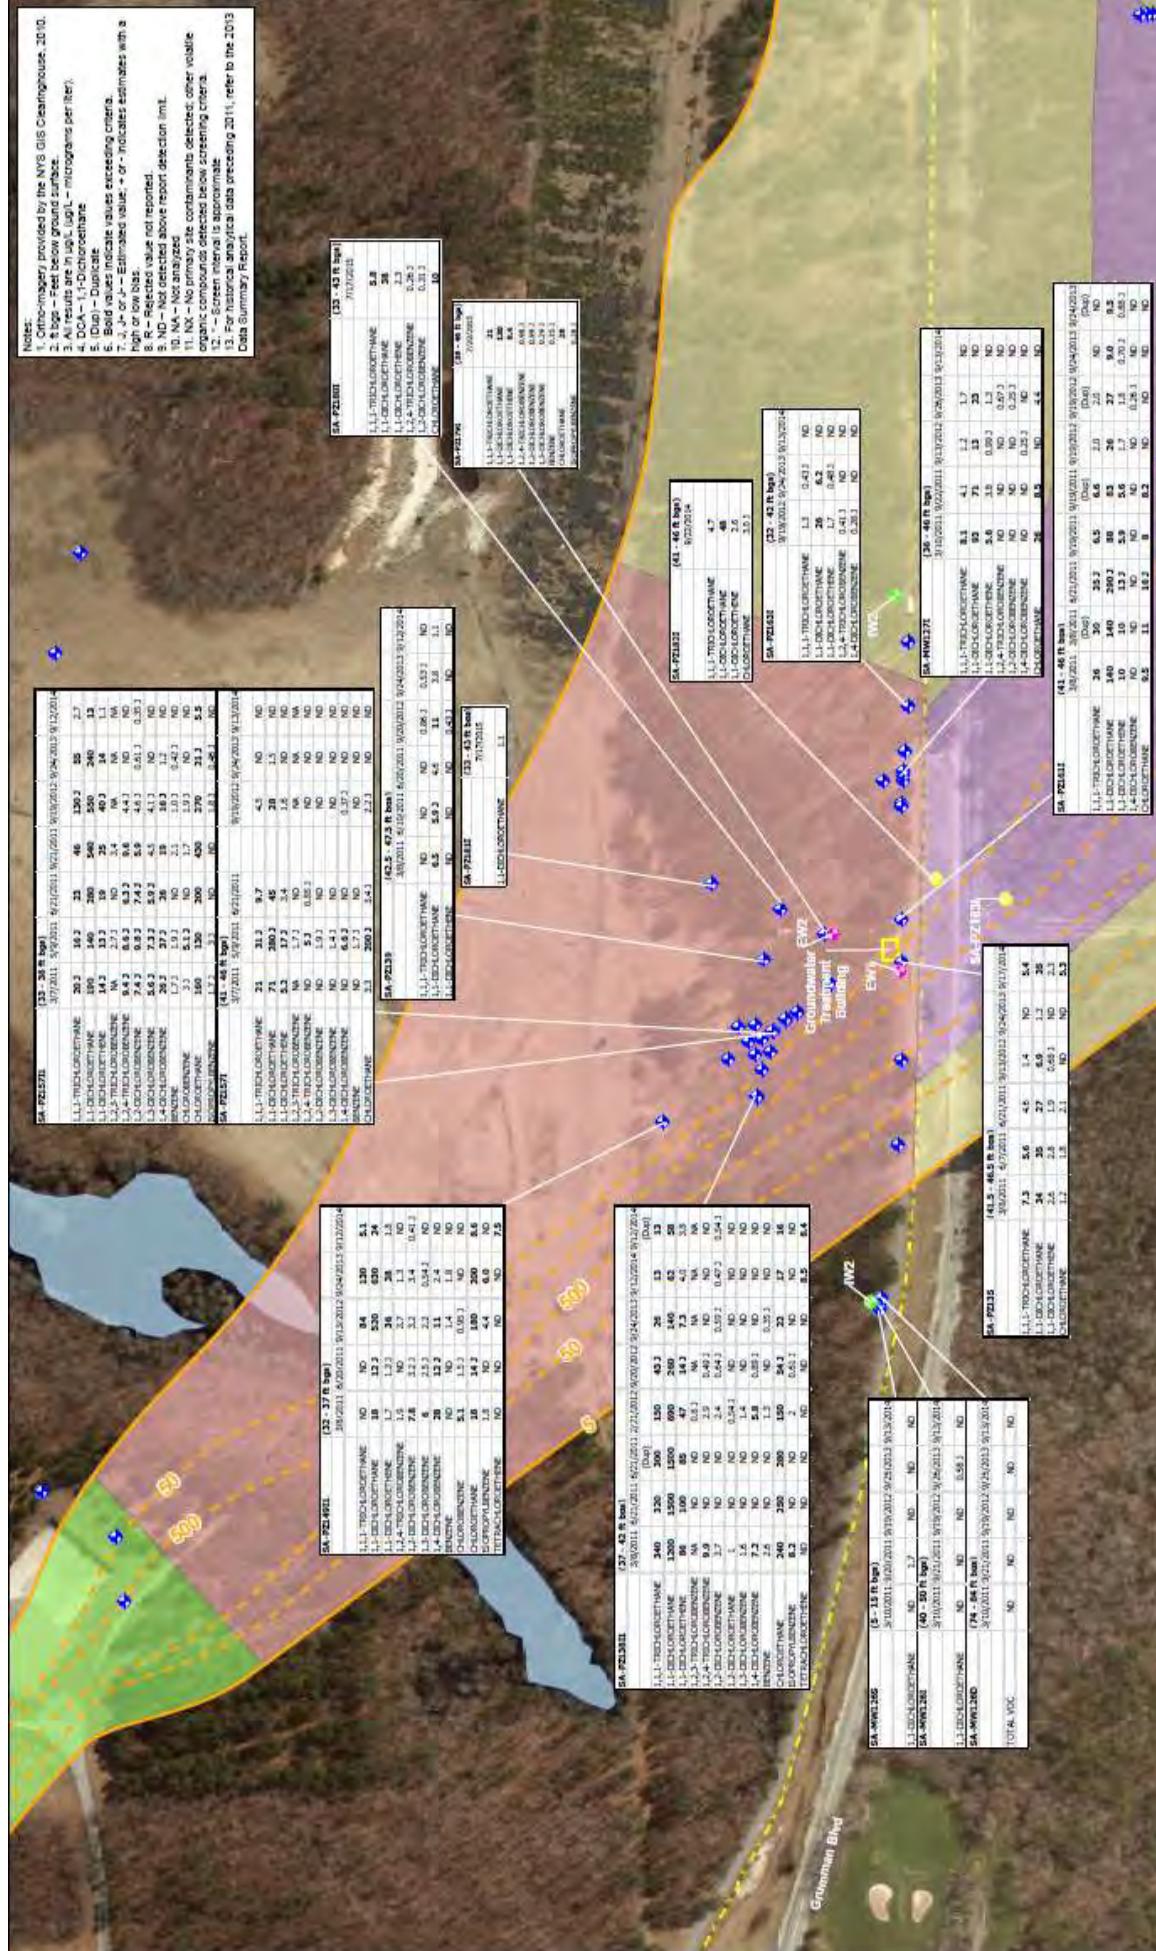
Fence Line Area Results

- Results at SA-PZ179I through SA-PZ181I confirm plume still in this general area
- 1,1-DCA found at all three locations; exceeded MCL at two locations

Supplemental samples were collected from three locations in the Southern Area for use in optimizing the location of the new FLTS extraction well. Piezometers SA-PZ179I, SA-PZ180I and SA-PZ181I were sampled for the first time in July 2015 (previously, these locations were used for gauging purposes only to evaluate the capture zone of the FLTS). Although VOCs were detected at SA-PZ181I (the northernmost of the three locations), none exceeded their MCL. VOC concentrations at the other two locations exceeded MCLs for at least three VOCs. At SA-PZ180I, VOCs exceeding MCLs included 1,1,1-trichloroethane (5.8 µg/L), 1,1-dichloroethane (38 µg/L) and chloroethane (10 µg/L). At SA-PZ179I, VOCs exceeding MCLs included 1,1,1-trichloroethane (21 µg/L), 1,1-dichloroethane (130 µg/L), 1,1-dichloroethene (8.4 µg/L) and chloroethane (28 µg/L). Based on the results of these supplemental samples, it was concluded that locating the replacement extraction well north of the existing EW-2 would optimize VOC recovery and treatment.
