RESTORATION ADVISORY BOARD MEETING NAVAL WEAPONS INDUSTRIAL RESERVE PLANT (NWIRP), CALVERTON RIVERHEAD SENIOR CENTER, RIVERHEAD, NEW YORK TUESDAY, NOVEMBER 13, 2018

TECHNICAL PROGRESS – SITE 7 FUEL DEPOT UPDATE

TECHNICAL PROGRESS - SITE 6A SOUTHERN AREA FENCELINE GROUNDWATER EXTRACTION TREATMENT SYSTEM OVERVIEW

TECHNICAL PROGRESS – POLY- AND PERFLUOROALKYL SUBSTANCES (PFAS) SITE 2 AND AIRCRAFT PAINT HANGAR SITE INSPECTION (SI), FACILITY WIDE PRELIMINARY ASSESSMENT (PA), AND COMMUNITY RELATIONS

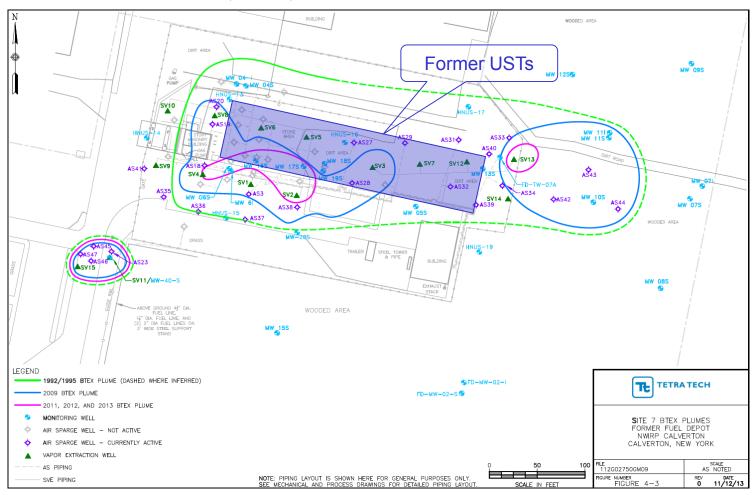
1992/1995, 2009, and 2011 to 2013 Plume Boundaries

System Performance

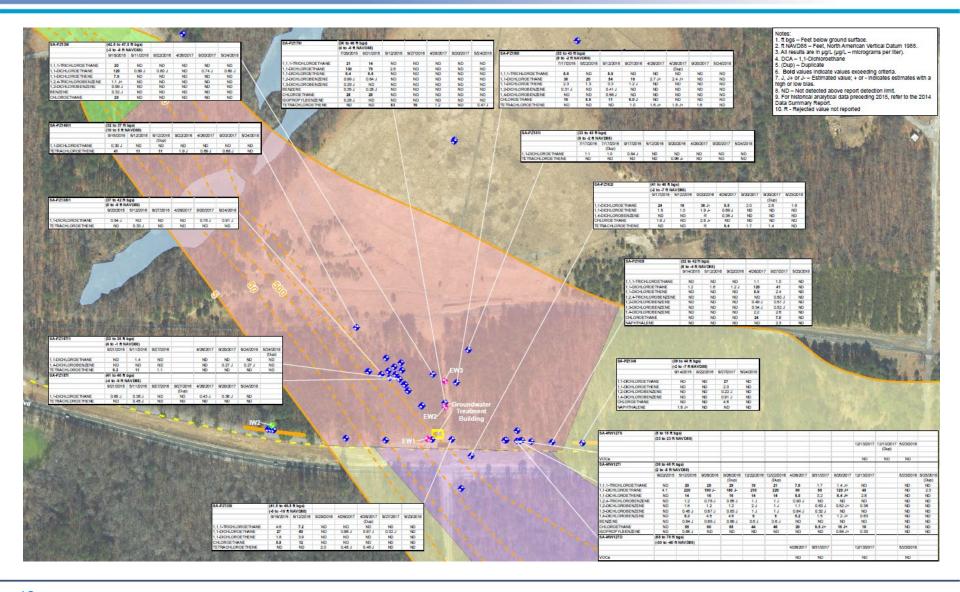
Fence Line Area – Spring 2018

Of the 15 groundwater samples collected from the Fence Line Area, no MCLs were exceeded. In addition, no VOCs were detected in 10 of the 15 groundwater samples. Of the four surface water samples, two in-river porewater locations, and two piezometers samples collected from the Peconic River area, no operable unit (OU) 3 Remedial Design Benchmarks were exceeded, and VOCs were not detected in the surface water samples.

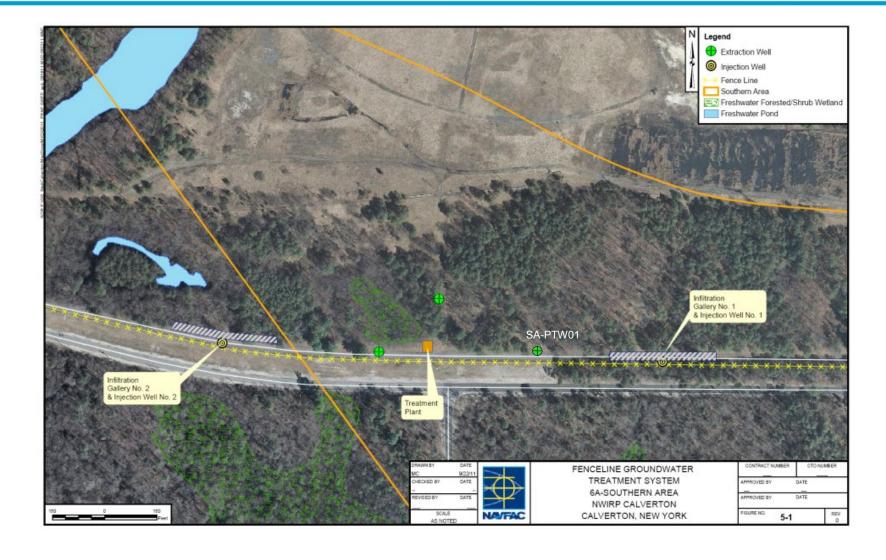
Fence Line Treatment System Overview

- Record of Decision in May 2012.
- Selected remedy for Fence Line Area Land use controls and monitoring with extraction, treatment, and infiltration. System started up on 8 October 2013.
- Fence Line Treatment System (FLTS) overview:
 - Four extraction wells (EW-1, EW,2, EW-3 and SA-PTW1), design capacity up to 100 gpm.
 - Volatile Organic Compounds (VOCs) removed via air stripping -Treated groundwater injected into subsurface meeting Maximum Contaminant Levels (MCLs).
- Pumping at EW1/EW-2/EW-3 suspended as VOC concentrations are below MCLs.
- SA-PTW1 temporary connection to FLTS in July 2017 to treat persisting VOCs in the vicinity of nearby well SA-MW127I.

The FLTS system uses extraction wells, air stripping equipment, and infiltration galleries, in order to control the VOC plume. Construction started in October 2012 and was completed in October 2013, and system start-up occurred on October 8, 2013. To address declining productivity in extraction well EW-2, it was taken off-line and well EW-3 was brought on-line in February 2016. In order to address persistent VOC concentrations observed in the vicinity of SA-MW127I, the FLTS was temporarily connected to an existing, adjacent pump test well (SA-PTW1) in July 2017, and pumping at EW-1 and EW-3 was suspended since VOC concentrations were below maximum contaminant levels (MCLs).

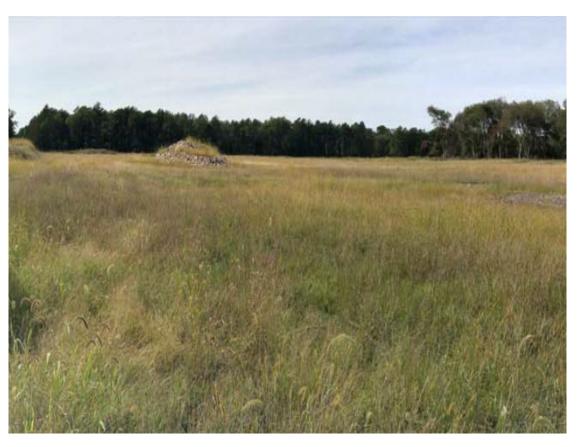
- Used as an active Fire Training Area from the 1950's until 1996
- Aqueous Film Forming Foams (AFFF) used to extinguish fires
- PFAS was used to manufacture AFFF from the 1960's to 2001

Looking west northwest

- 28 Monitoring wells tested at the Site 2 monitoring well network
- 4 On-property
 monitoring wells had
 at least one
 groundwater sample
 with an exceedance
 of the EPA drinking
 water Lifetime
 Health Advisories
- Moderate concentrations noted near and downgradient of the former Fire Training Area

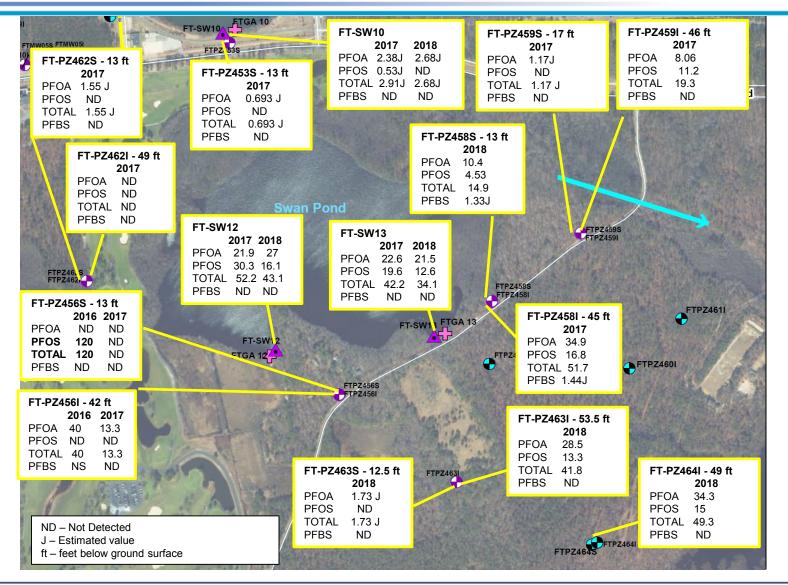
Site 2 – Former Fire Training Area PFAS Results (ng/L)

One offproperty monitoring well in 2016, had an exceedance of the EPA drinking water Lifetime Health Advisories

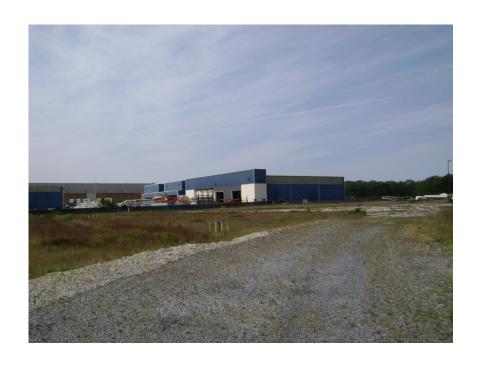
- Aircraft paint hangars north and west of Site 6A were identified as having fire suppression systems that contained AFFF
- 1980's: The AFFF deluge system was tested
- Hangars were equipped with trough drains, which would have routed water/material to an Industrial Waste Treatment Plant (IWTP)
- AFFF could have flowed through drainage swales at Site 6A or discharged to McKay Lake

Looking northwest

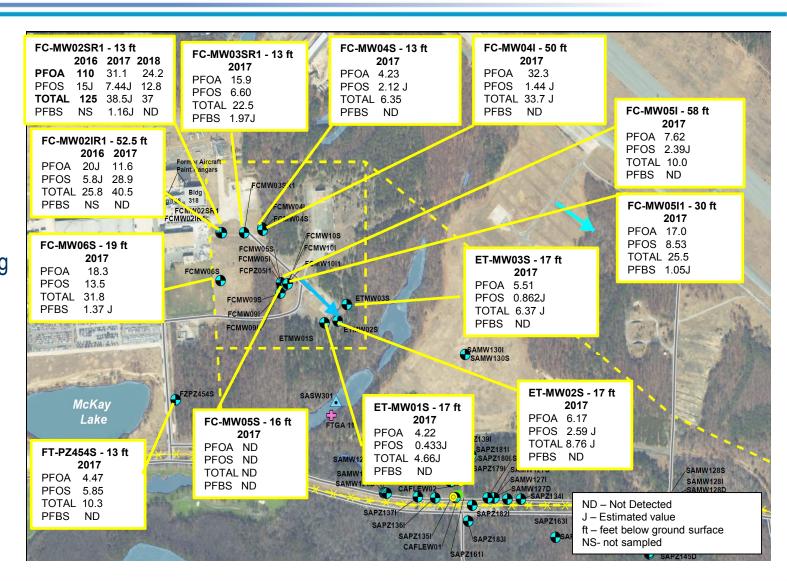
Aircraft Paint Hangars On-Property PFAS Results (ng/L)

- 33 Monitoring wells tested at the Site 6A monitoring well network
- One monitoring well exceeded the EPA drinking water Lifetime Health Advisories in 2016, but is below the advisories in 2017 and 2018

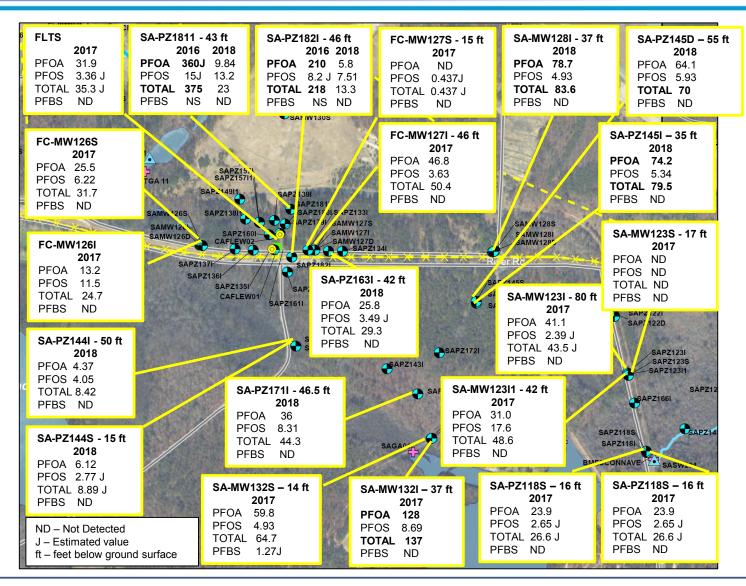
Aircraft Paint Hangars On-Property PFAS Results (ng/L)

• 6 Monitoring wells at the fence line and off-property had at least one groundwater sample with an exceedance of the EPA drinking water Lifetime Health Advisories

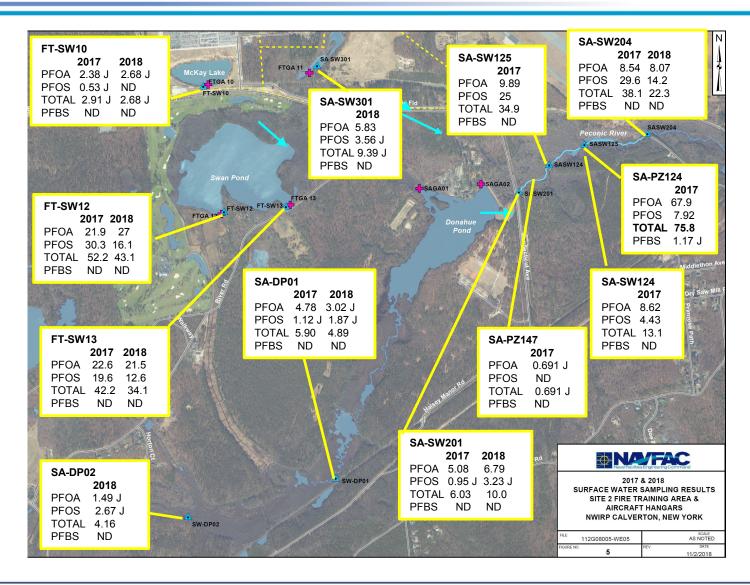
Site 2 and Aircraft Paint Hangars Surface Water

- 10 Surface water sample locations and 2 pore water sample locations
- All results are below the calculated surface water screening value
- 1 Pore water sample exceeds the EPA drinking water Lifetime Health Advisories
