Site Management Plan
Fiscal Years 2023-2024

Naval Weapons Station Yorktown Cheatham Annex
Williamsburg, Virginia

December 2022

Prepared for NAVFAC Mid-Atlantic
by CH2M HILL, Inc.
Virginia Beach, Virginia
Contract N62470-16-D-9000
CTO 5692

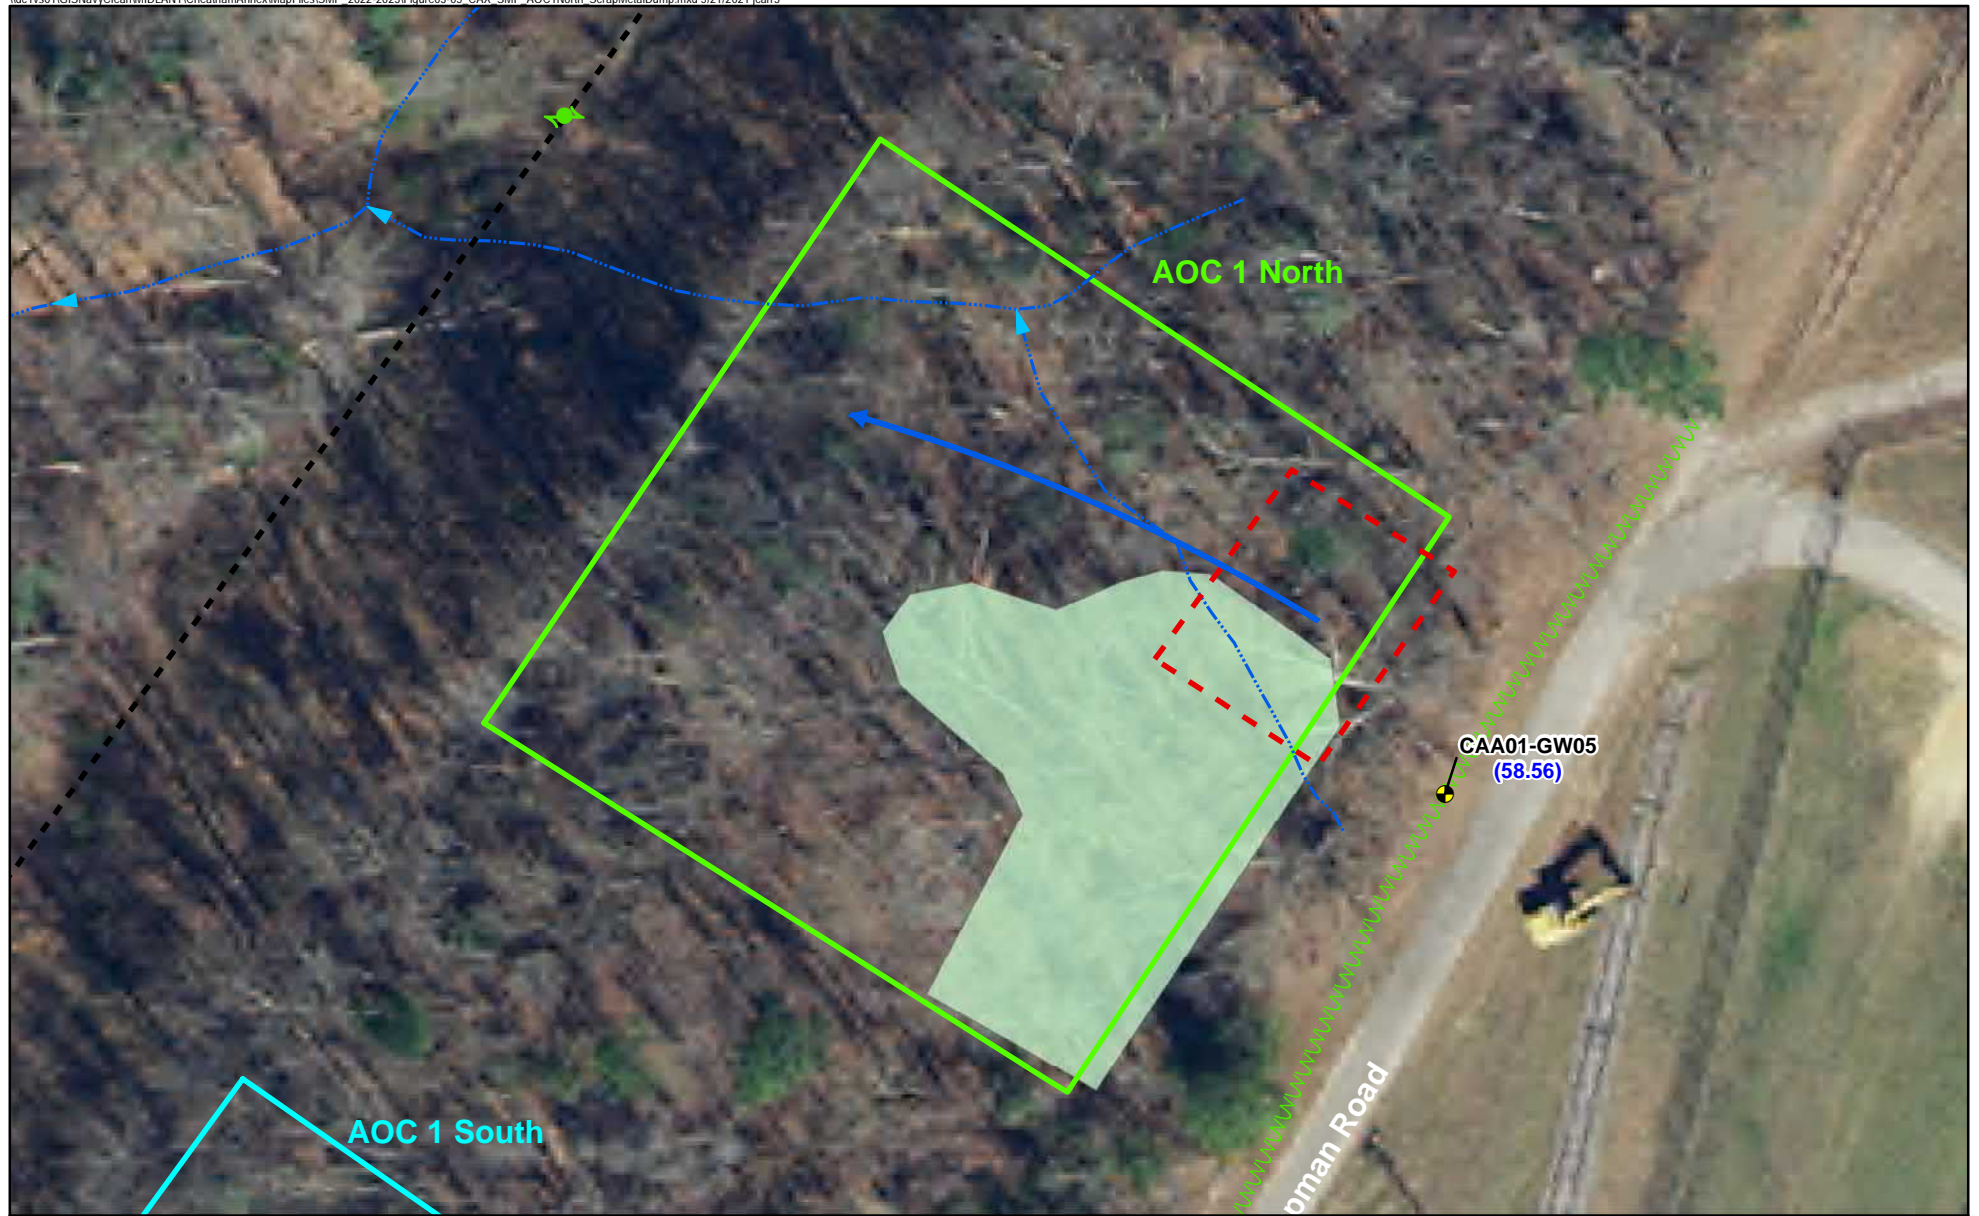
Figure 3-4
Site 9 - Transformer Storage Area
Site Management Plan
Cheatham Annex
Williamsburg, Virginia

Site 9 is a former transformer storage area. Between 1973 and 1980, electrical transformers, some of which contained PCBs, were reportedly stored at the site for repair or disposal. The storage area was not paved; however, it was enclosed by an earthen wall. Transformers were not stored at the site after 1980, and the area was graded and covered with gravel. The IAS described Site 9 as approximately 7,000 square feet (ft²) in size and located adjacent to the northwest corner of CAD 16. However, a closer look at soil waste characterization sample results for an intended, but canceled, MILCON project between CADs 6 and 16, and a subsequent interview with a long-term CAX employee, revealed that the transformer storage area was located adjacent to the northwest corner of CAD 6. Apparently, transformers and electronic components were brought on-site, crushed, and loaded onto rail cars for disposal. The activities the employee described are consistent with apparent objects and activities in between CADs 6 and 16 shown in historic aerial photos, such as heavy equipment, components/debris scattered about, ground scarring, and nearby railroad tracks. Based on this new information, the Site 9 Study Area Boundary was updated to include the area between CADs 6 and 16 (**Figure 3-4**). The original Site 9 Study Area Boundary (adjacent to the northwest corner of CAD 16) is also shown on **Figure 3-4**, since a number of studies have been conducted there, and the best approach to close that area needs to be determined. A summary of the relevant document and action milestones is below.

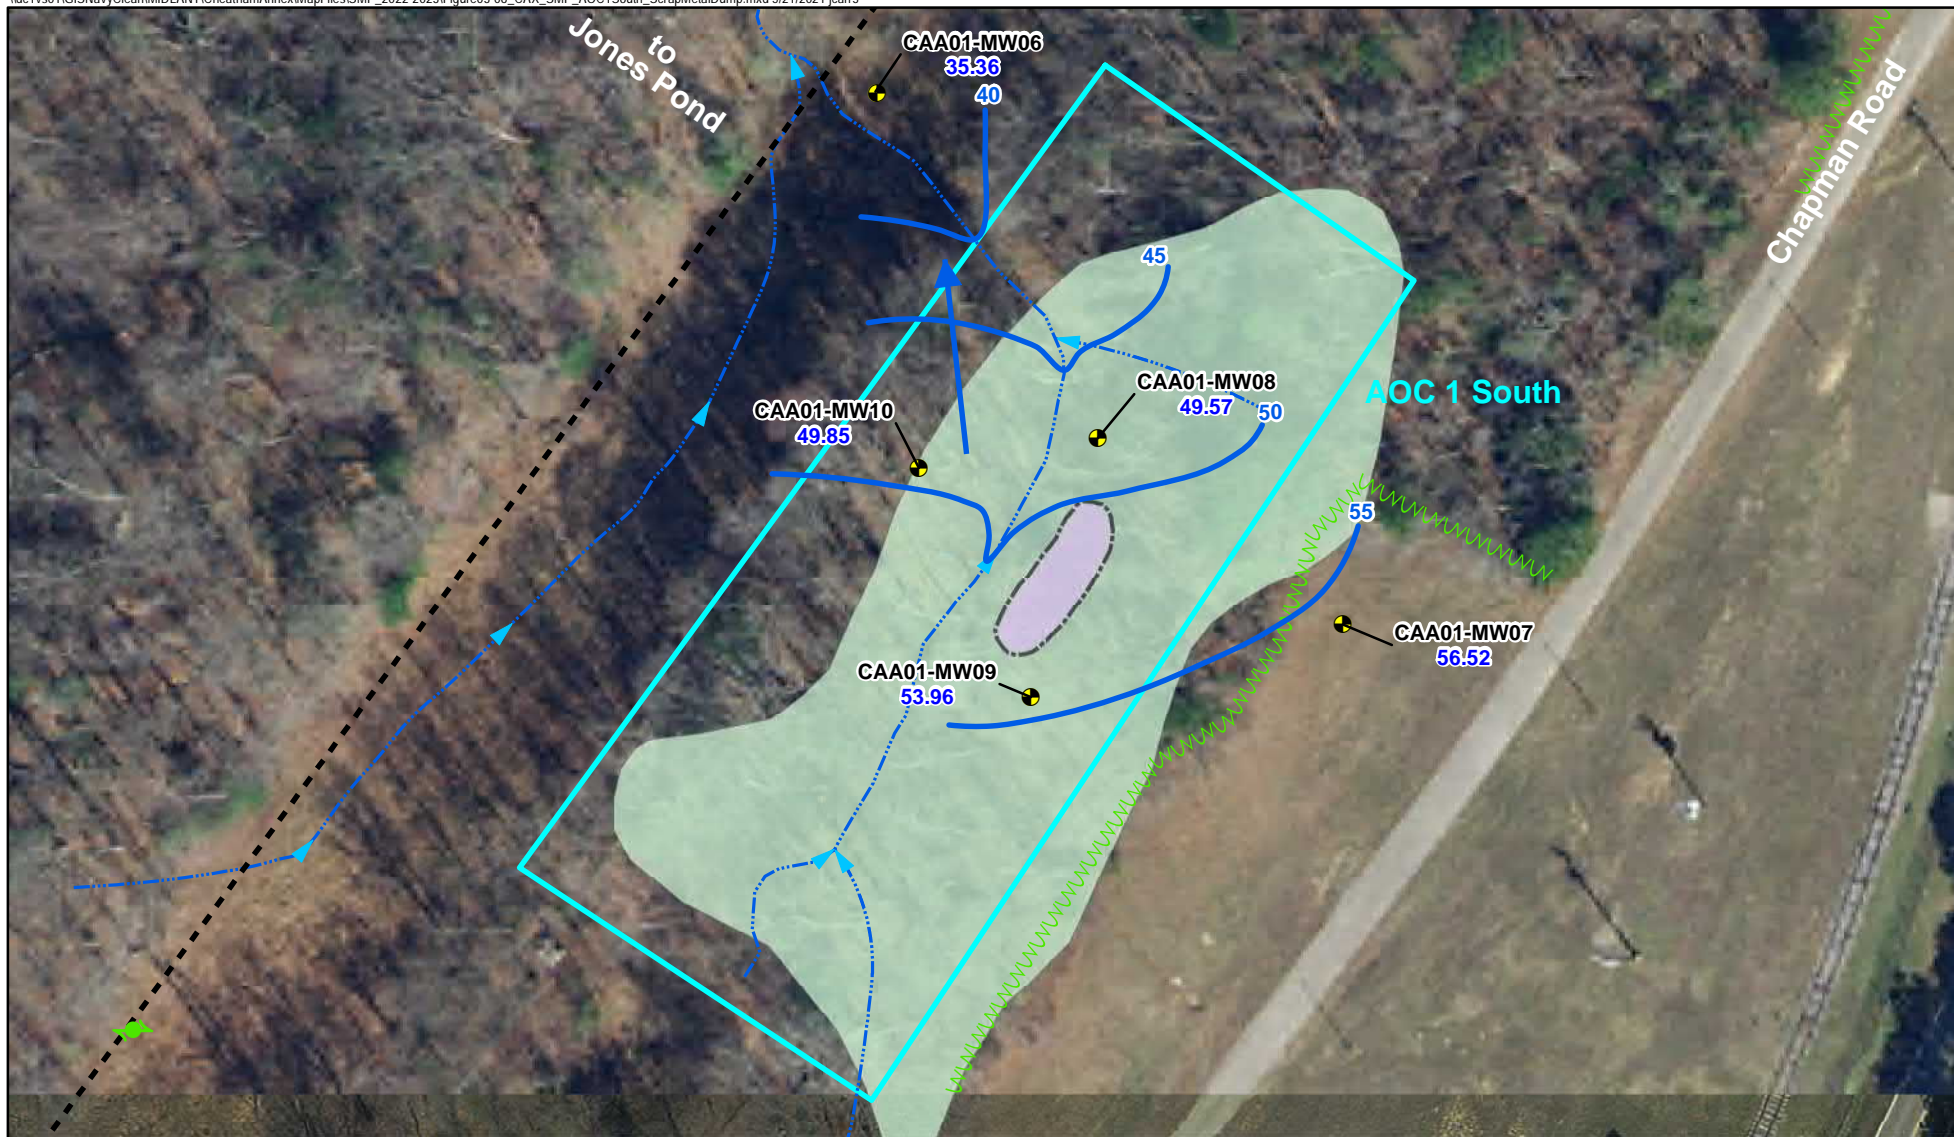
Figure 3-6
AOC 1 South - Scrap Metal Dump
Site Management Plan
Cheatham Annex
Williamsburg, Virginia

53.96 - Groundwater Elevation (ft amsl)
Imagery: Virginia Commonwealth, 2017

Debris Debris observed at AOC 1 South consisted primarily of piles of concrete, empty 55-gallon, rusted drums, and a large surface pile of metal debris.

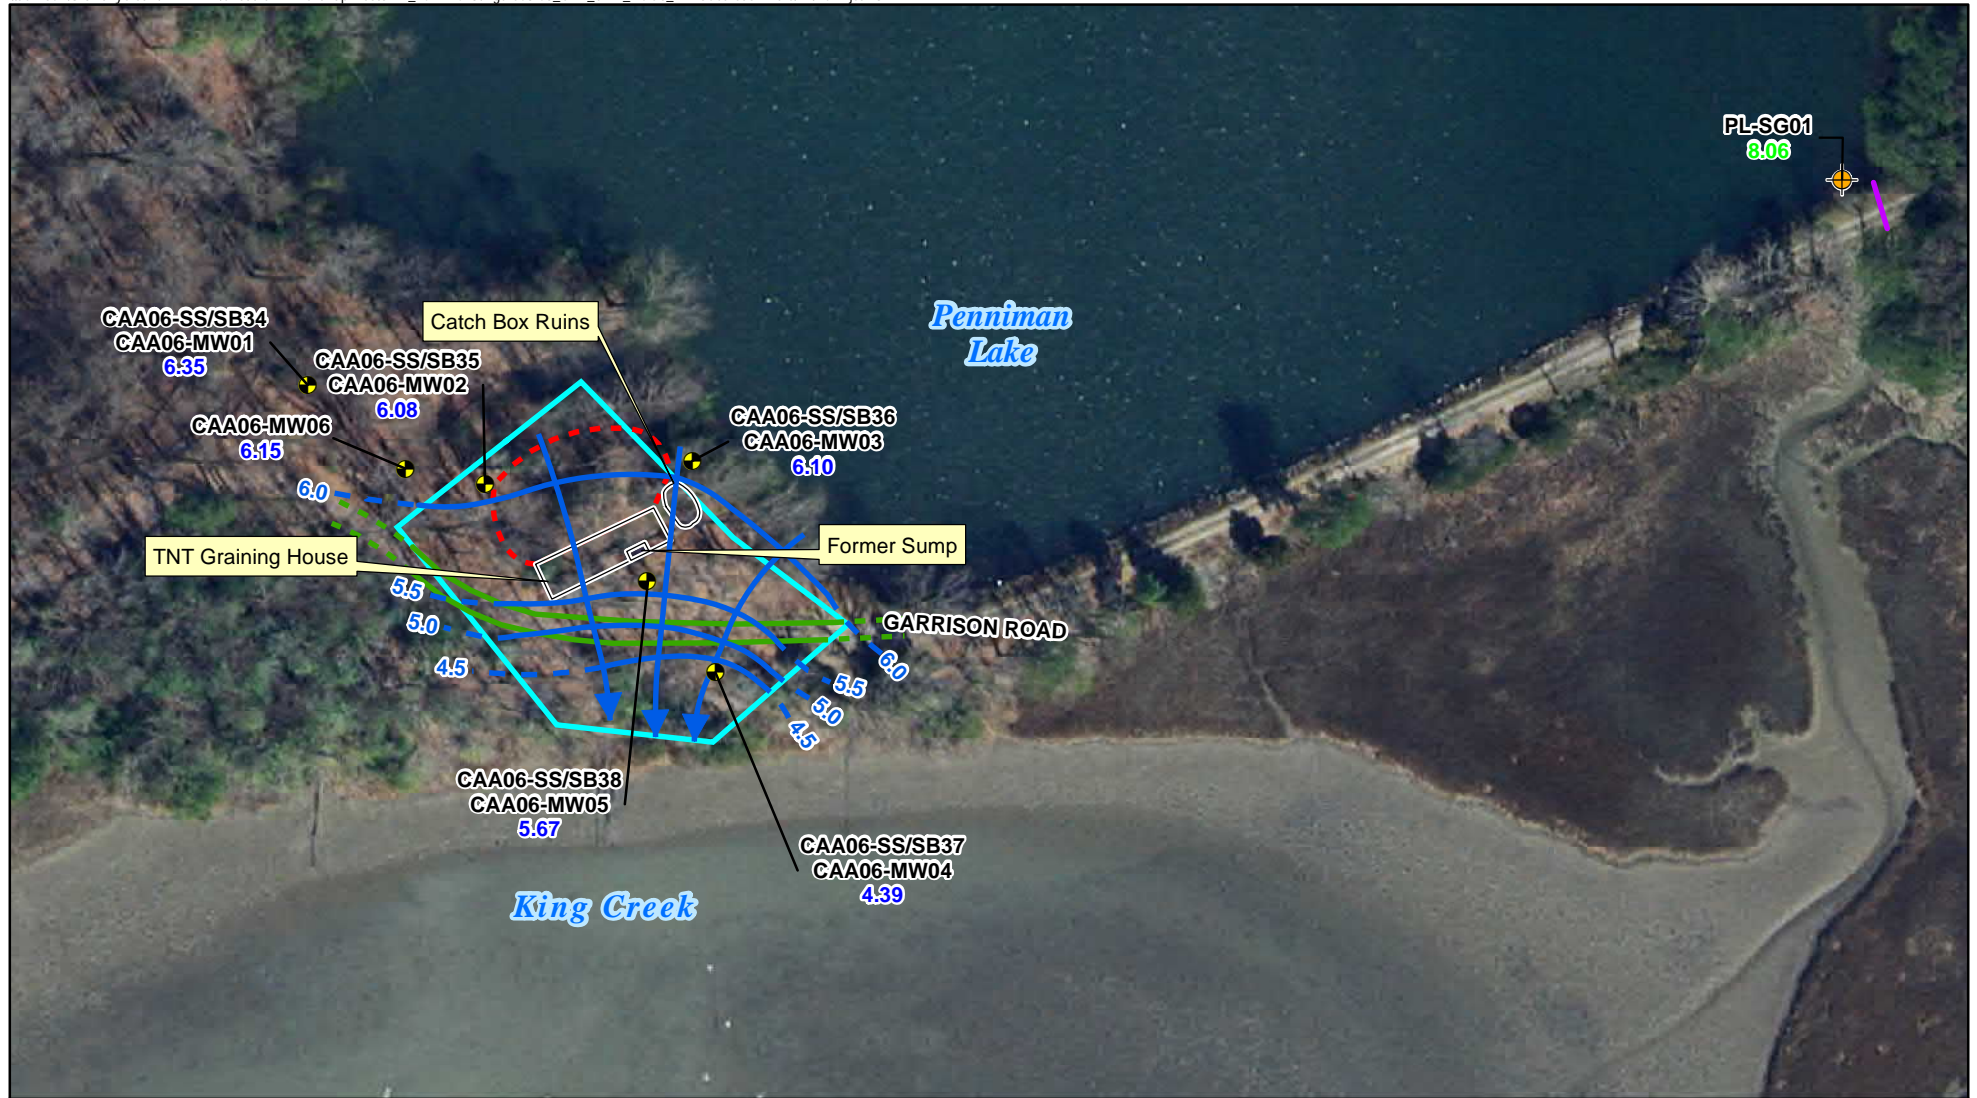
Figure 3-8
AOC 6 - TNT Subareas
Site Management Plan
Cheatham Annex
Williamsburg, Virginia

6.15 - Groundwater Elevation (ft amsl)
8.06 = Surface Water Elevation (ft amsl)
Imagery: Virginia Commonwealth, 2017

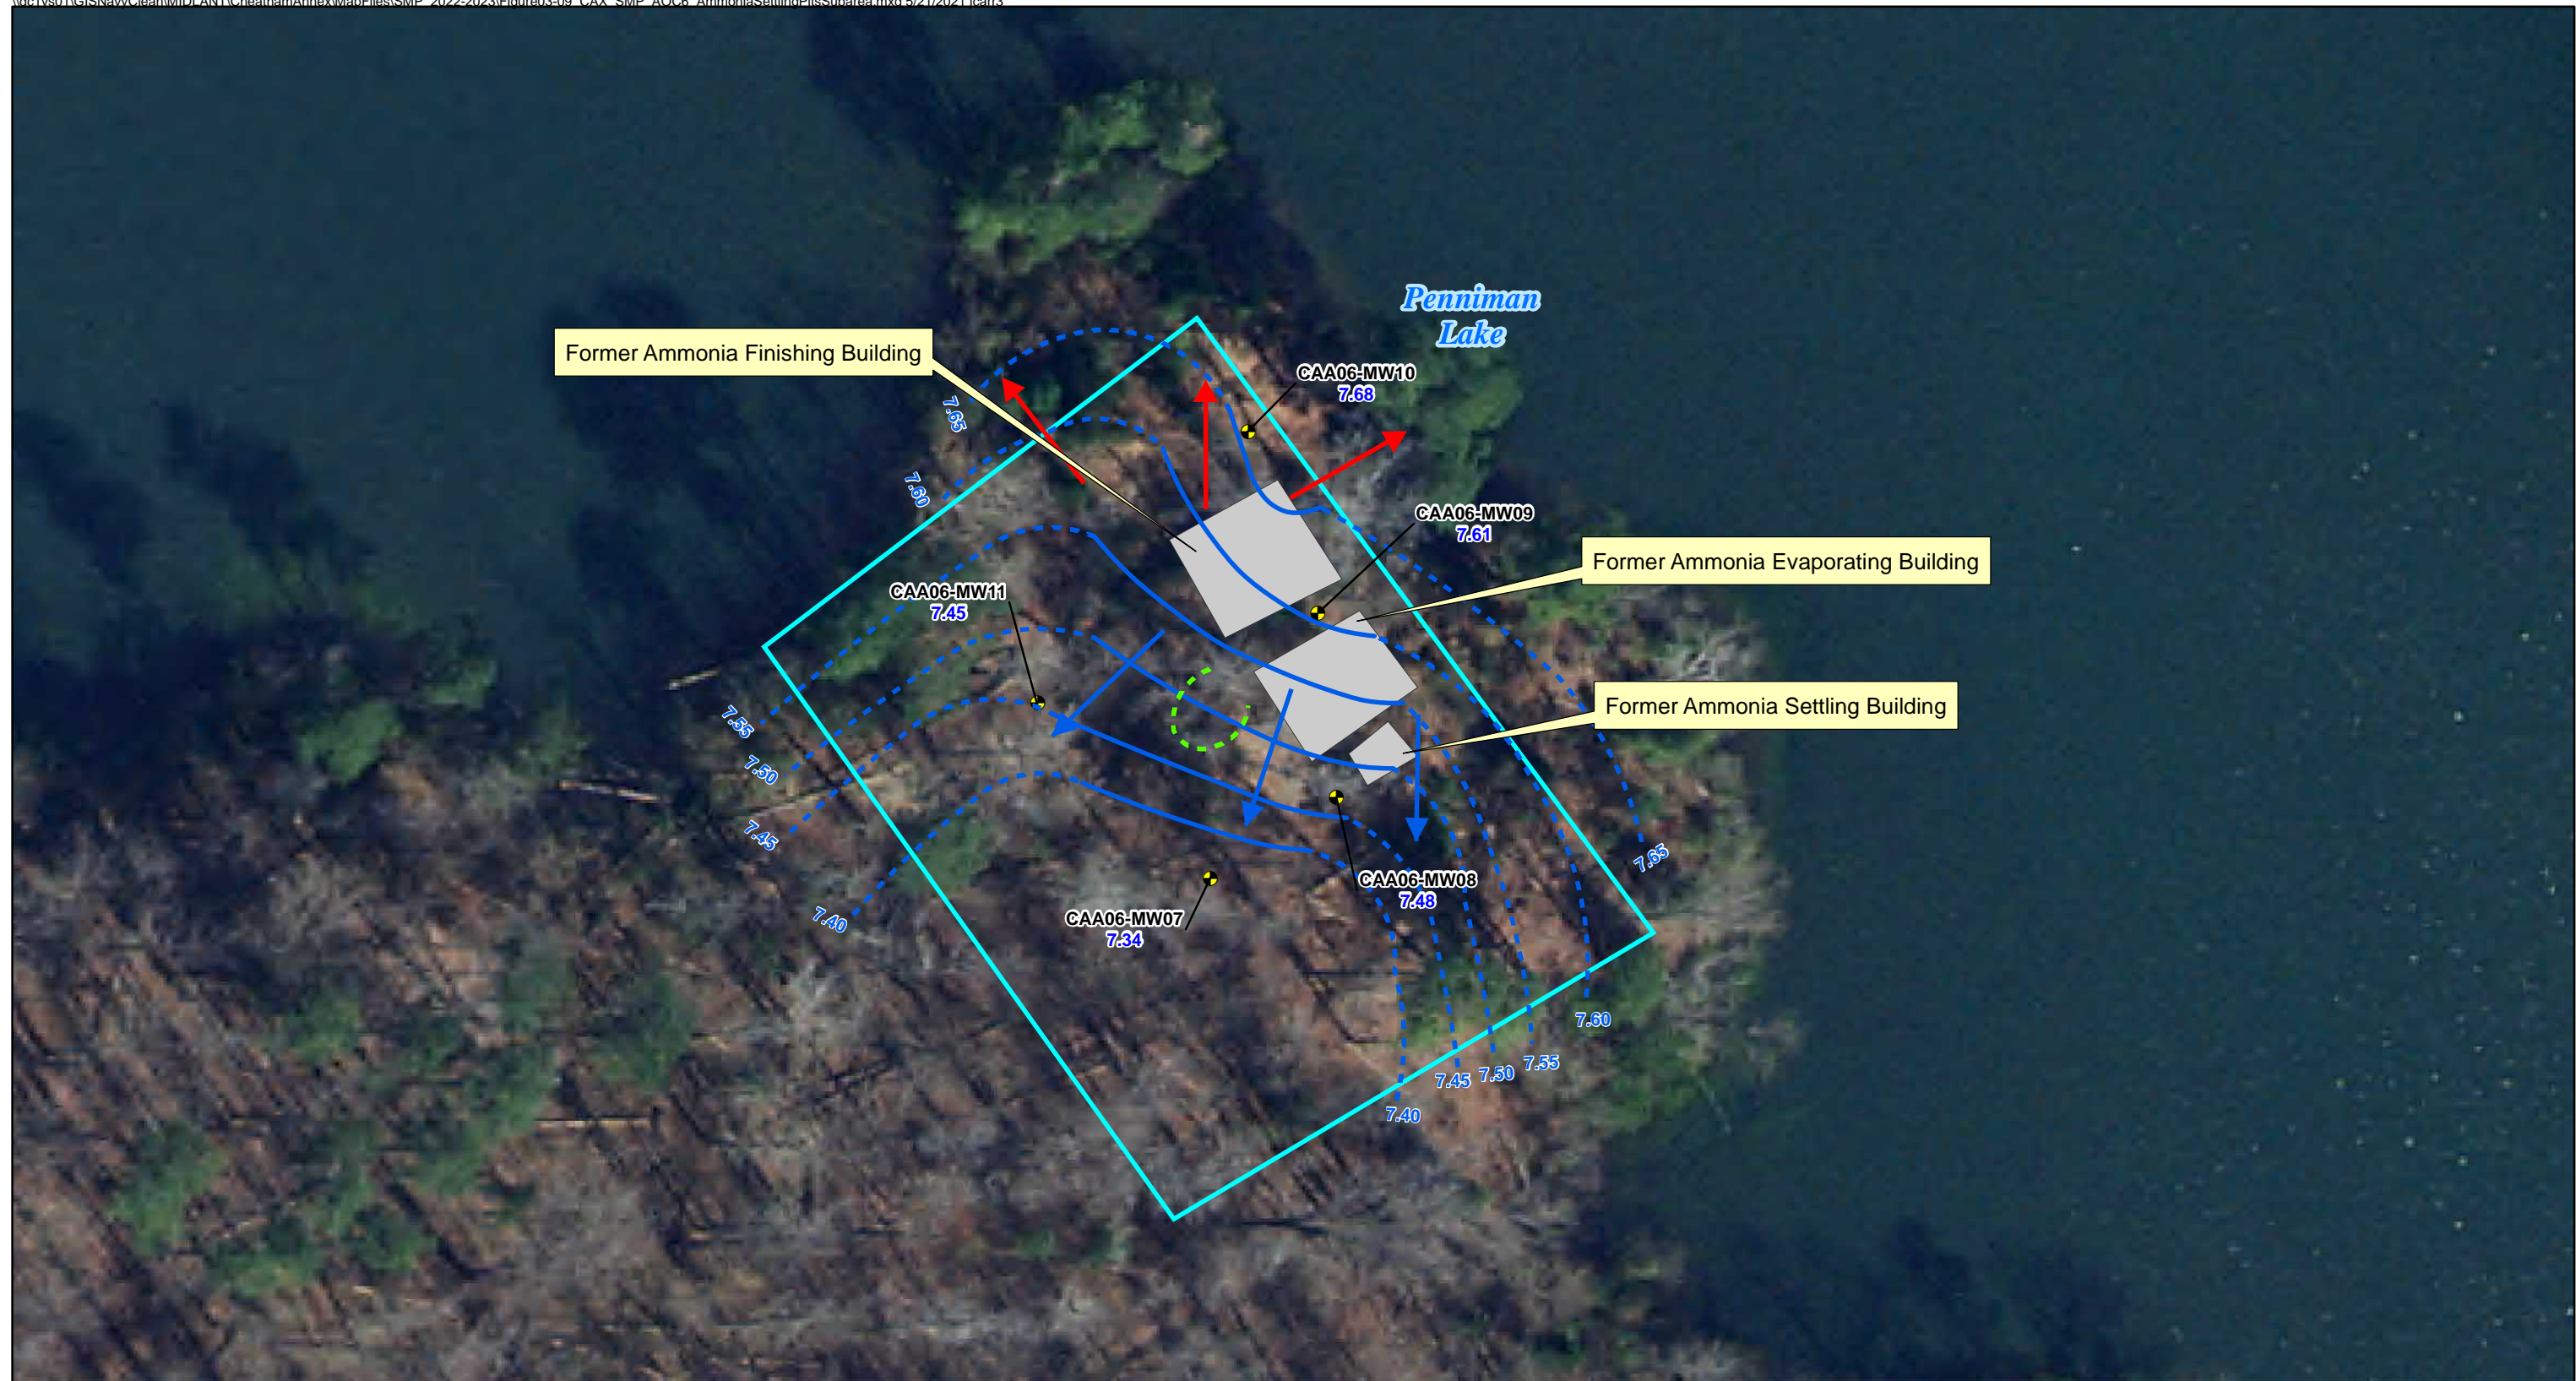
Based on the results of the SI (CH2M HILL, 2012b), an RI field investigation was conducted in 2013 to further evaluate soil and groundwater at the AOC 6 TNT Subareas (**Figure 3-8**) and an ESI field investigation was conducted in 2014 to further evaluate soil and groundwater at the AOC 6 Ammonia Settling Pits Subarea (**Figure 3-9**). However, based on the results of the HHRA prepared for the ESI, the CAX Partnering Team decided that preparation of an RI report was the appropriate course for the Ammonia Settling Pits Subarea. The results of both RI reports are presented in the summary table that follows.

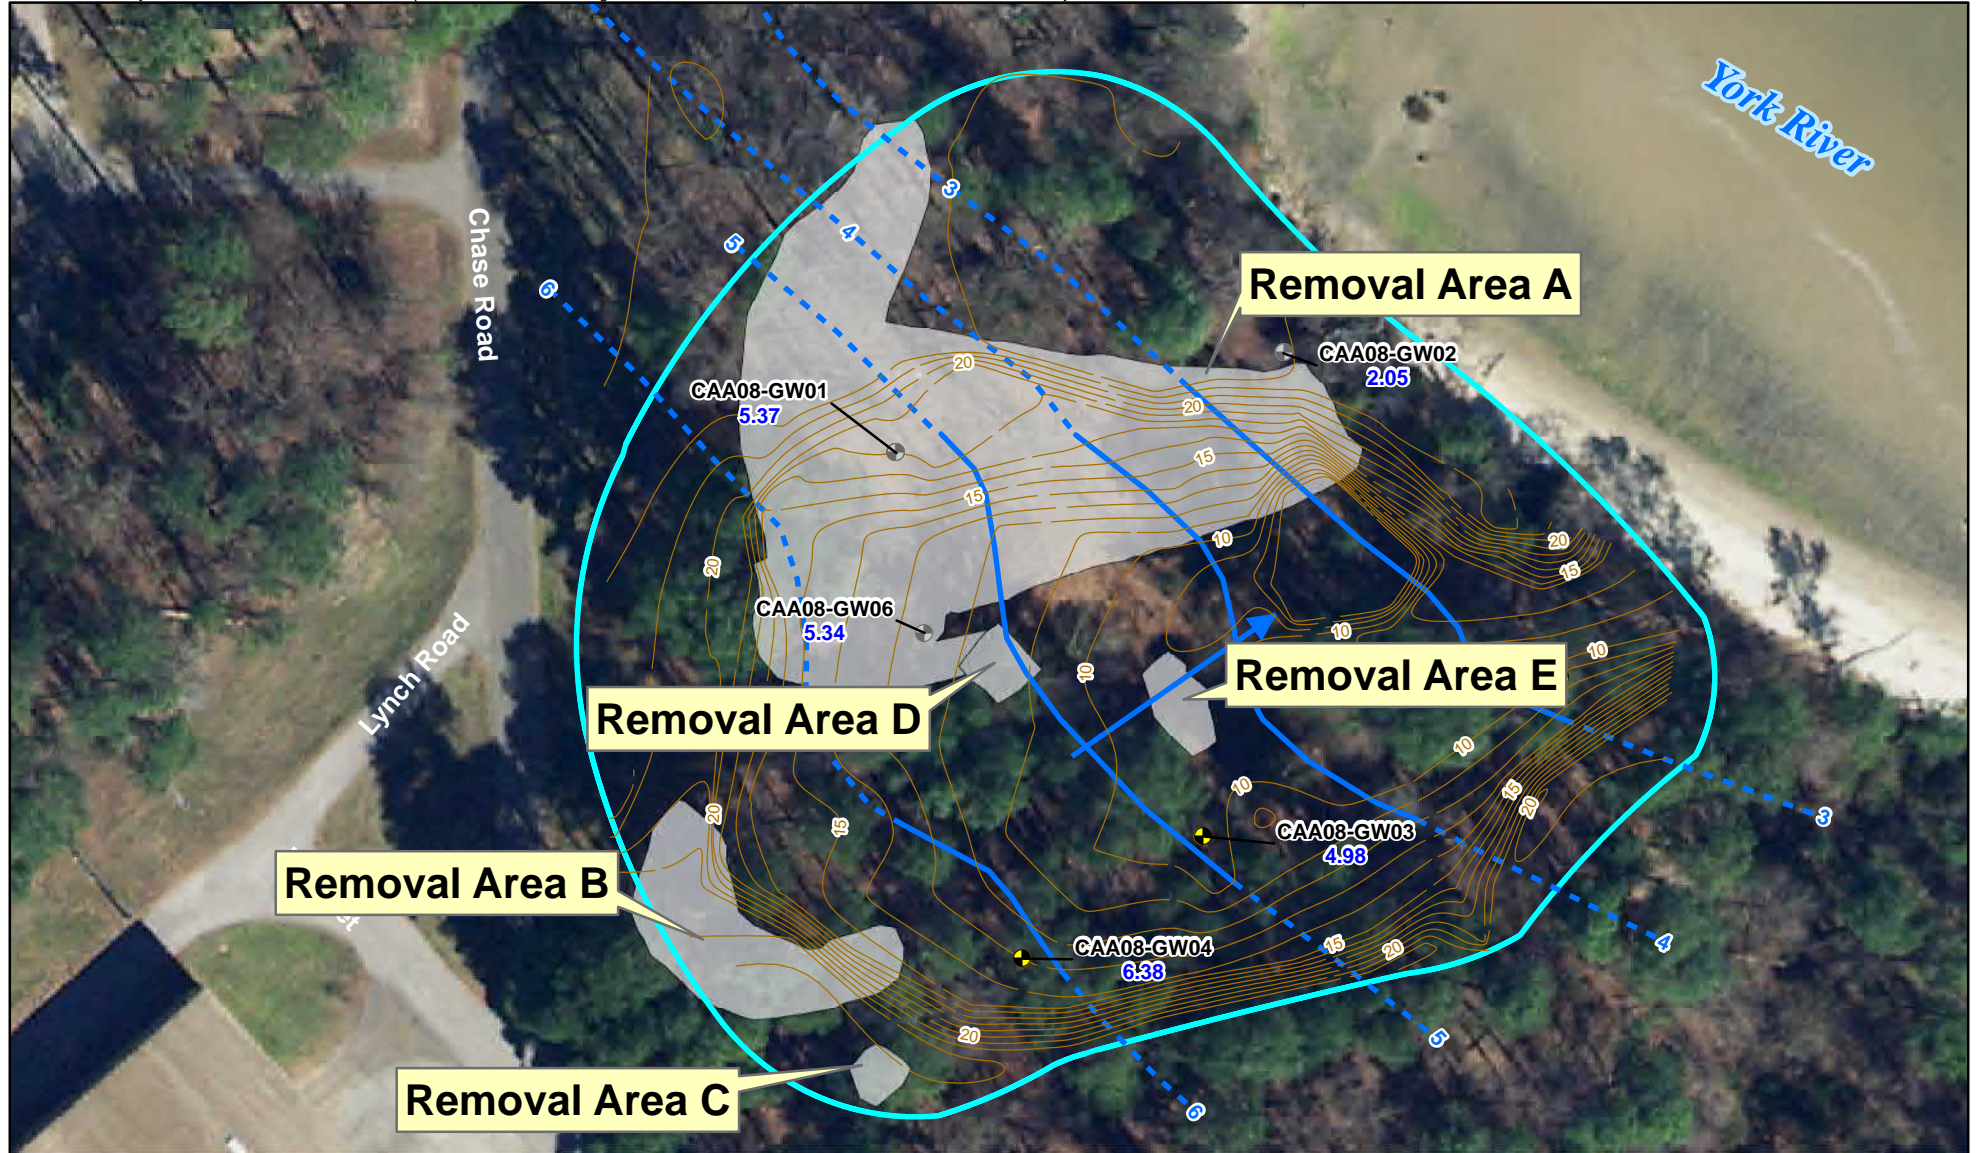
Figure 3-9
AOC 6 - Amonia Settling Pits Subarea
Site Management Plan
Cheatham Annex
Williamsburg, Virginia

- Monitoring Well Location
 - Removed/Abandoned Monitoring Well
 - Elevation Contour prior to Removal Action (feet)
 - Inferred Groundwater Contour (feet)
 - Groundwater Contour (feet)
 - Approximate Direction of Groundwater Flow
 - Approximate Study Area (Active RI) (2.5 acres)
 - Final Excavation Limits
- 5.34 - Groundwater Elevation (Prior to Removal Action)
Imagery: Virginia Commonwealth, 2017

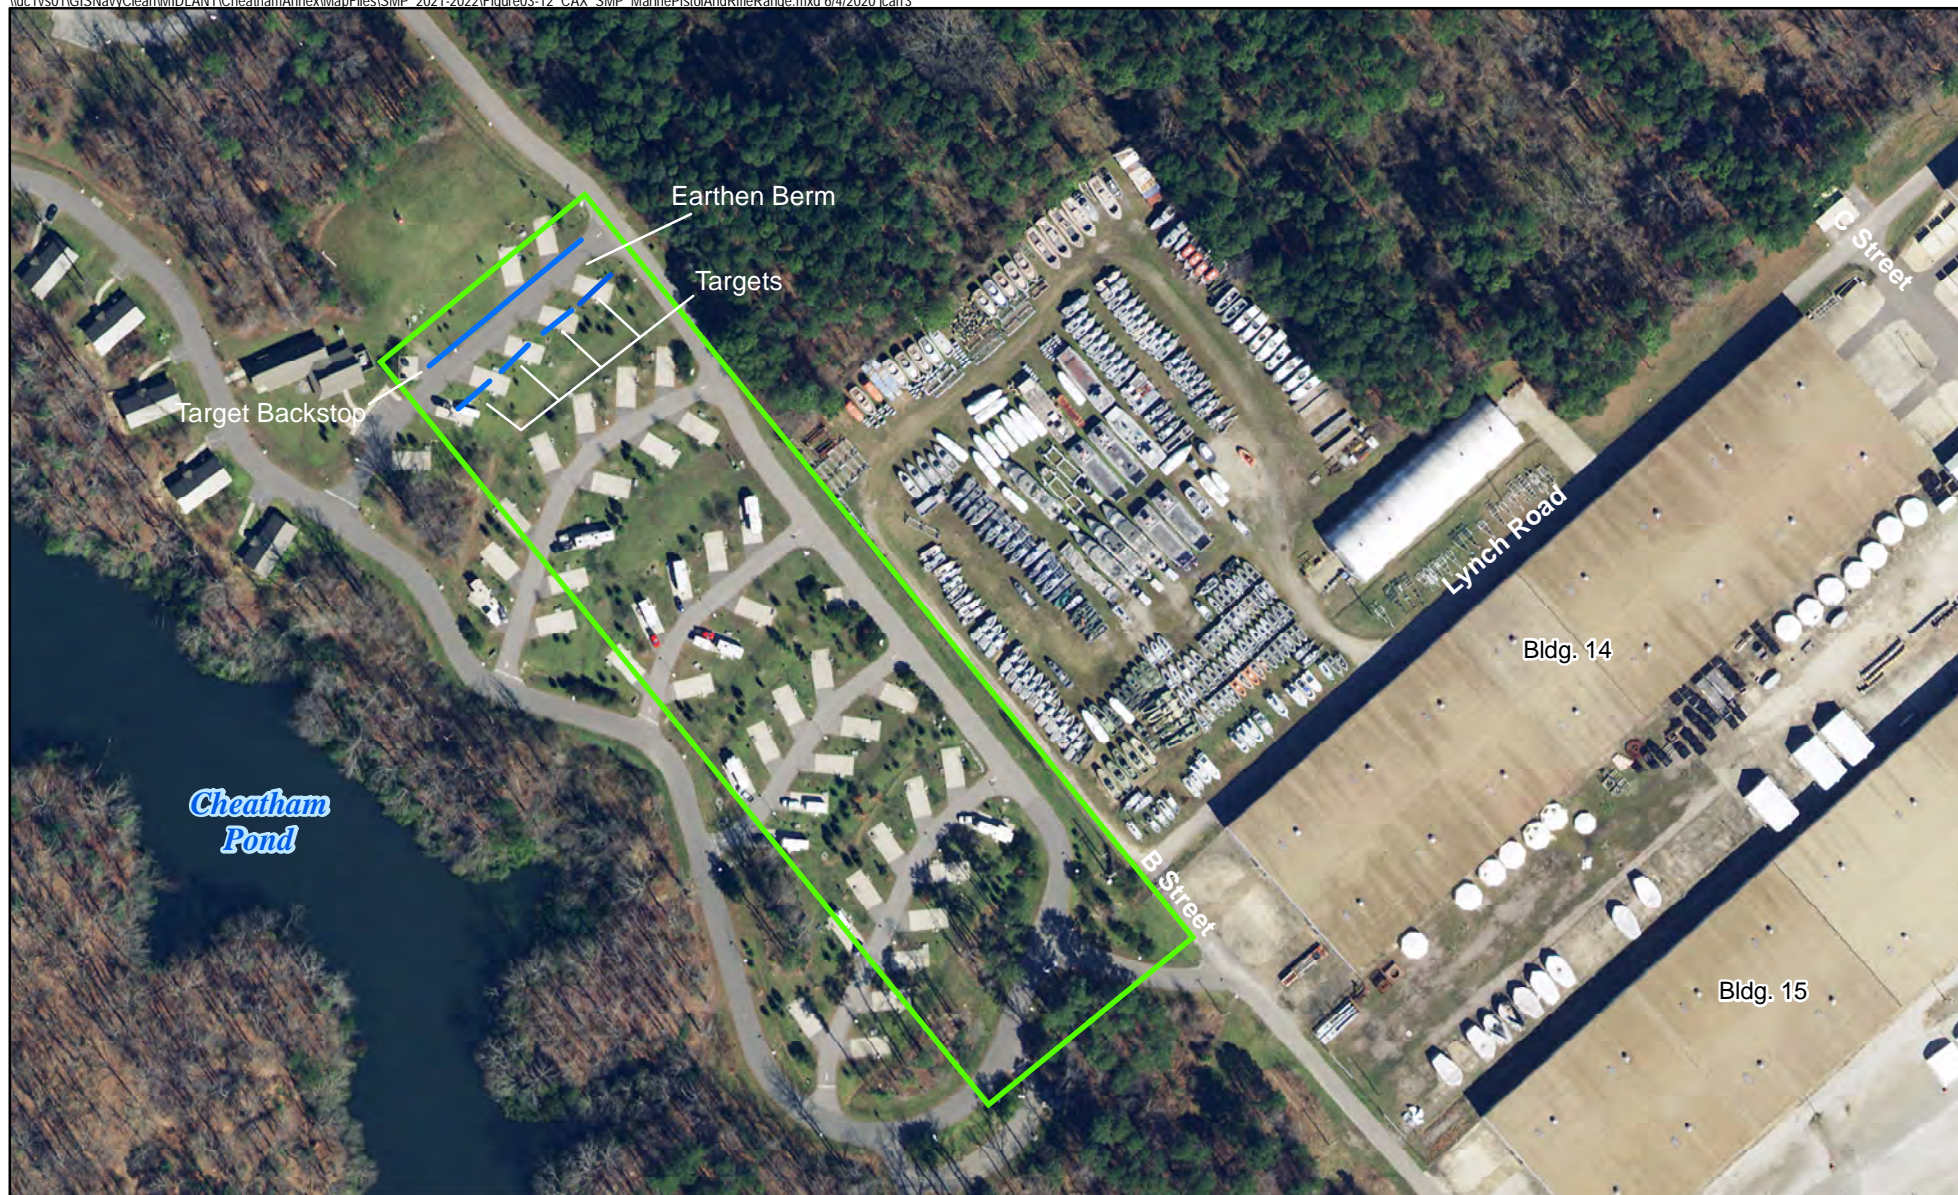
Figure 3-11
AOC 9 - Penniman Lake Historical Industrial Areas
Site Management Plan
Cheatham Annex
Williamsburg, Virginia

AOC 9 was originally defined as Penniman Lake, a 48-acre surface water body located in the southeastern portion of CAX that was created in 1943 when a portion of King Creek was dammed (**Figure 3-11**). Following completion of the Pond Study, catch-and-release fishing restrictions were recommended for Penniman Lake, as a conservative measure that was not based on a human health risk assessment. Subsequently, fishing restriction signs (catch-and-release only) were posted in August 2000. However, Penniman Lake is a downgradient receiving body and not the source of contamination. Therefore, a desktop evaluation of the historic building uses and activities upgradient of Penniman Lake was conducted in an effort to identify a potential source (or sources) of contamination. The Desktop Study identified 44 areas of interest within the watershed with the potential to serve as source areas of contamination and established the 171-acre AOC 9 study area boundary, which encompasses the structures, areas, and drainages currently under investigation as part of the ESI. In addition, since the PSLP was an explosives manufacturing facility during WWI, AOC 6 was identified as an area of interest for explosive compound contamination within the Penniman Lake watershed. The CAX Partnering team agreed that the explosive compound contamination would be investigated as part of AOC 9. A summary of relevant documents and action milestones is presented below.

investigation of the industrial area upgradient of Penniman Lake is warranted to identify potential sources of contamination to Penniman Lake sediment. A records search was performed and additional evaluation to characterize potential historical sources of the SI-identified COPCs was recommended for 44 areas. The need for a more comprehensive reference data set reflecting non-CERCLA inputs to the lake also was documented.
