Naval Weapons Station Yorktown
Cheatham Annex

Environmental Restoration Advisory
Board Meeting
November 10, 2022

Cheatham Annex
Site 7 – Old DuPont Disposal Area
Field Work Update

Cheatham Annex
AOC 8 – Area South of Site 7
Field Work Update

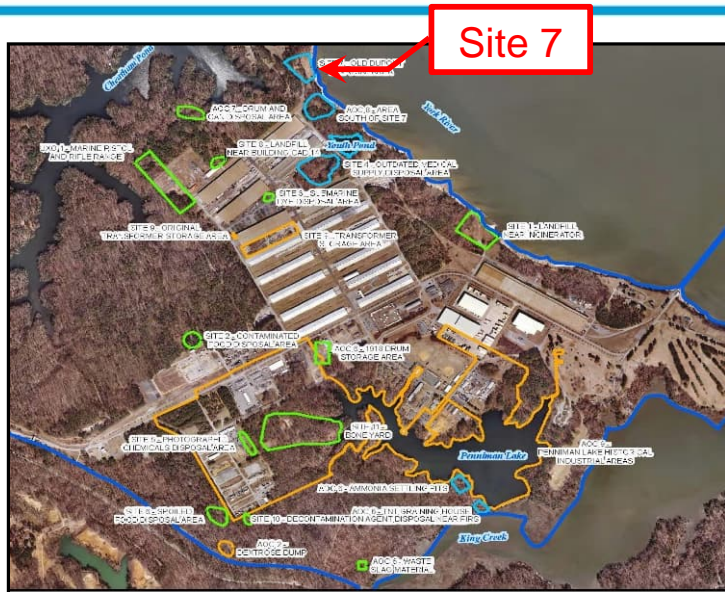
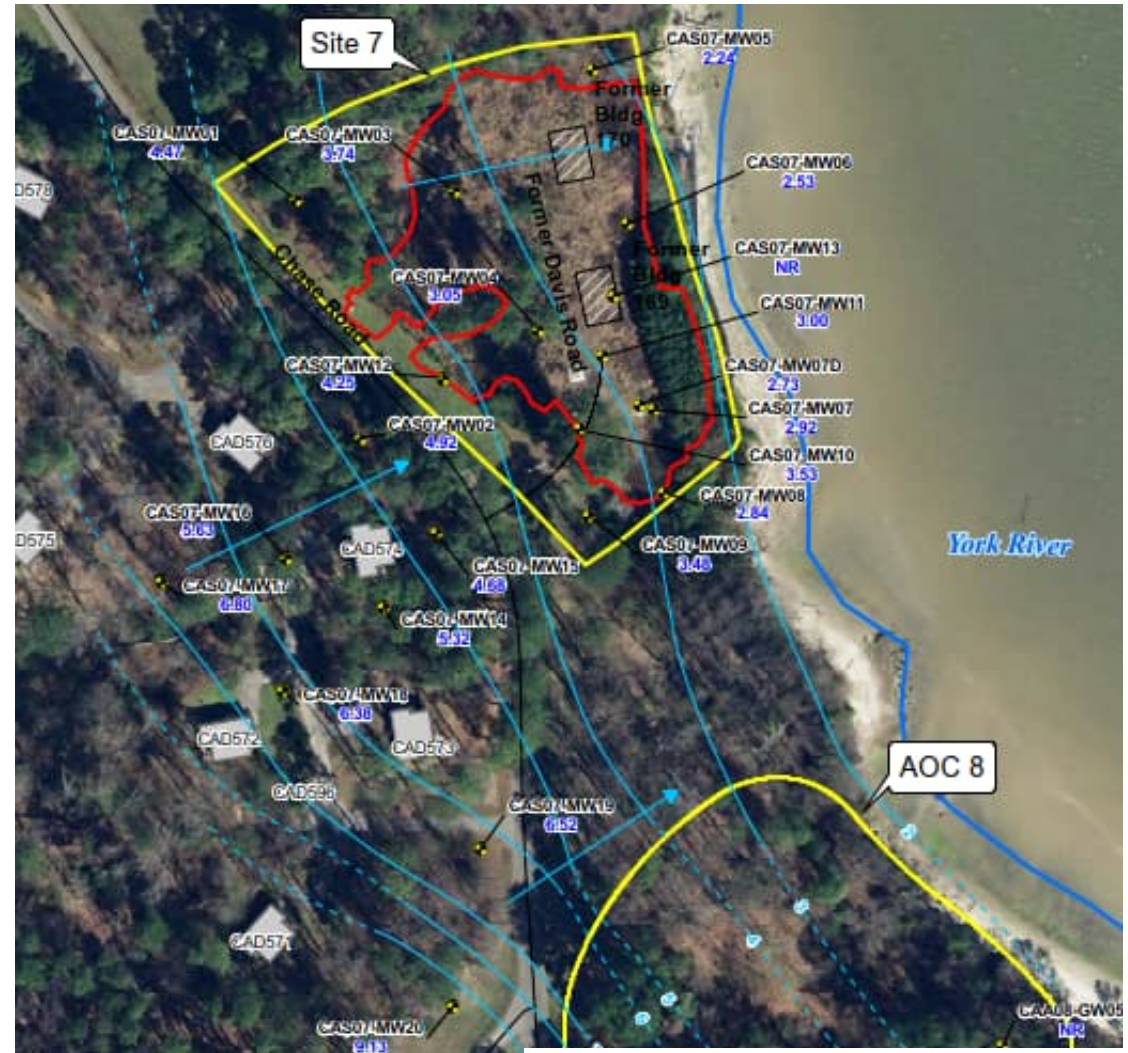
CAX ERP – Site 7

Notes:
 Water levels taken on November 2, 2020 between 9:30 am and 11:30 am, during high tide.
 NR - Not Recorded
 2.53 - Groundwater Elevation (ft amsl)
 Imagery: Virginia Commonwealth, 2017

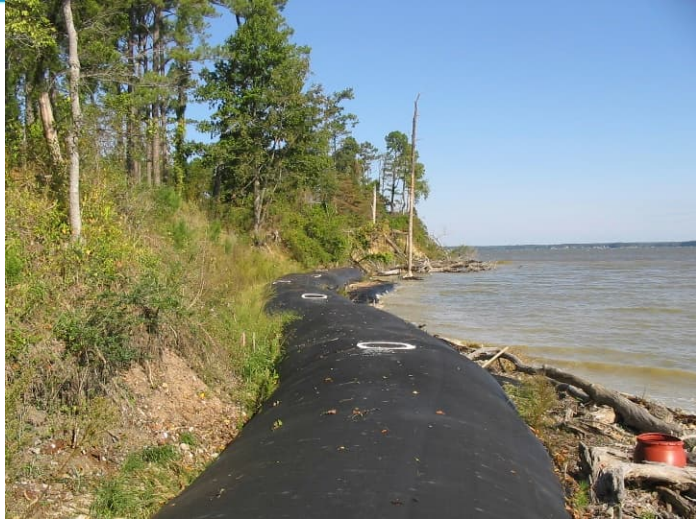
Shoreline facing north - 2006

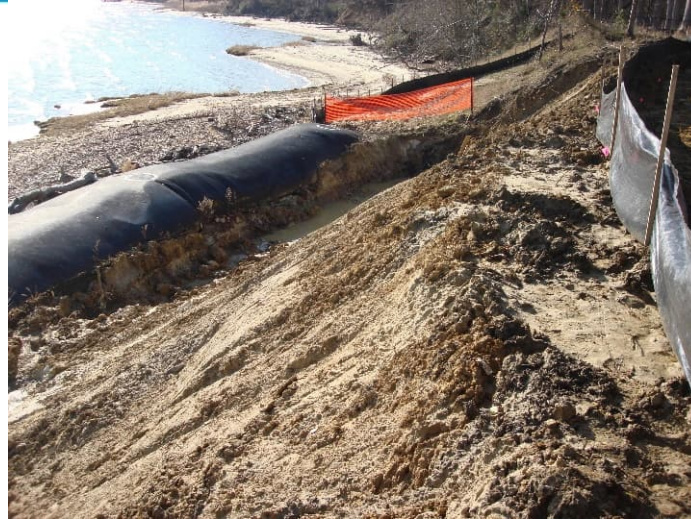
Shoreline facing south - 2008

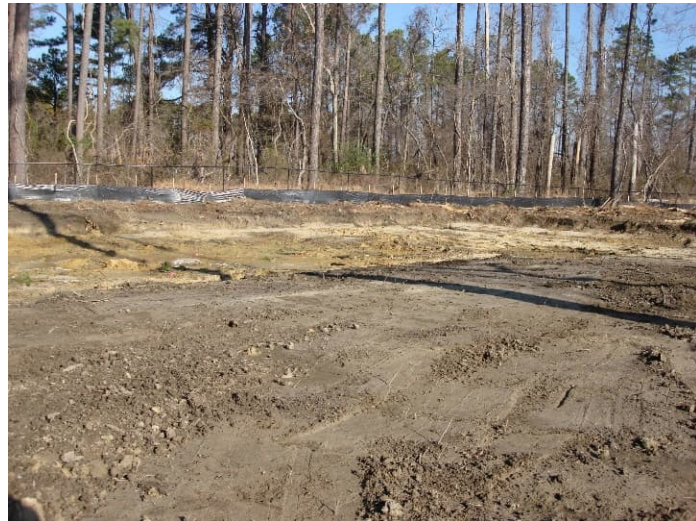
Site facing west - 2008

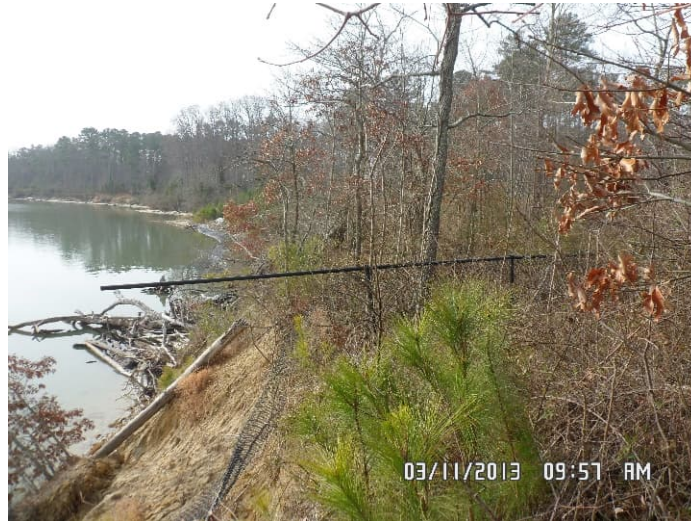
Shoreline facing south - 2013

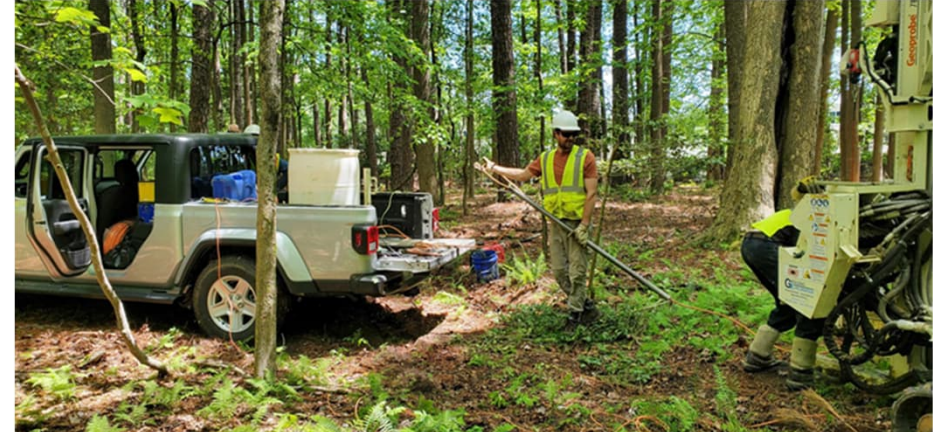
Hydrogeological data collection with HPT tooling

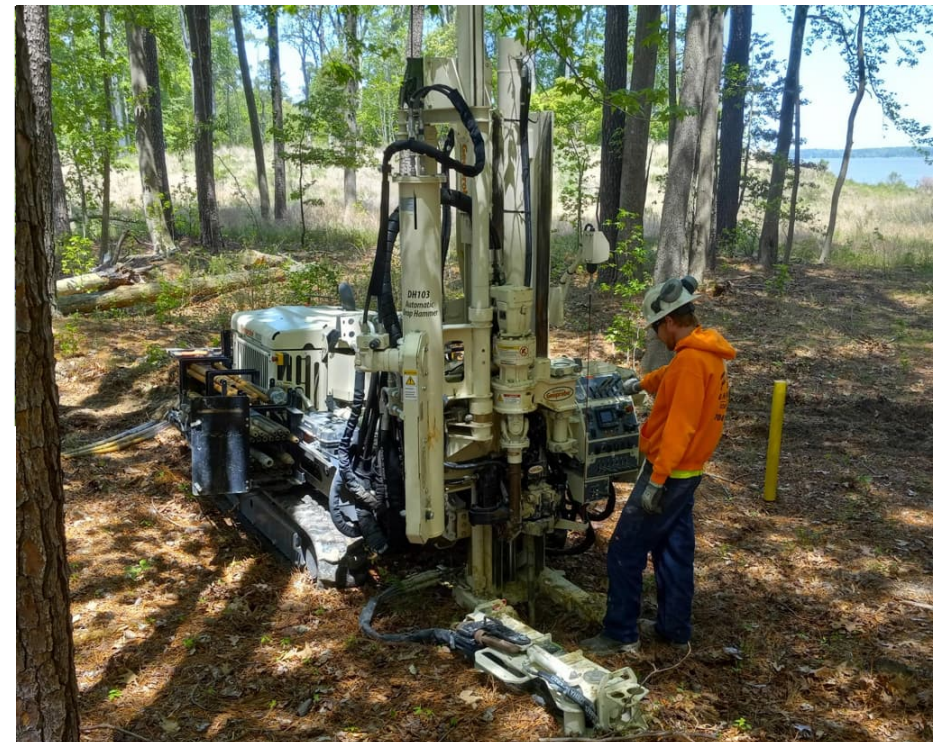
Groundwater sample collection with DPT rig

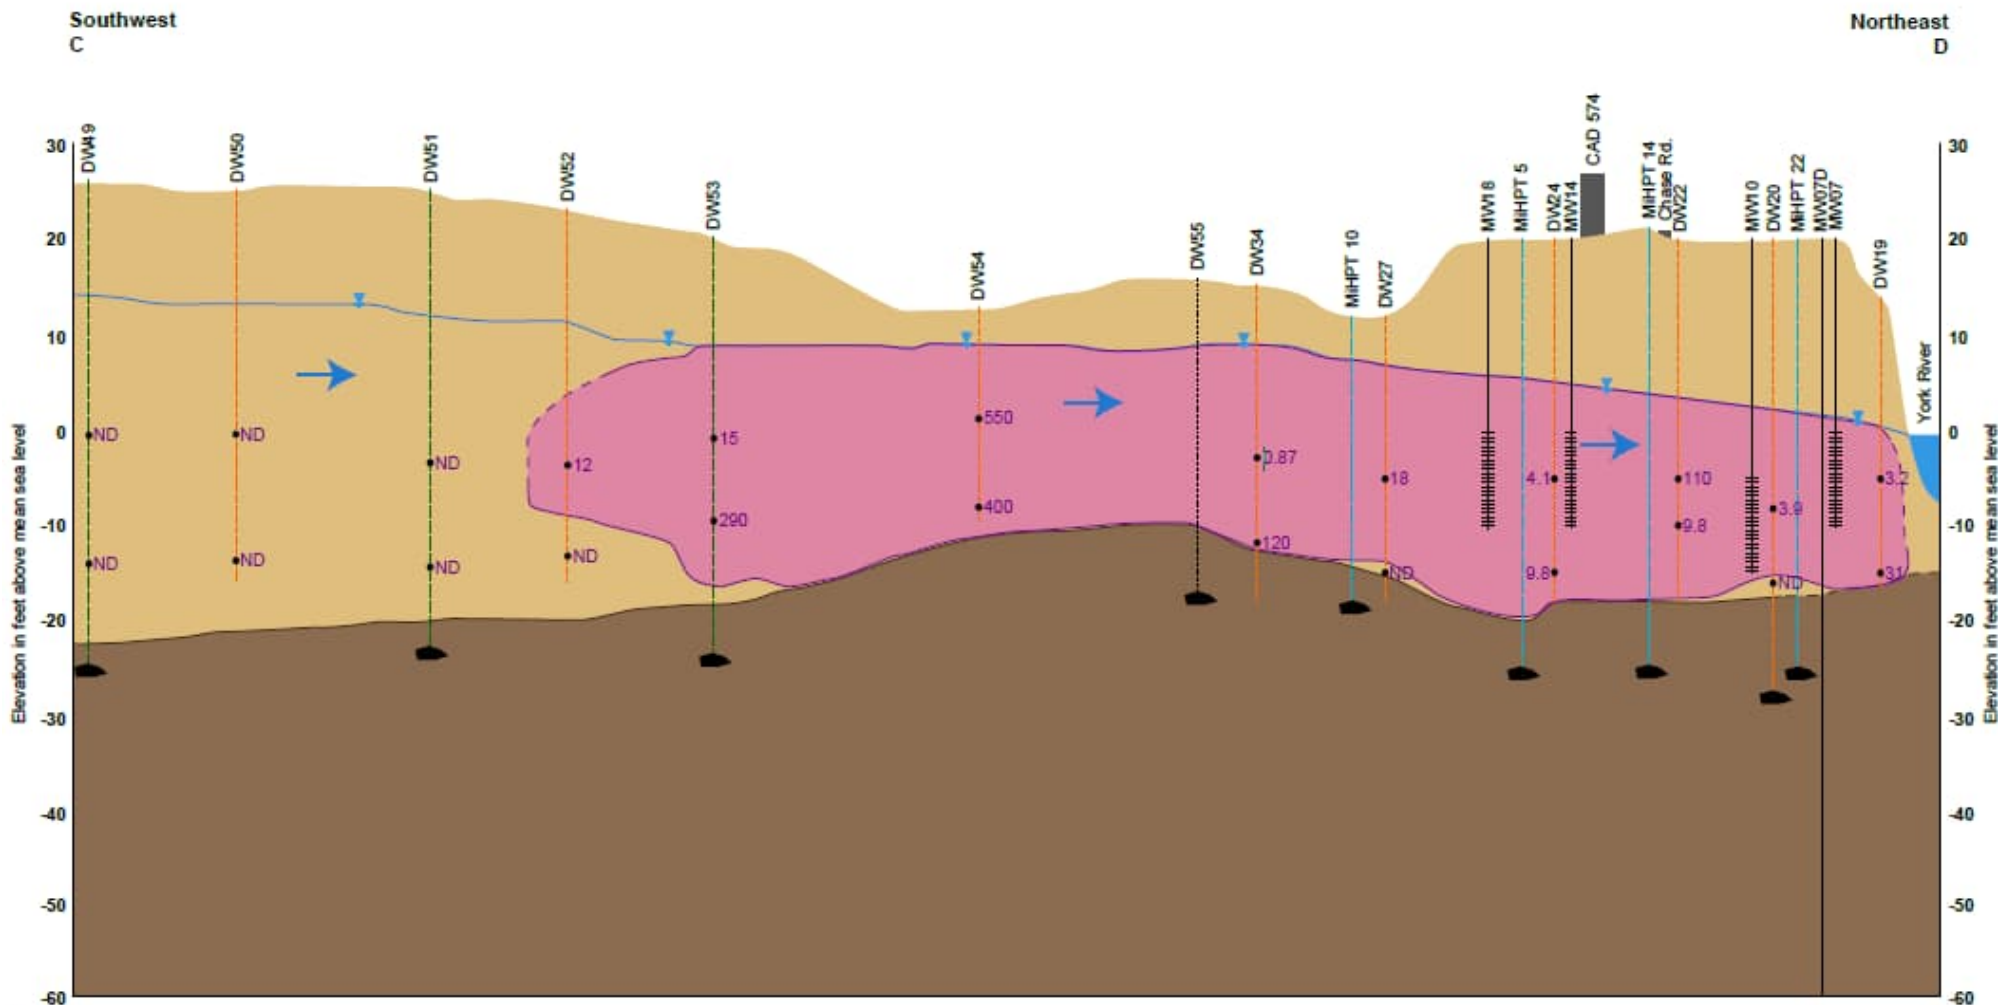
Site 7 Cross Section

- **Highest TCE concentration was found at DW54 (550 ug/l) (see Site 7 Groundwater Contaminant Distribution Figure)**
- **TCE degradation products also found in groundwater (notably cis-1,2-DCE)**
- **Groundwater contamination present mostly in the deeper portion of the aquifer**
- **Presence of a high conductivity zone from the ground surface to approximately 45 feet below ground surface, which transitions into a low conductivity zone beyond 45 feet deep (see Site 7 Cross Section)**

Site 7 TCE Concentrations Cross Section Cheatham Annex Williamsburg, Virginia

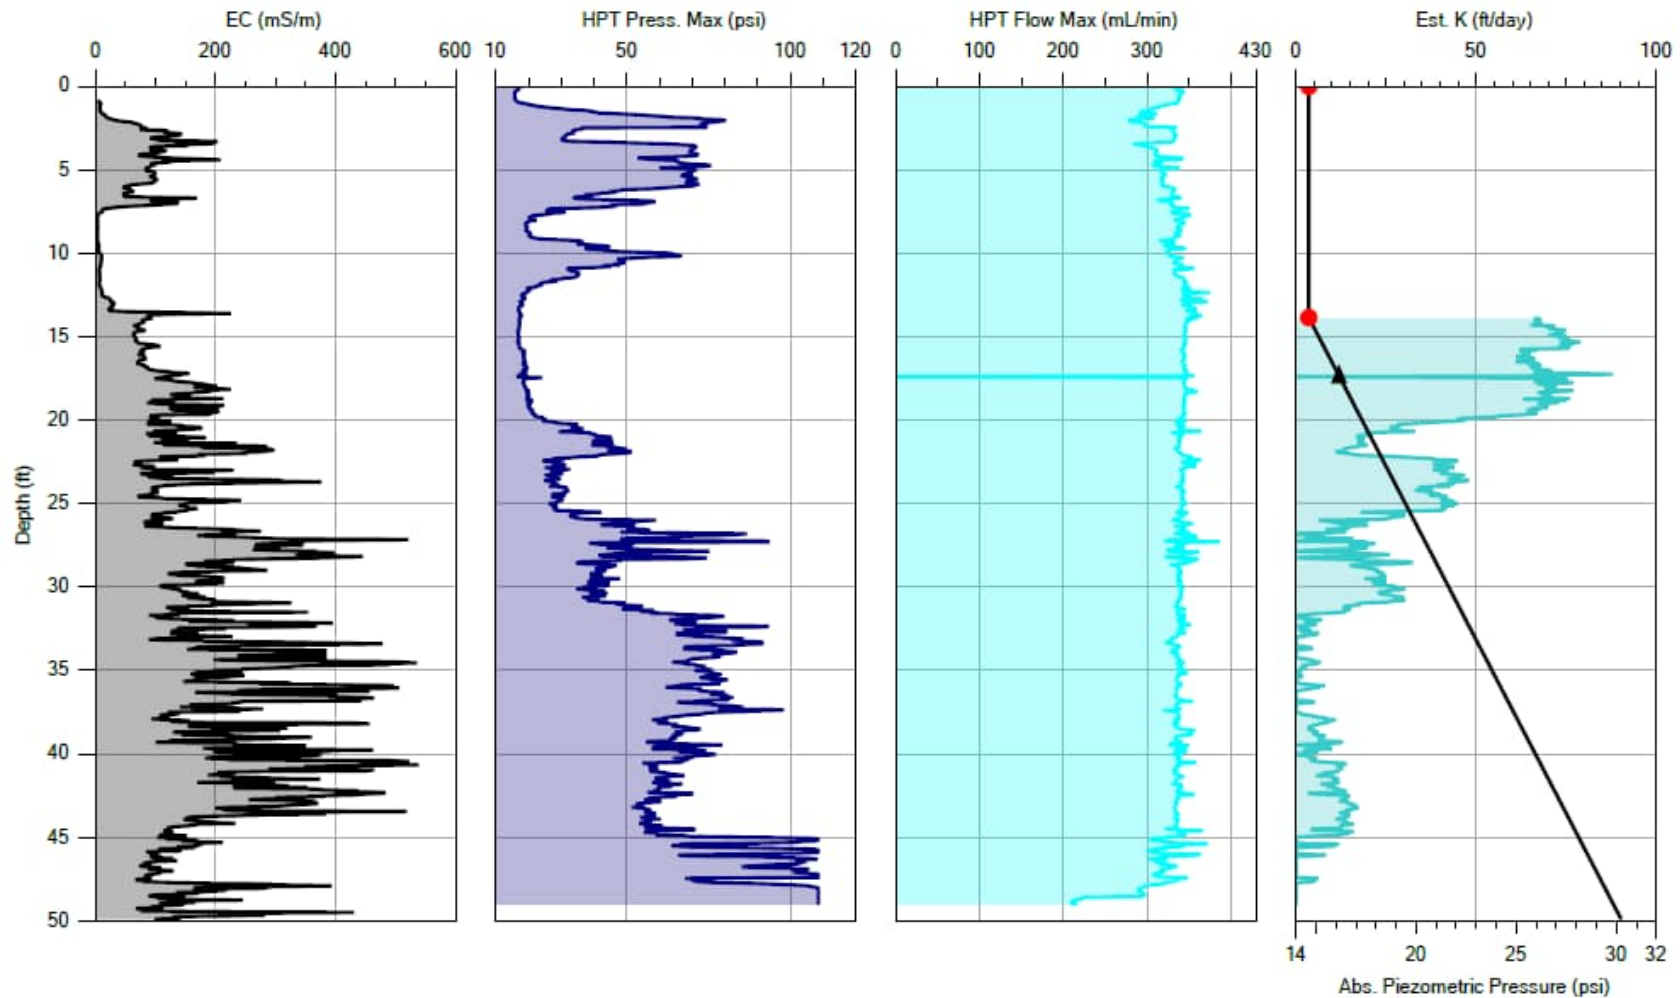
HPT Log Example

Company:	Eagle Synergistic	Operator:	HJ	File:	CAS07-DW51.HPT
Project ID:	21.143	Client:	Jacobs	Date:	5/4/2022
				Location:	Cheatham Annex

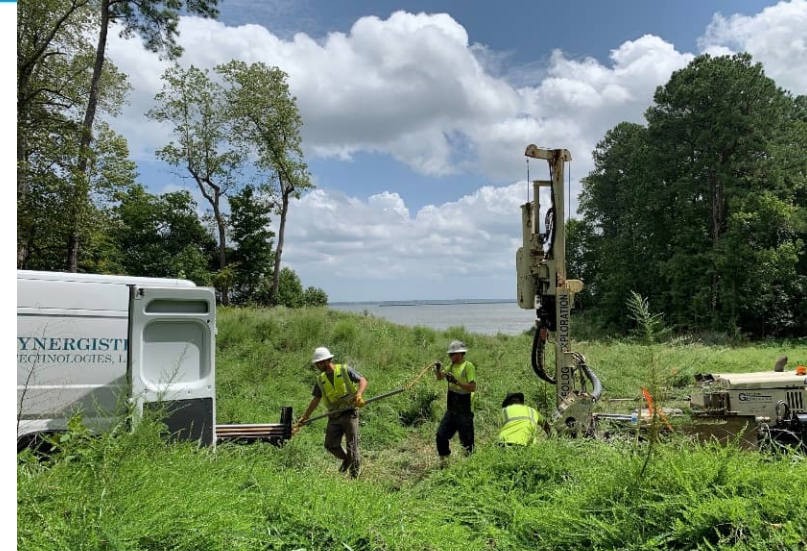
Hydrogeological data collection with HPT tooling

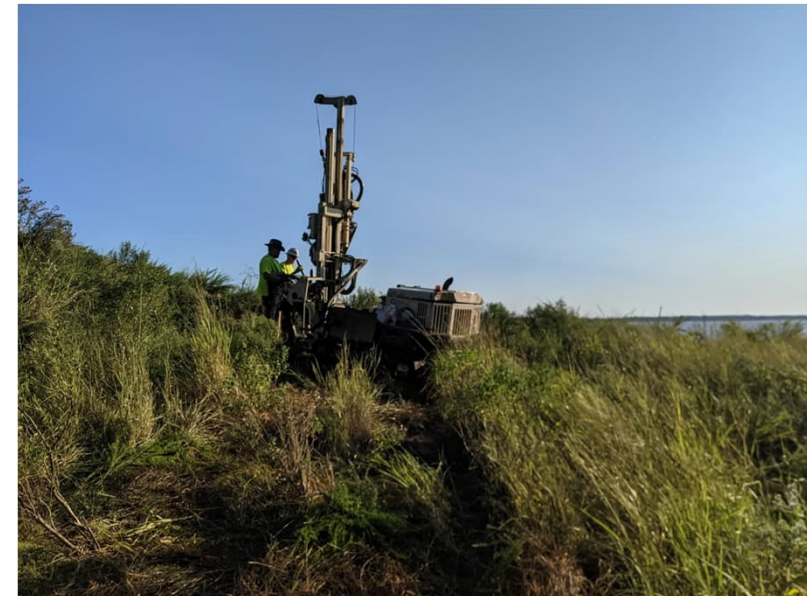
Groundwater sample collection with DPT rig

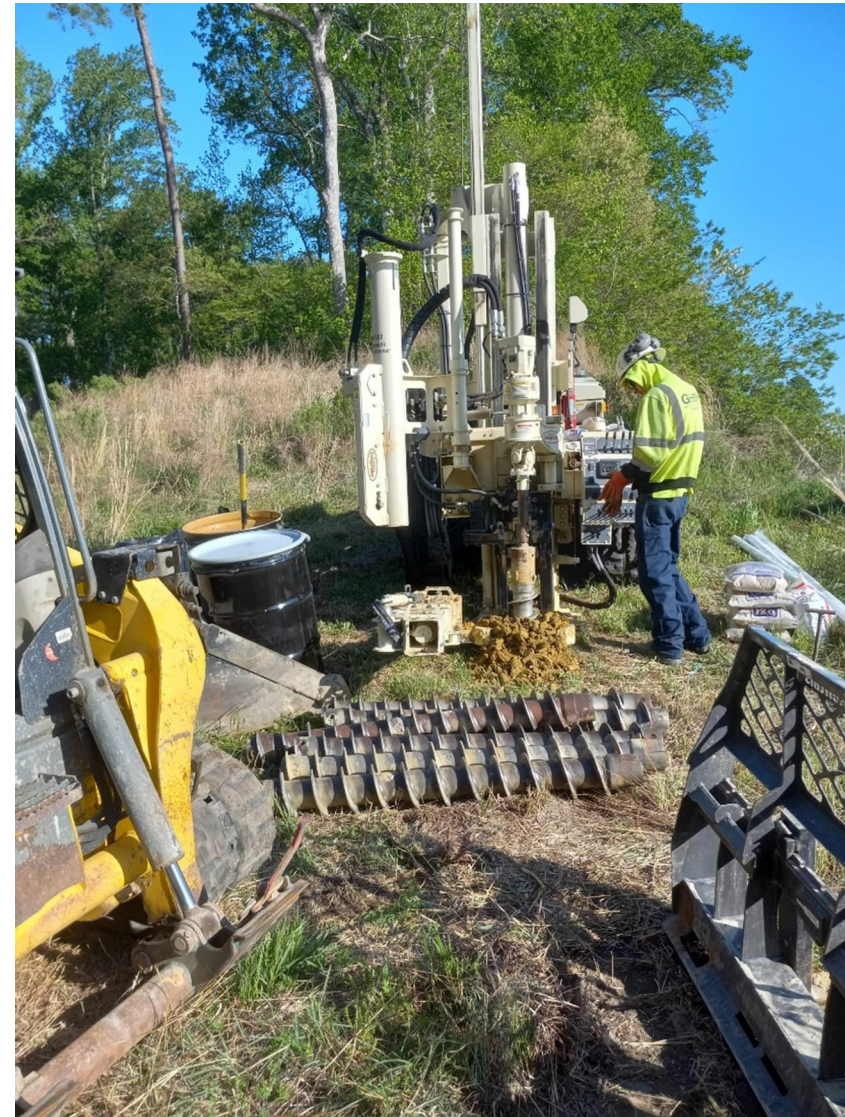
Installation of groundwater monitoring well

- Installed and developed 6 permanent groundwater monitoring wells
- Collected groundwater samples and analyzed for VOCs
- Collected water quality, geochemical, and geophysical parameters
- Measured water level in existing and new monitoring wells
- Described and logged subsurface soil lithology during monitoring well installation
