Site Management Plan Fiscal Years 2024–2028

Naval Station Norfolk Norfolk, Virginia

Prepared for NAVFAC Mid-Atlantic by CH2M HILL, Inc. Virginia Beach, Virginia Contract N62470-21-D-0007 CTO N4008522F4497

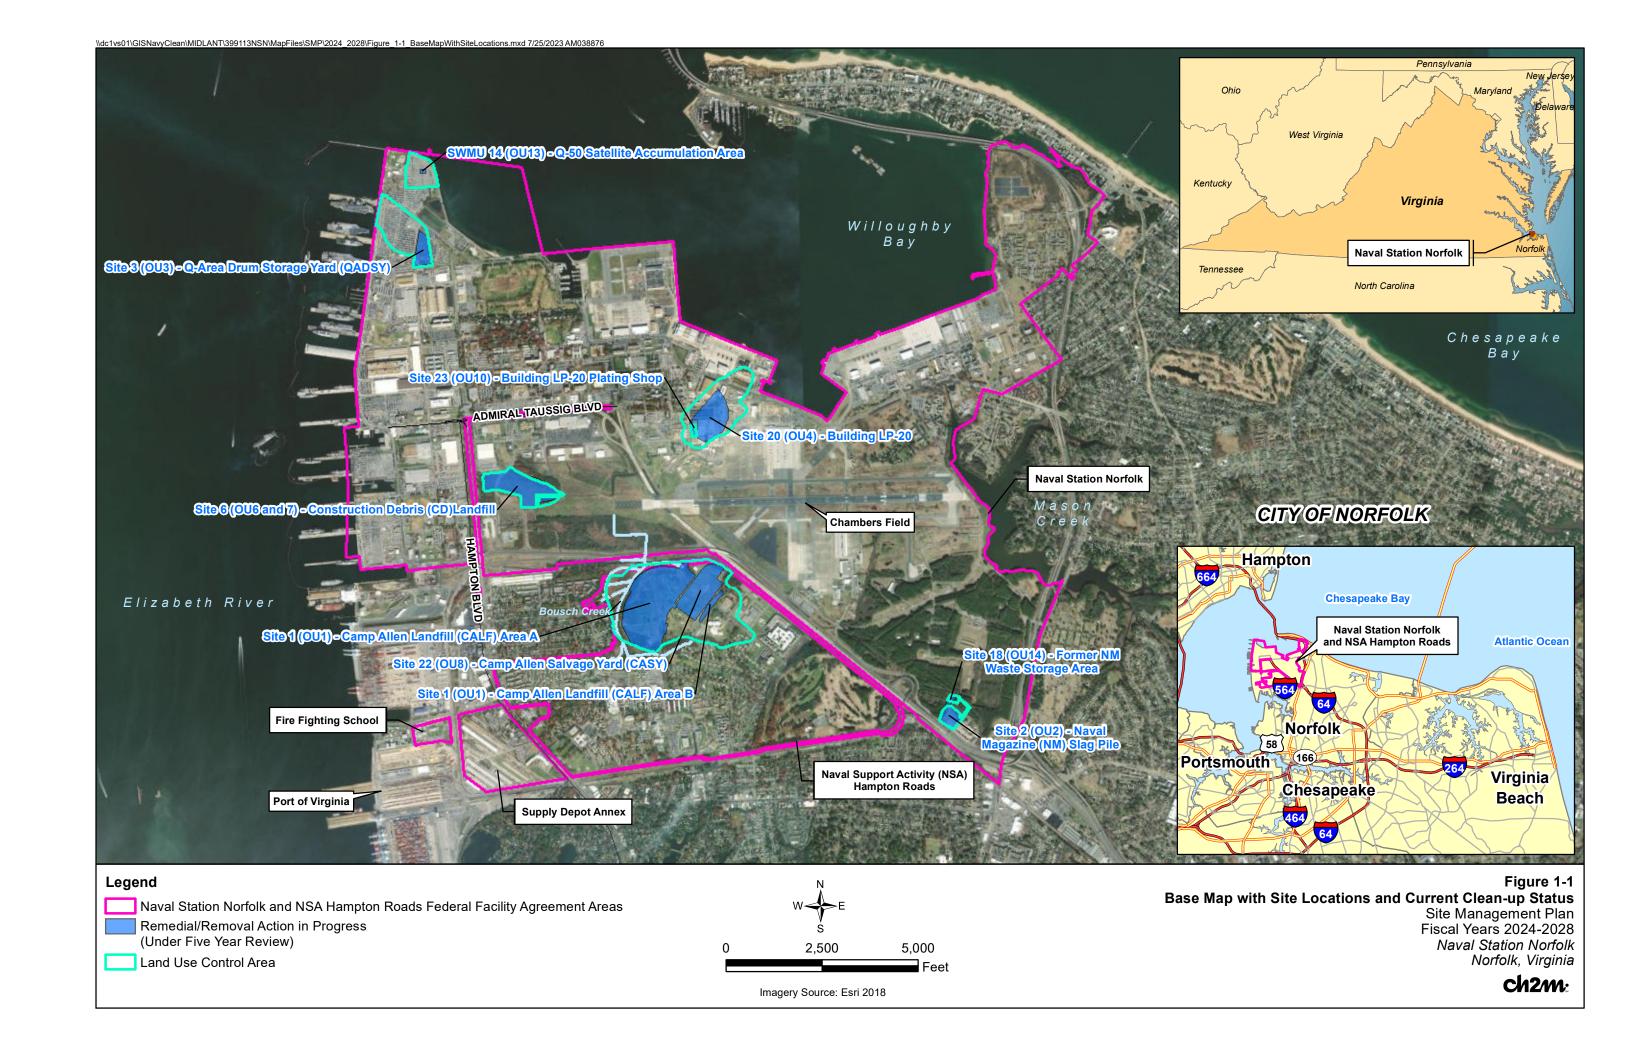
This section provides information regarding the ERP sites (**Section 2.1**) and SWMUs (**Section 2.2**) at NSN that have been investigated and are currently undergoing remediation, and per- and polyfluoroalkyl substances (PFAS) basewide investigations that are ongoing (**Section 2.3**). The locations of the sites that are currently undergoing remediation are shown on **Figure 1-1**.

The Q-50 Satellite Accumulation Area (SWMU 14) (**Figure 2-9**) is located in the northwestern corner of NSN, as shown on **Figure 1-1**. SWMU 14 consisted of a concrete storage pad surrounded by a grass-covered field. The pad served as a 90-day hazardous waste accumulation area where wastes generated by various operations were processed (sampled, identified, labeled, and packaged) before being shipped for eventual disposal. The original concrete pad for the accumulation area has since been removed.

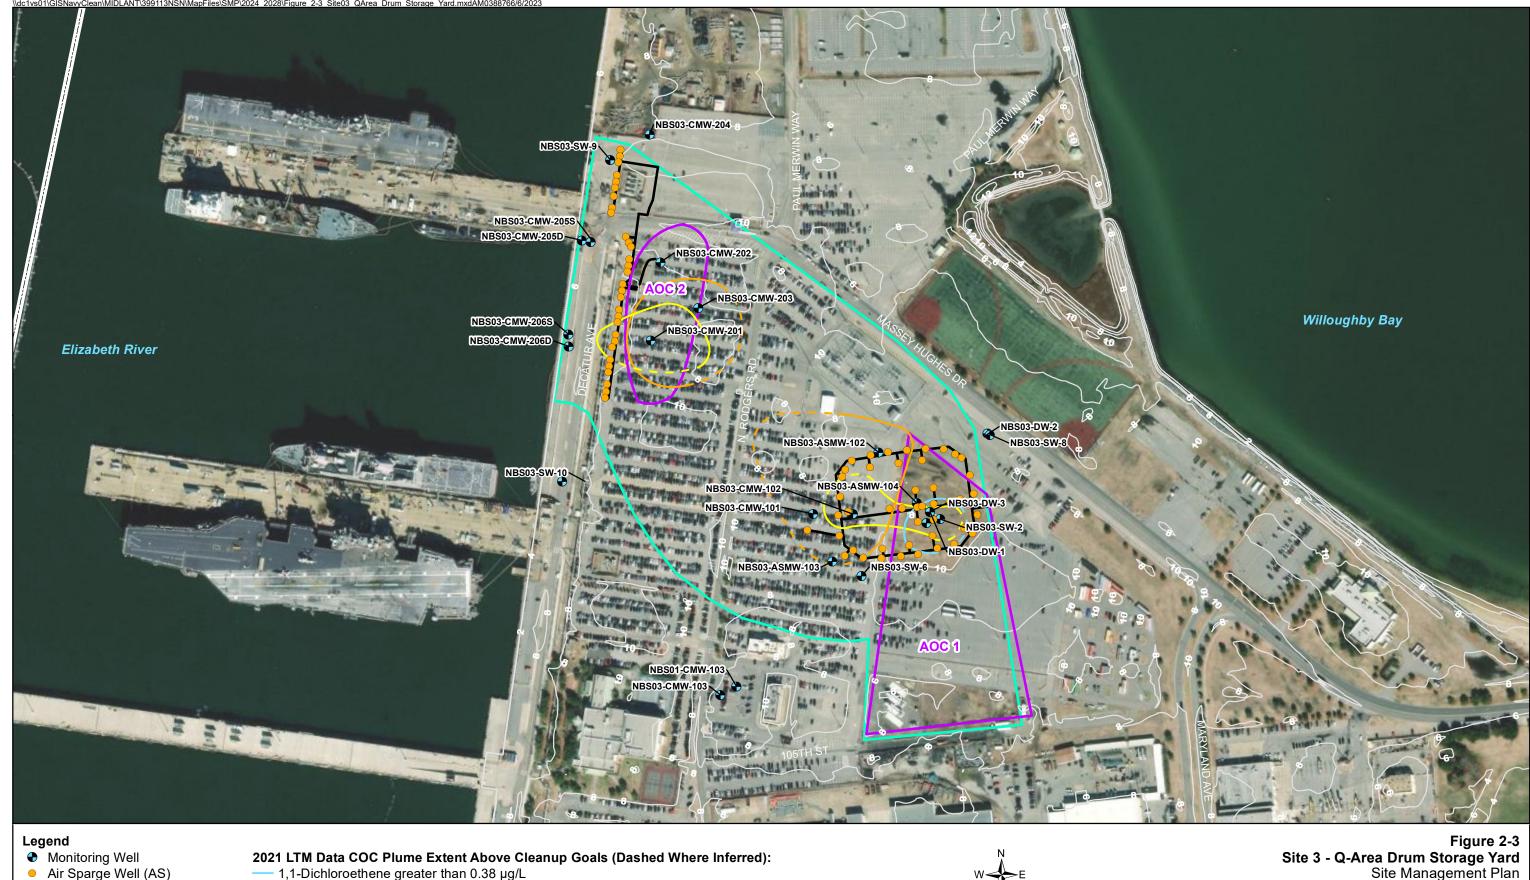
- Piping for AS System
- Land Use Control Area
- AOC Boundary
 Installation Boundary
- 1,1-Dichloroethene greater than 0.38 μg/L
- TCE greater than 5 μg/L
- Topographic Contour (2ft Interval) Vinyl Chloride greater than 0.08 μg/L
