# Site Management Plan Fiscal Years 2021-2025

Naval Station Norfolk Norfolk, Virginia

December 2020

Prepared for NAVFAC Mid-Atlantic by CH2M HILL, Inc. Virginia Beach, Virginia Contract N62470-16-D-9000

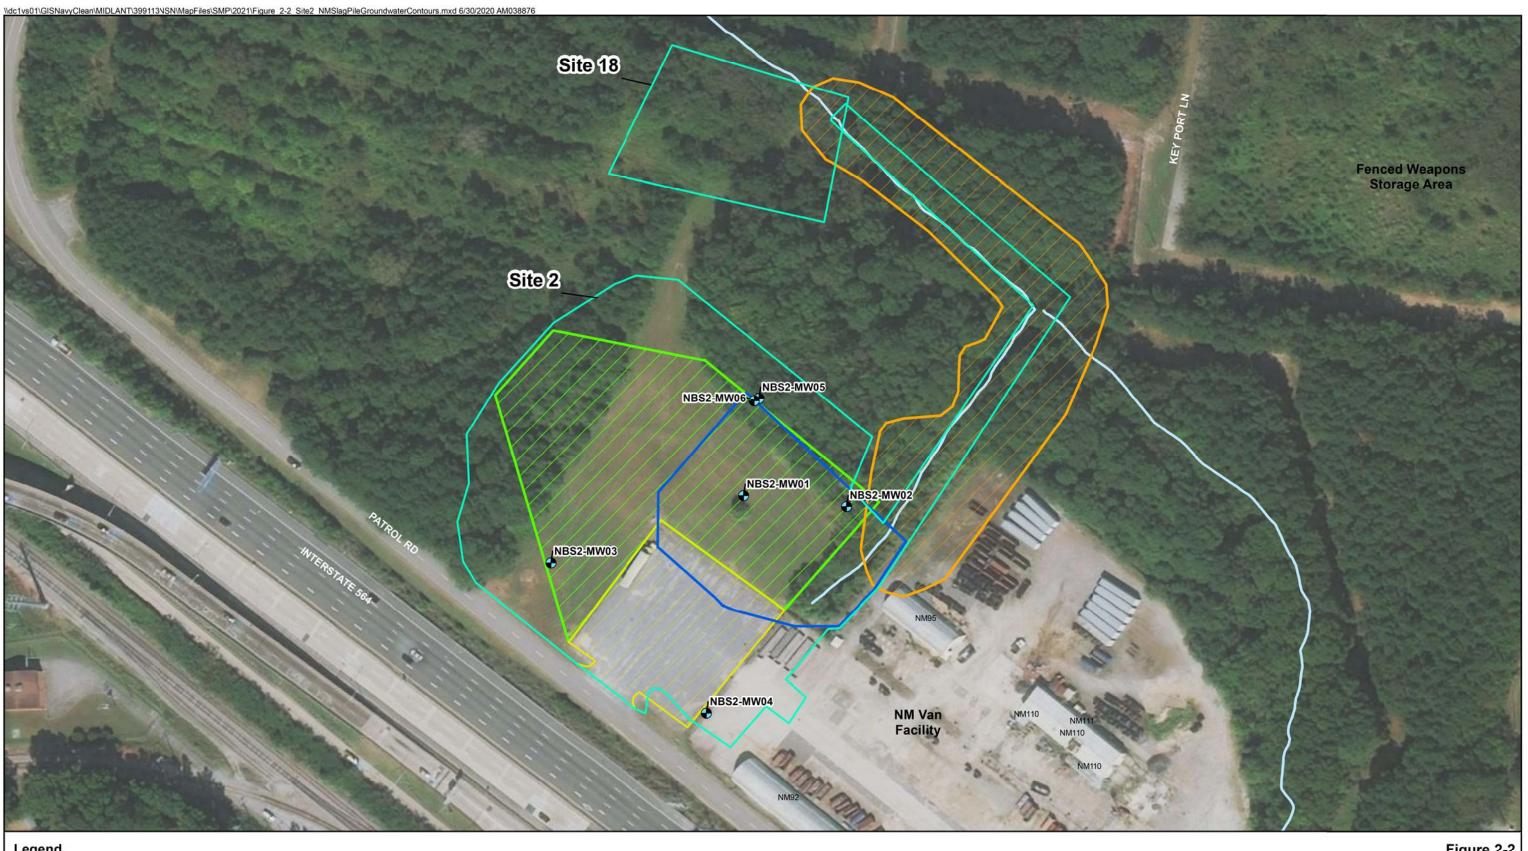
Figure 2-2 Site 2 - NM Slag Pile FY2021 Site Management Plan Naval Station Norfolk Norfolk, Virginia

The Naval Magazine Slag Pile (Figure 2-2) is a 1-acre disposal area for slag generated by an aluminum smelting operation during the 1950s and 1960s. The slag is a residual cindery material formed from the fusion of flux materials, such as limestone, with impurities from the aluminum ore and ash from the blast furnace fuel. In order to create a level surface upon which the slag could be deposited, fly ash and/or bottom ash (derived from coal burning operations elsewhere at NSN) was used as fill material at the site. During the smelting operation, the slag pile area was defined by a lack of vegetation around the site near the slag pile. The site surface has since been regraded and vegetation planted. Prior to remediation activities, the surface of the site consisted of a gravel parking lot and an open grassy field.

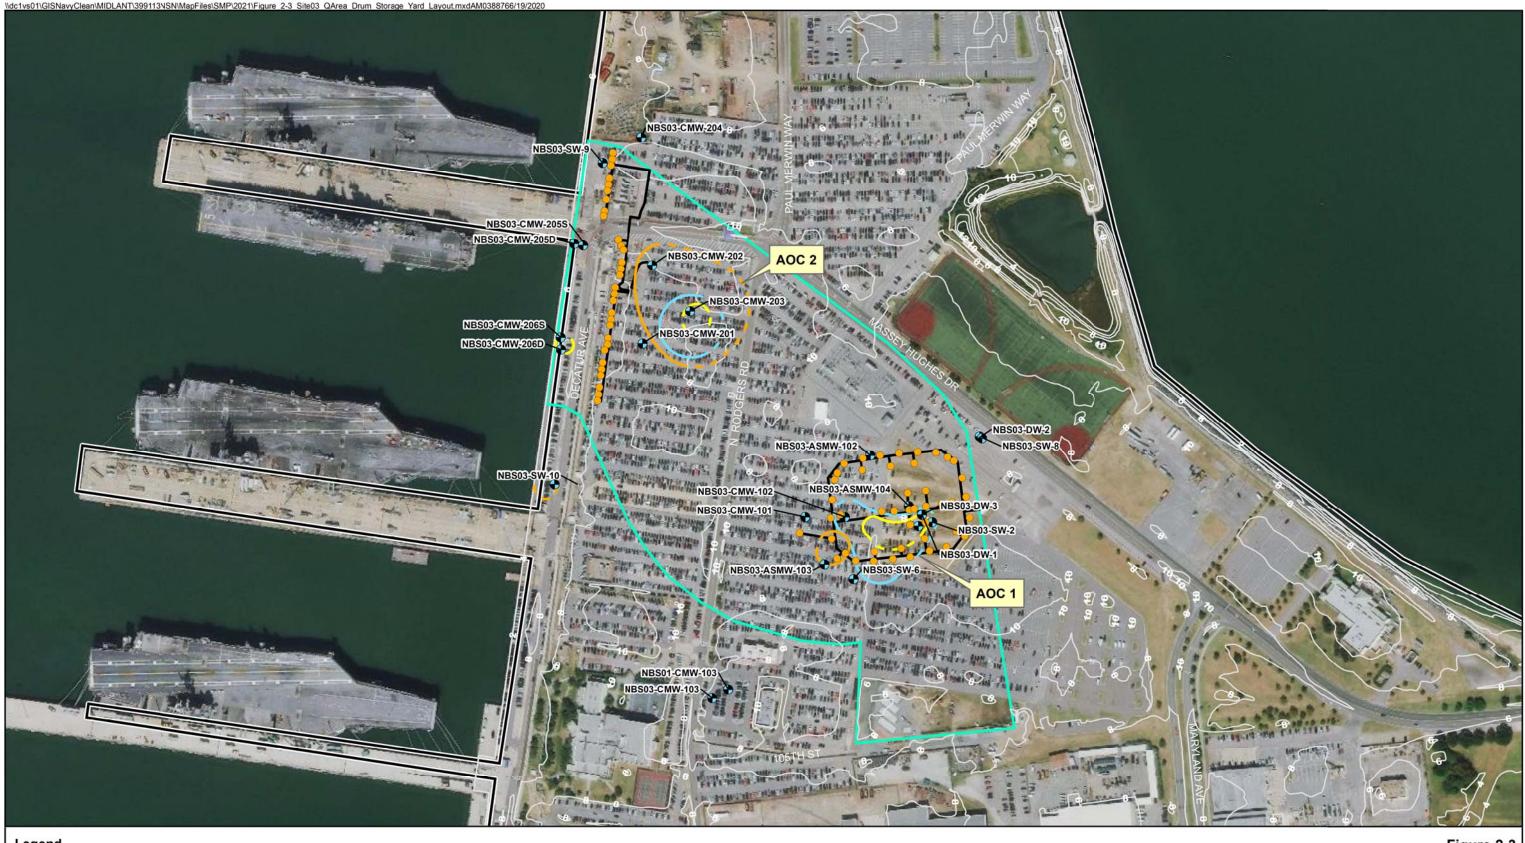
Figure 2-3 Site 3 - Q-Area Drum Storage Yard FY2021 Site Management Plan Naval Station Norfolk Norfolk, Virginia

The Q-Area Drum Storage Yard, shown on **Figure 2-3**, was previously a compound that occupied approximately 5 acres in the northwestern corner of the NSN near the carrier piers. This area of NSN was created by dredging operations in the early 1950s as the Base expanded. The Q-Area Drum Storage Yard was an open earthen yard that was used from the 1950s until the late 1980s to store tens of thousands of drums. Most of the drums contained new petroleum products, various chlorinated organic solvents, paint thinners, and pesticides. Previous investigations showed dark stains on the soil and oil-saturated soil throughout the storage yard, indicating past spills. The northern portion of the yard, which was used to store leaking or damaged drums and hazardous materials, was particularly stained.

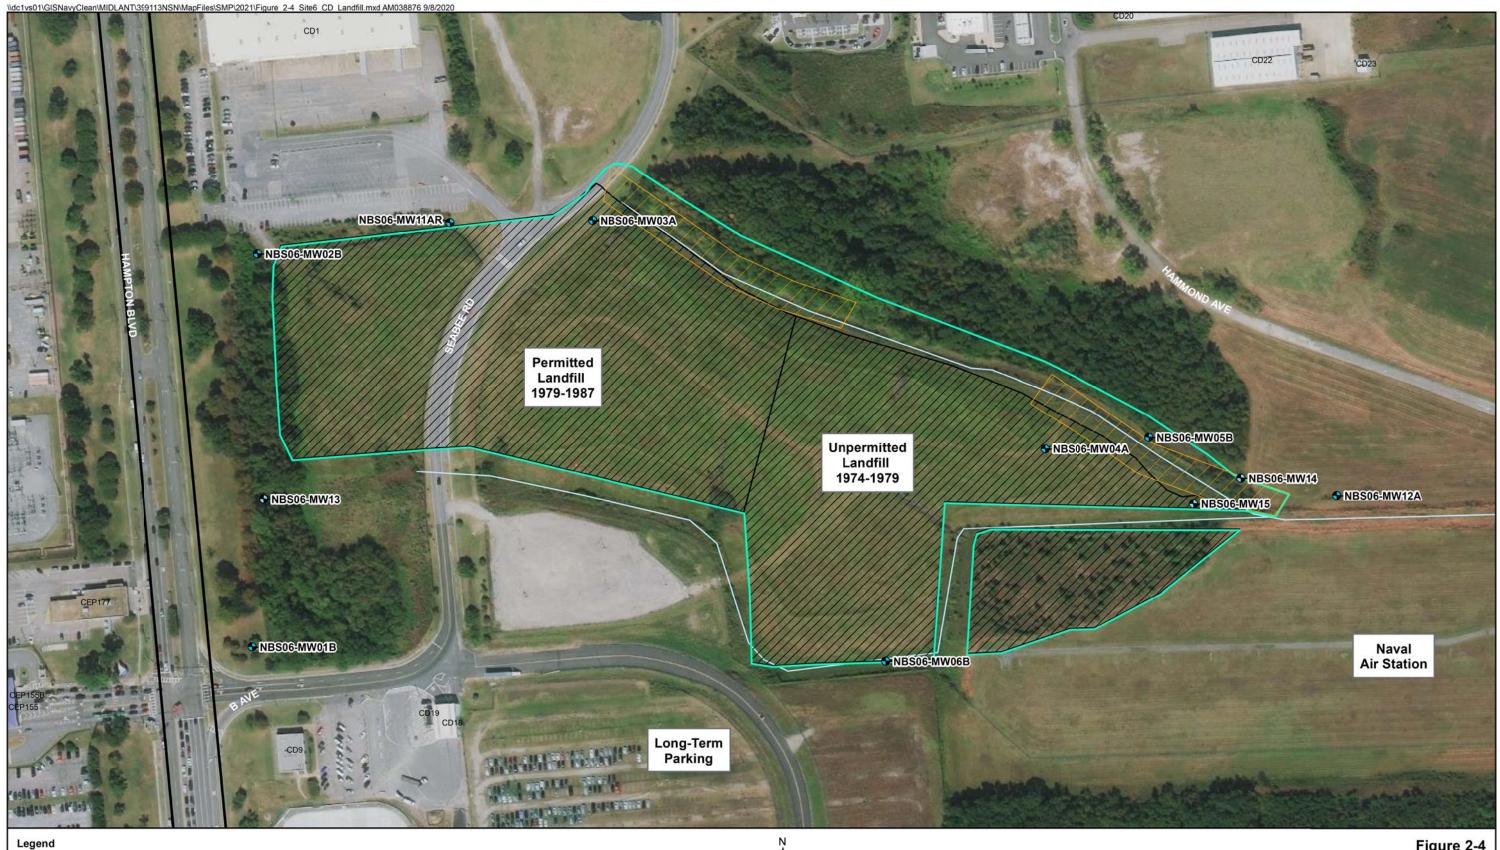
Figure 2-4 Site Map Site 6 - CD Landfill FY2021 Site Management Plan Naval Station Norfolk Norfolk, Virginia

In October 1979, NAVFAC received a permit from the Virginia Department of Health to use the landfill (western portion) for disposal of demolition debris and other non-putrescible wastes, excluding fly ash, incinerator residues, chemicals, and asbestos. Blasting grit used for sandblasting cadmium-plated aircraft parts was deposited at the landfill until 1981, when the blasting grit was tested and found to exceed the USEPA extraction procedure toxicity limit for cadmium. The grit was classified as a hazardous waste, and onsite disposal of the material ceased. Landfilling operations continued in the western portion of the site until 1987. At the time the landfill permit was granted, a portion of the southeastern corner of the site was regraded to allow for runway expansion at the Naval Air Station. The design of the runway expansion specified that excess material was to be spread over the landfill and not removed from the site.

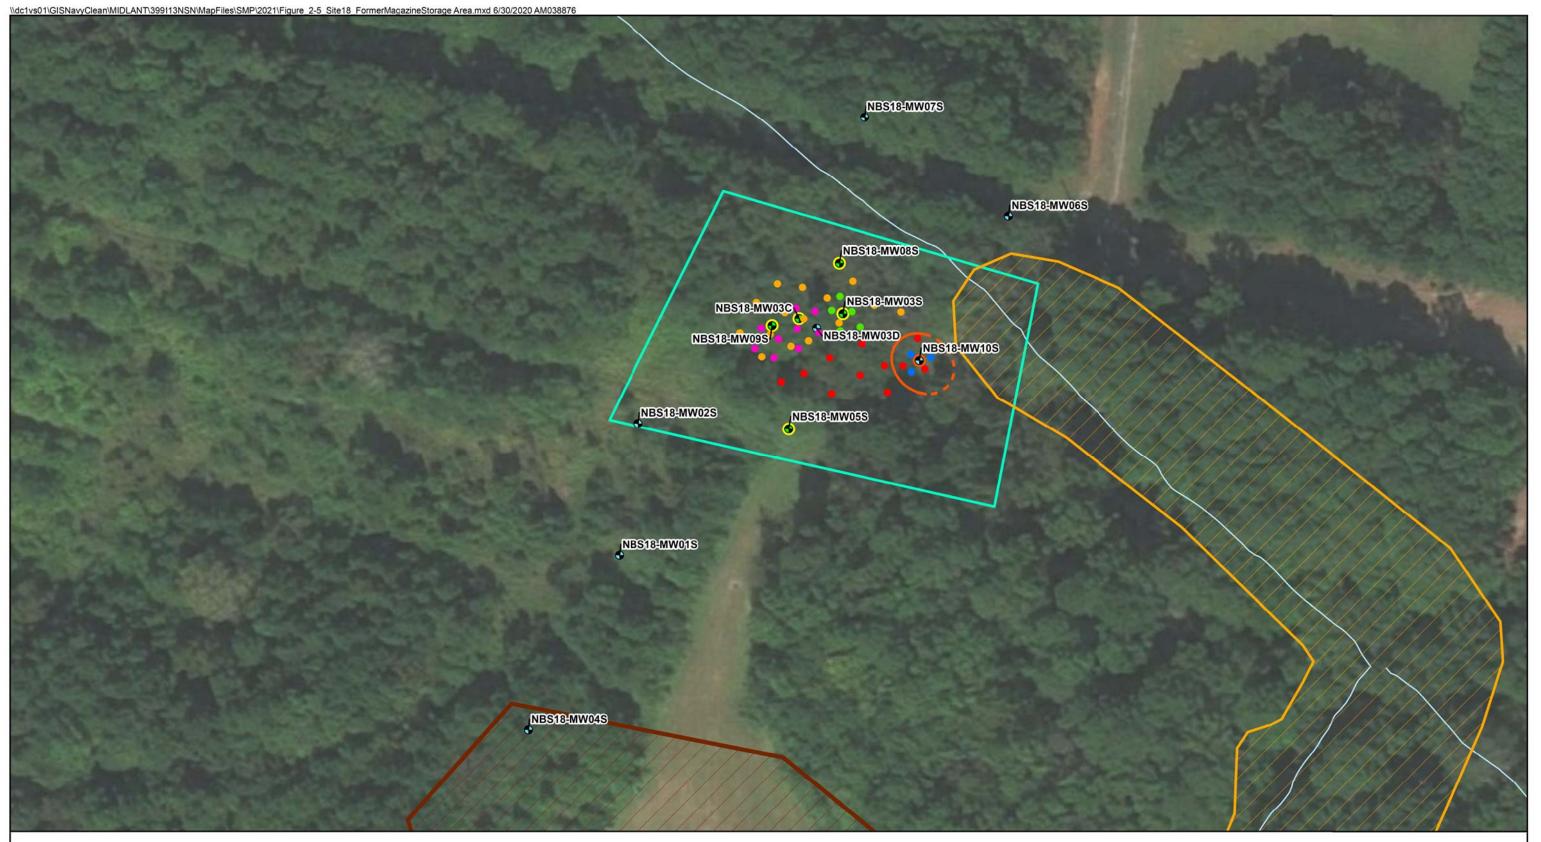
Figure 2-5 Site 18 - Former Naval Magazine Storage Area FY2021 Site Management Plan Naval Station Norfolk Norfolk, Virginia

The former Naval Magazine Storage Area (**Figure 2-5**) is located in the southeastern corner of NSN and was used from 1975 to 1979 to store drums of hazardous waste, consisting of waste oil, metal plating solutions and sludges, chlorinated organic acids (including TCE and 1,1,1-trichloroethane), and paint stripping solutions. Spillage of waste oil and hazardous wastes occurred in this area. A pit was excavated, and an existing drainage ditch was widened and lengthened to channel waste oil and contaminated runoff into an unlined pit. Oil and contaminated water were periodically pumped from the pit and transported to a wastewater treatment plant.

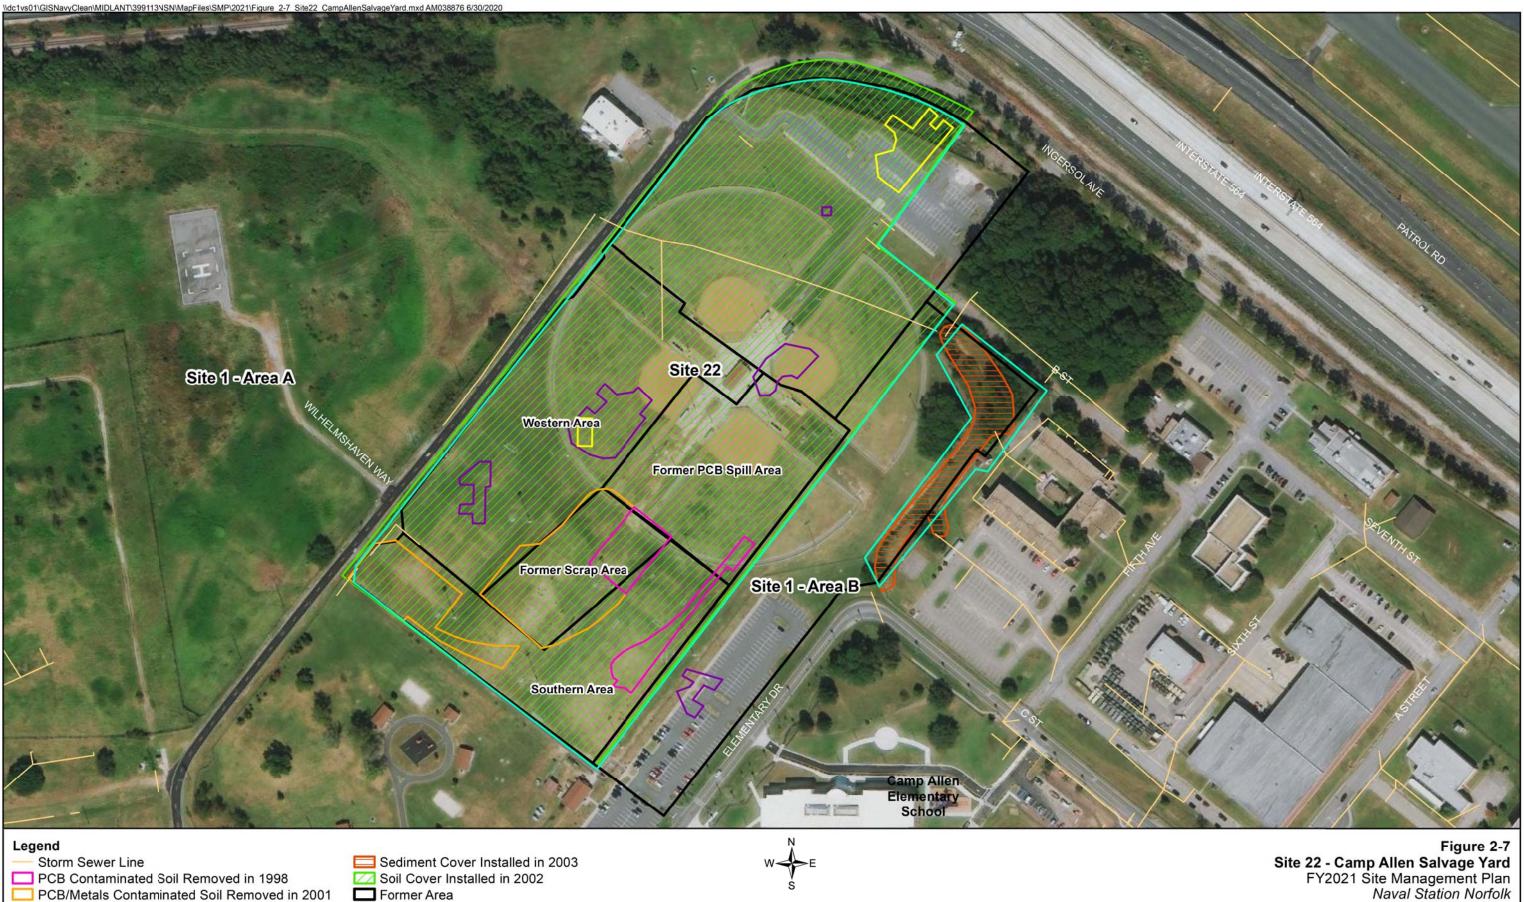
Figure 2-7 Site 22 - Camp Allen Salvage Yard FY2021 Site Management Plan Naval Station Norfolk Norfolk, Virginia

The CASY operated from the 1940s until 1995, salvaging and processing scrap materials generated at NSN. The CASY is located between Area A and Area B of the CALF site (Site 1), as shown on **Figure 2-7**. The CASY activities have included storage and management of waste oils, used chemicals, and scrap industrial and commercial equipment. Metal smelting, various recycling activities, and miscellaneous burning also occurred at the CASY. In addition, the facility was used to store acids, paint thinners, solvents, pesticides, and transformers. A polychlorinated biphenyl (PCB) spill occurred at the CASY in 1989, when a transformer was damaged by a forklift. The Public Works Center responded to the spill and conducted a preliminary cleanup at that time. When operations ceased in 1995, the buildings, incinerators, and rail lines were demolished.

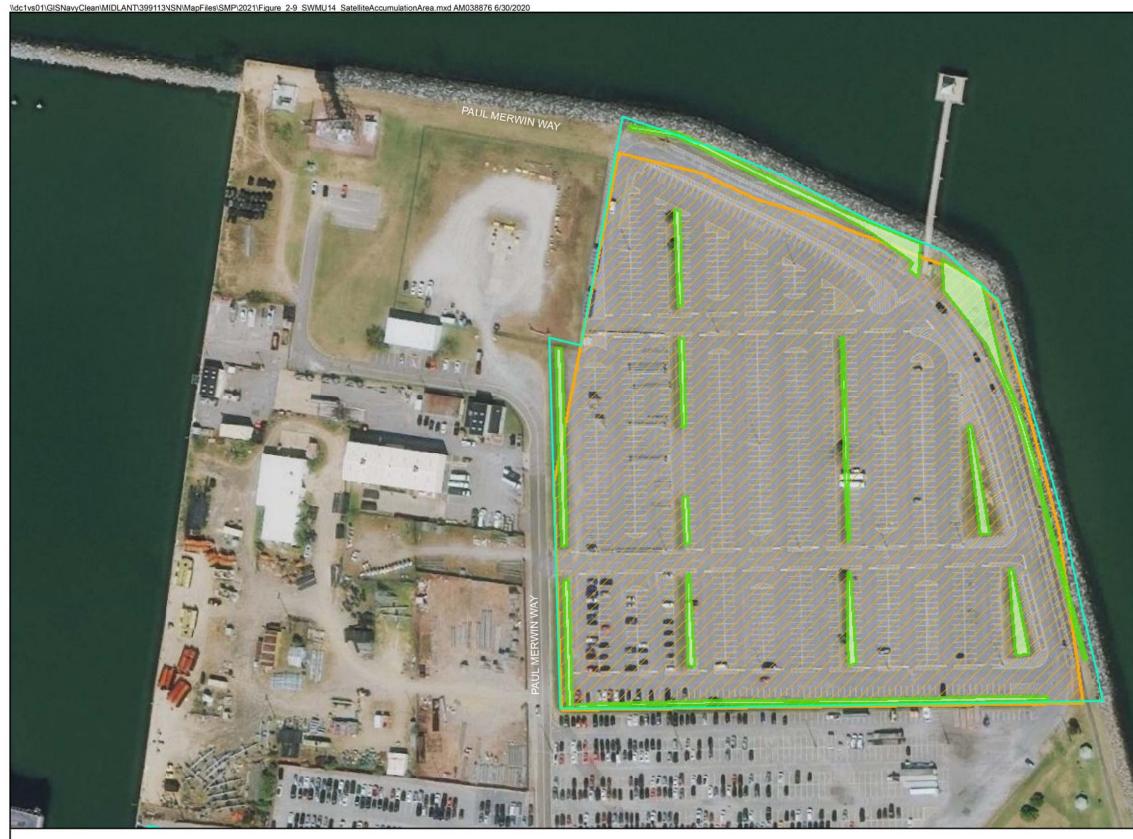
The Q-50 Satellite Accumulation Area (SWMU 14) is located in the northeastern corner of NSN, as shown on **Figure 2-9**. SWMU 14 consisted of a concrete storage pad surrounded by a grass-covered field. The pad served as a 90-day hazardous waste accumulation area where wastes generated by various operations were processed (sampled, identified, labeled, and packaged) before being shipped for eventual disposal. The original concrete pad for the accumulation area has since been removed. A new pad was installed west of the original location and is used for temporary storage of CERCLA IDW materials.
