**FINAL THIRD FIVE YEAR REVIEW NORFOLK NAVAL SHIPYARD
PORTSMOUTH VA**

Third Five-Year Review

Norfolk Naval Shipyard
Portsmouth, Virginia

This report documents the Third Five-Year Review for Operable Unit (OU) 2 (Sites 3, 4, 5, and 6 Soils), OU4 (Site 17), and OU6 (Site 10) at Norfolk Naval Shipyard as required by the Comprehensive Environmental Response, Compensation, and Liability Act (CERCLA) in accordance with CERCLA §121(c), as amended, and the National Oil and Hazardous Substances Pollution Contingency Plan, Part 300.430(f)(4)(ii) of the Code of Federal Regulations.

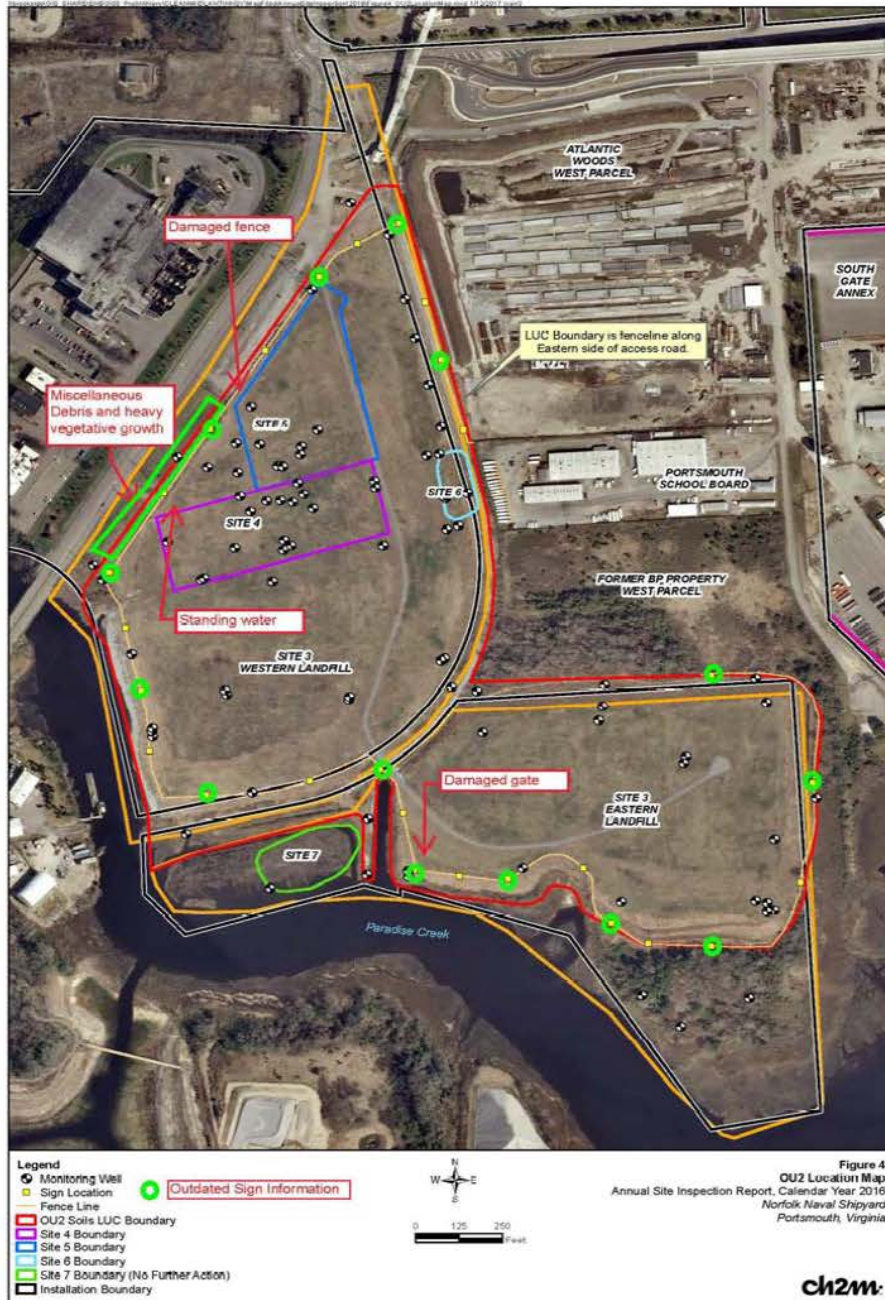
3 - Miscellaneous debris has accumulated outside the northwest perimeter fence to include mainly trash items
5 - A section of Western Landfill fencing to the northwest is leaning at roughly 60 degrees from the ground surface
5 - Sections of Western Landfill fencing on the western perimeter and along the road have heavy vegetative growth
5 - An Eastern Landfill access gate (east of the southern drainage ditch and north of Paradise Creek) appeared damaged and slightly pushed opened but still locked.
6 - Thirteen signs on the perimeter fence have outdated NAVFAC contact information.
7 - Vegetative overgrowth was noted in site drainage structures
9 - Near the northeast corner of Site 4 is an approximate 4' x 12' area with standing water and phragmites growth, which could indicate a depression in the soil cover or an improperly draining swale/ditch
(Enter suggested improvements to this form)

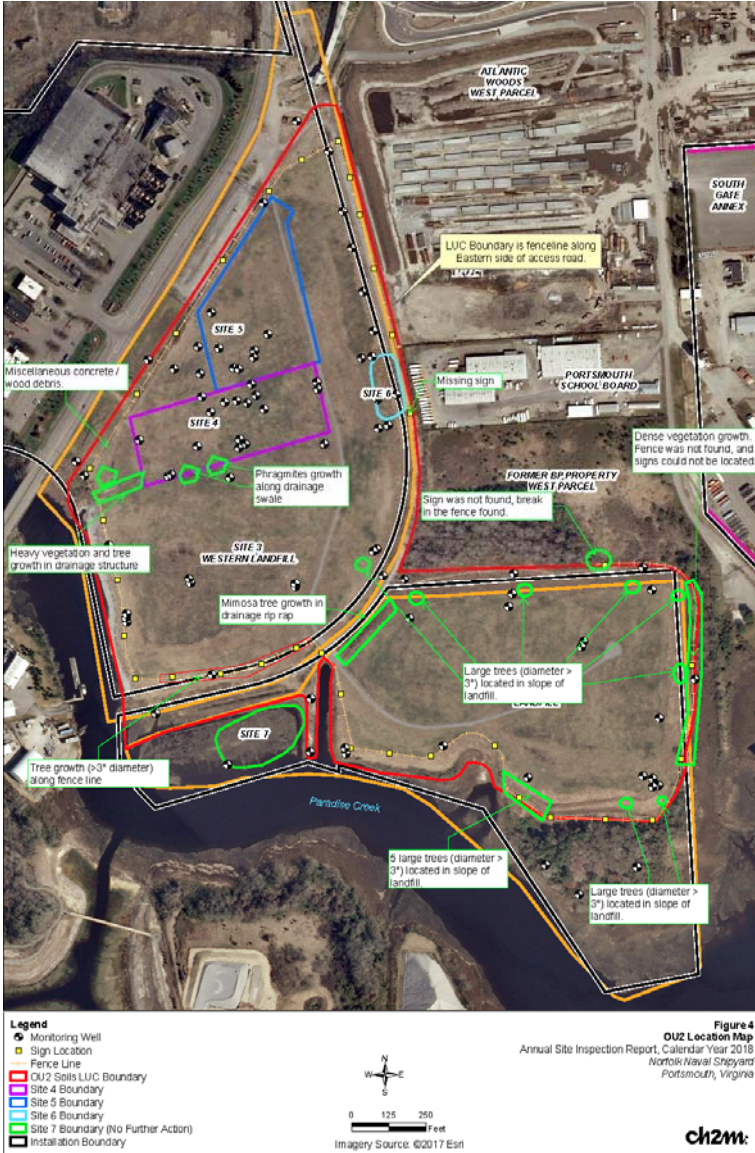
Site Specific Question 5 - A break in in the perimeter security fence was noted north of Site 3 - Eastern Landfill
Site Specific Question 6 - Signs were missing or could not be found at 4 locaitons along the perimeter fencing.
Site Specific Question 8 - All monitoring wells outside of the fence were found to be equipped with locks; monitoring wells within the locked security fence were not locked.
Site Specific Question 9 - Large diameter trees (>3") were observed along the edge of the landfill cap or in the slope of the landfill cap in various areas of Site 3.
(Enter suggested improvements to this form)
