**Preliminary Assessment for  
Per- and Polyfluoroalkyl Substances**

Naval Auxiliary Landing Field Fentress  
Chesapeake, Virginia

December 2021

Prepared for NAVFAC Mid-Atlantic  
by CH2M HILL, Inc.  
Virginia Beach, Virginia  
Contract N62470-16-D-9000  
CTO WE01

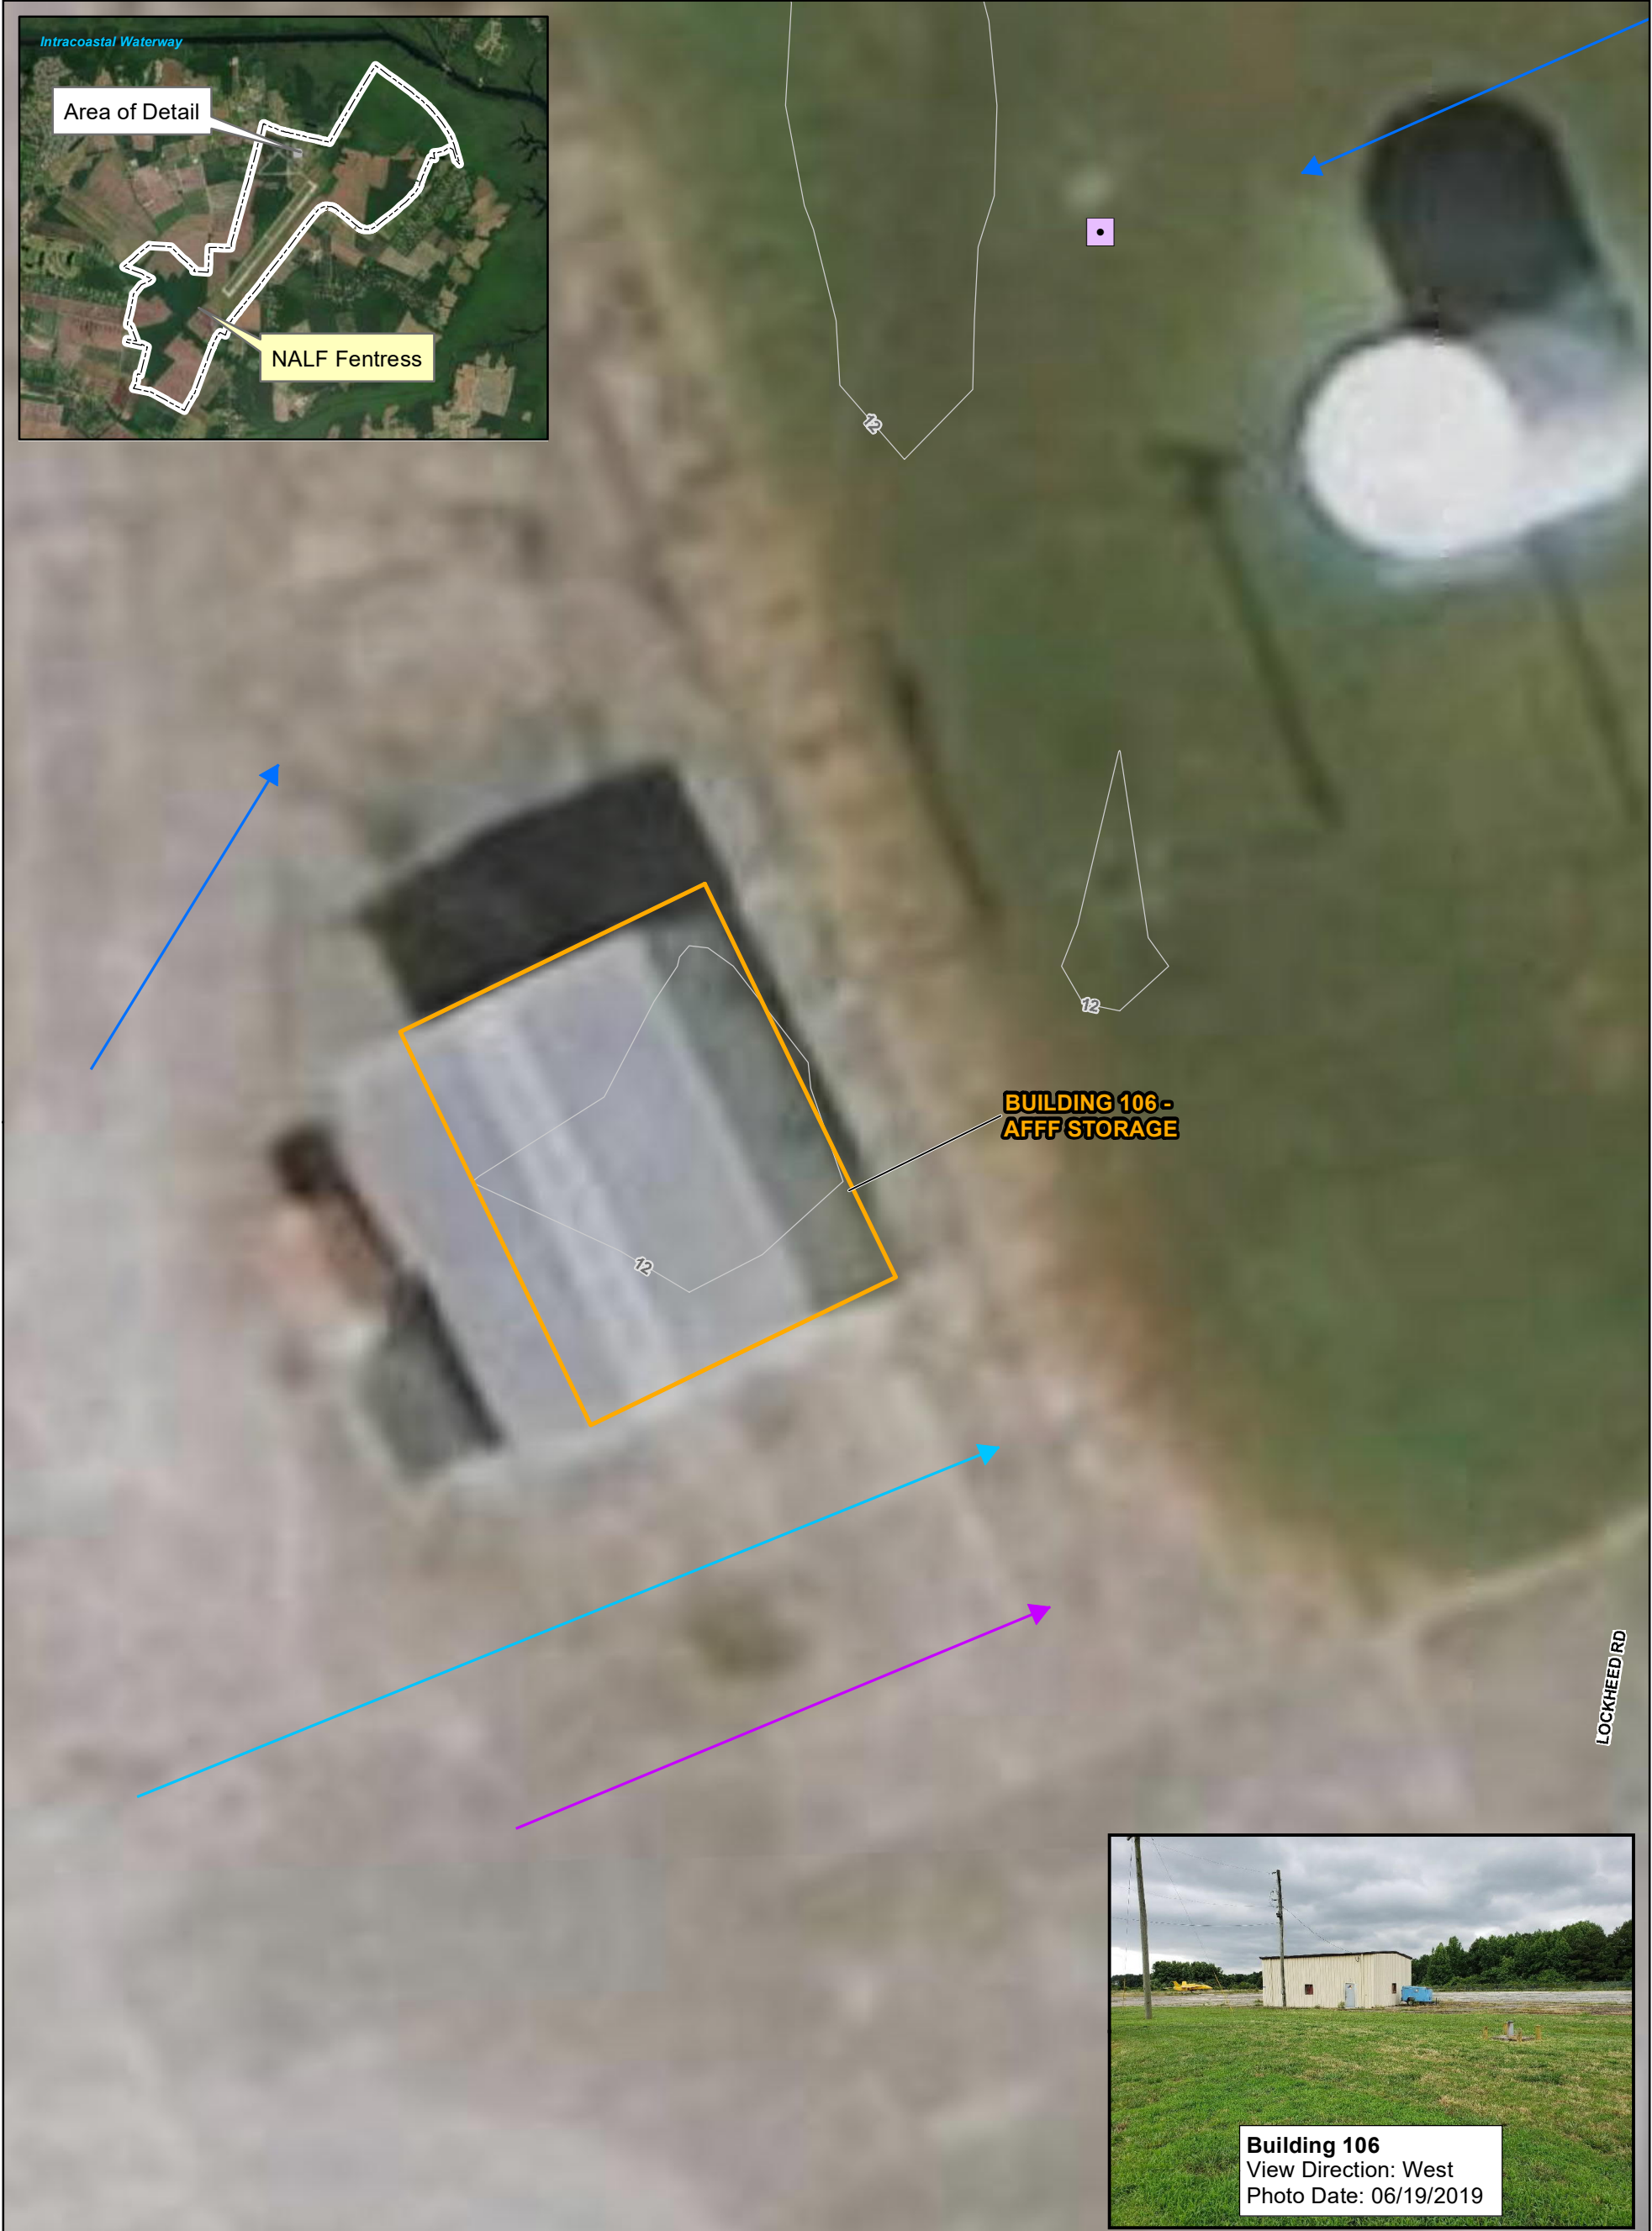
Figure 4-2  
Building 106 - AFFF Storage  
PFAS Preliminary Assessment  
NALF Fentress  
Chesapeake, Virginia

AFFF potentially released at Building 106 was likely transported via surface runoff from paved areas to the adjacent grassy areas northeast of the building to the sewer drain that leads to the WWTP (**Figure 4-2**). PFAS that infiltrated the subsurface soil likely migrated to the underlying Columbia/surficial aquifer. Groundwater flow in the Columbia/surficial aquifer is generally to the east or northeast toward the North Landing River. The Yorktown aquifer is generally confined within the north area of NALF Fentress. Groundwater flow in the Yorktown aquifer is to the east-northeast toward the North Landing River. PFAS could be transported northeast via advection and dispersion with groundwater flow partitioning to sediment and surface water where the discharge occurs into the river.

Additional investigation, including groundwater and soil sampling, is recommended at Building 106. It is recommended that the sampling be combined with further investigations at AOC 1.

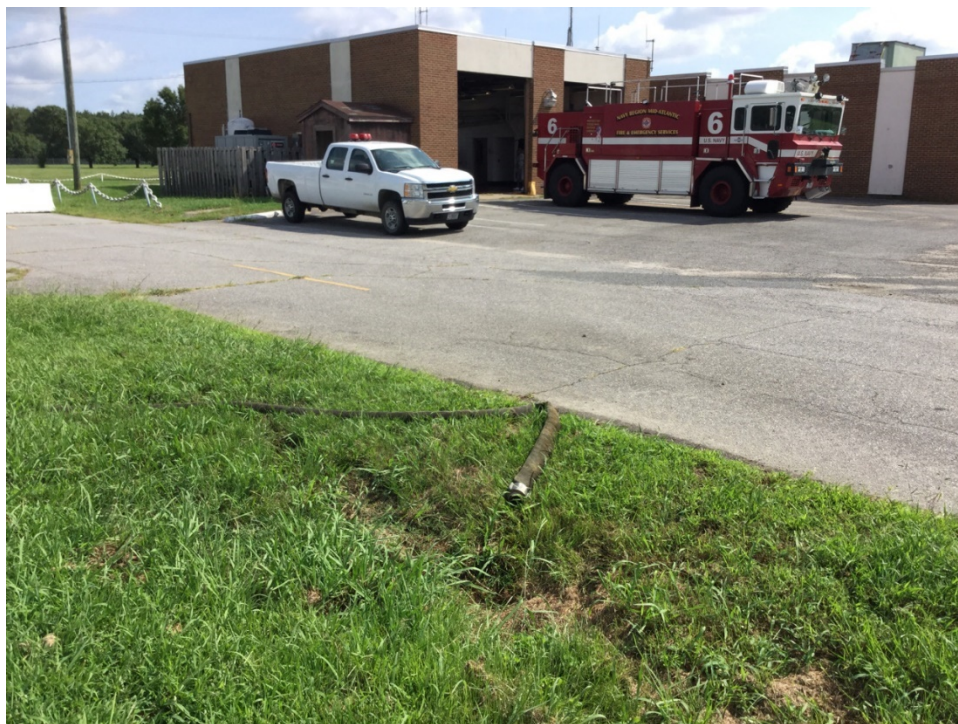
Photo 9: The southwest side of the Fire Station (Building 100); there is a sewer drain in the grassy area of the photo  
View Direction: Facing north, September 3, 2020

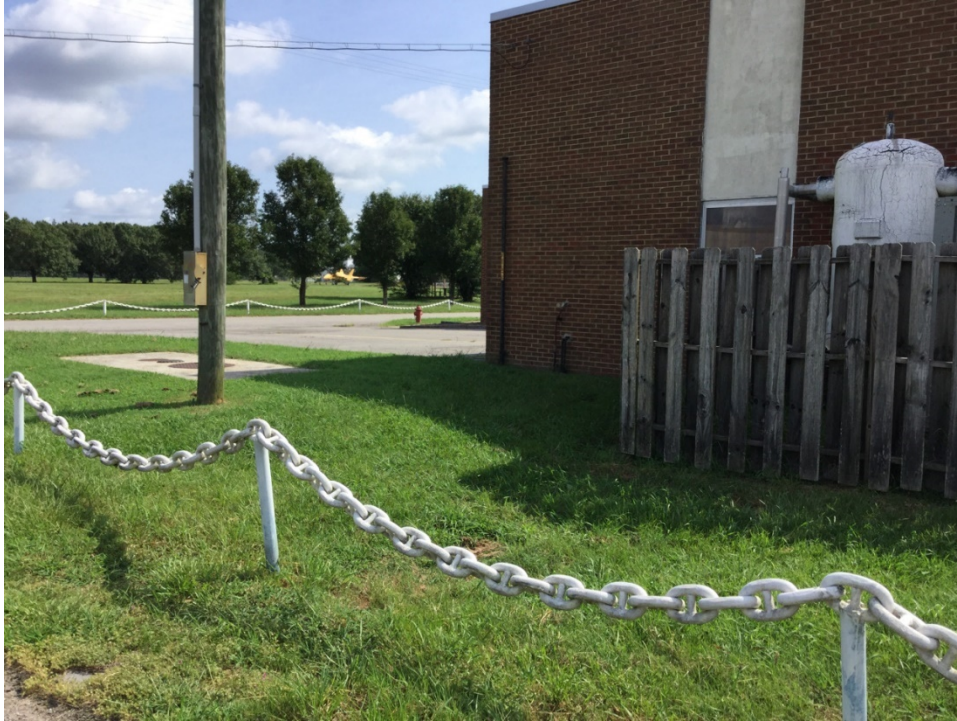
Photo 11: Location of drains near the west side of the Fire Station (Building 100)  
View Direction: Facing north, September 3, 2020

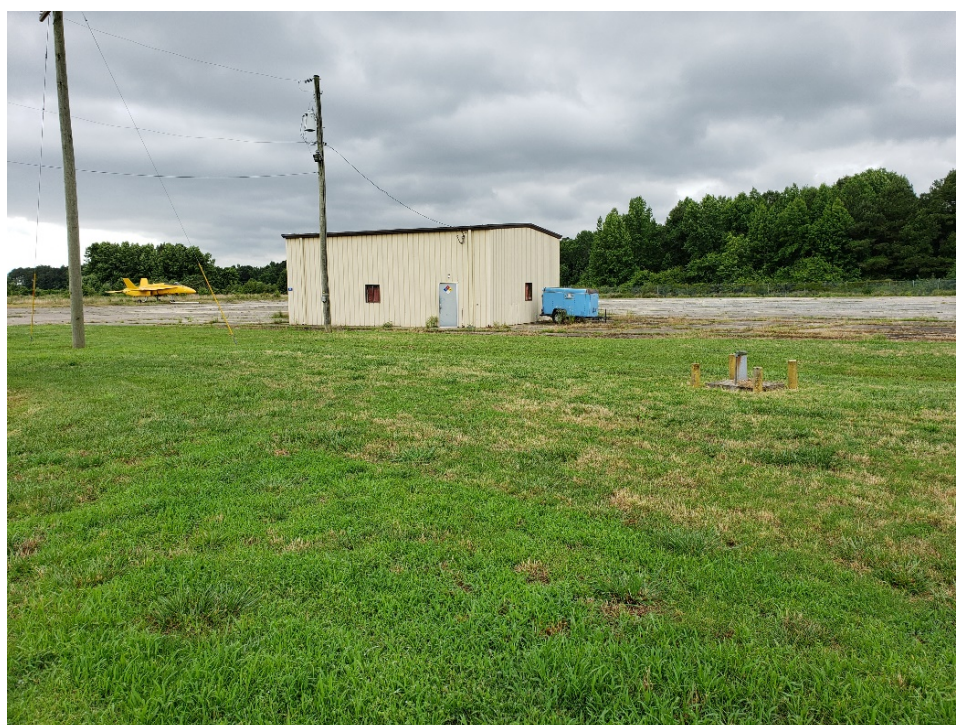
Photo 24: Building 106; former AFFF storage and transfer area  
View Direction: Facing west, June 19, 2019

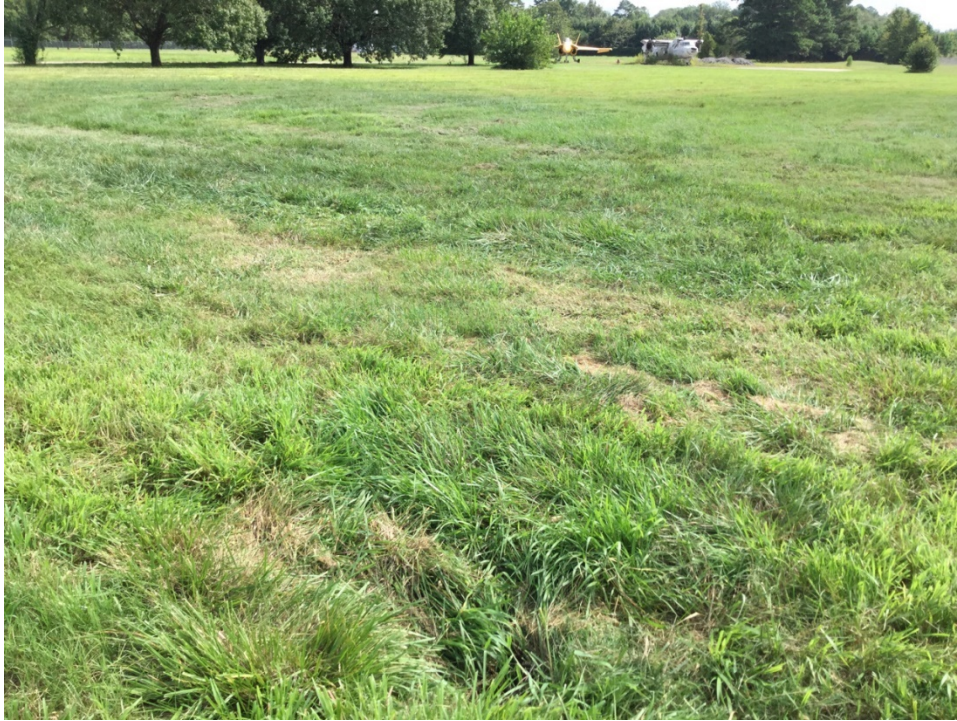
Photo 31: 1980 F-4 Phantom Crash location; sewer drain is obscured by tall grass  
View Direction: Facing north, September 3, 2020

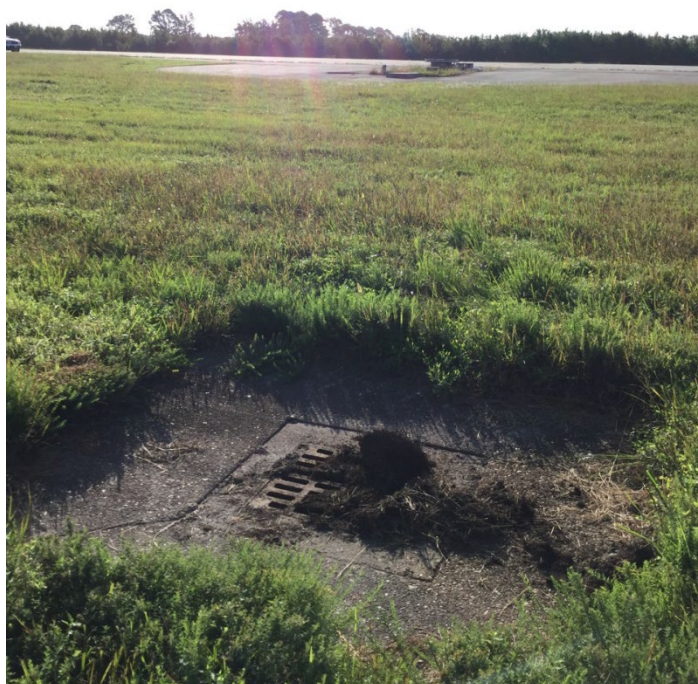
Photo 36: The sewer drain to the west of the 2001 F-14 Tomcat Crash location where water on  
the runway drains  
View Direction: Facing east, September 3, 2020

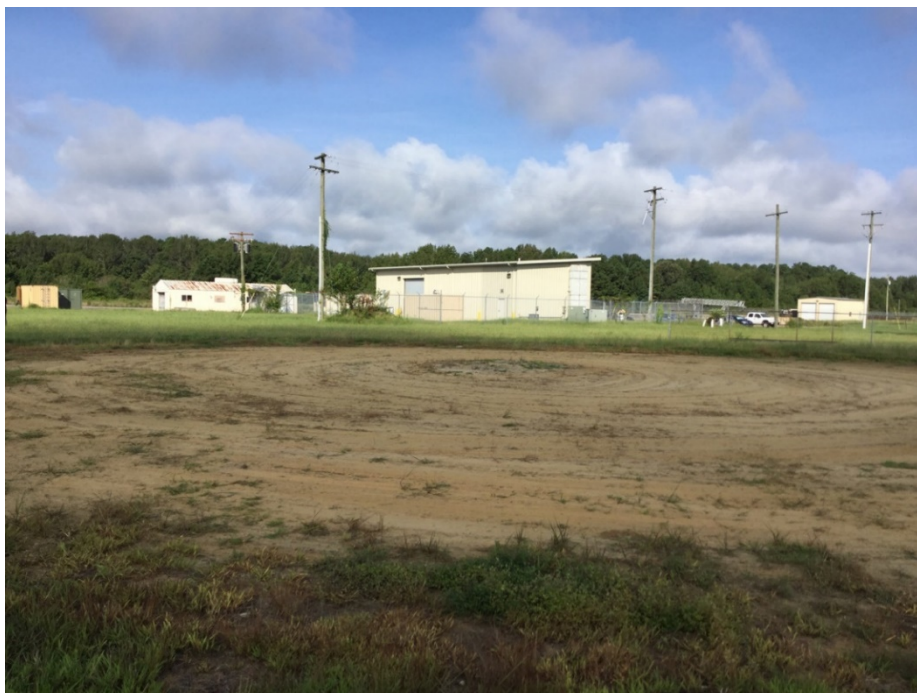
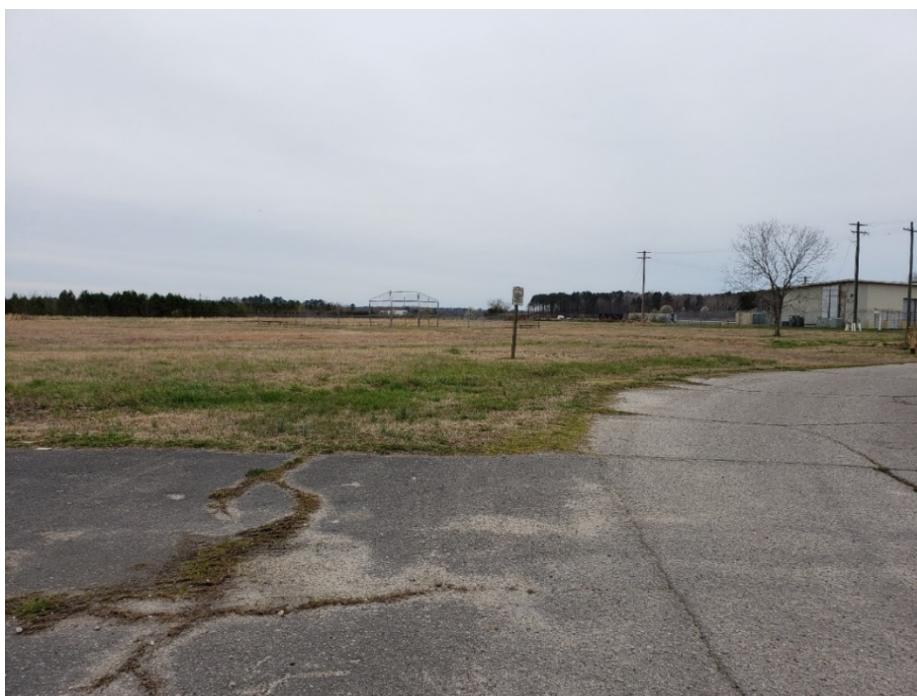
Photo 39: The approximate former location of the E-2 Hawkeye on Side of Tarmac  
View Direction: Facing west, September 3, 2020

Photo 40: The approximate former location of the E-2 Hawkeye on Side of Tarmac  
View Direction: Facing south, March 5, 2020

Additional investigation, including groundwater and soil sampling, is recommended at the E-2 Hawkeye on Side of Tarmac. It is recommended that the sampling be combined with further investigations at AOC 1.

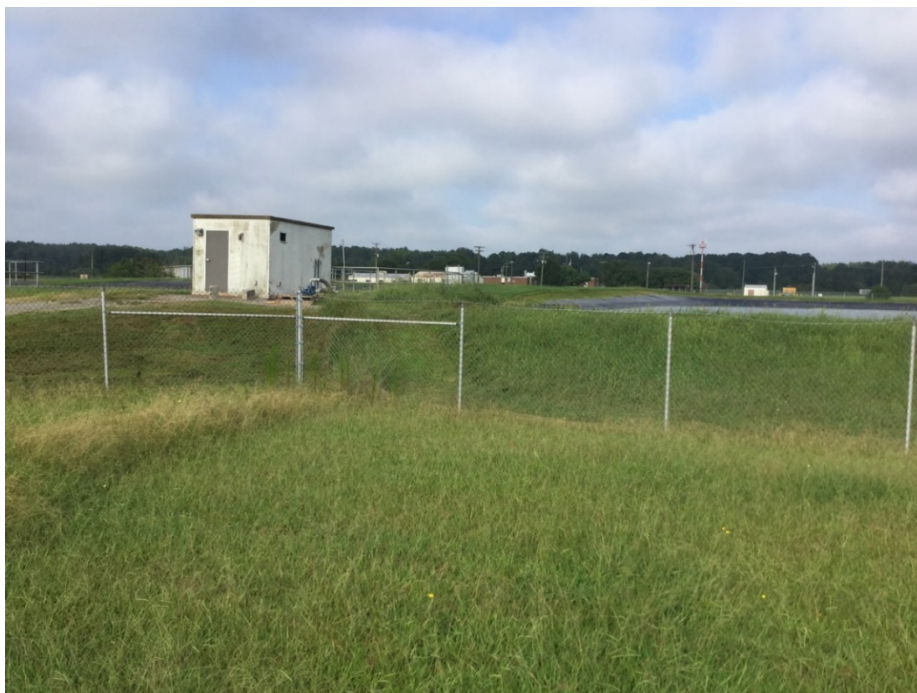
Photo 51: The east side of the Current Wastewater Treatment Plant and the berm and ditch that control surface water flow within the site  
View Direction: Facing west, September 3, 2020

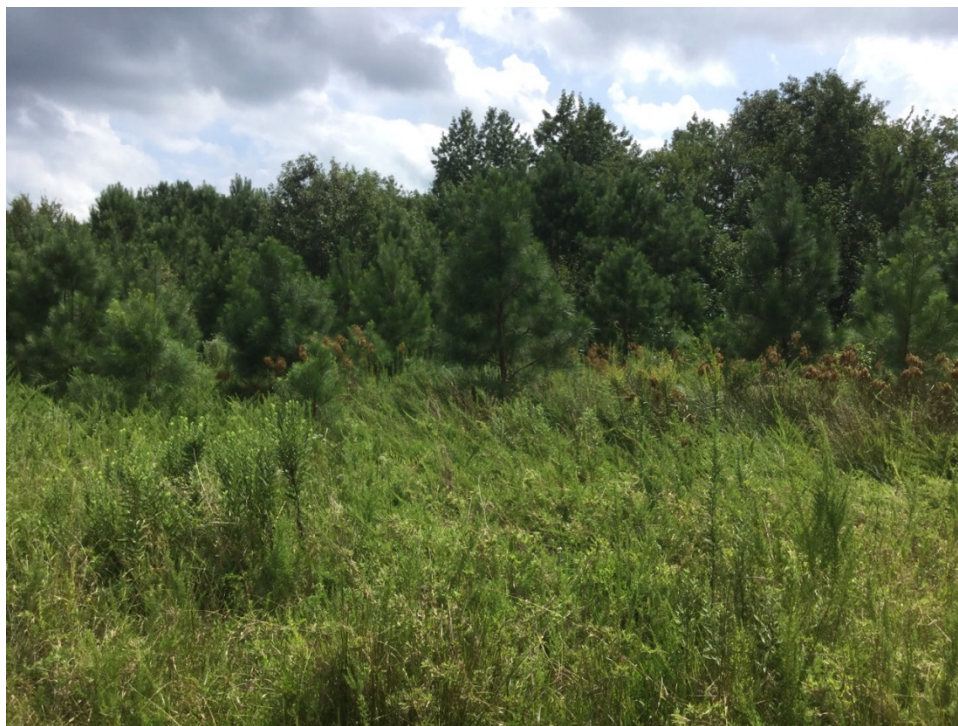
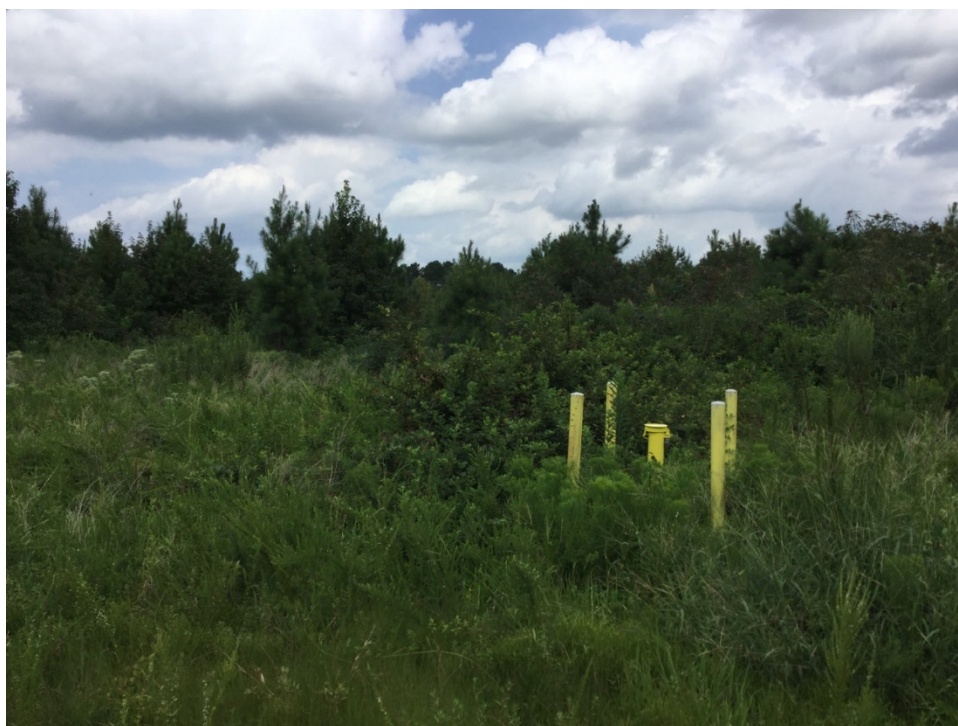
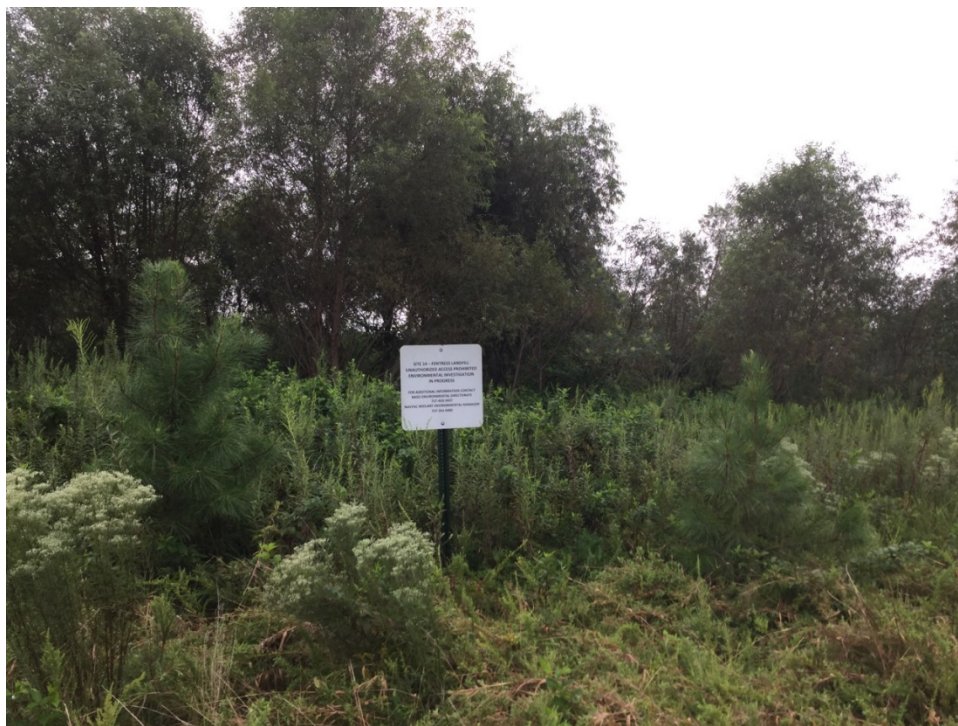
Photo 57: Site 14 – Fentress Landfill which is now covered in thick vegetation that limits access  
View Direction: Facing east, September 3, 2020

Photo 58: Site 14 – Fentress Landfill which is now covered in thick vegetation that limits access  
View Direction: Facing north, September 3, 2020

Photo 59: Site 14 – Fentress Landfill which is now covered in thick vegetation that limits access  
View Direction: Facing southeast, September 3, 2020
