**Project Management Plan
Fiscal Years 2021-2025**

Naval Air Station Oceana
Virginia Beach, Virginia

Prepared for NAVFAC Mid-Atlantic
by CH2M HILL, Inc.
Virginia Beach, Virginia
Contract N62470-16-D-9000
CTO 5379

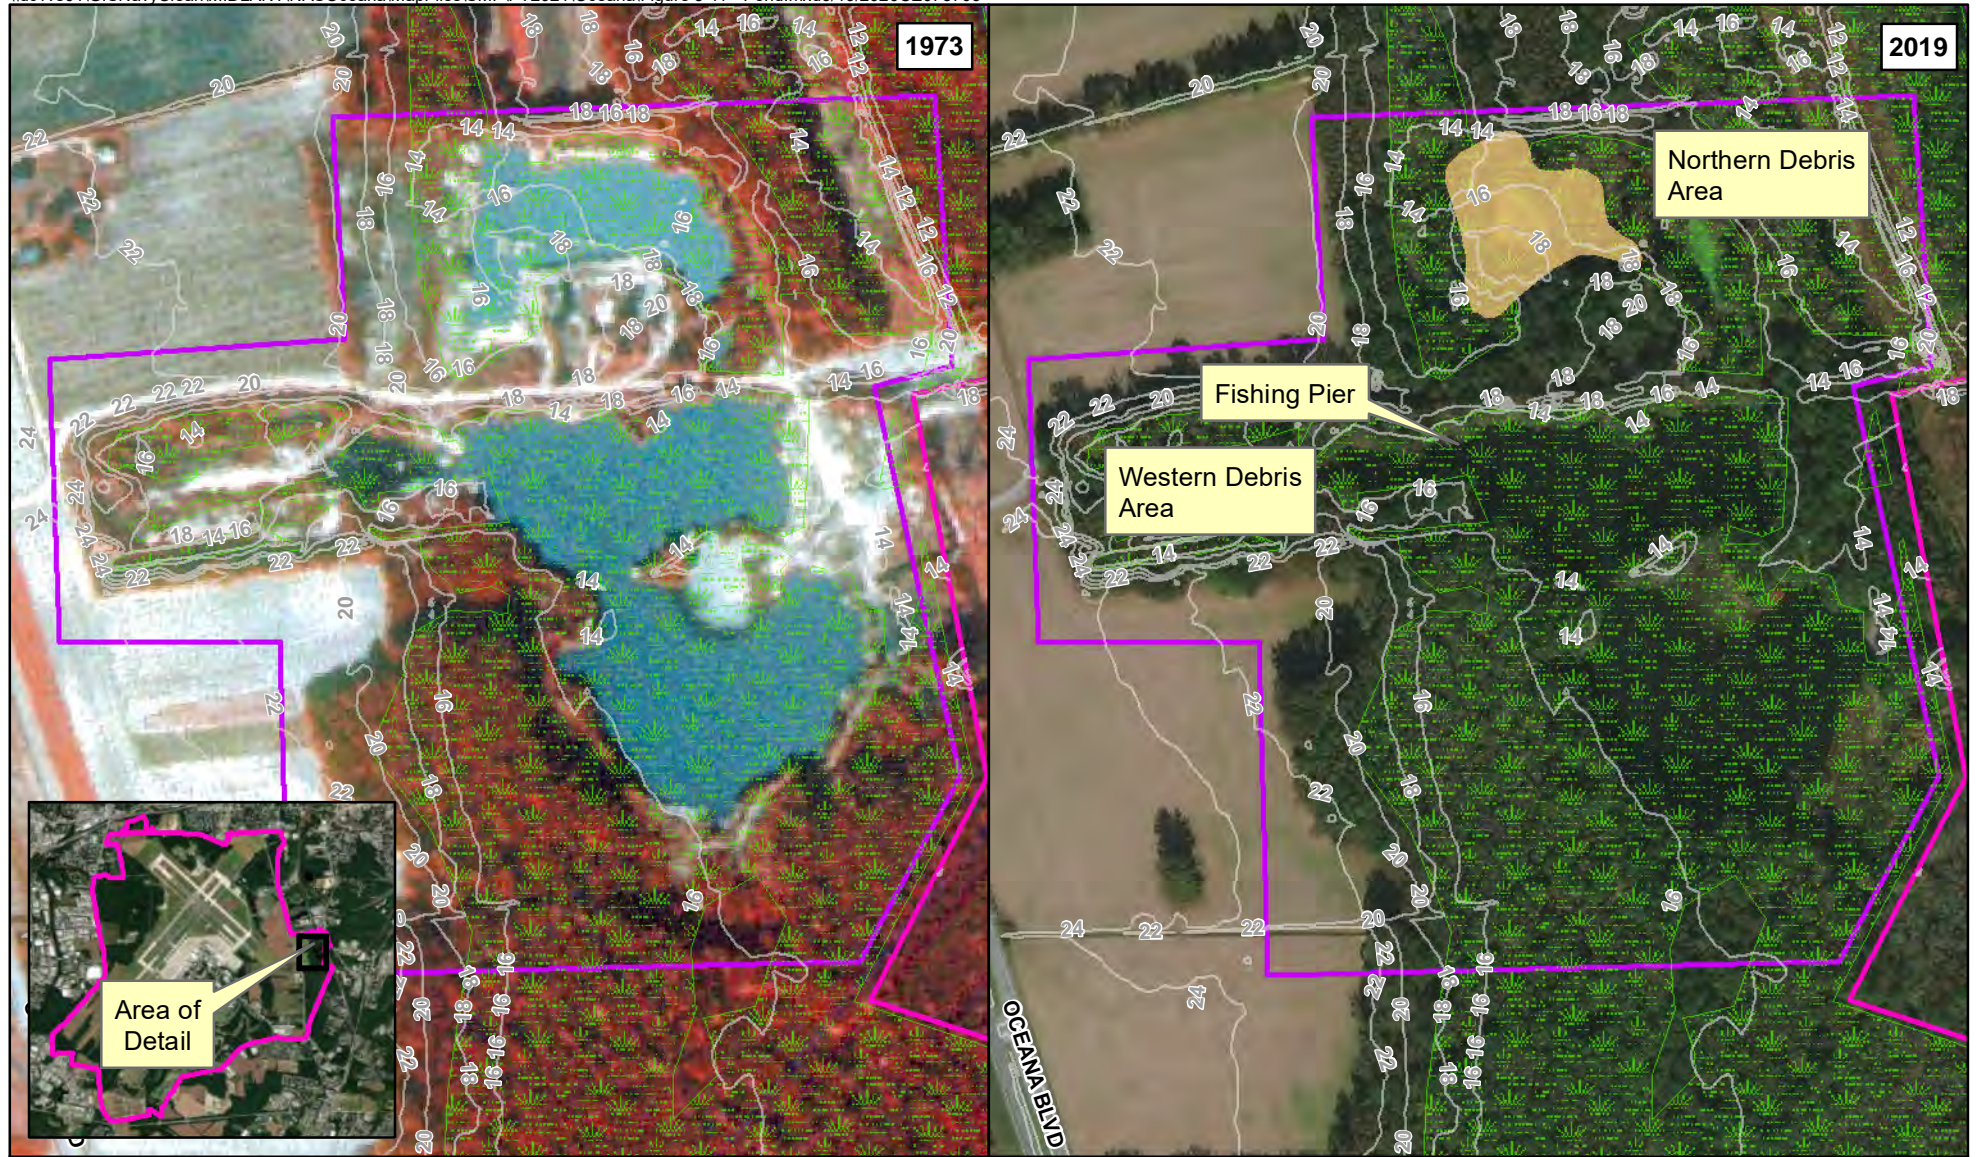
Figure 3-10
Construction Debris Landfill Site Layout
NAS Oceana
Virginia Beach, Virginia

Construction Debris Landfill is located in the northeastern portion of NAS Oceana. A detailed map of the SWMU is presented on **Figure 3-10**. The site is an approximately 0.55-acre unlined landfill. The years of operation are unknown, but the site was discovered in 1986 and was reported to be in use at the time of the RFA. Based on a recent review of aerial photography, it appears that activities within the site boundary may have begun in the late 1950s or early 1960s. The landfill was designated for construction debris; however, no controls were in place to prevent other waste from being disposed of. Based on observations during the RFA, the waste disposed of at the site included construction debris, furniture, empty paint cans, tires, and scrap metal (EarthTech, 1989).

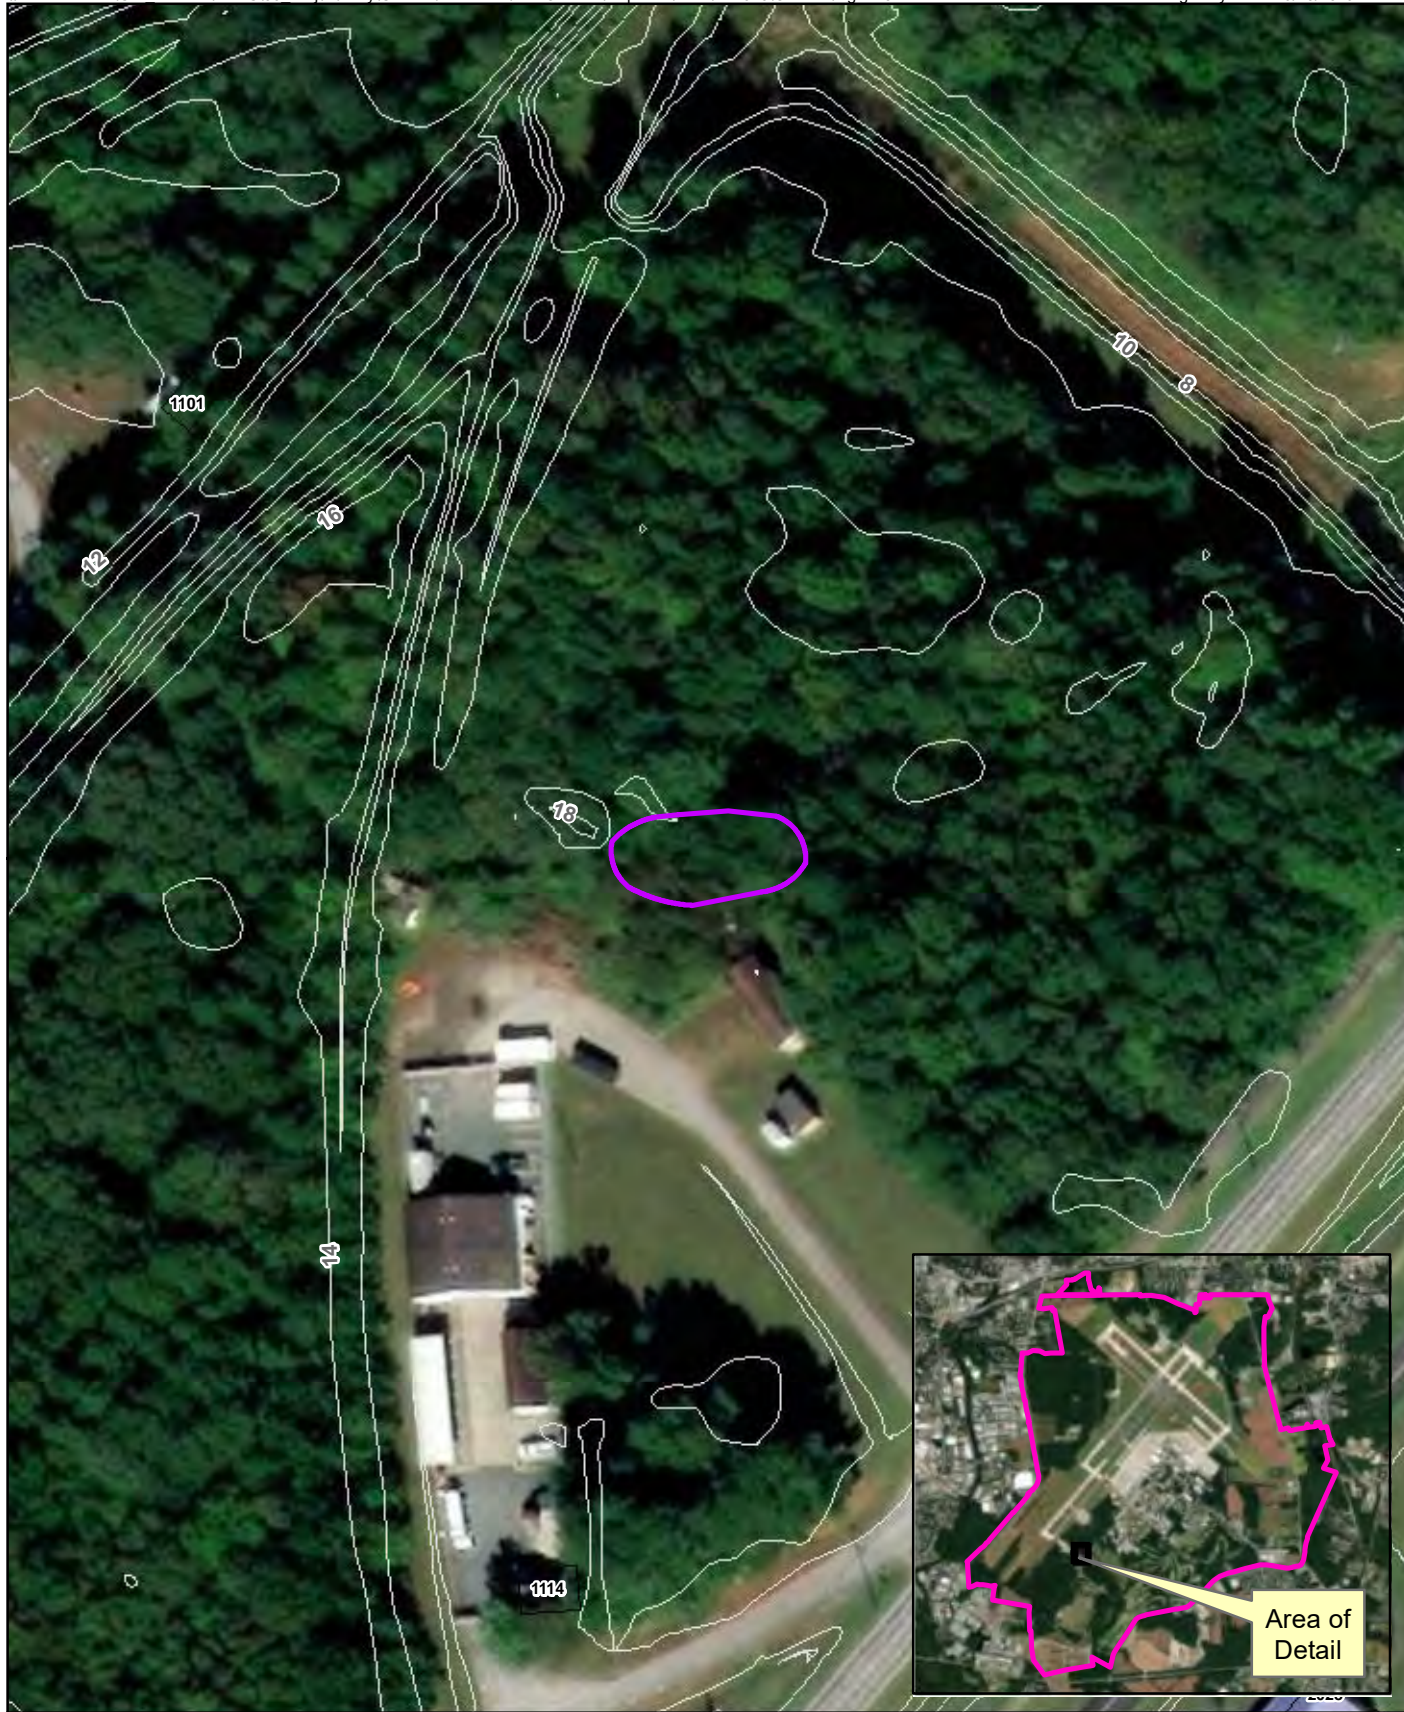
Figure 3-13
Former Wastewater Treatment Plant (WWTP) Layout
NAS Oceana
Virginia Beach, Virginia

The former Wastewater Treatment Plant (WWTP) was located at the northwestern part of NAS Oceana, west of the active runway. A detailed map of the site is presented on **Figure 3-13**. In the mid-1970s, NAS Oceana was connected to the Hampton Roads Sanitation District regional collection system; however, prior to that time all sanitary and industrial wastewater was treated at the on-installation plant (Buildings SD1 through SD10). The WWTP was put in operation in 1951 and prior to that, another WWTP was operated approximately 1,500 feet northeast of the WWTP. The effluent from the WWTP was discharged to a ditch running to the west of NAS Oceana. Sludge from the WWTP was either applied to land on the western edge of the installation, given away as fertilizer, or disposed of in landfills (Rogers, Golden & Halpern, 1984).

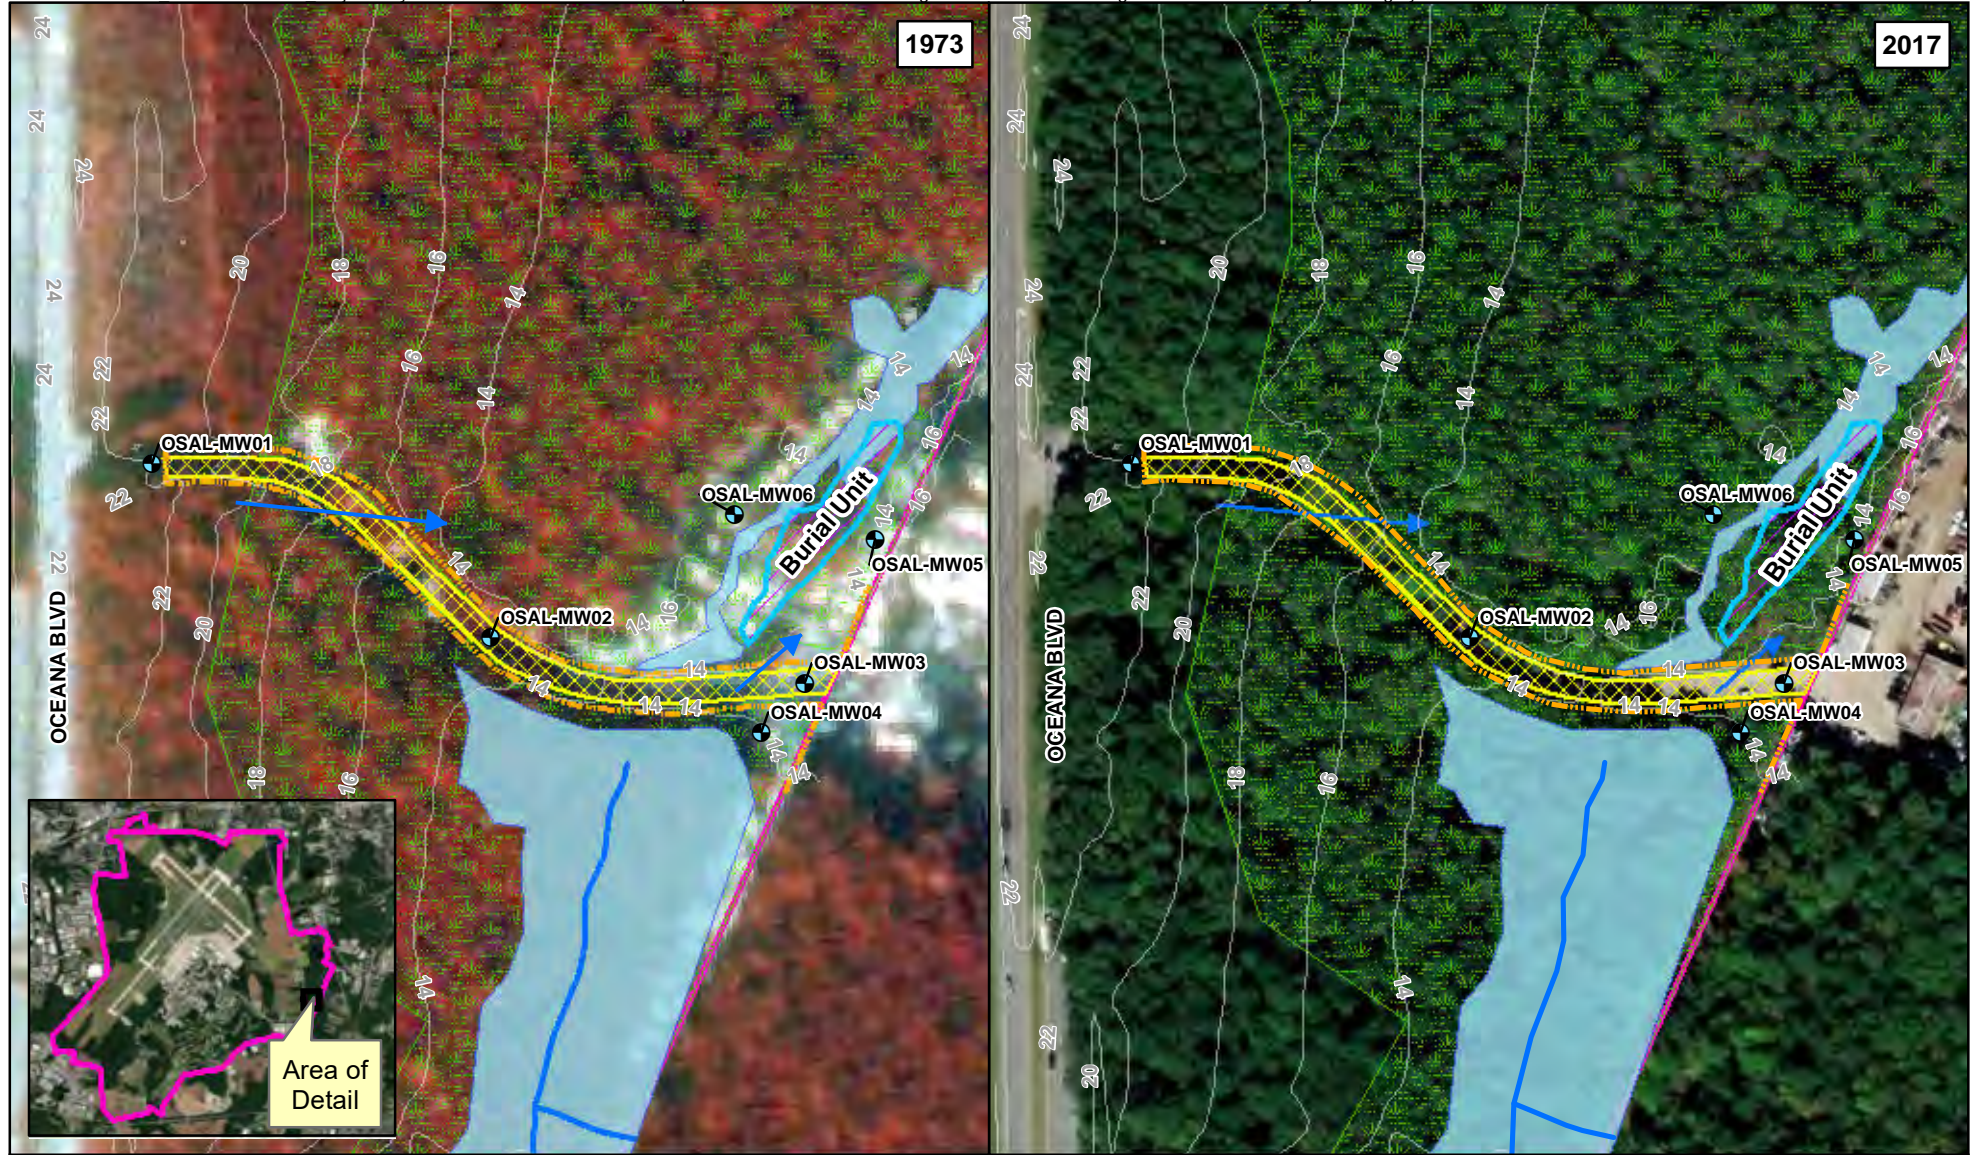
Figure 3-16
SWMU 26 Layout
NAS Oceana
Virginia Beach, Virginia

SWMU 26 (identified as SWMU 65 in the RFA [EarthTech, 1989]) southeast of Building 220 (Fire Station), consisted of a partially buried tank that was filled with waste fuel and oil, ignited, and extinguished with fire extinguishers. A detailed map of the SWMU is presented on **Figure 3-16**. SWMU 26 was used for fire extinguisher training exercises from the 1960s to the 1980s. The tank was removed from the ground by 1990. When in use, the burn residue and water were removed from the tank to an adjacent swale through a valved underdrain. Stormwater collects in the swale, but it does not drain to any surface water bodies. In 2001, SWMU 26 was closed with NFA. However, SWMU 26 was reopened for PFAS investigation based on the evaluation of sites with potential PFAS contamination (**Table 3-1**).

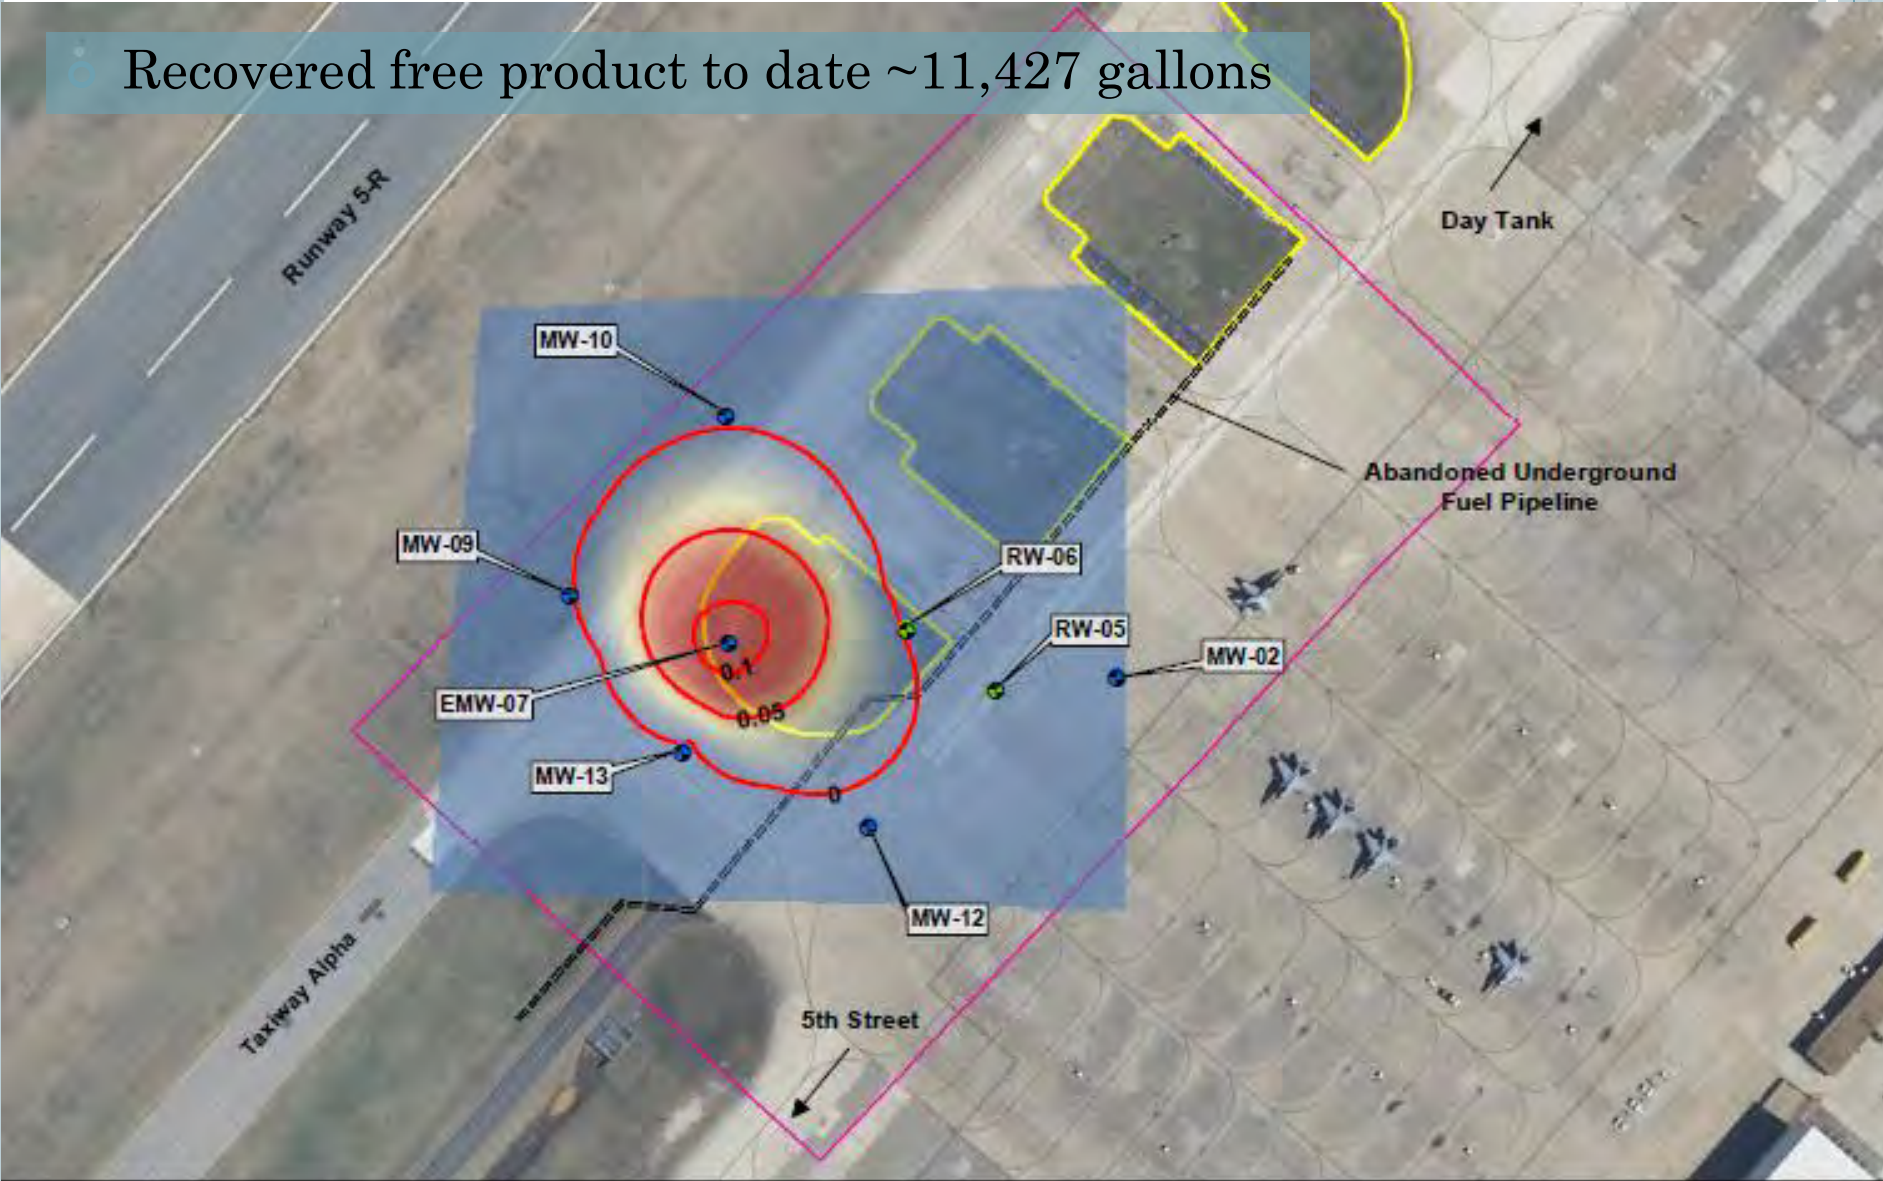
Figure 4 - Free Product Contour Map (April 2019)
FITWING
Naval Air Station (NAS) Oceana
Virginia Beach, Virginia

Recovered free product to date ~11,427 gallons

- Monitoring Well
- Recovery Well
- Abandoned Underground Fuel Pipeline
- Fuel Pit Boundary
- FITWING Site Boundary

PATH FORWARD: Continue efforts with solar skimmer at FITWING, manual hand bailing
*****NOTE – PFOA and PFOS above the USEPA Lifetime Health Advisory based upon IDW results.**

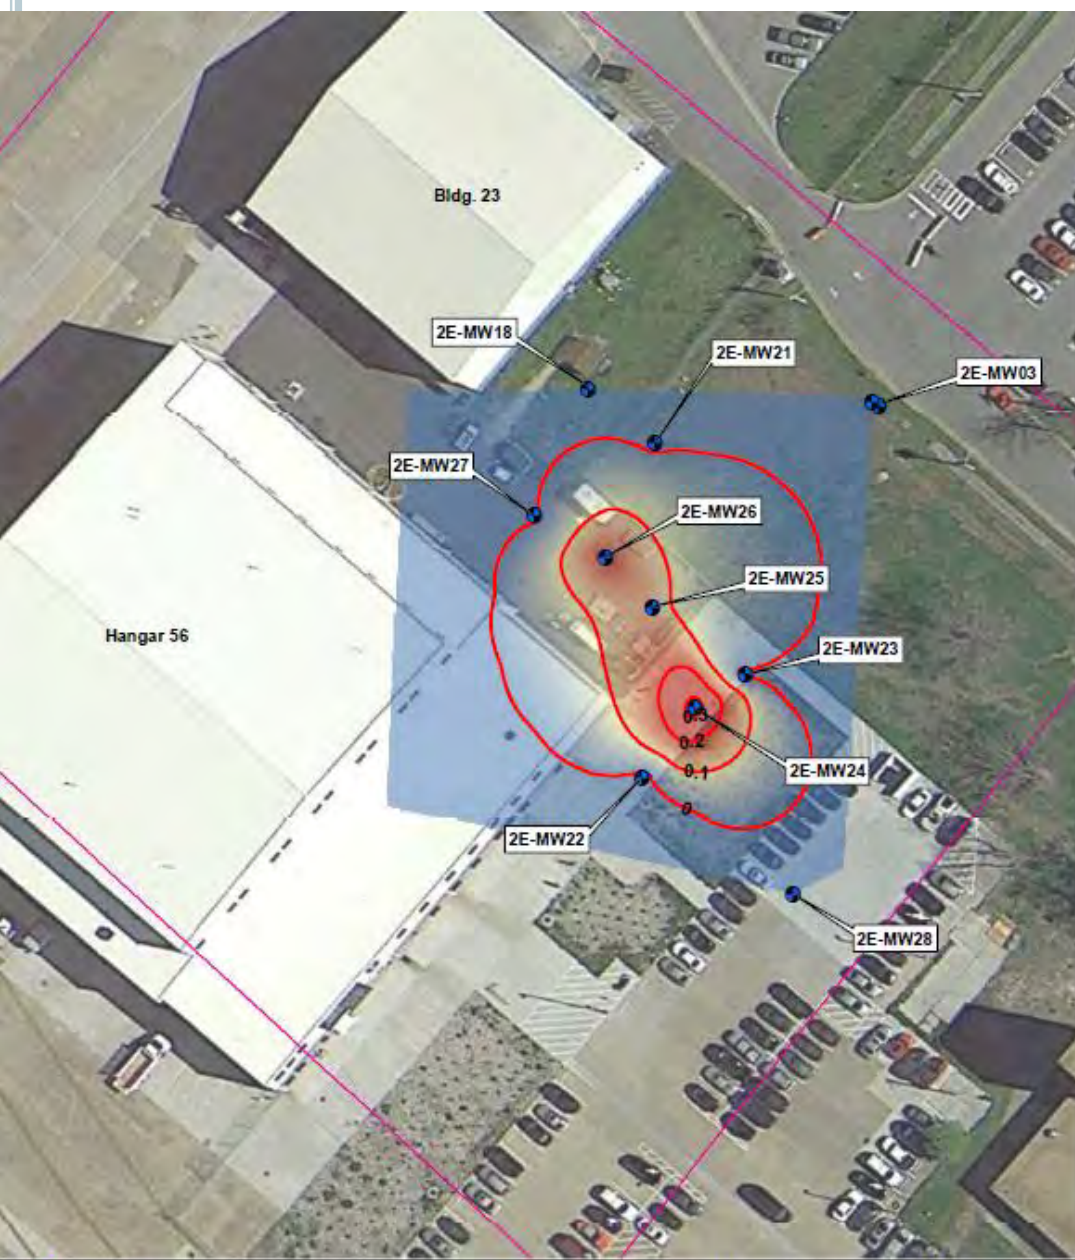
Figure 4 - Free Product Contour Map (April 2019)
SWMU 2E
Naval Air Station (NAS) Oceana
Virginia Beach, Virginia

- Recovered free product to date ~192 gallons

*****NOTE – have not tested physical site for PFOA/PFOS concentrations greater than USEPA Lifetime Health Advisory (70 ppt).**

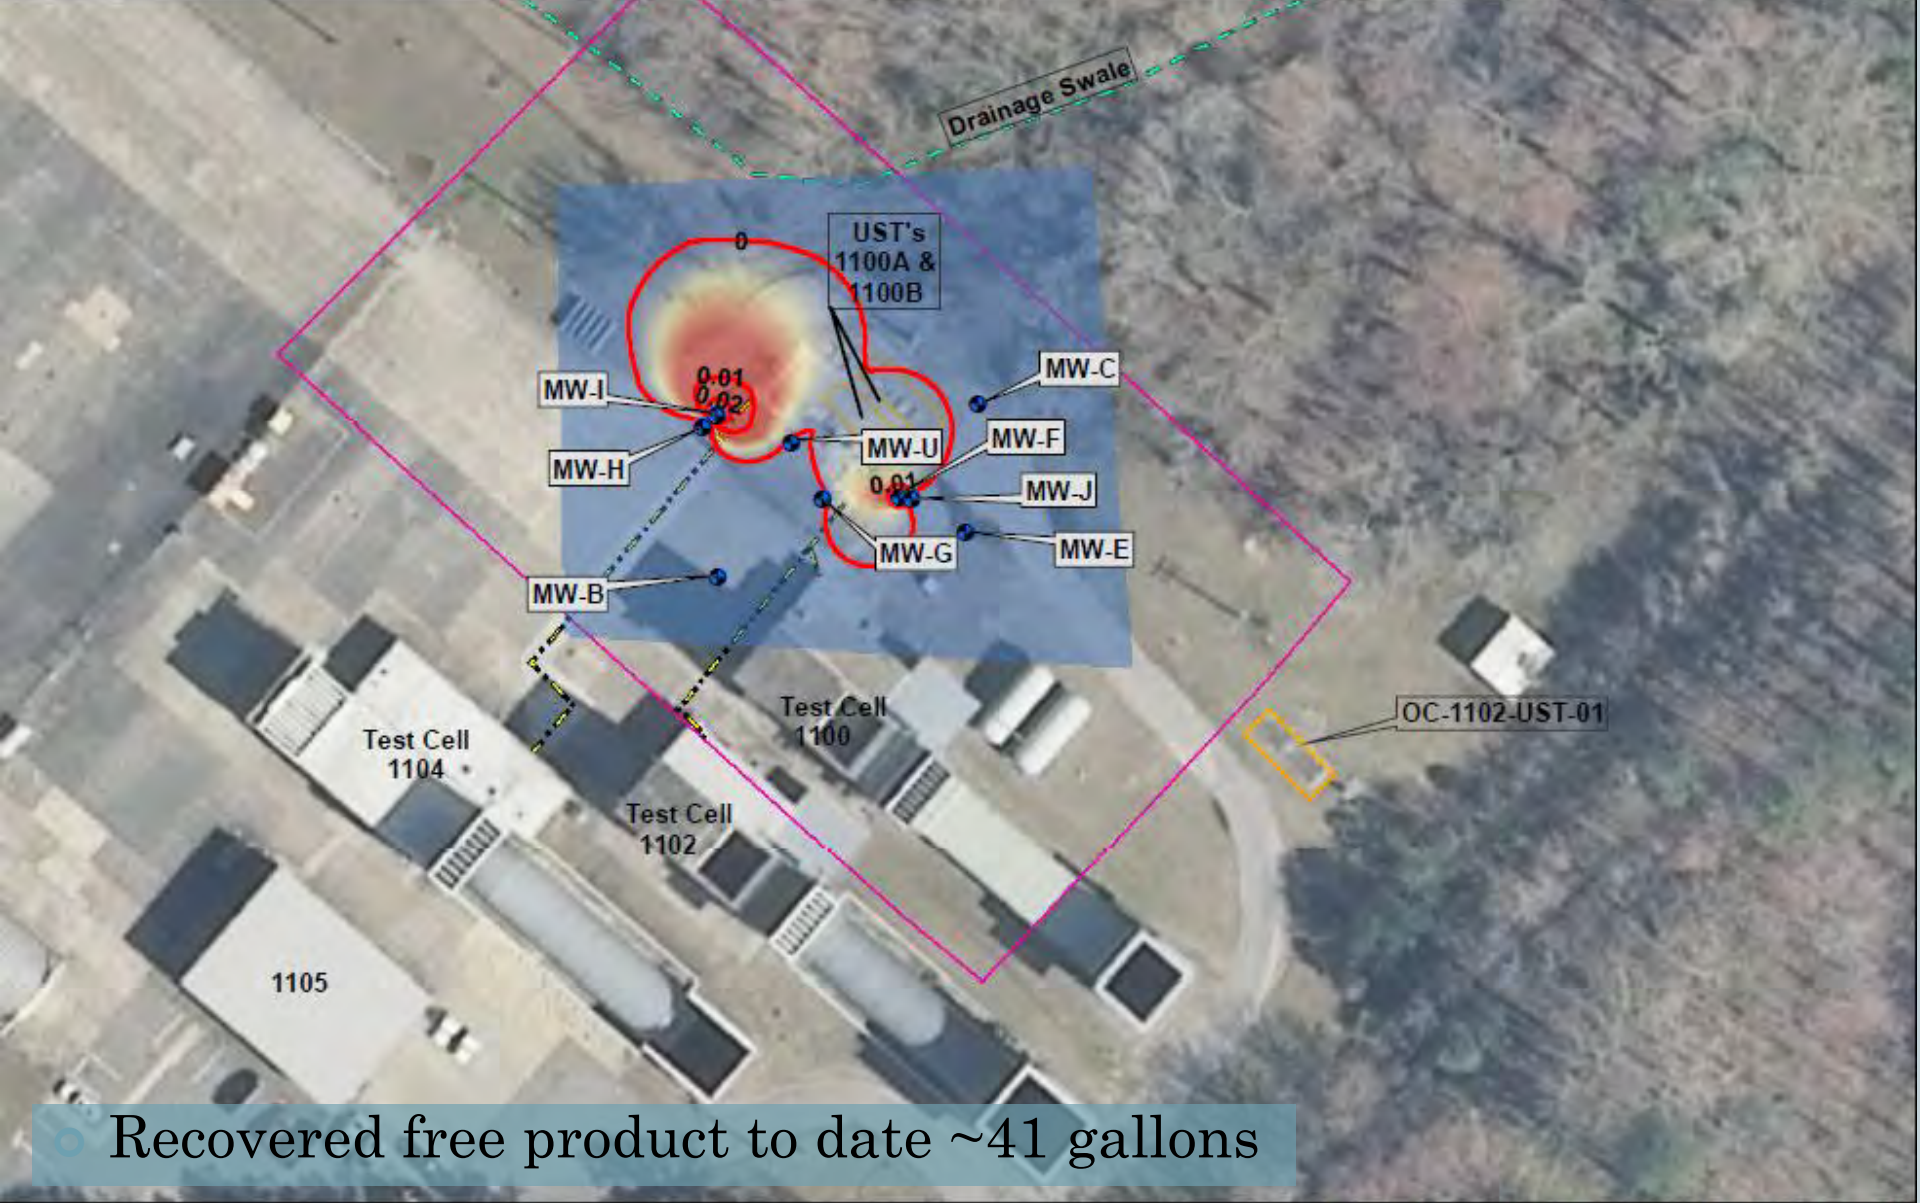
Figure 4 - Free Product Contour Map (April 2019)
 Jet Test Cell
 Naval Air Station (NAS) Oceana
 Virginia Beach, Virginia

PATH FORWARD: Continue free product recovery (bailing and AFVR).

***NOTE – AQ IDW generated detected PFOA + PFOS concentrations at 647 ppt.

Recovered free product to date ~41 gallons
