MINUTES FROM THE 18 JULY 2017 RESTORATION ADVISORY BOARD  
MEETING NAS KEY WEST FL  
07/18/2017  
TETRA TECH, INC.

# NAS KEY WEST RESTORATION ADVISORY BOARD

## 18 JULY 2017 MEETING SUMMARY

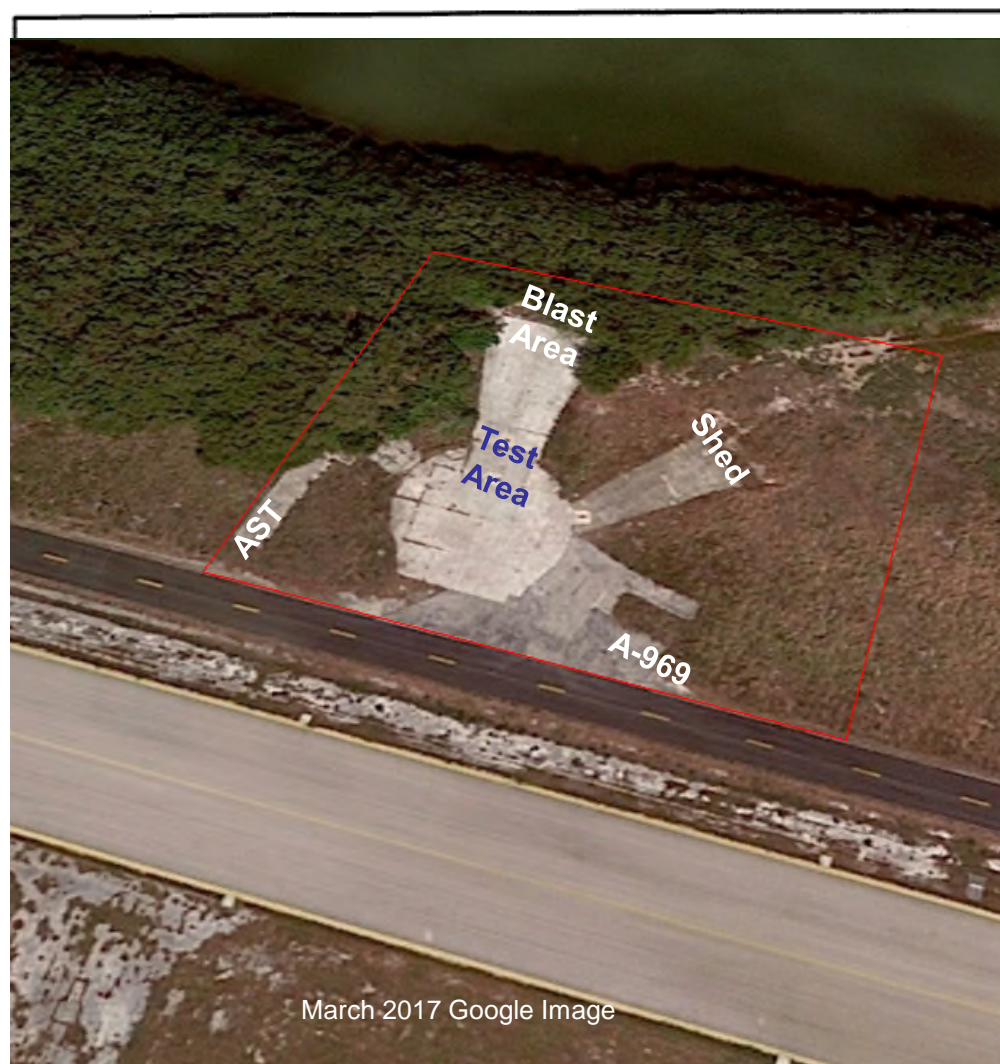
March 2017 Google Image

**1969:** Jet Engine Test Cell, associated with building A-969, used for the testing of repaired jet engines

**1987-1995:** Jet engines were fueled from a bermed 5,000 gallon above ground storage tank (AST) containing JP-5 fuel

- 1989:** A leak resulted in the release of approximately 700 gallons of JP-5 from the AST. Approximately 600 gallons were recovered and 10 cubic yards of contaminated soil were excavated and removed from the spill site.
- 1992:** An overturned oil drum and stained soil were observed.
- 1994:** Contamination Assessment Report (CAR) identifying Dichloroethene (DCE) and benzene plumes in the eastern part of the site.
- 1995:** Groundwater evaluation conducted at the site. Subsequently, a pump and treat system was installed. The system operated for one year, but did not recover any free product.

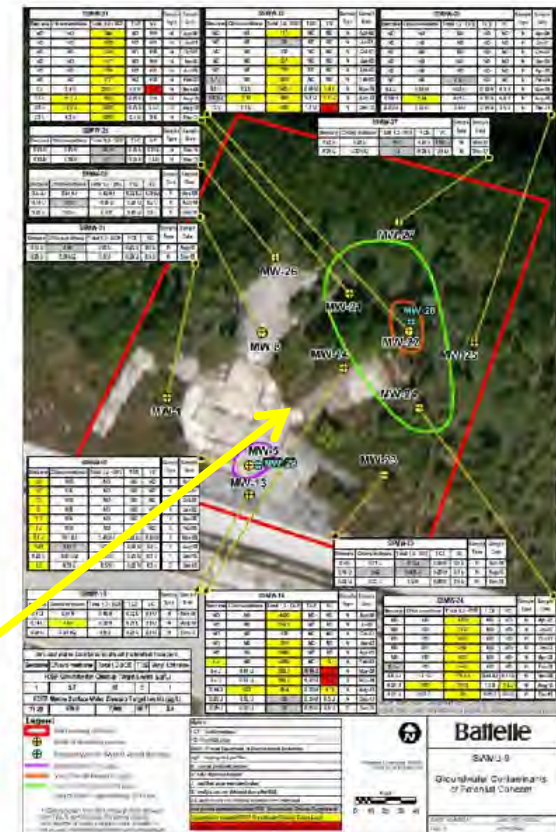
Figure 17-1. SWMU 9 Proposed Monitoring Well Locations

Figure from 2016  
 Sampling and Analysis Plan

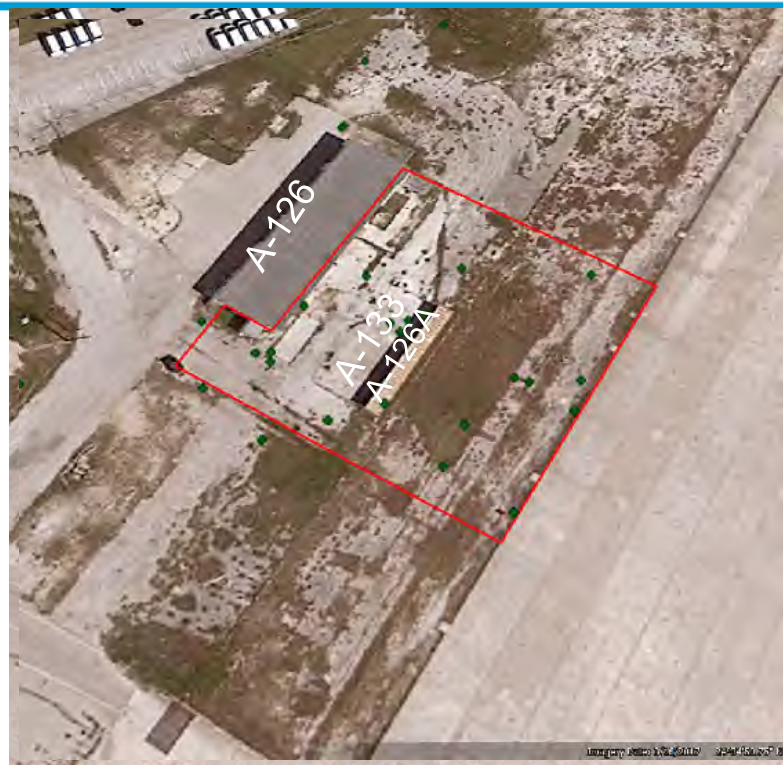
**2008:** A total of 23 monitoring wells were closed in the vicinity of the Site. These wells were located around Building A126 and Building A133 and were on both the east and west sides of the chain link fence separating these service buildings from the aircraft parking area. An odor of hydrocarbons was detected in the monitoring wells that were extracted in the immediate vicinity of the Hazardous Substances Storage Area, Building A126A.

Wells remaining after abandonment

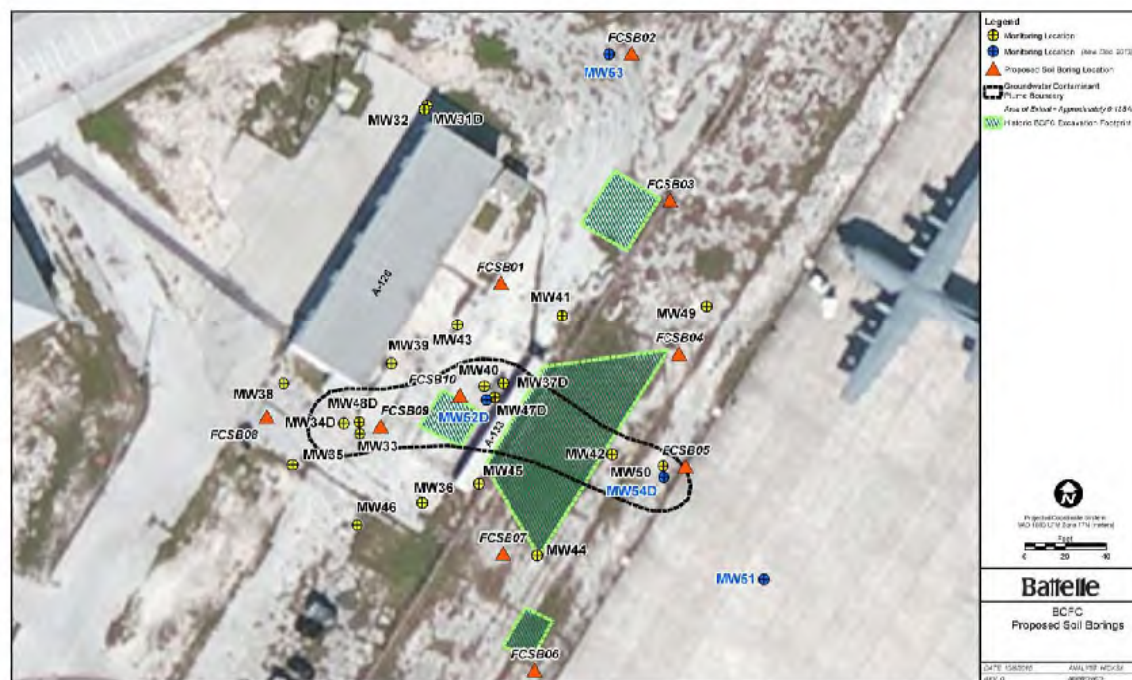
Figure from 2016  
Sampling and Analysis Plan

**2016:** Soil samples collected to determine if any contamination was present in upper three feet of the site. Wells were also sampled for first quarter semi-annual. Current sampling results demonstrate remaining contamination has been delineated and is confined to less than 1/4 acre within site boundary.

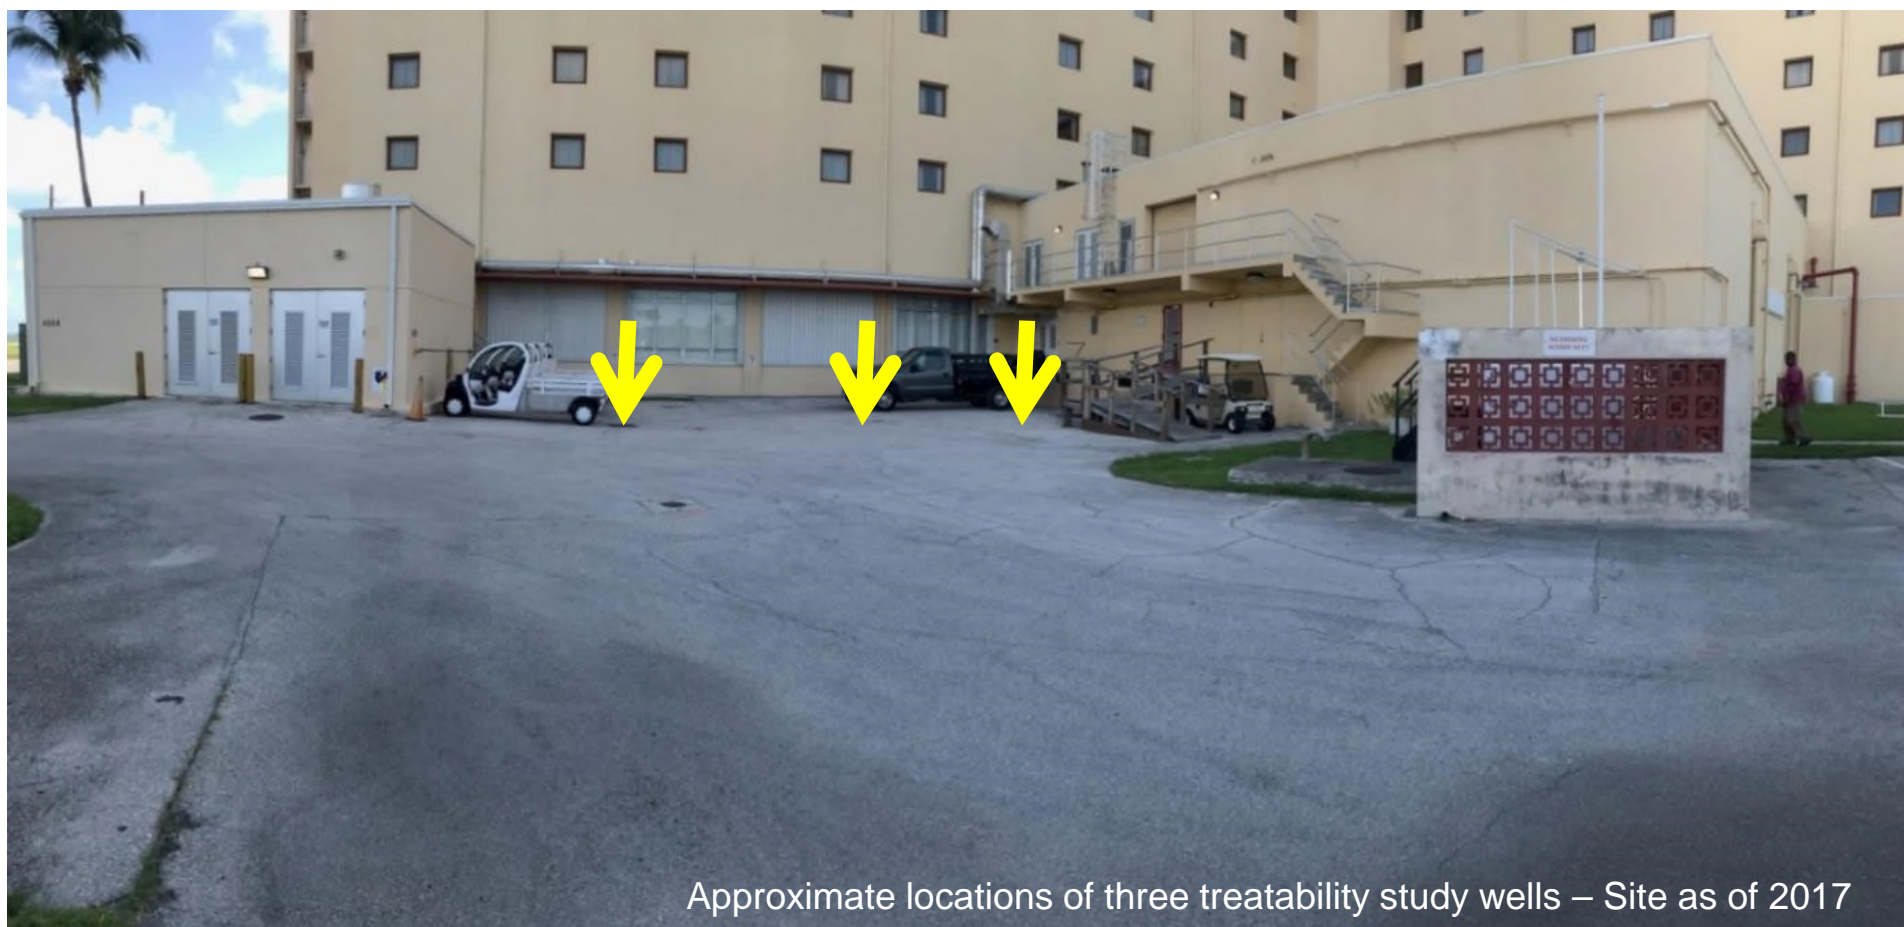
Approximate locations of three treatability study wells – Site as of 2017

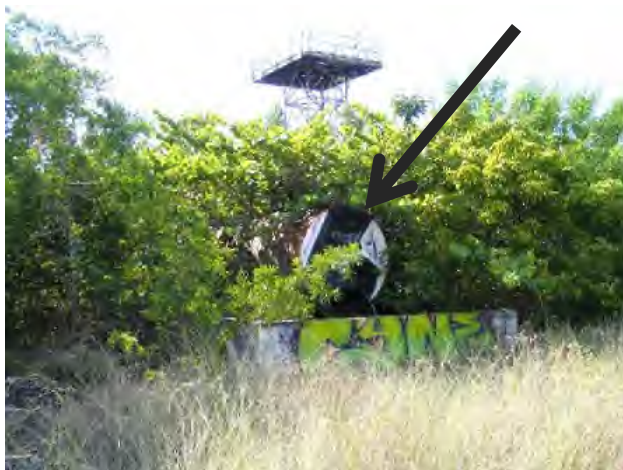
**1996: The Site has a 2,000-gallon AST and a 300-gallon AST, previously used to store diesel fuel for emergency generators, both closed in place 1996. The Closure Report indicated that soil and groundwater near the 2,000-gallon AST showed signs of petroleum hydrocarbons. It was recommended that a Contamination Assessment be performed.**

2,000-gallon AST

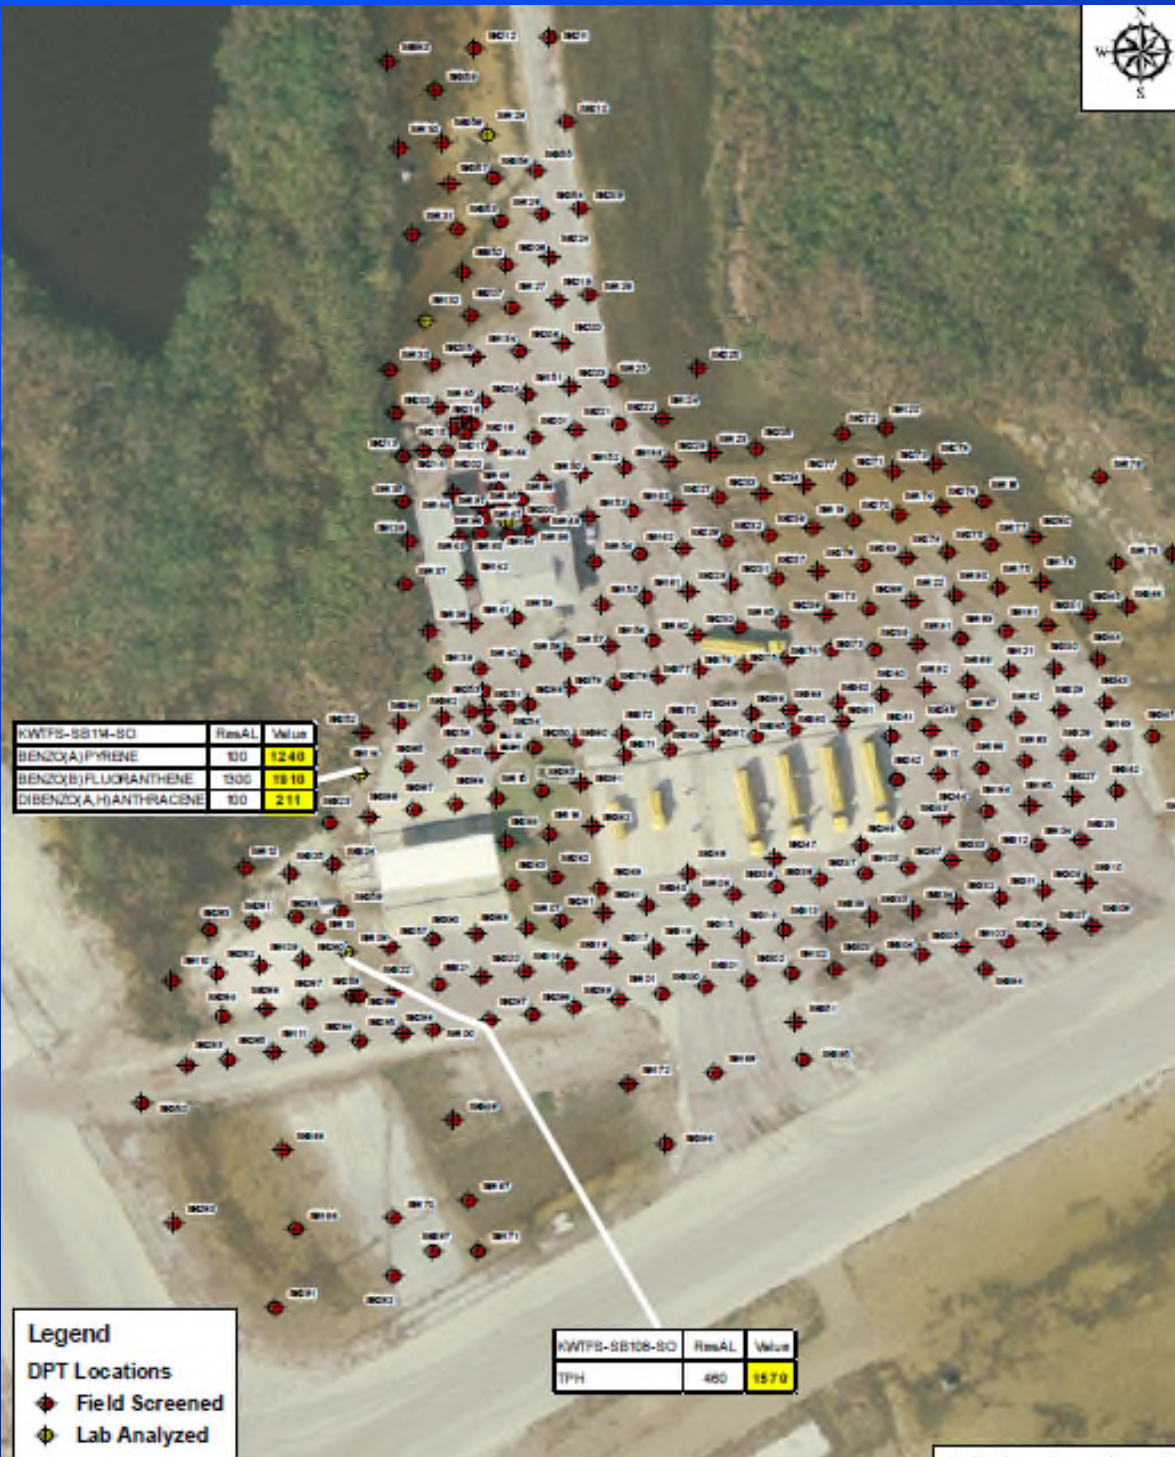
Soil: Collected 596 soil samples via direct push points in 2010, and assessed for petroleum compounds. Limited petroleum contamination was identified, but was concluded to be an indication of groundwater impacts not soil- assessment concluded no significant source areas in soil and no further investigation of soil necessary (Tetra Tech 2011).

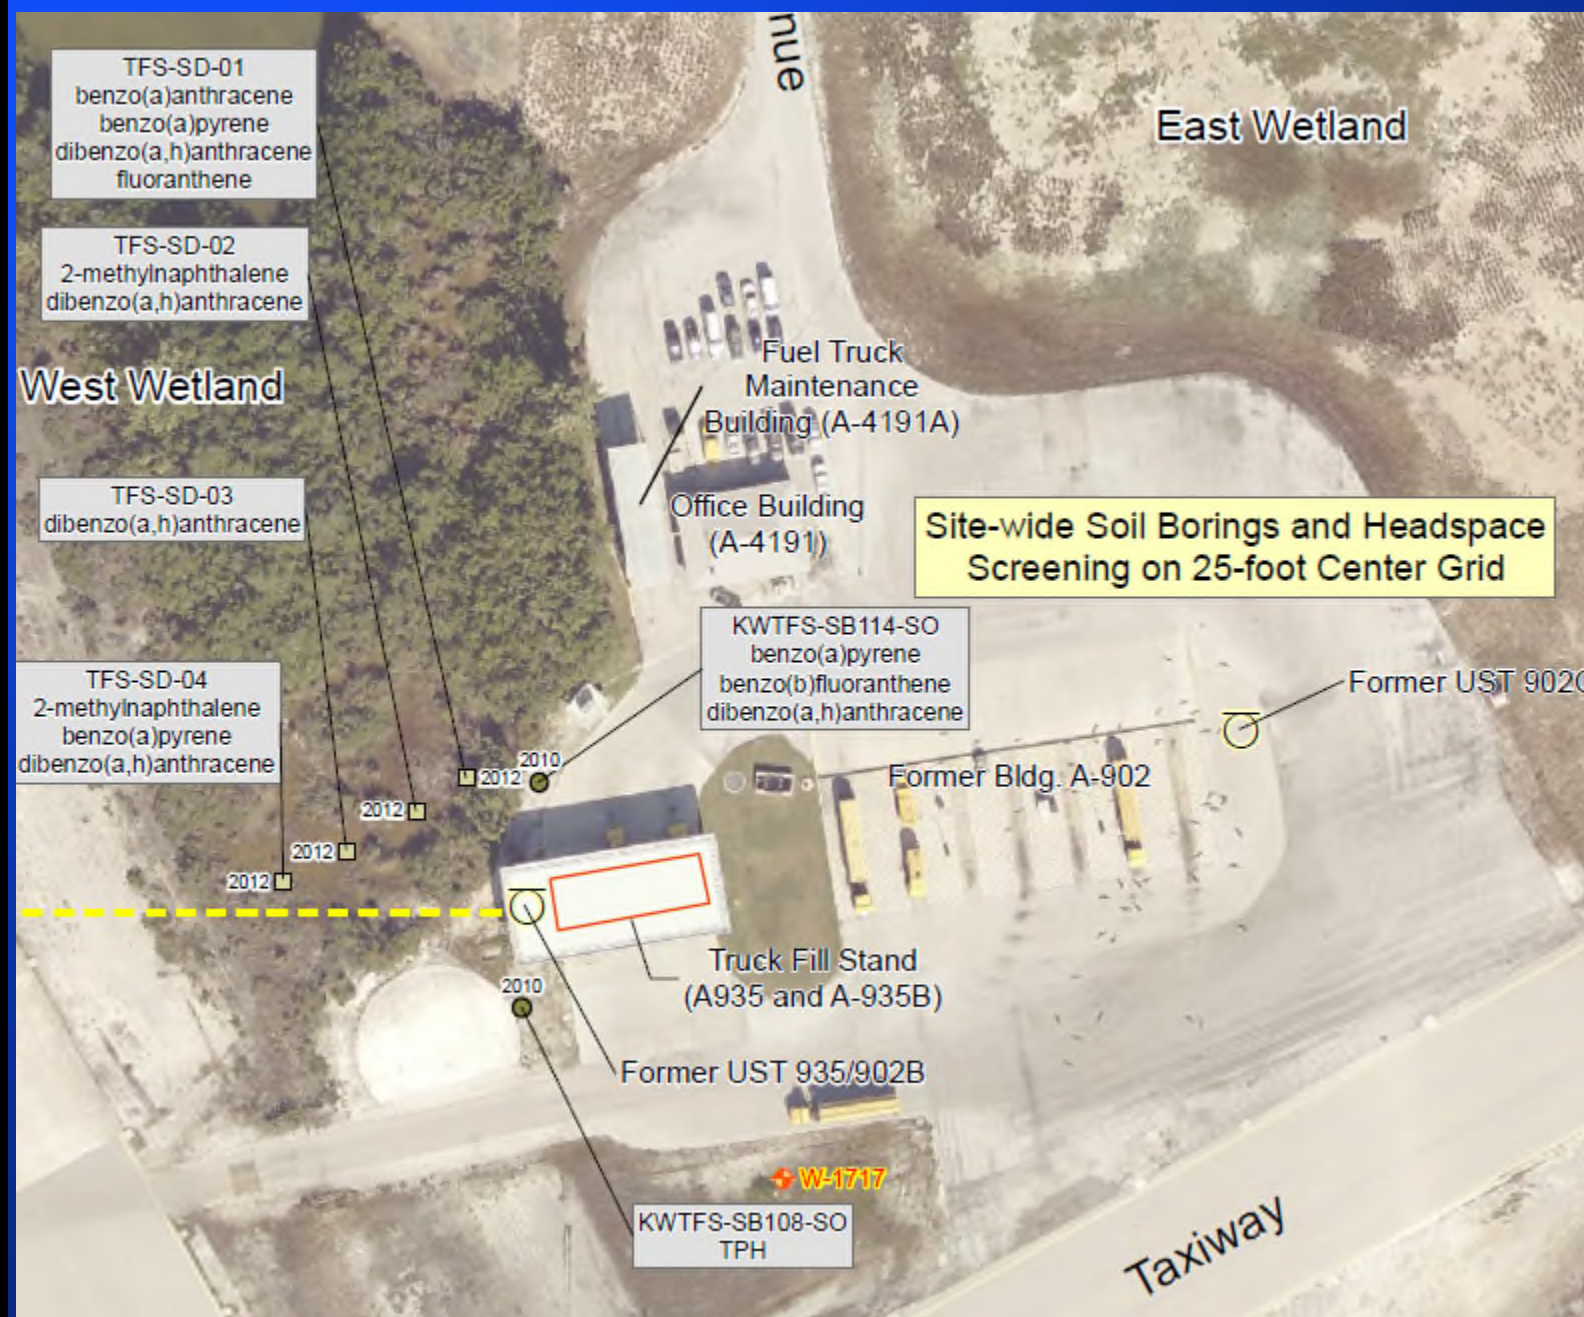
Sediment sampling in 2012: PAHs exceeded applicable screening levels in West Wetland

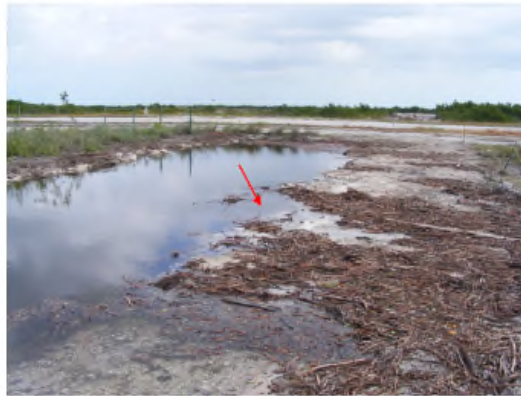
A22 Drainage Ditch

Arrow marks the approx. location of suspect UXO in water in the drainage ditch on west side of Taxiway D.

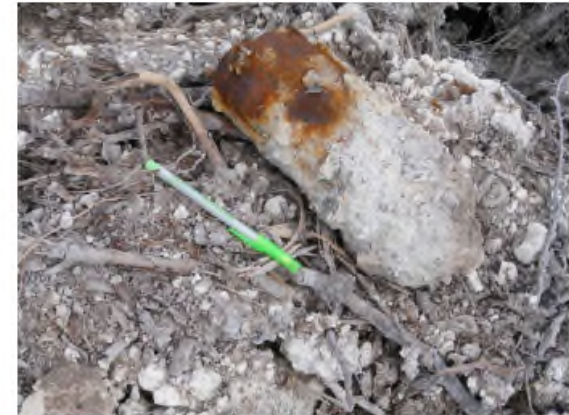
A950 Spoils Pile

Photo 2 of suspect UXO on top of excavated material in lay down area.

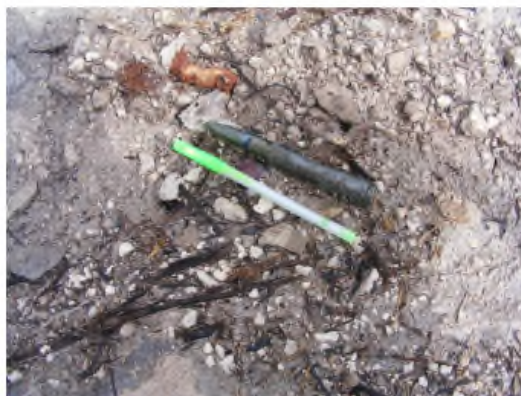
Photo of suspect bullet on south side of drainage ditch, west side of Taxiway D.

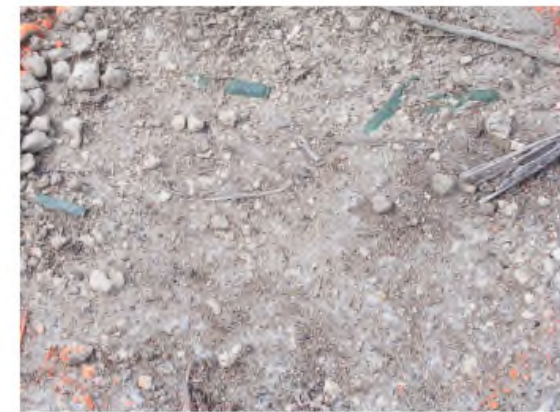
Bullets on ground at the base of the pile of excavated material in lay down area.
