INSTALLATION RESTORATION PROGRAM

NAVAL SUPPORT FACILITY-
INDIAN HEAD
3838 STRAUSS AVENUE
INDIAN HEAD, MARYLAND
20640-5133

RESTORATION ADVISORY BOARD (RAB) MEETING MINUTES

Date of Meeting: April 24, 2014, 6:00 pm

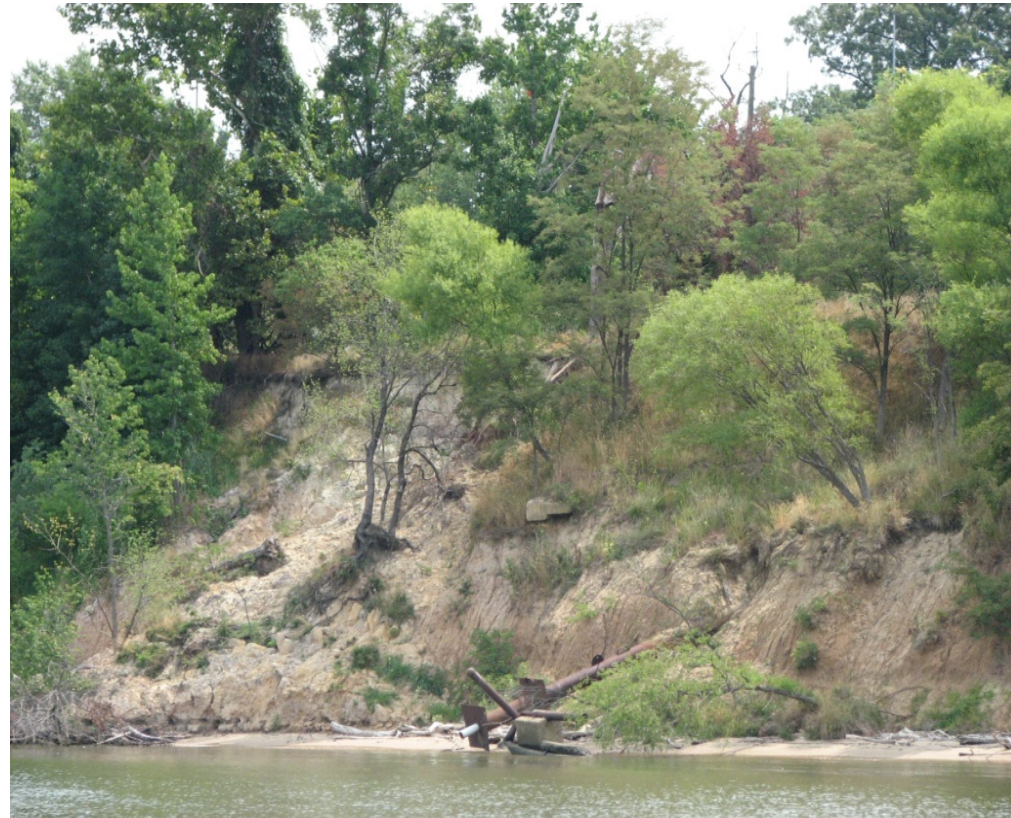
Pre-existing Shoreline Conditions

- **Average historical rate of erosion of – 1.5 ft/year.**
- **Shoreline erosion exacerbated by:**
 1. **Wave activity**
 2. **3 – 5 mile fetch**
 3. **Ground water seepage**
 4. **Soil characteristics**

Question: Can you determine the amount of erosion that has historically occurred since 1890?

Answer: Yes, about 1.5 feet/year or 290 feet total.

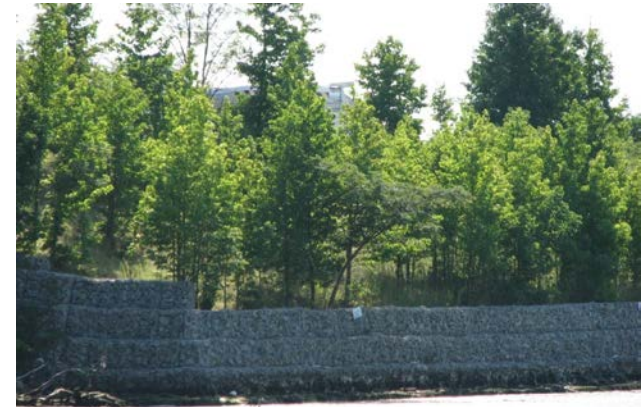
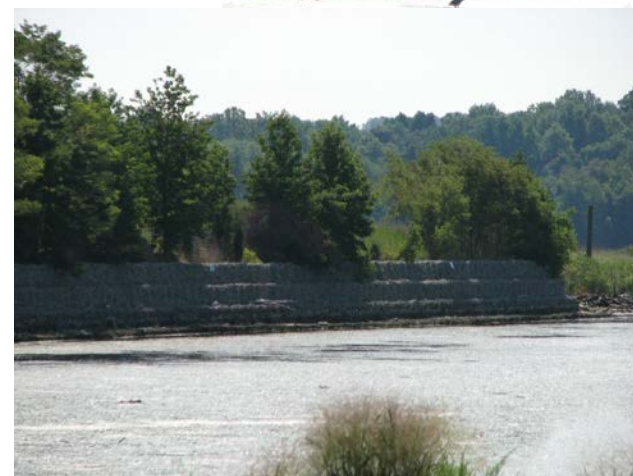
Previous Methods of Shoreline Stabilization

- **Gabion baskets were installed at the Strauss Avenue Thermal Treatment Point and along the shoreline below Riverview Village in the mid 1990s to control erosion**
- **Installation of gabion baskets hardens the shoreline and does not provide the opportunity to enhance wildlife habitat**
- **Structural integrity of the design often is compromised by upland slumping, causing the gabion baskets to shift**

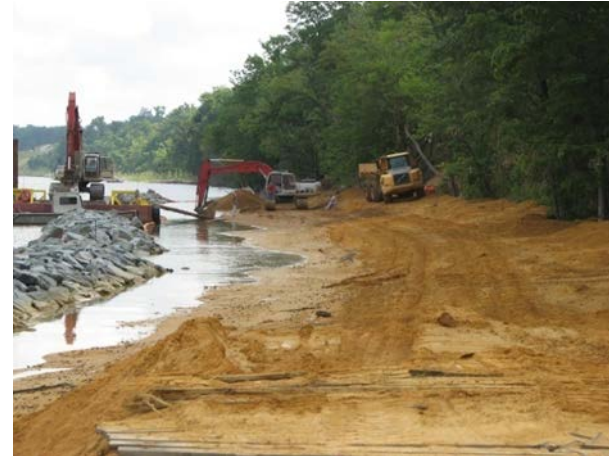
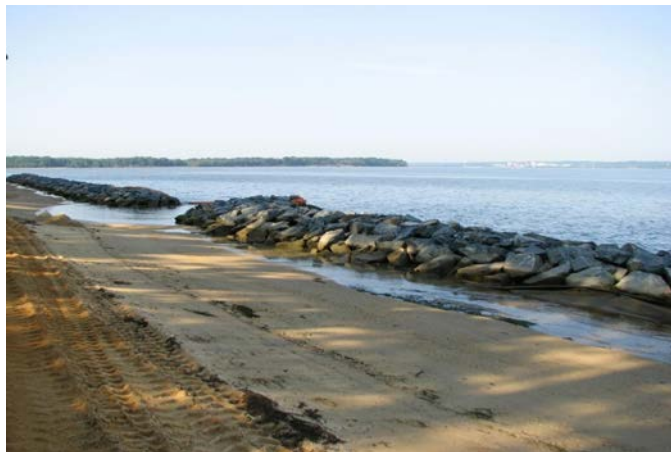
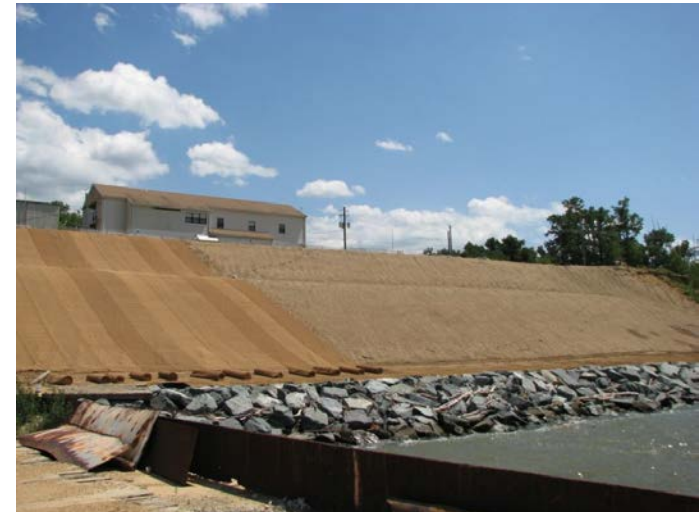
Project Summary – Shoreline Protection

- **17,100 lineal feet of shoreline protected**
- **This includes:**
 - **14,170 lineal ft of sills**
 - **2,160 lineal ft of breakwaters**
 - **610 lineal ft of revetment**
 - **1,230 lineal ft of cobble beach**
 - **1,260 lineal ft of high bank reconstruction**

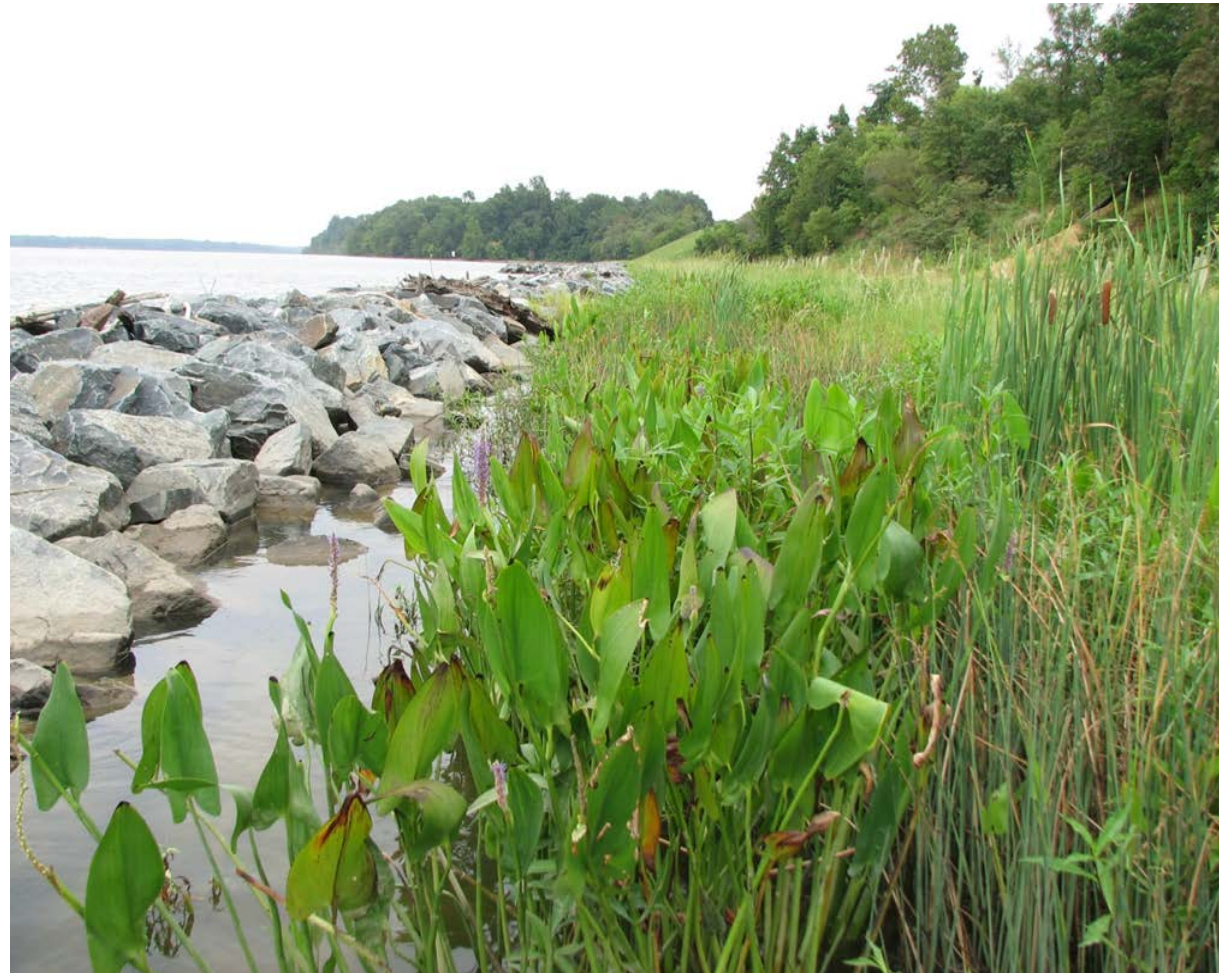
Project Summary – Habitat Creation

- **Created 18 acres of intertidal wetland, shrub/scrub and riparian floodplain habitats**
- **Areas created with sand fill behind shoreline structures**
- **89,000 trees, shrubs and wetland plugs planted in all Phases**
- **Post construction surveys have shown increases in SAV habitat, predator/prey fish interactions and biomass**

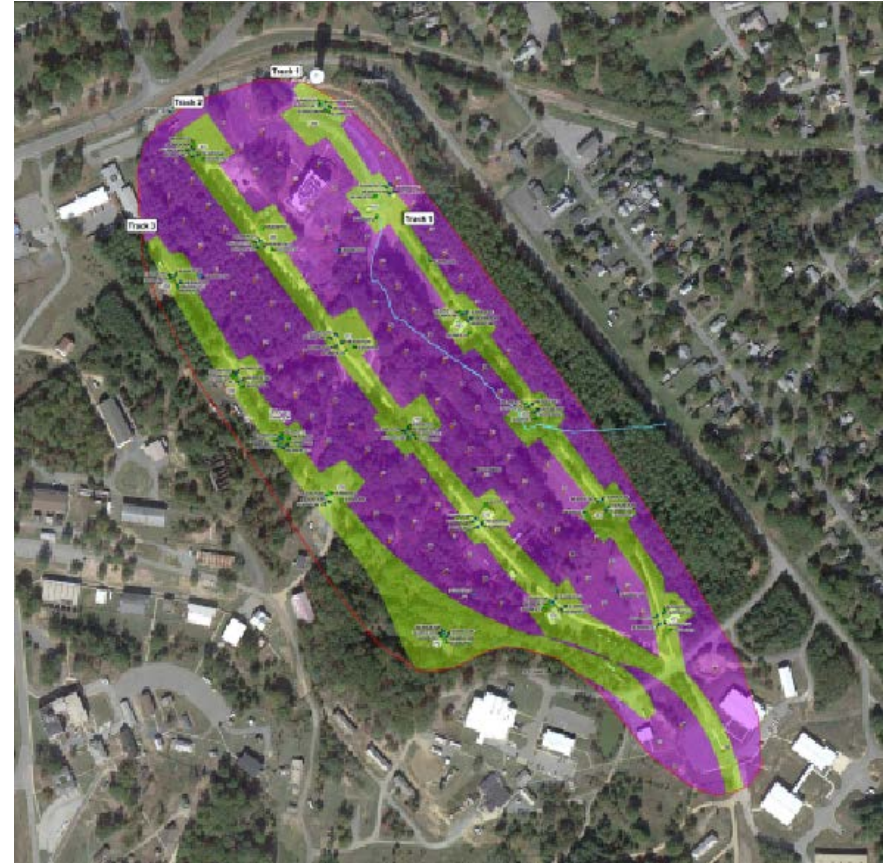
Site Pictures

- 52-acre land site
- Consists of an area where propellant grains were spilled during transportation of the propellant by rail
- Transportation of grains started between 1927 and 1942 and ended in the late 1980s
- Facility operations may have resulted in MEC and MC being released into the environment

- PA, 2005
 - Observed propellant grains on the ground surface outside Building 188
 - Recommended an SI for MEC (Munitions & Explosives of Concern) and an RI for MC (Munitions Constituents)
- SI, 2010
 - Performed aerial photographic analysis
 - Conducted MEC inventory at 2 of 3 former railroad tracks and 12 former dry houses (Buildings 174, 175, 176, 177, 181, 182, 183, 188, 204, 206, 207, and 210)
 - Spatial distribution of propellant grains around the buildings indicated that propellant grains are widely distributed throughout building entranceways, walkways, loading docks, crawl spaces, and down spouts.
 - Recommended a NTCRA (non-time critical removal action) for the propellant grains to remove the propellant grains from around the buildings and the tracks.
 - Recommended an RI for MC to investigate soil and groundwater

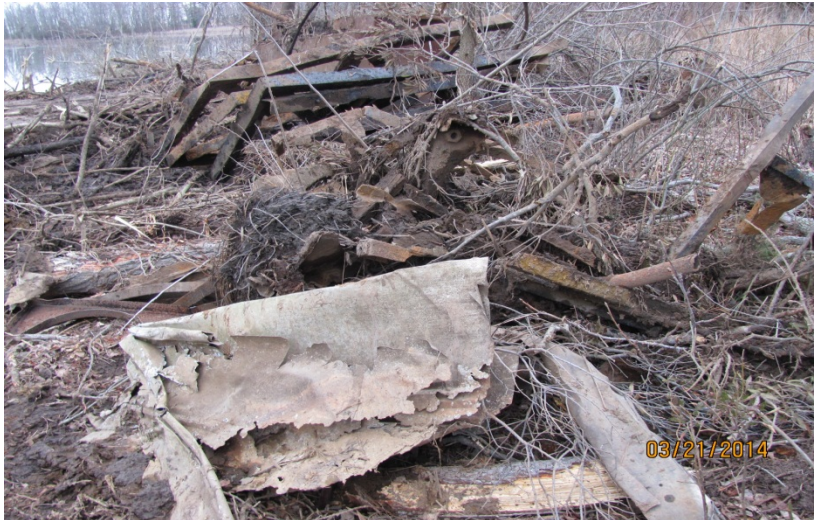
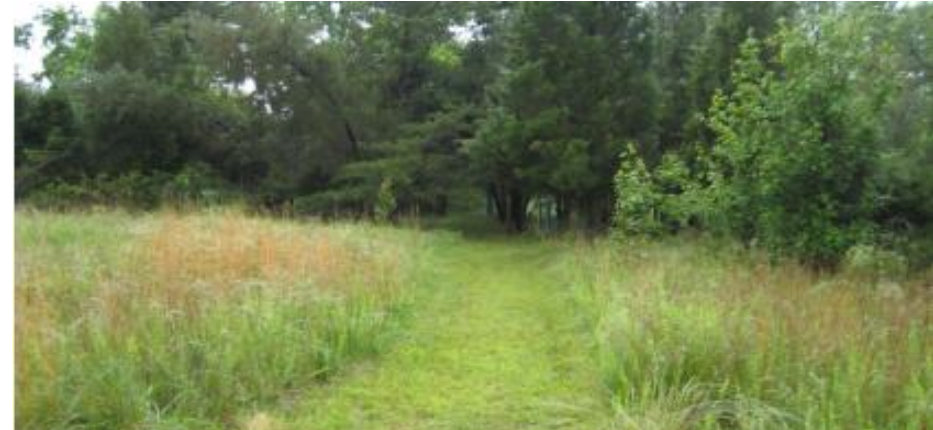
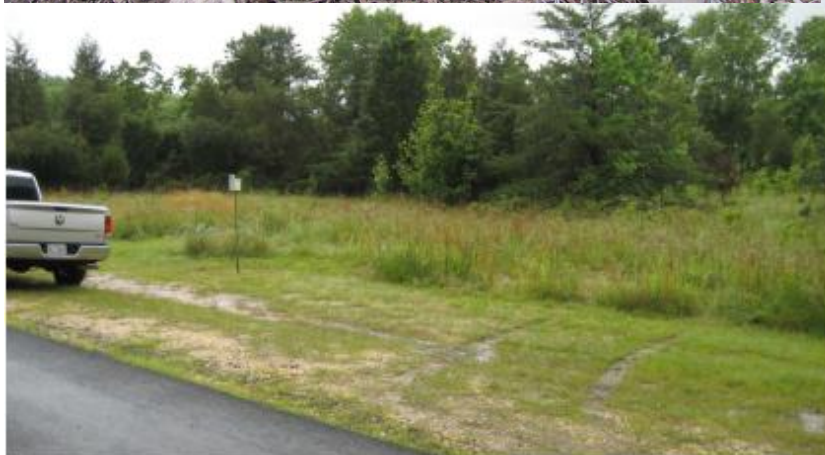
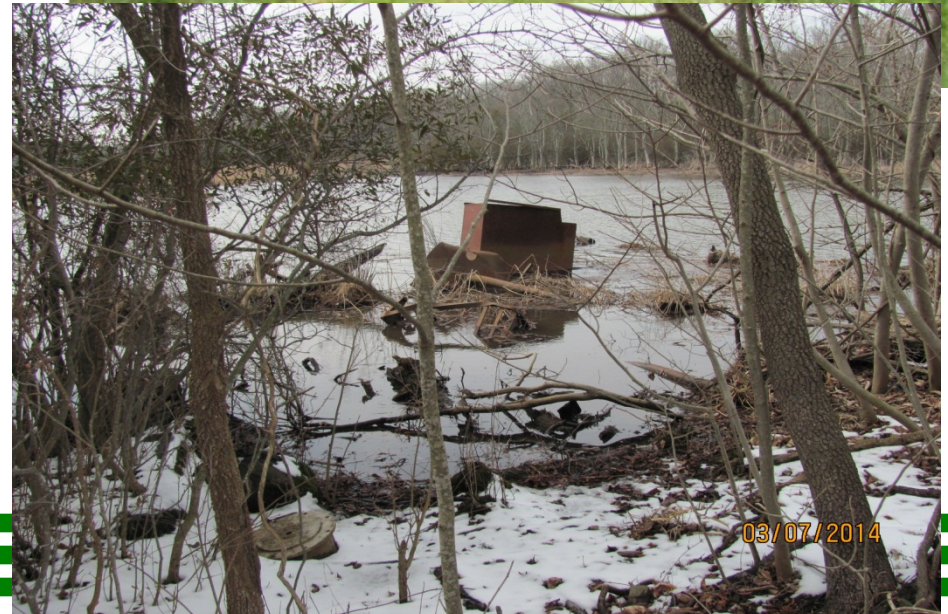
Site 36 Photographs

- *Surface Debris Removal (continued)*
 - *Debris separated into categories*
 - *Non-UXO*
 - *MPPEH*
 - *MEC*
 - *Non-hazardous MPPEH demilitarized and re-classified as MDAS*
- *Disposal*
 - *Non-UXO (sent off-site for recycling)*
 - *MDAS (sent to metal reclamation/recycling facility for smelting)*
- *Site Restoration/De-Mobilization*
 - *Off-site March 31, 2014*

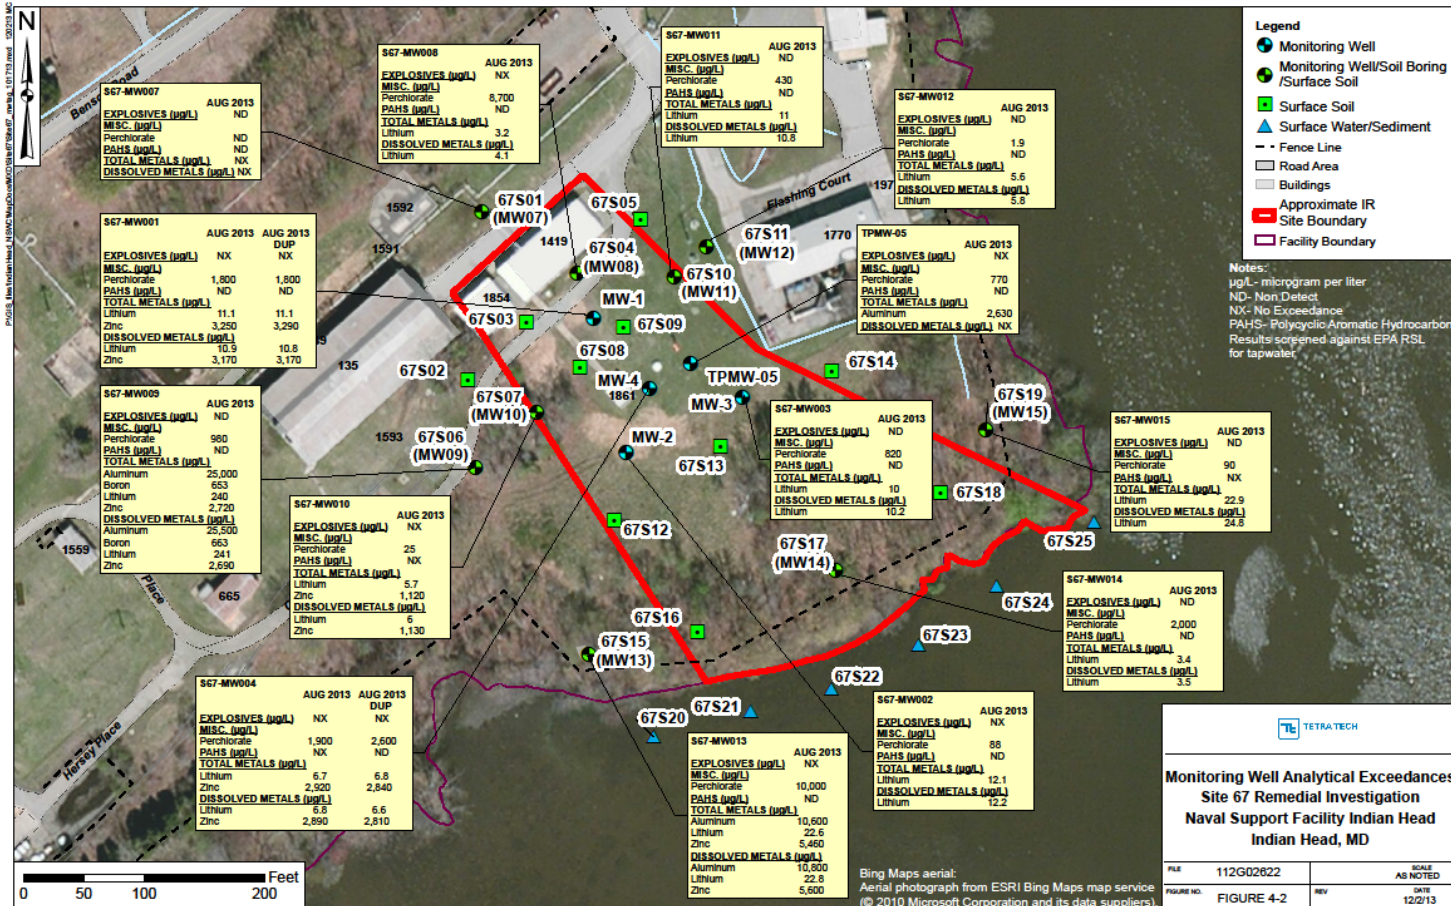
Site 67 Phase 1 Results

Site 67 Perchlorate Isoconcentrations (August 2013)

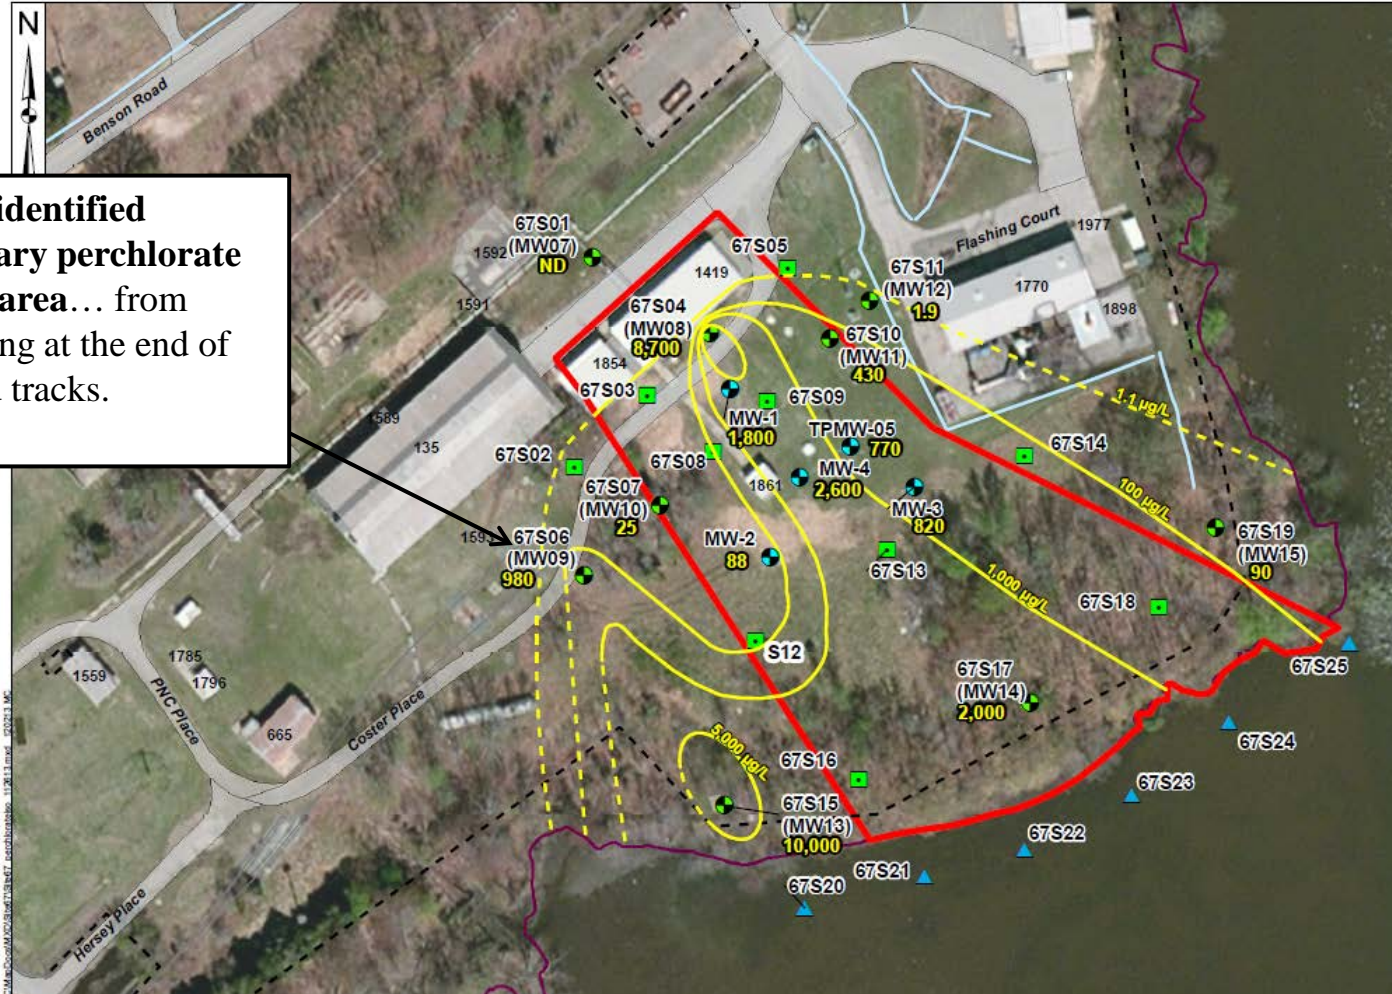
Newly identified secondary perchlorate source area... from unloading at the end of railroad tracks.

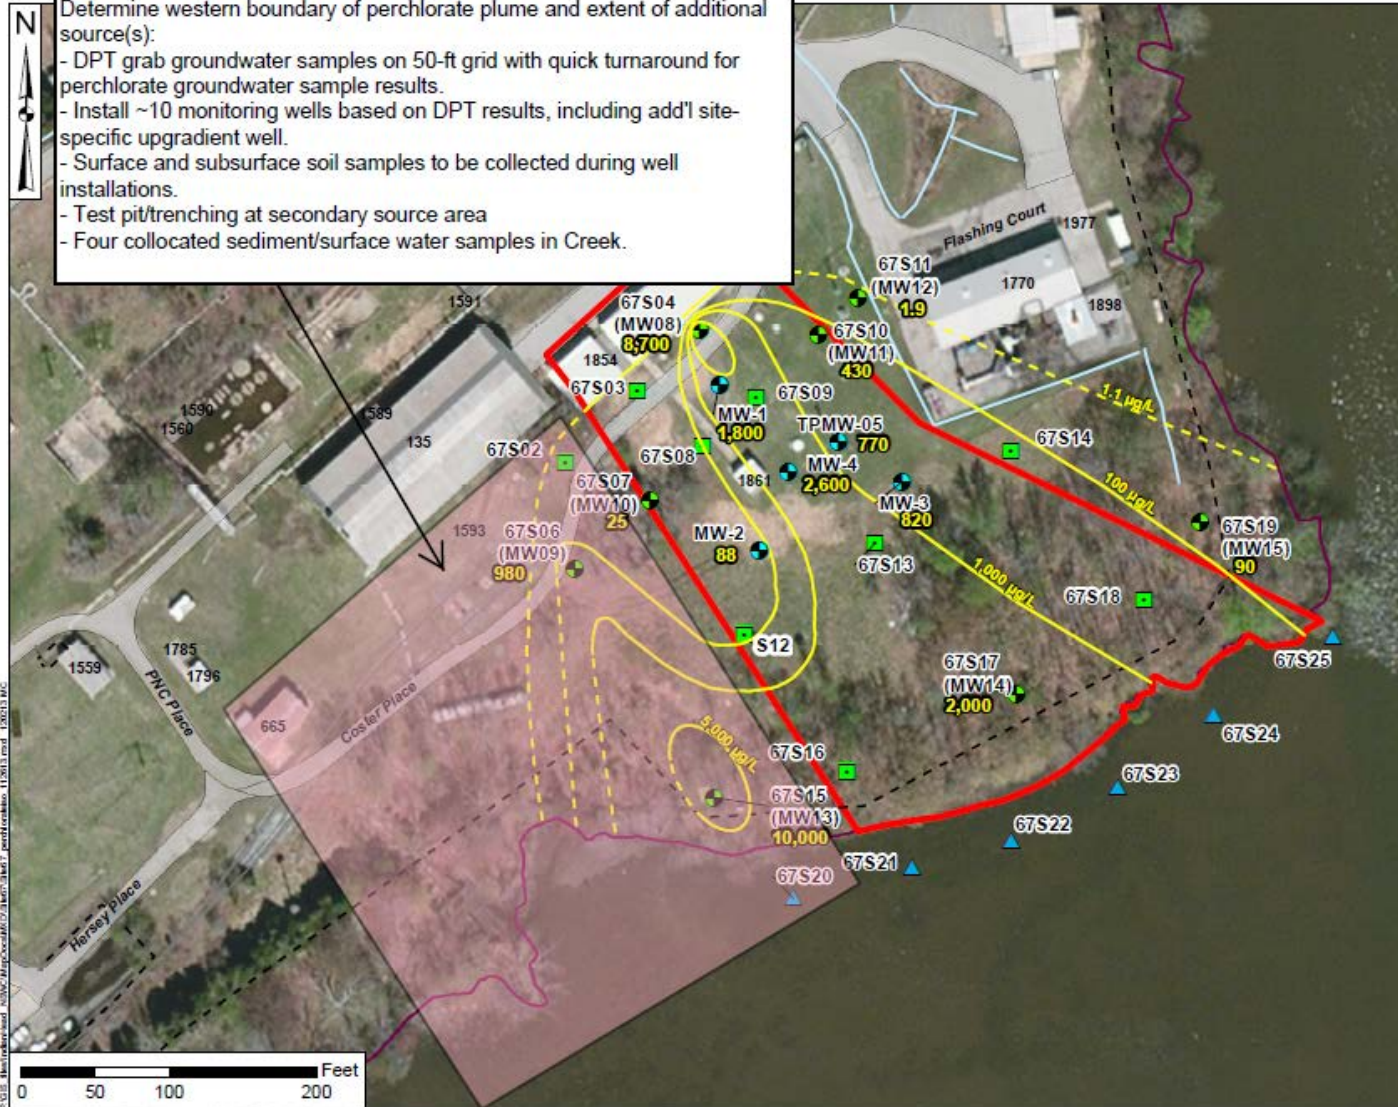
Determine western boundary of perchlorate plume and extent of additional source(s):

- DPT grab groundwater samples on 50-ft grid with quick turnaround for perchlorate groundwater sample results.
- Install ~10 monitoring wells based on DPT results, including add'l site-specific upgradient well.
- Surface and subsurface soil samples to be collected during well installations.
- Test pit/trenching at secondary source area
- Four collocated sediment/surface water samples in Creek.
