### INSTALLATION RESTORATION PROGRAM

## NAVAL SUPPORT FACILITY INDIAN HEAD

### RESTORATION ADVISORY BOARD (RAB) MEETING MINUTES

Date of Meeting: October 19, 2017, 6:00 pm

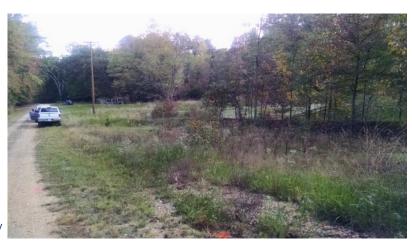
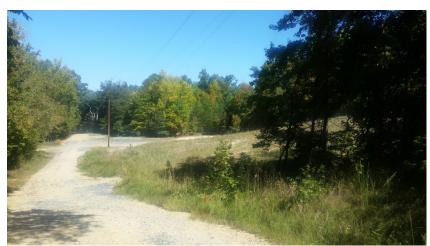
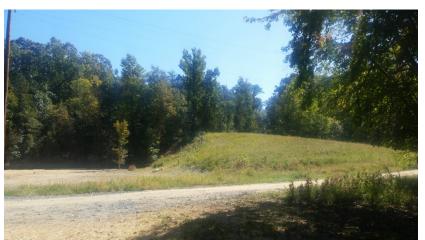
## **Borrow Source Area**

**Before**

After

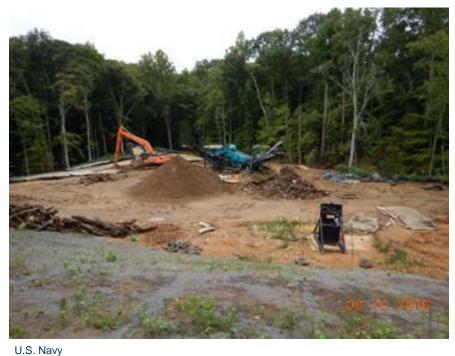
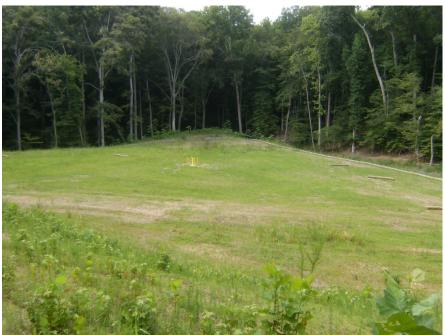
# **Restoration Completion- October 2017**

- Excavation of landfill completed down to native soil and no wastes remain
- All Munitions and Explosives of Concern/Material Potentially Presenting an Explosive Hazard (MEC/MPPEH) removed
- Soil, construction debris, and scrap metal disposed off site
- Clean soils used to backfill borrow source area
- Site restoration completed (topsoil, seeding, and planting)
- Demobilization of equipment and personnel

Before After

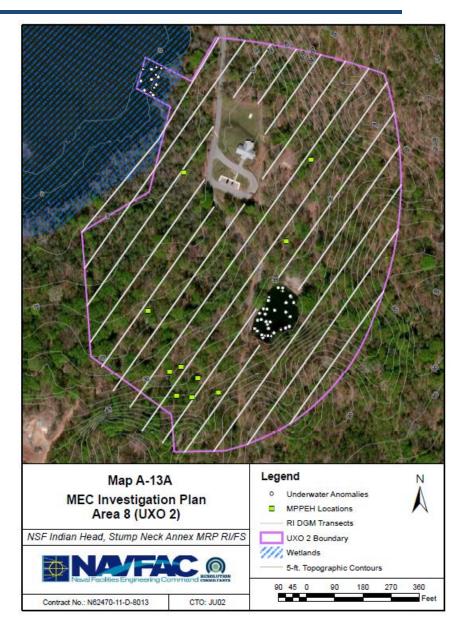
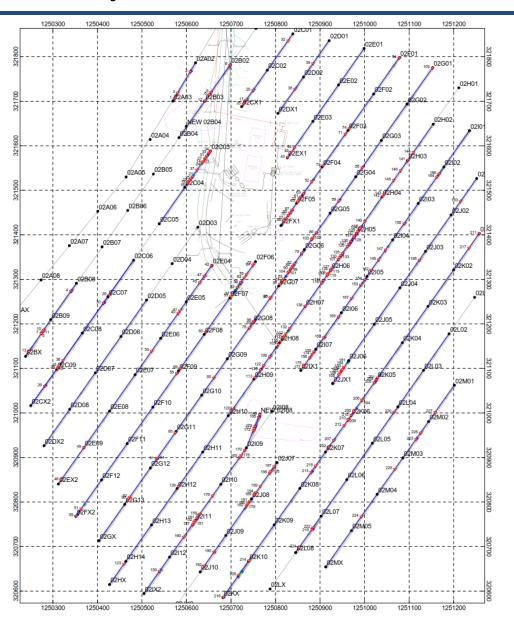
# MEC RI Approach – Area 8 (UXO 2)

- Land-based DGM on statistical transect design
- Removal of underwater anomalies via magnet

- DGM survey resulted in 227 identified anomalies requiring investigation
- Nine munitions-related debris items encountered
- Items included:
  - Mine components/parts
  - Torpedo warhead, empty
  - Projectile parts
  - Fragment
  - 57mm AP projectile
- No items contained explosive hazards
- 93% of targets were cultural debris (i.e., not munitions-related)

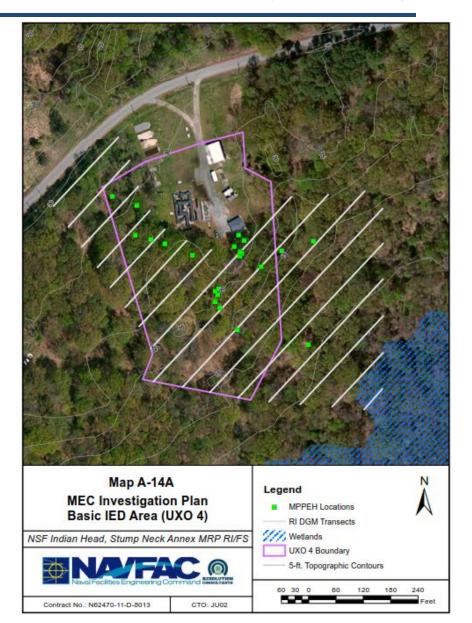
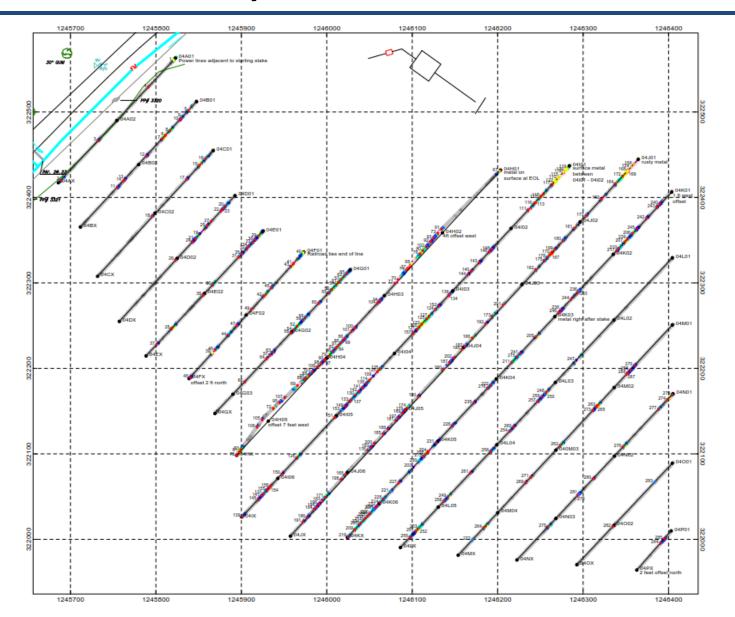
# MEC RI Approach – Basic IED Area (UXO 4)

DGM on statistical transect design

- DGM survey resulted in 285 identified anomalies requiring investigation
- 35 munitions-related debris items encountered
- Items included:
  - Practice mines/mine components
  - 75mm projectiles, shrapnel (empty)
  - Fuzes
  - 500lb Bomb (empty)
  - 2.75in Rocket fins
  - Practice grenade
  - 60mm & 81mm Mortars (empty)
- No items contained explosive hazards
- 84% of targets were cultural debris (i.e., not munitions-related)

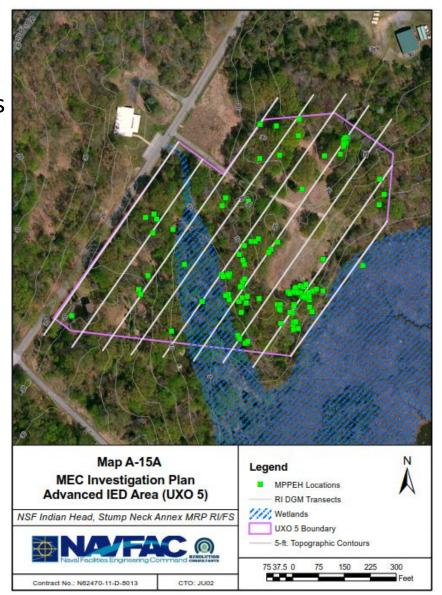
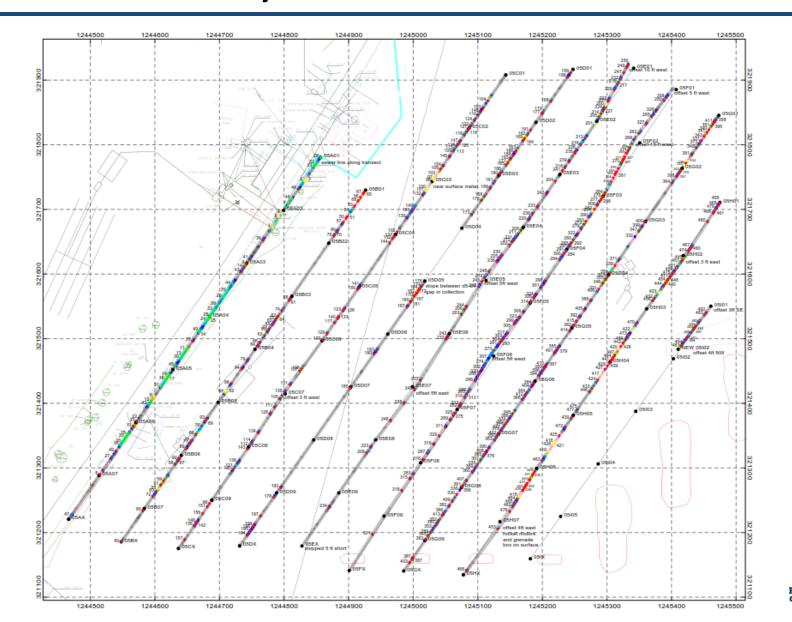
# MEC RI Approach – Advanced IED Area (UXO 5)

DGM on statistical transect design

- DGM survey resulted in 492 identified anomalies requiring investigation
- 169 munitions-related debris items encountered
- Items included:
  - Fuzes/fuze parts (mostly M100)
  - 5in Rocket warhead (inert)
  - 2.75in Rocket motor component
  - 20lb Bombs (empty)/bomb parts
  - 100lb Bomb (inert)
  - BDUs 28 (inert)
  - BLUs 7 (inert)
  - BLU 36 (inert)
  - CS Smoke canister (inert)
  - 105mm projectile (inert)
  - 75mm projectile, shrapnel (empty)
  - 20mm cartridge (inert)
  - Practice mine
- No items contained explosive hazards

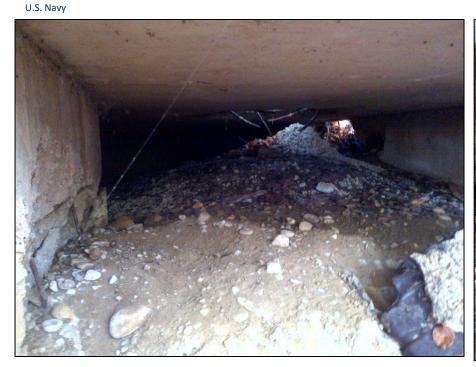
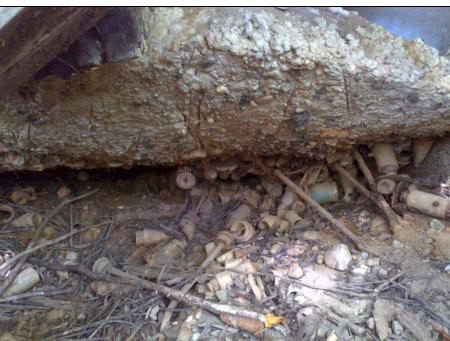
#### MEC RI Approach – UXO 5 Bunker

Remove top of concrete, excavate exposed munitions items, and remove munitions encased in concrete from bunker for inspection

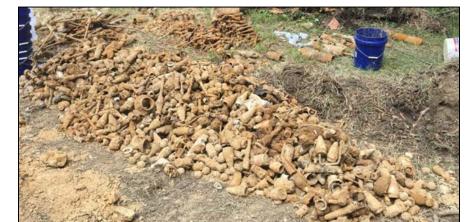
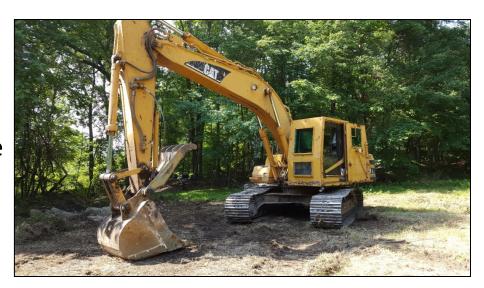
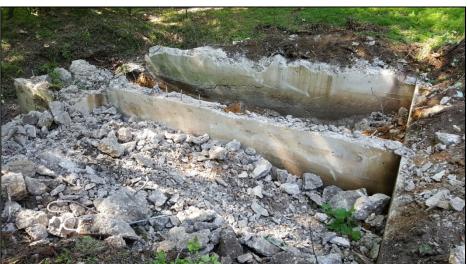
## Preliminary MEC RI Results – UXO 5 Bunker

- Recovered over 2,000 lbs of munitions debris
- Items consisted of pieces/parts of munitions and inert ordnance items
- No items have contained explosive hazards
- Some items remain encased in concrete

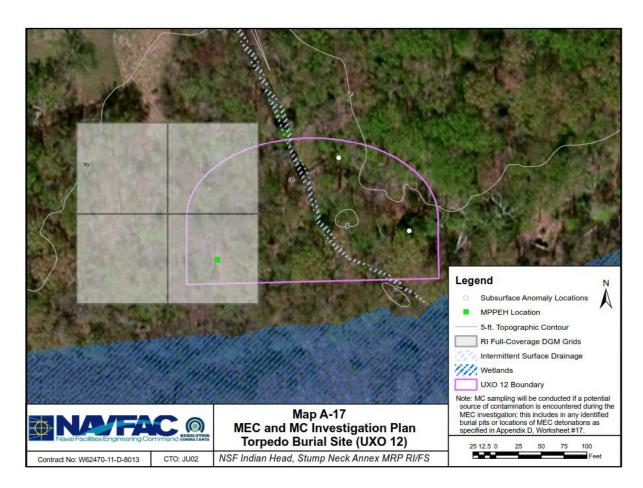
#### MEC RI Approach – Torpedo Burial Site (UXO 12)

Full-coverageDGM (1 ac)

- DGM identified several potential burial areas
- Investigation revealed that no burial pits are present
  - Various debris appears to have been deposited on the surface
    - Deepest anomaly was recovered at a depth of 18 inches
  - 99% of anomalies were cultural debris (i.e., not munitions-related)
- Non-hazardous munitions-related items included:
  - 57mm projectile
  - Igniter
  - Sea mines (empty)

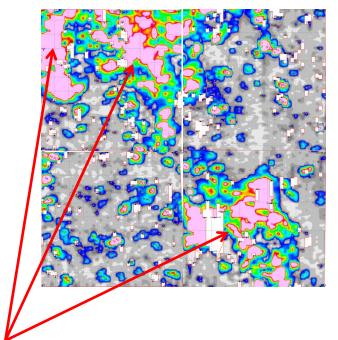
Identified Locations Indicative of Potential Disposal Areas

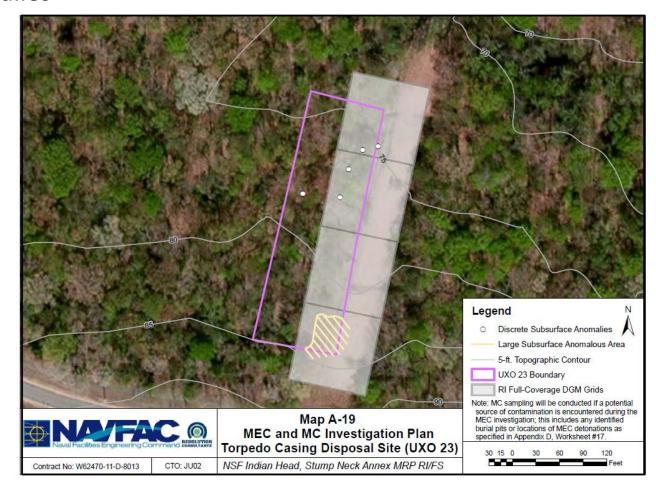
#### MEC RI Approach – Torpedo Casing Disposal Site (UXO 23)

- RI Goal:
  - Identify/characterize munitions items associated with the identified subsurface anomalies
- RI Approach:
  - Full-coverageDGM (1 ac)

- DGM identified a burial pit and several isolated anomalies
- Burial pit:
  - Depth exceeds 11 feet
  - Removed numerous large pieces of Naval materiel
    - None contain explosive hazards
  - No torpedo casings identified
- Isolated anomalies:
  - Included 90mm projectiles and practice bombs
    - None contained explosive hazards

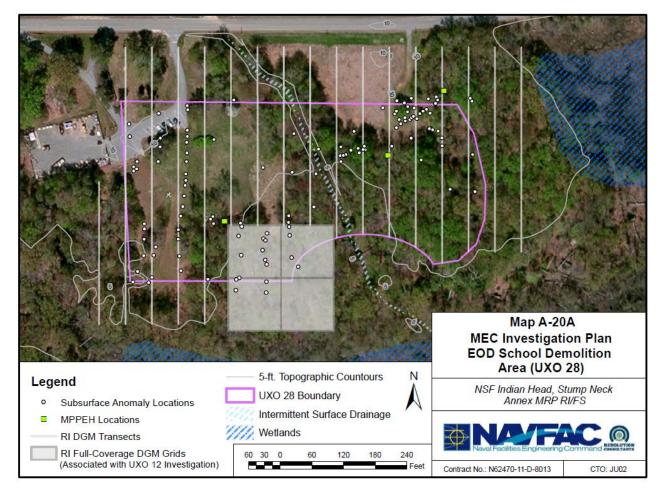
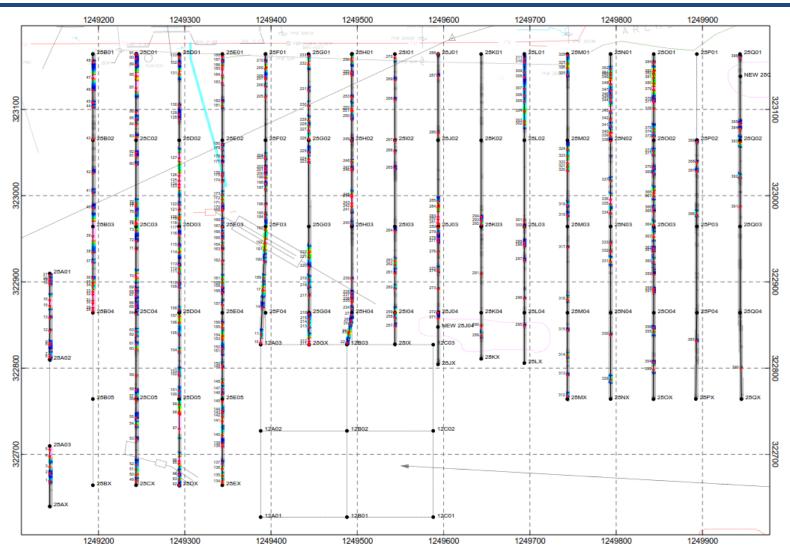
#### MEC RI Approach – EOD School Demolition Area (UXO 28)

DGM on statistical transect design

- DGM survey resulted in 396 identified anomalies requiring investigation
- Seven munitions-related debris items encountered
- Items included:
  - M4 magazine
  - Flares, empty
  - Bomb fuze, British
  - Projectile base, 57mm
  - Fuze pieces/parts
- No items contained explosive hazards
- 68% of targets were identified as 'scrap metal'

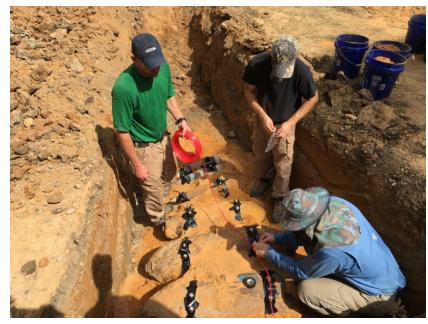
## **Demolition Event**

- Demolition conducted on 27
   September to perforate non-hazardous munitions items prior to sending them to the processing facility
  - Ensured processing facility's workers can readily identify the items as non-hazardous
  - Items perforated with commercial explosives
  - Post-detonation soil samples were collected from the trench

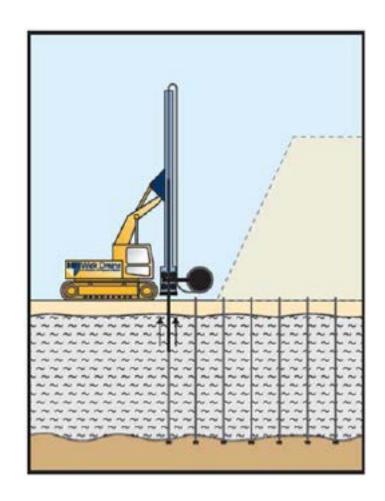
#### IR Site 17-Technology

- Installing closely-spaced (2-3 ft.) vertical conduits to shorten contaminant diffusion pathways in low permeability zones
- Improvement of delivery methods
- Creation of hundreds of vertical reaction zones to degrade Chlorinated Volatile organic compounds (CVOCs)
- Zero Valent Iron (ZVI) amendment has been shown to promote effective degradation of CVOCs in groundwater

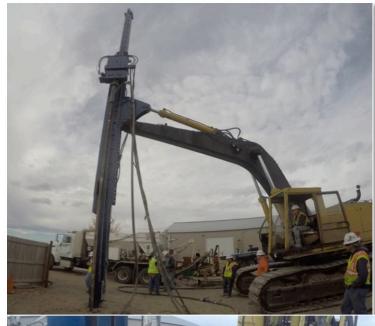
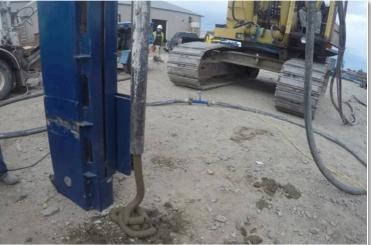
#### IR Site 17-The "Bomber" Method

- The "Bomber" is a soil stabilization technology that delivers cement grout into subsurface voids
- Specialized equipment quickly injects grout into fill or natural soil via a direct push technique

100+ installs per day	X
Close spacing (2-3 ft)	X
Depths > 50 ft	X
Low costs (< \$1 per foot)	X

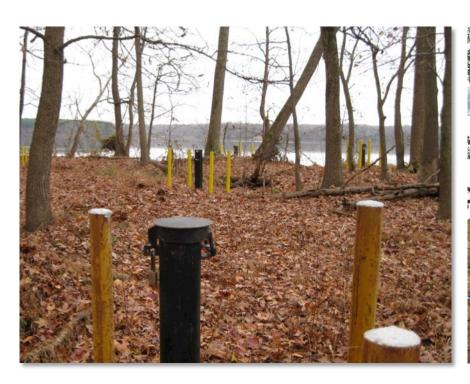
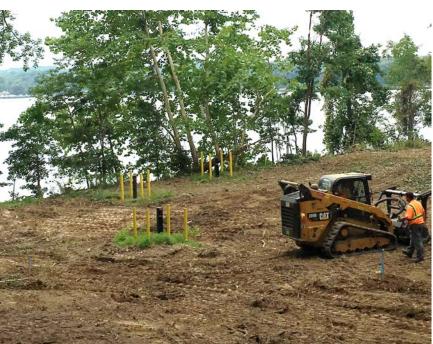
#### Vegetation removal

Before After

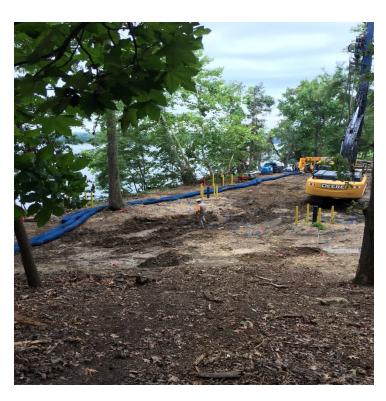
Erosion control tubing was placed along the edge of the site to prevent runoff during rain events.

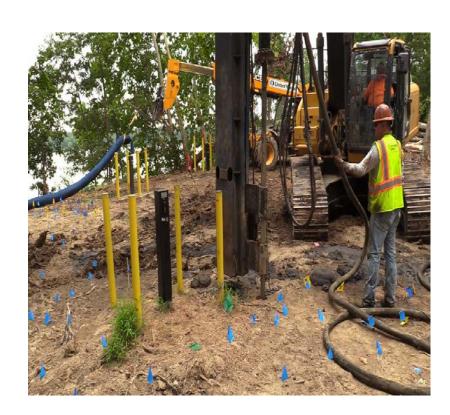
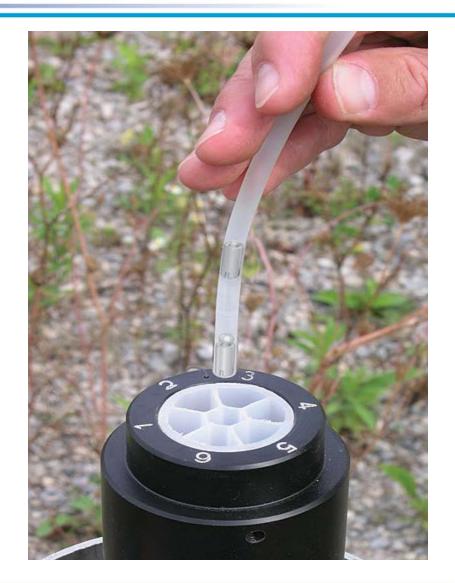
Column Installation

- Installed 600 reaction columns over the two weeks (delays due to weather)
- One reaction column installed every 1.5 minutes during operation.
- Installation of Continuous Multilevel Tubing (CMT) sampler within the reaction column to a depth of 25 ft.

- The bomber requires a full day of assembly
- Hose clogged at the 90 degree fitting near the top of the mast
- Weather

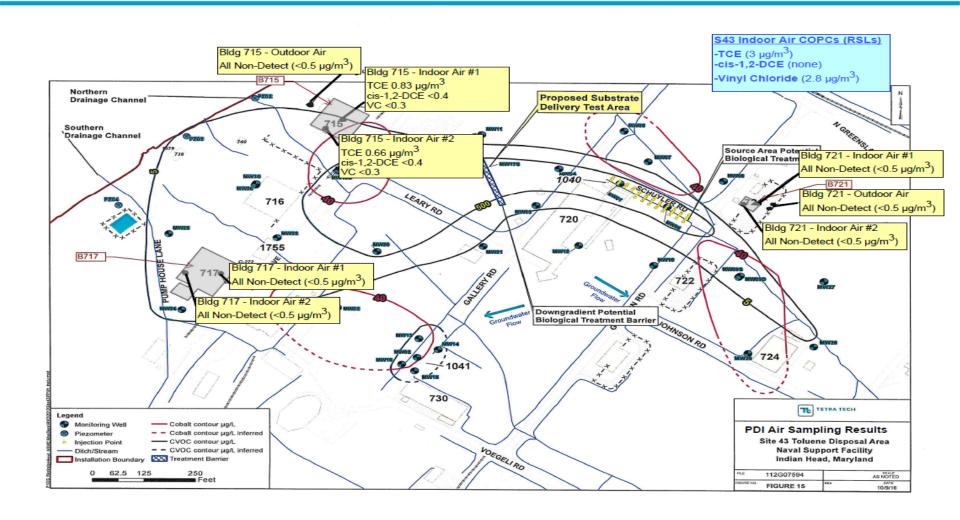
#### IR Site 43- Air Sample Results

Units are micrograms per cubic meter (µg/m3)

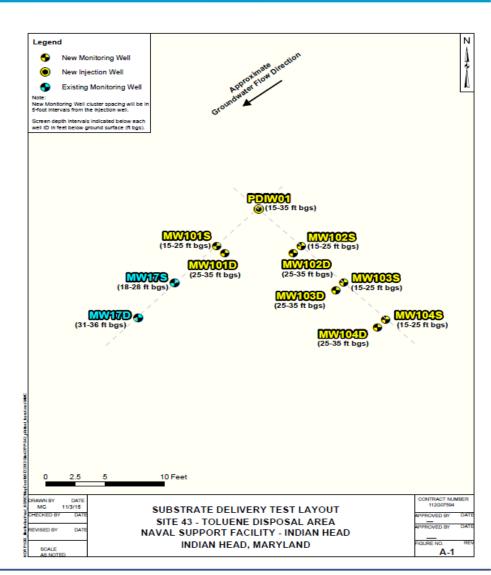
#### **Injection Substrate Distribution Test**

- The test will be conducted by injecting sodium bromide and EOS (emulsified soybean oil, lactate, and micronutrients) concentrate/water mixture at PDIW01.
- EOS was chosen for the Site 43 injection due to its demonstrated success and cost-effectiveness in treating chlorinated solvent contamination at Navy and other Department of Defense (DoD) restoration sites (ESTCP, 2008 and 2010).
- EOS also can be used to generate optimal redox conditions to address other potential site Chemicals of Concern (COCs) such as cobalt.
- The electron donor injection will specifically target groundwater within the soils/sediments of the
- shallow, unconfined aquifer. The thickness of the contaminated aquifer in the test area treatment zone
- is approximately 20 feet and extends from below the water table to the top of the underlying basal clay
- aquitard (approximately 15 to 35 feet bgs).
