INSTALLATION RESTORATION PROGRAM

NAVAL SUPPORT FACILITY
INDIAN HEAD
3838 STRAUSS AVENUE
INDIAN HEAD, MARYLAND
20640-5133

RESTORATION ADVISORY BOARD (RAB) MEETING MINUTES

Date of Meeting: April 19, 2018, 6:00 pm

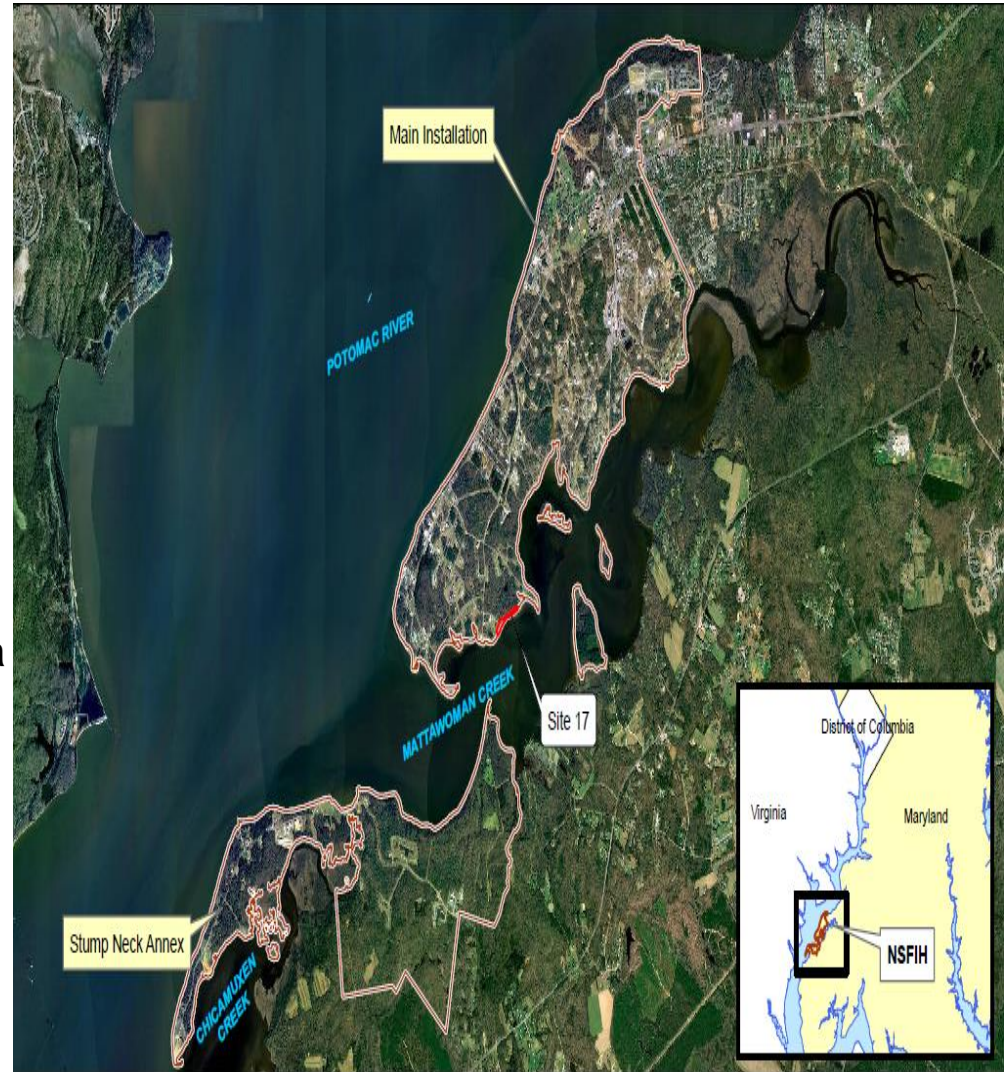
IR Site 17-Site Map

- Site 17 is a 1,000-foot stretch of shoreline along Mattawoman Creek where metal parts were discarded from the 1960s until the early 1980s. The discarded materials included rocket motor casings, shipping containers, empty drums, and various metal parts. Based on a Remedial Investigation (RI) that was completed for this site (CH2M, 2004), two shallow groundwater plumes were identified: North Plume and South Plume. Each plume is defined by an area of attainment, which is the area where the site remediation goals were exceeded for the primary constituents of concern (COCs)—trichloroethene (TCE), cis-1,2-dichloroethene (cis-1,2-DCE), and vinyl chloride (VC).

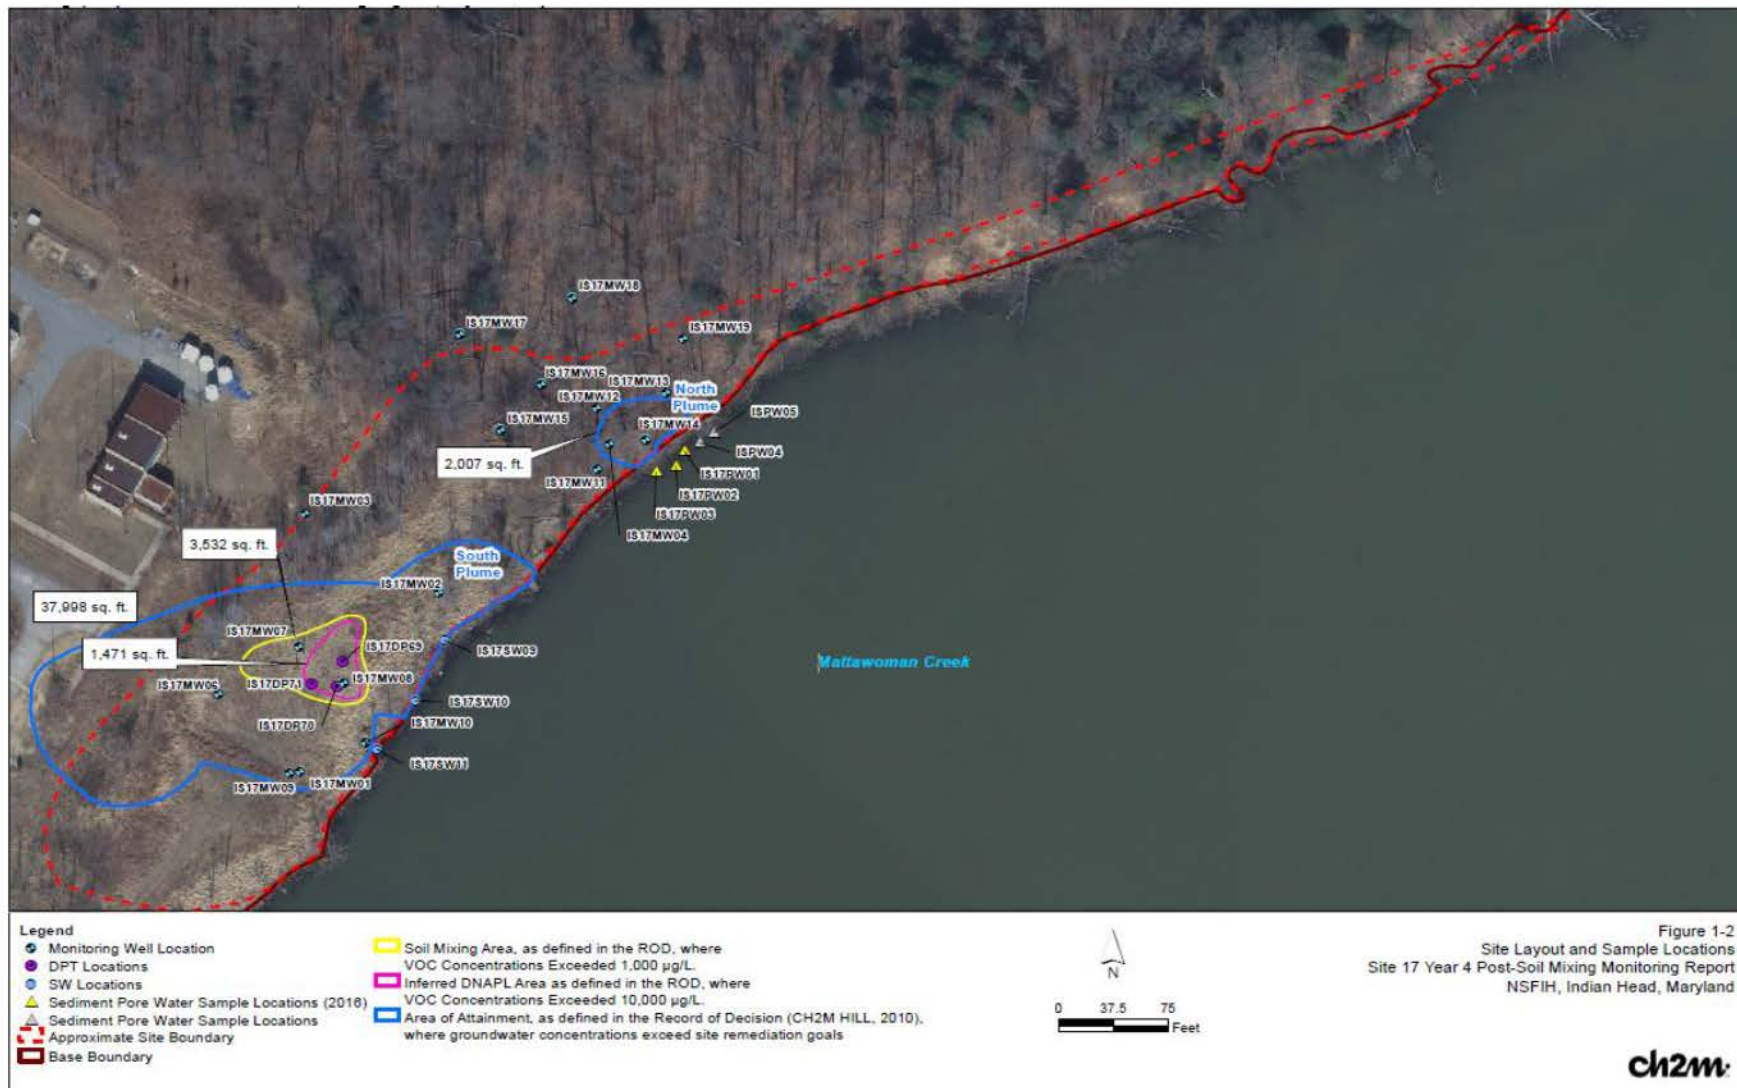
IR Site 17- South Plume Results

1. Average concentrations based on analytical data from IS17DP69, IS17DP70, & IS17DP71, and IS17MW07 & IS17MW08, respectively.
2. µg/L = microgram per liter
3. Δt = change in time
4. TCE = trichloroethene
5. DCE = cis-1,2-dichloroethene
6. VC = vinyl chloride
7. The source zone area initially had TCE concentration greater than 100,000 ug/L.

- **Since the soil mixing, concentrations of TCE, DCE, and VC have decreased in the source area by 98%.**
- **Removal of soil sampling in the south plume due to the effectiveness of the soil mixing.**

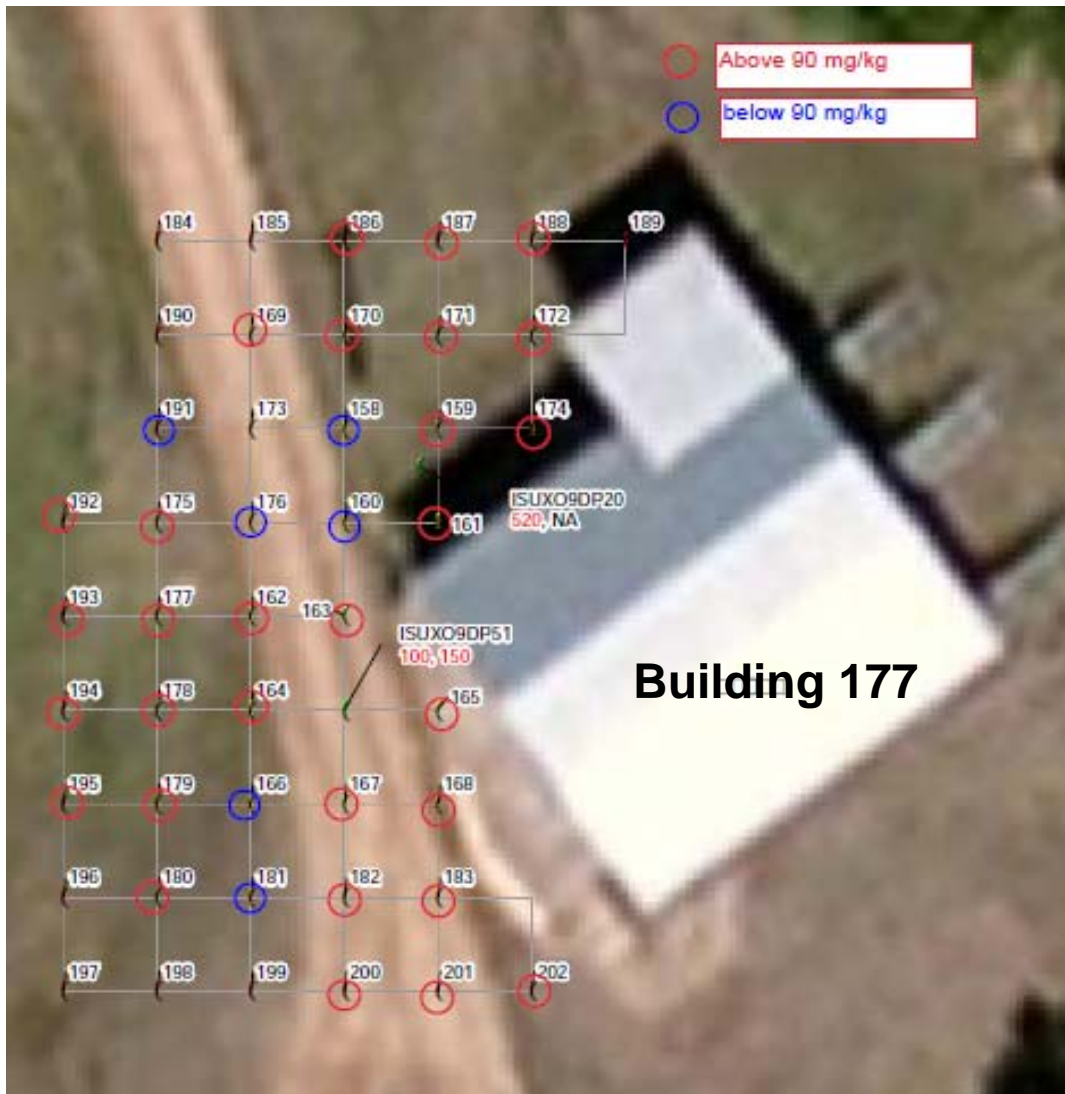
UXO 9 Arsenic Evaluation

Example of the systematic “grid” sampling and step-outs of the soils in front of the dry-house/storage buildings.

Step-outs will occur around locations that exceed a 90 mg/kg criteria.

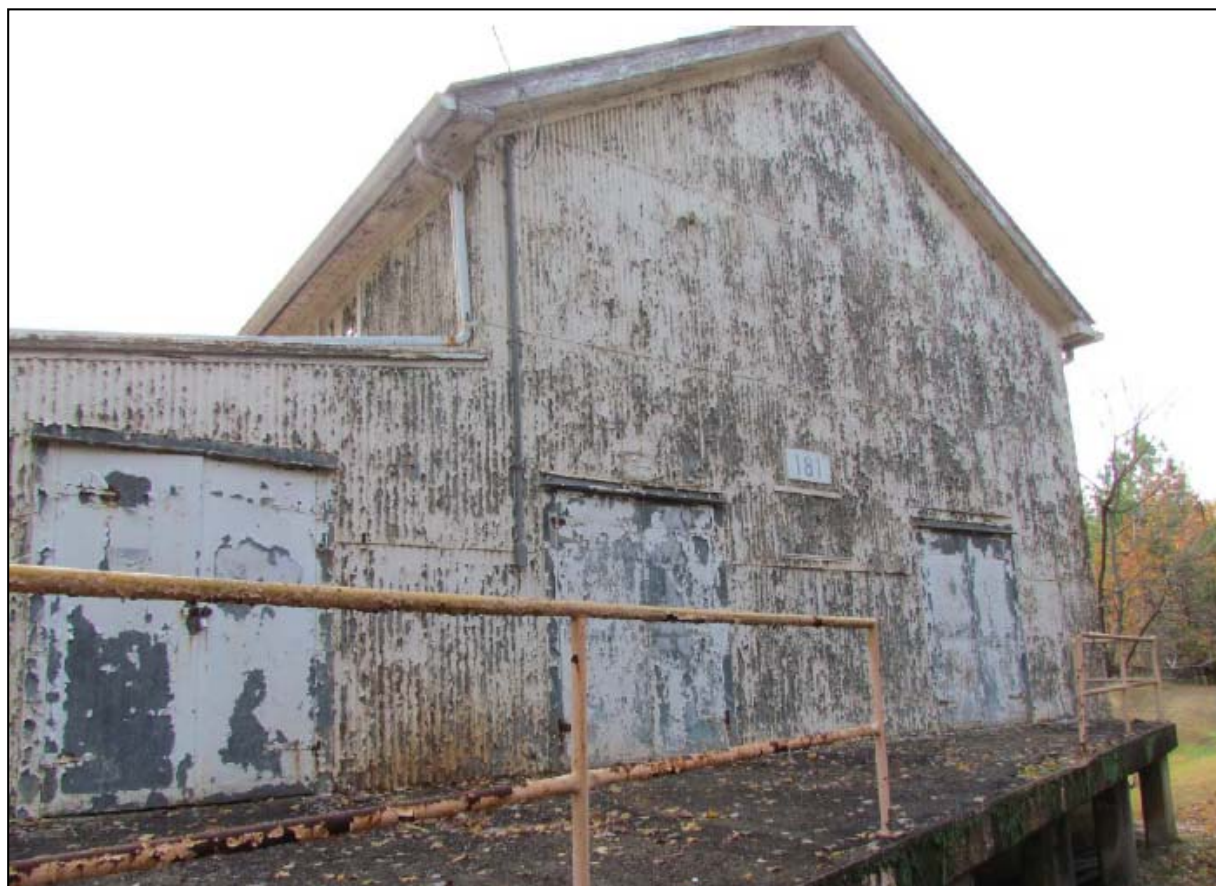
Preliminary results from paint chip analysis (highest result in mg/Kg):

Lead - 211,000
Chromium - 25,100
Zinc - 76,600

Photo of Building 181 on site with extensive paint deterioration on exterior walls and railings.

Answer: Yes, the source is important to determine an appropriate remedy and potentially eliminate a continuing source such as lead paint that is peeling off of old buildings.

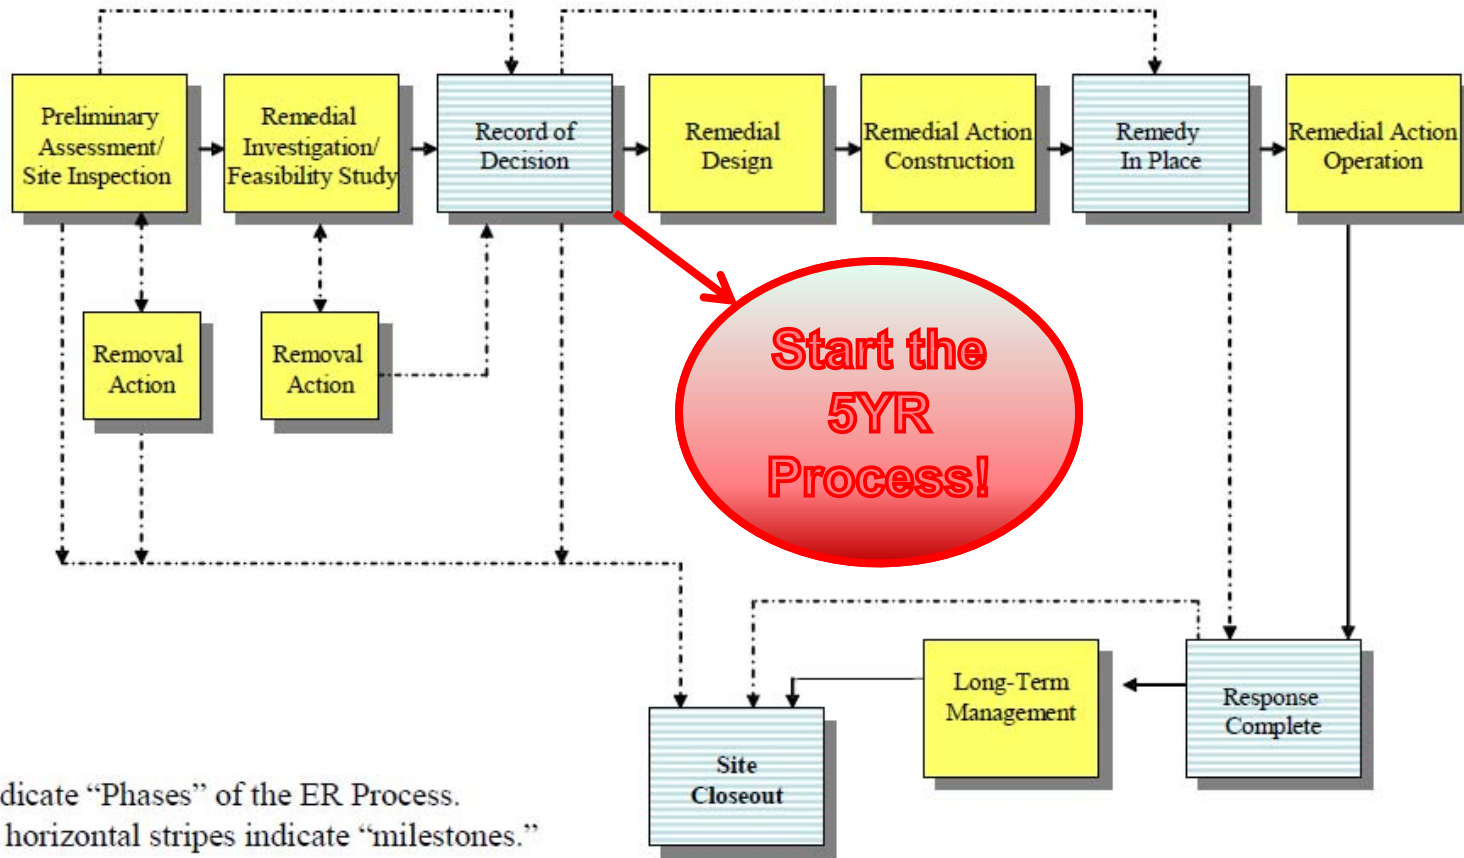
The 5YR and CERCLA

Yellow boxes indicate “Phases” of the ER Process.
 Boxes with blue horizontal stripes indicate “milestones.”

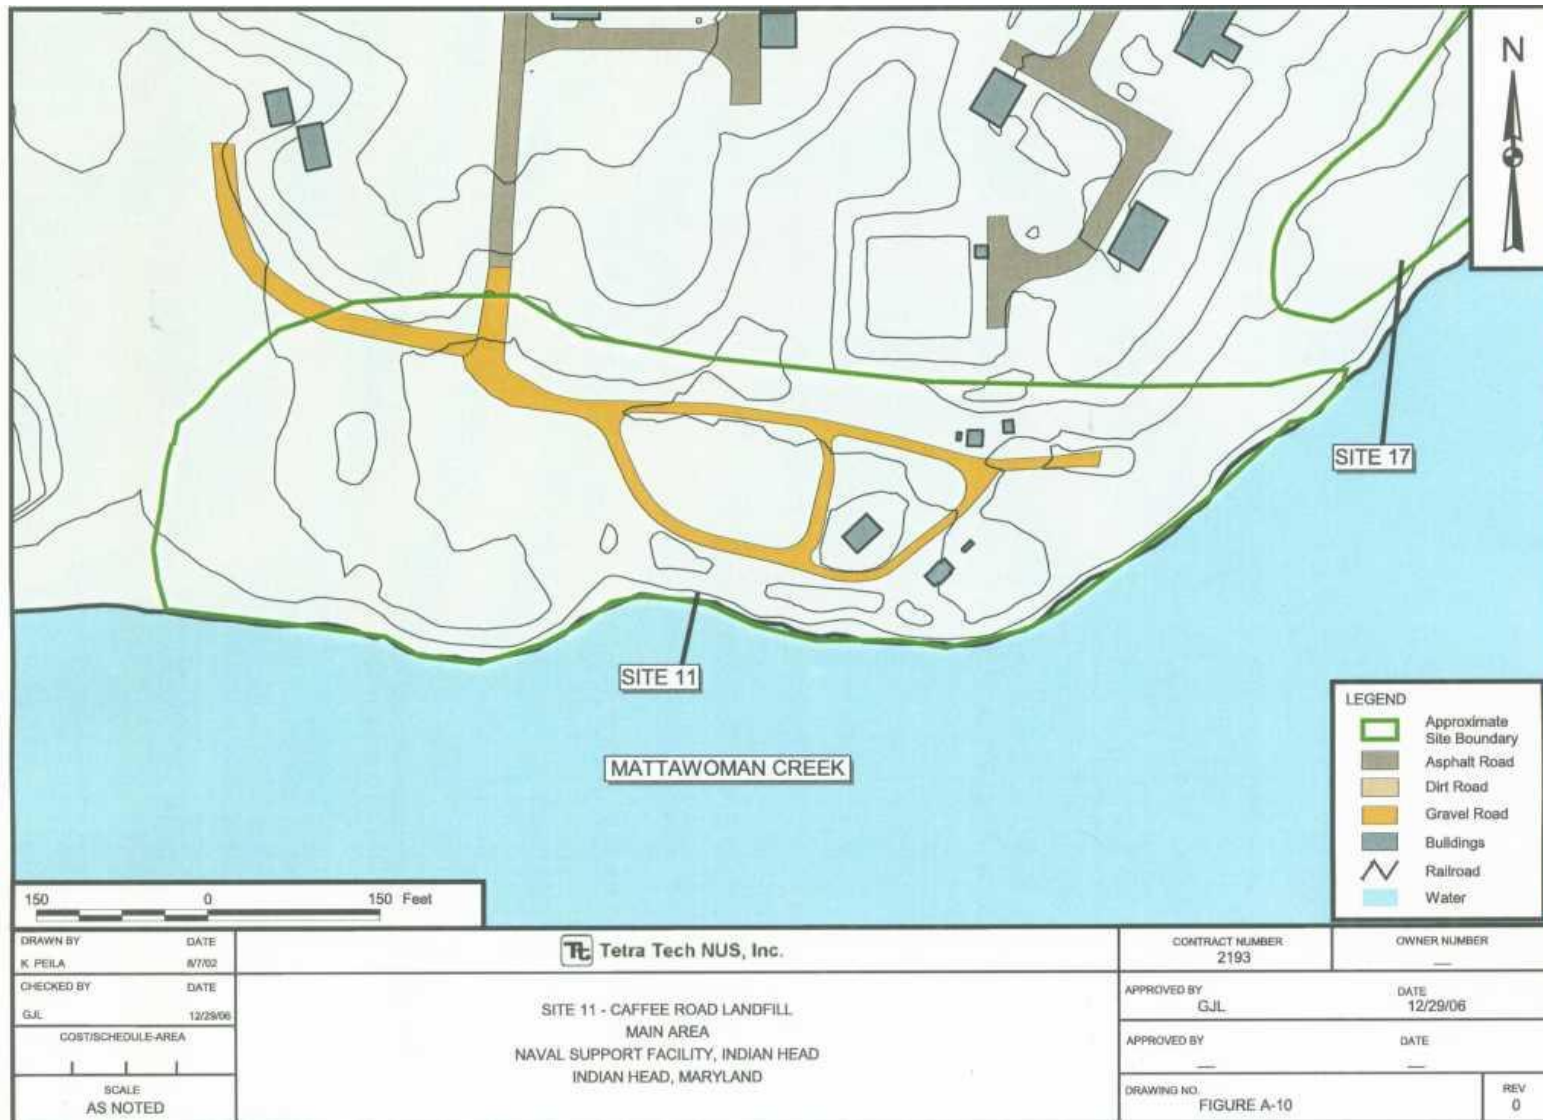
Site 11 – Caffee Road Landfill

Data Evaluation: Contaminant concentrations demonstrate decreasing or no trend. Contaminant concentrations continue to exceed background levels, and the EPA's Maximum Contaminant Levels (MCLs), which is the maximum allowable amount of a contaminant in drinking water.

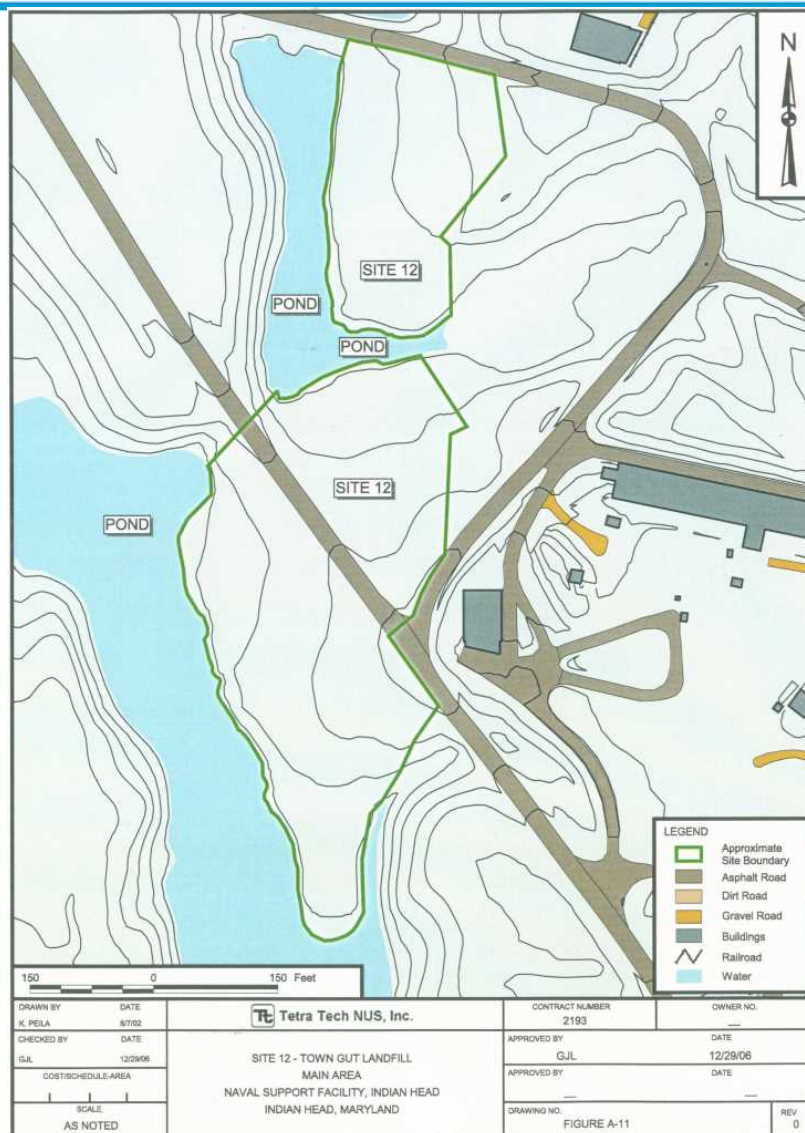
Site 12 – Town Gut Landfill

Implementation & Performance: Remedy has been implemented as described in the ROD in the south plume area. However, recently discovered site conditions in the north plume area contain high levels of contaminant concentrations and is currently being evaluated to implement remediation technologies.

Recommendations: COC concentrations in the North Plume warrant consideration for active treatment of the highest concentration area to optimize the remedy. Monitoring and COC trend analysis should continue until site remediation goals (SRGs) are met.

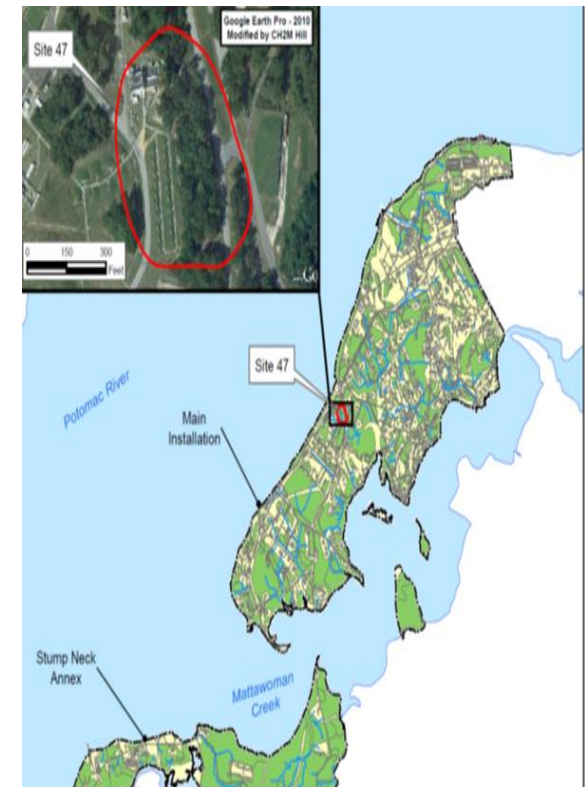
- Site 47 - Mercuric Nitrate Disposal Area
 - Buildings 856, 856A, 856B, 856C, and 1794 - offices, laboratories, and magazines.
- Mercuric nitrate disposal area
 - From 1957 to 1965, mercuric nitrate was used in Building 856 as a catalyst in the production of missile propellant and was reportedly disposed at a location near the southeast corner of the building.
 - Reportedly disposed as a solution containing 1 ounce of mercuric nitrate dissolved in a 55-gallon drum of 98 percent nitric acid. An estimated 274 pounds of mercuric nitrate were disposed.
 - Disposal area was approximately 4 feet by 6 feet and was covered with limestone chips for neutralization; evidence of the disposal area no longer exists
- Carbon tetrachloride was also used and may have been poured into drains or stored in leaky drums
- Tetrachloroethene was detected during the RI, but the source is unknown

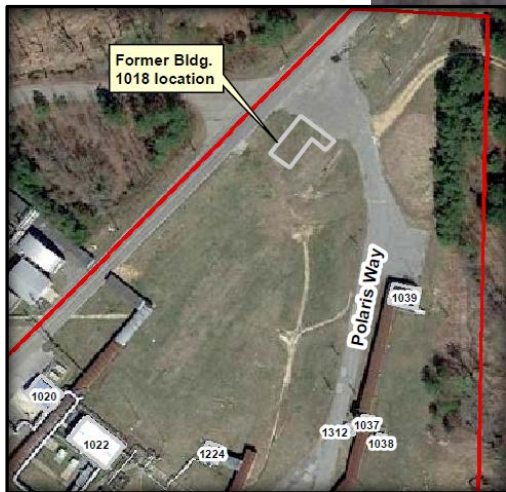
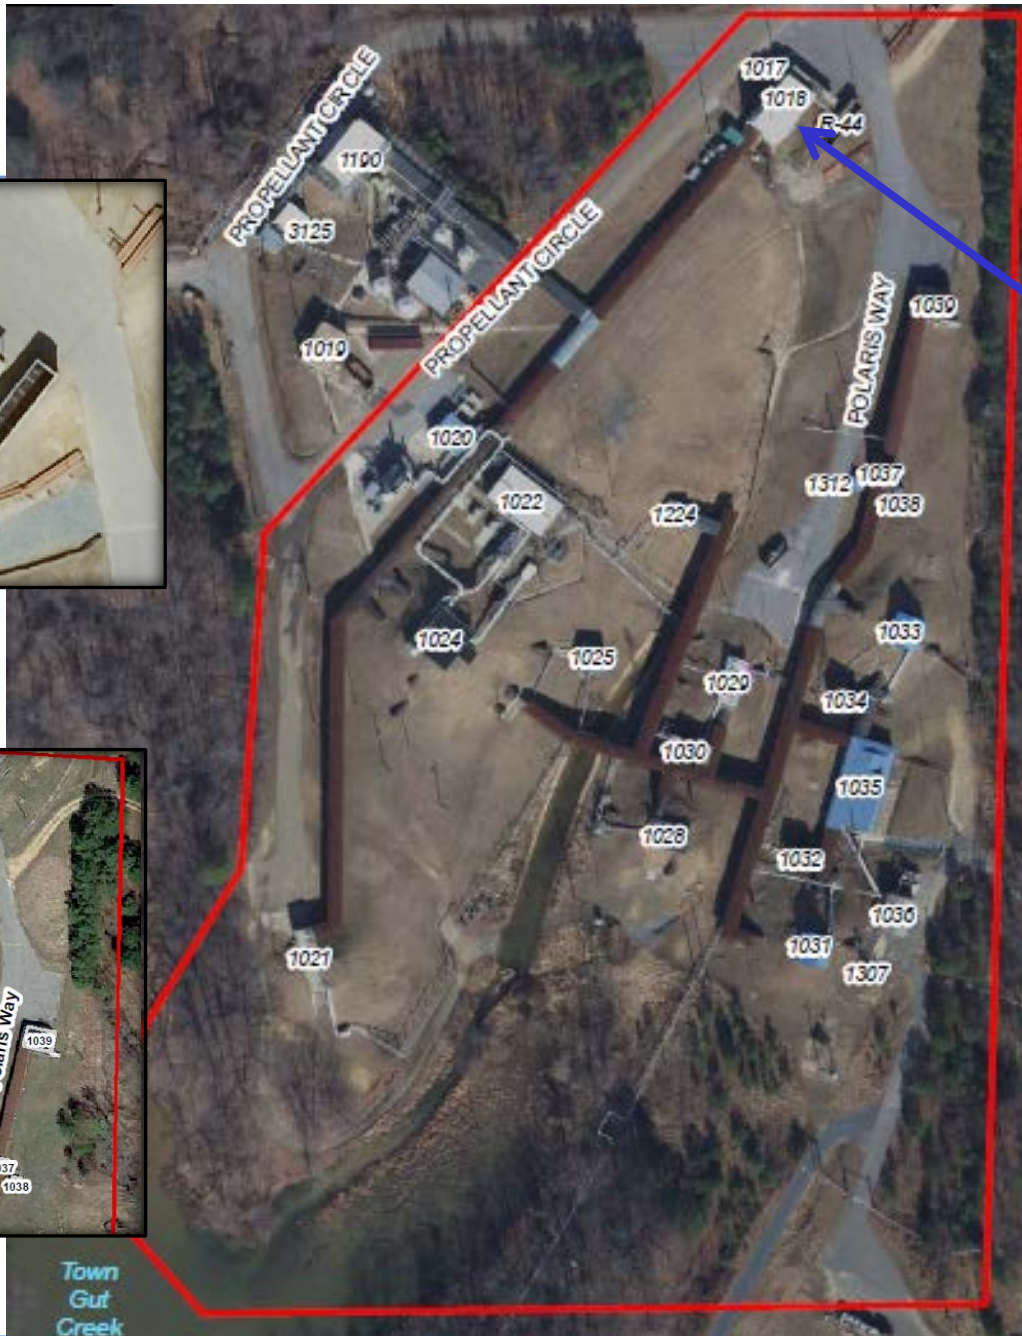
Former Building 1018

Surface releases of perchlorate during unloading and building rinse-outs

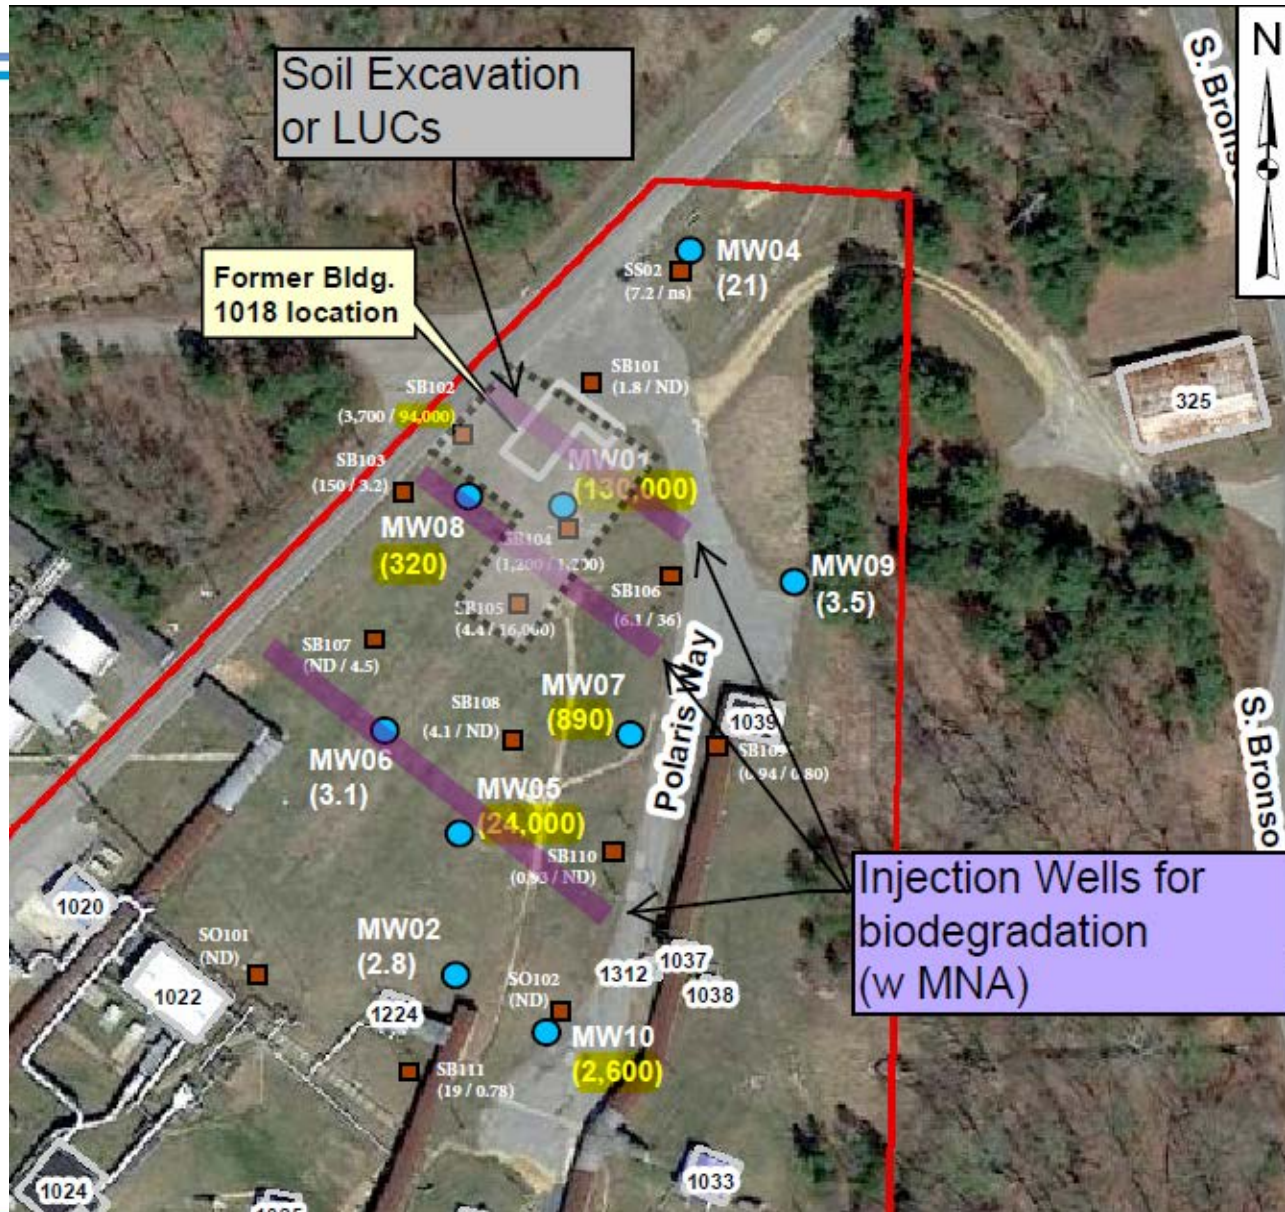
Site 69 Potential Remedy

- Interim Remedial/Removal Action in source area to address perchlorate in soil
- Address perchlorate in groundwater through source treatment (enhanced biodegradation)
- Monitored natural attenuation
- Industrial Land Use Controls
