INSTALLATION RESTORATION PROGRAM

NAVAL SUPPORT FACILITY INDIAN HEAD

RESTORATION ADVISORY BOARD (RAB) MEETING MINUTES

Date of Meeting: October 13, 2022, 6 p.m.

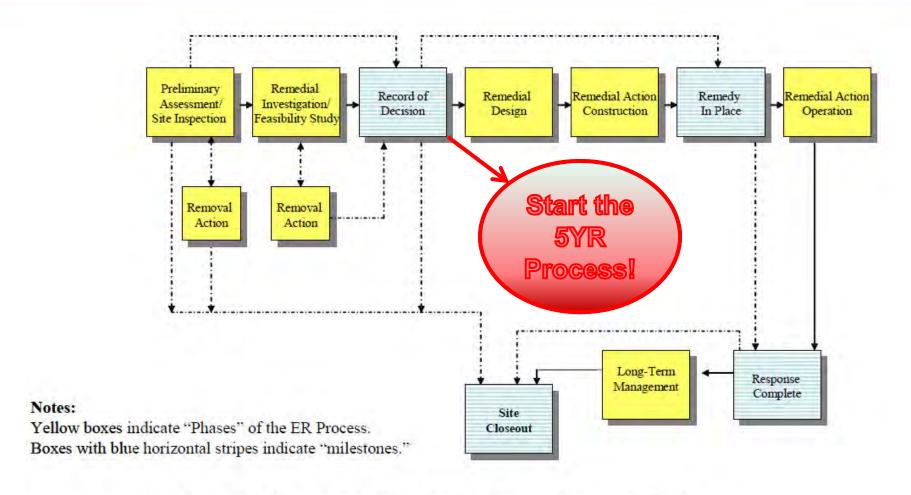
Figure 5-1. DON Environmental Restoration Process – Phases and Milestones

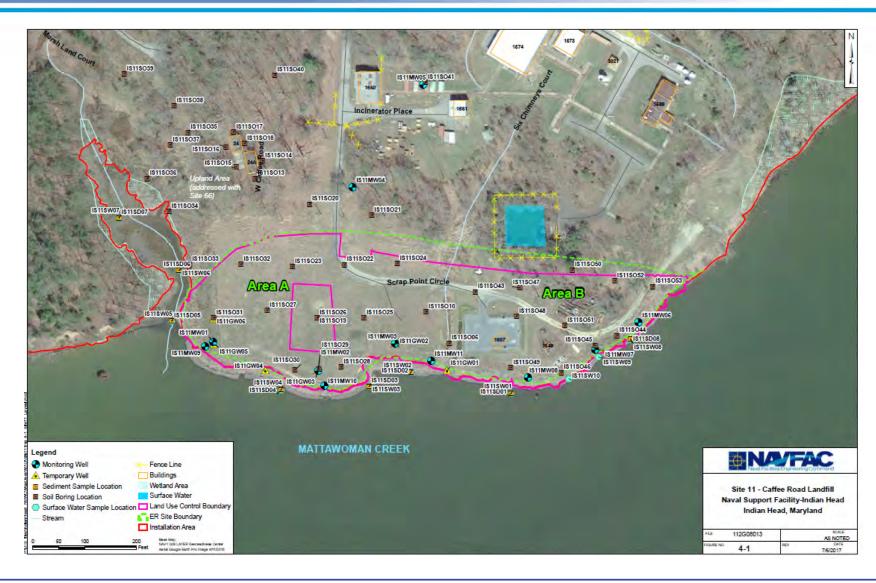
Site 11 - Caffee Road Landfill

Implementation & Performance: Remedy has been implemented as described in the ROD, and is and is functioning as intended.

Selected Remedy: Landfill with protective soil cover. Shoreline stabilization. Land-Use controls (LUCs). Groundwater Monitoring.

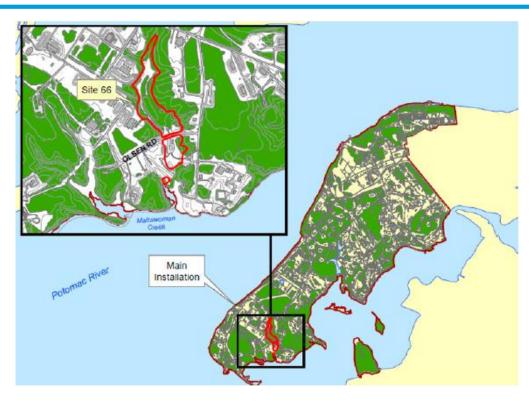
Site 66, Turkey Run Disposal Area, is approximately 13 acres in size and is near the south end of the Main Installation.

- The site was an unregulated dump area discovered in 2003
- Contains various solid wastes, including ash, construction debris, metal scrap, lead flooring, scrap wood, asphalt, clinker, and laboratory bottles.
- 2007: Site Inspection (SI) was completed
- 2010: Remedial Investigation (RI) completed
- 2014: Expanded RI completed
 - Recommended additional investigation, a BERA, and a wetland delineation to fill data gaps.

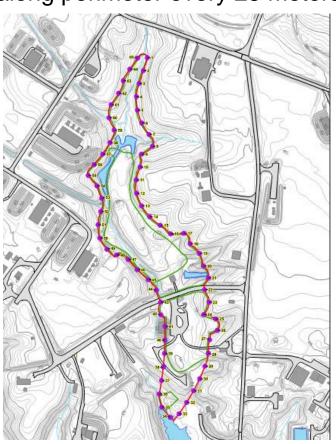
Site Boundary Survey

Surveyed 13 acres with stakes placed • along perimeter every 25 meters

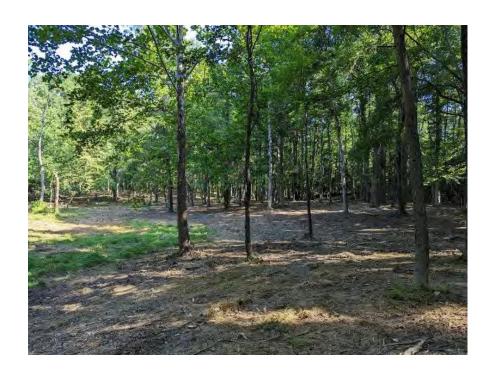
Vegetation Clearance

Approximately 11 acres were cleared of vegetation, excluding wetland areas

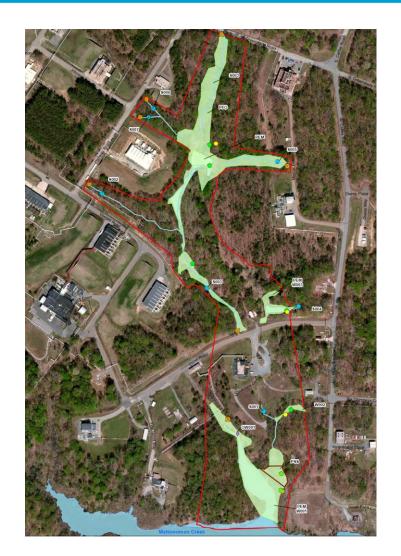
- Completed as part of the expanded RI
- Four wetlands (W001-W004), one open water feature (OW001), and seven waterbodies (S001-S007) were identified
- These features are likely to be considered jurisdictional waters of the United States because of the observed and inferred connectivity of all the wetland and waterbody features to Mattawoman Creek, a traditional navigable waterbody

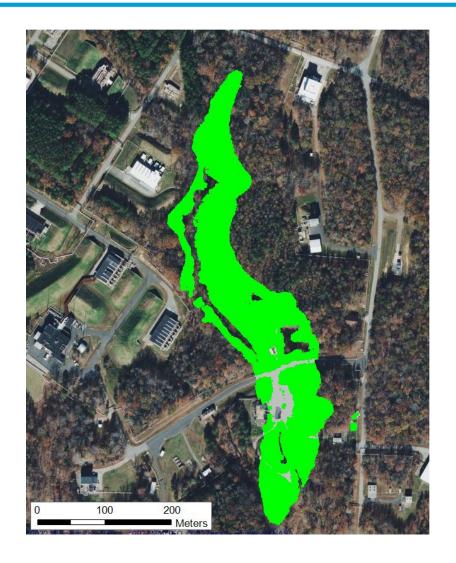
Gamma Walkover

Performed radiological scanning of the site surface on approximately 10 acres of the site (green area on figure); excluded wetland areas and potential asbestos locations

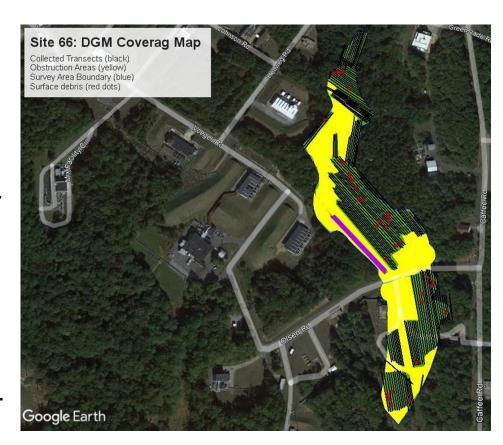
DGM Survey

- Use DGM data from Resistivity/Induced Polarization (IP) surveys to refine the vertical and lateral extents of the landfill and to improve the understanding of the volumes and types of wastes buried.
- Approximately 9 acres of resistivity/IP data was collected across the accessible areas of the site (black lines)
- Data gaps exist at obstruction areas (yellow) that include parking lots, building, wetlands, steep terrain, etc.

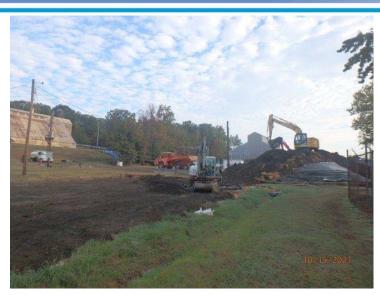
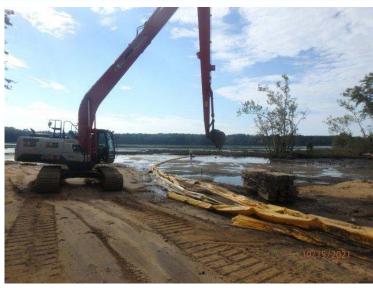
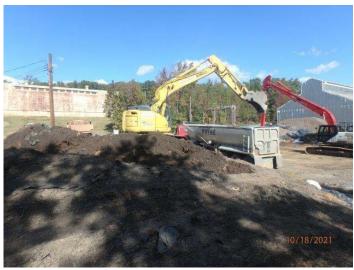
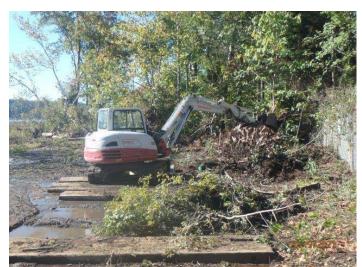
Site 67 Area Photos

- Contractor mobilized to site in February 2021
- Stormwater infrastructure inspection completed via closed-circuit television (CCTV)
- Trees, shrubs, and other vegetation removed
- Property survey, pre-construction survey, and pre-excavation sampling completed
- Excavation completed for target removal areas (TRAs) 1-5
- Additional contamination found in TRA 6 & 7; excavation expanded via step-outs
- TRA 7 was mostly sediment removal within Mattawoman Creek; turbidity curtain used for sediment control

- Placement of select fill and topsoil completed in excavated areas.
- Transportation & disposal (T&D) of on-site soils complete.
- Wetland restoration completed in September 2022.
- Stormwater repairs/pipe lining to be completed after contract modification.
- Confirmation samples revealed more widespread contamination that didn't meet cleanup goals (mostly arsenic and lead) in vicinity of TRA 6.
- Zinc remains a potential COC within TRA 7 and Mattawoman Creek.
- Pilot study is underway to address sediment and additional characterization is planned for soil and groundwater.

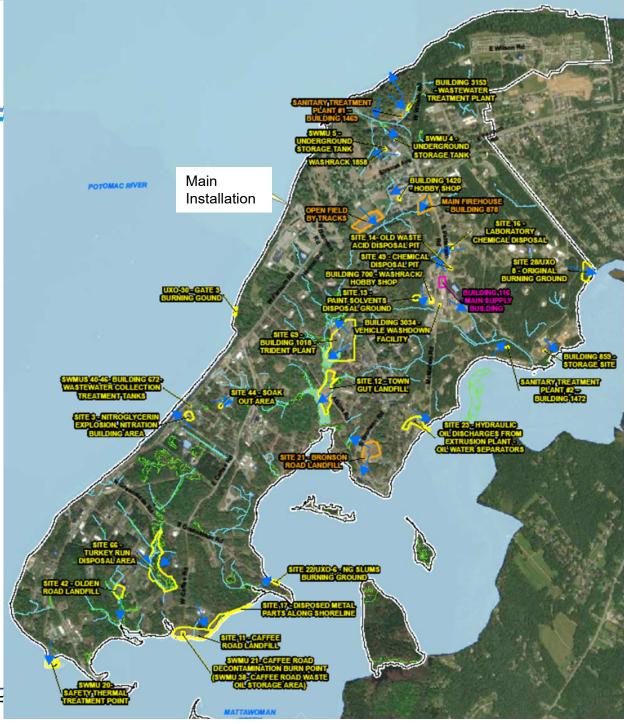
- A total of 30 areas were evaluated for the Main Installation in the Draft PA.
- A total of 25 were recommended for no further action at this time due to no documented releases of PFAS.
- A total of 5 areas were recommended for further investigation as a part of an SI.

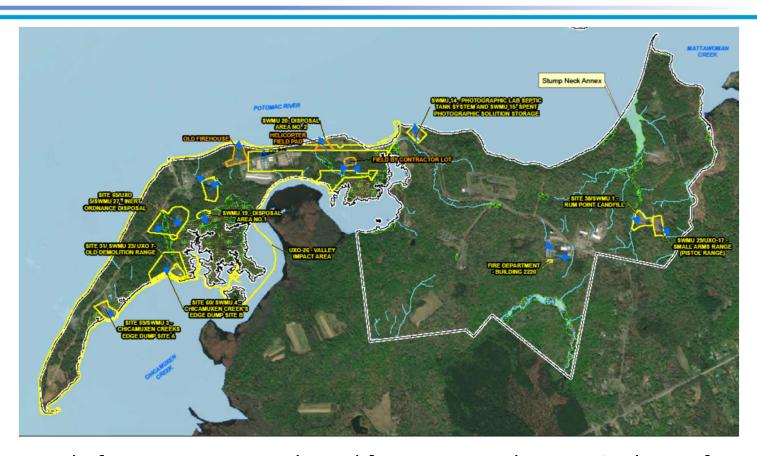
Draft PFAS PA Findings – Stump Neck Annex

- A total of 15 areas were evaluated for Stump Neck Annex in the Draft PA.
- A total of 12 were recommended for no further action at this time due to no documented releases of PFAS.
- A total of 3 areas were recommended for further investigation as a part of an SI.
