Environmental Restoration Program Naval Air Station Patuxent River

Spring 2019 Restoration Advisory Board Meeting

2 April 2019

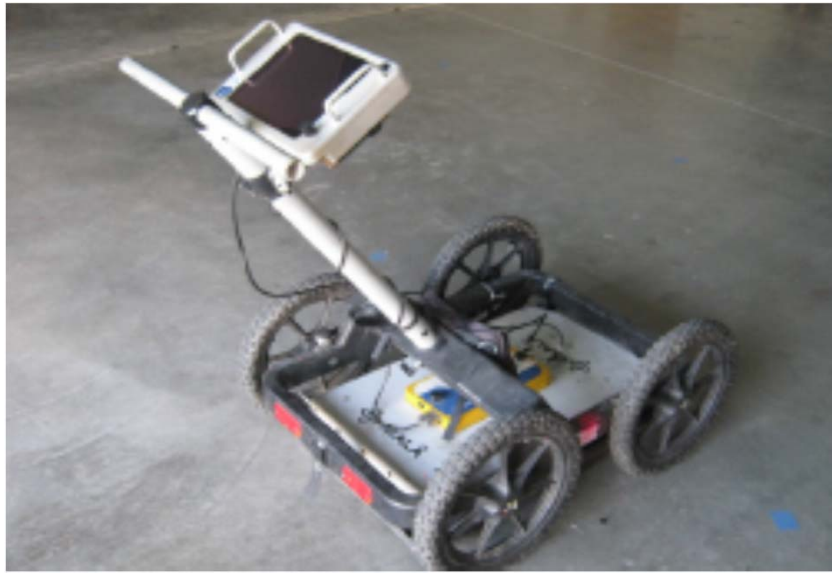
Ground Penetrating
Radar

Site 21 Geophysics

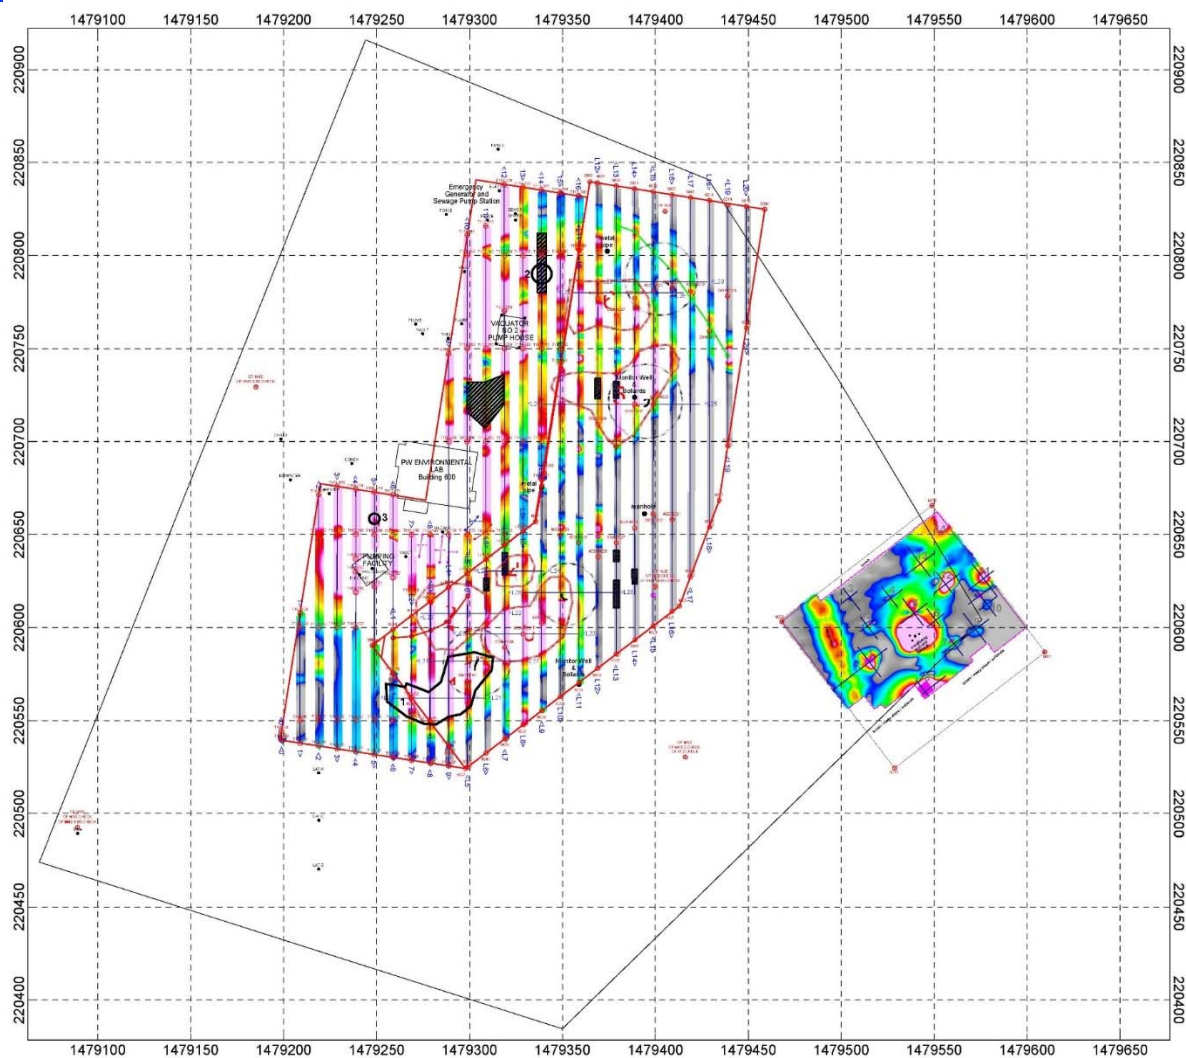
Site 21 Site Geophysics

- No contamination associated with sludge
- No detected mercury
- Significant subsurface debris associated with demolition of clarifiers and digesters
- Unrelated area of solvent contamination in soil and groundwater
 - Likely associated with past surficial disposal practices

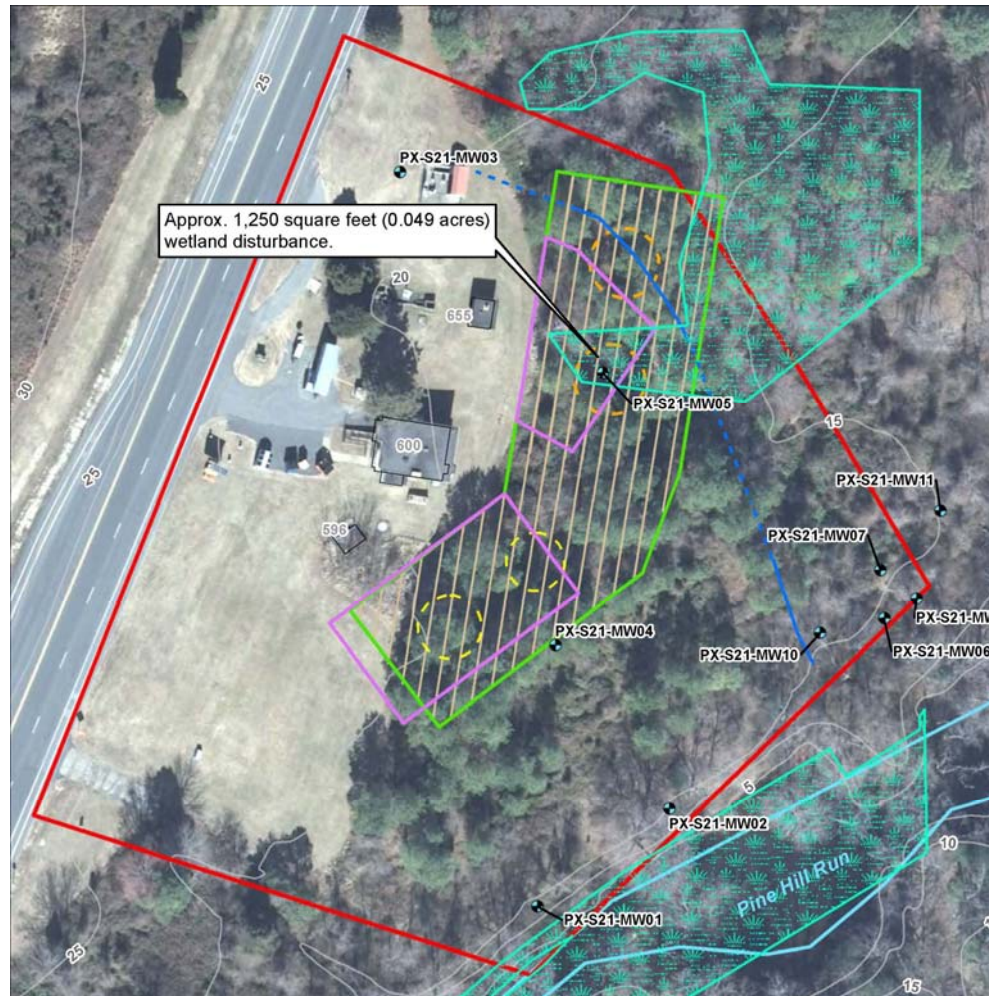
Site 21 Limits of Excavation Digester/Clarifier Area

- Excavate debris
 - Recycle metal and concrete
 - Dispose of any waste
 - Sample for mercury
 - Reuse clean soil
- Excavate and dispose of solvent-contaminated soil
