NAS Patuxent River Restoration Advisory Board

PFAS Update Naval Air Station Patuxent River And Webster Outlying Field

28 April 2021

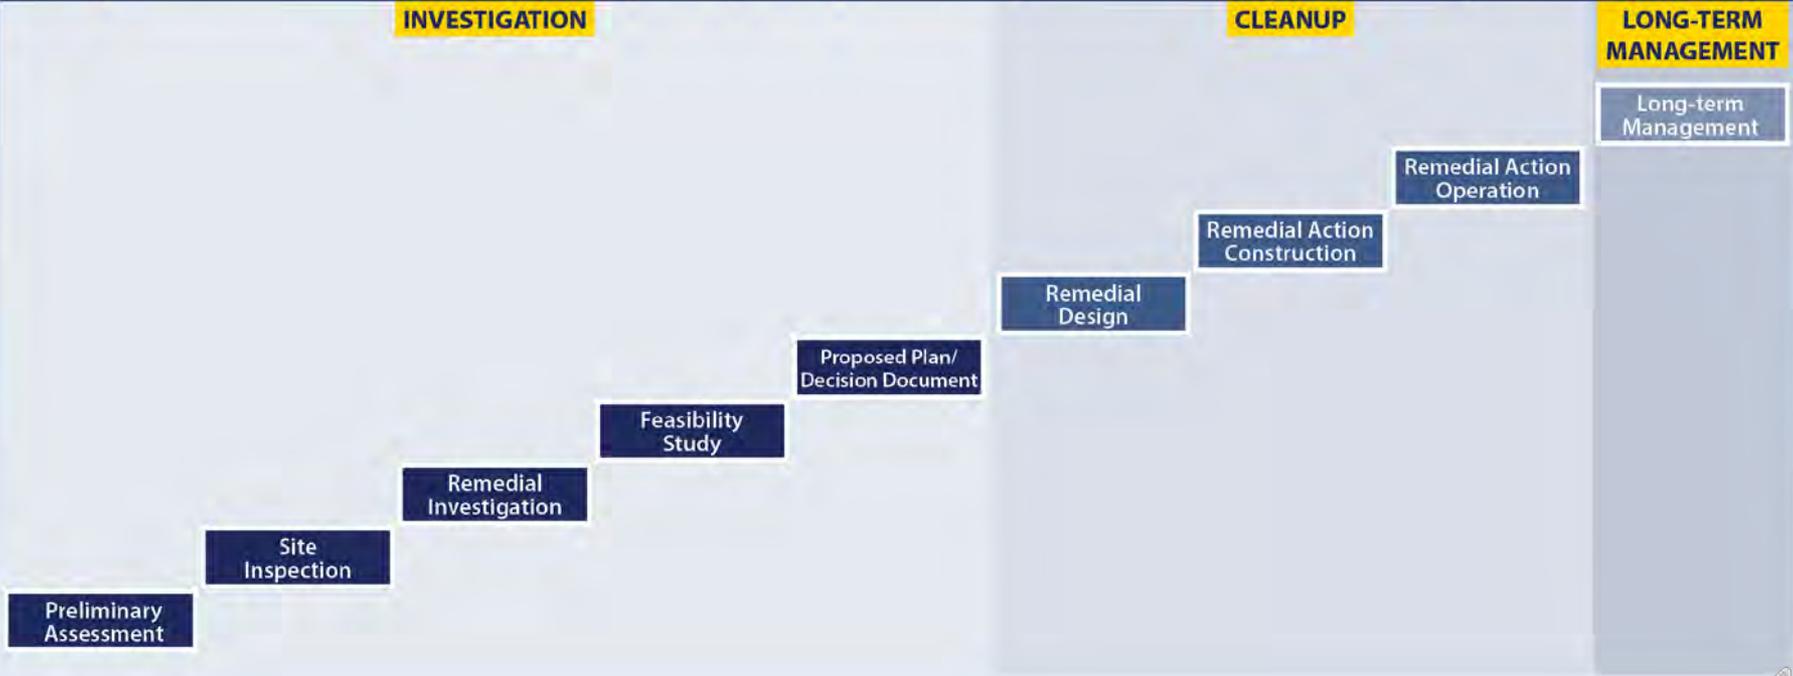
Comprehensive Environmental Response, Compensation, and Liability Act (CERCLA) Process

INVESTIGATION

CLEANUP

LONG-TERM MANAGEMENT

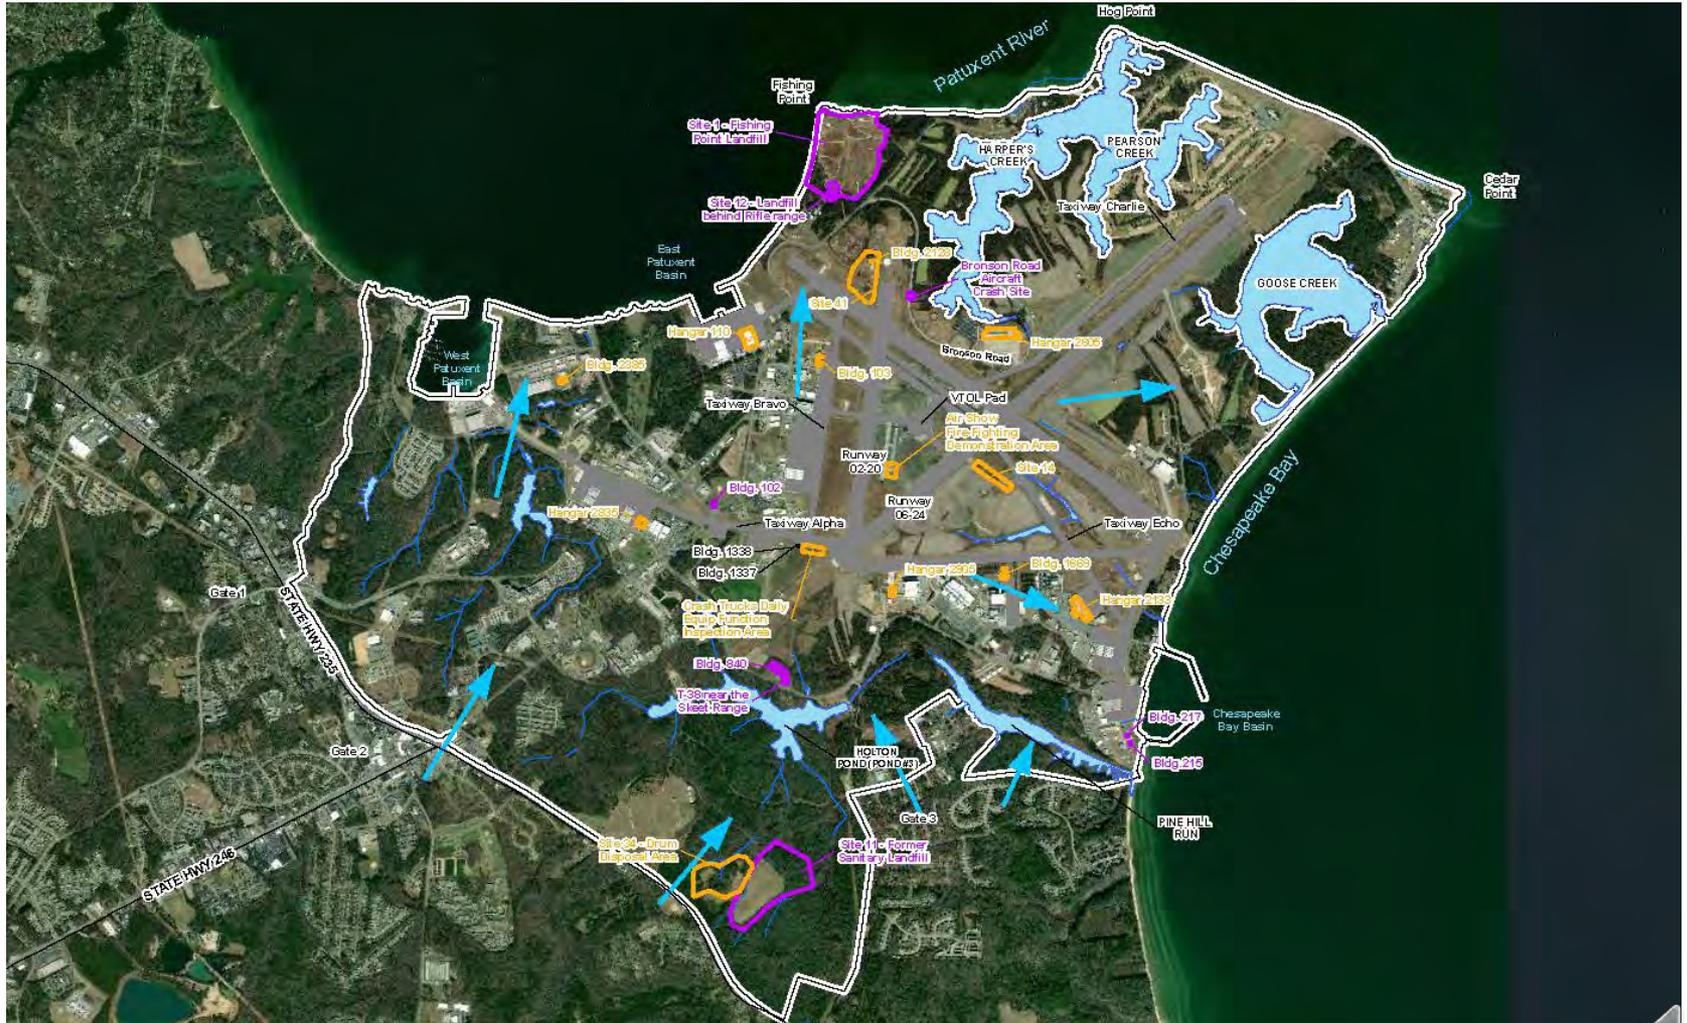
PA Results NAS Patuxent River

- 16 Areas of Interest (AOIs) identified
 - Firefighter training areas
 - Firefighter demonstration areas
 - Crash response areas
- 3 ERP sites
 - Site 34
 - Tested for PFAS unrelated to PA
 - Two former landfills (Sites 1 and 11)
 - Possible past disposal of AFFF

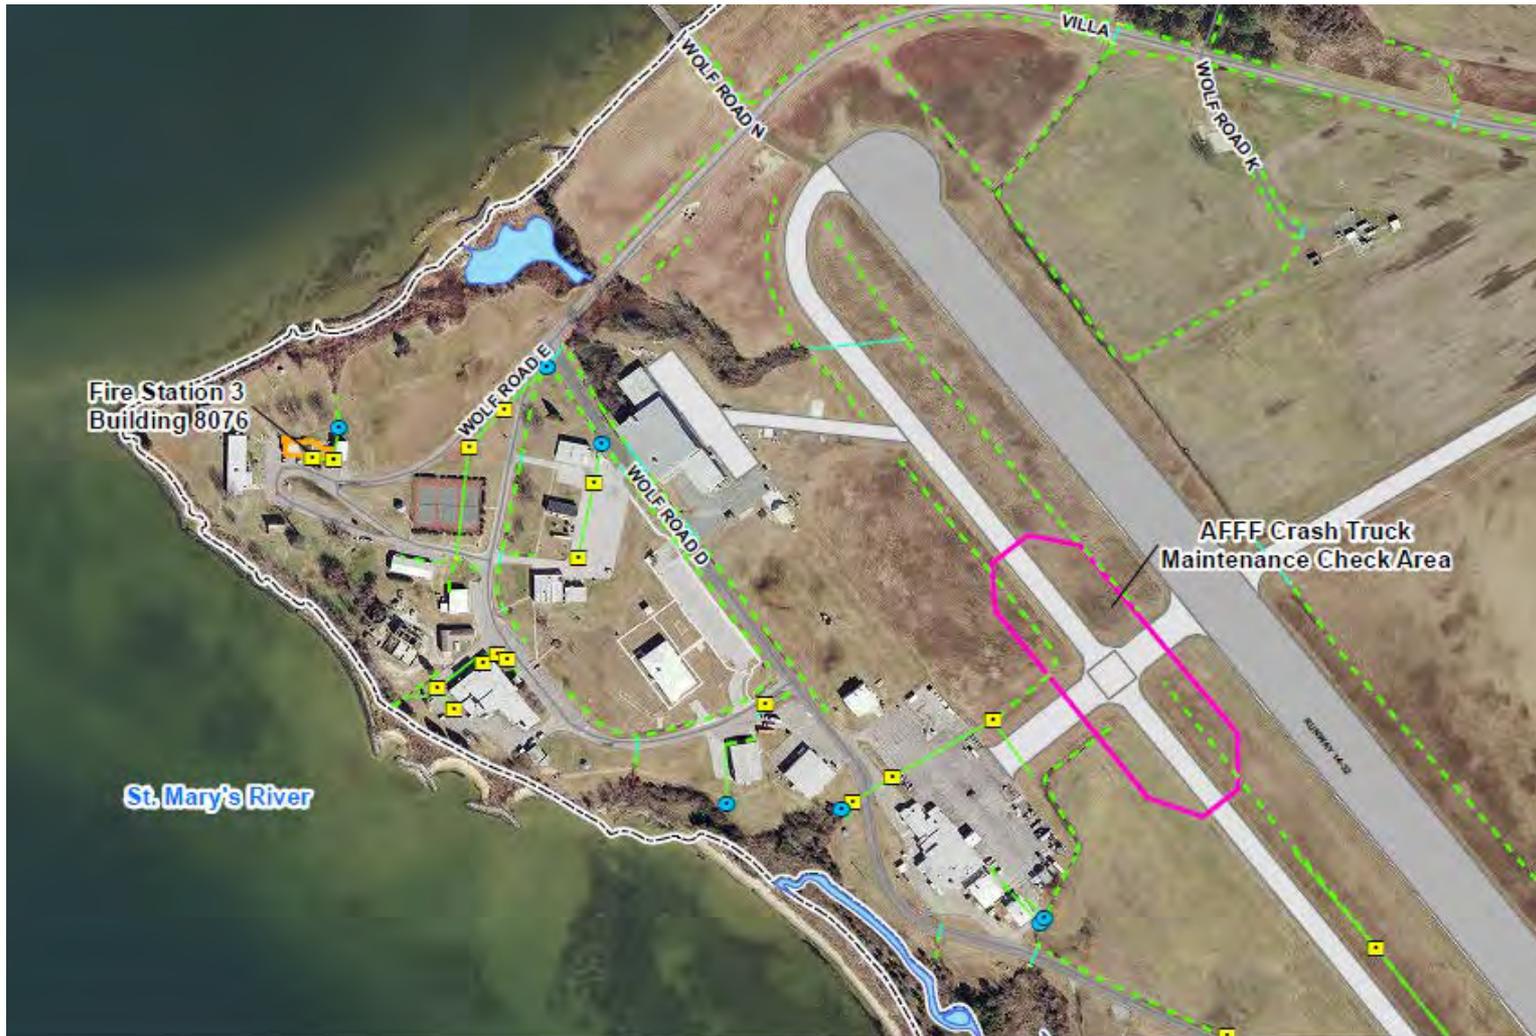
PA Results Webster Field

- 2 AOIs identified
 - AFFF Crash Truck Maintenance Area
 - Historical AFFF equipment spray checks
 - Discontinued in 1990s
 - Since then only checked with water
 - Fire Station 3 (Building 8076)
 - Storage of AFFF

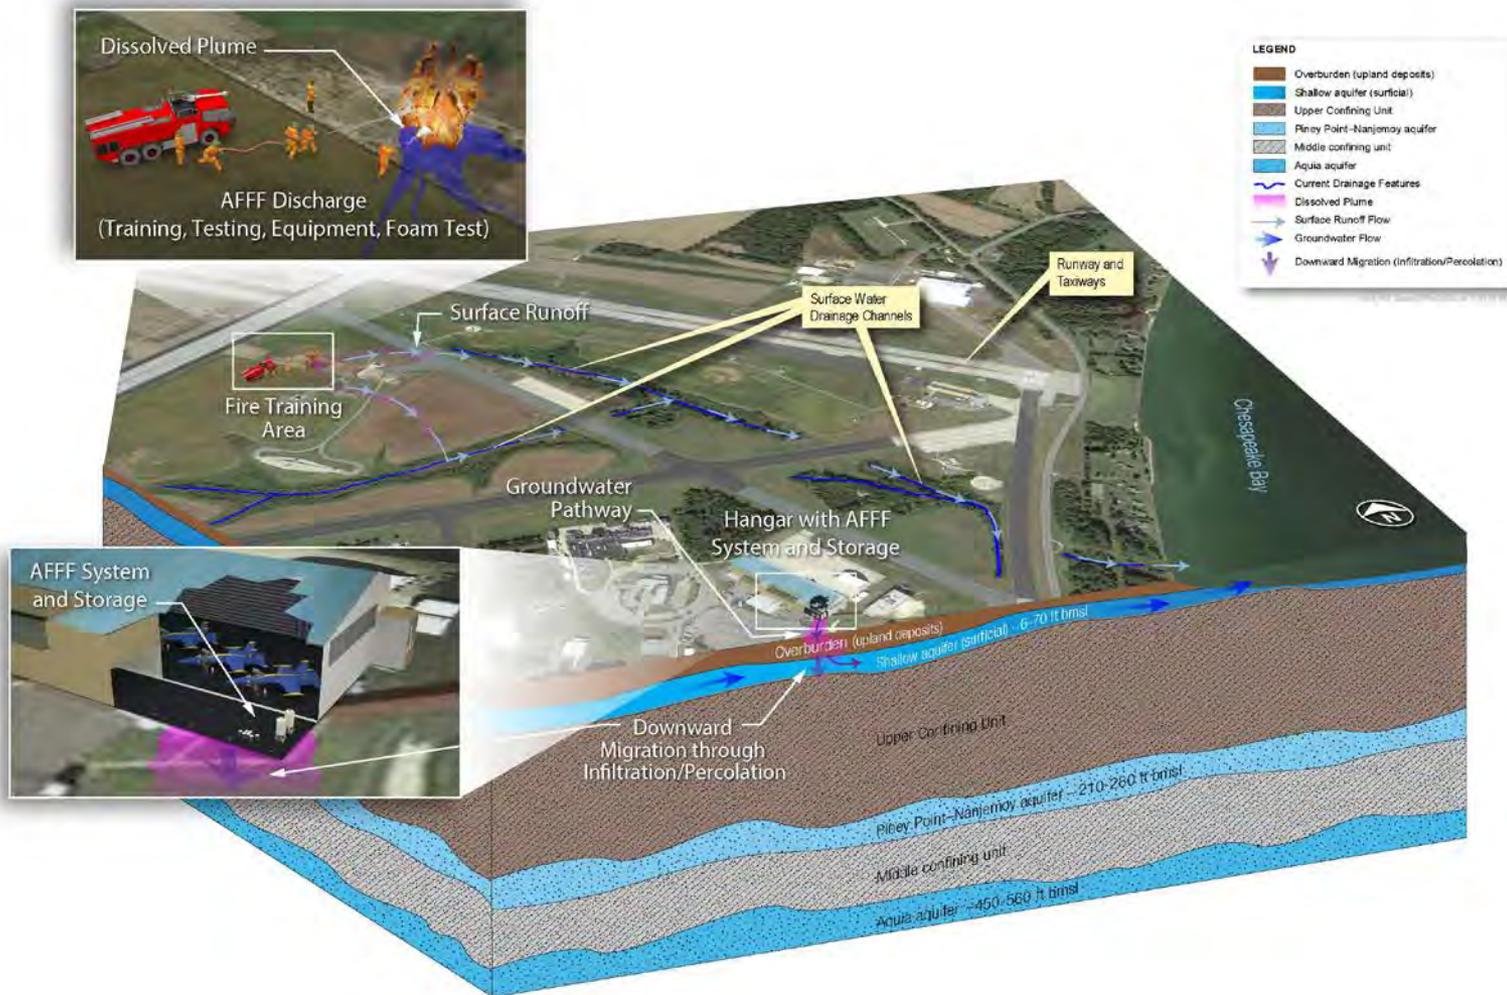
Conceptual Site Model

- PFAS releases impact shallow groundwater
- Shallow groundwater discharges to nearby streams and rivers
- Deeper groundwater protected by thick clay layers that isolate aquifers from surface releases
- **No known concerns with off-base drinking water supplies**
- **Both base's drinking water sampled twice**
 - No detections of PFAS

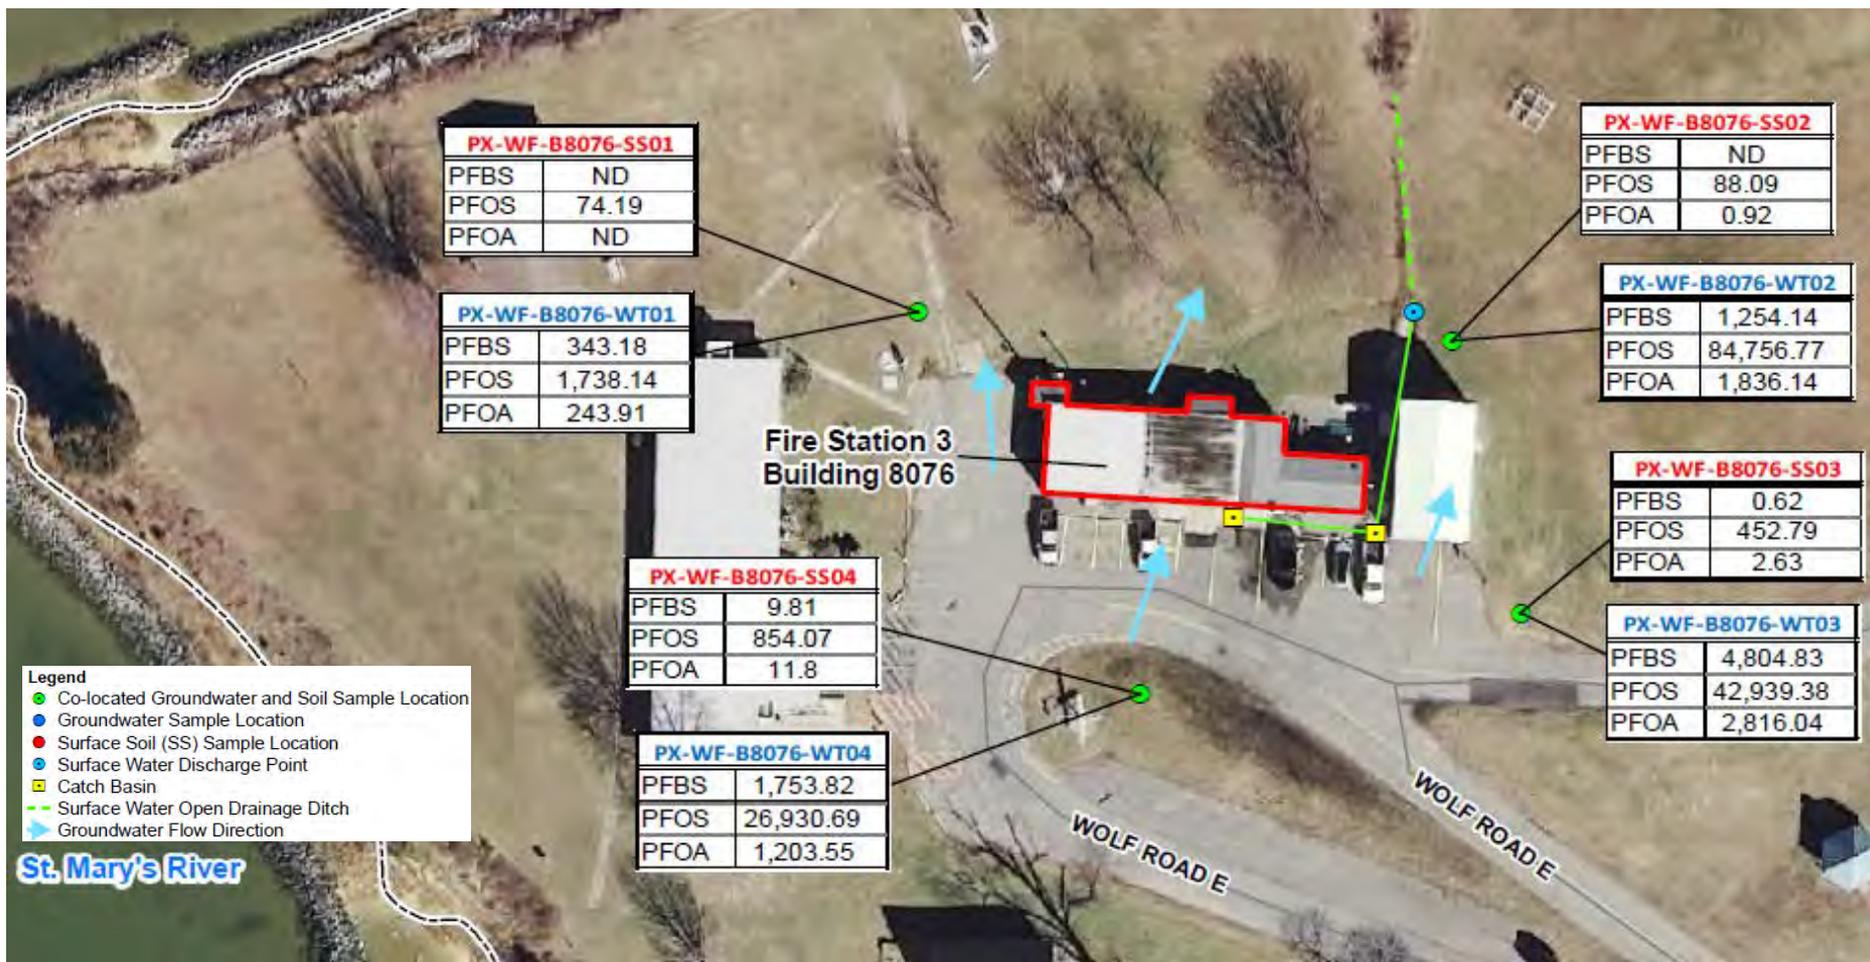
Firehouse 3

- Fieldwork completed in October 2020
- Received final validated data December 2020
- Detections of PFOS, PFOA, and/or PFBS in groundwater at all 16 Pax River AOIs and both Webster Field AOIs
- Concentrations above applicable screening levels
 - PFOS: 40 PPT
 - PFOA: 40 PPT
 - PFBS: 400 PPT

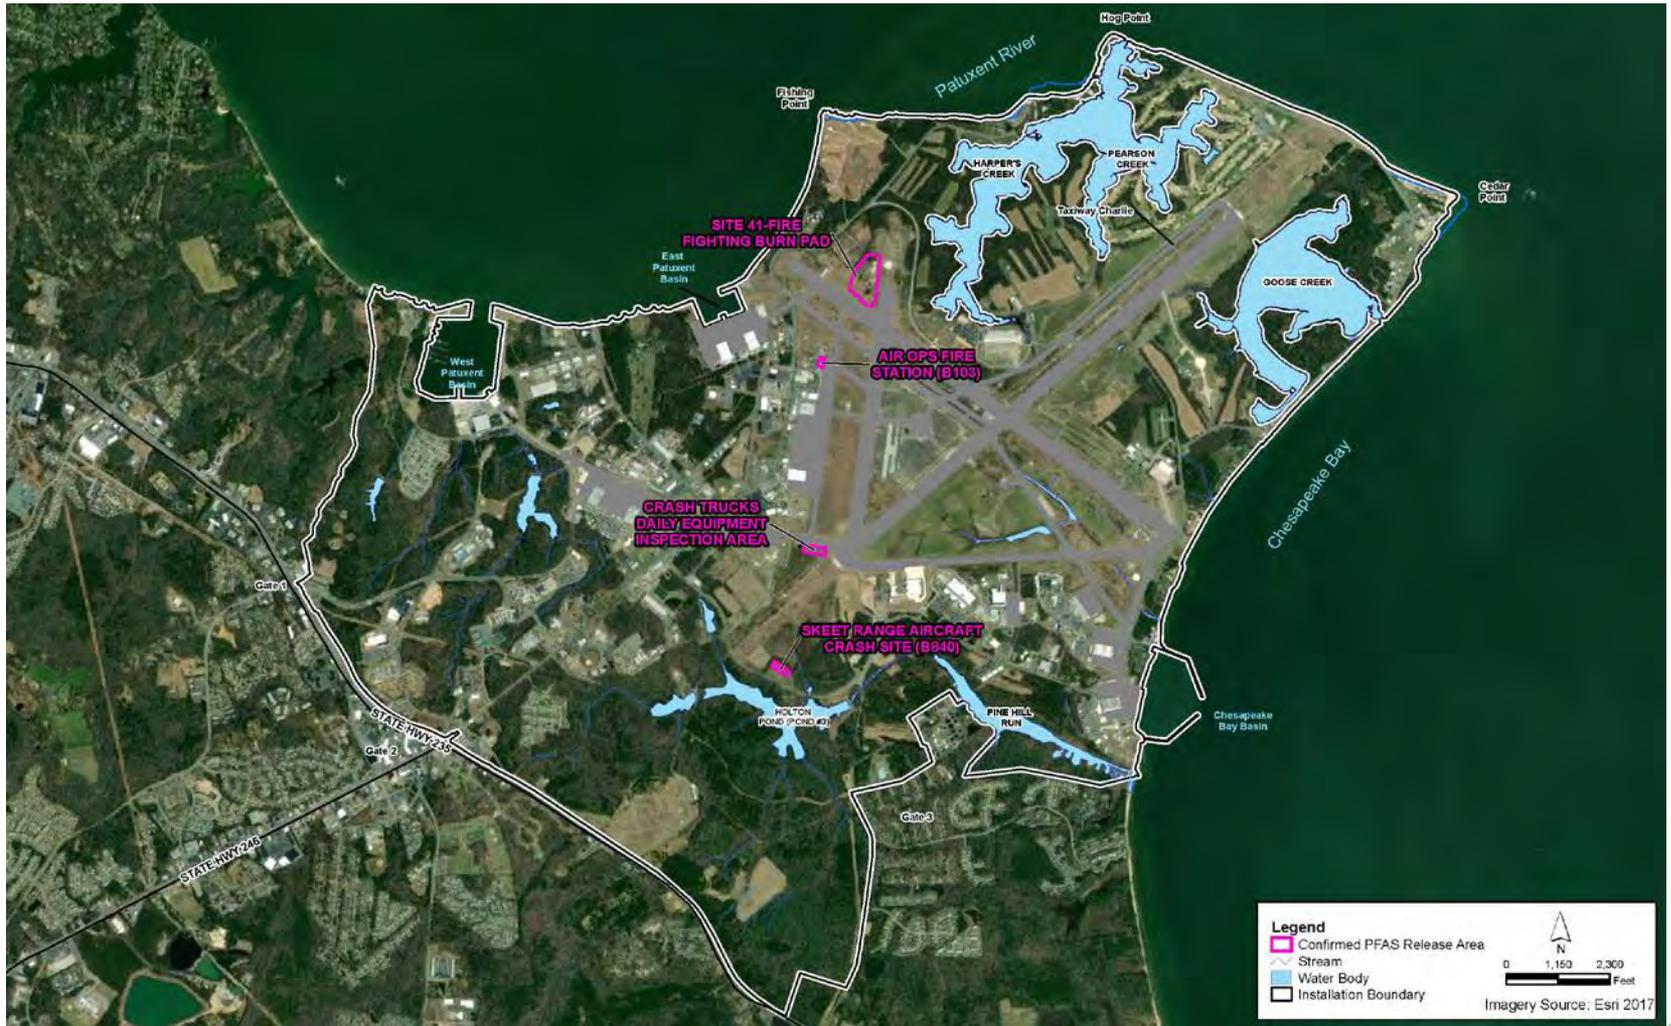
AOIs > 10,000 PPT

- PFAS detected at all 16 AOIs
 - 4 contained concentrations of PFOS or PFOA in shallow groundwater above 10,000 PPT
 - 3 contained concentrations of PFOS or PFOA in shallow groundwater between 1,000 PPT and 10,000 PPT
 - 9 contained concentrations of PFOS or PFOA in shallow groundwater between 100 PPT and 1,000 PPT
- The following focuses on the 4 AOIs with concentrations above 10,000 PPT
- Figures for the remaining 12 AOIs are provided at the end of the presentation

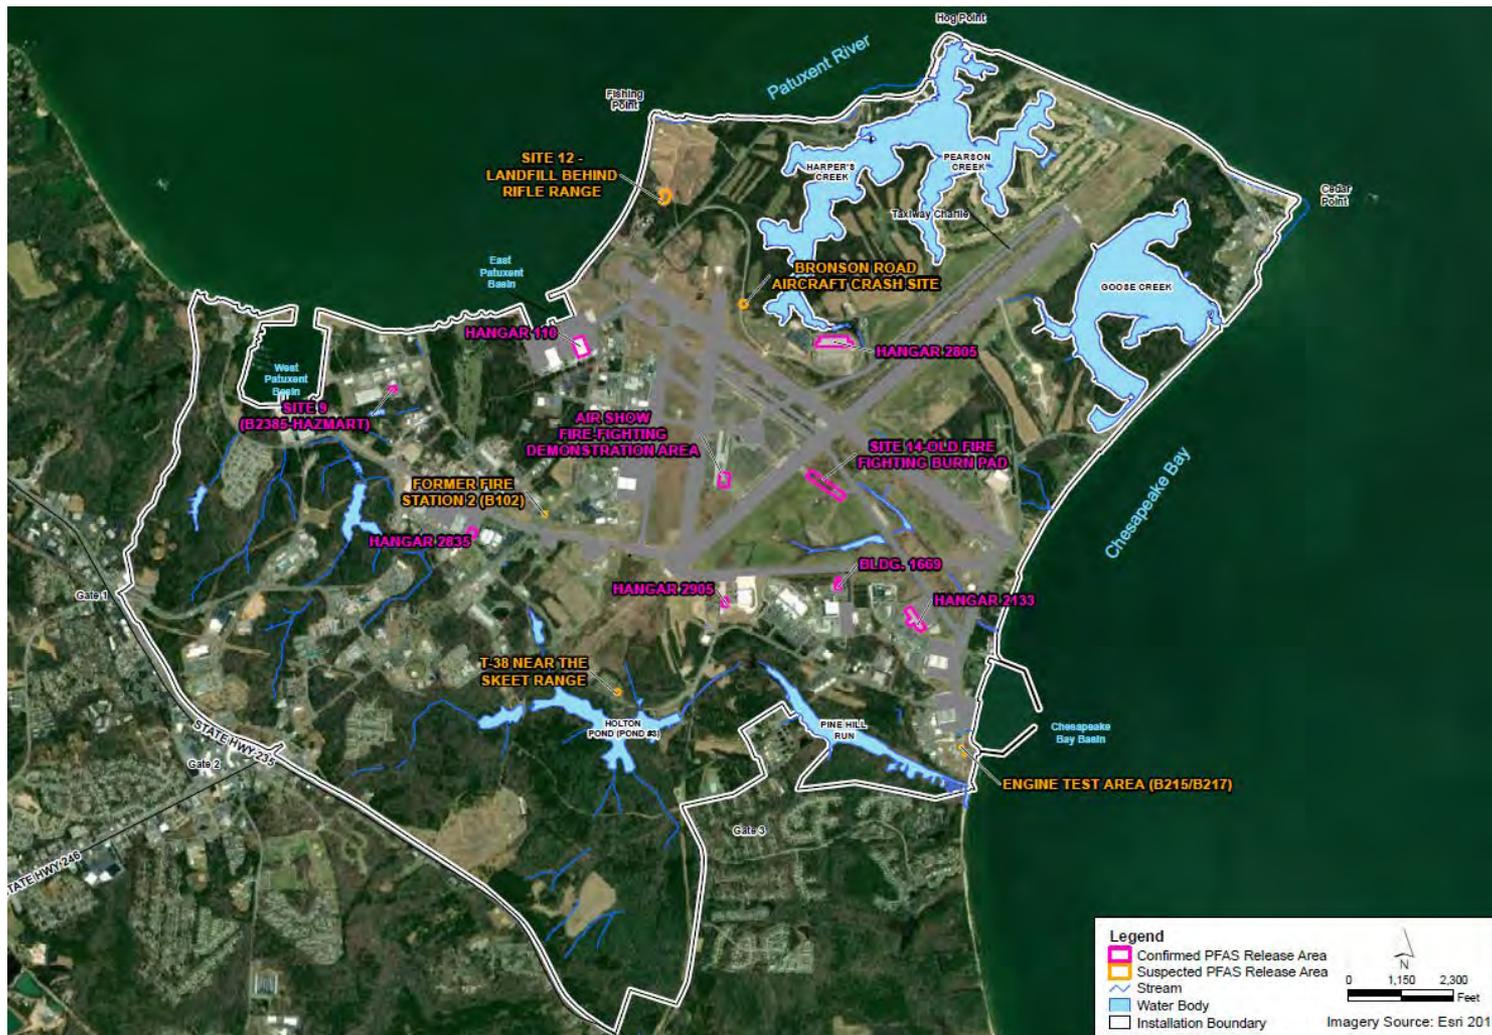
AOIs < 10,000 PPT

Sampling results and figures for the 12
AOIs with PFOS or PFOA, in groundwater
below 10,000 PPT
