**FINAL PRELIMINARY ASSESSMENT FOR PER AND POLYFLUOROALKYL  
SUBSTANCES WEBSTER OUTLYING LANDING FIELD NAS PATUXENT RIVER  
MD**  
04/01/2019  
CH2M HILL

**Preliminary Assessment for  
Per- and Polyfluoroalkyl Substances**

Naval Air Station Patuxent River - Webster Outlying Landing Field  
St. Inigoes, Maryland

April 2019

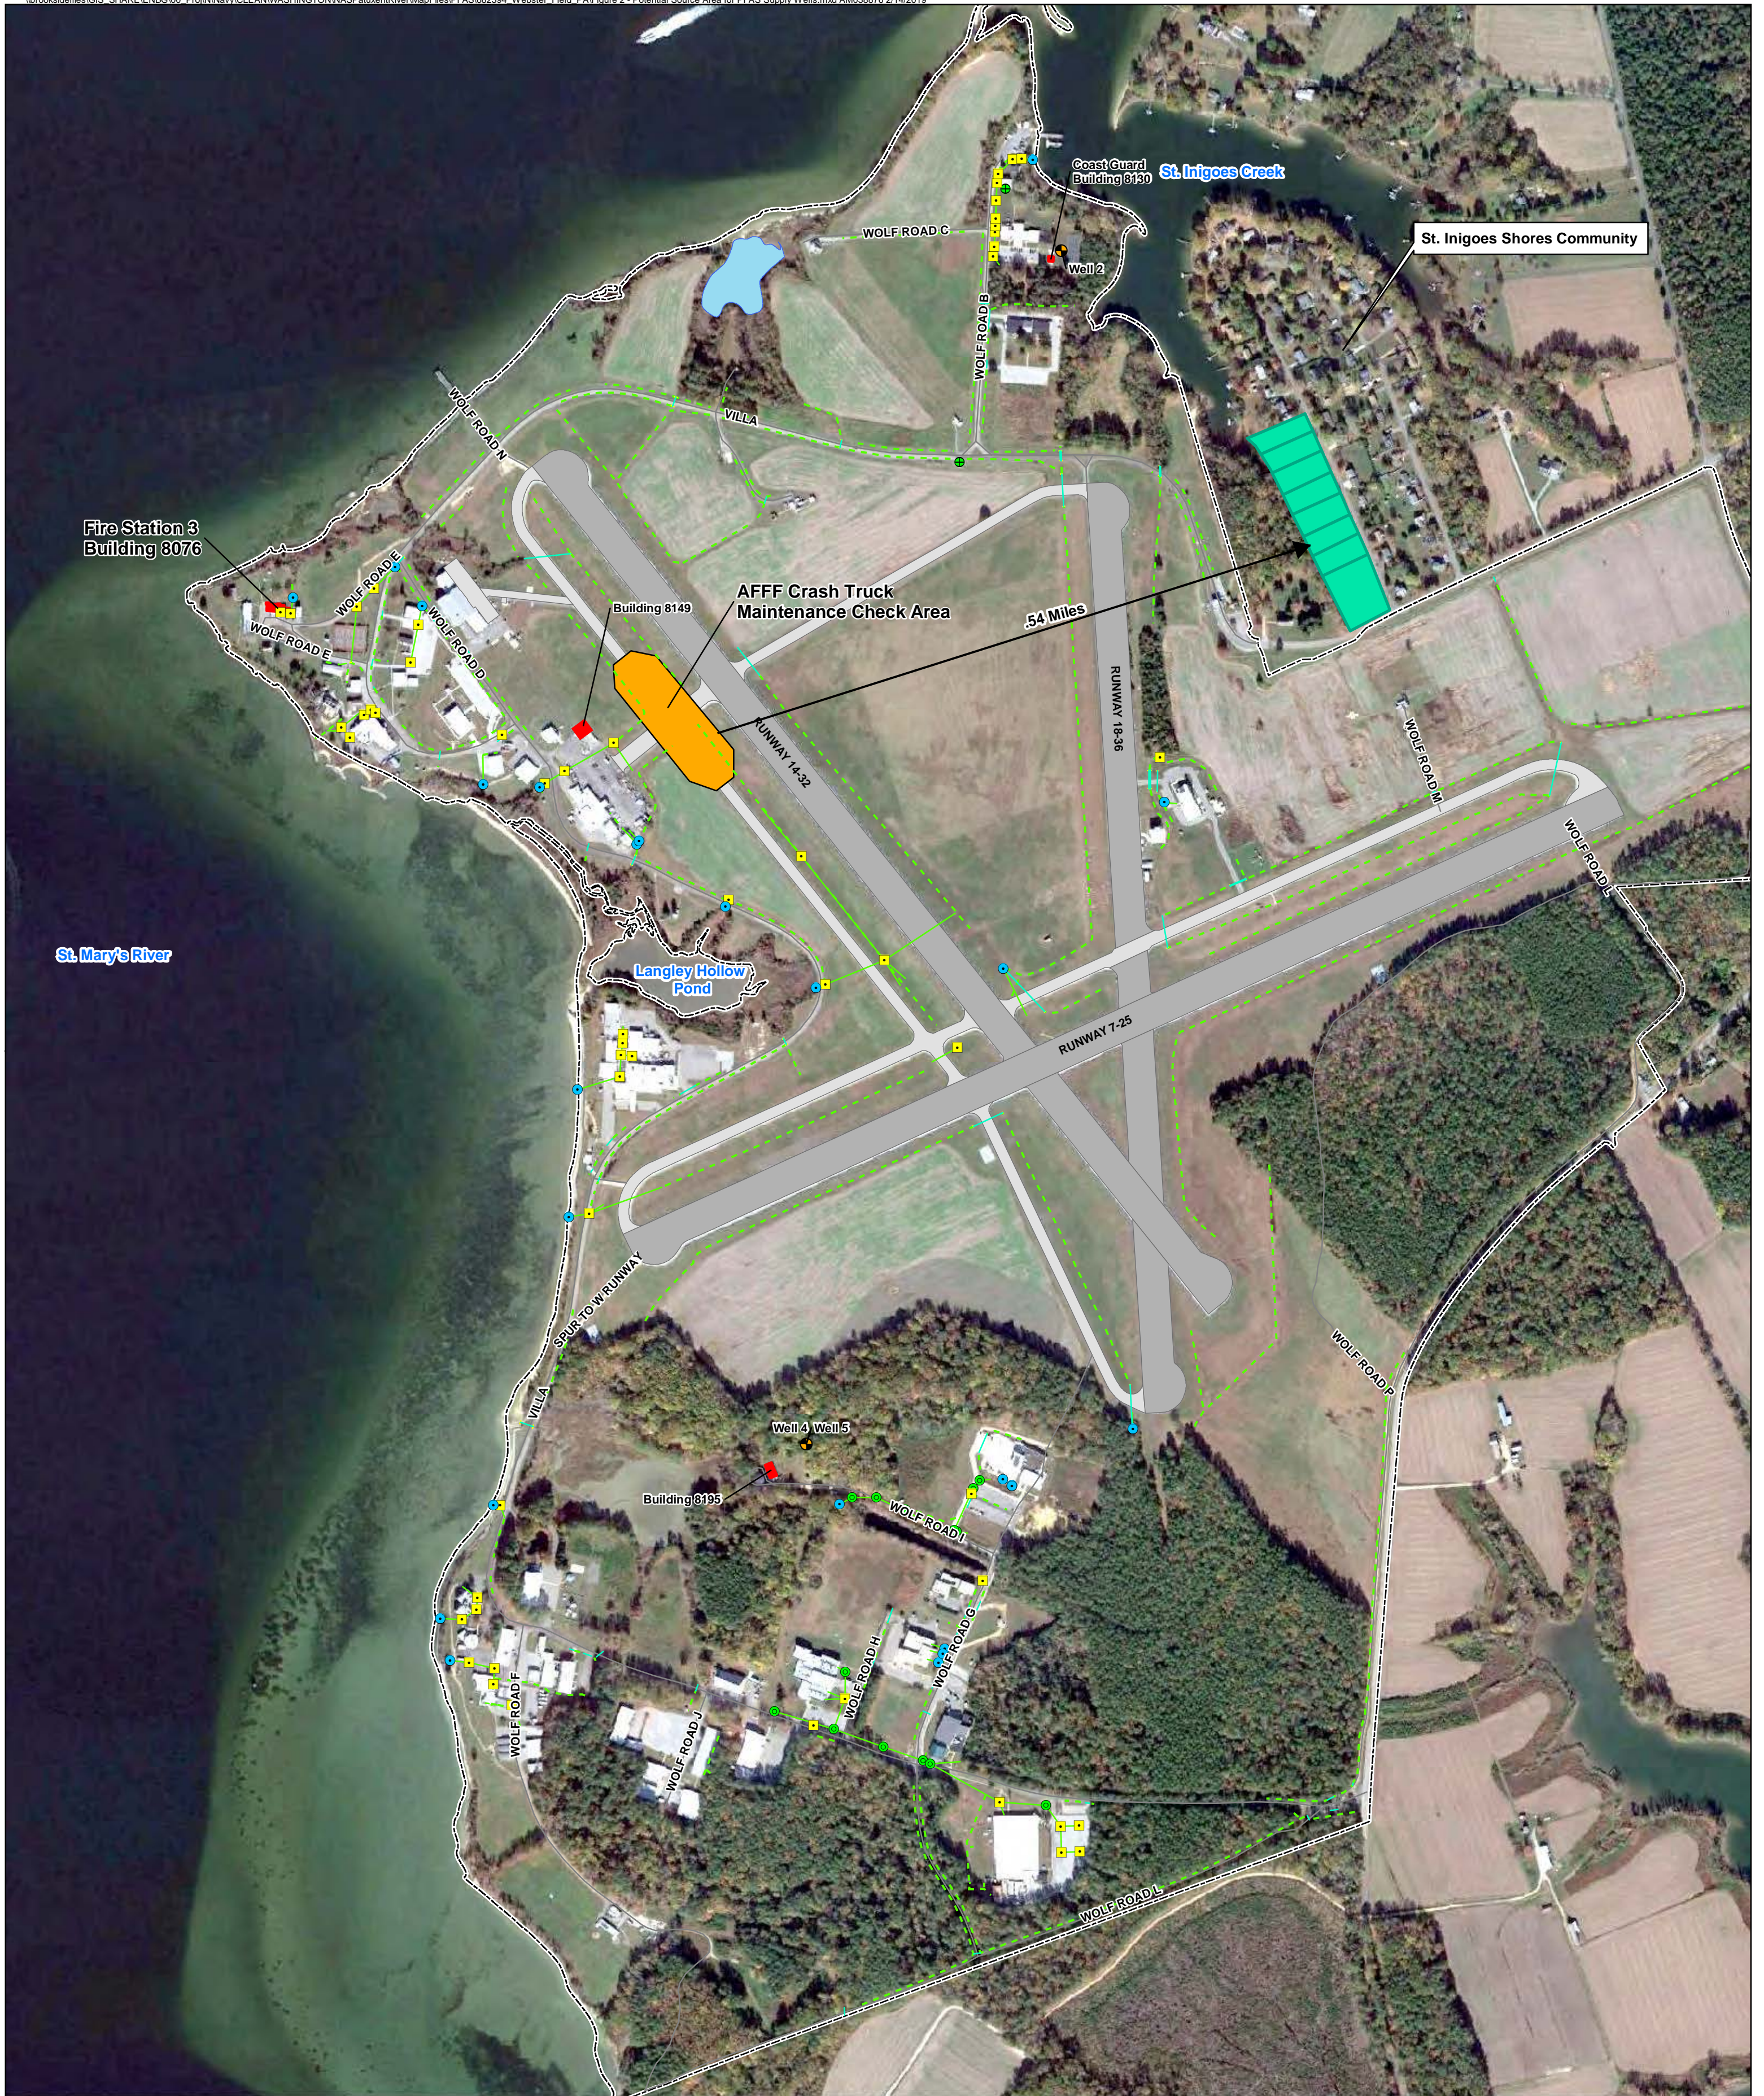
Figure 2  
Potential Source Area for PFAS  
NAS Patuxent River Webster Field Annex  
St. Inigoes, Maryland

There are three community supply wells at Webster Field. Well 2 is located at Building 8130 (Coast Guard Building) and Wells 4 and 5 are located at Building 8195 (**Figure 2**). Wells 2 and 4 are screened in the Aquia aquifer at 537 feet and 539 feet, respectively; however, Well 4 is not functioning and is expected to be replaced in 2019. Well 5 is screened in the deeper Upper Patapsco aquifer at 884 feet. These wells connect to the main water supply for the whole Base.

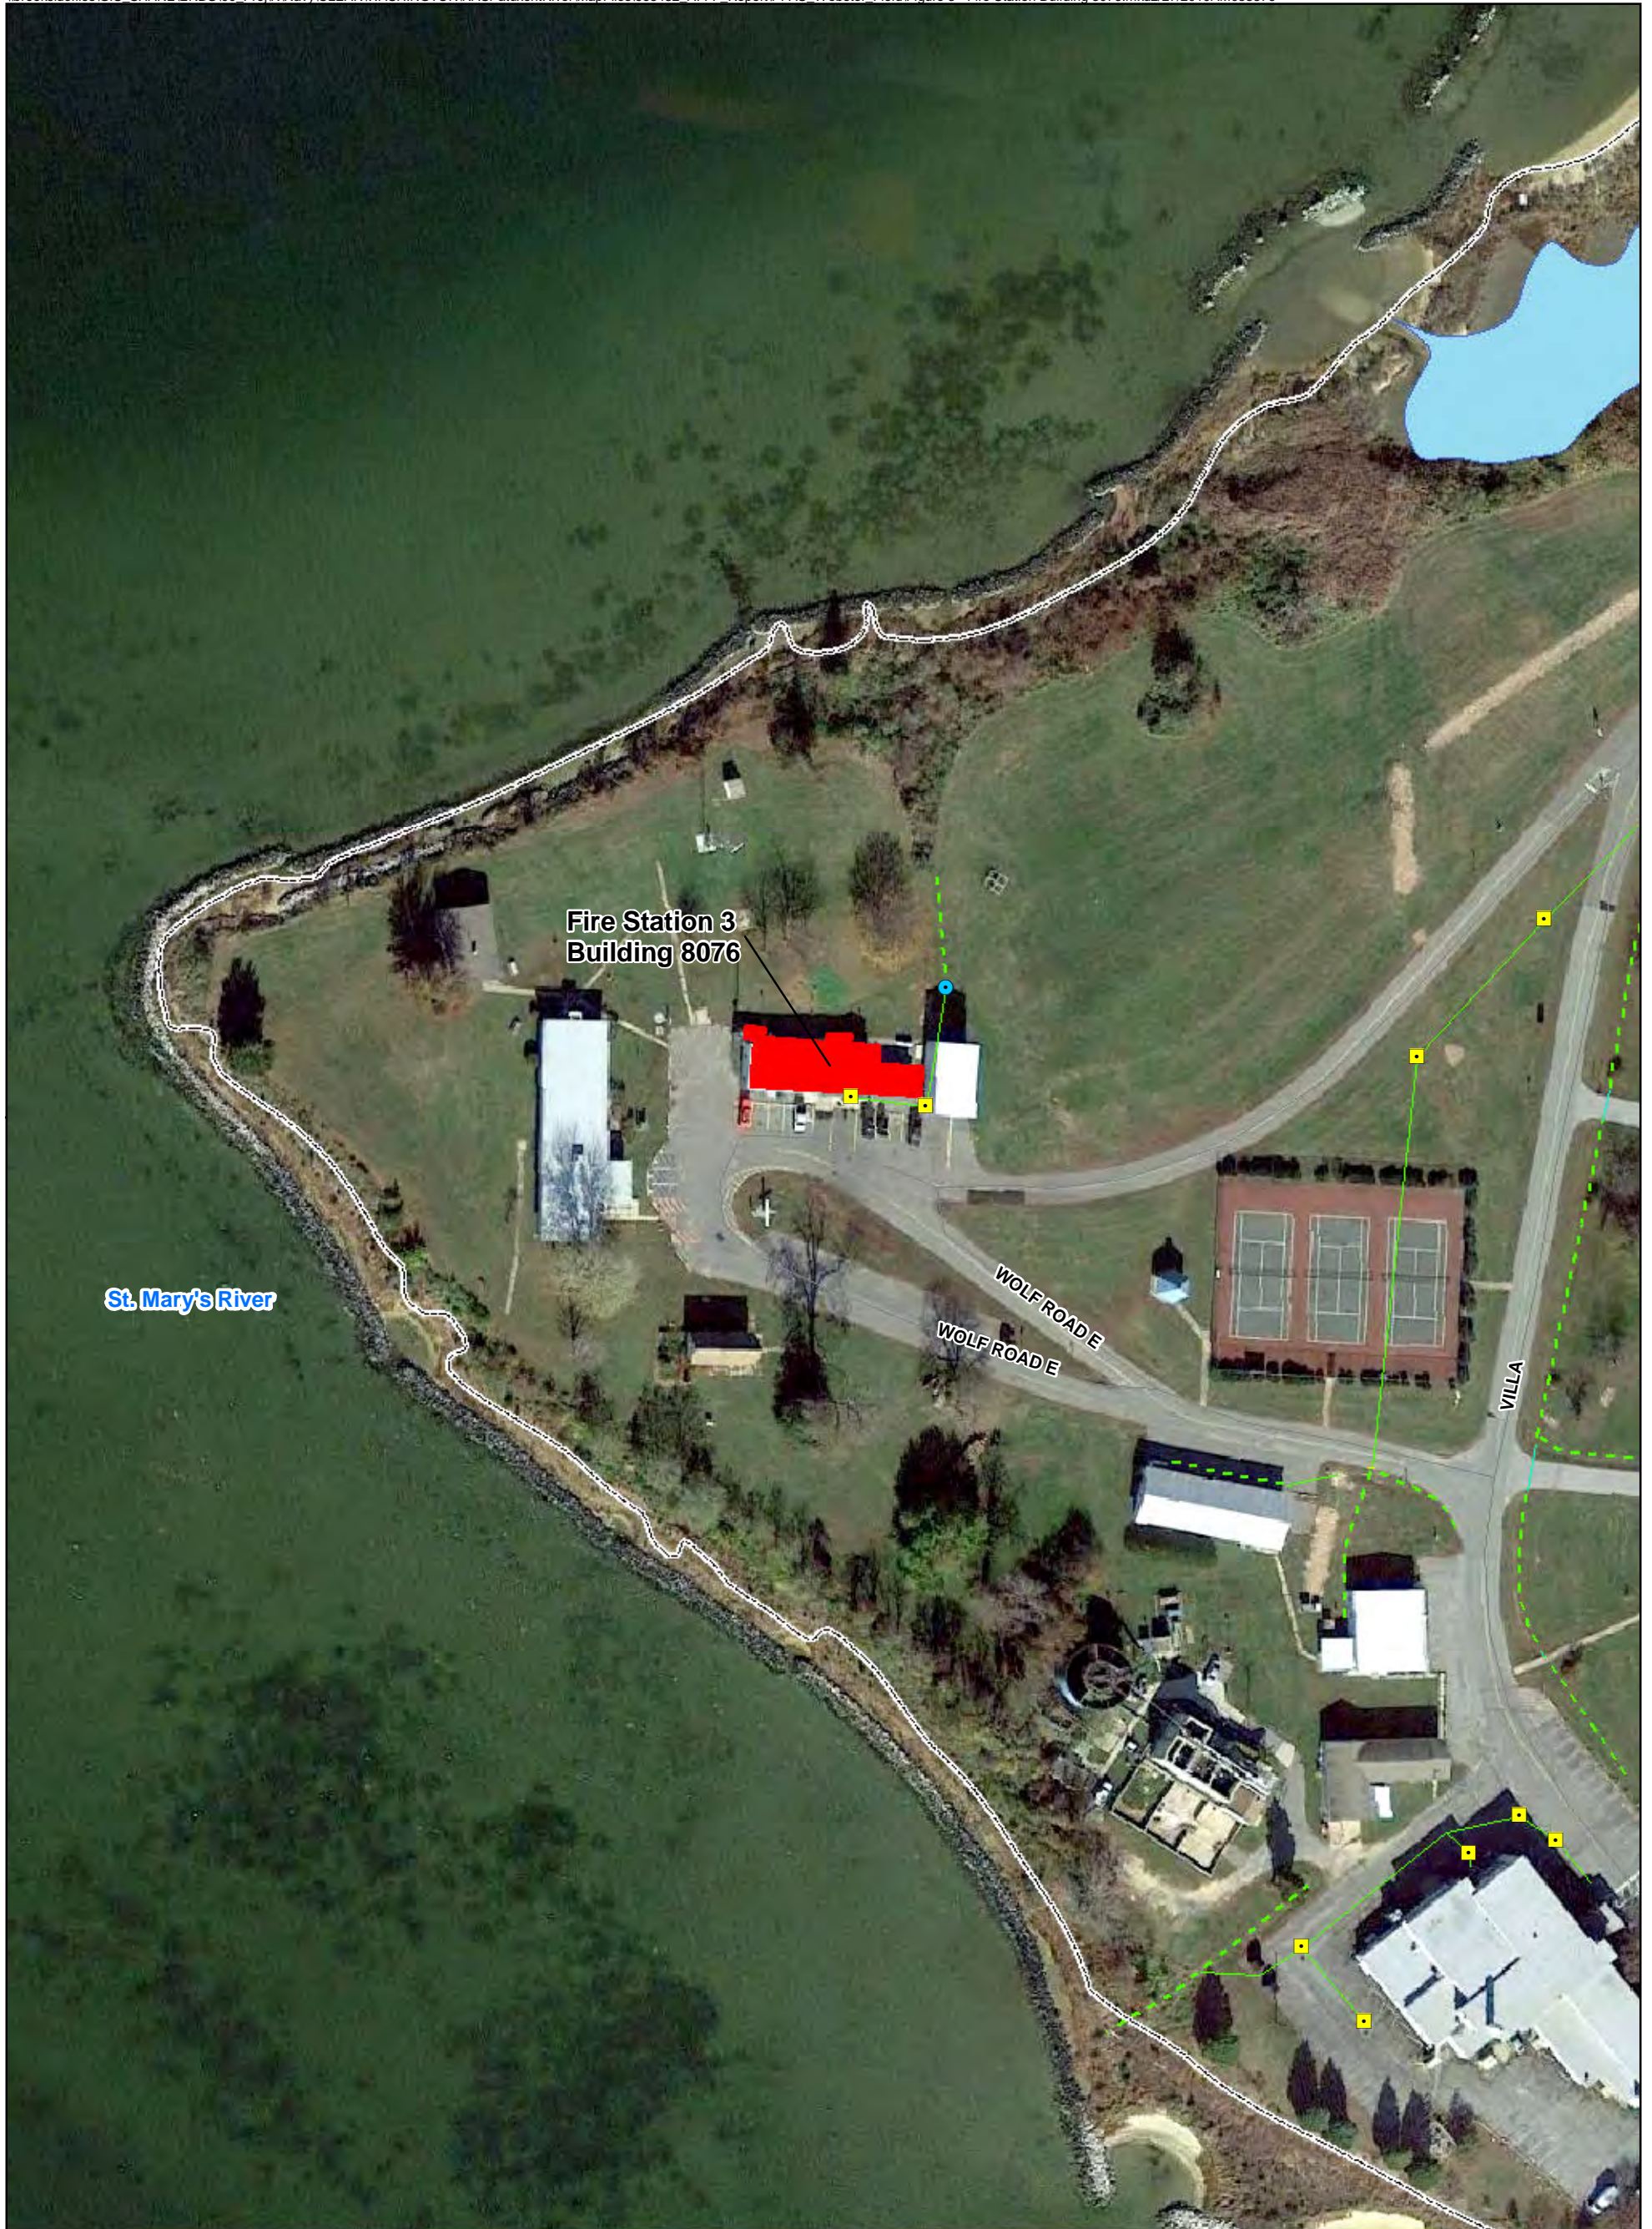
Figure 3  
Fire Station, Building 8076  
NAS Patuxent River Webster Field Annex  
St. Inigoes, Maryland

Webster Field Fire Station 3 stores approximately 310 gallons of 3M Light Water 3 percent AFFF, MIL-Spec F-24385F in the crash truck and the two separate tanks at Building 8076. Records regarding the date the AFFF was first stored at the facility or whether other AFFF formulations, besides 3M product, were ever stored were not found. Five-gallon buckets are used to fill the AFFF to the crash truck from the storage tanks. There is no record of where empty containers are disposed. Currently, only water is used when the crash truck is tested for spray patterns to make sure the equipment is working properly (interview with Michael Carroll [**Appendix E**]). The spray checks in the past were conducted daily at the Crash Truck Maintenance Check Area, as discussed in **Section 4.2.2**.

Groundwater in and around Webster Field can only be practically accessed by wells. This area is entirely paved, with minimal natural ground exposure. Landscaped areas surrounding Fire Station 3 consist of grasses, shrubs, and mulch. There is a parking lot to the east of the building. The pathway to groundwater could be exposed through cracks in the pavement, which may or may not have been present during the daily equipment checks. There are two active supply wells (Wells 2 and 5) within Webster Field (**Figure 2**). The nearest supply well to Fire Station 3 is Well 2, approximately 0.7-mile northeast of the site. The other supply well (Well 5) is approximately 0.9 mile south to southeast of the site; however, these wells are screened in deeper aquifers and testing data indicates no detections of PFAS constituents. The potential for PFAS contamination in shallow groundwater is minimal at this site.

This area is entirely paved, with minimal natural ground exposure. Landscaped areas surrounding Fire Station 3 consist of grasses, shrubs, and mulch. There is a parking lot to the east of the building. There is no evidence of a PFAS release at this site. However, if PFAS had been released to soil at Fire Station 3, the nature of the asphalt surface surrounding the building would limit infiltration to soil or air transport of dust from potential PFAS-impacted soil particles. The potential for PFAS contamination in soil is minimal at the site.

Fire Station 3 stores approximately 310 gallons of 3 percent AFFF solution in the crash truck and the two separate tanks at Building 8076. Currently, spray checks are conducted daily with water, and spray checks were performed in the past at the Crash Truck Maintenance Check Area. There is a potential of AFFF being released at Fire Station 3 from possible spills during transfer or refilling of AFFF to the crash truck. Therefore, additional investigation is recommended for Fire Station 3 through a SI.

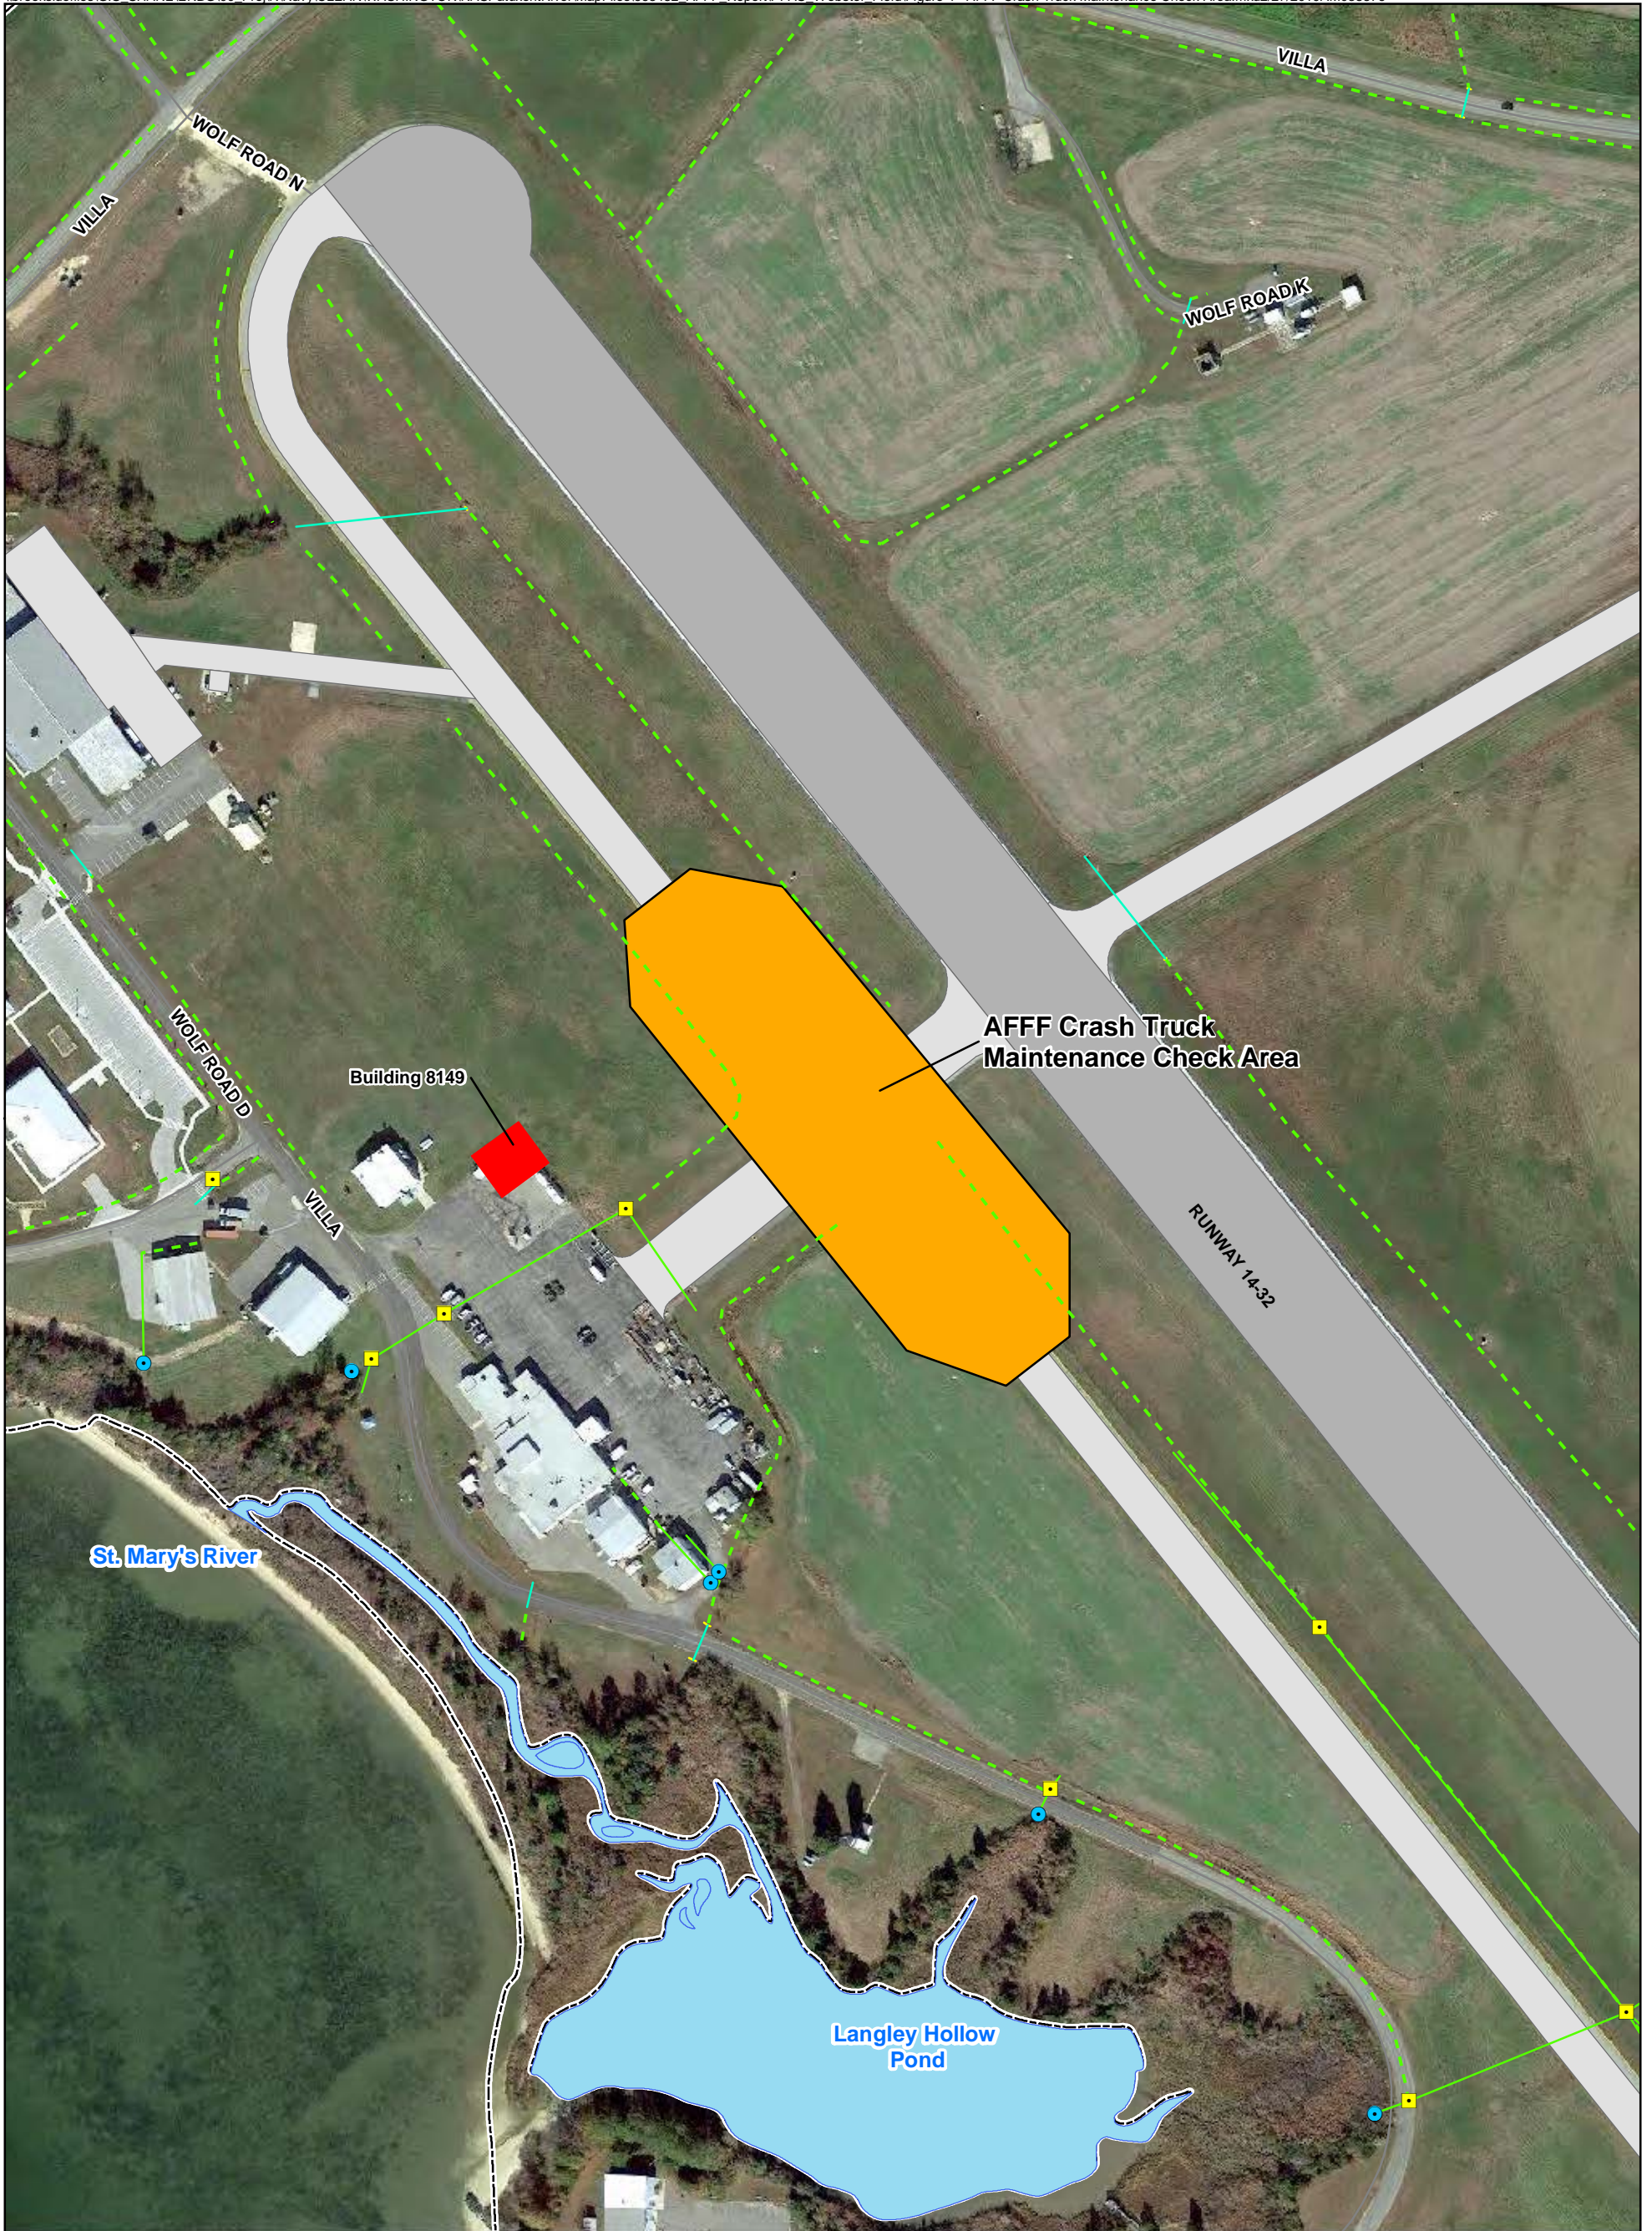
Groundwater in and around Webster Field can only be practically accessed by wells. This area is entirely paved, with minimal natural ground exposure. The pathway to groundwater could be exposed through cracks in the pavement, which may or may not have been present during the monthly equipment checks. Cracks in the pavement and/or overland flow of AFFF during equipment checks to nearby unpaved areas may potentially have allowed some migration of AFFF to groundwater. There are two active supply wells within Webster Field (**Figure 2**). The nearest supply well to The AFFF Crash Truck Maintenance Check Area is approximately 0.5-mile northeast of the site. The other well is approximately 0.6 mile southeast of the site. The potential exists for shallow groundwater contamination from PFAS at the site because AFFF spray checks were conducted monthly over an extended period in the past. Drinking water wells are screened in the deeper aquifers and have been tested for PFAS; no detections of PFAS constituents were noted.

This area is entirely paved, with minimal natural ground exposure. The pathway to soil could be exposed through cracks in the pavement, which may or may not have been present during the monthly equipment checks. Because the area is paved, soil contaminated with PFAS is minimal. Workers and trespassers could be exposed to AFFF

At the AFFF Crash Truck Maintenance Check Area, the crash truck from Fire Station 3 performed monthly AFFF spray checks along the taxiway. Although the area is entirely paved, the pathway to groundwater and soil could be exposed through AFFF runoff and cracks in the pavement. Because an exposure pathway from a release to environmental media and from environmental media to potential receptors exists, the AFFF Crash Truck Maintenance Check Area is recommended for additional investigation through a SI.
