SWMU 9 Statement of Basis and IR 1 and IR 8 Proposed Plans

Tetra Tech NUS

March 27, 2000

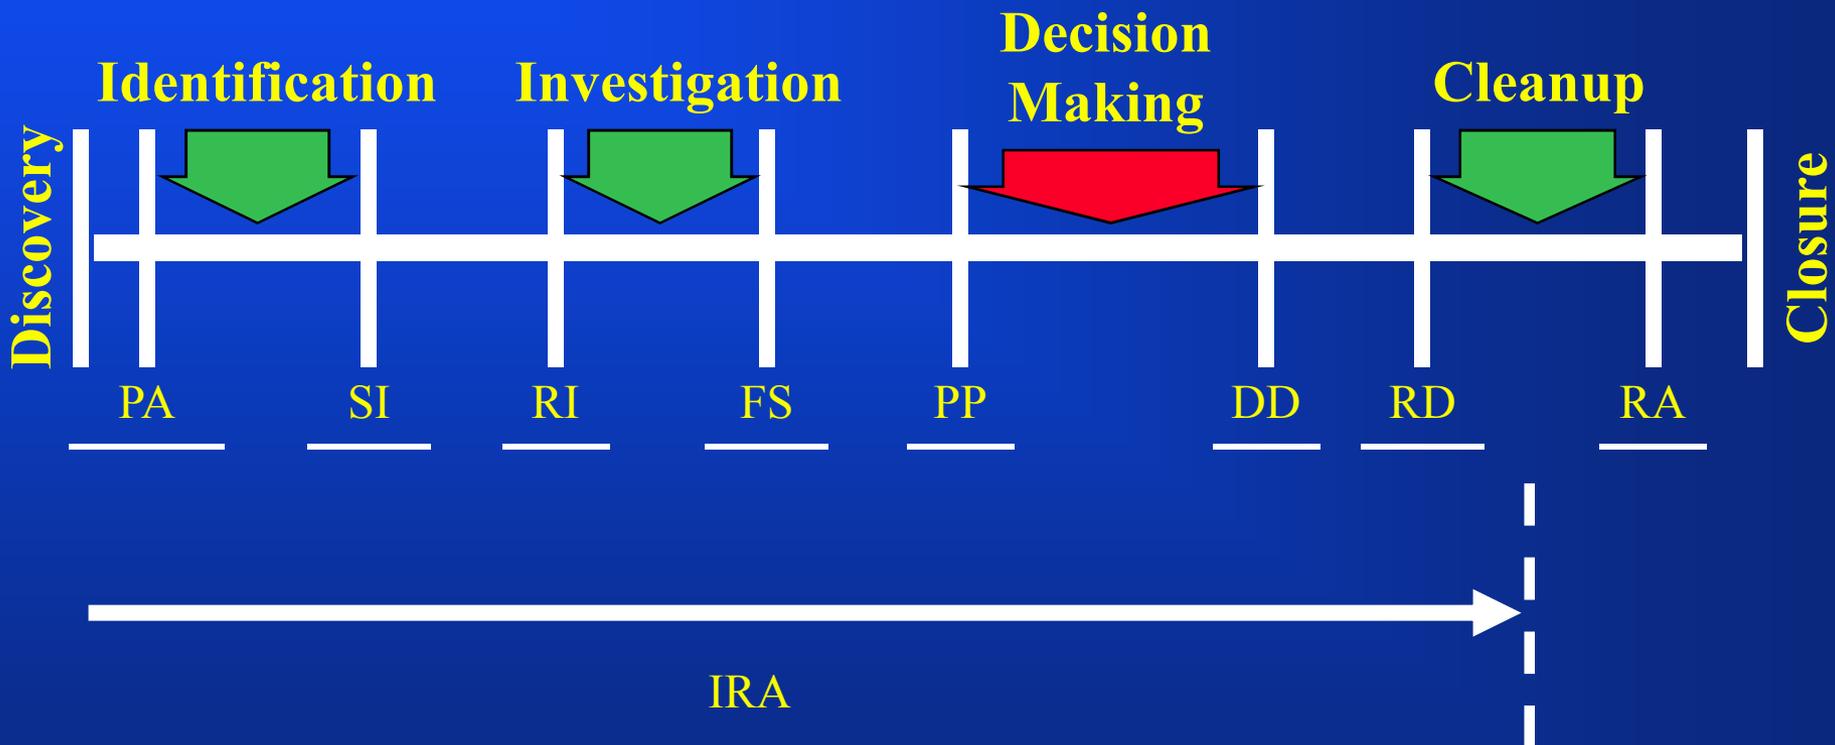
The Typical Life of a Hazardous Waste Site

Note: The CERCLA hazardous waste site life-cycle process is described in the Code of Federal Regulations, Chapter 40, Part 300.

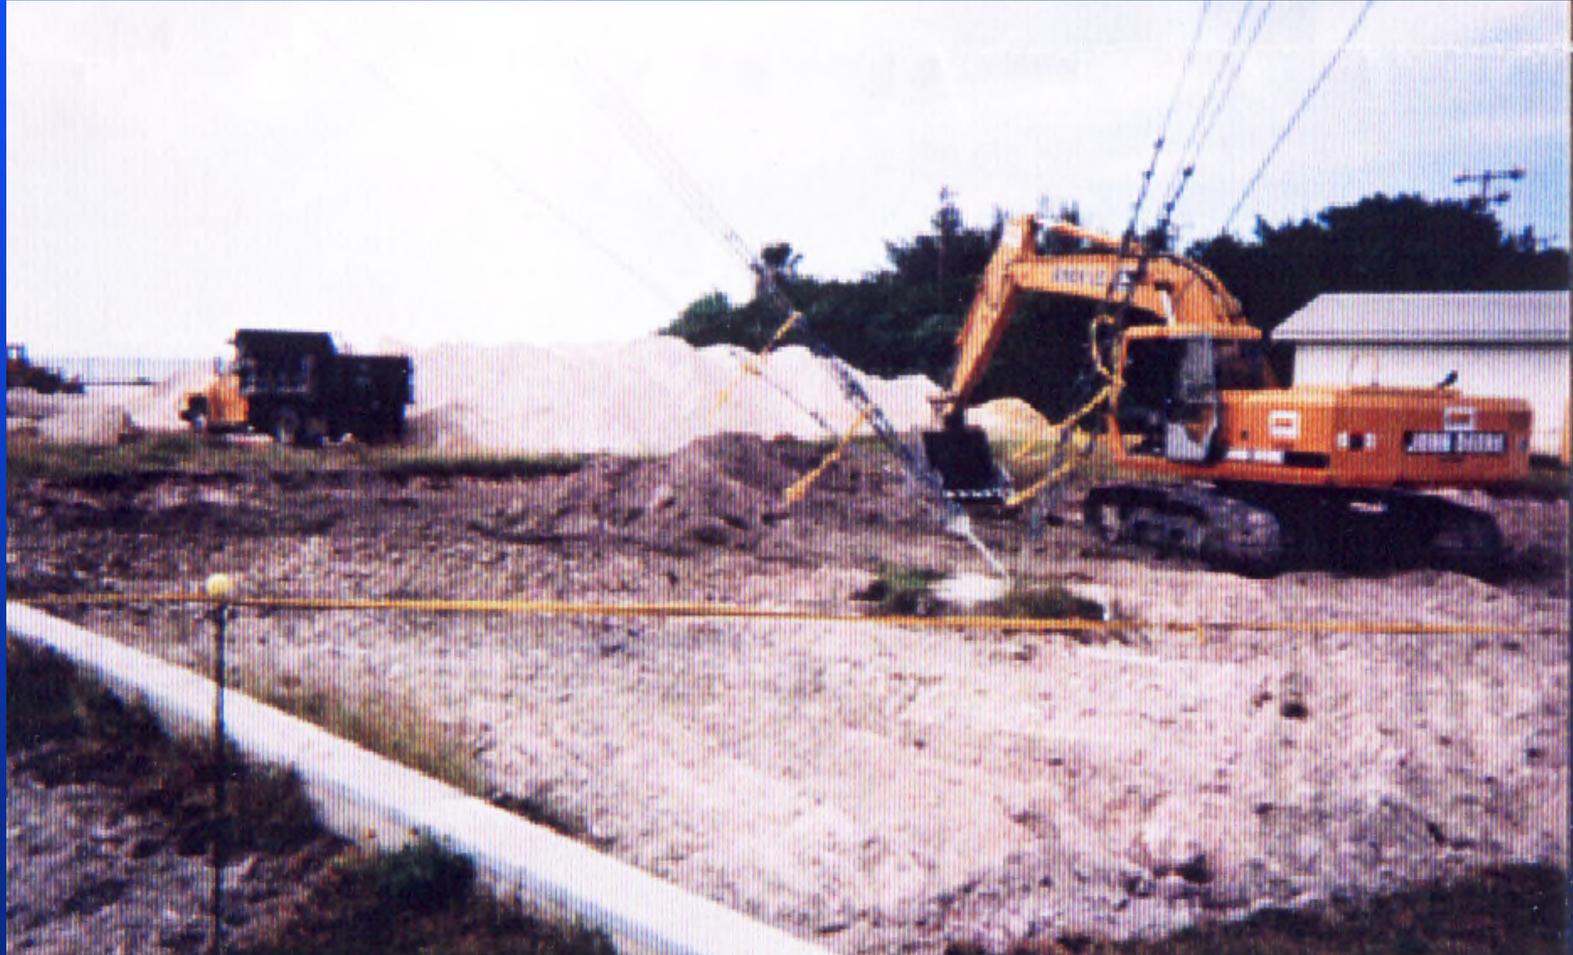
IR 1 - Excavation of Contaminated Soils

- **1995 - An IRA was performed:**
 - **Removed 4,878 cubic yards of lead-contaminated soil**
 - **Reduced the highest lead concentration in soil from 35,200 milligrams per kilogram (mg/kg) to 680 mg/kg**
 - **Confirmation sampling was performed to ensure removal of highly contaminated soil**

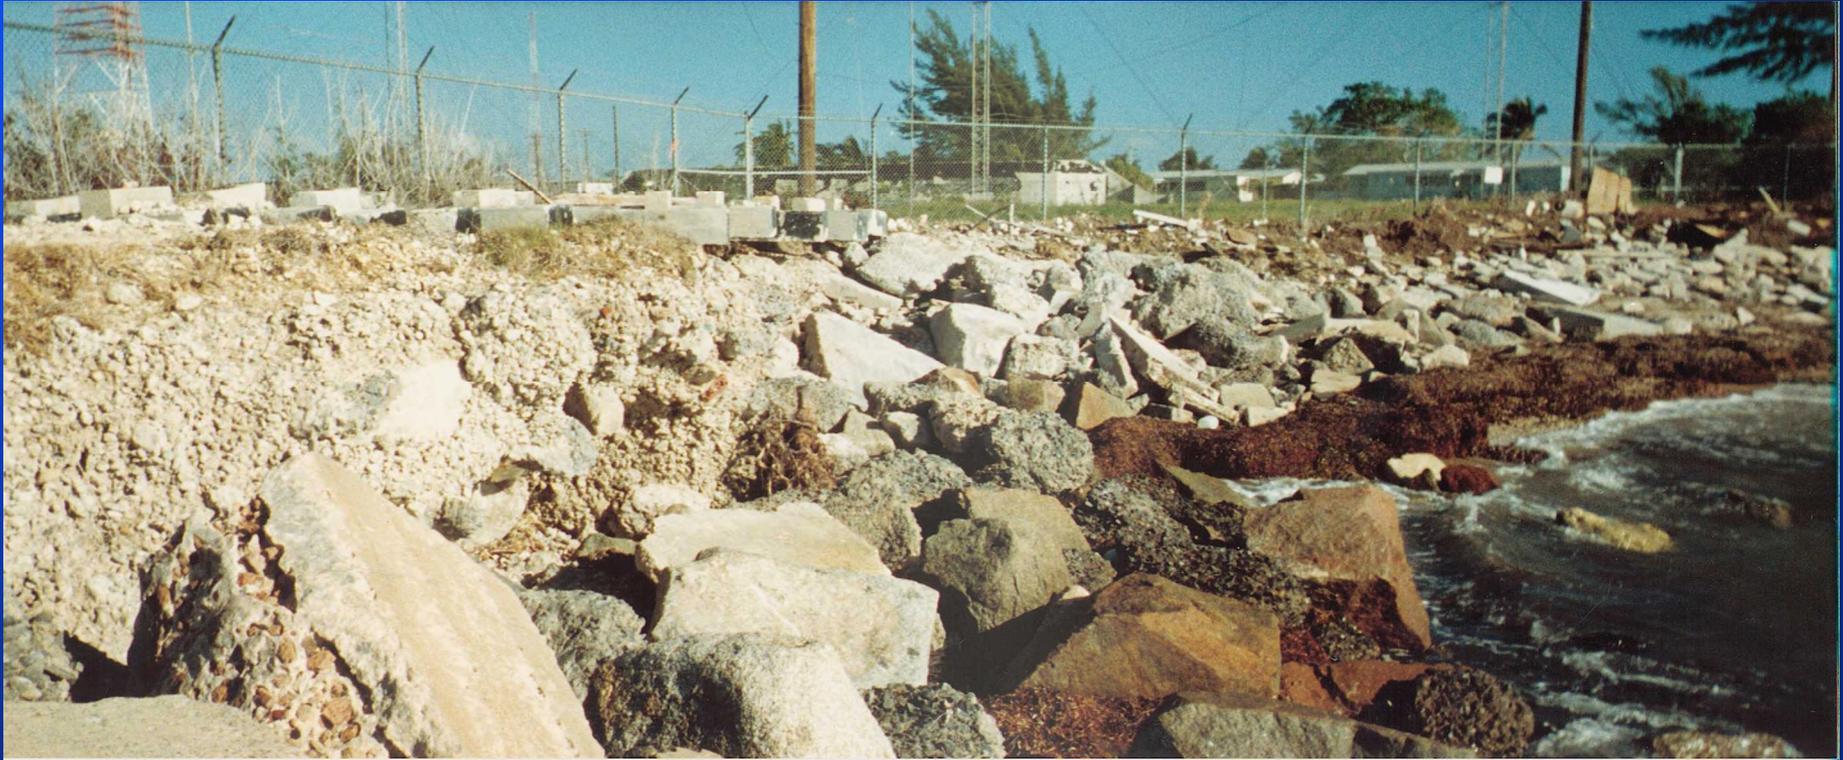
IR 1 - Shoreline Erosion East of Site

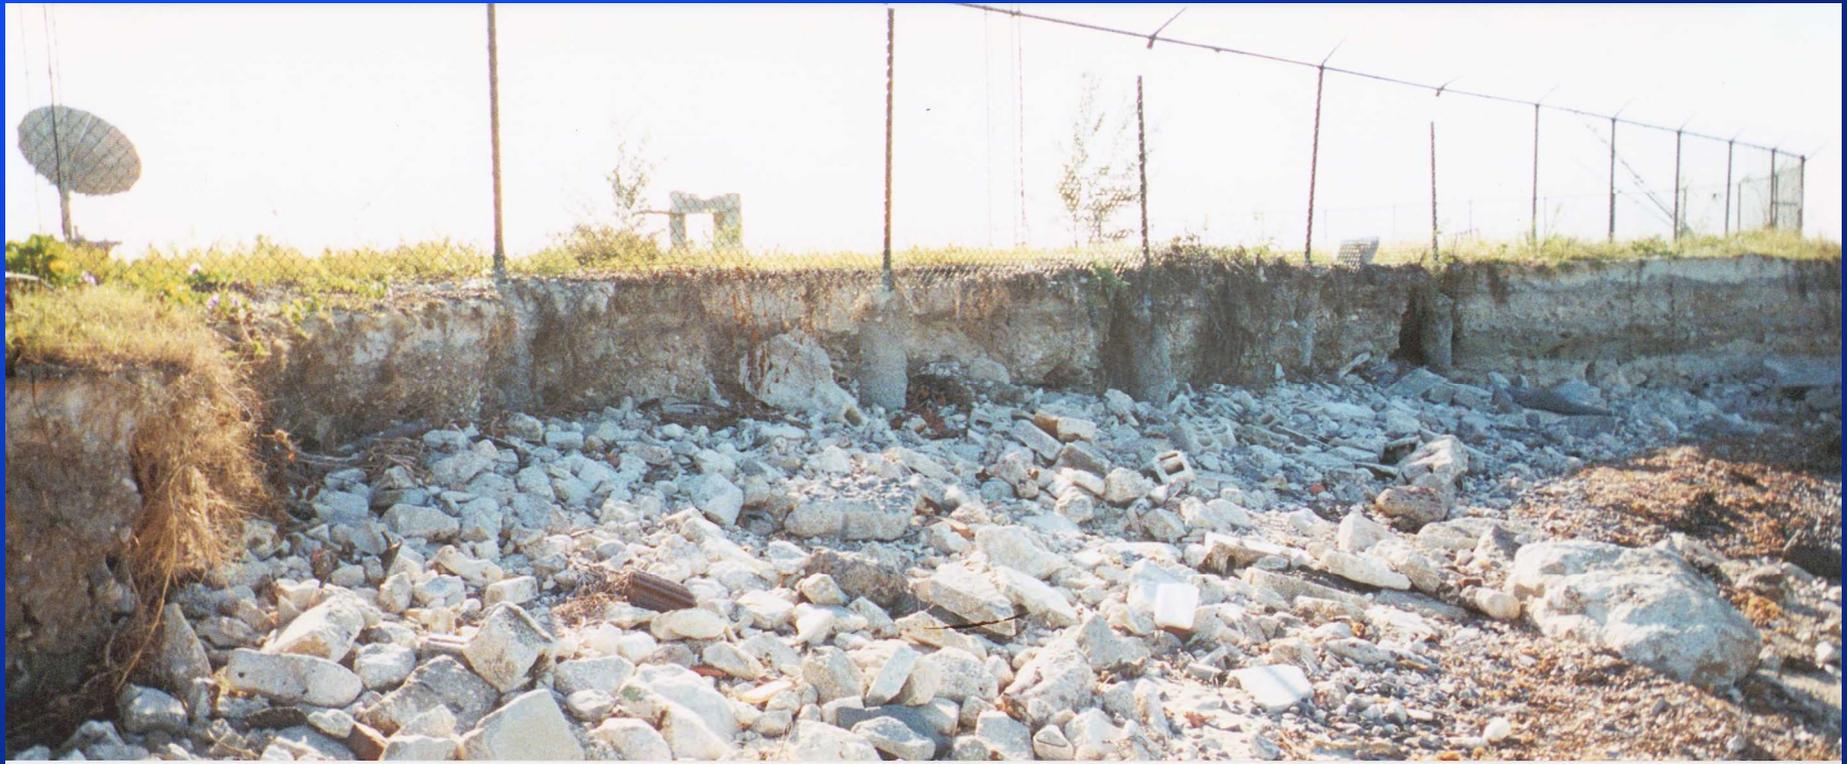
IR 1 - Erosion at Western Fence

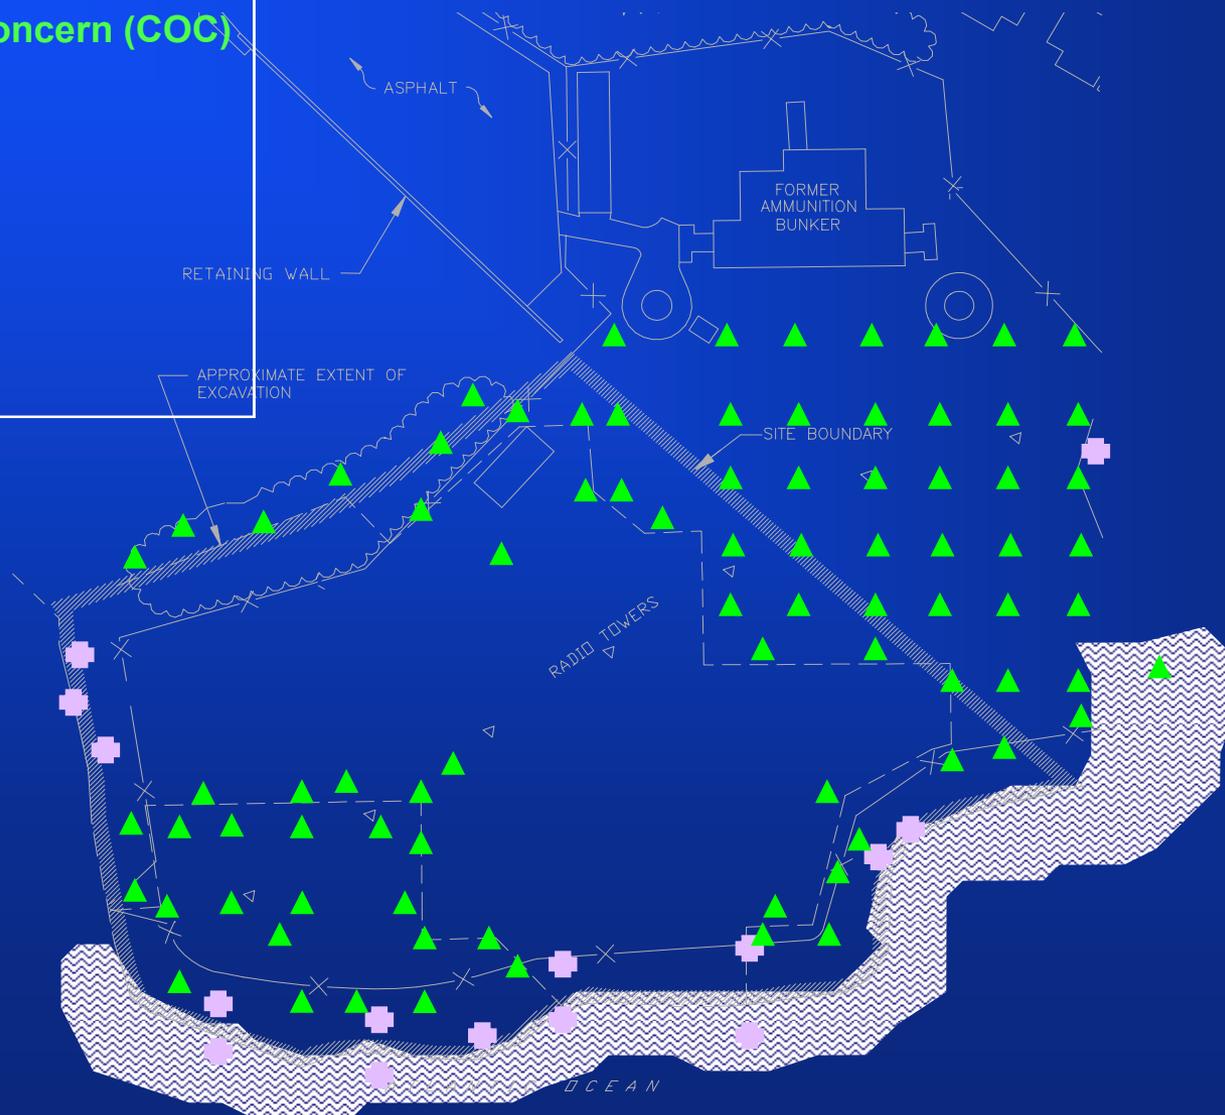
IR 1 - COC Location Map

Chemical of Concern (COC)

- Inorganics
 - Arsenic
 - Antimony
 - Copper
 - Iron
 - Mercury
- Organics
 - Aroclor

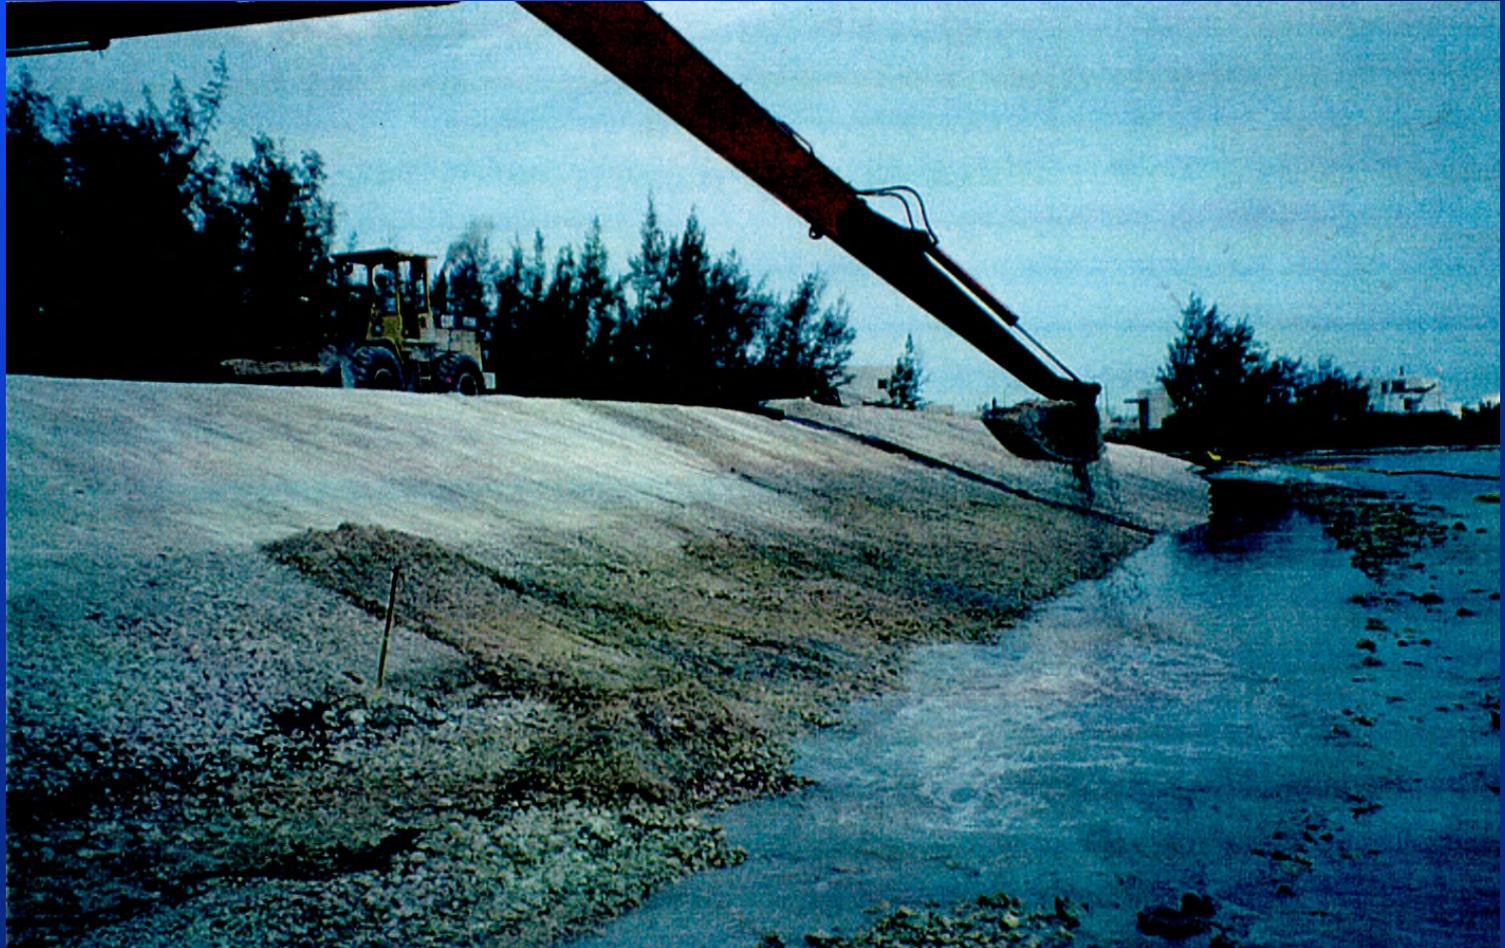
IR 8 - Preparation of Base Material

- **1997 - An IRA was performed:**
 - **Removed debris from shoreline**
 - **Installed shoreline protection system**
 - **Planted Sea Purslane on seaward slope**
- **Shoreline protection system earned the 1998 Excellence in Technology Award from the International Erosion Control Association**

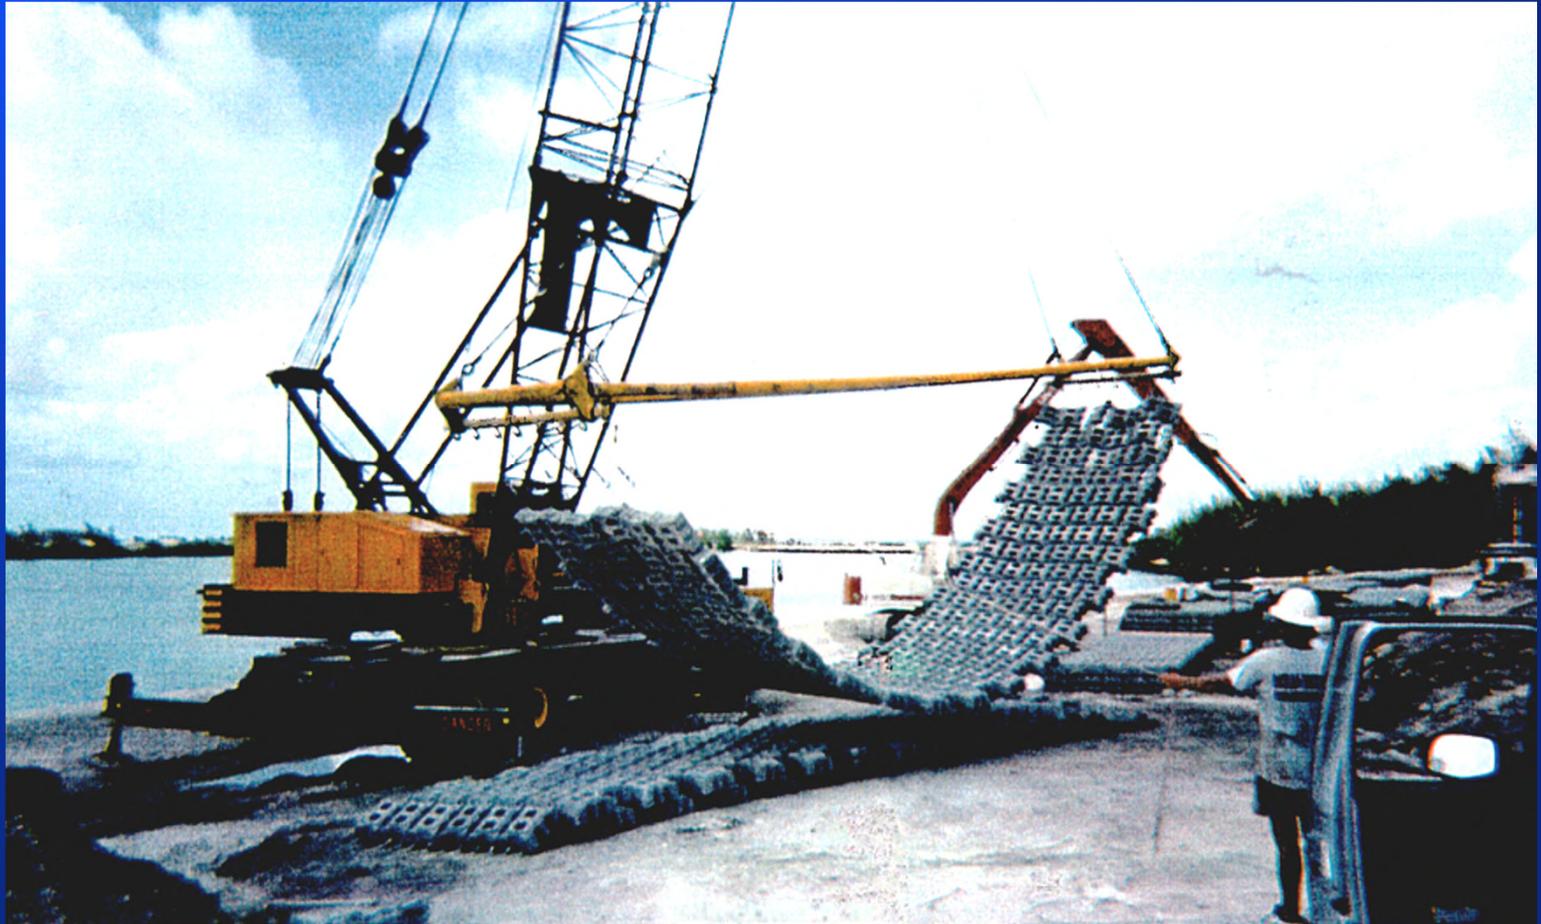
IR 8 - Articulated Concrete Block Used on the Slope

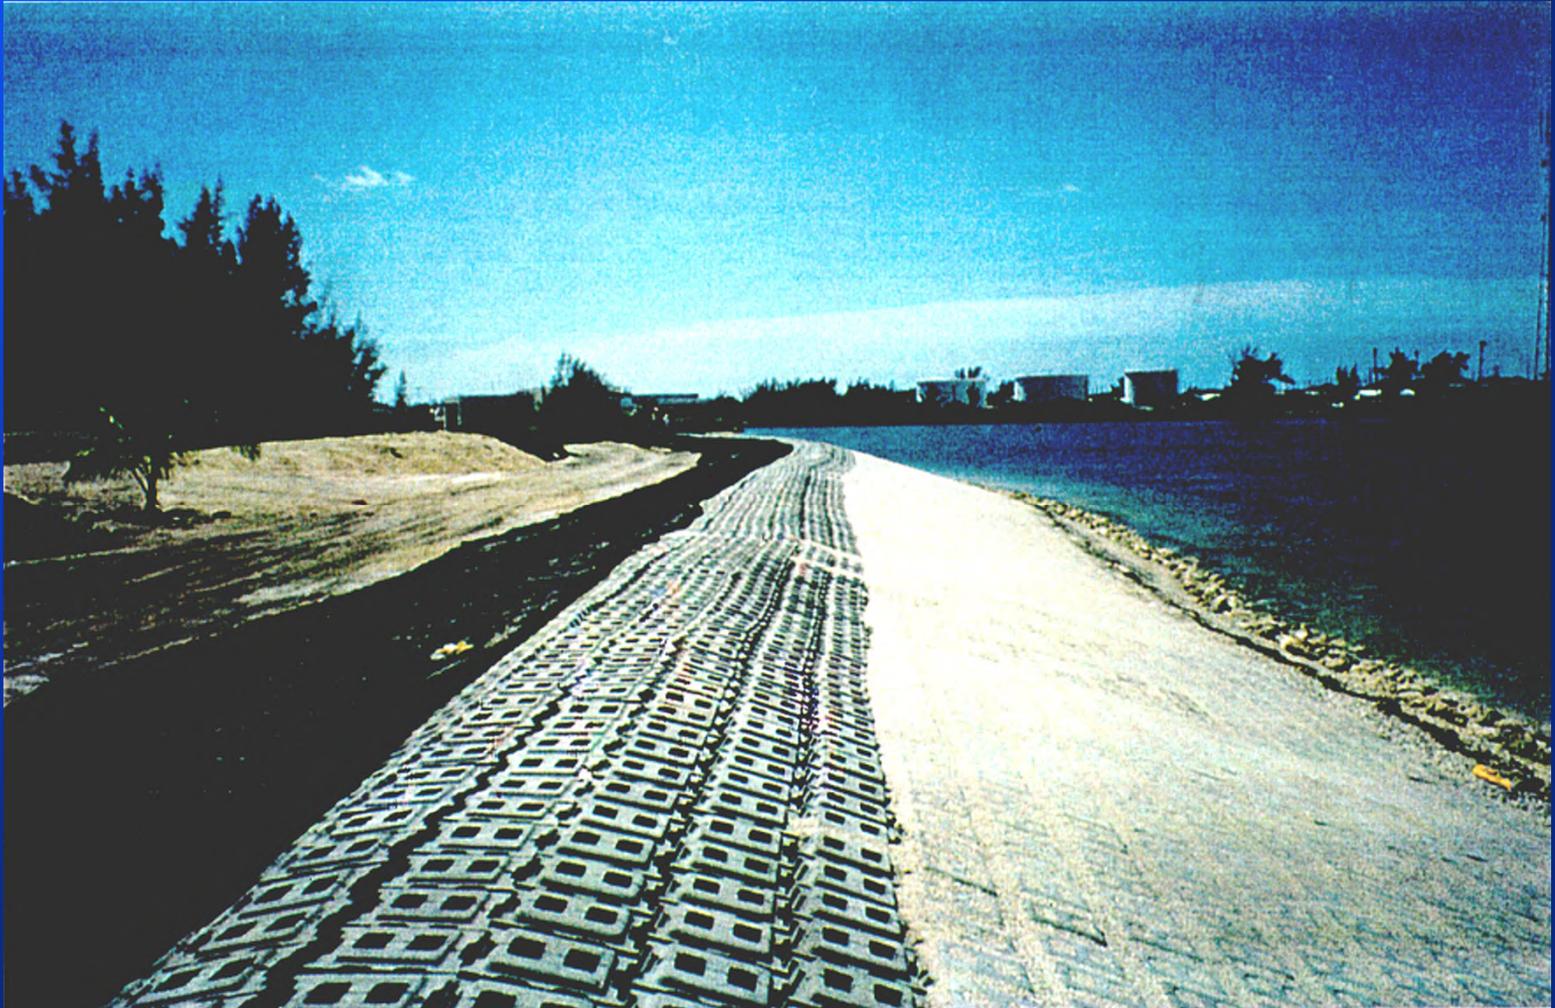
IR 8 - Revetment In Place

- **Land use controls with monitoring of groundwater quality**
 - Shoreline protection system survived Hurricane Georges without any erosion
 - Prevent future residential use
 - Elevated levels of chemicals detected during monitoring will trigger the NAS Key West Partnering Team to discuss any future actions
 - Land-use controls with monitoring will be protective of human health and the environment
- **Minimal costs are associated with implementing and administering land-use controls with performance monitoring**

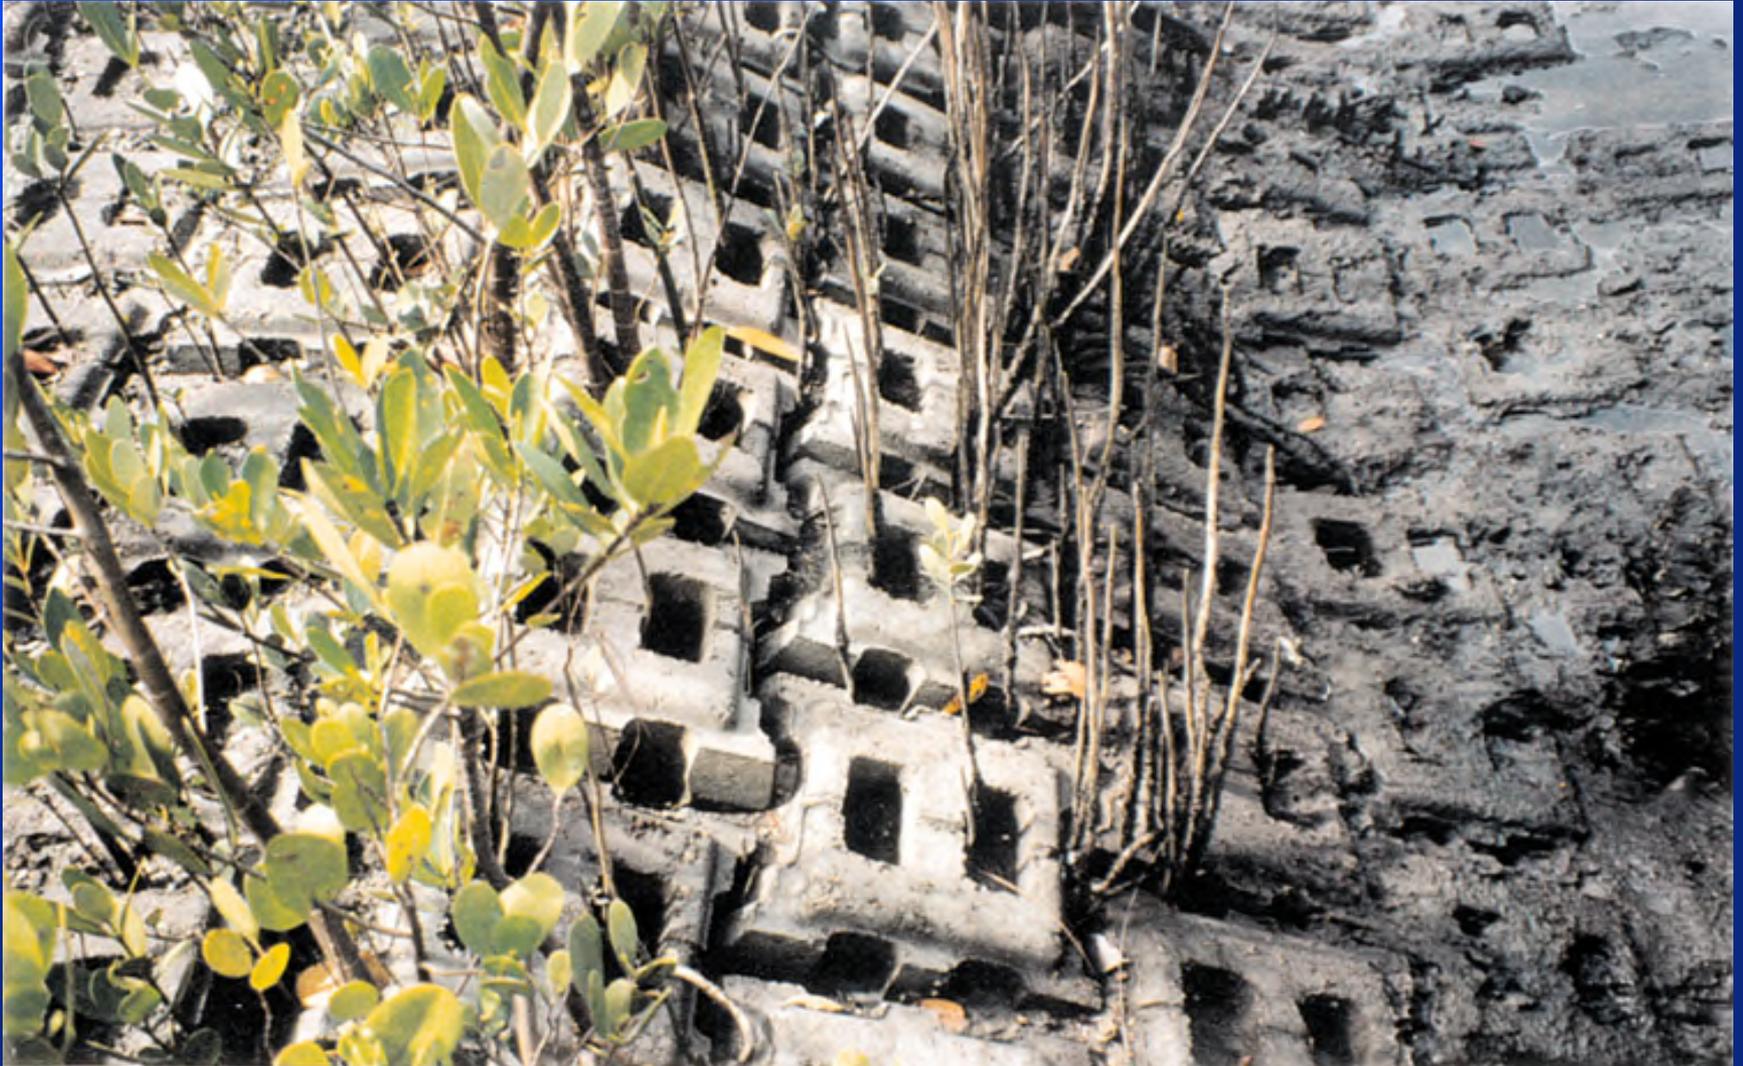
IR 8 - Mat Was Designed to Promote Flora Growth

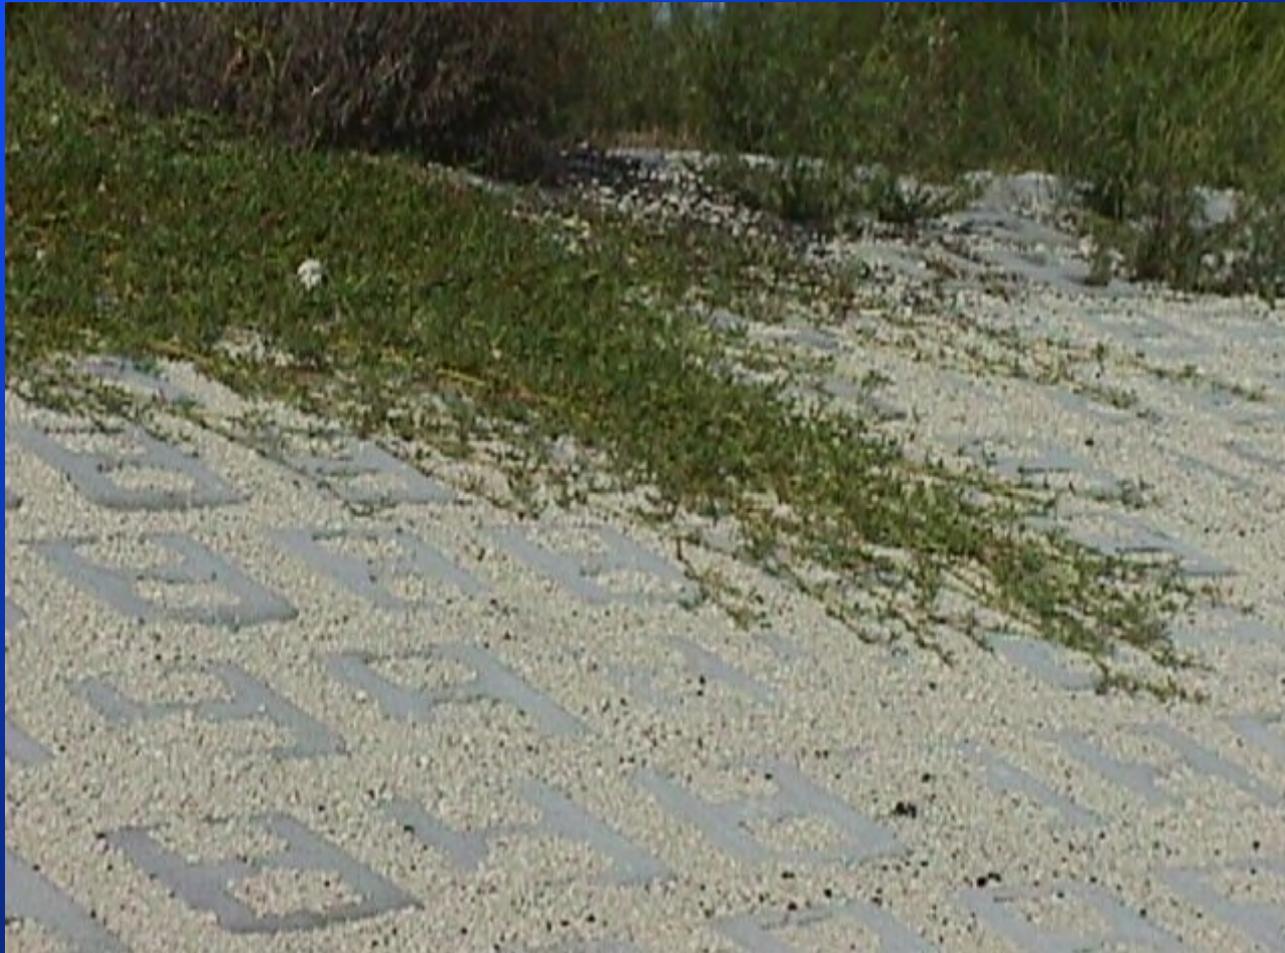
IR 8 - Sea Purslane

Growing Down the Slope
