# **DRAFT FINAL ENVIRONMENTAL ASSESSMENT**

## **CONSTRUCTION OF A JOINT MARINE-NAVY RESERVE CENTER IN THE DES MOINES, IOWA REGION**

**September 2015**

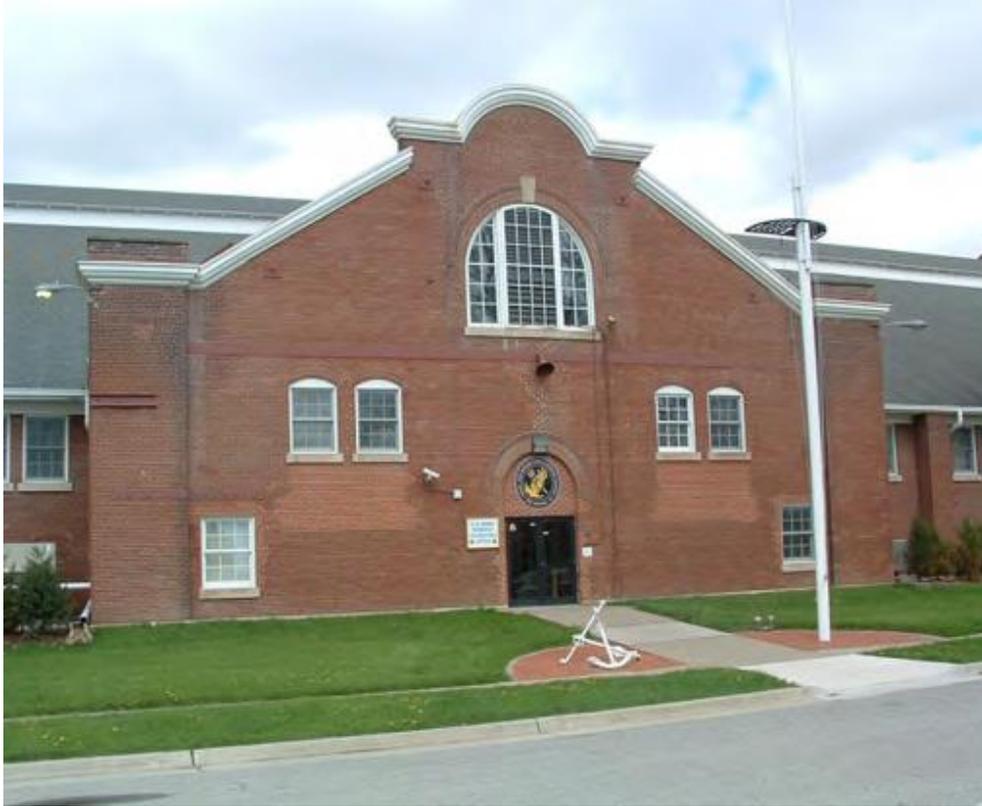
**Figure 1-2 Joint Marine-Navy Reserve Center (Building 47) at Fort Des Moines**

The current Joint Marine-Navy Reserve Center is located in Building 47 at Fort Des Moines, an Army reserve installation that is home to a host of activities and commands with varied missions and operations. The building is owned by the Army and leased to the Marine Corps and Navy reserve units. Building 47 is listed in the National Register of Historic Places as a contributing property to the Fort Des Moines National Historic Landmark. Conversion of the building into a reserve training facility occurred in the mid-1950s and consisted of constructing a reserve training building inside the outer red brick envelope of the historic structure, historically referred to as the "Riding Hall" (see Figure 1-2).

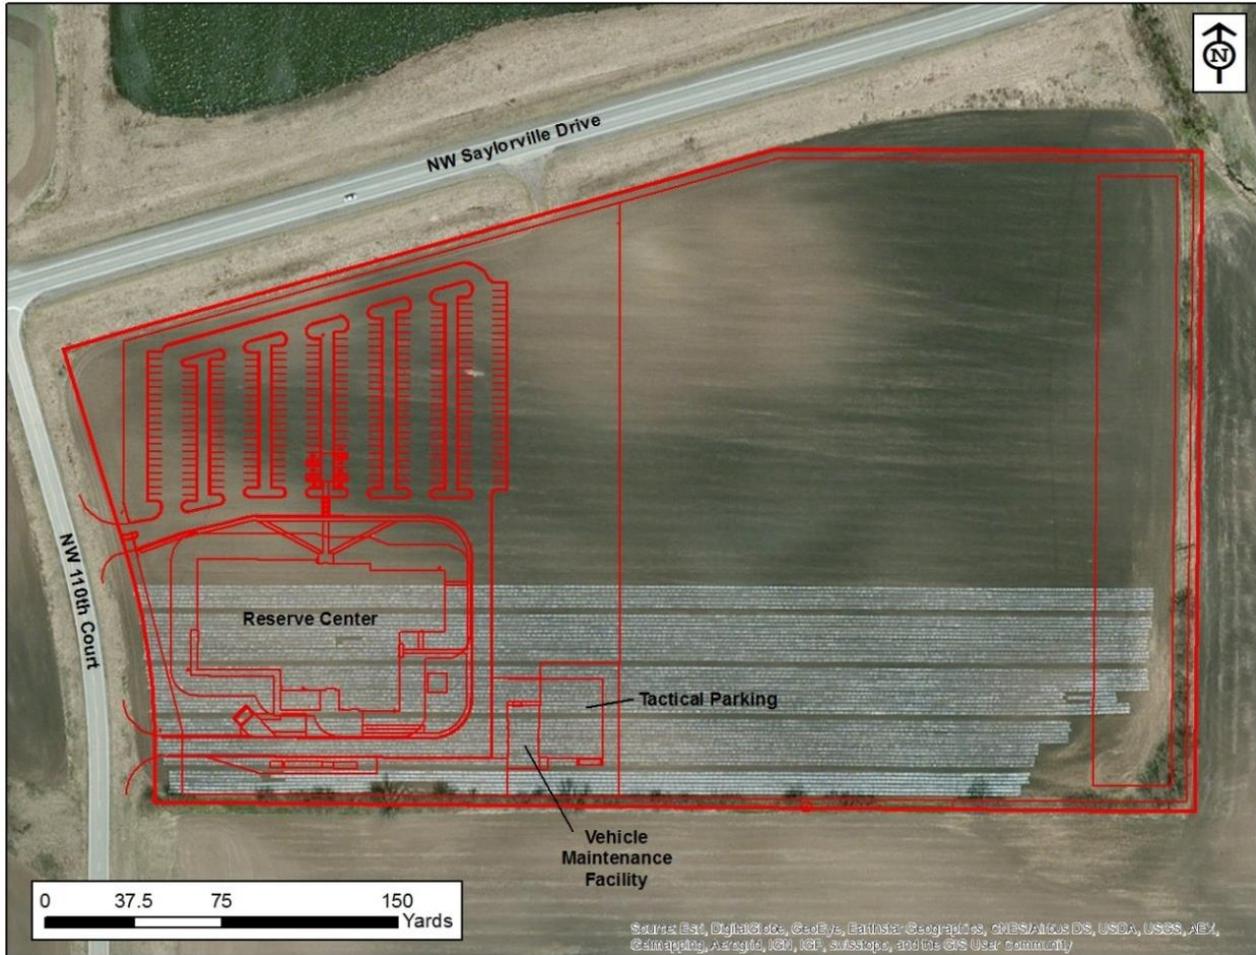
**Figure 2-2 Joint Marine-Navy Reserve Center Site Concept Plan**

The proposed facilities include a 46,200-square foot reserve training building, an 800-square foot vehicle wash rack, and associated parking facilities (Figure 2-2). The facilities would be constructed on the western portion of the parcel to make use of the existing roadways along the boundary. The eastern portion of the parcel would be utilized for stormwater management.

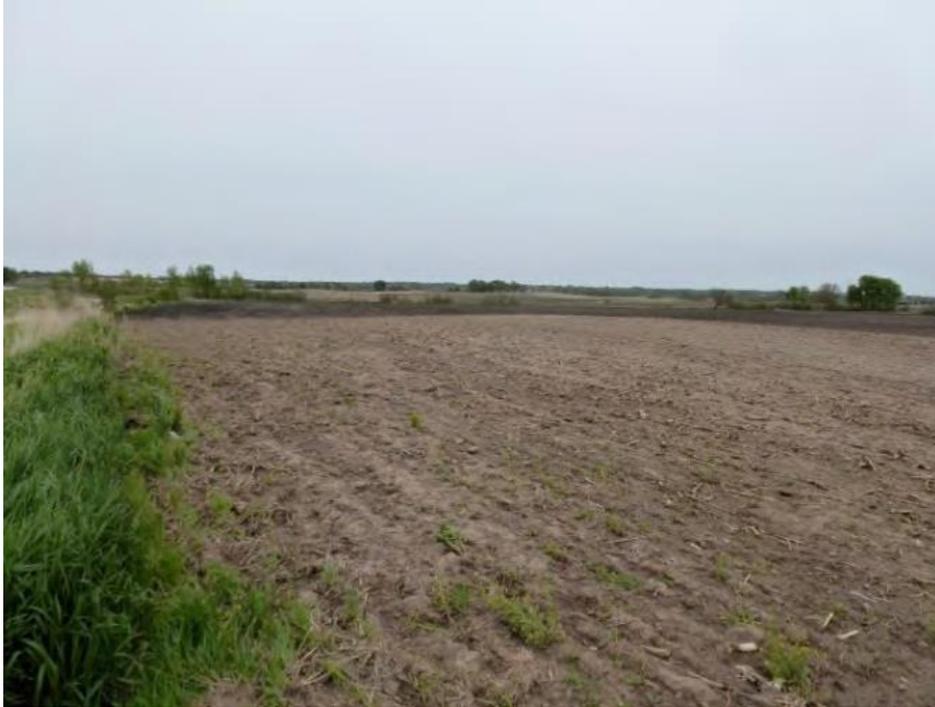
**Figure 2-3 Property looking east (DoN 2014)**

Site preparations would include site clearing, excavation, filling, and preparation for construction. Paving and site improvements would include grading, parking for approximately 270 vehicles, roadway paving, sidewalks, landscaping, fencing, signage, and storm water drainage. The parcel is undeveloped property that was previously utilized for agricultural crop production. No buildings exist on the property (Figure 2-3).

This site has been in crop agriculture for over 80 years and contains no forested areas (Figure 2-3). Since both the Indiana or Northern long-eared bats prefer forested areas that include trees with peeling bark, no impacts are anticipated to these protected bats because no suitable habitat exists on or in the vicinity of this property.

This site has been in crop agriculture for many years and contains no wet grassland areas (Figure 2-3). Since the orchid prefers undisturbed wet grasslands, no impacts are anticipated to the orchid because no suitable habitat exists on or in the vicinity of this property for the western prairie fringe orchid.

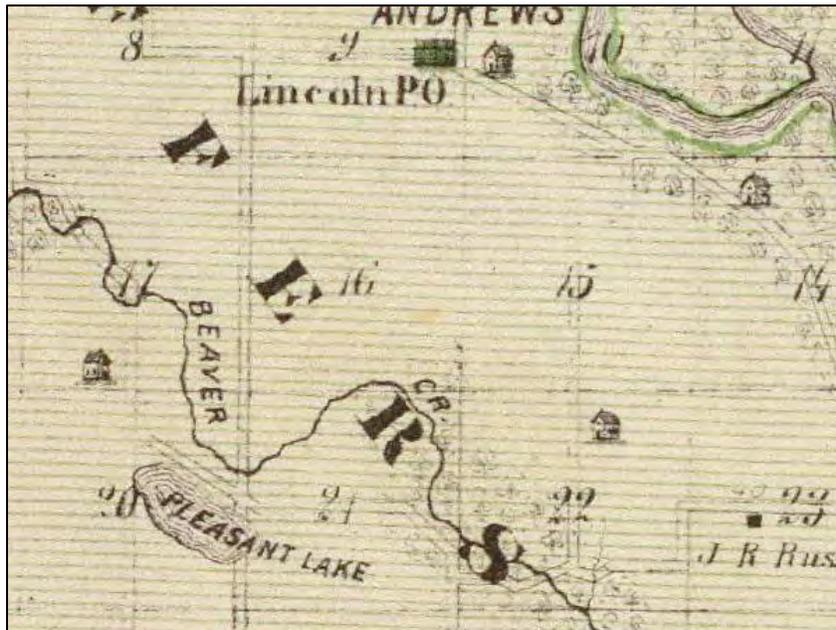
To assess the potential for historic era archaeological resources being located in the survey area, detailed maps dating from 1875 through 1965 were evaluated to determine if any buildings or structures were likely to be in the project area or immediate vicinity. In researching the historic maps and available documents (Deed) several things became clear. First, there is no indication of any building or structure on the Steddom Parcel dating back to 1875 (figure 4).

Figure 4. 1875 A.T. Andreas' Atlas map showing Section 16 north of Beaver Creek

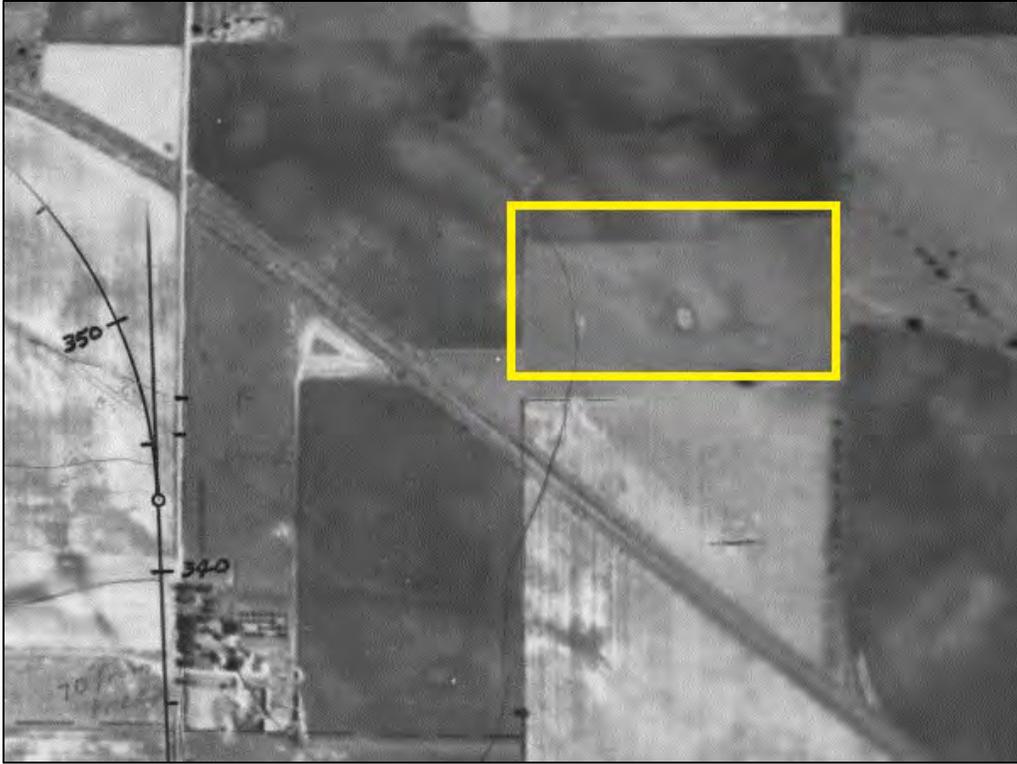
Secondly, the railroad spur off the “Inter Urban Electric” Railroad line that traversed the eastern perimeter of the survey area (section 16) does not appear until after 1914 (figure 6) on the 1918 USGS 15-foot Quadrangle map of Camp Dodge (figure 7); and by 1938 the spur rail line is gone from the landscape as noted on the 1938 USDA aerial photograph of the Steddom Parcel (figure 8).

Figure 8. 1938 USDA aerial photo showing the project area (yellow). Note that the railroad spur no longer exists along the Section 16 east boundary.

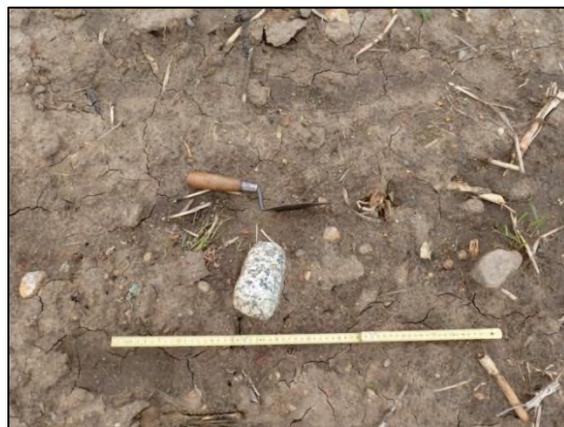
Further, just prior to the field inspection, the region experienced heavy rains. This combination of factors served to provide excellent surface visibility (100 percent); and, with the recent rains, the soil on any objects in the field was cleaned of dust and highlighted (figure 15).

Figure 15. Close-up view of a typical cobble scatter on the moraine typifying the excellent field conditions and surface visibility

The field methodology employed to conduct the survey of the 24.42-acre Steddom Parcel consisted of pedestrian transects spaced 3–5 meters apart covering the entire parcel. Further, even though the surface visibility was 100 percent and recent rains further highlighted objects in the field (figure 15), a hand excavated STP was placed in the study area to provide a view of the soil horizons present on site; (maximum depth -38cm).

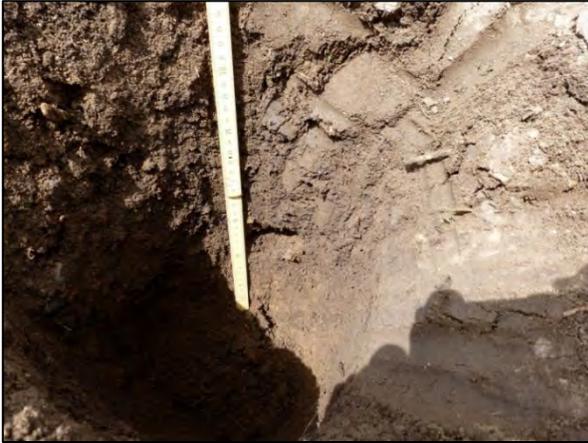
Figure 16. Hand-excavated shovel test pit No. 1 placed on the moraine, showing C horizon interface at -33 cm

Overall the soil structure revealed in STP-1 suggests that there is a robust plow zone overlaying a transitional zone which may be a B horizon that has been impacted by plowing on top of a B/C horizon (Stratum 3). This may be interpreted as eroded moraine exposures whereby the plowing and natural processes have deflated the soil exposing the glacial substrate with gravel and cobble inclusions. The lighter soils exposed in plowed fields are an indicator for moraines resulting from the retreat of the Des Moines Lobe of the Wisconsin Glacier during the Pleistocene/Holocene interface.

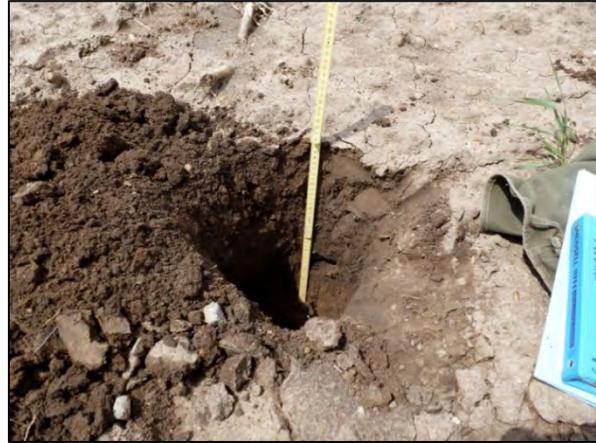
Figure 17. Overview of STP No.1

Therefore, a field survey method was implemented that had been approved by the OSA and SHPO staff which consisted of parallel pedestrian transects 3–5 meters apart over the entire 24.42-acre project area. Further, since the surface visibility was extraordinarily clear, it was decided that STPs were not necessary. The exception however, was the placement of one STP on the deflated moraine hummock located in the north center of the parcel (figures 16 and 17). Appendix A is a copy of the field drawing of the north profile of STP 1.

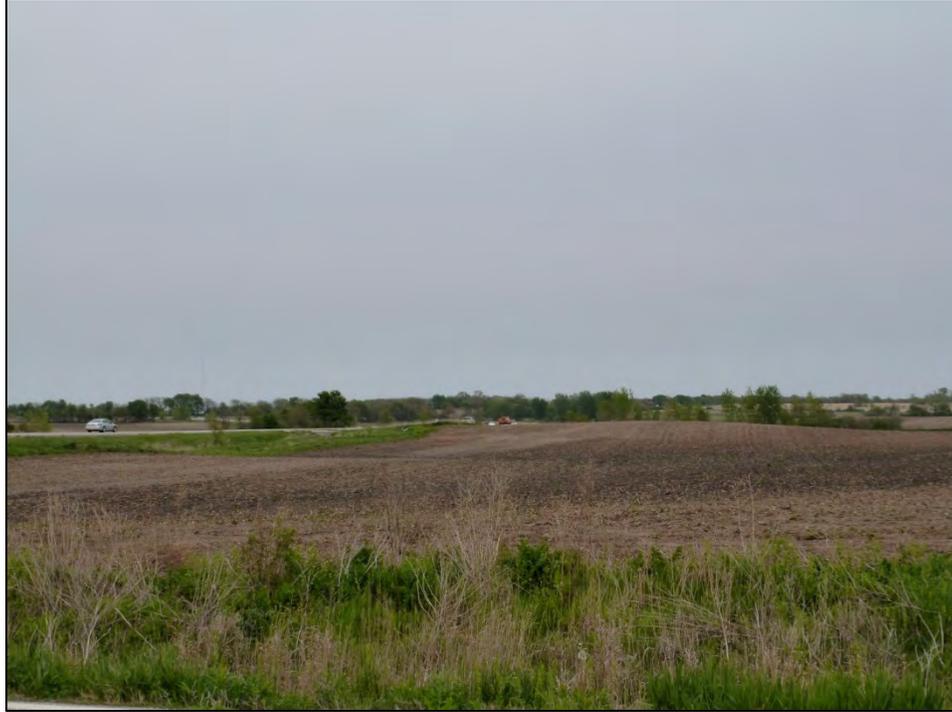
The transect intervals were oriented on an east-west axis parallel to the southern perimeter of the parcel. Closer intervals were employed on three areas where exposures of the Pleistocene moraines were noted, most prominently by distinctly lighter soil coloration and high concentrations of cobbles (figure 18).

Figure 18. View looking northeast of the Steddom Parcel showing the moraine

The three areas containing cobbles were characterized by lighter soils than the surrounding dark-brown wet low landform. The typical moraine exposures were 5YR2.5/1 with a mix of 5YR3/2 (Munsell). No artifacts were noted; however, there is a consistent scatter of cobbles ranging in size from 2–3 cm to more than 20 cm. All cobbles exhibit glacial abrasions or are heavily burnished due to natural processes, e.g. glacial patenting.

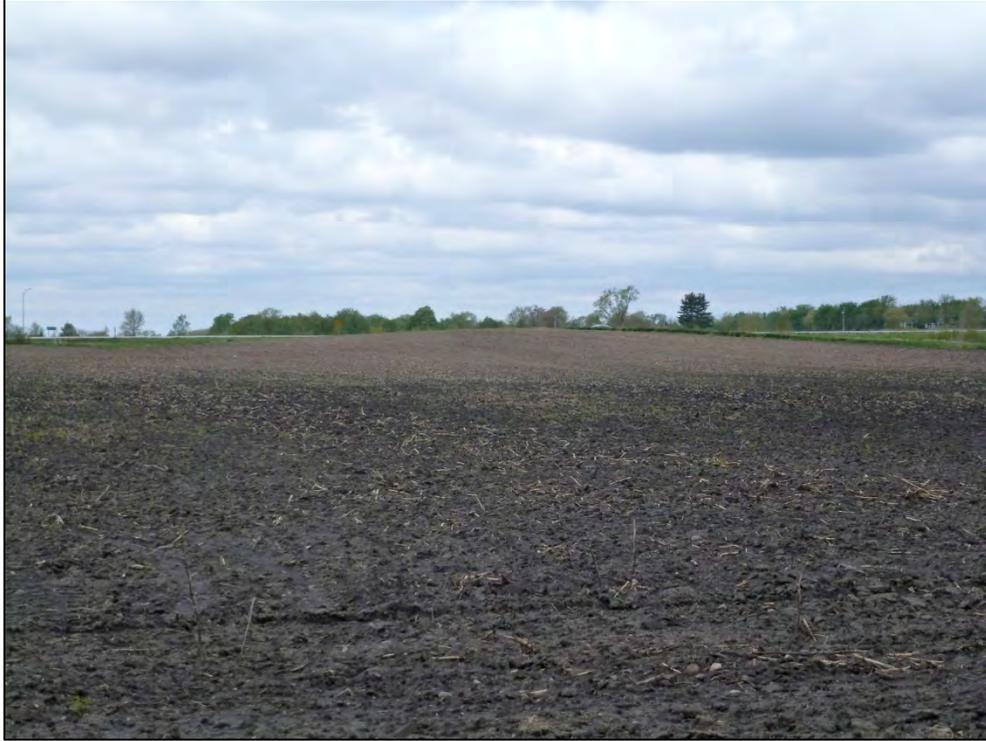
Figure 19. View of moraine on Steddom Parcel looking to Northwest from the abandoned Railroad bed, arrow indicating location of STP-1

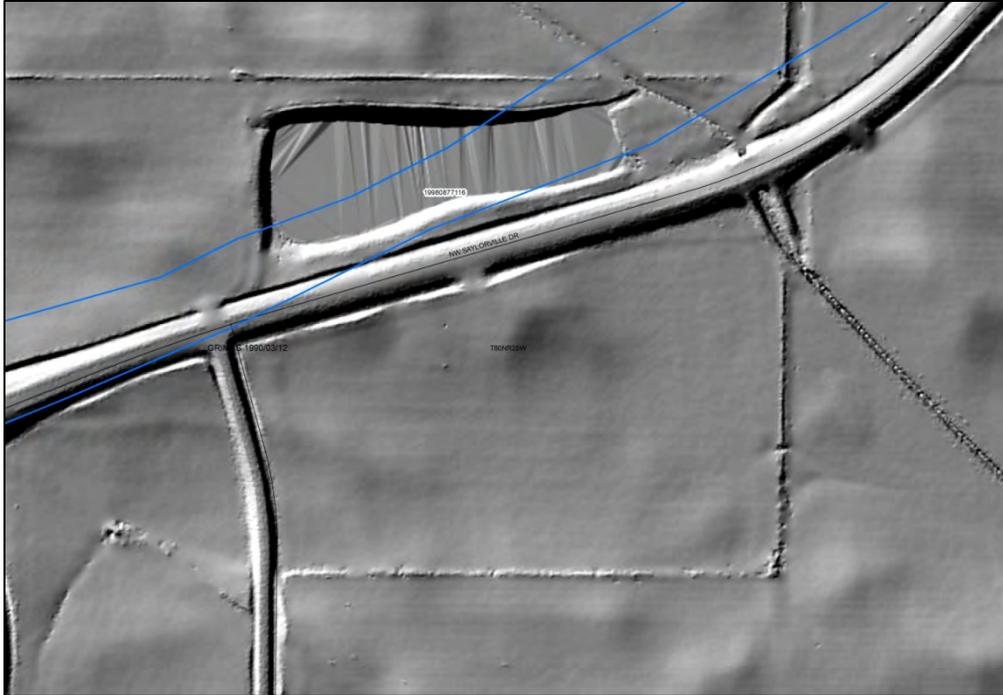
Figure 20. LiDAR image of the Steddum Parcel; note shadow labeled T80N/R25W; this is the terminal moraine (OSA)

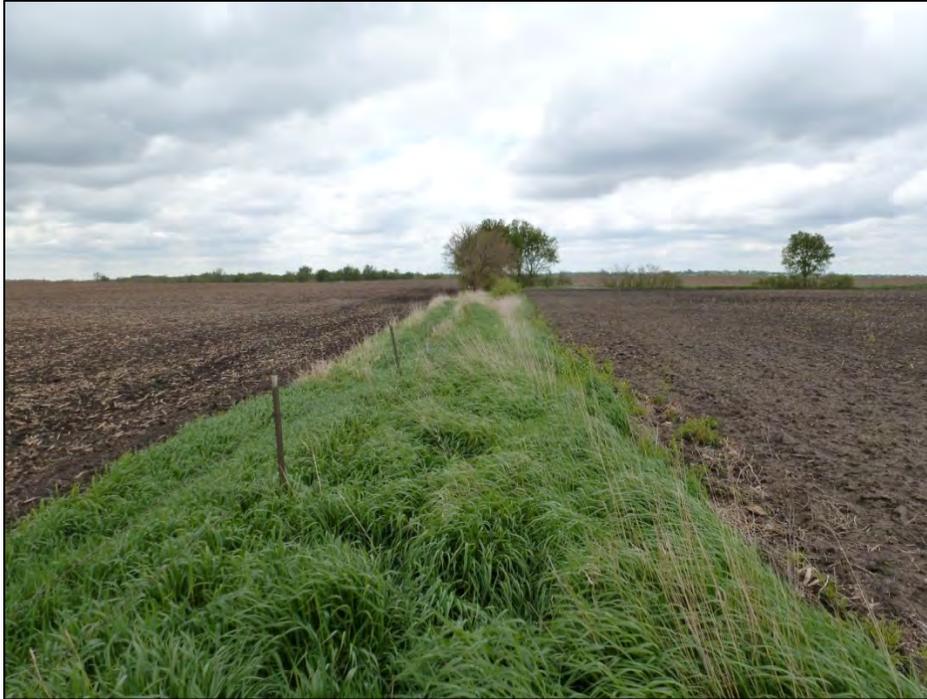
Figure 21. View of the eastern fence line of the Steddum Parcel looking south; grass berm is the ca 1918 railroad bed towards site 13PK1004

The reconnaissance survey successfully identified the abandoned spur railroad bed (figure 21) oriented north/south along the eastern property boundary. This abandoned line was walked in its entirety and no remnants of the old rail line remained, only a slight elevated clay berm. At the far southeast corner of the Steddum Parcel are the ruinous remains of what appears to be a cistern and a support structure notched to accept rail ties (figures 22–24), which was recorded and entered into the State of Iowa archaeological site database as 13PK1004. The type of concrete is characteristic of early twentieth century product. The matrix consists of coarse sand/gravel aggregate; a type that seems to have been replaced by more sophisticated technology around the time of World War II.

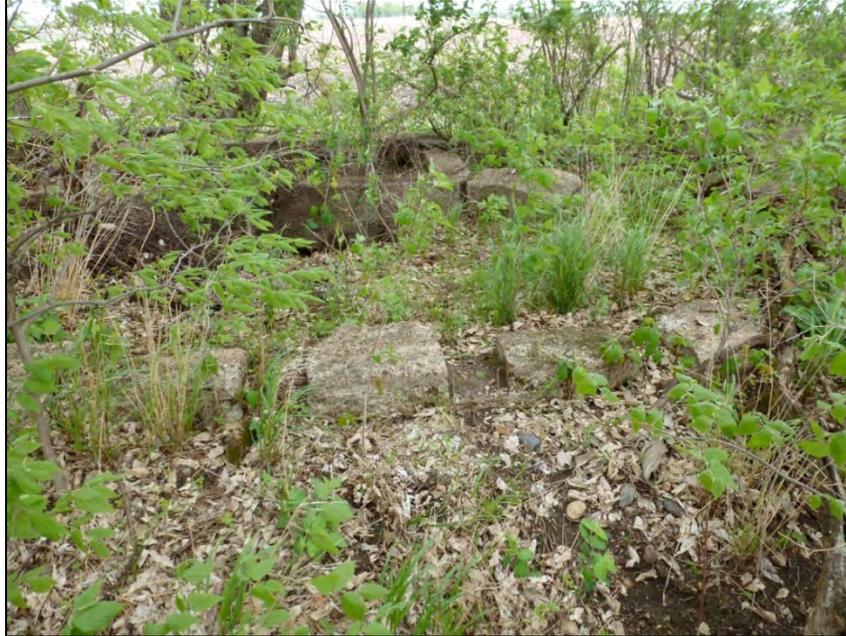
Figure 22. View facing east showing site 13PK1004; the ca 1918 concrete culvert/cistern feature associated with the railroad

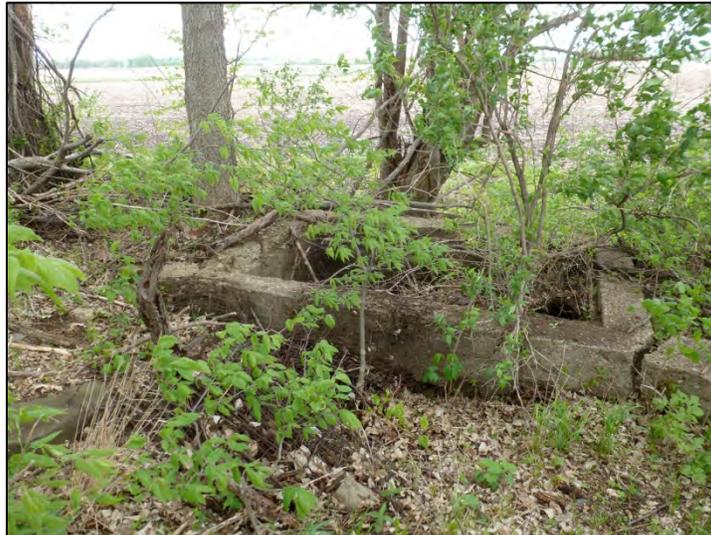
Figure 23. Site 13PK1004: View facing south of the ca 1918 concrete cistern

The function of these remains is unknown, there is no indication that they are farm related, and the 1918 map of Camp Dodge does not show a freight landing, etc. on this portion of the spur railroad line. Since the location of these concrete remnants is near the historic Camp Dodge boundary, they likely are associated with some type of army activity, or possibly as a cattle underpass, though that is unclear.

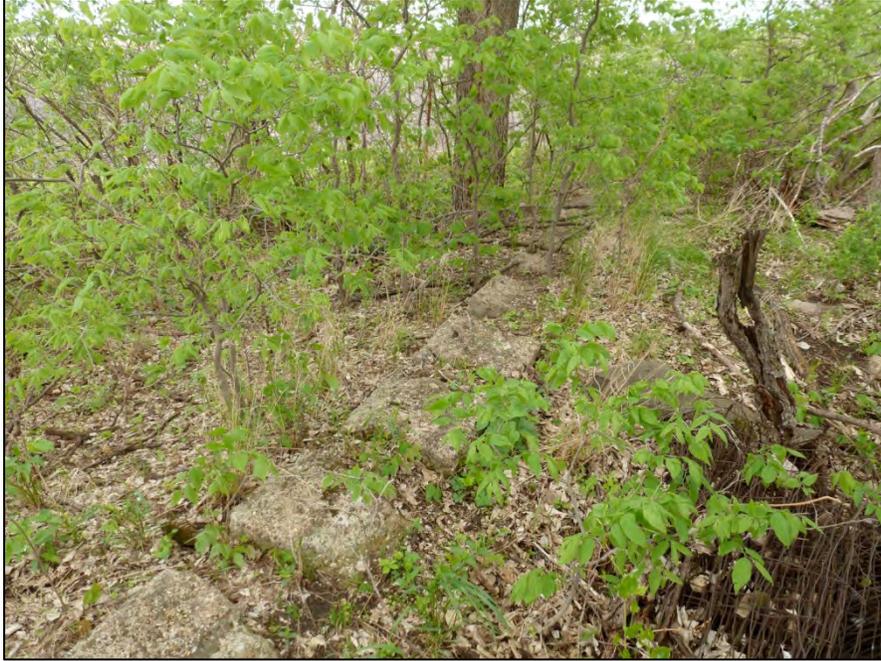
Figure 24. Site 13PK1004: View looking southwest of the concrete culvert associated with the 1918 railroad

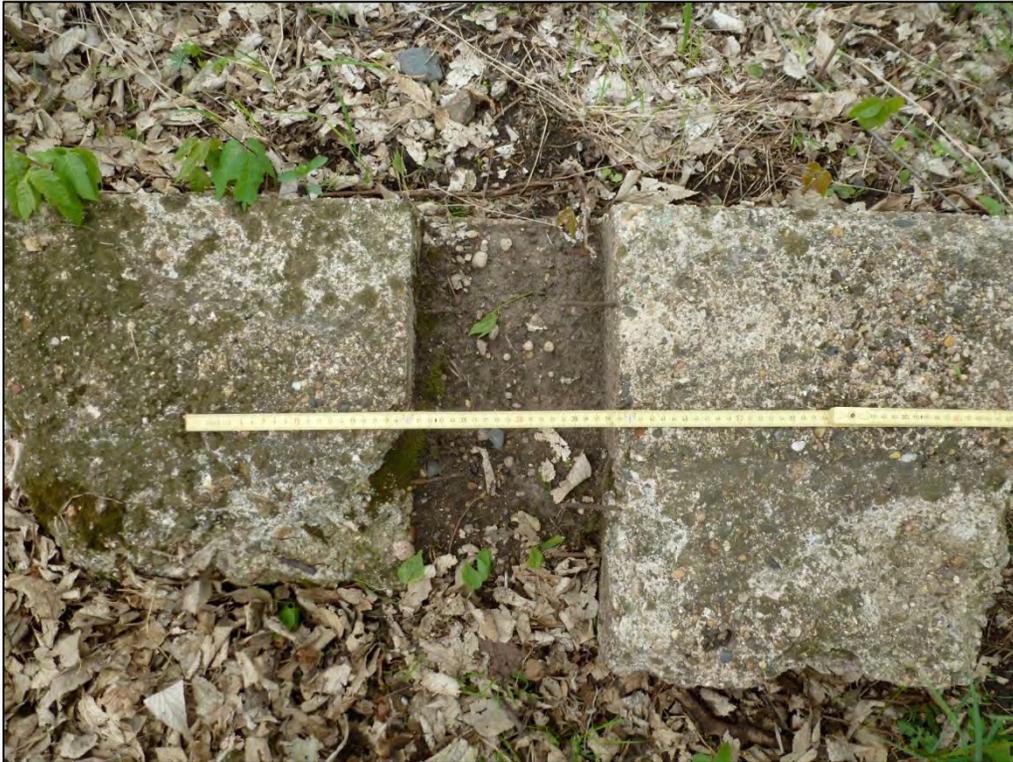
Figure 25. Site 13PK1004: Close-up of the concrete feature illustrating a notch for placement of rail ties ca 1918

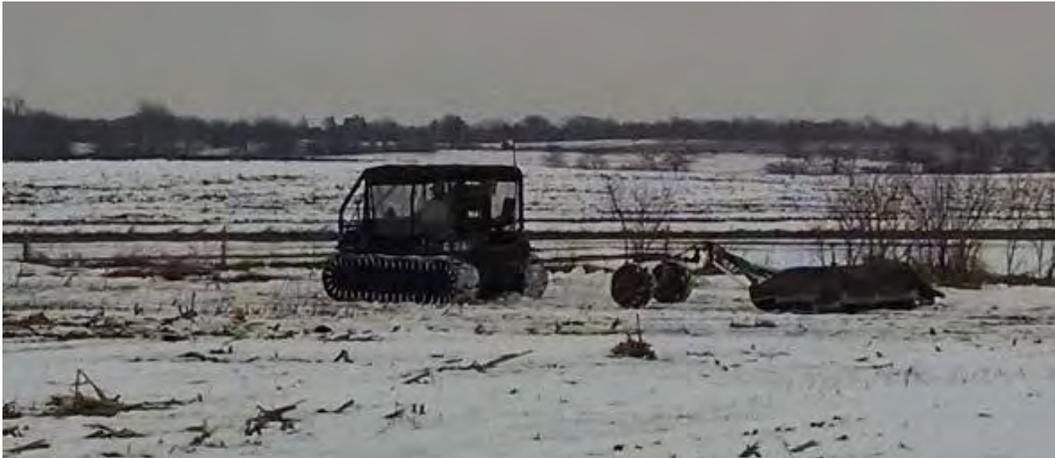
Figure 4-1: EM61 Towed Array Sled

Data were collected using a towed array sled, which consisted of three, 1 m by 0.5 m air-cored coils secured on a fiberglass and ultra-high-molecular-weight plastic sled, a Trimble 5700 Real-Time Kinematic (RTK) Global Positioning System (GPS) (Figure 4-1), a Panasonic Toughbook which acts as the data recorder, batteries, processing electronics, and an amphibious Argo ATV which towed the sled during DGM collection. The coils are mounted on the sled at 13 centimeter (cm) from the ground to the bottom of the coil. The EM61-MK2's transmitter generates a pulsed primary magnetic field, which then induces eddy currents in nearby metallic objects. The receiver measures the secondary magnetic field generated by the eddy currents at four time intervals in the bottom coil (Geonics, 2005). Earlier time gates provide enhanced detection of smaller metallic objects. Secondary voltages induced in both coils are measured in millivolts (mV).

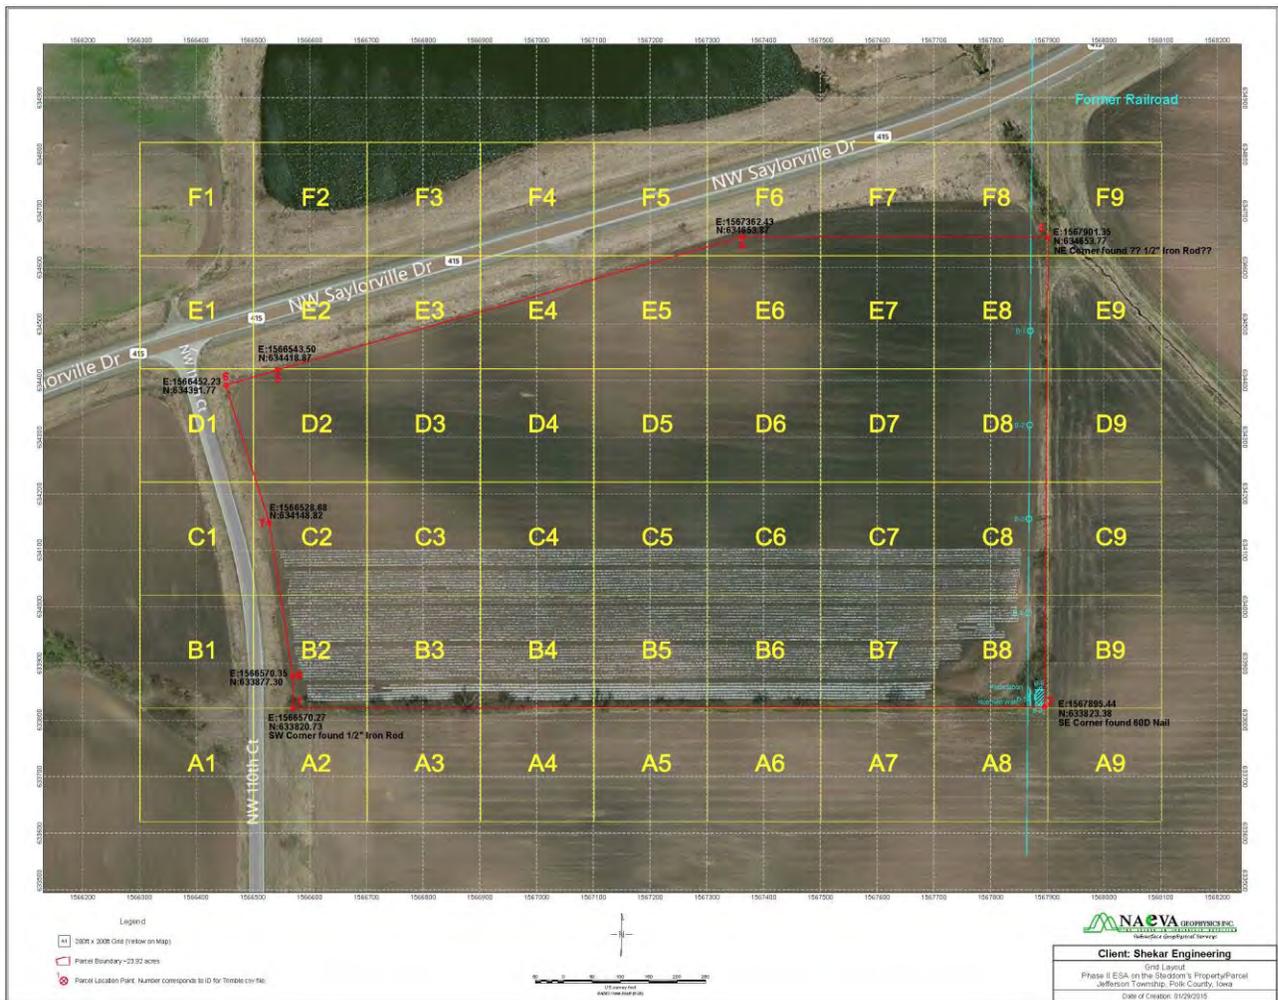
Figure 4-2: Site Map with 200ft x 200ft Grid Overlay

automatic mode at 15 readings per second. GPS antennas were mounted just off-center of the three-coil towed array platforms to allow for placement of static item jigs and on top of the tow-vehicles to provide real-time positional tracking capabilities. The position of the center of each of the three coils was calculated in the collection software using the known position and offset of the GPS antenna and a continuously updated velocity vector. System electronics were securely mounted in the vehicle's compartment and the data loggers were located in the driver's compartment to allow monitoring of system function. The tow vehicles were equipped with Trimble's AgGPS FmX Displays which allowed the operators to maintain regularly spaced, straight line profiles with zero on-ground control. The position of each EM61-MK2 reading between GPS updates was interpolated by the editing software.

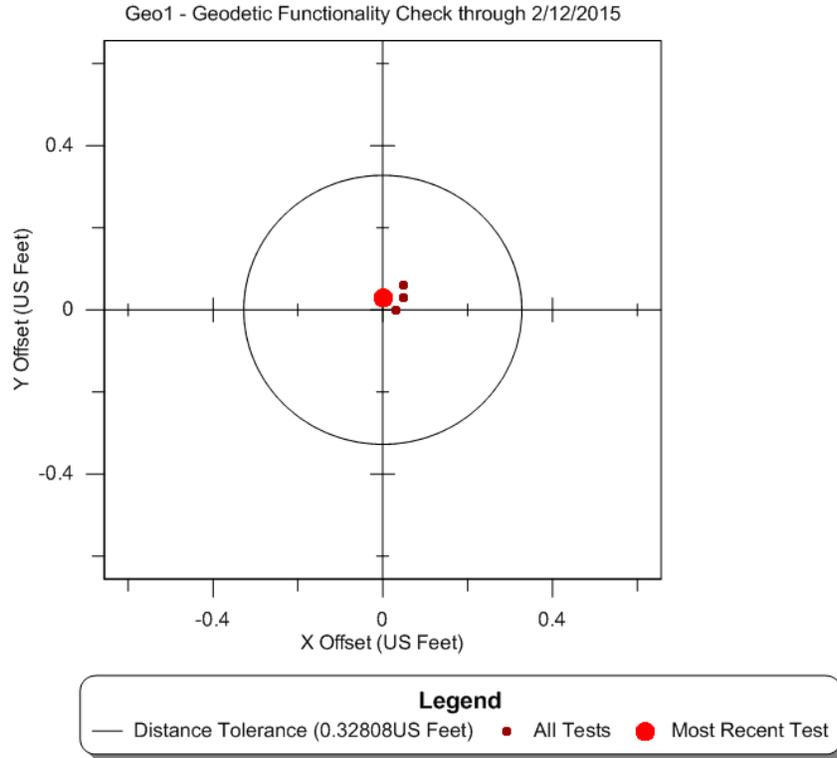
Figure 4-3: GPS QC Results

exhibited no significant interference as a result of cable motion or proximity of vehicle, respectively.

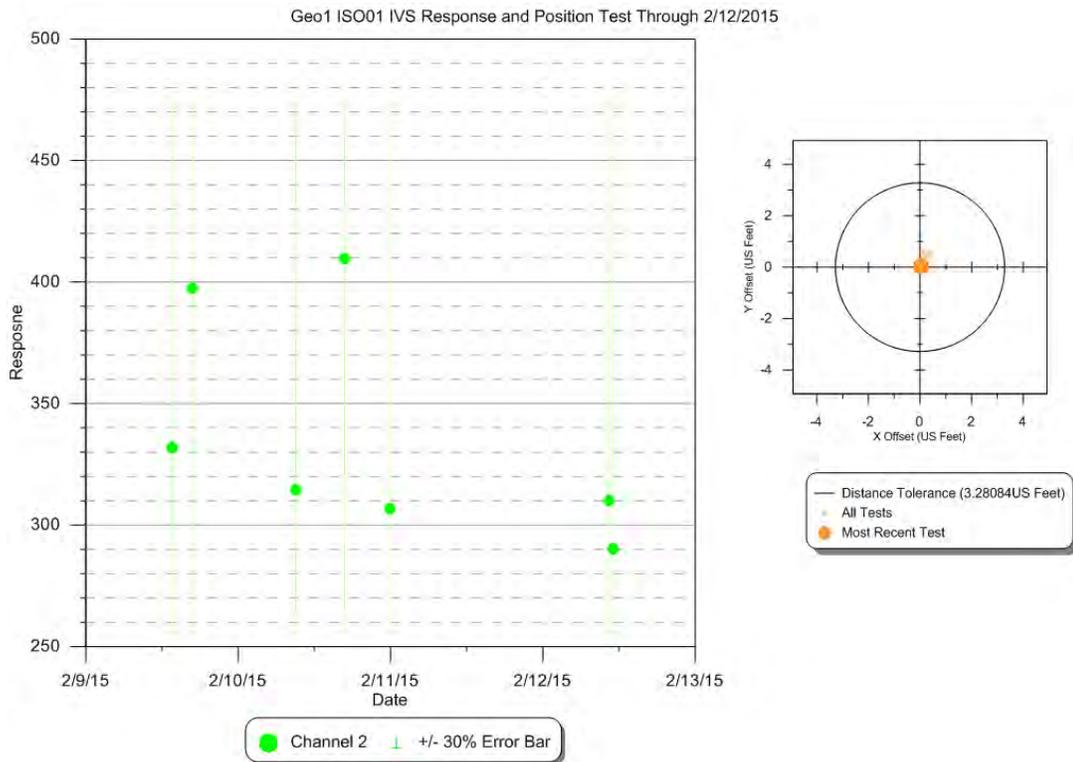
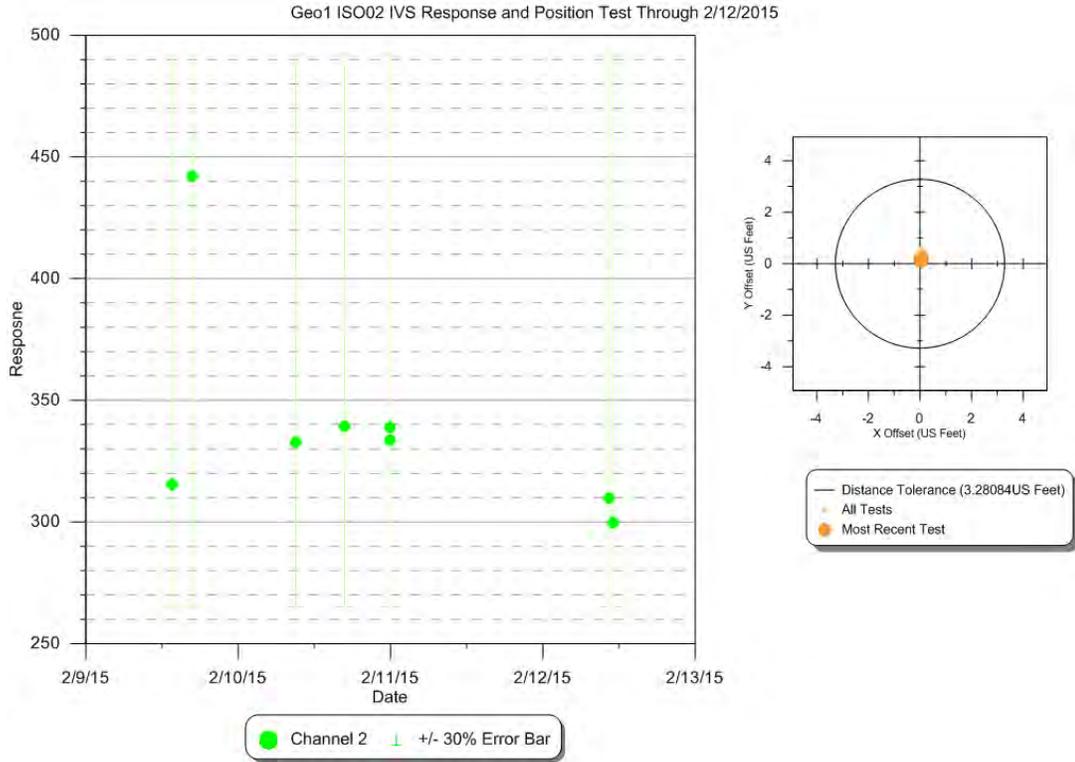
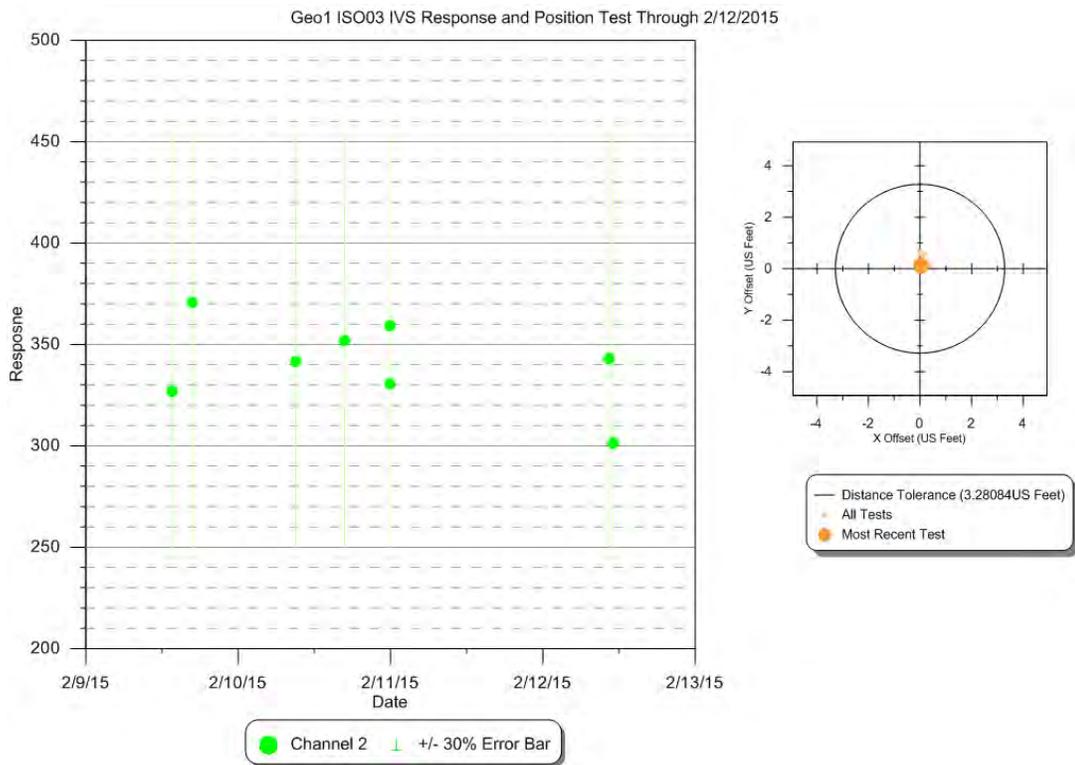
Analysis and contouring of IVS data demonstrated the suitability of the location for seeding and testing. The EM61-MK2 was able to detect the buried seeds items above background levels. Daily beginning and end of day IVS data compared well, with all ISO seed items being detected with consistent amplitude characteristics and locations to within 25 cm of the recorded location (Figure 4-5, 4-6 & 4-7). This satisfied the detection and positioning repeatability criteria.

Figure 4-5: IVS ISO01 Results

Figure 4-6: IVS ISO02 Results

Figure 4-7: IVS ISO03 Results
