# Near Miss Report

## Unprotected Excavation below Building Floor

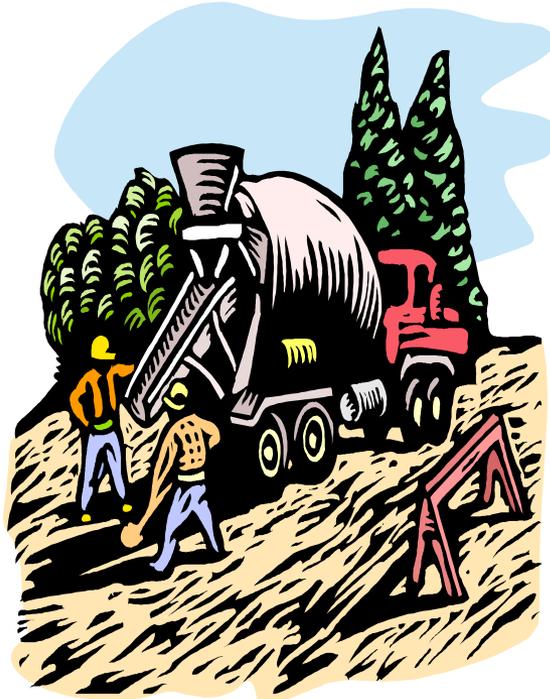
**Activity:** An employee advised the PWD site safety manager (SSM) of a possible unsafe condition in the galley related to a repair project for a clogged sewer line. Upon investigation, the SSM found an unprotected 7ft excavation through the floor slab with a portion undermining the floor slab to locate the pipe. The SSM also found no excavation permit, no excavation competent person on site, and no ladder for accessing and egressing the trench. The SSM immediately stopped work until all items were adequately addressed.

**Possible Causes:**

- Failure to follow proper trench and excavating procedures

- Proper sloping or benching as well as proper shoring and shielding must be used during trench and excavation operations – especially those exceeding 5ft deep - to protect both the operators and adjacent facilities, equipment, and utilities
- An excavation competent person shall be involved in the planning and execution of trenching and excavation operations
- Ladders must be within 25ft of any worker in trenches 4ft deep or greater.
