# Near Miss Report

## Unprotected Outdoor Electrical Outlets

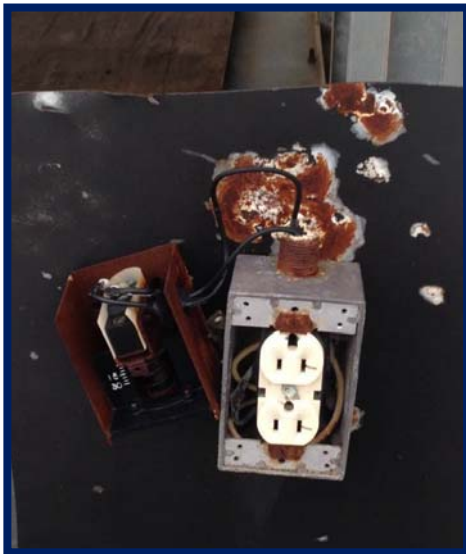
**Activity:** An employee responding to a trouble call for a leaky roof was searching for roof leaks around an HVAC unit when he discovered missing cover plates on an electrical outlet's junction box and the HVAC unit's pressure switch. The employee confirmed that both the outlet and the pressure switch were energized and open to the atmosphere at the time of discovery. The employee immediately reported the unsafe condition to his supervisor and the safety office. The unsafe condition was abated with appropriate cover plates, and awareness training was held for the shops employees to ensure that hazards are temporarily or permanently mitigated before leaving work unattended.

**Possible Causes:**

- Deviation from standard operating procedures for electrical work

- Electrical wires and exposed energized electrical contacts shall be adequately protected from adverse environmental conditions and unintended contact
- Ensure that all hazards have been abated or secured before leaving worksite
- Use ORM to identify risks of electrical from energized equipment.
