NEAR MISS

1. Type of work being performed:
Front End Loader/Backhoe - Moving soil.
2. Corrective Action at Initial Notification and indicate if and when follow up information will be provided:
Stopped work on heavy equipment operations. Safety Stand Down held at the site for all employees. Further corrective actions will be provided by the contractor within three working days.

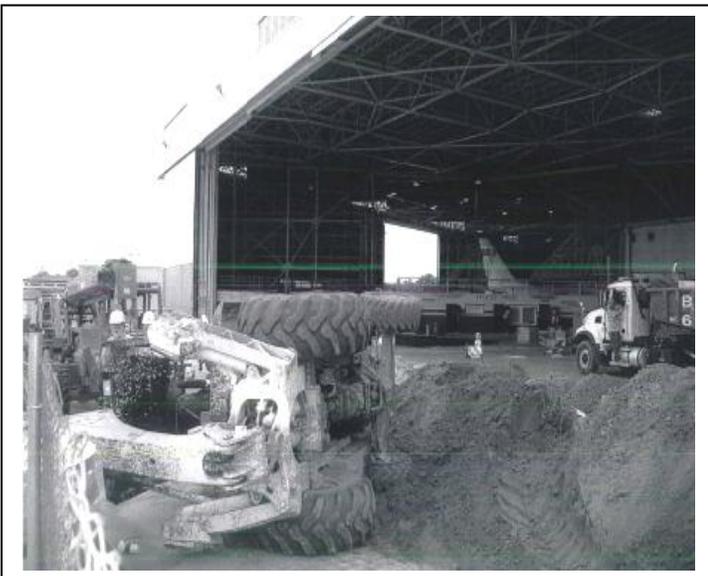
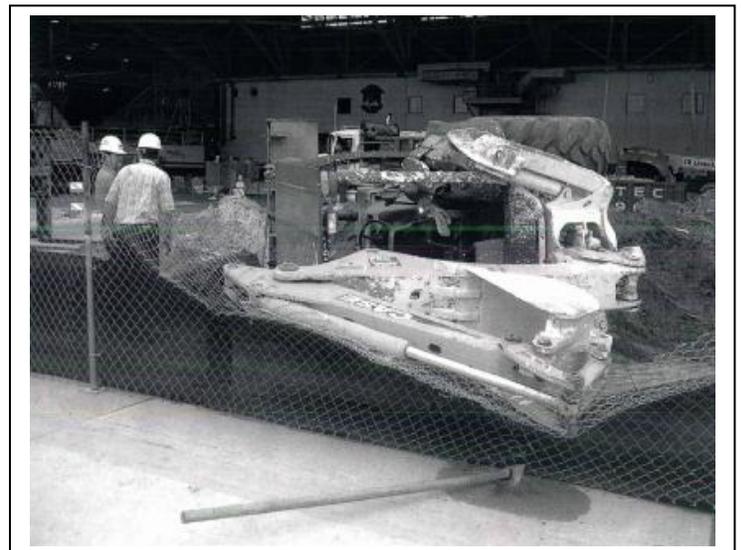
3. Extent of property damage if applicable:
No visible damage to equipment
4. Brief description of mishap, including extent of injuries, direct and indirect cause of the mishap:
Contractor was relocating excavated soil from a trench. The equipment operator was moving a load of soil in the front end loader. The operator was an experienced operator who has many years of equipment operating experience. The equipment operator drove up onto a mound of soil (approximately 4 ft high) at a 45 degree angle and raised the bucket to deposit the load onto the mound. The backhoe's center of balance shifted and the backhoe tipped over onto its side. The equipment operator had his safety belt on and was not thrown from the equipment. The equipment operator sustained no injuries.

5. Lessons learned:
 - Driving on a slope should only occur perpendicular to the slope.
 - Ensure load is evenly distributed in the front end loader bucket.

- Be aware of surroundings and plan work accordingly. Due to the proximity of the project site to the flight line, there was limited space between the trench excavation and jobsite fence.

- **Proper use of the safety belt prevented serious injury.**
