Accident Abstract

Accident Type: Crane turn over
Injury: None
Type of work: Delivery Truck
Equipment: Trailer Mounted
Category IV
Crane

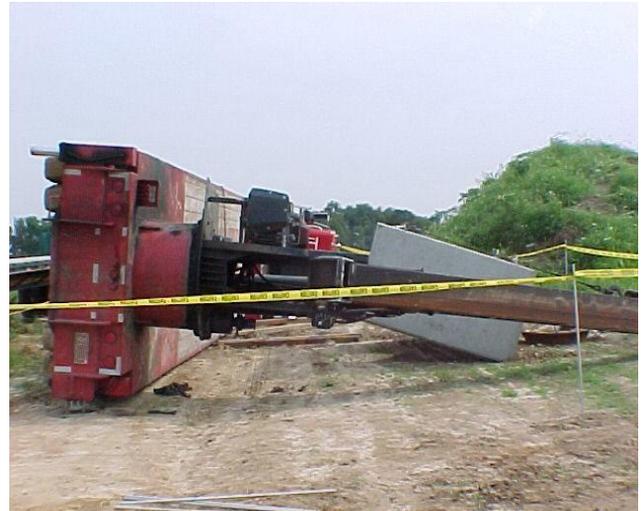
Operator was attempting to lift a 1,400 lb. pre-cast manhole top section from a trailer carrying sections of pre-cast manholes. The operator had positioned the Trailer Mounted Telescoping Boom Category IV Crane next to the material hauling trailer. The operator lowered the outriggers located in the rear of the trailer to the ground and then began to rig the pre-cast section that was to be lifted. Upon rigging the pre-cast section he started the lift and repositioned the pre-cast section on the trailer to ensure stability for the remainder of the lift. The operator then lifted the pre-cast section and began to rotate to the left when he felt the trailer rock a little. He then started to rotate back to the right to set the load back down when he felt the right side of the trailer start to rock. He then tried to rotate to the left again to stable the load. The load then continued back to the right and caused the trailer-supported crane to roll over.

Problem/cause: Operator did not fully extend the right out rigger. Operator used the equipment knowing that the left outrigger had a hydraulic leak and still operated the equipment. The operator stated that he had informed his employer that the outrigger was leaking and they replied that they would repair the problem during his upcoming vacation.

- 1) Failure to identify equipment as a crane requiring crane procedures including inspection checklists identified in the contract documents. Site manager did not realize the equipment met the definition of a crane.
- 2) Knowingly using equipment with leaking hydraulics.

Contractor site managers must be made aware of the contractor requirements for crane quality assurance at the beginning of each project. Special attention needs to be made to assure contractor site managers understand the definition of what constitutes a crane.
