Property Damage

Falling Brick Tower

- **Building Demolition**

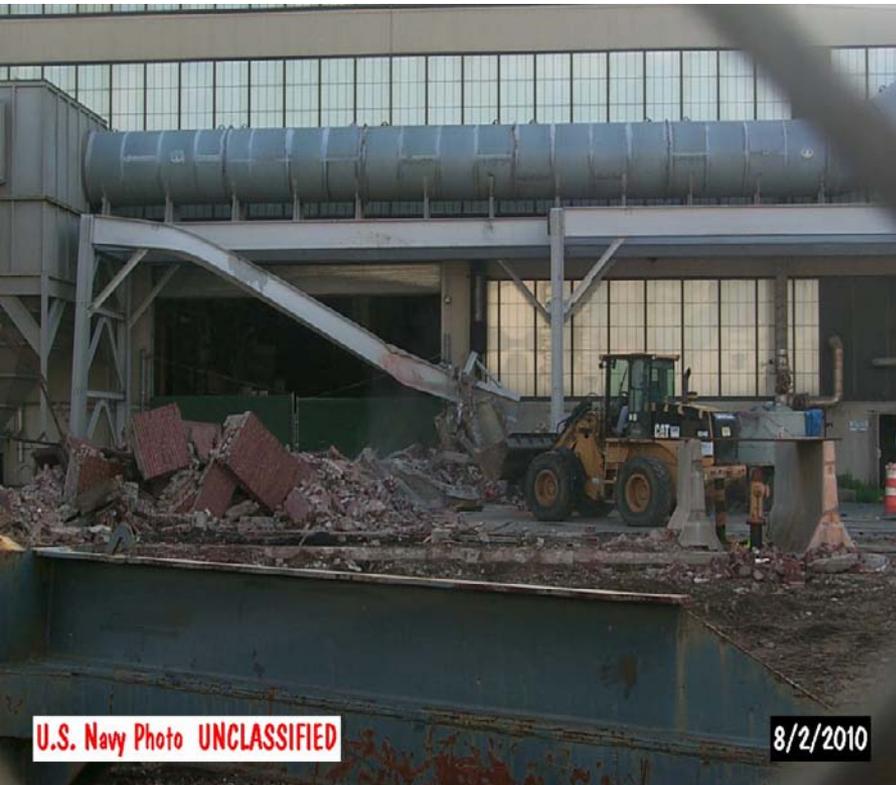
- **Activity:** The contractor was tasked to remove an old fire house and a 62 foot high brick tower. This tower was used to hang fire hoses to dry. The fire house portion of demo was complete. The contractor had indicated his initial plan to demo the brick tower was to remove several top sections by hand, then use a grappler to complete the demo. This plan changed when the contractor found the top section (Roof) was made of concrete. The contractor attempted to pull the top concrete section down with wire rope attached to an excavator when the base of the tower collapsed. The brick tower fell East striking and damaging a beam.

- Failure to use proper equipment and approach for demolition.

- AHA did not detail the hazards.

- Contractor did not notify FEAD prior to starting this critical activity.

- Failure to provide an Engineering and Demolition Plan by a Registered Professional Engineer as required by EM385 1-1

- Ensure a Engineering and Demolition Plan is provided by a Registered Professional Engineer.

- AHA must be site specific for each definable feature of work and must ensure all control measures are followed.

- Ensure diligence is followed in all three phases of QA / QC.
