TDS-NAVFAC EXWC-CI-1403

## Mitigating Concrete Damage Caused by Engine Exhaust Surface Temperature below 500°F

Supersedes TDS-2058-SHR

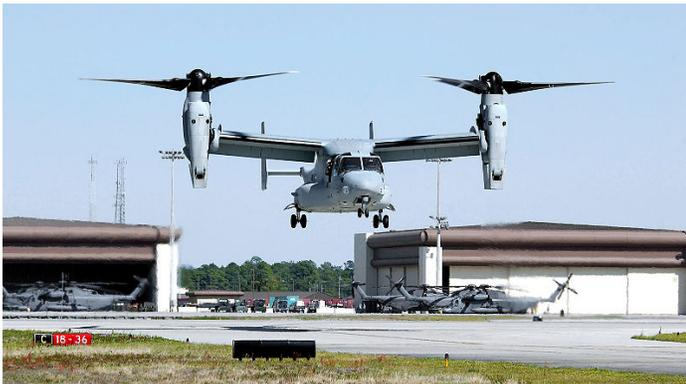
MV-22 Landing

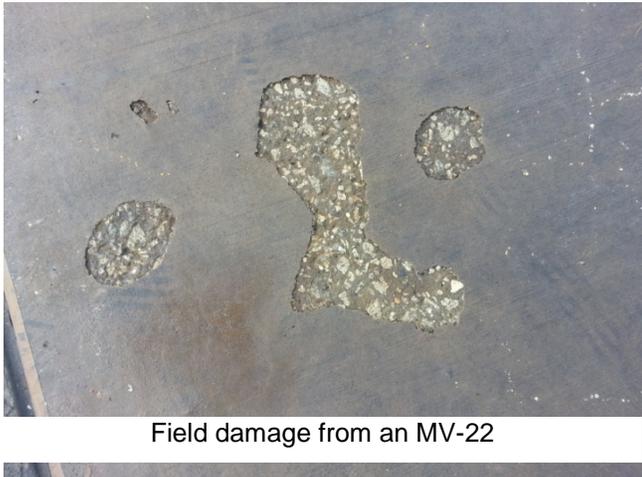
MV-22, AV-8B, and F/A-18 aircraft can damage your concrete pavements! Portland cement concrete pavements at locations where these aircraft are based are either already damaged or can be damaged. The damage occurs in the form of "scaling" of the top 1 to 2 inch of the pavement surface. Pavement fragments from these surface scales have the potential to produce foreign object damage (FOD) to aircraft engines. The elevated temperature exhaust gases from these aircraft coupled with spilled fluids damage ordinary Portland cement concrete airfield pavements. The damage occurs progressively to the pavement surface due to repeated thermal cycling and chemical reaction of the spilled aircraft fluids with the cement paste. Pavement damage from these aircraft has been observed in various locations.

Three factors are considered to be the major contributing causes of the pavement failure. These factors are thermal fatigue, vapor pressure, and chemical degradation. Thermal fatigue is evidenced by the fact that failures have occurred without the presence of oils or fuels and that scaling failure planes have been observed to fracture aggregates. Vapor pressure could be detrimental in the case of saturated or partially saturated pores where the water vapor pressure cannot be relieved fast enough during the heating phase. Chemical degradation results in a significant loss of strength, up to 50% in some cases, which accelerates the failure. Chemical degradation by itself could result in raveling of the concrete but would not produce scaling. Chemical degradation alone could not reproduce the observed failures. In the experimental investigation, accurate simulation of the thermal fatigue was considered essential for proper reproduction of the failure mechanism. The experimental and numerical analyses were therefore focused on investigating thermal fatigue as a primary cause of failure. Engine oil was applied to the samples to evaluate the resulting strength degradation.

Field damage from an MV-22

1. Sodium silicate application dramatically improves a concrete pavements ability to resist damage from exhaust temperatures below 500°F. Applying sodium silicate is the most affordable way to mitigate damage as it does not require reconstruction. It only requires the surface to be cleaned and proper sodium silicate application

2. A high temperature aggregate like an igneous traprock, expanded shale, or expanded slate should be used as coarse aggregate in new concrete mix designs. Unlike a concrete mix for a JSF, the fine aggregate can be a natural sand. However, sodium silicate must be applied. This option is intended when new construction is planned.

3. Multifilament polypropylene fibers at a dosage of 3lbs/ cubic yard of concrete add an extra layer of protection against damage when it is financially feasible to do so.
