Building Integrated Photovoltaic (BIPV) Roofs for Sustainability & Energy Efficiency

Technology Description

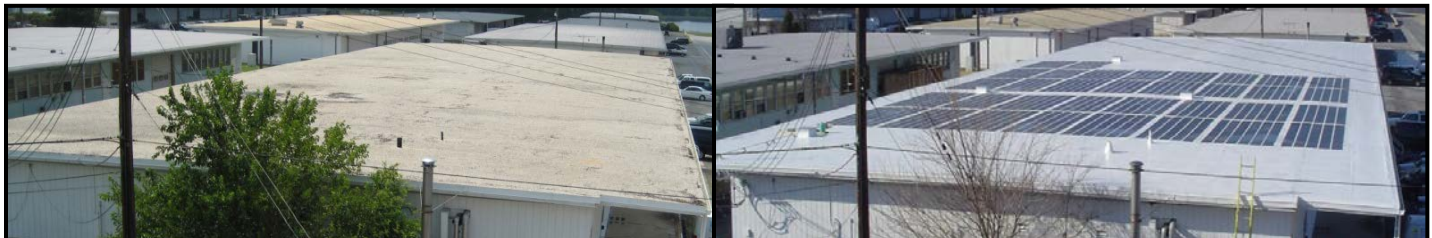
Before (left) and after (right) photos of the demonstration system at NAS Patuxent River, MD

DoD Environmental Security Technology Certification Program funded EXWC to demonstrate and validate how well BIPV roofs perform as both PV and roofing systems. The study evaluated an existing BIPV roof at Luke AFB and new systems at NAS Patuxent River and MCAS Yuma. Roof integrity, energy output, roof reflectivity and roof temperature data were collected and analyzed. Operations and maintenance requirements were qualitatively evaluated.
