**Final**  
**Site Management Plan**  
**Fiscal Year 2012**

Atlantic Fleet Weapons Training Area - Vieques  
Vieques, Puerto Rico

**Final  
Site Management Plan  
Fiscal Year 2012**

**Atlantic Fleet Weapons Training Area - Vieques  
Vieques, Puerto Rico**

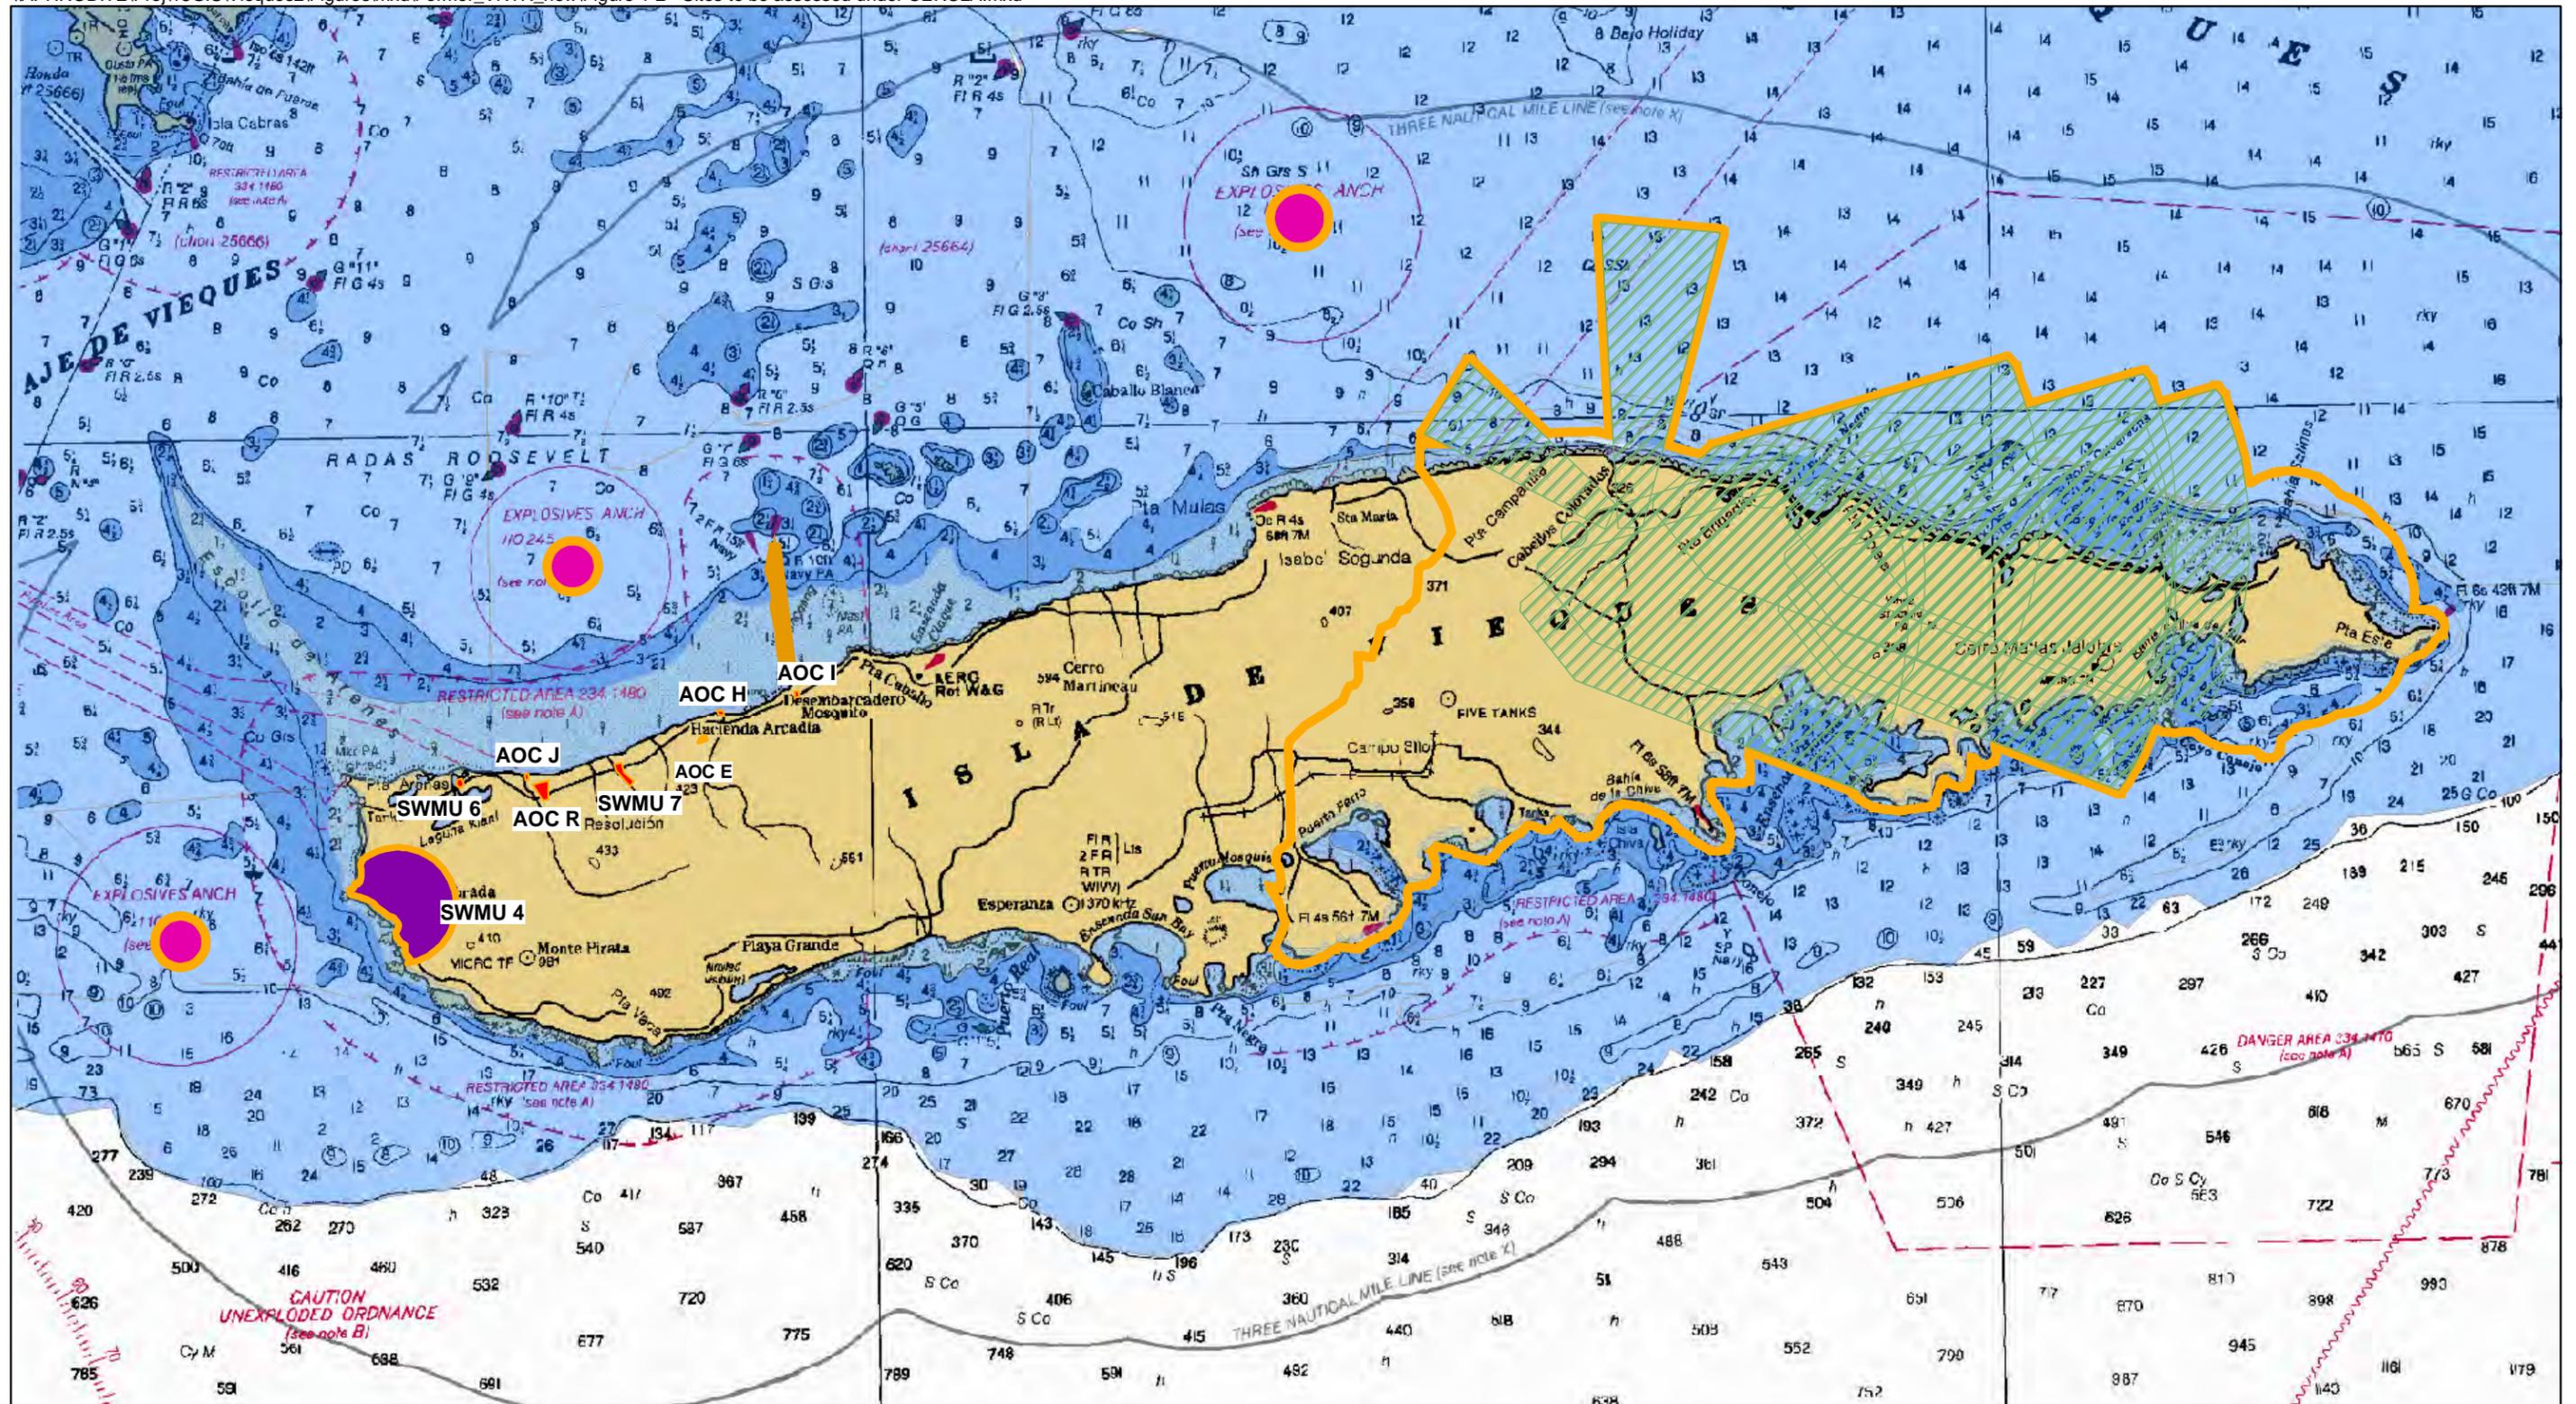
**Figure 1-2**  
**Vieques Sites to be Assessed Under CERCLA**  
*Site Management Plan, FY 2012*  
*Vieques, Puerto Rico*

- Agreed Areas of Proposed NPL Site
  - Anchorage Location Boundary
  - Western Vieques Environmental Sites
  - SWMU 4 (Former OB/OD Site)
  - Artillery Safety Fan
- 
- Water Depth**
  - 0-10 Feet
  - 10 - 150 Feet
  - Greater Than 150 Feet

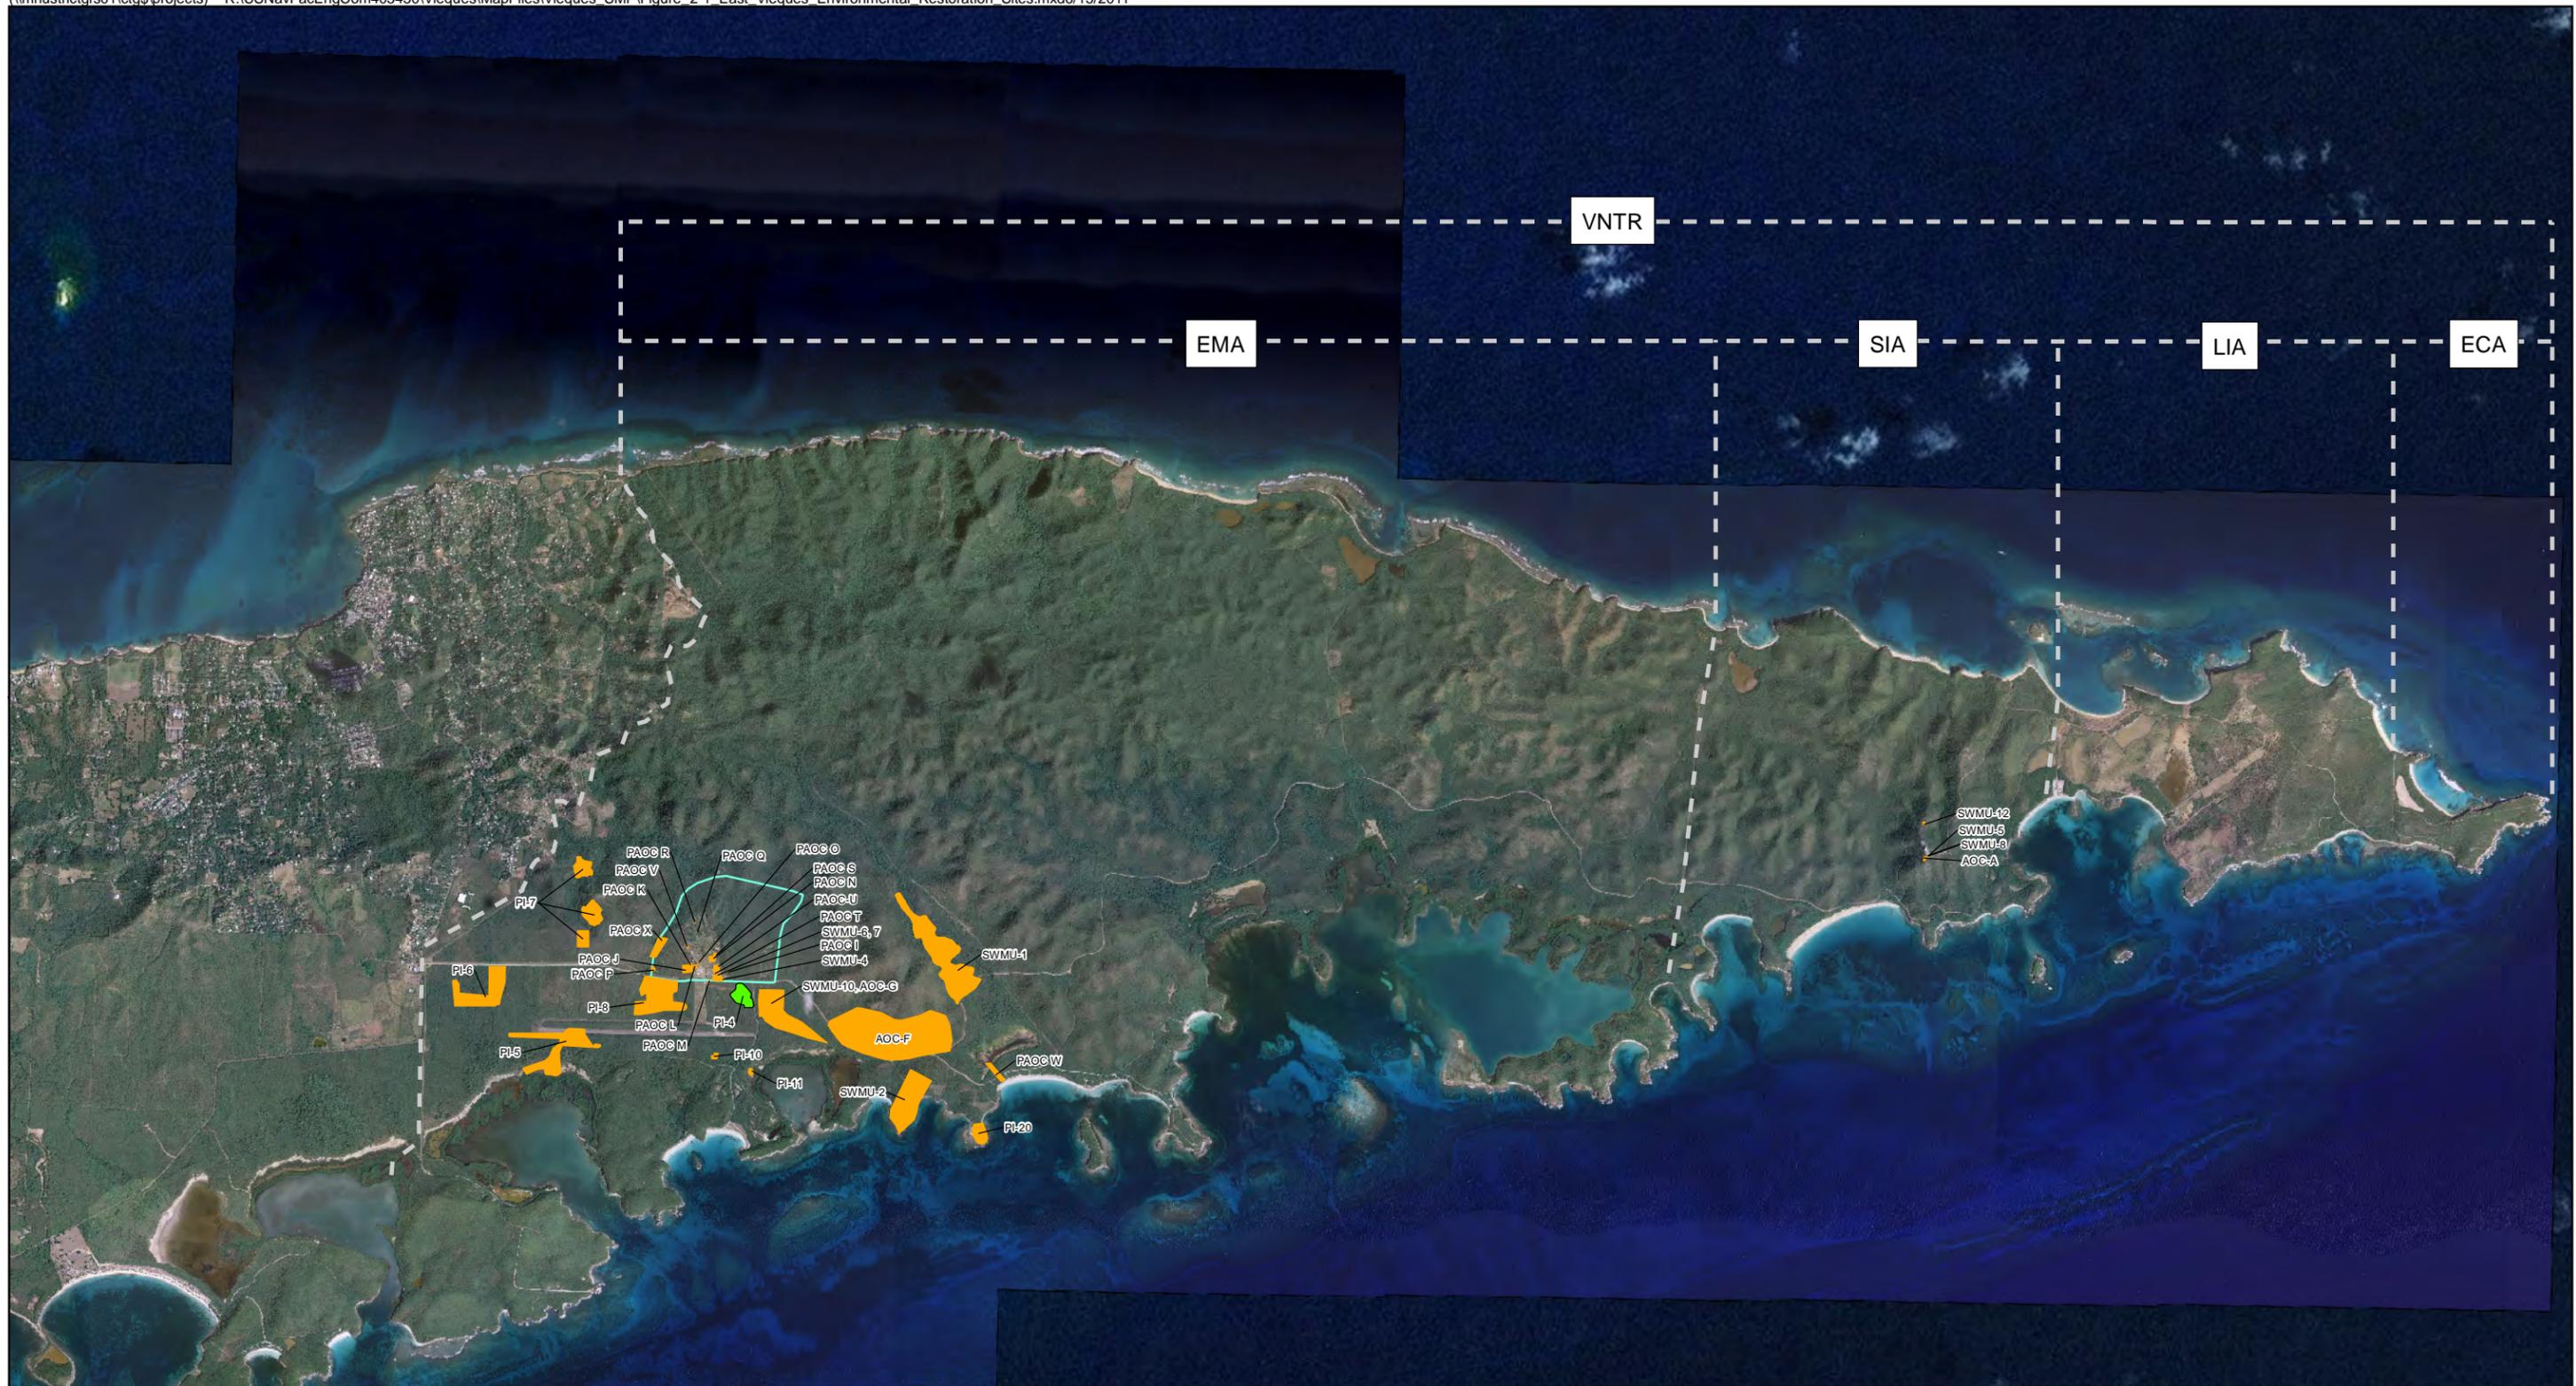
**Figure 2-1**  
**East Vieques Environmental Restoration Sites**  
Site Management Plan, FY 2012  
Vieques, Puerto Rico

**Legend**  
■ Sites – Decision Document  
■ Sites – Under Investigation  
□ Camp Garcia

During the development of the Description of Current Conditions Report (CH2M HILL, 2001b) and the EBS (NAVFAC, 2003a), several additional potential environmental sites were identified based on the review of historical aerial photographs and facility records. The locations of the PI sites and PAOCs are shown on **Figure 2-1**.

An interview conducted in June 2000 with an employee from NASD (CH2M HILL, 2001b) indicated that a former vehicle maintenance area at Camp García existed immediately north of the main road at the location shown on **Figures 2-1**. A review of the historical aerial photos indicates that all structures were demolished prior to 1980. The interviewee was not aware of any hazardous material or hazardous waste releases at the site. During the EBS VSI conducted in October 2002, there was no evidence of hazardous material, hazardous waste, petroleum, or munitions storage or disposal (NAVFAC, 2003a). However, due to the past use of this site, implementation of a PA/SI was performed. Evaluation of historical data collected at PAOC J is presented in the Final PA/SI Report (CH2M HILL, 2008e) and Final SI/ESI Report (CH2M HILL, 2010c). The PA/SI Report recommended NFA for PAOC J, pending confirmation that regional groundwater quality had not been adversely impacted by potential releases at PAOC J. Installation and sampling of the regional groundwater monitoring wells, as described in the SAP (CH2M HILL, 2009c), was completed in May 2009. The Final SI/ESI Report, which includes the regional groundwater evaluation, was submitted in August 2010 (CH2M HILL, 2010c). The results of the ESI indicated there had not been a CERCLA-related release from PAOC J that had adversely impacted groundwater quality. Therefore, based on the findings presented in the PA/SI Report and the Final SI/ESI Report, PAOC J was identified as requiring no action to be protective of unrestricted human use and ecological exposure and was therefore included in a Final No Action/NFA Decision Document (CH2M HILL, 2010f).

The site is located in an area north of the main road of Camp García, adjacent to PAOCs J and L, as shown on **Figure 2-1**. Interviewees identified PAOC K as being a potential source of petroleum contamination from washing vehicles on the vehicle wash rack. The structure was demolished prior to 1980. During a site visit in October 2002, no evidence of hazardous materials, hazardous waste, petroleum, or munitions storage or disposal was observed at the site (NAVFAC, 2003a). While there was no observable evidence of a release, a PA/SI was performed due to past vehicle washing activities at the site. However, due to the past use of this site, implementation of a PA/SI was performed. Evaluation of historical data collected at PAOC K is presented in the Final PA/SI Report (CH2M HILL, 2008e) and Final SI/ESI Report (CH2M HILL, 2010c). The PA/SI Report recommended NFA for PAOC K, pending confirmation that regional groundwater quality had not been adversely impacted by potential releases at PAOC K. Installation and sampling of the regional groundwater monitoring wells, as described in the SAP (CH2M HILL, 2009c), was completed in May 2009. The Final SI/ESI Report, which includes the regional groundwater evaluation, was submitted in August 2010 (CH2M HILL, 2010c). The results of the ESI indicated there had not been a CERCLA-related release from PAOC K that had adversely impacted groundwater quality. Therefore, based on the findings presented in the PA/SI Report and the Final SI/ESI Report, PAOC K was identified as requiring no action to be protective of unrestricted human use and ecological exposure and was therefore included in a Final No Action/NFA Decision Document (CH2M HILL, 2010f).

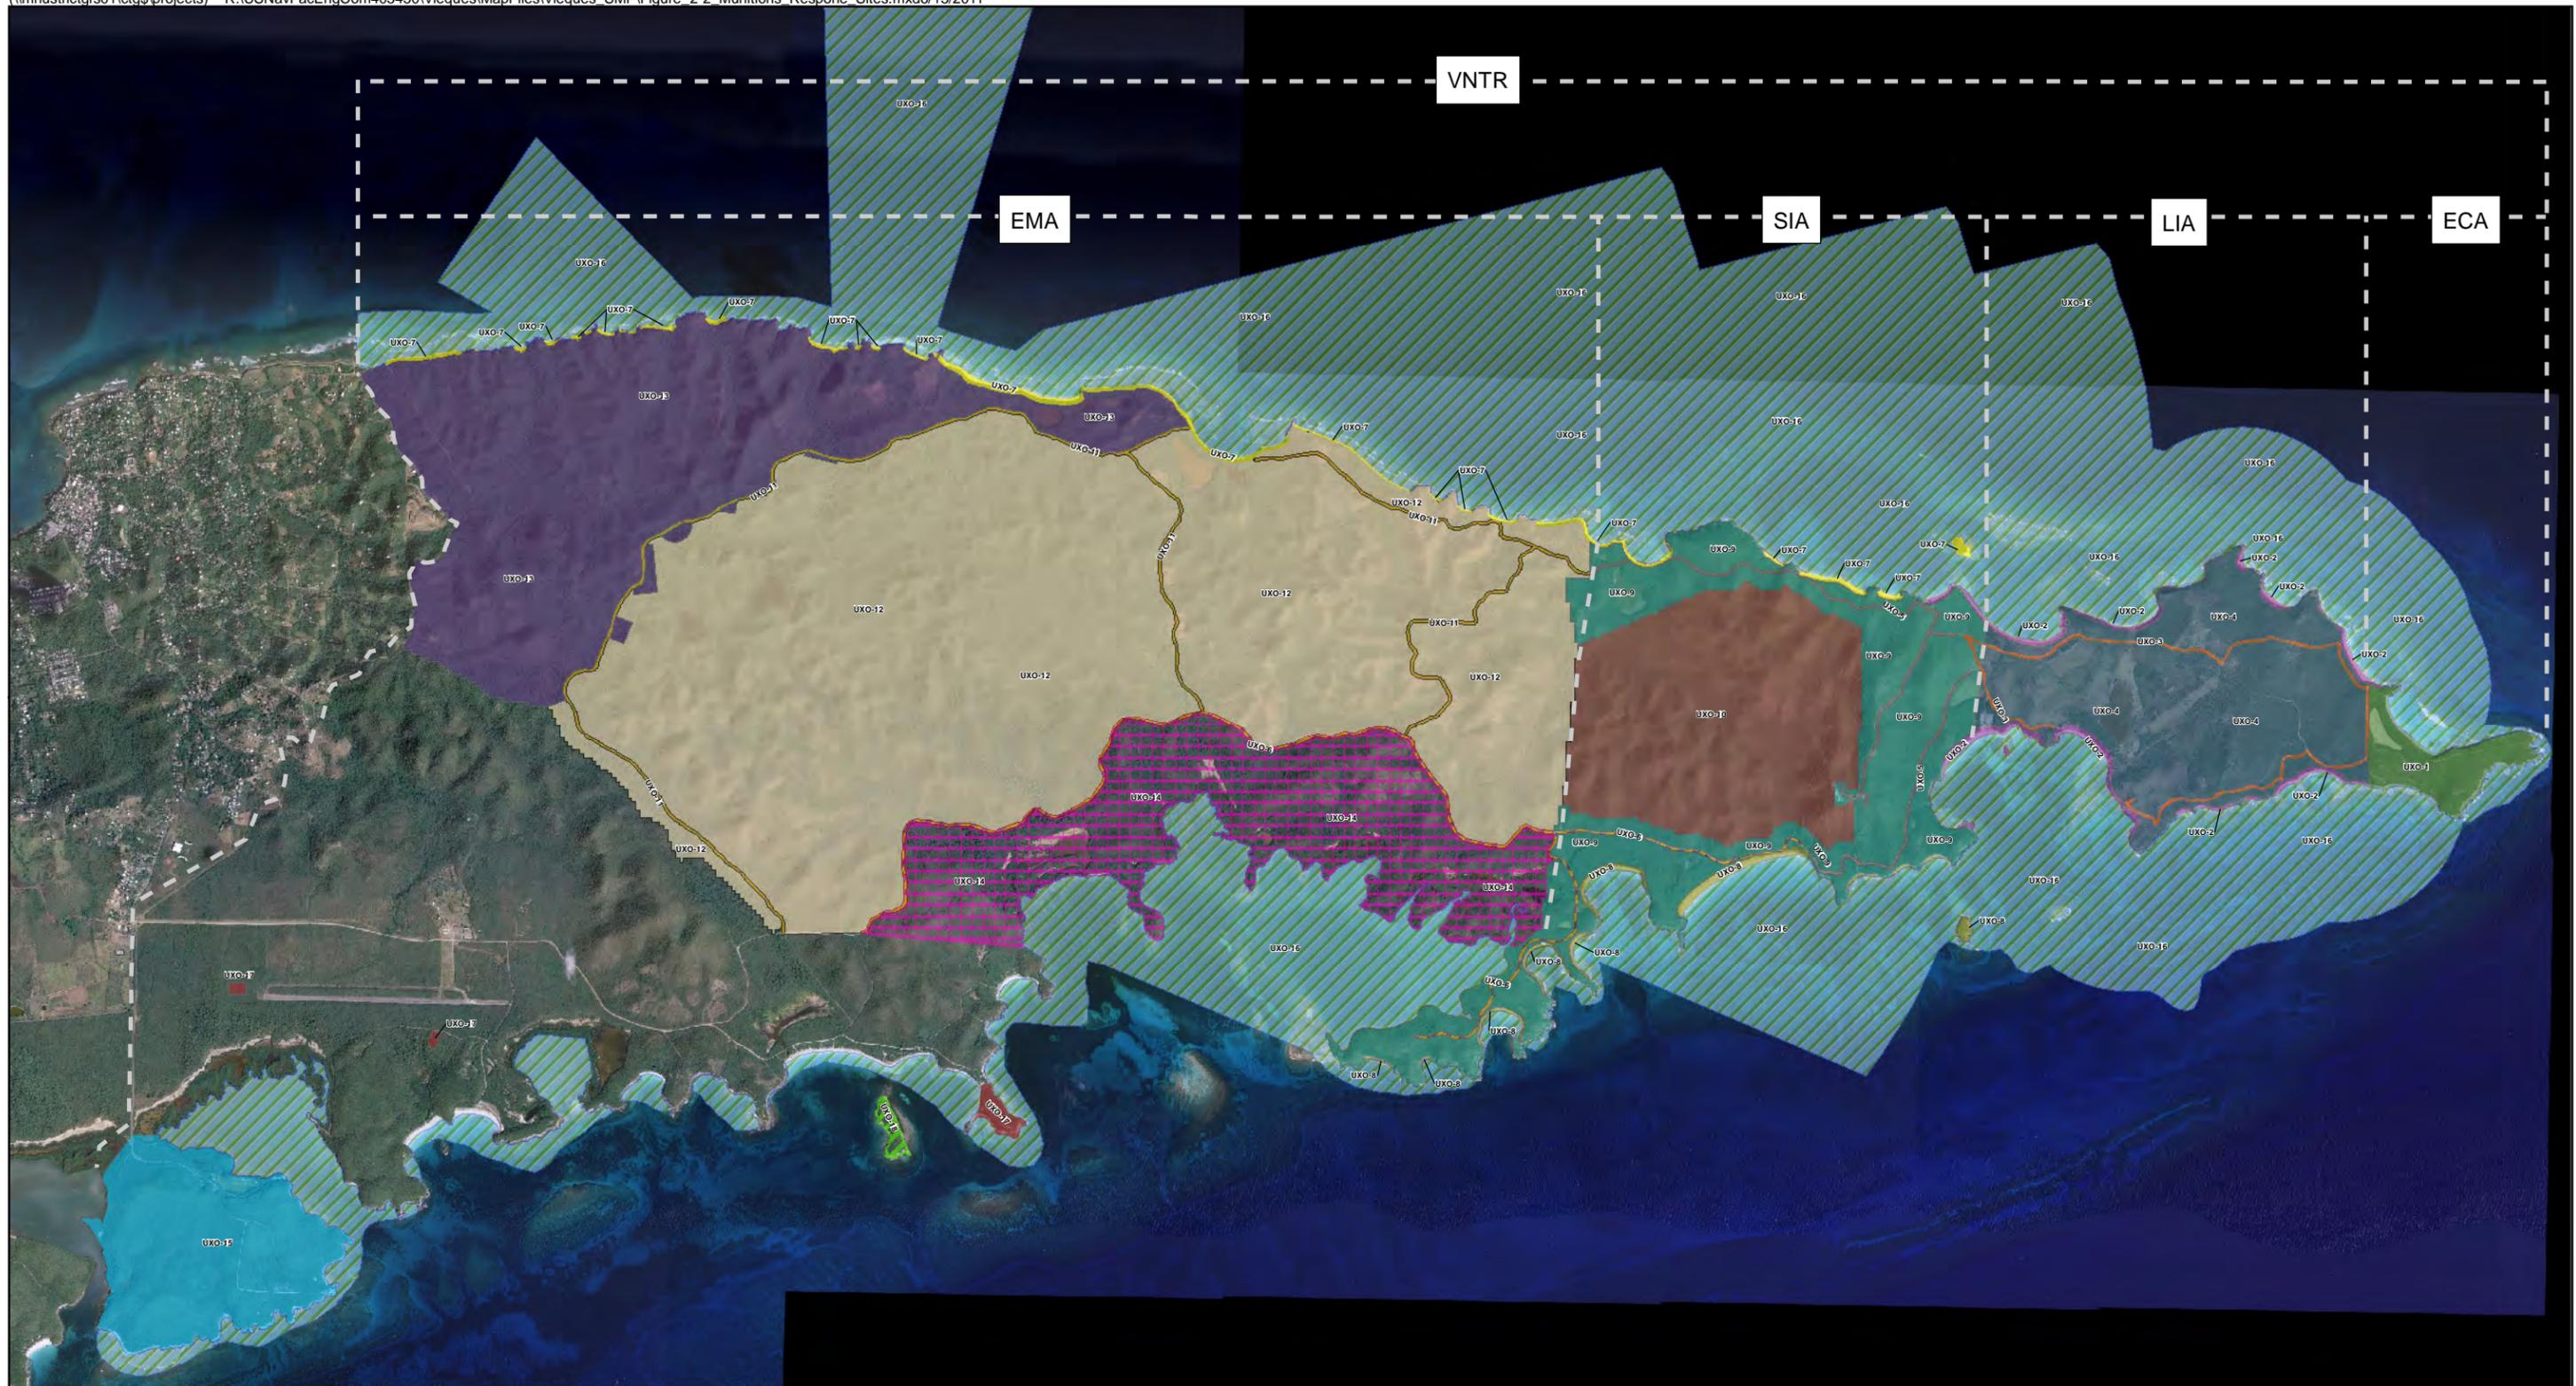
**Figure 2-2**  
**Munitions Response Sites**  
Site Management Plan, FY 2012  
Vieques, Puerto Rico

- UXO 1 - ECA
- UXO 2 - LIA Beaches
- UXO 3 - LIA Roads
- UXO 4 - LIA Interior
- UXO 5 - SIA Restricted Roads
- UXO 6 - EMA/SIA Public Roads
- UXO 7 - EMA/SIA North Beaches
- UXO 8 - SIA South Beaches
- UXO 9 - SIA Exterior
- UXO 10 - SIA Interior
- UXO 11 - EMA Public Roads
- UXO 12 - EMA Interior
- UXO 13 - EMA West
- UXO 14 - EMA South
- UXO 15 - Puerto Ferro
- UXO 16 - Underwater Areas
- UXO 17 - Camp Garcia Area (PAOC EE, PAOC FF, and PI 14)
- UXO 18 - Cayo de la Chiva
