**Re: VEGETATION CLEARANCE ECOLOGICAL FIELD SURVEY METHODOLOGY
COMPREHENSIVE LIABILITY ENVIRONMENTAL ACTION NAVY (CLEAN)
PROGRAM SITE INSPECTION /EXPANDED SITE INSPECTION 7 CONSENT
ORDER AND 15 PI / PAOC SITES**

SI/Expanded SI Preliminary Vegetation Clearance Mapping

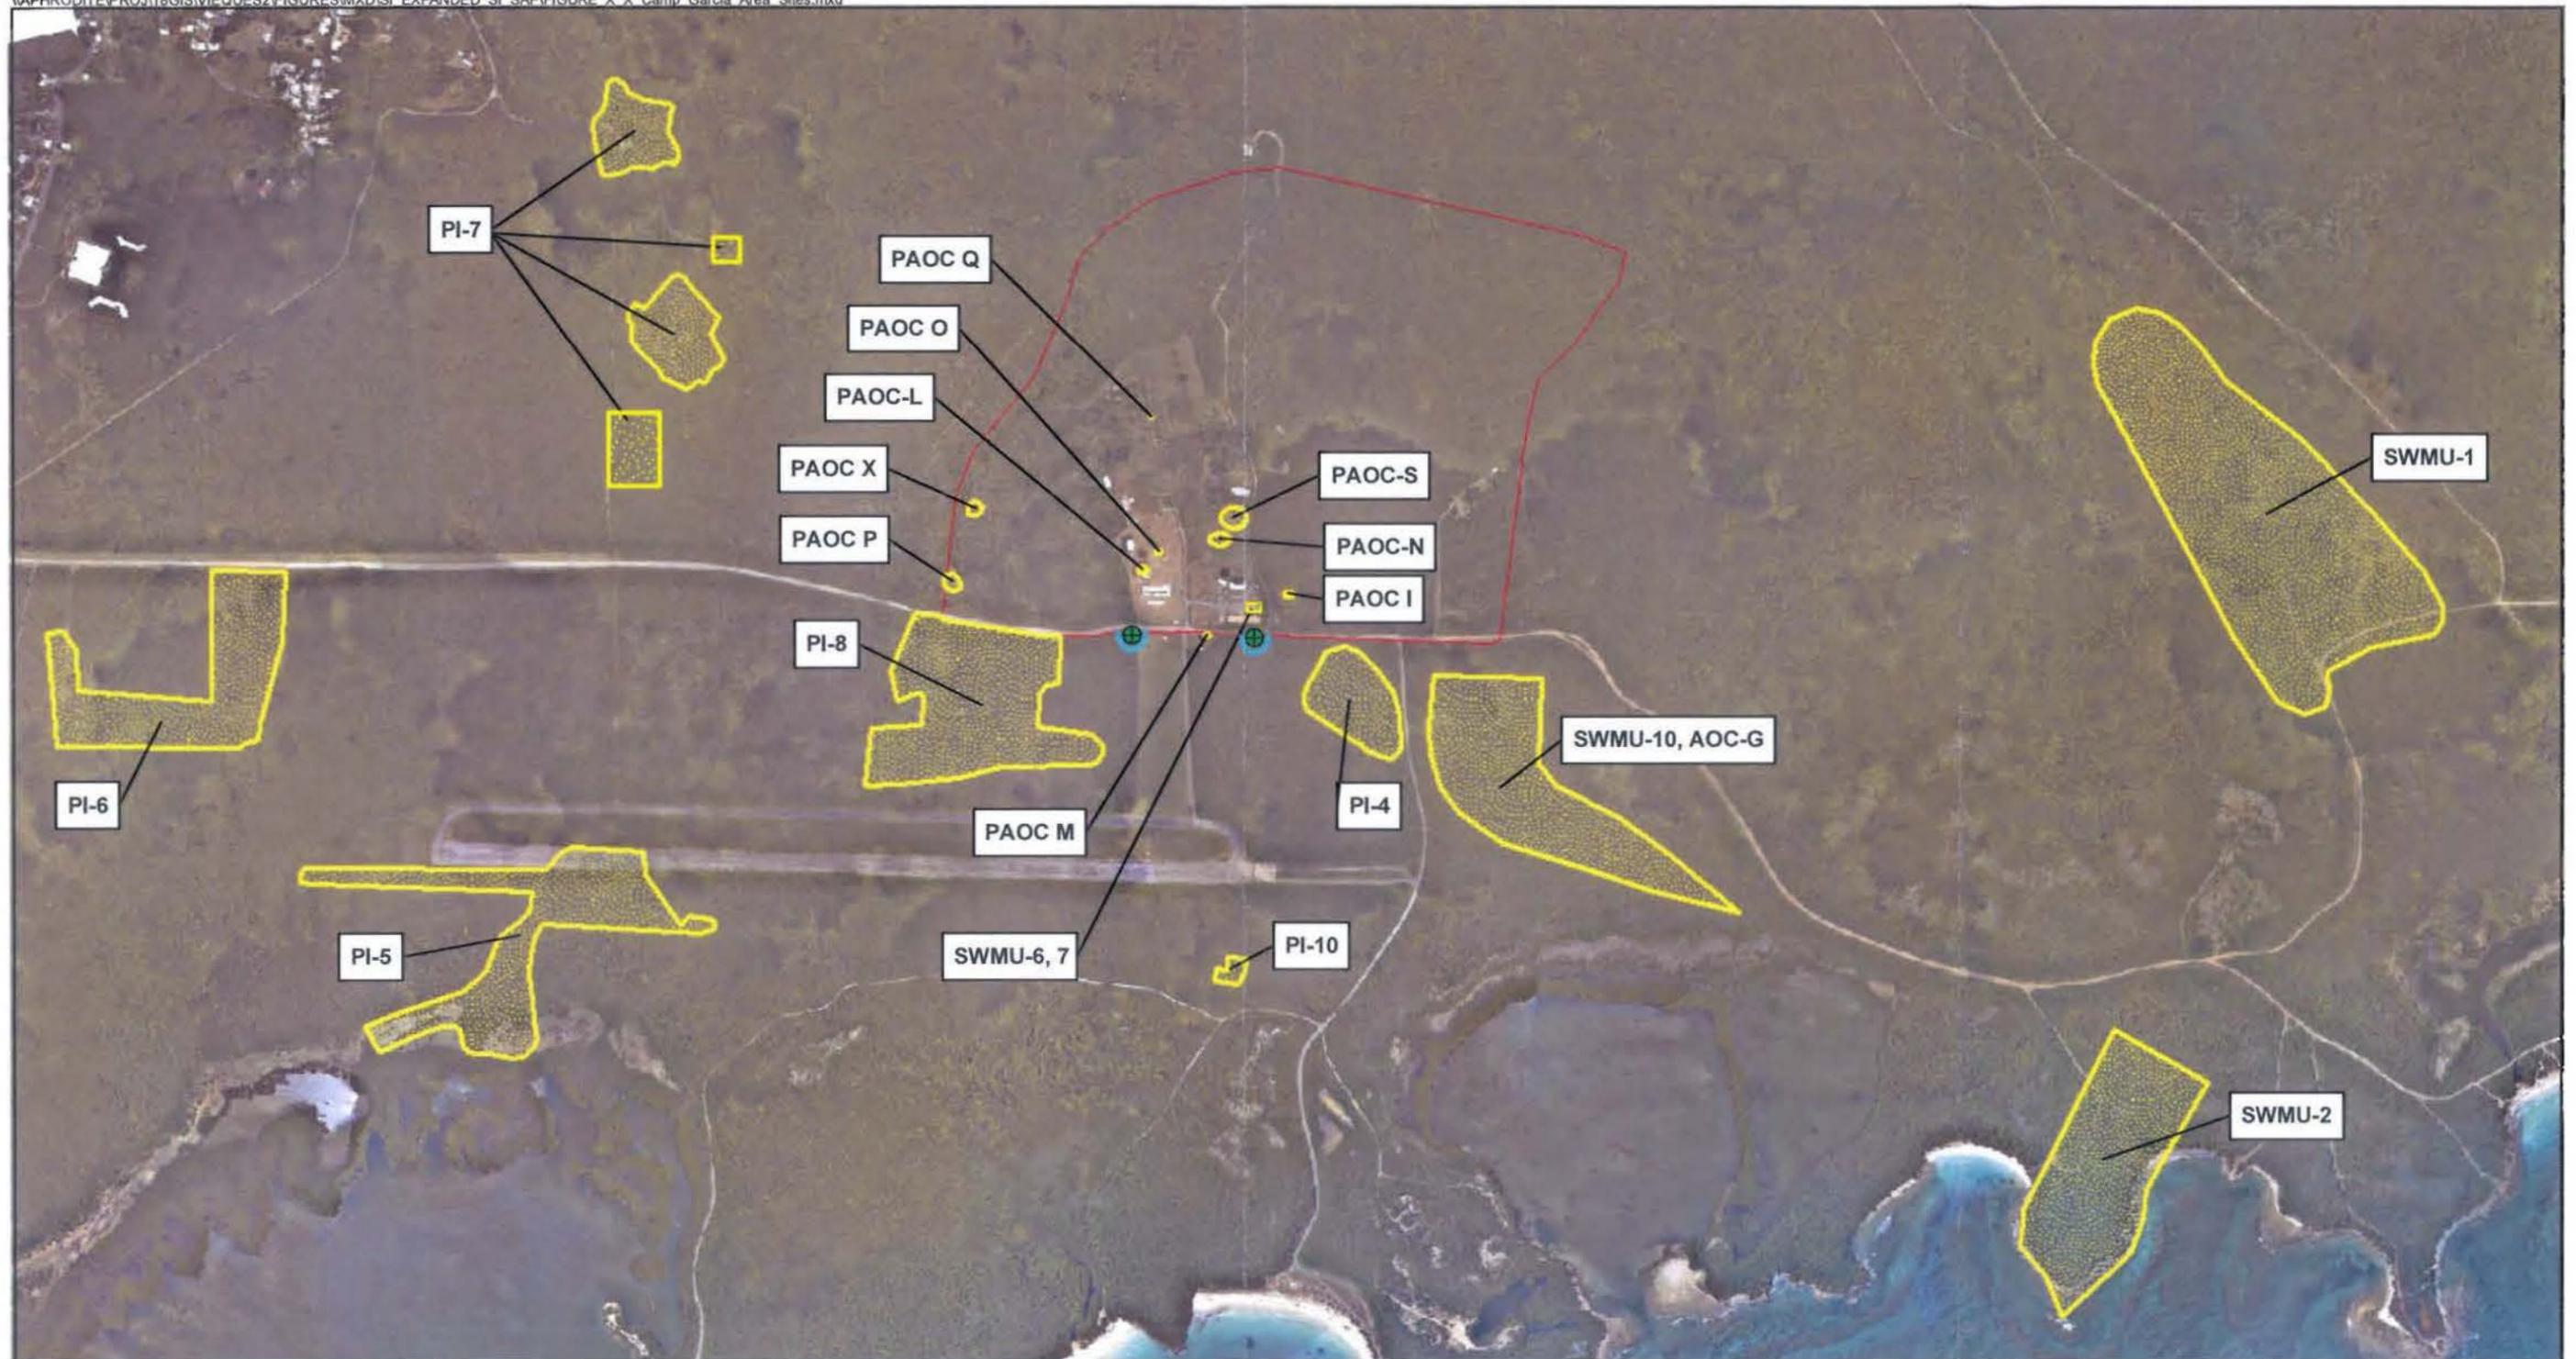
FIGURE 2
Camp Garcia Area Sites
SI/Expanded SI Sampling and Analysis Plan
Vieques, Puerto Rico

- Legend**
- Proposed Monitoring Well Location
 - Approximate Site Locations
 - Camp Garcia
 - Limits of Vegetation Clearing

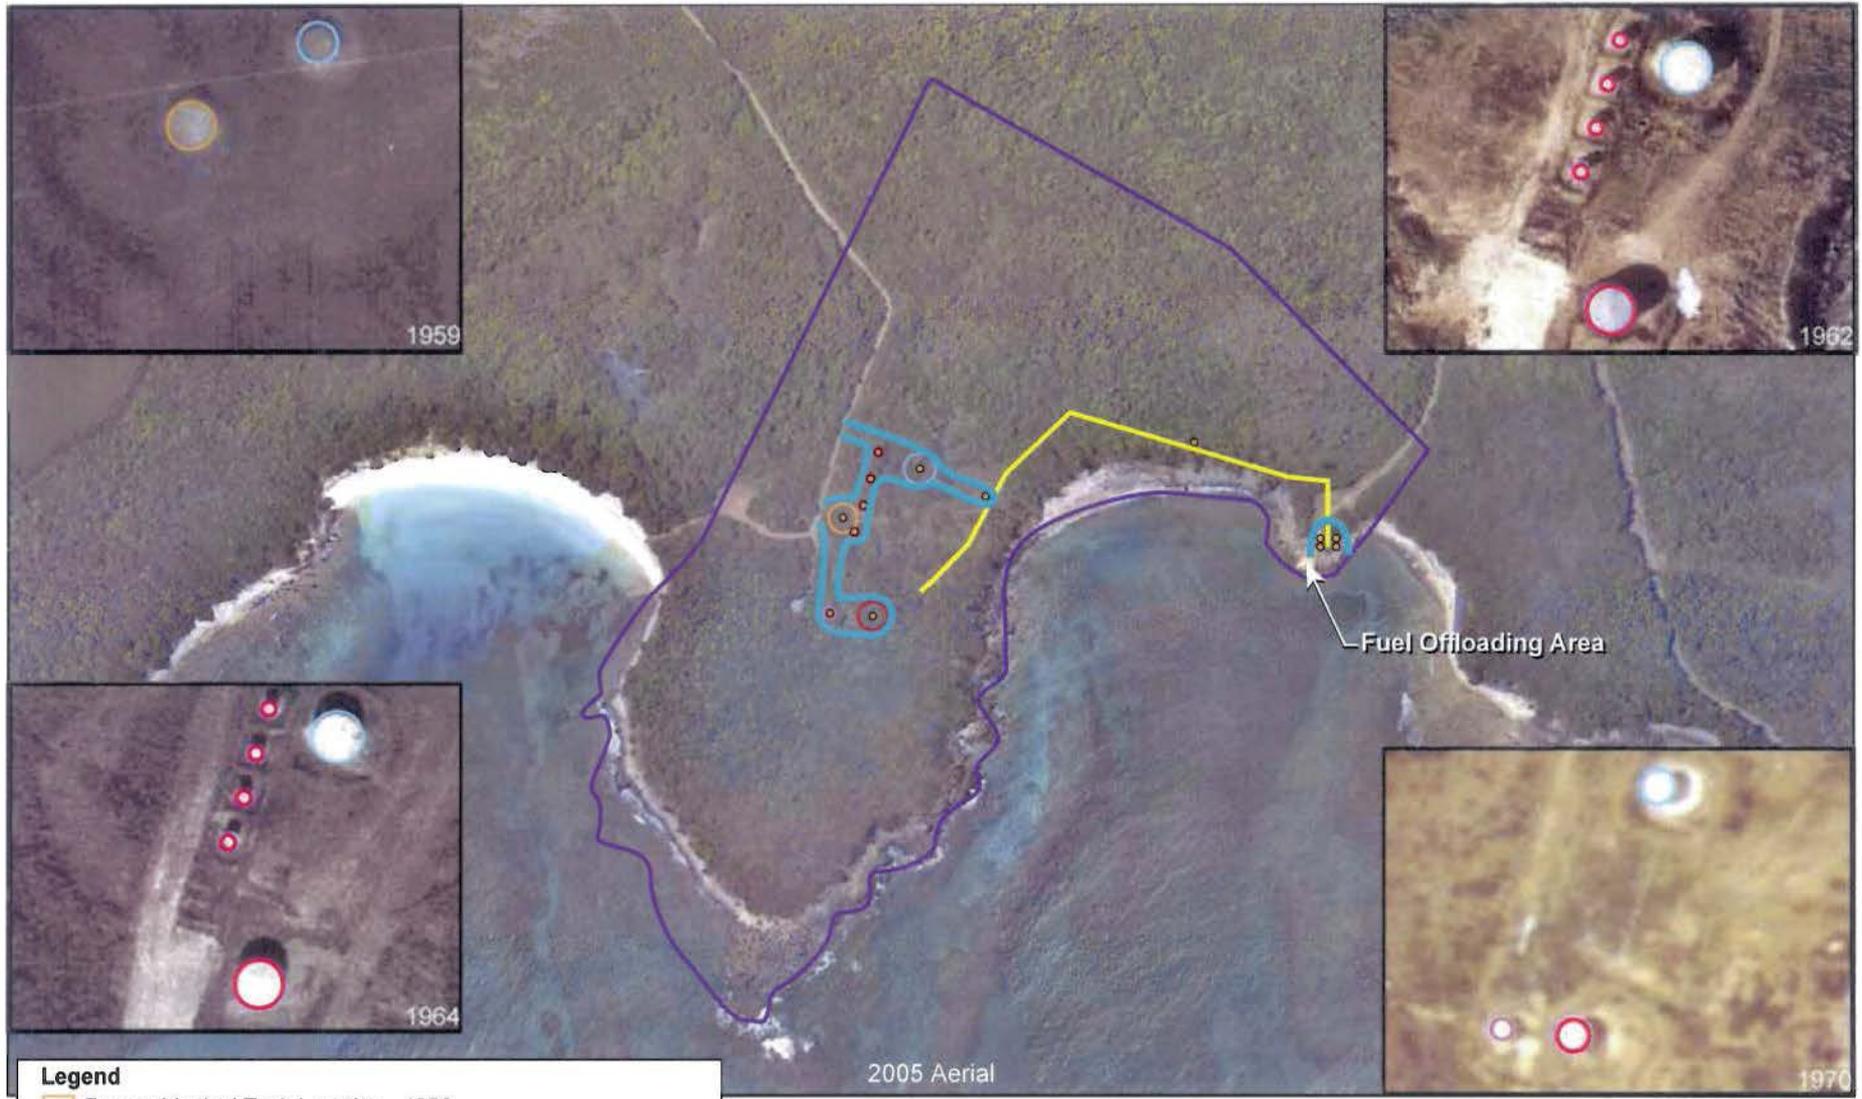
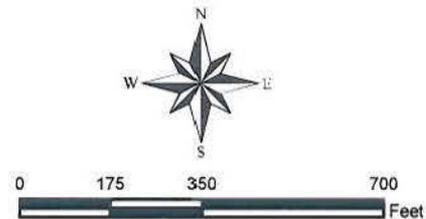
FIGURE 4
Composite Figure of Historical Tank Locations
and Proposed Sampling Locations, SWMU 2
SI/Expanded SI Sampling and Analysis Plan
Vieques, Puerto Rico

- Legend**
- Former Vertical Tank Location - 1959
 - Former Vertical Tank Location - 1970
 - Former Vertical Tank Location - 1959, 1962, 1964, and 1970
 - Former Vertical Tank Location - 1962, 1964, and 1970
 - SWMU, AOC Sites
 - Estimated Location of Buried Pipeline
 - Proposed Surface and Subsurface Soil Sample Location
 - Limits of Vegetation Clearing

Station ID	SWMU 2 – Fuels Offloading Site				
Station Coordinates (DD.MM.SS)					
Initial Site Visit Date					
Agency Site Visit Date					
Planned Site Investigation	Collect co located surface/subsurface soil samples beneath each of the eight former ASTs, two along the former pipeline, and four in the fuel offloading area. If contamination is observed or suspected during soil sampling, collect additional samples laterally to delineate source area and confer with regulatory agencies on the need for groundwater sampling.				
Mandatory Equipment for Investigation	Equipment	Clearance Width (ft)		Equipment	Clearance Width (ft)
Optional Equipment for Investigation	Equipment	Clearance Width (ft)		Equipment	Clearance Width (ft)
Important Environmental Elements Observed/Expected in Vicinity of Station	(Ephemeral Stream, Trees >3", Mangroves, Wetlands, Listed Species, Sale Flat, Lagoon)				
Recommended Sampling Equipment

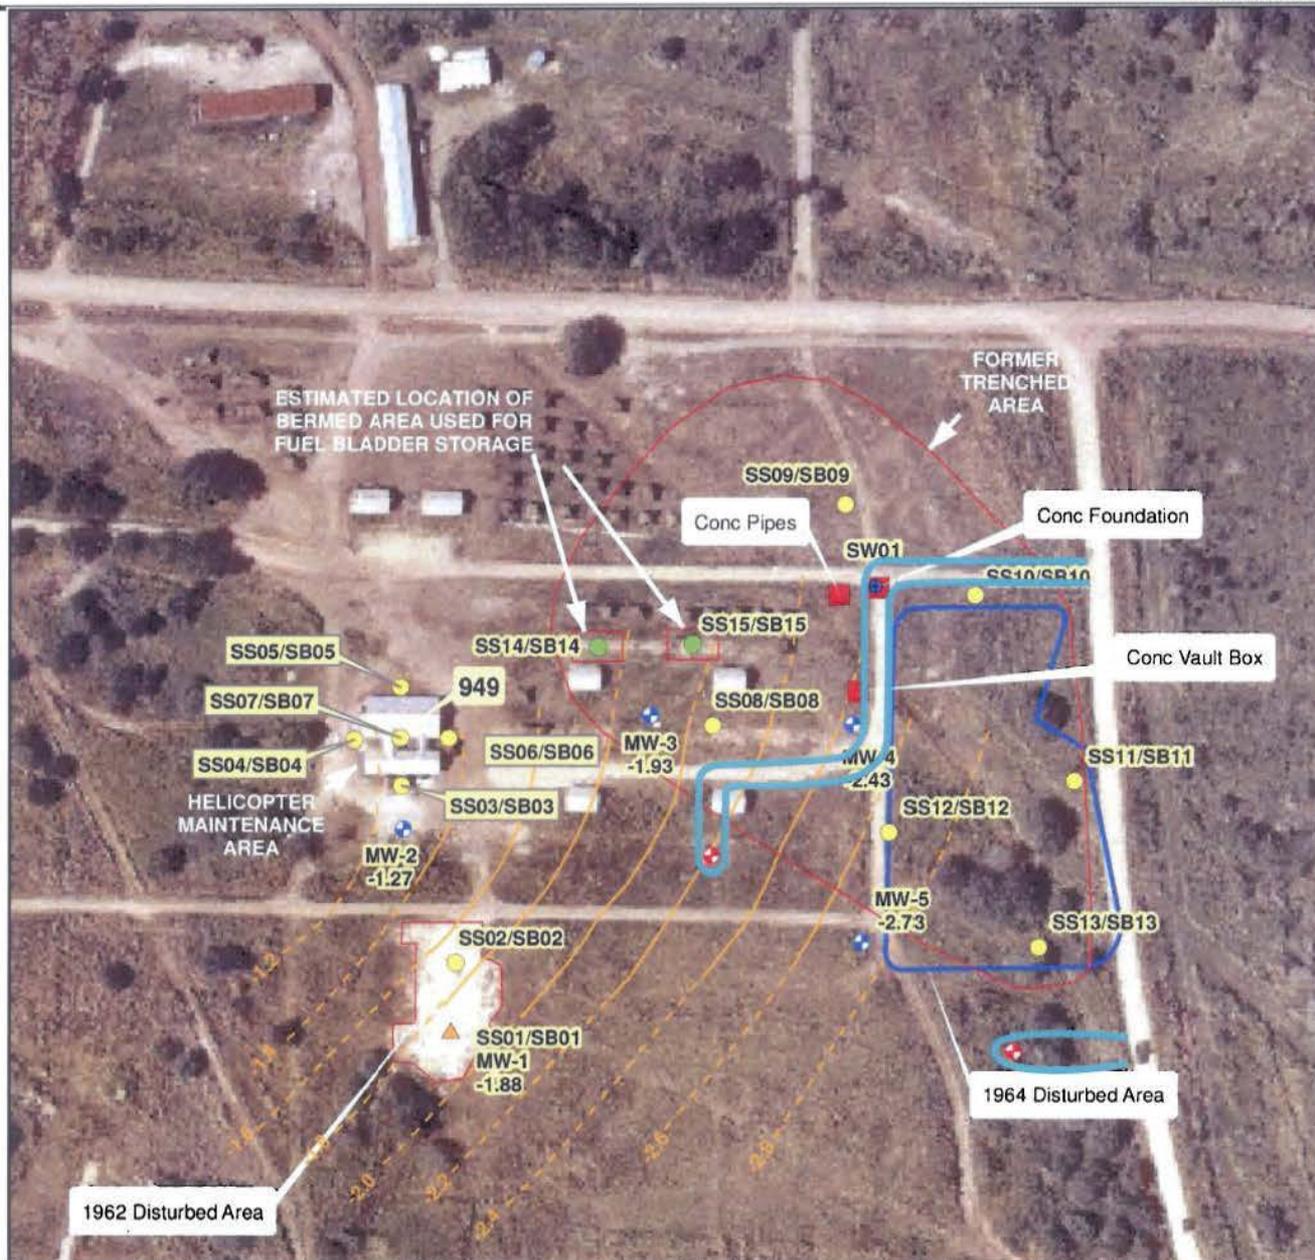
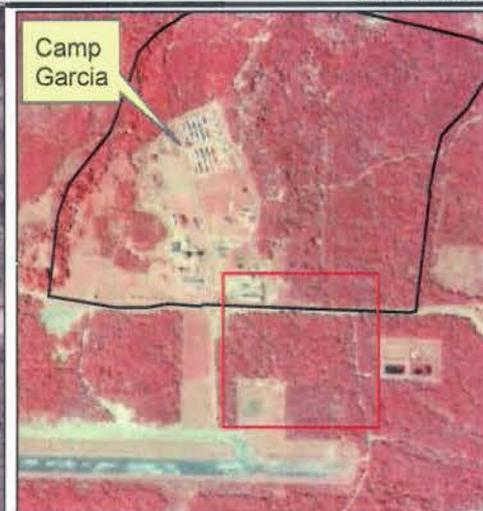
FIGURE 6
PI 4 Proposed Monitoring Well
SI/Expanded SI Sampling and Analysis Plan
Vieques, Puerto Rico

- PA/SI Monitoring Well Location With Water Elevation Feet Above Mean Sea Level
- Proposed Monitoring Well Location
- PA/SI Surface and Subsurface Soil Sample Location
- ▲ PA/SI Surface and Subsurface Soil Sample and Monitoring Well Location
- PA/SI Surface and Subsurface Soil Sample Location Co-located with EBS Surface Soil Sample Location
- PA/SI Surface Water Sample Location
- Concrete Pipes/Foundation Slab/Vault Box
- - - Estimated Peizometric Contours (dashed where inferred)
- Feature visible in 1964 Aerial Photograph
- Limits of Vegetation Clearing

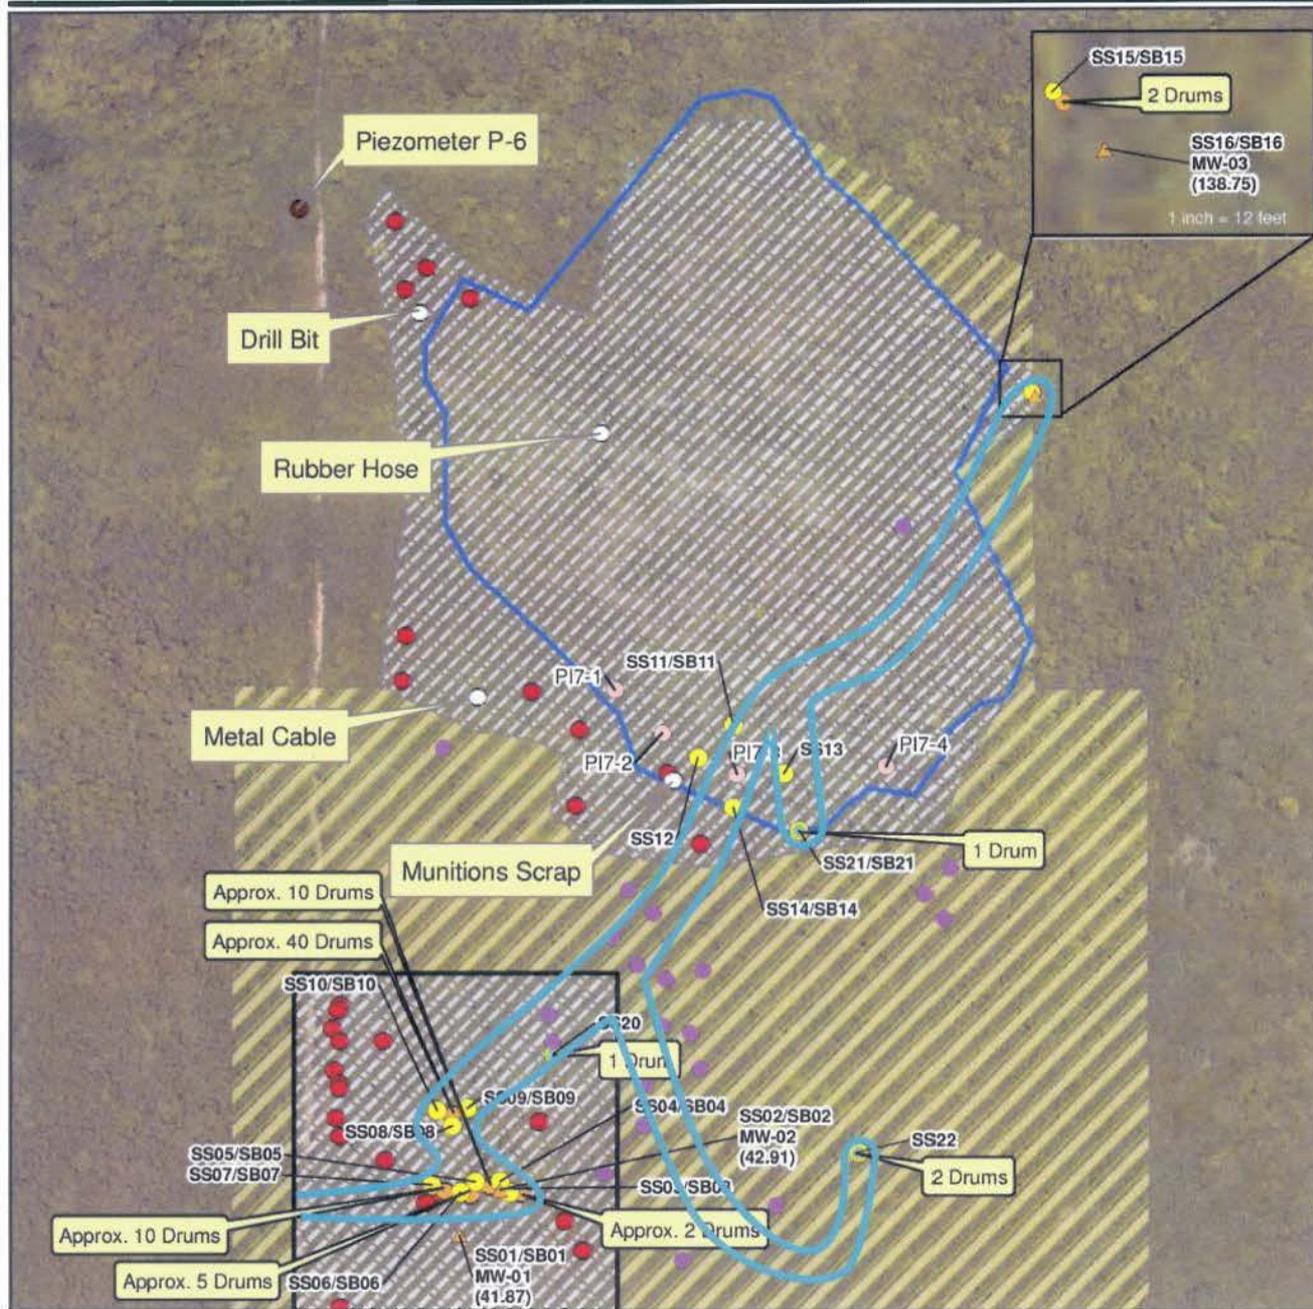
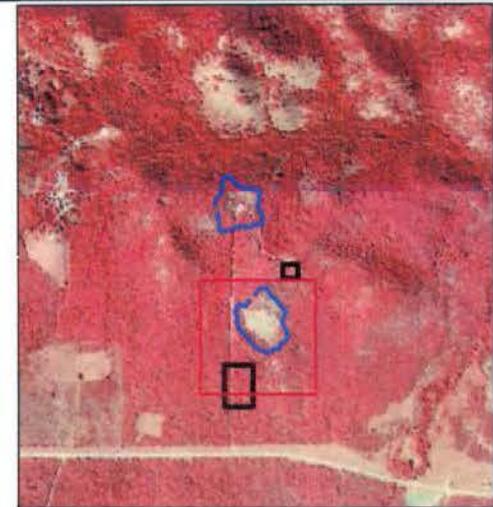
FIGURE 7
PI 7 Central Subsection -
Former Quarry
SI/Expanded SI Sampling and Analysis Plan
Vieques, Puerto Rico

- ▲ PA/SI Surface and Subsurface Soil Sample and Monitoring Well Location With Water Elevation, Feet Above Mean Sea Level
- PA/SI Subsurface and/or Surface Soil Sample Location
- Previously Installed Piezometer
- EBS Surface Soil Sample Location
- Drums Identified During 2005 Reconnaissance
- Drums Identified During 2006 Reconnaissance
- Metallic Sub-surface Anomalies Identified During 2005 Reconnaissance
- Surface Debris Identified During 2005 Reconnaissance
- Surface Debris Identified During 2006 Reconnaissance
- ▨ Area of August 2005 PA/SI Reconnaissance
- ▨ Area of March 2006 PA/SI Reconnaissance
- ▭ ERI Aerial Photo Analysis Area
- Limits of Vegetation Clearing

Station ID	PI 7 – Former Quarry, Tar Drum Disposal Area, and Radar Communication Area			
Station Coordinates (DD.MM.SS)				
Initial Site Visit Date				
Agency Site Visit Date				
Planned Site Investigation	Remove drums and collect confirmatory soil samples immediately beneath the drums.			
Mandatory Equipment for Investigation	Equipment	Clearance Width (ft)	Equipment	Clearance Width (ft)
Optional Equipment for Investigation	Equipment	Clearance Width (ft)	Equipment	Clearance Width (ft)
Important Environmental Elements Observed/Expected in Vicinity of Station	(Ephemeral Stream, Trees >3", Mangroves, Wetlands, Listed Species, Sale Flat, Lagoon)			
Recommended Sampling Equipment				
Recommended Clearing Method/Equipment				
Potentially Unavoidable Environmental Issues				
Additional Notes

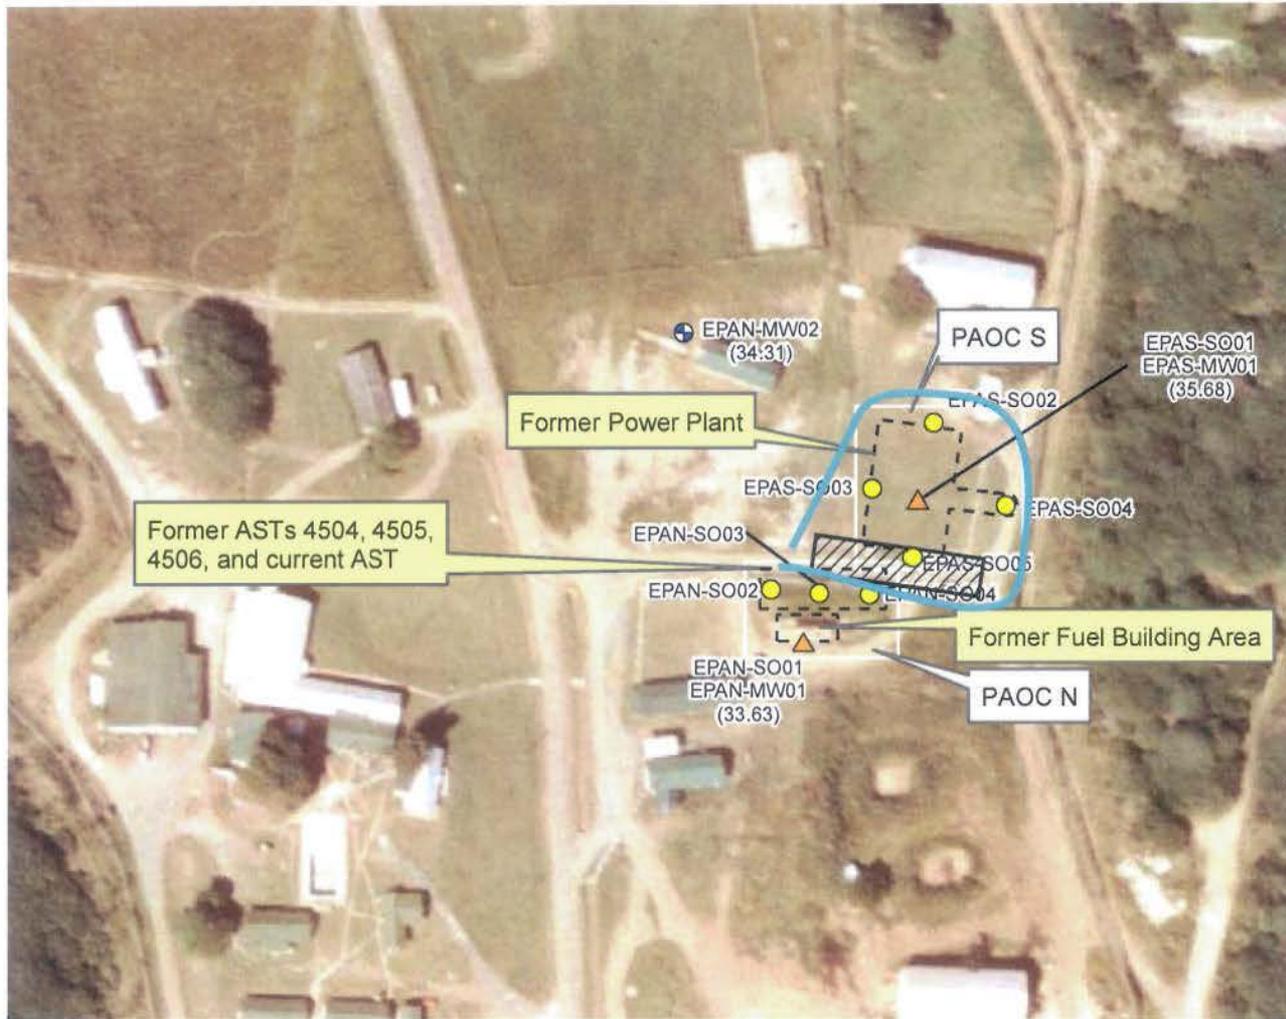
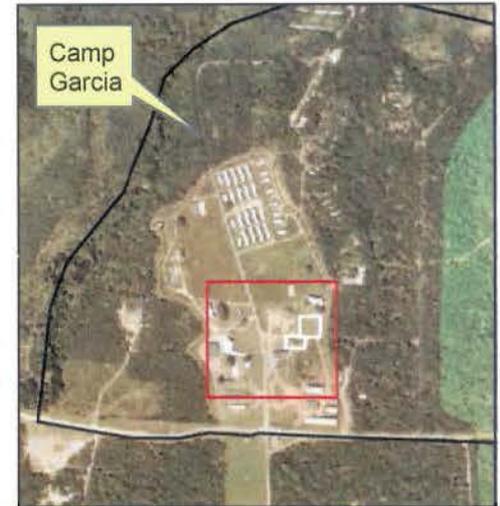
FIGURE 8
PAOCs N and S Geophysical Investigation,
1983 Aerial Photograph
SI/Expanded SI Sampling and Analysis Plan
Vieques, Puerto Rico

- ⊕ PA/SI Monitoring Well Location with Water Level Elevation, Feet Above Mean Sea Level
- PA/SI Surface and Subsurface Soil Sample Location
- ▲ PA/SI Surface and Subsurface Soil Sample and Monitoring Well Location with Water Level Elevation, Feet Above Mean Sea Level
- ▨ Proposed Area of Geophysical Investigation
- Limits of Vegetation Clearing

Station ID	PAOC N – Former Fuel Farm and Filling Station				
Station Coordinates (DD.MM.SS)					
Initial Site Visit Date					
Agency Site Visit Date					
Planned Site Investigation	Perform magnetic and electromagnetic surveys within area where underground pipeline would likely have traversed.				
Mandatory Equipment for Investigation	Equipment	Clearance Width (ft)		Equipment	Clearance Width (ft)
Optional Equipment for Investigation	Equipment	Clearance Width (ft)		Equipment	Clearance Width (ft)
Important Environmental Elements Observed/Expected in Vicinity of Station	(Ephemeral Stream, Trees >3", Mangroves, Wetlands, Listed Species, Sale Flat, Lagoon)				
Recommended Sampling Equipment					
Recommended Clearing Method/Equipment					
Potentially Unavoidable Environmental Issues					
Additional Notes

Station ID	PAOC S – Former Power Plant				
Station Coordinates (DD.MM.SS)					
Initial Site Visit Date					
Agency Site Visit Date					
Planned Site Investigation	Perform magnetic and electromagnetic surveys within area where underground pipeline would likely have traversed.				
Mandatory Equipment for Investigation	Equipment	Clearance Width (ft)		Equipment	Clearance Width (ft)
Optional Equipment for Investigation	Equipment	Clearance Width (ft)		Equipment	Clearance Width (ft)
Important Environmental Elements Observed/Expected in Vicinity of Station	(Ephemeral Stream, Trees >3", Mangroves, Wetlands, Listed Species, Sale Flat, Lagoon)				
Recommended Sampling Equipment					
Recommended Clearing Method/Equipment					
Potentially Unavoidable Environmental Issues					
Additional Notes

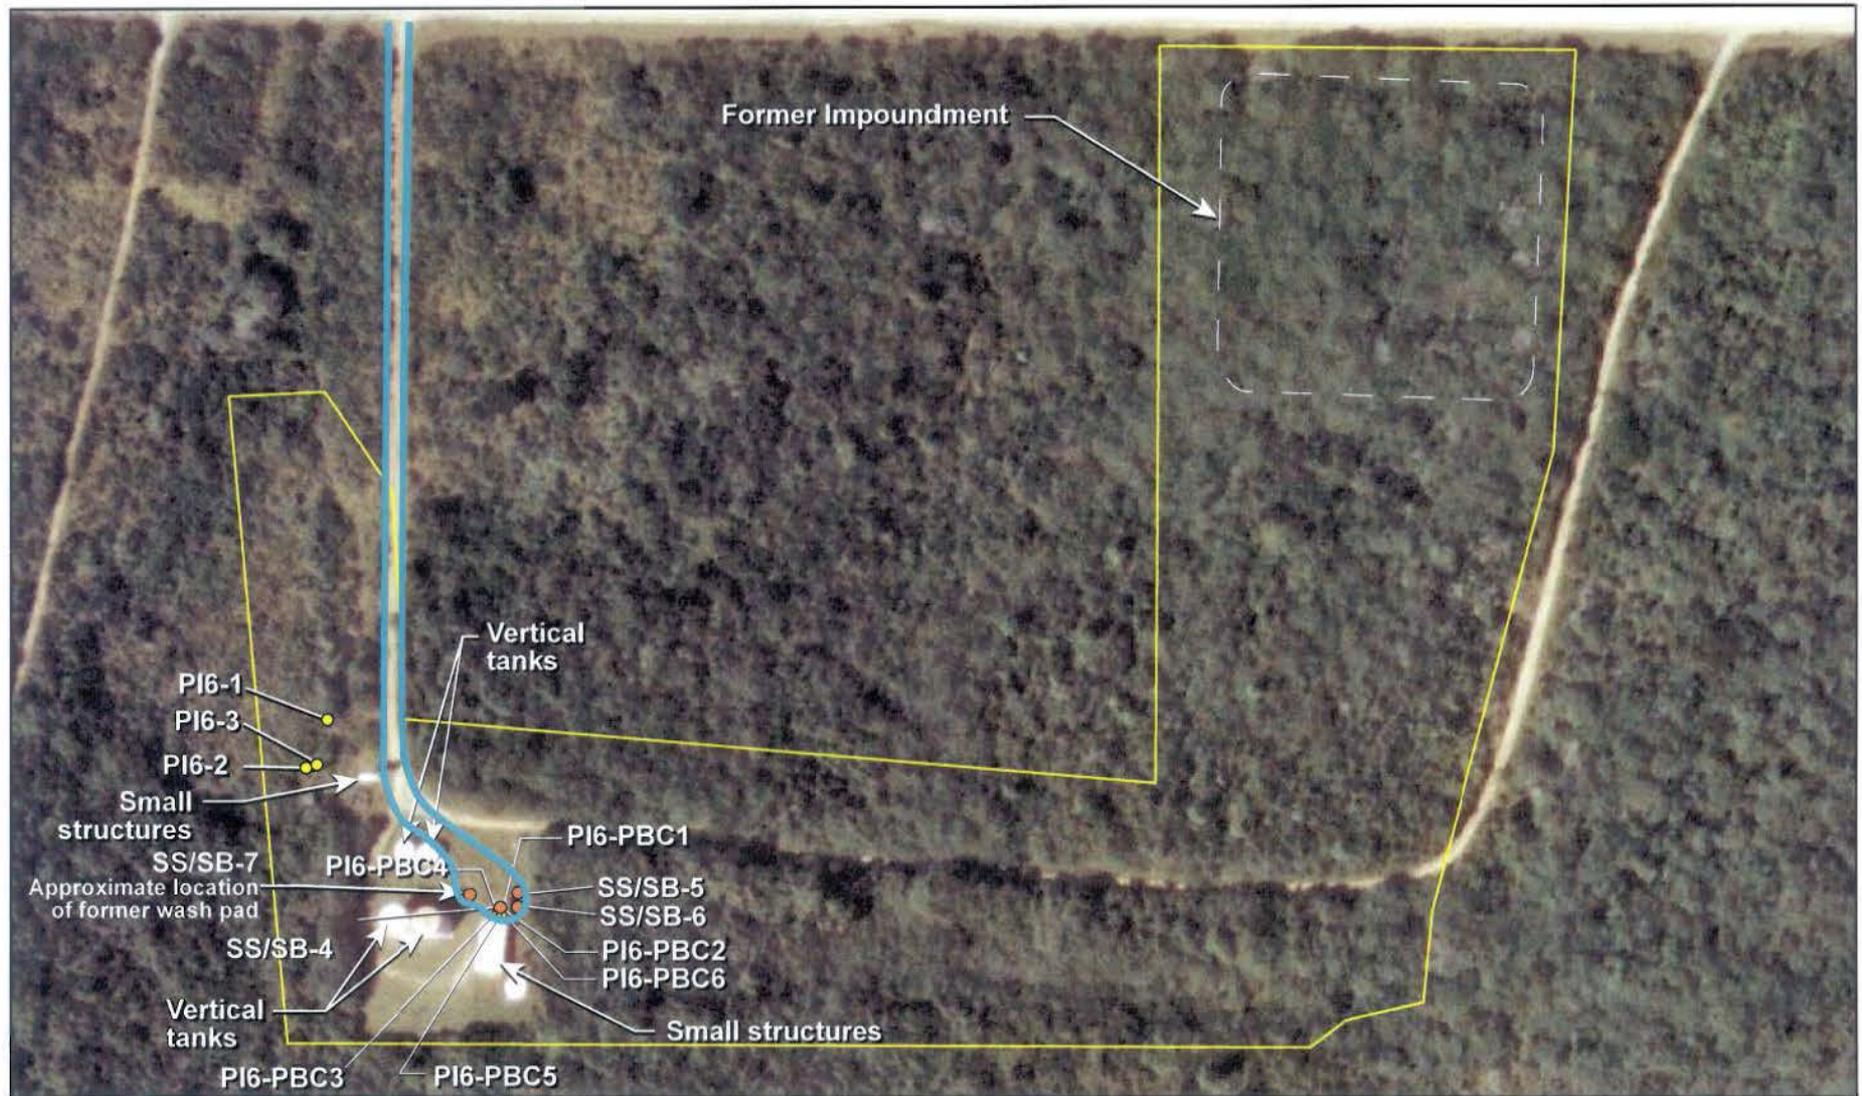
FIGURE 10
PI-6 1983 Aerial Photograph
SI/Expanded SI Sampling and Analysis Plan
Vieques, Puerto Rico

- PI-6
- Proposed Surface and Subsurface Sampling Locations
- EBS Surface Soil Sample Locations (PI6-1, 2, 3)
- EBS PCB Wipe Sample Locations (PBC1-6)
- Limits of Vegetation Clearing

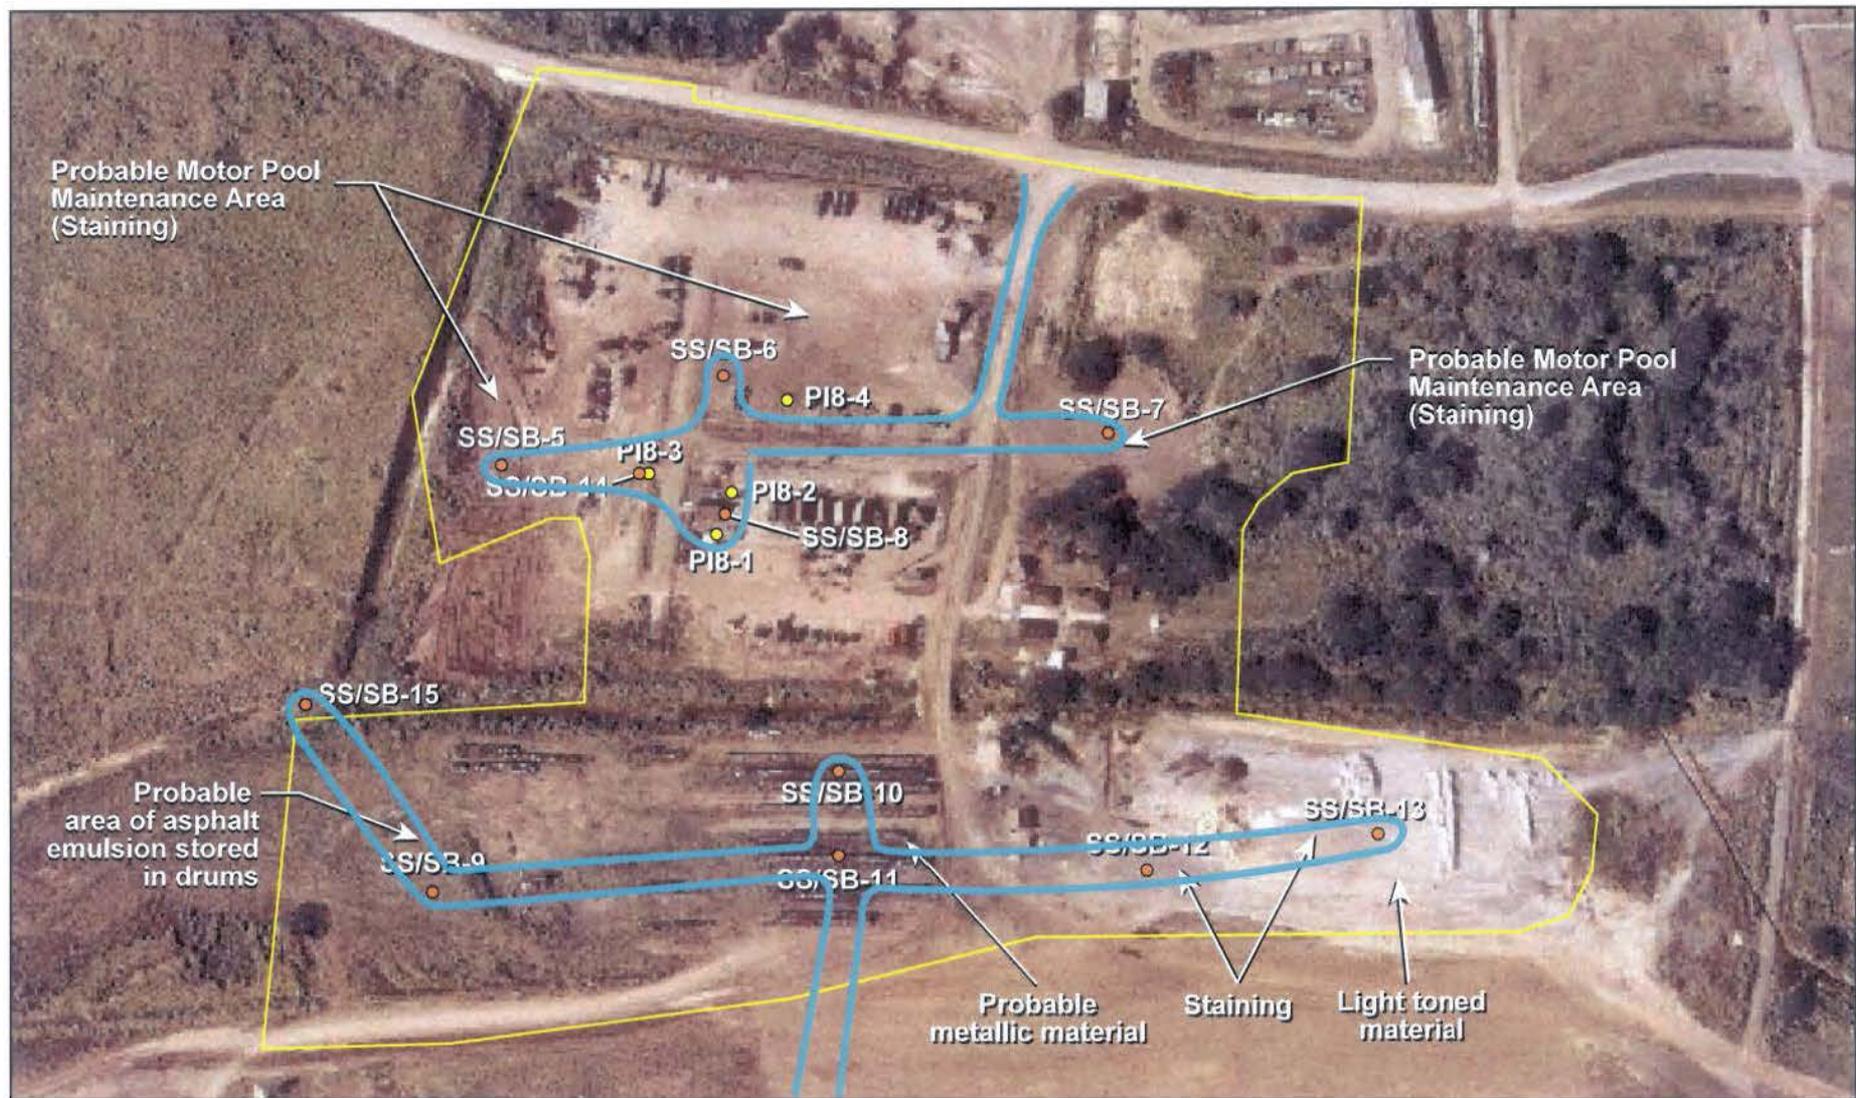
FIGURE 11
PI-8 Sample Locations,
1962 Aerial Photograph
SI/Expanded SI Sampling and Analysis Plan
Vieques, Puerto Rico

- PI-8
- EBS Surface Soil Sample Locations
- Proposed Surface and Subsurface Sampling Locations
- Limits of Vegetation Clearing

- Open storage of vehicles
- Equipment and multi-colored materials (some probably metallic)
- Heavy staining noted south of probable maintenance buildings

Station ID	PI 8 – Former Motor Pool Maintenance Area			
Station Coordinates (DD.MM.SS)				
Initial Site Visit Date				
Agency Site Visit Date				
Planned Site Investigation	Collect co-located surface/subsurface soil samples from the motor pool maintenance area (five locations); asphalt emulsion drum storage area, if drums are found using a metal detector (one location); metallic, multi-colored material area (two locations); light-toned material area (two locations); and drainage ditch adjacent to the maintenance area (one location).			
Mandatory Equipment for Investigation	Equipment	Clearance Width (ft)	Equipment	Clearance Width (ft)
Optional Equipment for Investigation	Equipment	Clearance Width (ft)	Equipment	Clearance Width (ft)
Important Environmental Elements Observed/Expected in Vicinity of Station	(Ephemeral Stream, Trees >3", Mangroves, Wetlands, Listed Species, Sale Flat, Lagoon)			
Recommended Sampling Equipment

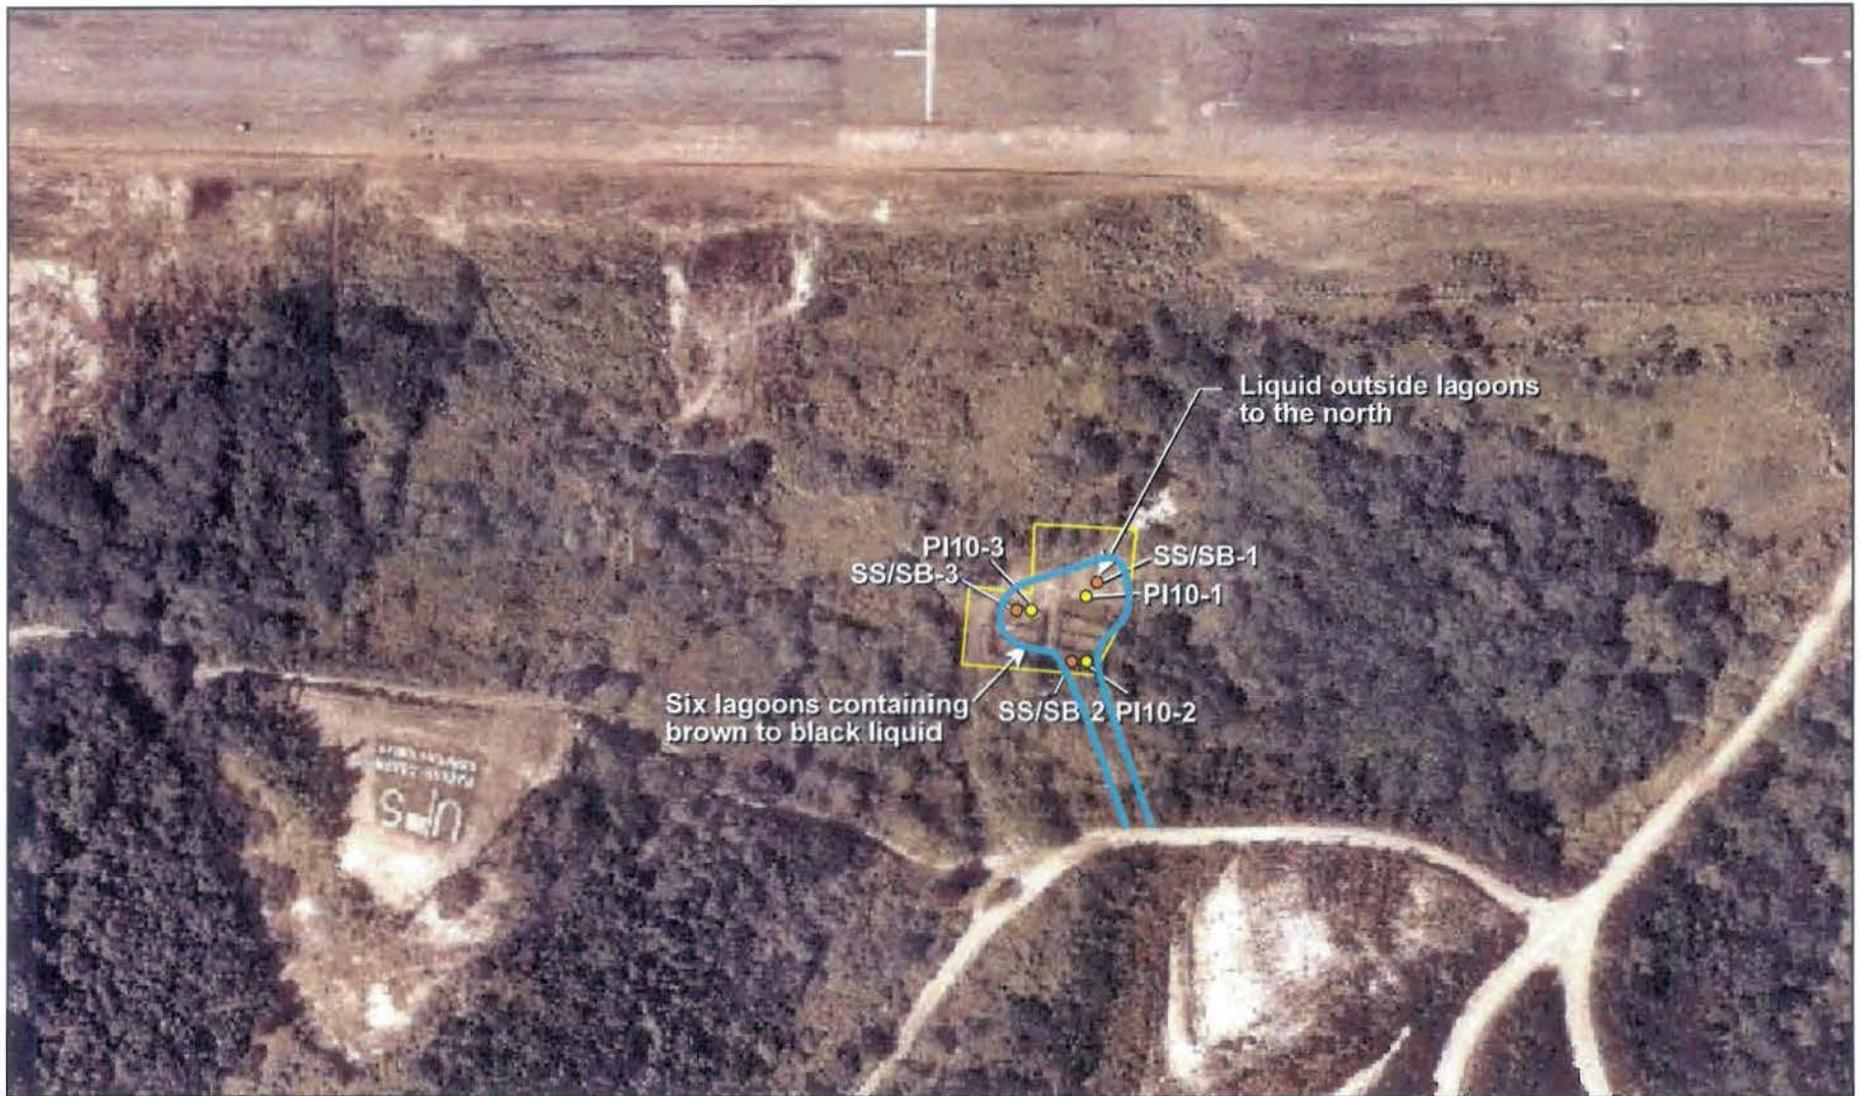
FIGURE 12
PI-10 Sample Locations,
1962 Aerial Photograph
SI/Expanded SI Sampling and Analysis Plan
Vieques, Puerto Rico

- PI-10
- EBS Surface Soil Sample Locations
- Proposed Surface and Subsurface Soil Sample Locations
- Limits of Vegetation Clearing

Station ID	PI 10 – Former Wastewater Leach Field			
Station Coordinates (DD.MM.SS)				
Initial Site Visit Date				
Agency Site Visit Date				
Planned Site Investigation	Collect co-located surface/subsurface soil samples from approximately the same three locations sampled in 2002.			
Mandatory Equipment for Investigation	Equipment	Clearance Width (ft)	Equipment	Clearance Width (ft)
Optional Equipment for Investigation	Equipment	Clearance Width (ft)	Equipment	Clearance Width (ft)
Important Environmental Elements Observed/Expected in Vicinity of Station	(Ephemeral Stream, Trees >3", Mangroves, Wetlands, Listed Species, Sale Flat, Lagoon)			
Recommended Sampling Equipment				
Recommended Clearing Method/Equipment				
Potentially Unavoidable Environmental Issues				
Additional Notes

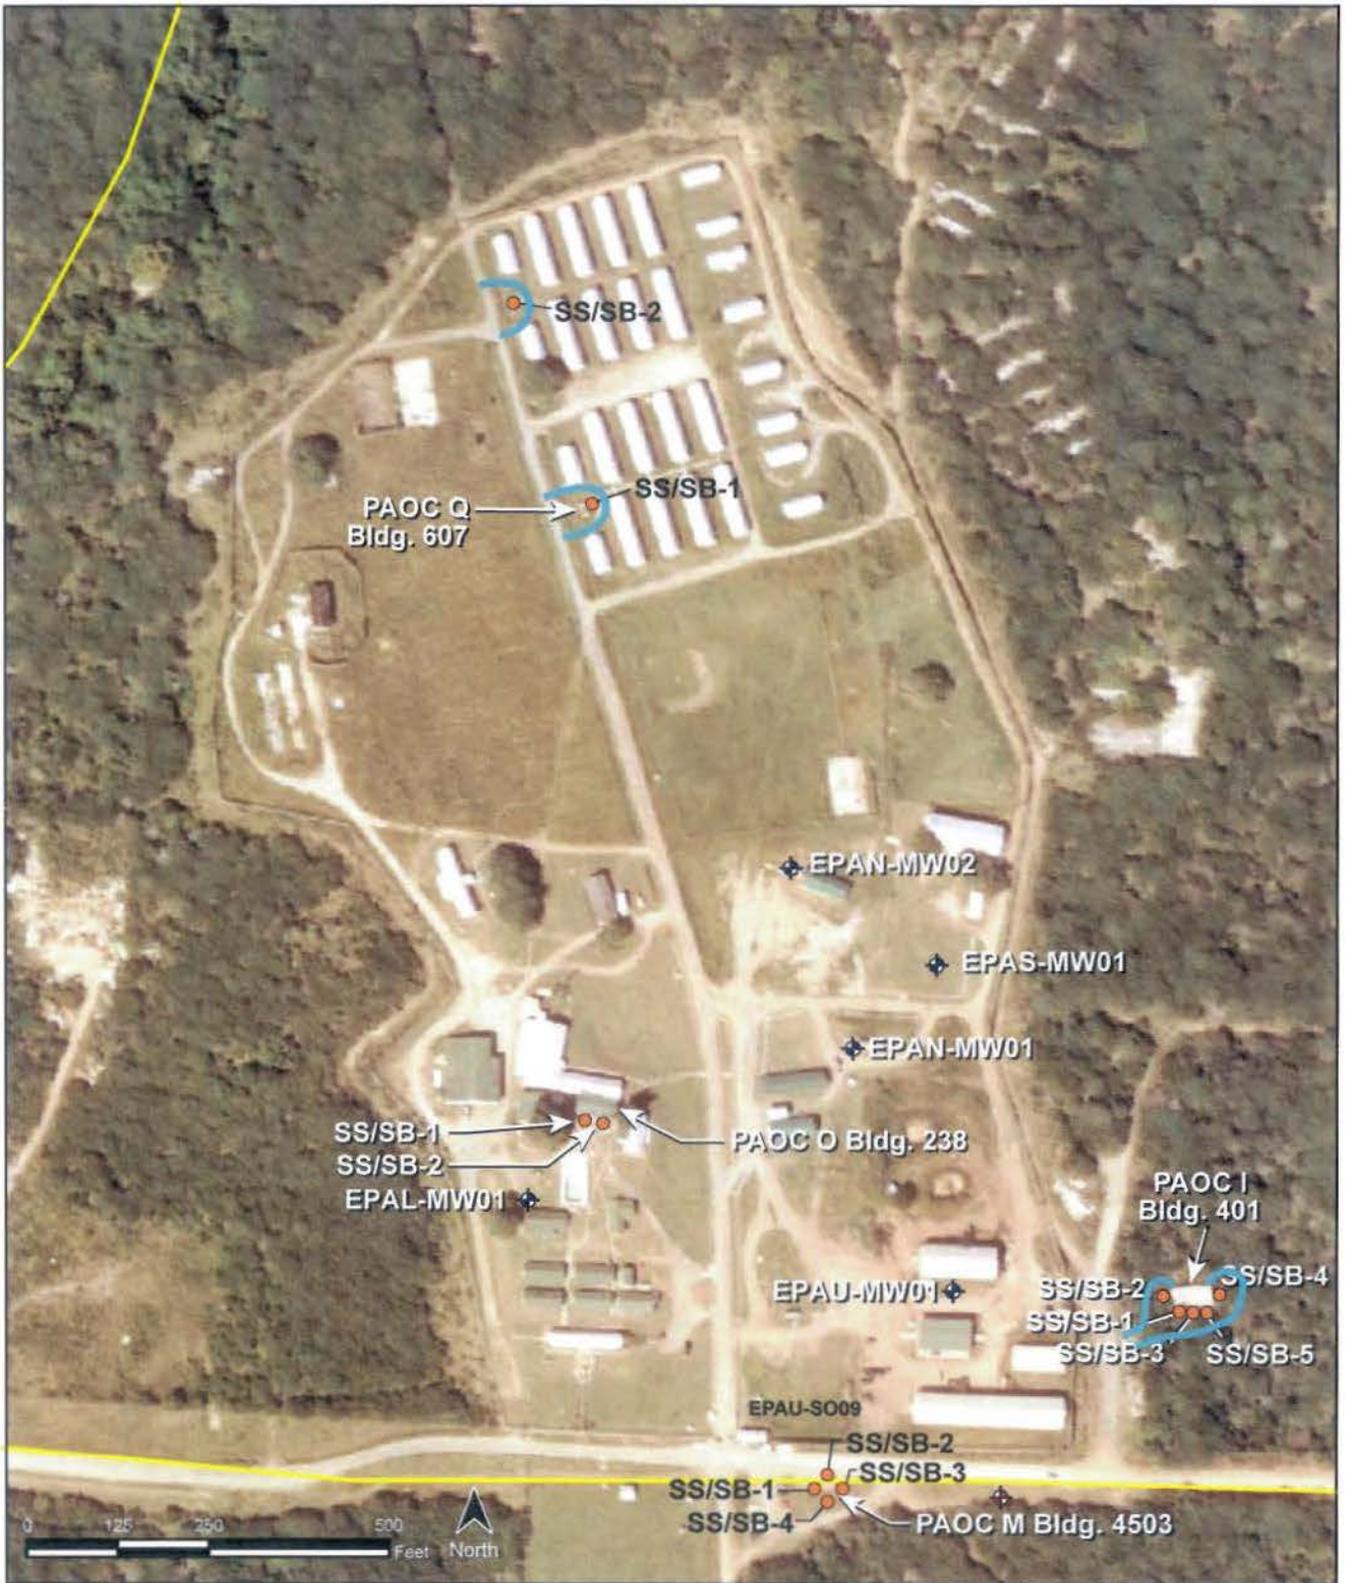
FIGURE 13
PAOCs I, M, O and Q Sample Locations,
1983 Aerial Photograph
SI/Expanded SI Sampling and Analysis Plan
Vieques, Puerto Rico

- Camp Garcia Area
- EBS Surface Soil Sample Location
- Proposed Surface and Subsurface Sampling Locations
- ◆ Monitoring Wells installed during the PA/SI
- ◆ Proposed Monitoring Well
- PAOC U Surface and Subsurface Sample Locations (PA/SI)
- Limits of Vegetation Clearing

Station ID	PAOC I – Former Power Plant and Mechanics Shop			
Station Coordinates (DD.MM.SS)				
Initial Site Visit Date				
Agency Site Visit Date				
Planned Site Investigation	Collect co-located surface/subsurface soil samples around building (one set adjacent to each door and pipe penetration).			
Mandatory Equipment for Investigation	Equipment	Clearance Width (ft)	Equipment	Clearance Width (ft)
Optional Equipment for Investigation	Equipment	Clearance Width (ft)	Equipment	Clearance Width (ft)
Important Environmental Elements Observed/Expected in Vicinity of Station	(Ephemeral Stream, Trees >3", Mangroves, Wetlands, Listed Species, Sale Flat, Lagoon)			
Recommended Sampling Equipment				
Recommended Clearing Method/Equipment				
Potentially Unavoidable Environmental Issues				
Additional Notes
