**Re: VEGETATION CLEARANCE ECOLOGICAL FIELD SURVEY METHODOLOGY
COMPREHENSIVE LIABILITY ENVIRONMENTAL ACTION NAVY (CLEAN)
PROGRAM SITE INSPECTION /EXPANDED SITE INSPECTION 7 CONSENT
ORDER AND 15 PI / PAOC SITES**

SI/Expanded SI Preliminary Vegetation Clearance Mapping

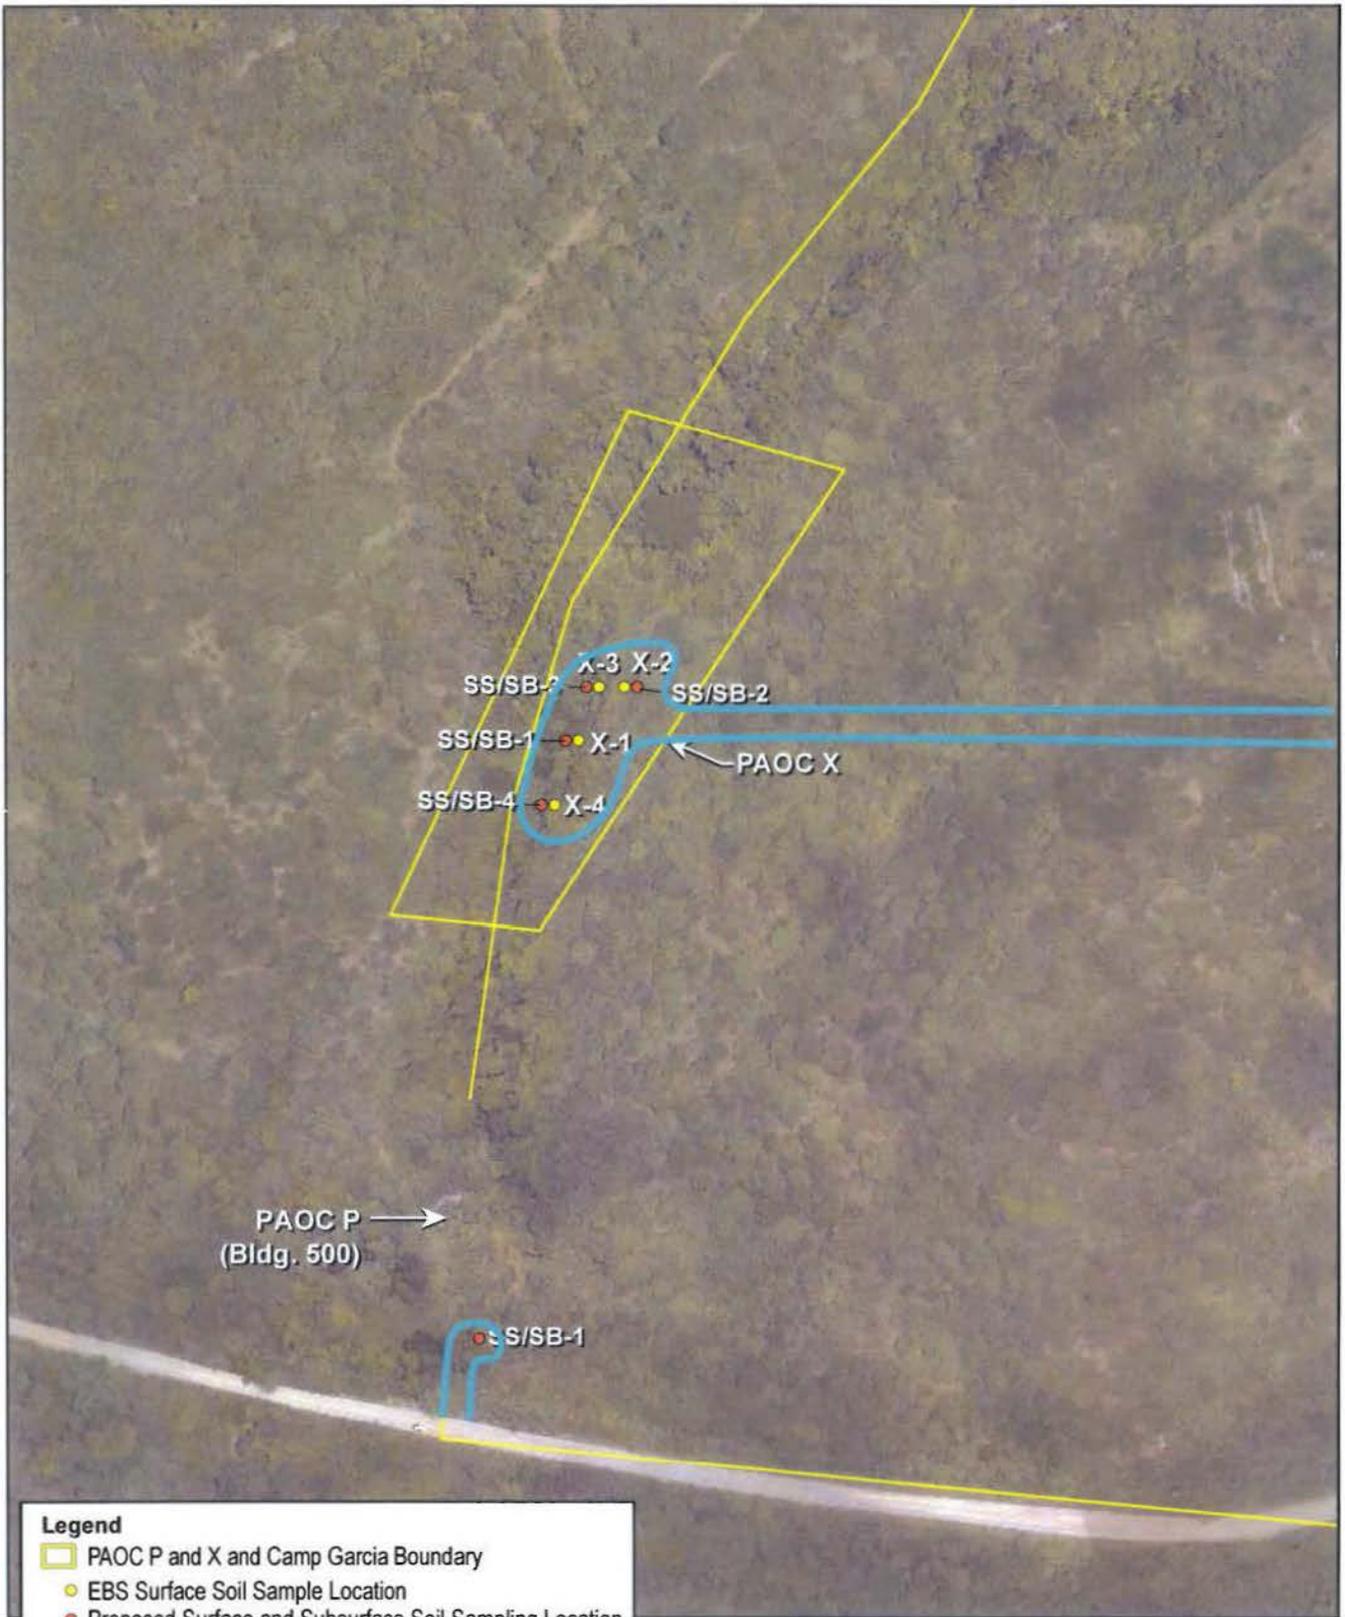
- PAOC P and X and Camp Garcia Boundary
- EBS Surface Soil Sample Location
- Proposed Surface and Subsurface Soil Sampling Location
- Limits of Vegetation Clearing

Station ID	PAOC P – Former Water Treatment Pumphouse				
Station Coordinates (DD.MM.SS)					
Initial Site Visit Date					
Agency Site Visit Date					
Planned Site Investigation	Collect a co-located surface/subsurface soil sample beneath the mobile generator.				
Mandatory Equipment for Investigation	Equipment	Clearance Width (ft)		Equipment	Clearance Width (ft)
Optional Equipment for Investigation	Equipment	Clearance Width (ft)		Equipment	Clearance Width (ft)
Important Environmental Elements Observed/Expected in Vicinity of Station	(Ephemeral Stream, Trees >3", Mangroves, Wetlands, Listed Species, Sale Flat, Lagoon)				
Recommended Sampling Equipment					
Recommended Clearing Method/Equipment					
Potentially Unavoidable Environmental Issues					
Additional Notes

Station ID	PAOC X – Debris Area in Ephemeral Stream			
Station Coordinates (DD.MM.SS)				
Initial Site Visit Date				
Agency Site Visit Date				
Planned Site Investigation	Remove debris and collect confirmatory soil samples from four locations immediately beneath the debris.			
Mandatory Equipment for Investigation	Equipment	Clearance Width (ft)	Equipment	Clearance Width (ft)
Optional Equipment for Investigation	Equipment	Clearance Width (ft)	Equipment	Clearance Width (ft)
Important Environmental Elements Observed/Expected in Vicinity of Station	(Ephemeral Stream, Trees >3", Mangroves, Wetlands, Listed Species, Sale Flat, Lagoon)			
Recommended Sampling Equipment				
Recommended Clearing Method/Equipment				
Potentially Unavoidable Environmental Issues				
Additional Notes
