# Final Remedial Investigation Status Report and Path Forward, UXO 15, Atlantic Fleet Weapons Training Area-Vieques, Former Vieques Naval Training Range, Vieques, Puerto Rico

PREPARED FOR: Vieques Environmental Restoration Program Technical Subcommittee  
PREPARED BY: CH2M HILL on behalf of the Navy  
DATE: May 23, 2014

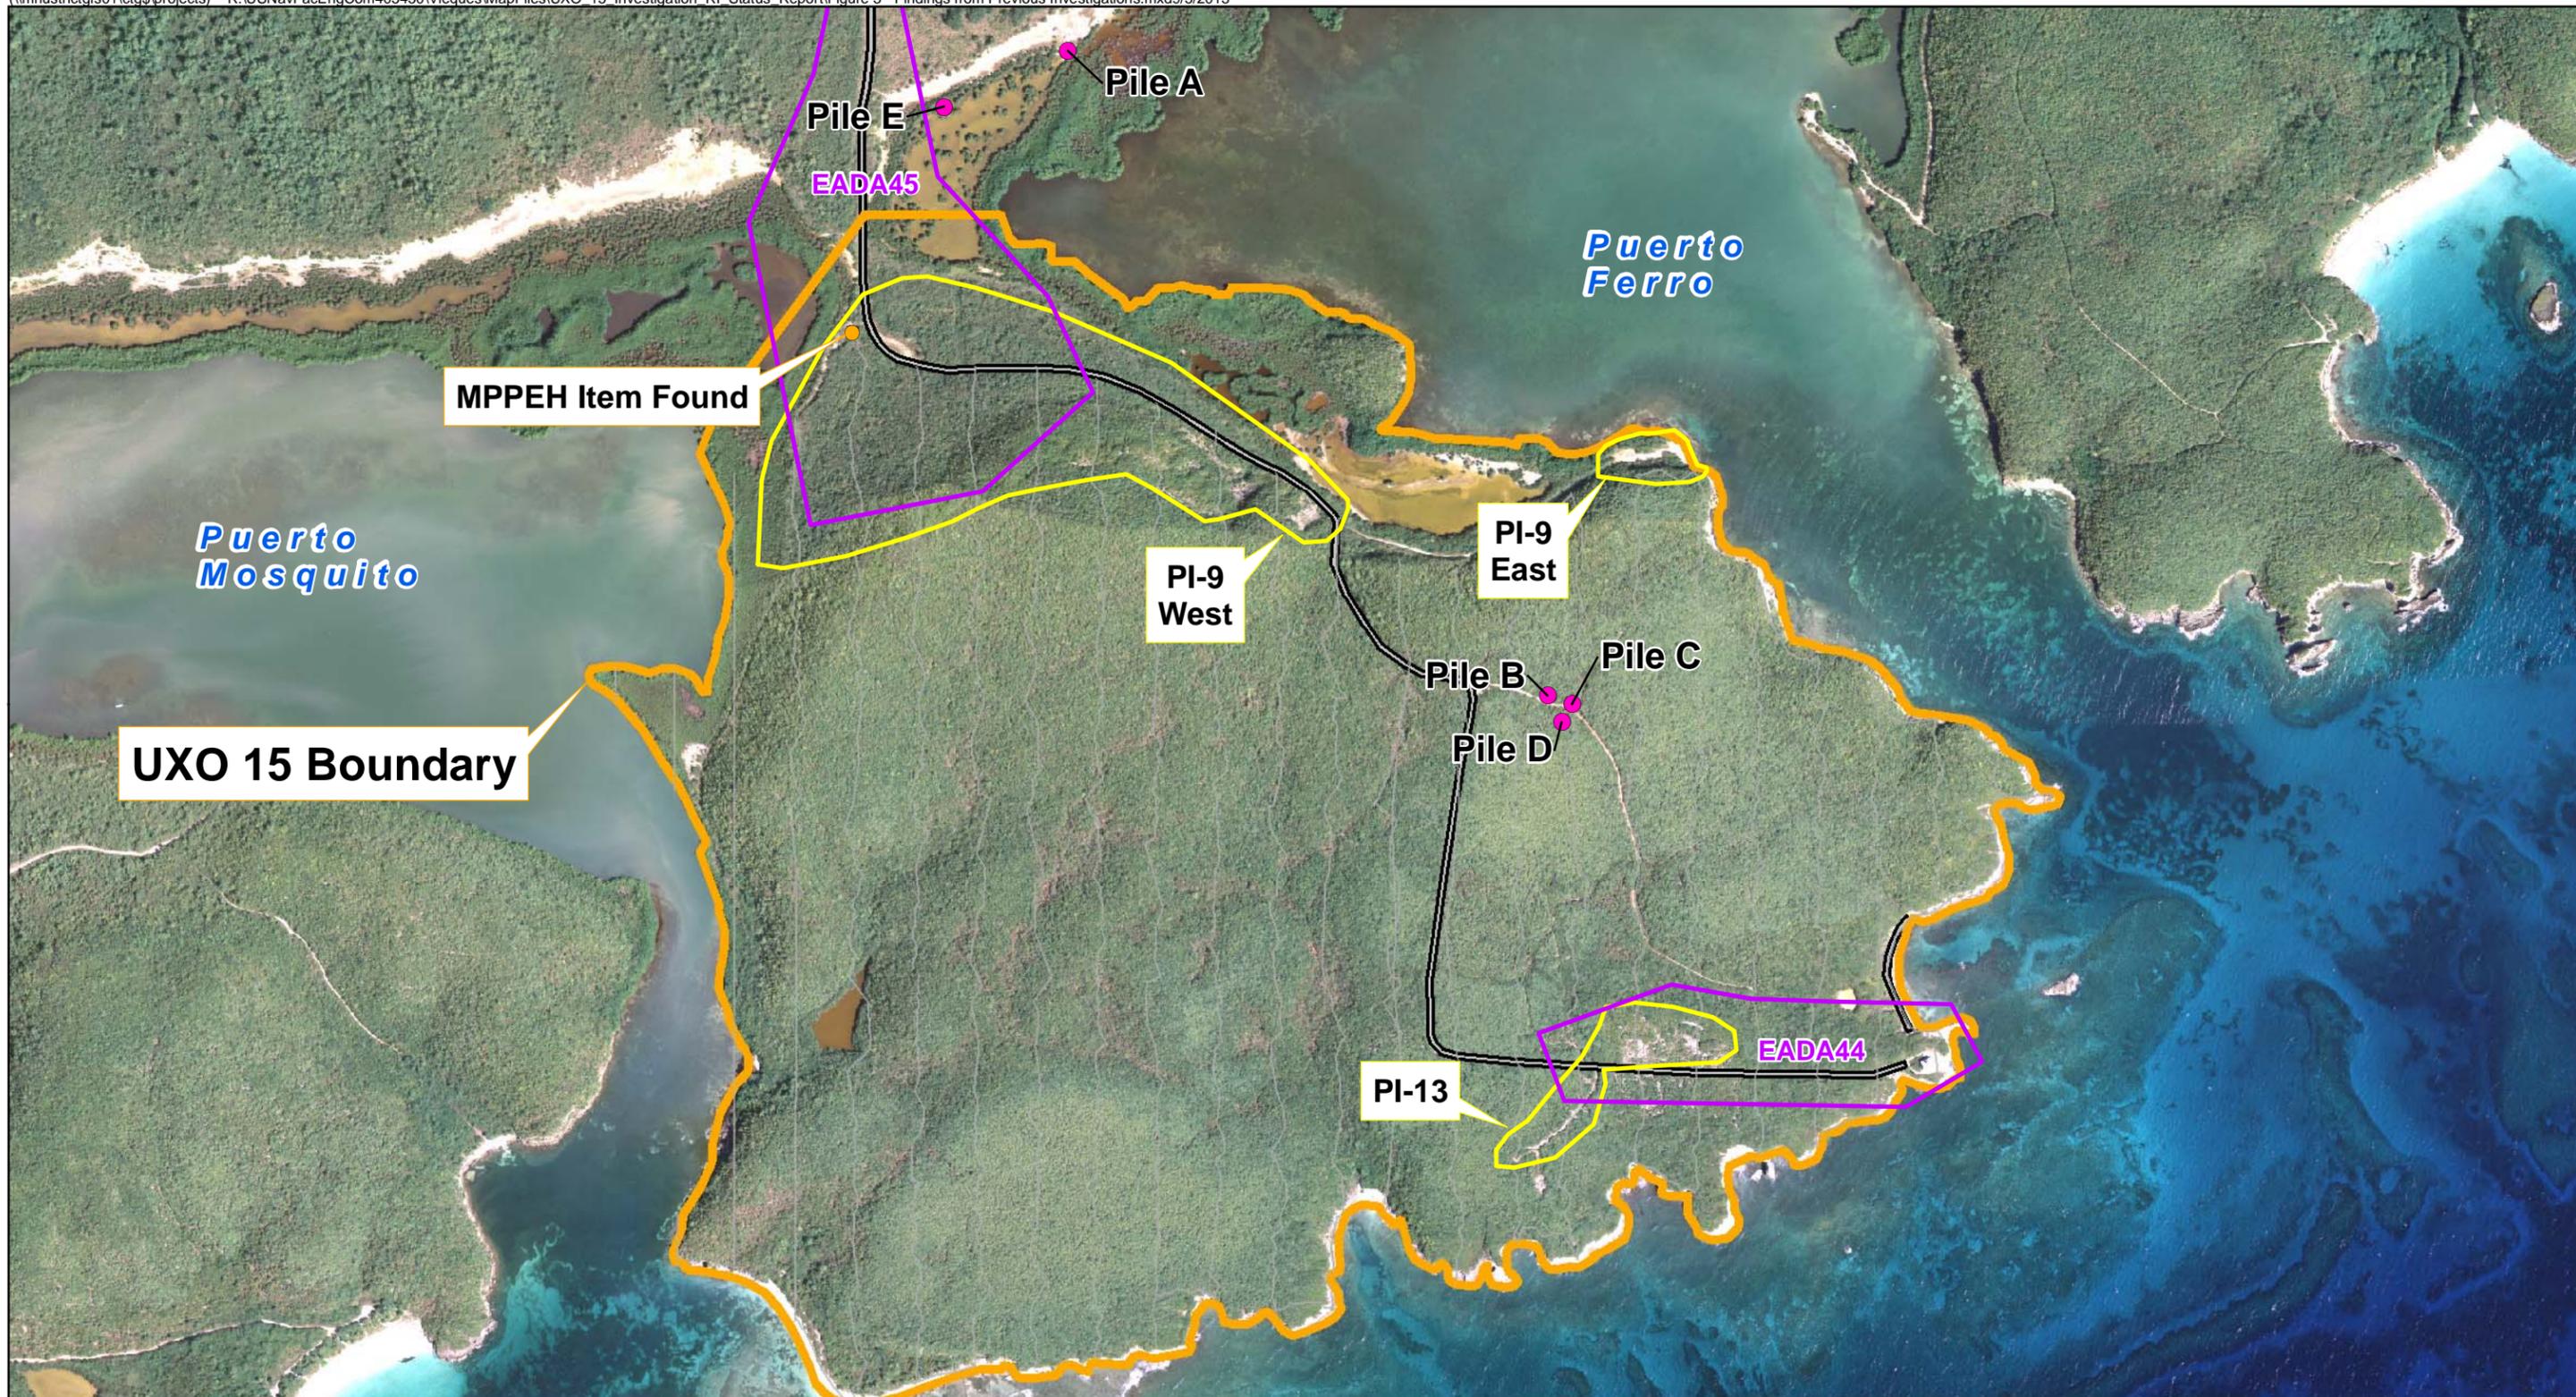
**Figure 2**  
**UXO 15 Site Features**  
 UXO 15 RI Status Report  
 Former Vieques Naval Training Range  
 Vieques, Puerto Rico

UXO 15 is located in the western portion of the Eastern Maneuver Area (EMA) and comprises Photo Identified (PI) Sites PI 9 and PI 13 (**Figure 2**). PI 9 was likely used for ammunition storage and possibly ammunition disposal based on historical information and aerial photographs. PI 13 may have been the firing point from which long-range artillery was launched to the Live Impact Area (LIA)/Surface Impact Area (SIA). Previous munitions investigations identified Munitions Debris (MD) and Material Potentially Presenting an Explosive Hazard (MPPEH), five debris piles, and two elevated anomaly density areas (EADAs), which are indicative of a

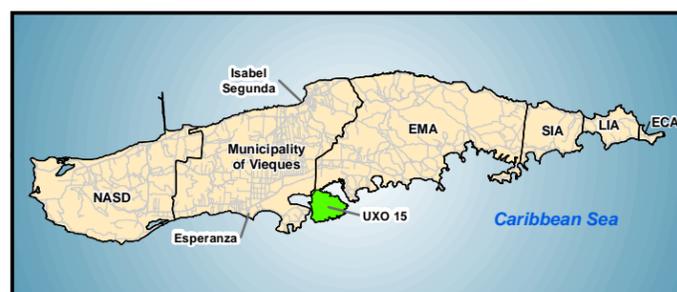
**Figure 3**  
**Findings from Previous Investigations**  
 UXO 15 RI Status Report  
 Former Vieques Naval Training Range  
 Vieques, Puerto Rico

- Legend**
- Debris Pile
  - MPPEH Item
  - Transect
  - Elevated Anomaly Density Area (EADA)
  - PI Areas
  - UXO 15

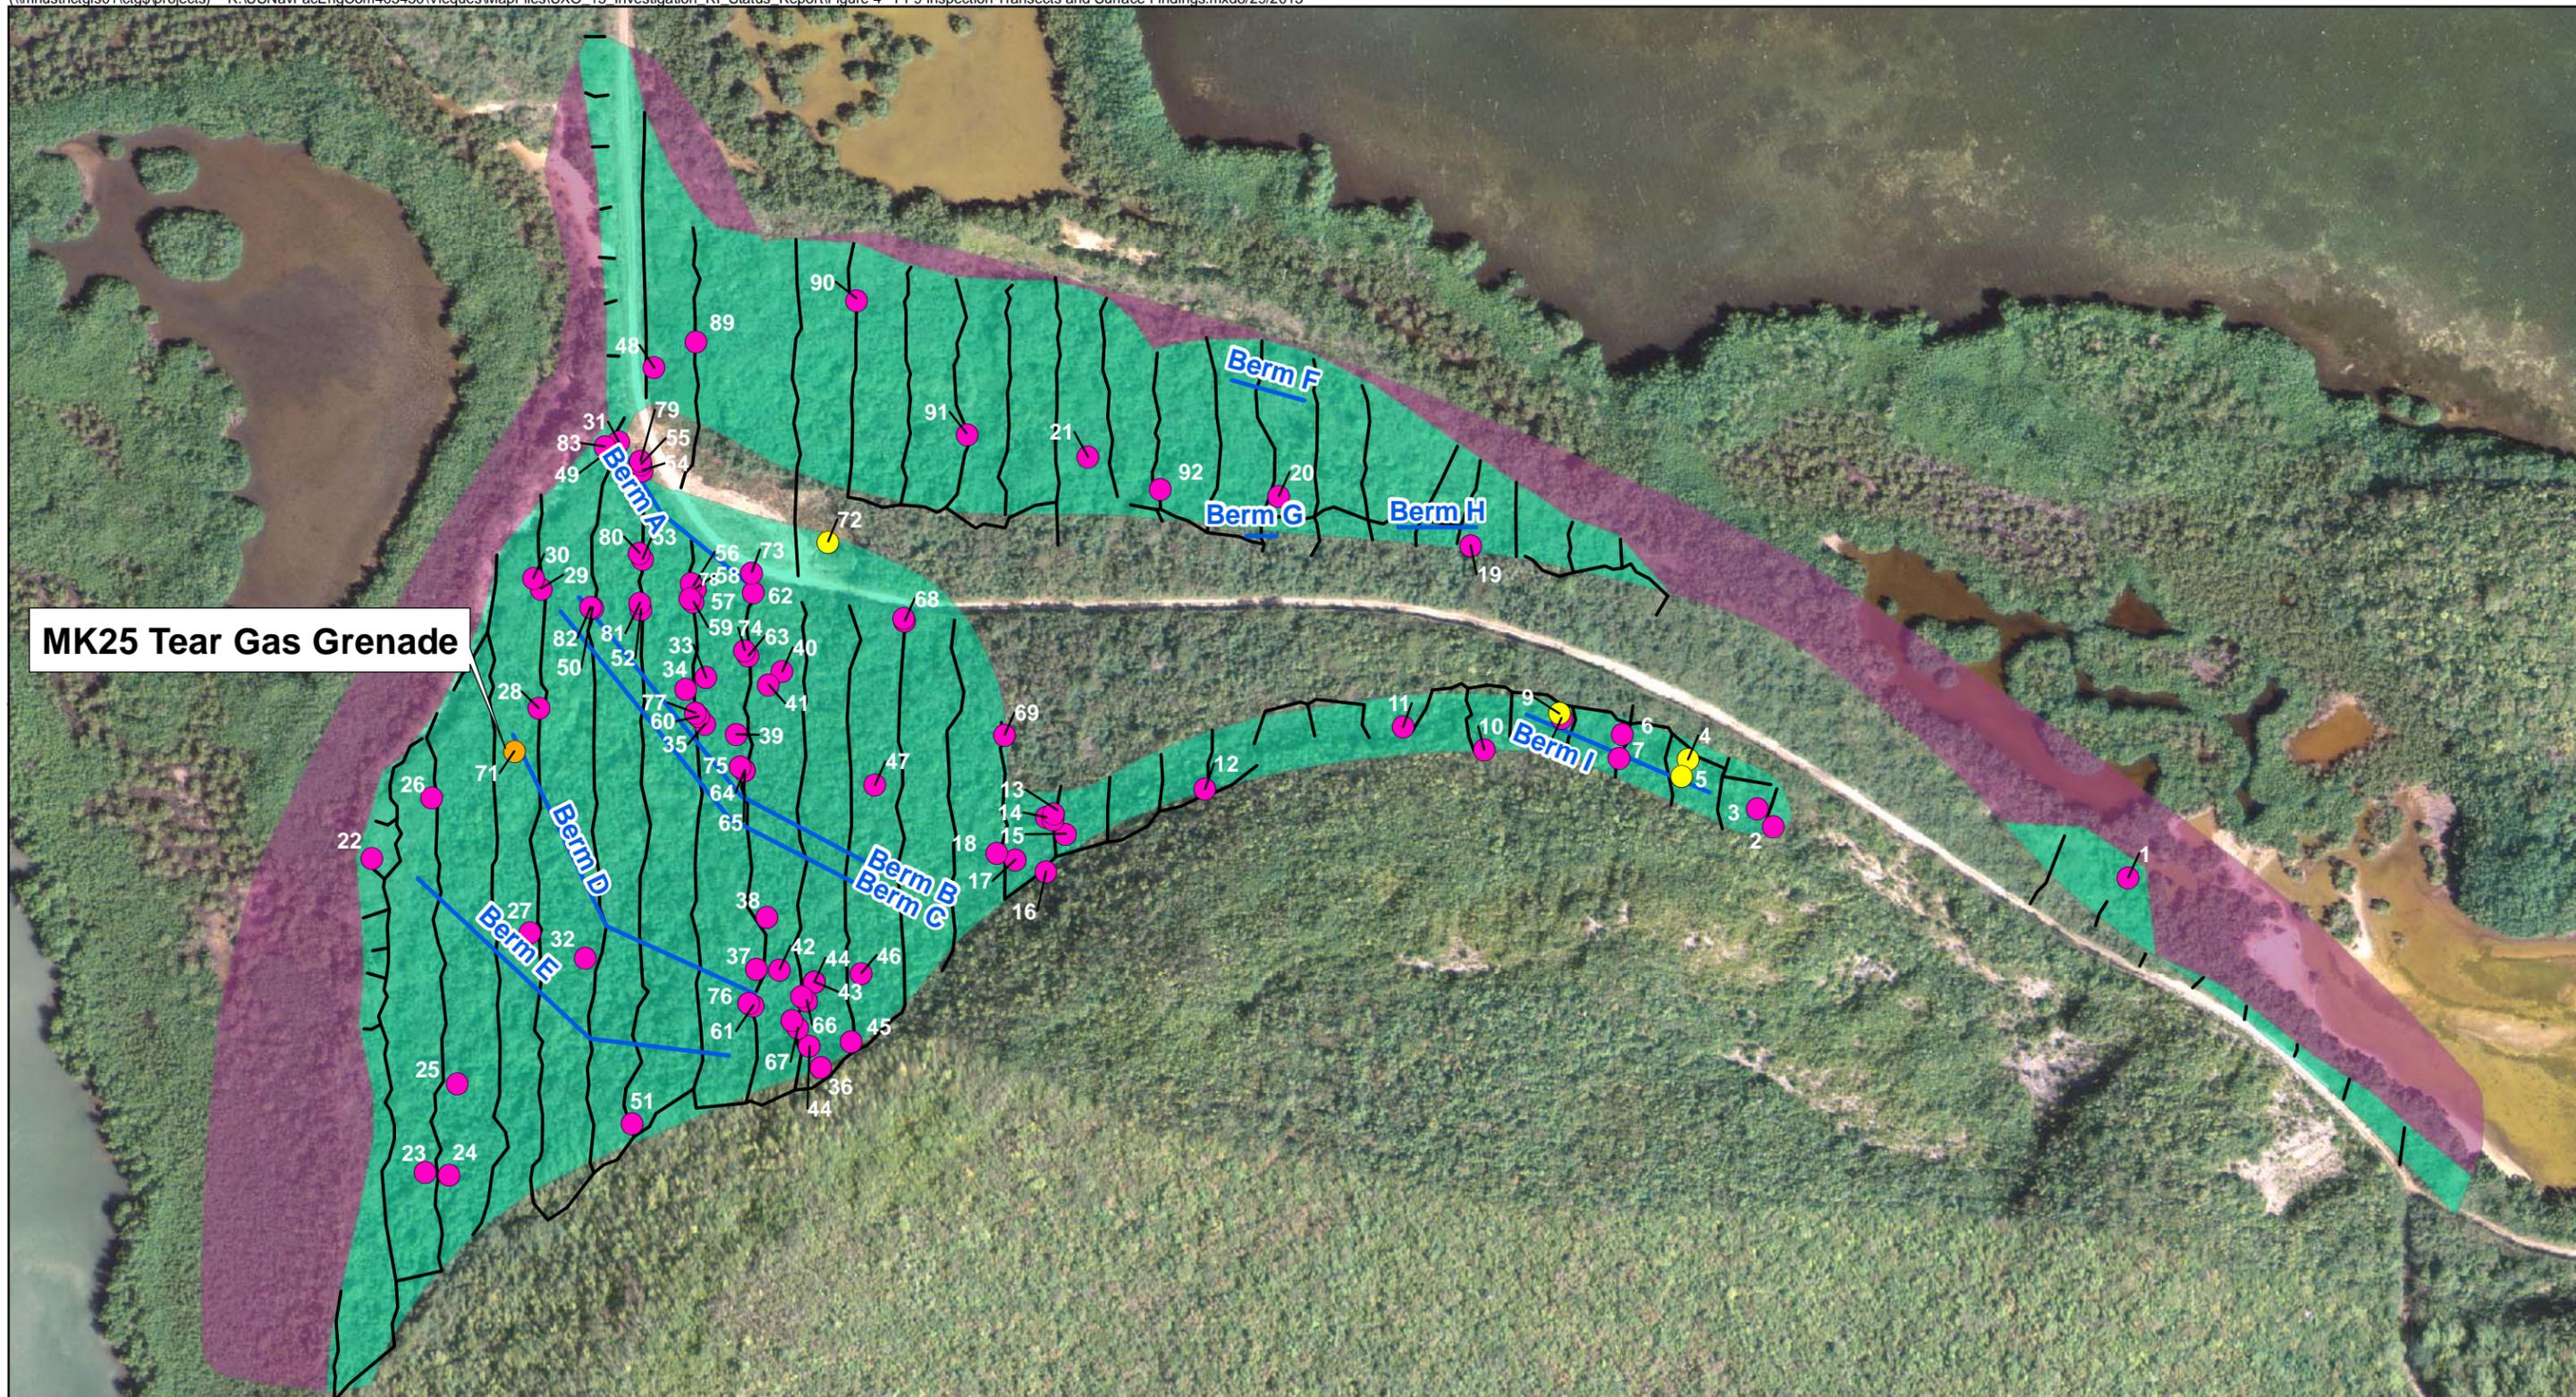
high density of ferrous metallic objects or ferrous iron that may be associated with bedrock, within UXO 15 (**Figure 3**) (CH2M HILL, 2012). Previous environmental investigations included a biological assessment and a bedrock survey to identify potential locations of buried munitions conducted as part of an Expanded Site Inspection (CH2M HILL, 2012).

The DGM area shown in **Figure 3** consisted of dense woods and vegetation and was bounded on the west and northeast by lagoons. Soft mud, dense low-hanging vegetation and general swamp conditions characterized the transition from firm ground to water in these areas. A gravel access road bisects the Site A metal fence extends along the southern edge of the road from the north to the gate. The topography was generally flat except near the southern boundary of the investigation area. This portion of the site contains relatively steep and rocky slopes with loose soils. Although the topography across the majority of the site was overall flat, the ground surface within the investigation area posed numerous walking hazards due to the abundance of tree roots, vines, localized mounds and depressions and rock outcrops.

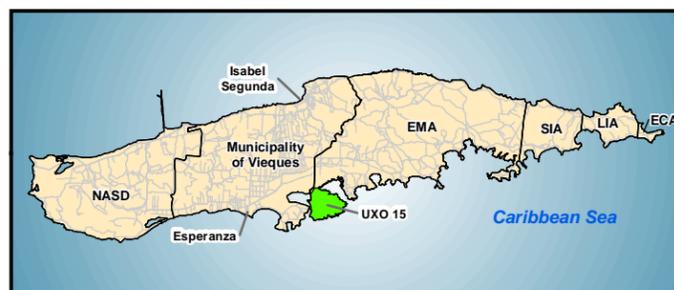
**Figure 4**  
**PI-9 Inspection Transects and Surface Findings**  
UXO 15 RI Status Report  
Former Vieques Naval Training Range  
Vieques, Puerto Rico

- MPPEH Item
- MD Item
- Range Related Debris/Cultural Debris
- Berm Location
- Surveyed Transect
- Inaccessible Area
- Proposed DGM Area

Note:  
The number above the item identified corresponds with the Item # in Table 1.

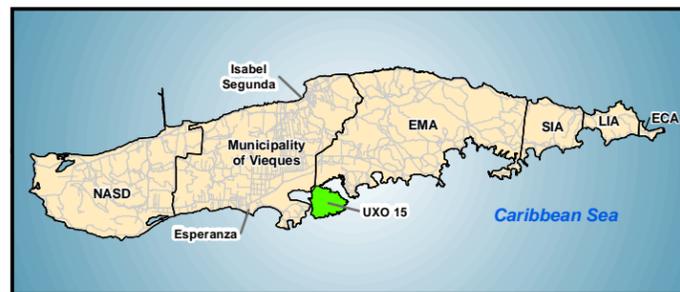
**Figure 5**  
**UXO 15 Dig Findings**  
UXO 15 RI Status Report  
Former Vieques Naval Training Range  
Vieques, Puerto Rico

- Legend**
- MD Item
  - Range-Related Debris/Cultural Debris
  - Berm Location
  - Surveyed Transect
  - Proposed DGM Area

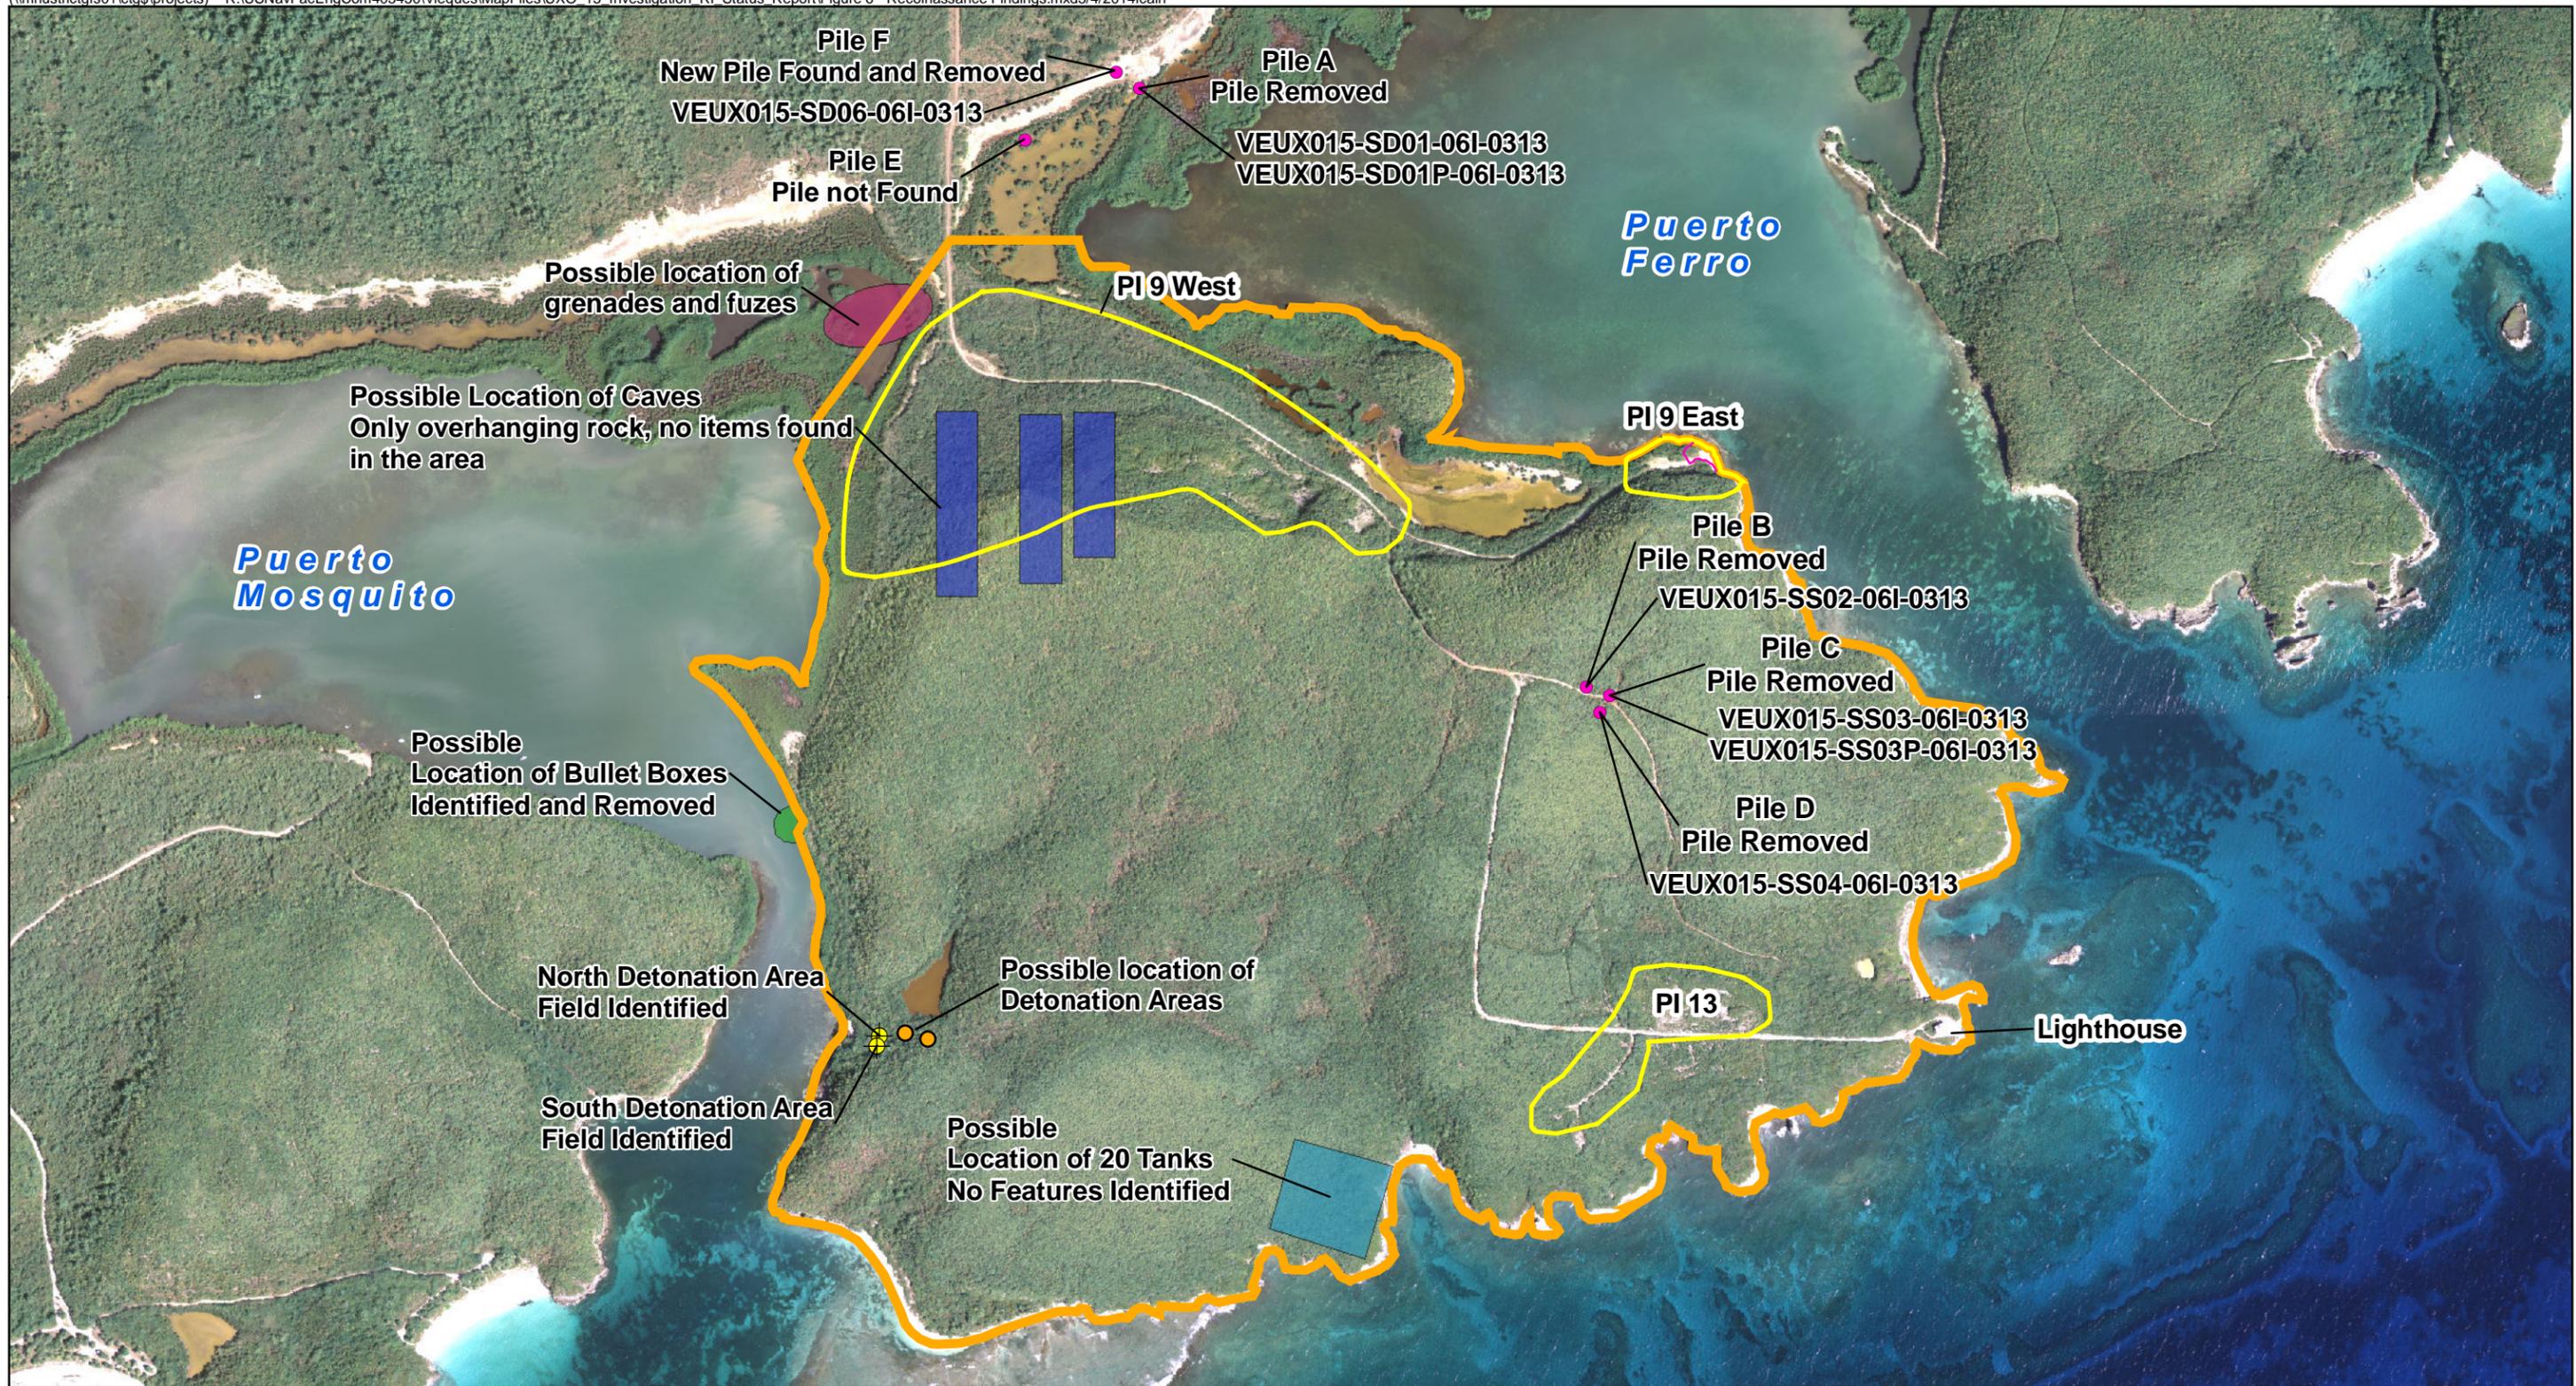
In total, 1,381 items were identified in the subsurface; 990 within the top 1 ft and 391 items from 1 to 2 ft, which indicates that most of the items found were closer to the surface. In areas of the berms and mound, the anomalies were investigated to the extent possible for this investigation. In most cases anomalies within the berms were investigated and found to be a sizeable completely buried object (e.g., metal pallets, lengths of wire rope, etc.) that was not possible to remove without the use of large equipment.

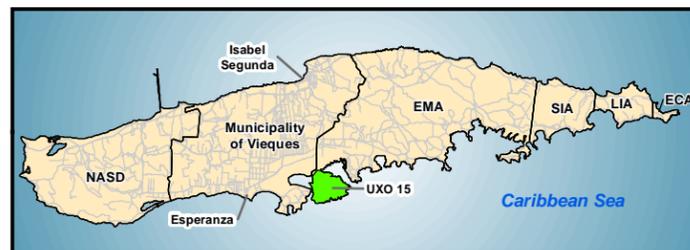
**Figure 6**  
**Reconnaissance Findings**  
 UXO 15 RI Status Report  
 Former Vieques Naval Training Range  
 Vieques, Puerto Rico

- Possible location of caves
- Possible location of grenades and fuzes
- Possible location of 20 Tanks
- Possible location of bullet boxes
- ⊕ Recon Pit Location
- Possible Detonation Point

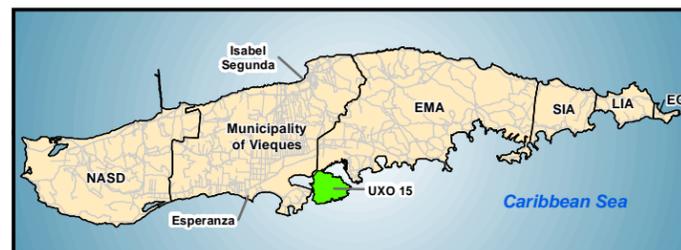
**Figure 7**  
**ERA/SI Munitions Items Removed**  
UXO 15 RI Status Report  
Former Vieques Naval Training Range  
Vieques, Puerto Rico

- Legend**
- ▲ Munitions Debris
  - ◆ Material Potentially Presenting an Explosive Hazard
  - Transect
  - PI Site
  - UXO15

Note:  
Number next to item indicates the quantity of Item.

Of the 34 munitions-related items identified previously during the ERA/SI, one MPPEH and 32 MD were reacquired and removed in April 2013 (**Figure 7**). One MD could not be found. Each item was transported to the CPC for processing.

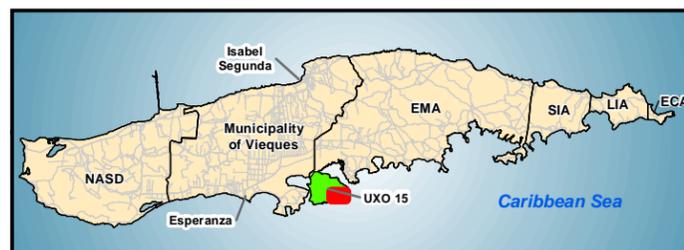
**Figure 8**  
**Bedrock Survey**  
 UXO 15 RI Status Report  
 Former Vieques Naval Training Range  
 Vieques, Puerto Rico

- Survey Point
- Elevated Anomaly Density Area (EADA)
- Soil Depth < 6"
- Soil Depth 6" - 24"
- UXO15
- Photo Identified Site

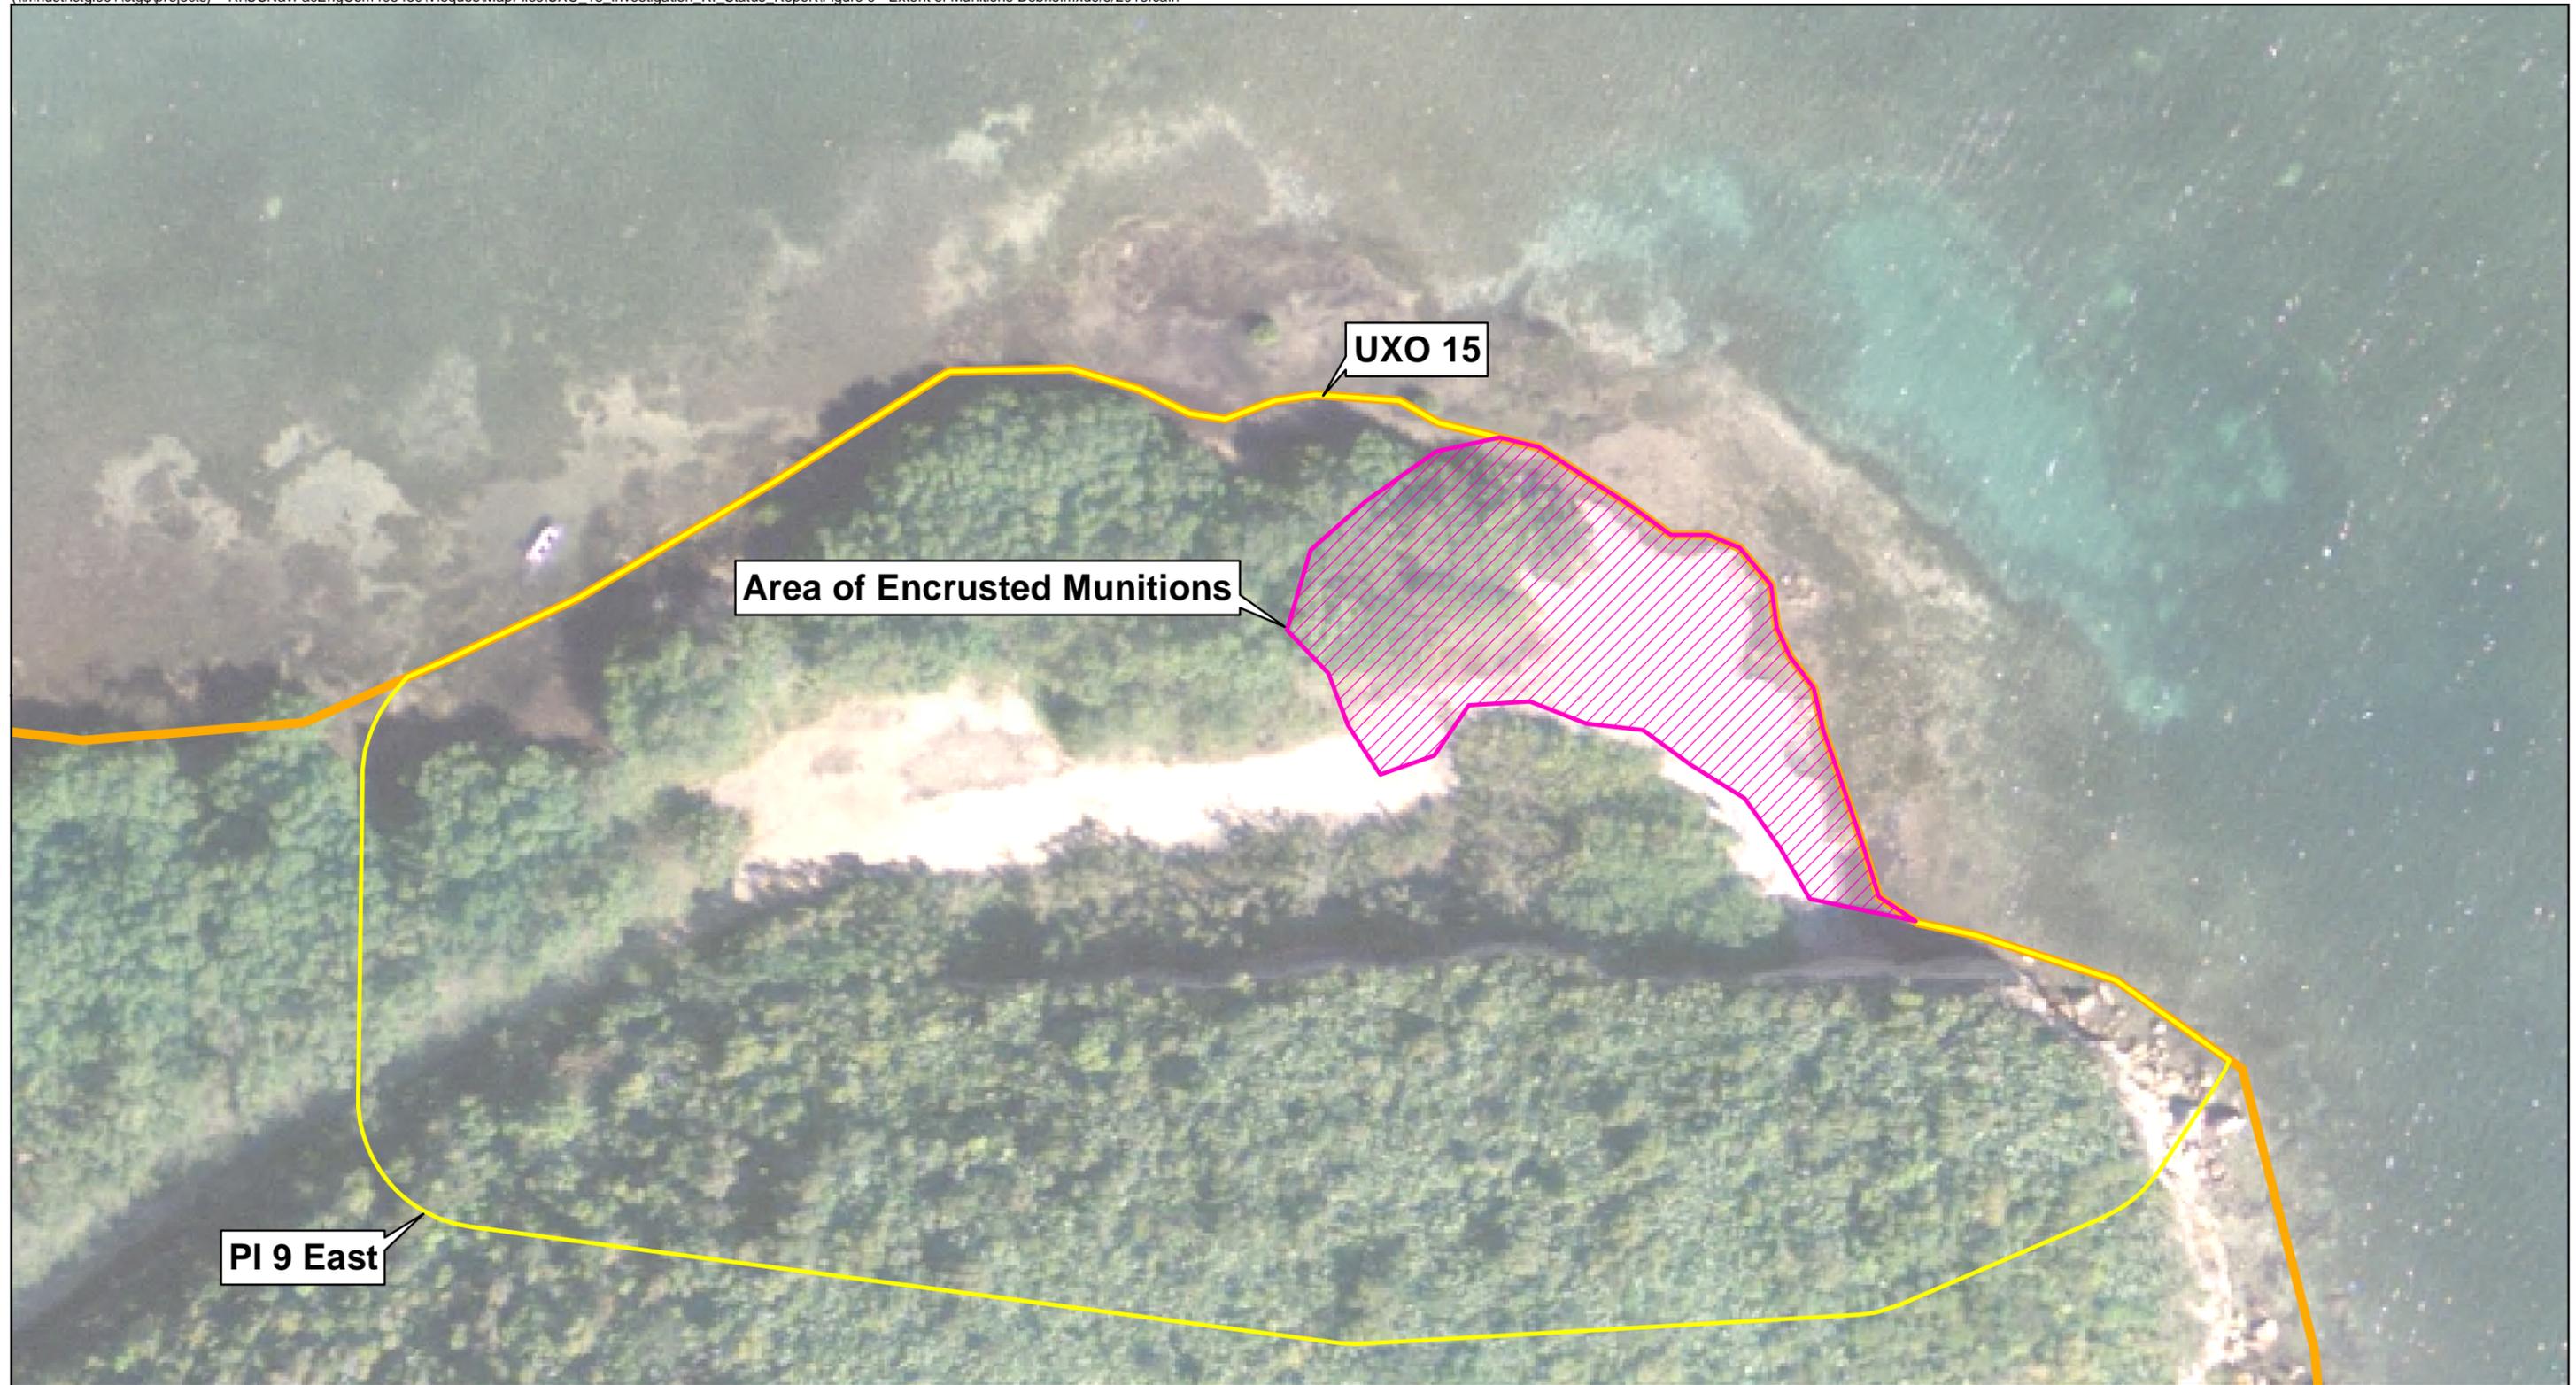
The depth to bedrock was found to be greater than 6 inches within only the central portion of EADA 44 (**Figure 8**). However, a magnetometer was used to sweep this area during the bedrock survey and no subsurface responses were detected. As a result, the potential for subsurface debris is unlikely in this area.

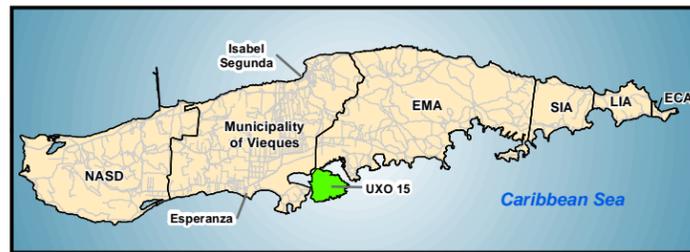
**Figure 9**  
**Extent of Munitions Debris**  
 UXO 15 RI Status Report  
 Former Vieques Naval Training Range  
 Vieques, Puerto Rico

- Legend**
- Extent of Munitions Debris
  - PI Site
  - UXO15

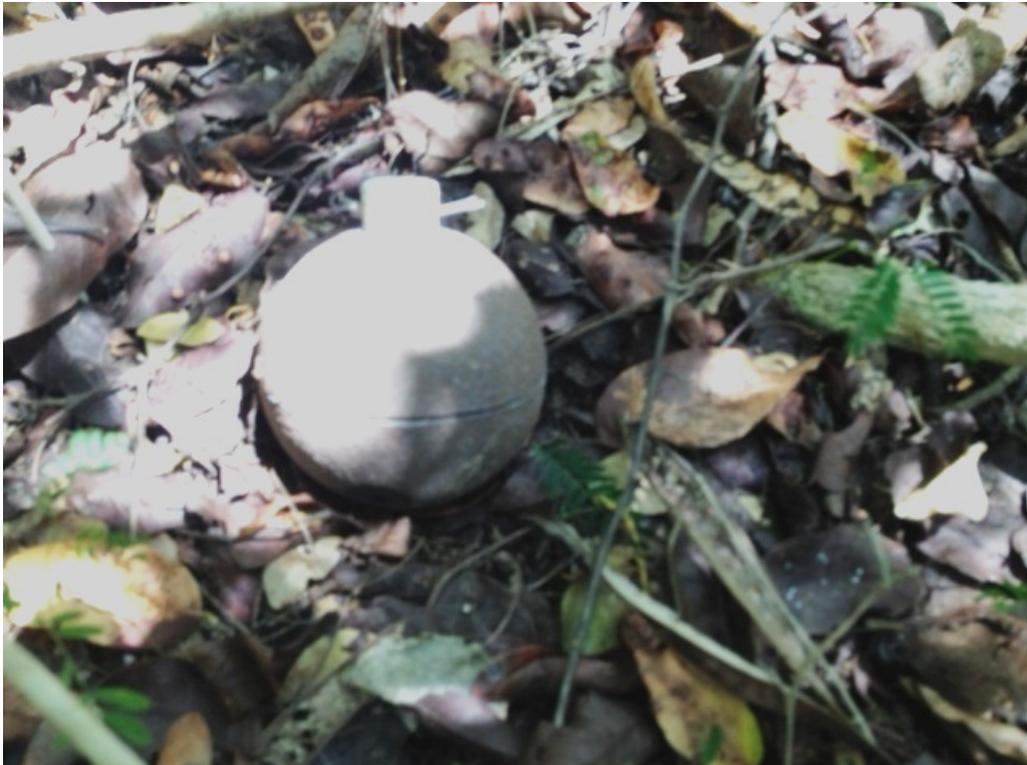
PHOTO 1

Tear gas grenade (MK25) classified as DMM (subsequently removed)

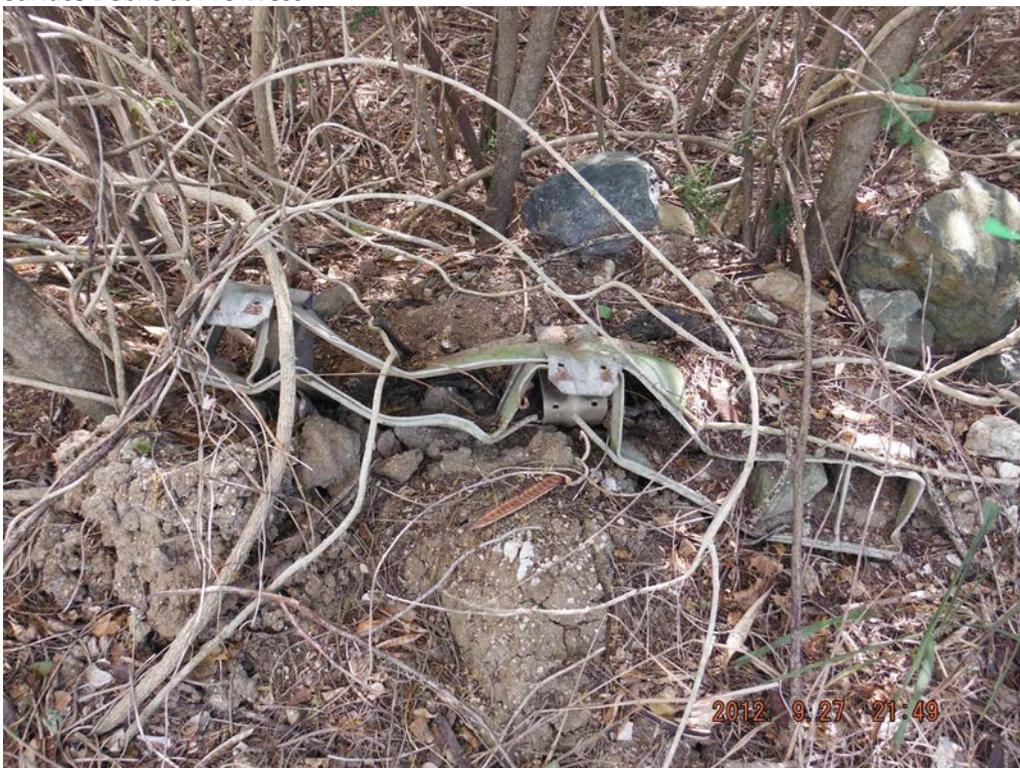
PHOTO 2

Surface Debris at PI 9 West

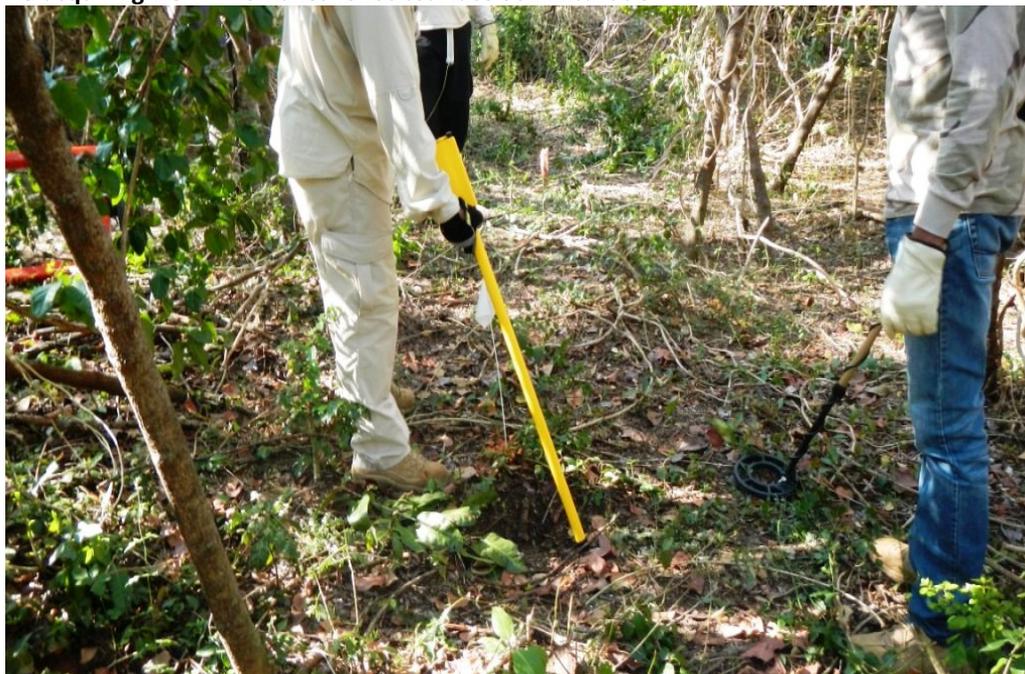
PHOTO 5

Subsurface Munitions Debris (8-inch propellant can) dug up and later disposed

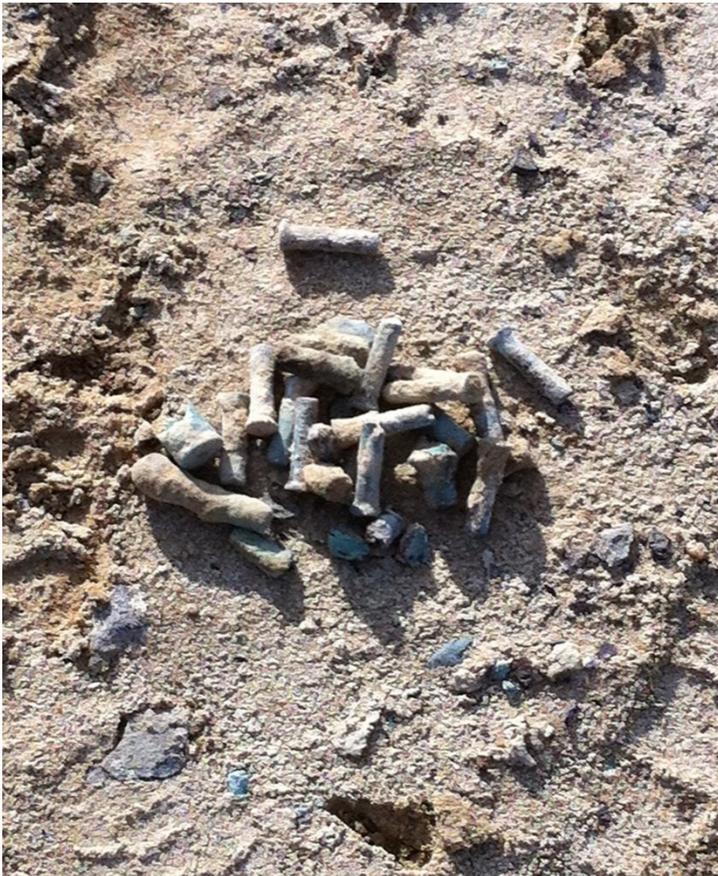
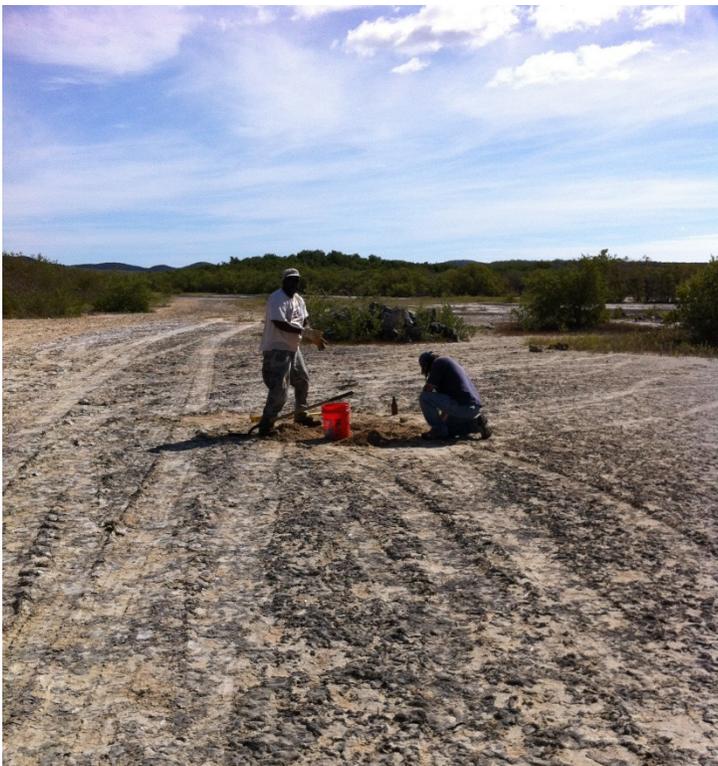
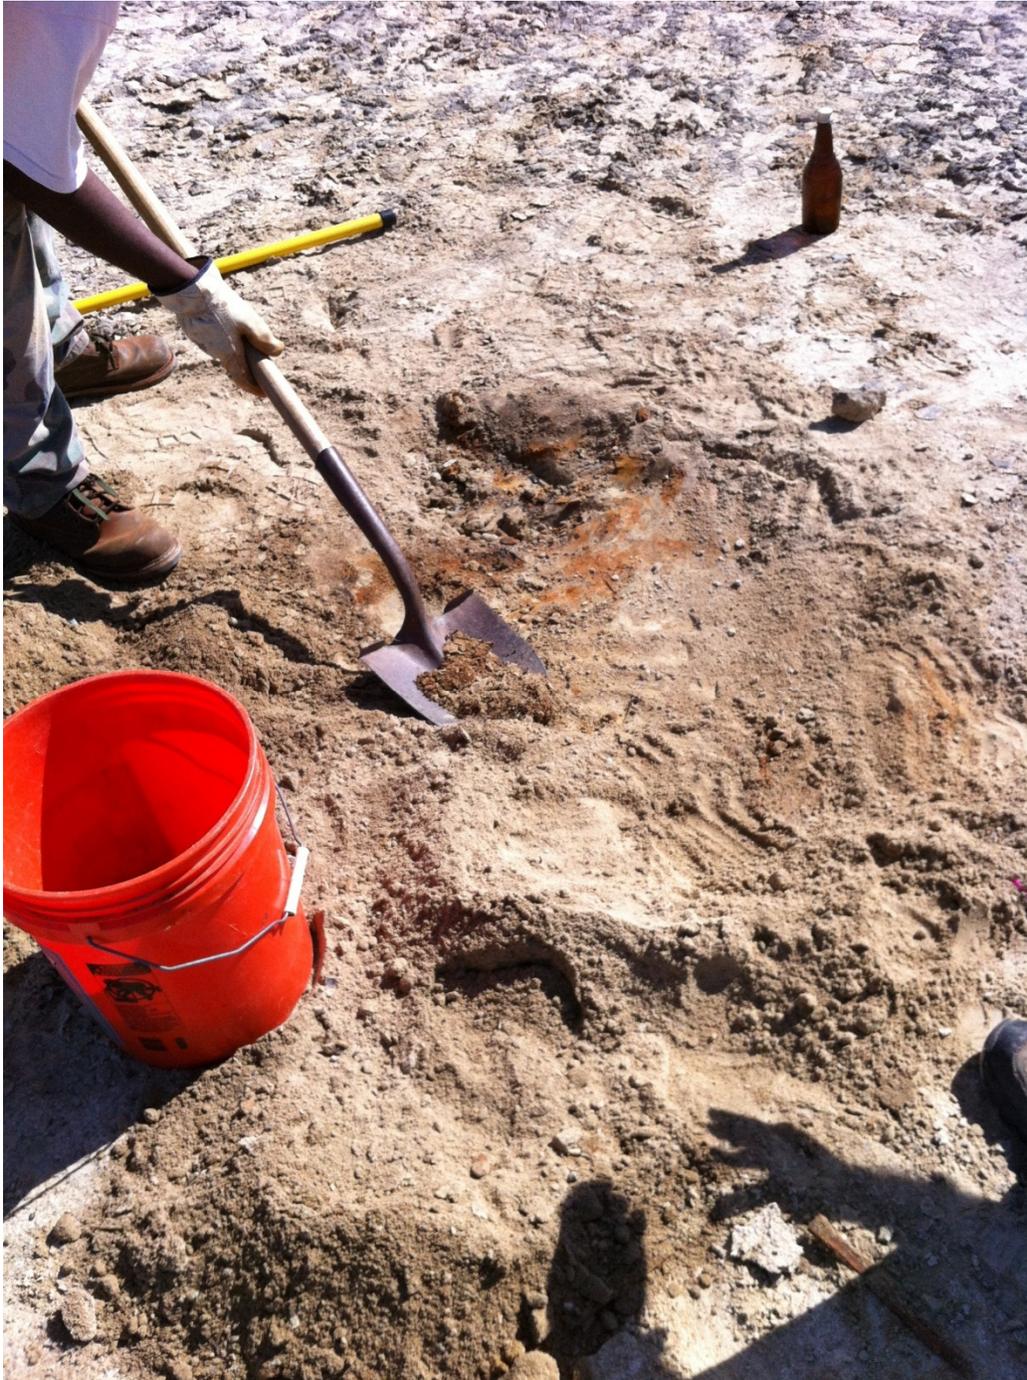
- Pile F- Located within a periodically flooded area adjacent to a lagoon on the western end of Puerto Ferro. Debris contained expended small arms shell casing and was approximately 16 square feet in size. **Photos 10A** through **10C** in **Attachment 1** show the debris found at debris pile F and the debris removal process.

**PHOTO 10A**  
**Debris Found at Debris Pile F**

**PHOTO 10B**  
**Debris Removal at Debris Pile F**

PHOTO 10C  
Debris Removal at Debris Pile F

Piles A through D and F were removed in March 2013 by USAE using both hand tools and a back hoe and transported to the Central Processing Center (CPC) within the Live Impact Area (LIA) for recycling and disposal. Piles B, C, and D also included the removal of surface soil that appeared to contain flakes of rust from the overlying debris that was removed. Two drums of soil/metal fragments were excavated at Piles C and D and placed into two drums. A composite sample was collected on July 30, 2013 from the two drums and analyzed for full TCLP and reactivity, corrosivity, and ignitability by Katahdin Analytical Services, Inc. of Scarborough, Maine. Analytical results for the sample showed the drum contents to be non-hazardous. The drums will be processed and shipped offsite accordingly.

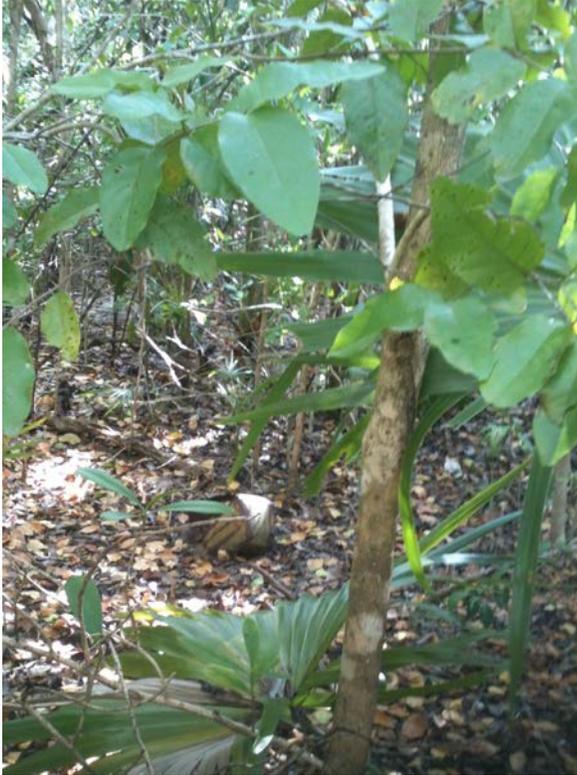
**PHOTO 11**  
**Community Identified Feature – Bullet Box Area**

- Possible location of 20 military tanks – No military tanks were found, but pads where vehicles may have been parked were identified
- Possible location of bullet boxes – Ammunition cans were identified and removed. No MEC or MD was identified. **Photo 11** in **Attachment 1** shows the location where the bullet boxes were found
