# Final Remedial Investigation Status Report and Path Forward, UXO 15, Atlantic Fleet Weapons Training Area-Vieques, Former Vieques Naval Training Range, Vieques, Puerto Rico

PREPARED FOR: Vieques Environmental Restoration Program Technical Subcommittee  
PREPARED BY: CH2M HILL on behalf of the Navy  
DATE: May 23, 2014

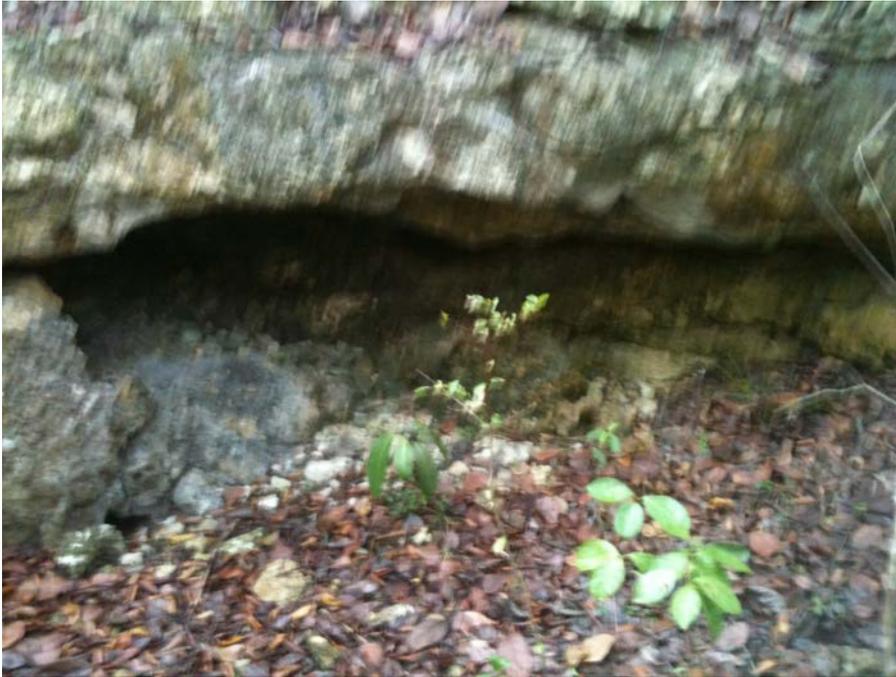
PHOTO 14  
Community Identified Feature – “Cave” Formation

- Possible location of grenades and fuzes – No items were found in the area
- Possible location of caves – no caves or cave complexes were located; however, a few overhanging rock ledges and trenches that appear to have once been covered with camouflage netting were found on the southern end of PI-9 West. No munitions items were identified in these areas. **Photo 14** in **Attachment 1** shows the location of the feature probably mistaken to be a cave

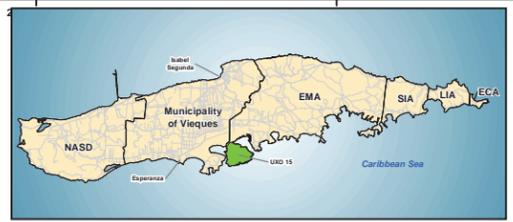
**Figure 3**  
**DGM Investigation Area**  
 Digital Geophysical Mapping Report UXO 15  
 Atlantic Fleet Weapons Training Area - Vieques  
 Former Vieques Naval Training Range  
 Vieques, Puerto Rico

**Legend**  
 Idealized Transect Location  
 Proposed DGM Area

The DGM area shown in **Figure 3** consisted of dense woods and vegetation and was bounded on the west and northeast by lagoons. Soft mud, dense low-hanging vegetation and general swamp conditions characterized the transition from firm ground to water in these areas. A gravel access road bisects the Site A metal fence extends along the southern edge of the road from the north to the gate. The topography was generally flat except near the southern boundary of the investigation area. This portion of the site contains relatively steep and rocky slopes with loose soils. Although the topography across the majority of the site was overall flat, the ground surface within the investigation area posed numerous walking hazards due to the abundance of tree roots, vines, localized mounds and depressions and rock outcrops.

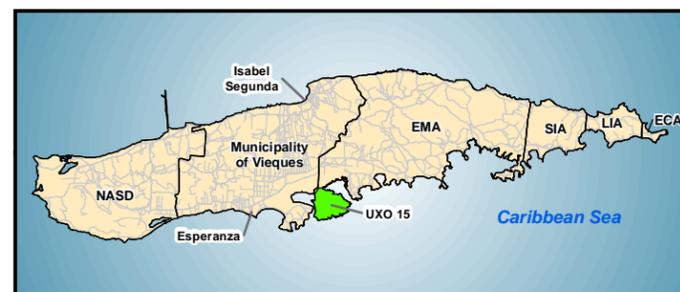
**Figure 4**  
**Surveyed DGM Transect Layout**  
 Digital Geophysical Mapping Report UXO 15  
 Atlantic Fleet Weapons Training Area - Vieques  
 Former Vieques Naval Training Range  
 Vieques, Puerto Rico

- Surveyed Stake Point Location
- Surveyed Transect
- Proposed DGM Area

After completion of the vegetation clearance and surface clearance, survey stakes were placed along these transects to assist with location control for the DGM. The surveying was performed by ECLS, a North Carolina based land surveying firm licensed and registered in Puerto Rico. CH2M HILL UXO personnel provided subsurface anomaly avoidance support during the placement of the stakes. Stakes were labeled with a unique identifier consisting of the transect ID and a sequential number that re-started at "1" with each new transect. Stakes were placed at a maximum spacing of 25 meters (82 feet) or at shorter distances, as necessary, to maintain both line of sight from one stake to the next as well as a straight-line walking segment between successive stakes for the DGM system. The start and end locations of each transect was identified with flagging tape. The tape was labeled with the transect ID as well as whether it represented the transect start or end location. The results and details of the surveying activities are presented in the surveyor report (ECLS, 2012). **Figure 4** presents the locations of the "as-surveyed" transects. Differences between the survey coverage in the idealized transect layout (**Figure 3**) and actual surveyed transect locations (**Figure 4**) near the lagoons are the result of inaccessible or unsafe site conditions due to deep mud or standing water at the time of the vegetation clearance. Transect IDs in **Figure 4** contain the prefix "UXO15". The total length of surveyed transects for the DGM at UXO 15 was 5,550 linear meters (18,209 linear feet).

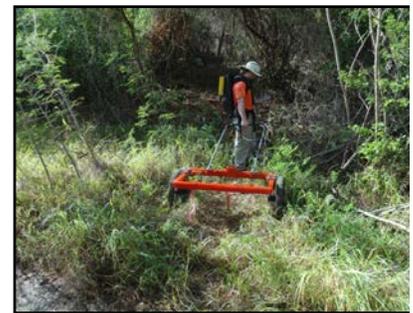
UXO 15 Data Collection with Fiducial Positioning

Positioning of the EM61-MK2 was maintained using fiducial markers inserted in the data at the staked intervals along each transect because Global Positioning System (GPS) satellite coverage is not possible beyond the road at UXO 15. Because data were collected in four-channel mode, the top coil of the EM61-MK2 was not utilized.

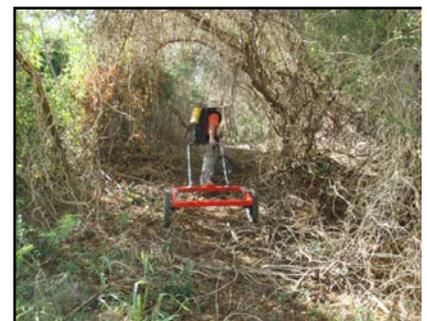
UXO 15 Data Collection Along Transects

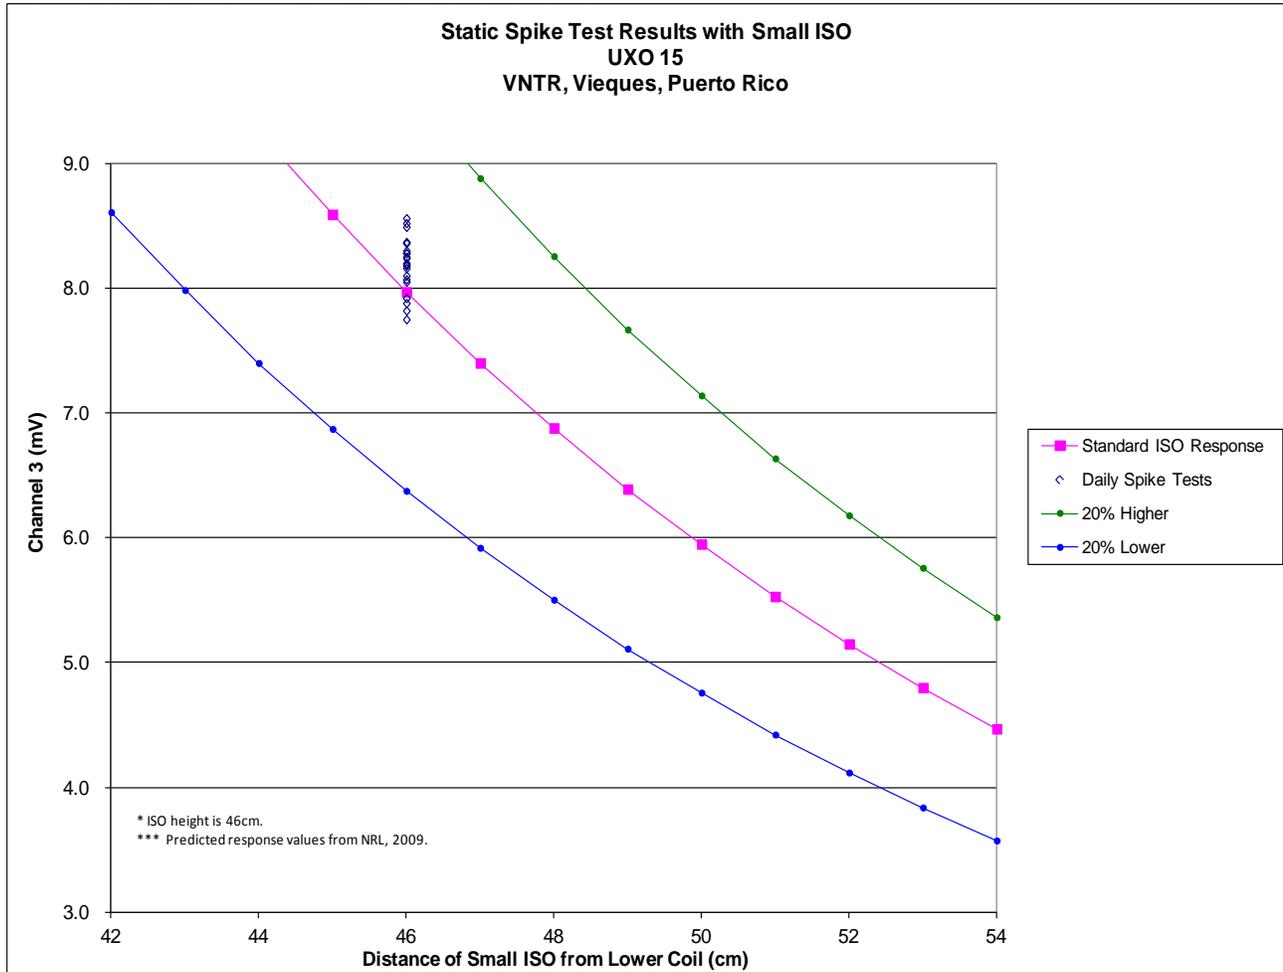
FIGURE 6  
Channel 3 Small ISO Static Test Results for UXO 15 DGM

**Figure 6** presents the results of the daily static tests conducted throughout the production survey (September 12-19, 2012) at UXO 15 in order to evaluate the DGM system functionality and consistency. The MQO for this test was that the response of a small ISO placed at a fixed height above the center of the stationary transmit coil would be within  $\pm 20\%$  of the predicted responses from NRL, 2009. The average response from a small ISO placed horizontally above the coil at a height of 46 centimeters (18 inches) was 8.19 mV. Standard deviation was 0.22. The predicted Channel 3 response from NRL (2009) for this item at this height is 8.0 mV.

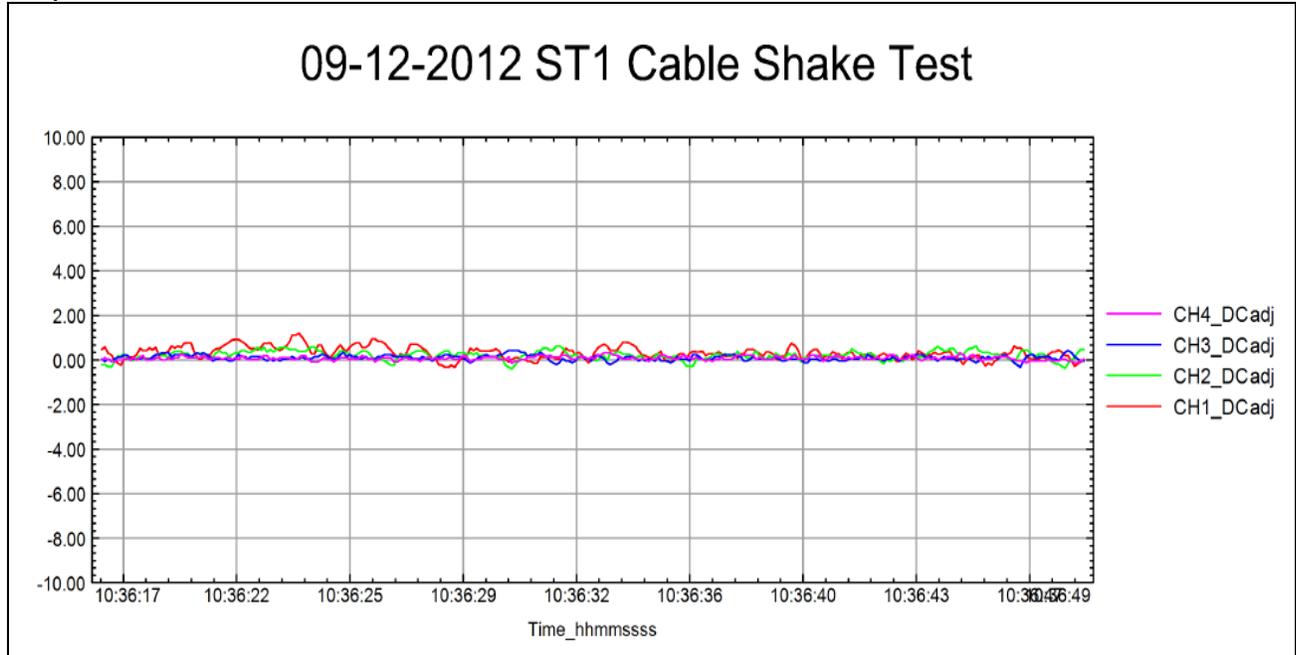
**FIGURE 7**  
**Sample Vibration QC Test Results for UXO 15 DGM**

Additional QC tests performed for the DGM at UXO 15 included personnel, vibration (i.e. cable shake) and repeat data tests. **Figures 7 through 9** demonstrate representative graphs generated for each QC test. The final processed data used for target selection met the QC requirements for the DGM. Some of the vibration and personnel QC test results depicted a higher degree of noise impacting Channel 1. This noise was closely monitored each day by the field team, data processor and QC Geophysicist. It was determined that the noise was limited to only Channel 1 and did not impact the data quality or target selection process for UXO 15. The results of the GSV process and the results presented in **Figures 5 and 6** are diagnostic of the system performance and indicate that the EM61-MK2 was consistently providing high-quality DGM data.

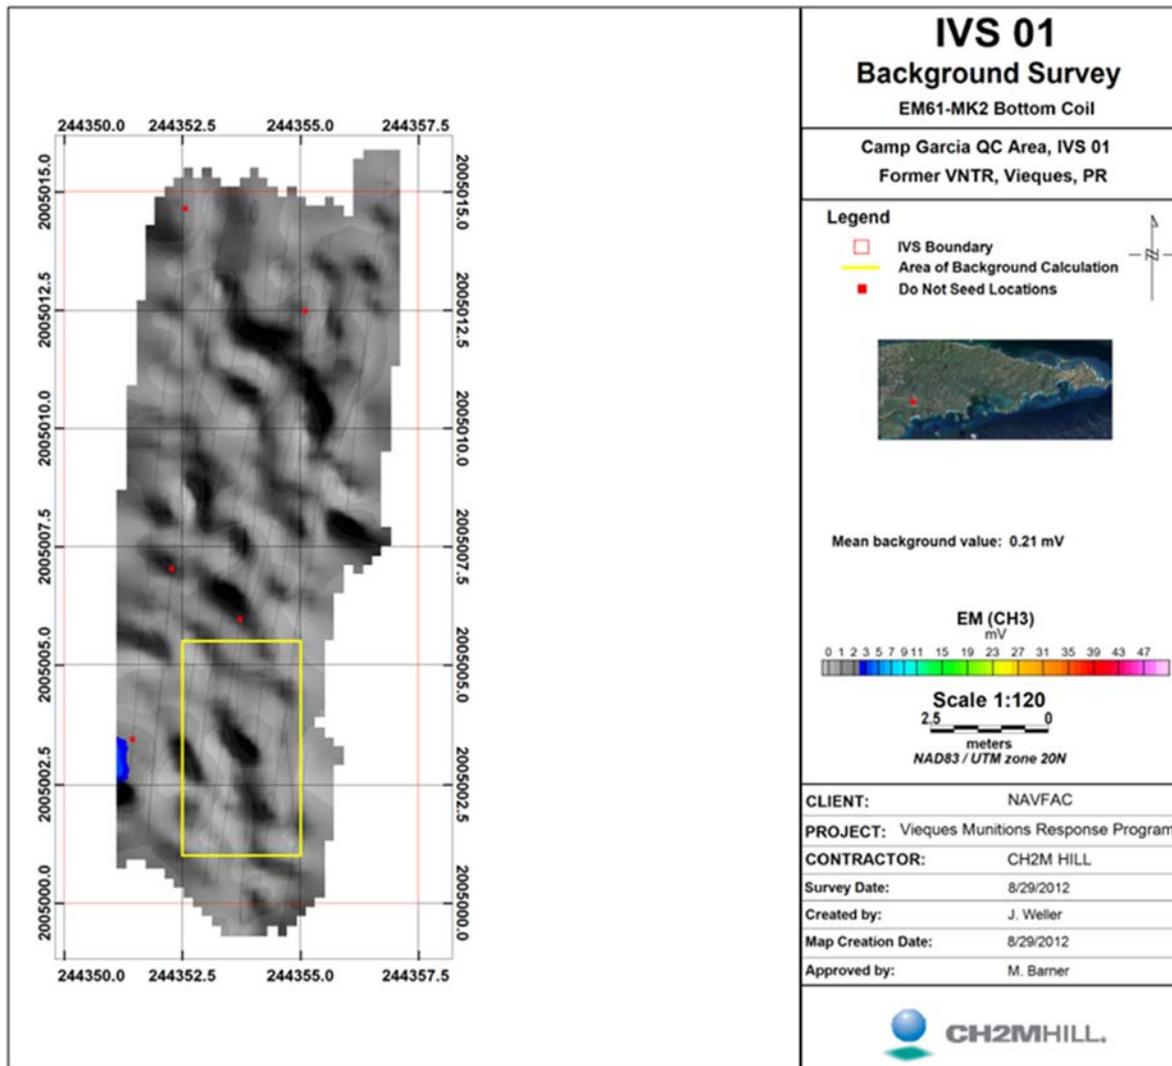
**FIGURE 3**  
**IVS 01 Background Survey**  
 VNTR, Vieques, Puerto Rico

The results of the background survey indicated suitable conditions for construction of an IVS. A small portion of the southwestern corner of the survey area yielded responses above 2.5 mV on Channel 3 (the current VNTR program target selection threshold). A statistical analysis was conducted on the background data from within the areas identified by the yellow rectangle on **Figure 3**. The mean Channel 3 response was 0.21 mV.

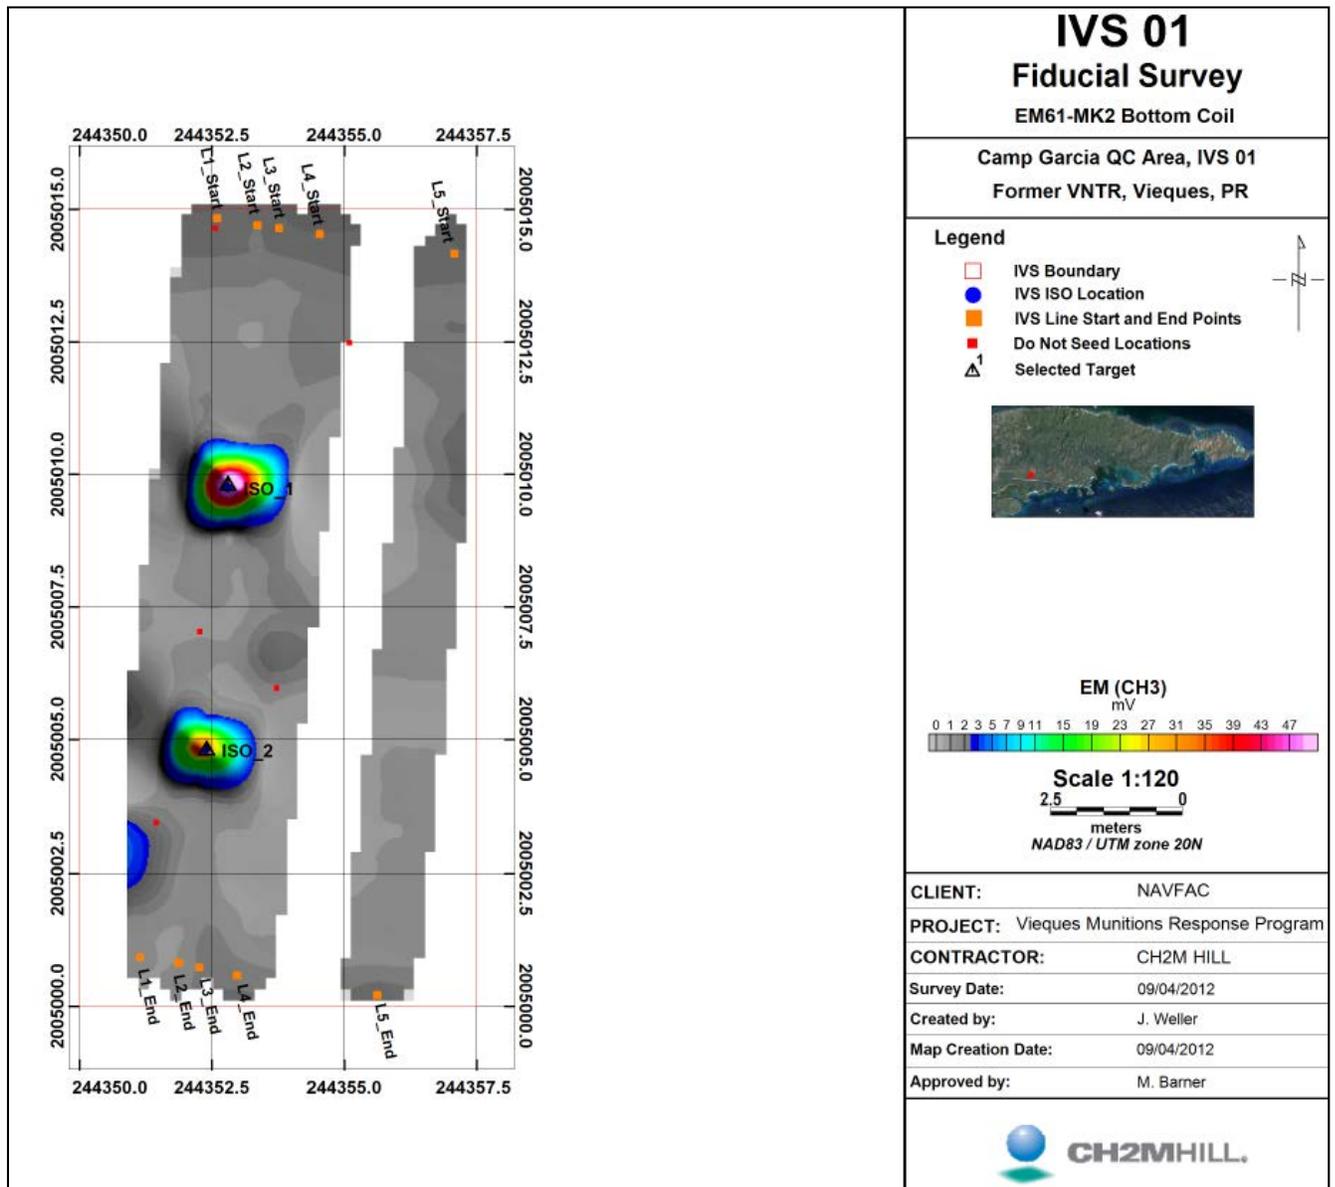
FIGURE 4  
**5-Line IVS 01 Results from 9/4/2012**  
 VNTR, Vieques, Puerto Rico

The results of the IVS survey in **Figure 4** indicate that the background responses were relatively low and consistent with the background survey results. The buried ISOs were successfully detected by the EM61-MK2 system and selected as targets during data processing. The DGM System Positioning MQO ( $\pm 25$  cm)

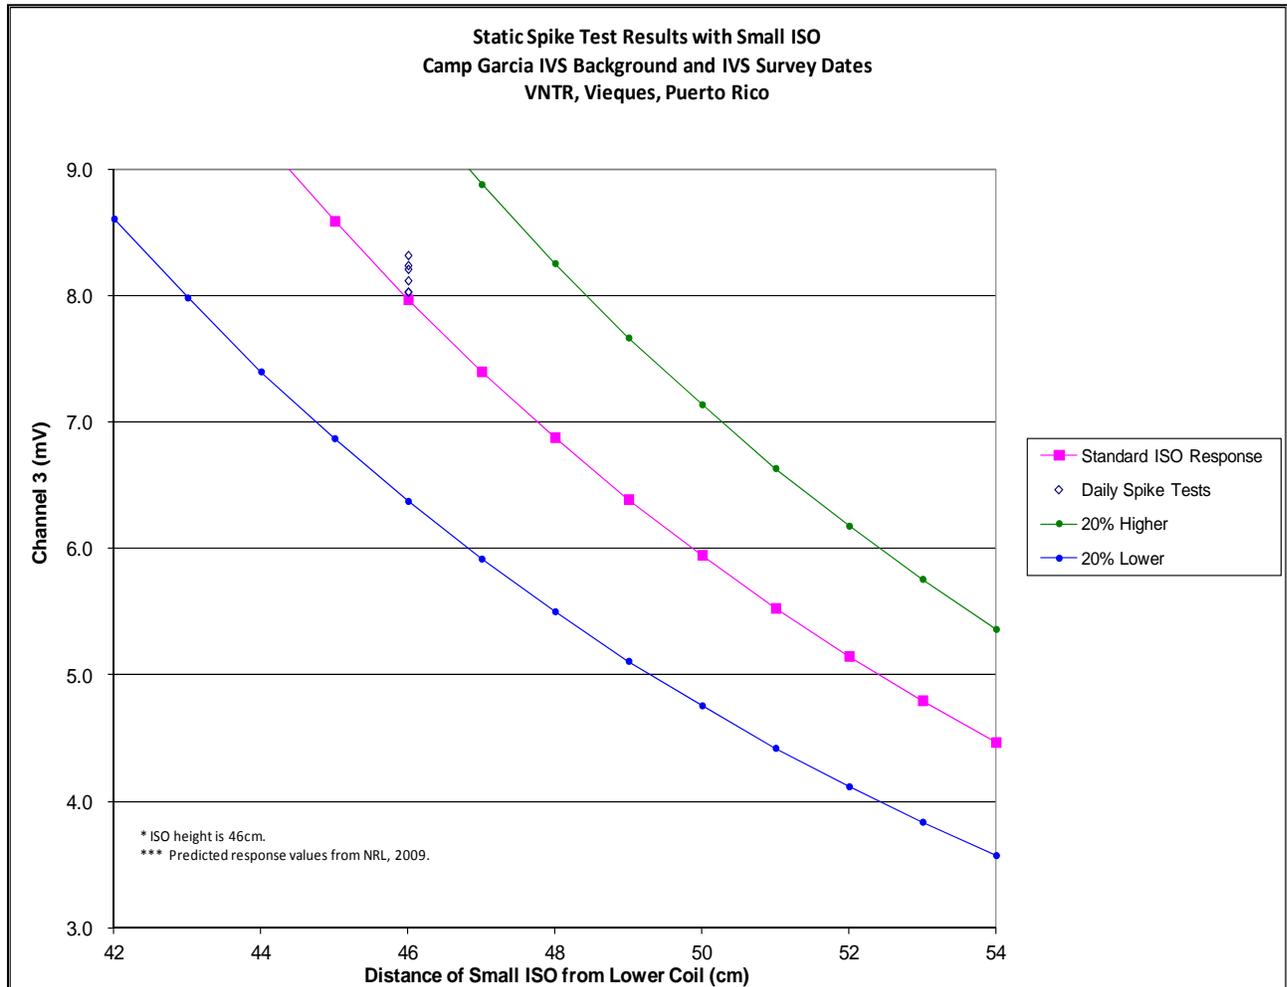
FIGURE 6  
**ISO Static Test Results, IVS 01**  
 VNTR, Vieques, Puerto Rico

The results of the static ISO tests from the dates of the background survey and the 5-line IVS survey are presented as **Figure 6**. The results of the daily QC static tests from the production DGM will be provided in the final UXO-15 investigation report.

The results of the static spike tests are within the tolerance of the predicted response values and meet the MQO. The average Channel 3 response for the static tests from the dates of the 5-line IVS surveys was 8.2 mV compared to a predicted Channel 3 response of 8.0 mV for a horizontal ISO (orientation on wooden stand) at a height of 46 cm. The standard deviation of the responses from the static tests conducted on the dates of the 5-line surveys was 0.12 mV.
